# Pre-Refurbishment & Demolition Asbestos Survey for Witney Town Council

West Witney Sports and Social Club  
Burford Road  
Witney  
OX29 0NB

**Amiantus Environmental Consultants Ltd.**

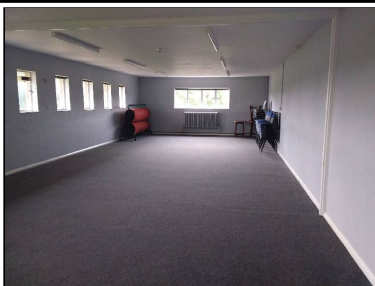
Survey Date:	Lead Surveyor	Survey Type	Floor	Analysis
	12 Jun 2025	Dudley Firkins	Refurbishment & Demolition survey	1st Floor	N/A
	Building	Room	Item	Quantity	
	West Witney Sports Club	Function Room 101	No materials to the solid walls, solid flooring and plasterboard ceiling of the function room were suspected of containing asbestos	N/A	
	Sample No (S,SP,P,As)	Product Type	Surface Treatment	Condition	Accessibility
	Visual (P)	N/A	N/A	N/A	N/A
	Material Risk Score				
	N/A				
Recommended action	No further action required				
Surveyor comments	No Suspect Materials.

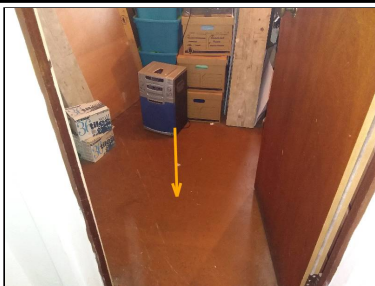
Survey Date:	Lead Surveyor	Survey Type	Floor	Analysis
	12 Jun 2025	Dudley Firkins	Refurbishment & Demolition survey	1st Floor	No Asbestos Detected (0)
	Building	Room	Item	Quantity	
	West Witney Sports Club	Store 103	Lino to floor	9m²	
	Sample No (S,SP,P,As)	Product Type	Surface Treatment	Condition	Accessibility
	DF005675 (S)	Vinyl floor tiles (1)	Completely Sealed (0)	Low Damage (1)	Occasionally likely to be disturbed
	Material Risk Score				
	N/A				
Recommended action	No further action required				
Surveyor comments	Non-Asbestos lino to timber.

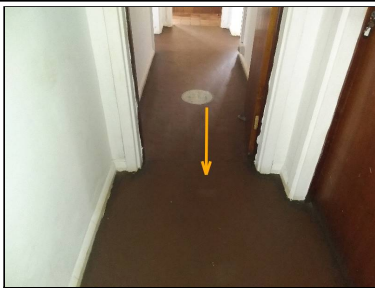
Survey Date:	Lead Surveyor	Survey Type	Floor	Analysis
	12 Jun 2025	Dudley Firkins	Refurbishment & Demolition survey	1st Floor	No Asbestos Detected (0)
	Building	Room	Item	Quantity	
	West Witney Sports Club	Corridor 104	Lino to floor	5m²	
	Sample No (S,SP,P,As)	Product Type	Surface Treatment	Condition	Accessibility
	As DF005675 (SP)	Vinyl floor tiles (1)	Completely Sealed (0)	Low Damage (1)	Occasionally likely to be disturbed
	Material Risk Score				
	N/A				
Recommended action	No further action required				
Surveyor comments	Non-Asbestos lino to timber.

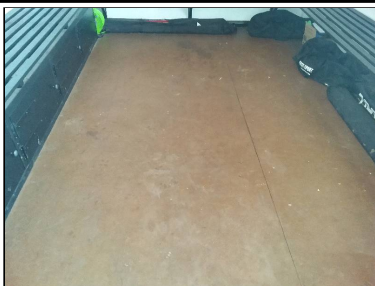
Survey Date:	Lead Surveyor	Survey Type	Floor	Analysis
	12 Jun 2025	Dudley Firkins	Refurbishment & Demolition survey	1st Floor	No Asbestos Detected (0)
	Building	Room	Item	Quantity	
	West Witney Sports Club	Changing Room 105	Lino to floor	15m²	
	Sample No (S,SP,P,As)	Product Type	Surface Treatment	Condition	Accessibility
	As DF005675 (SP)	Vinyl floor tiles (1)	Completely Sealed (0)	Low Damage (1)	Occasionally likely to be disturbed
	Material Risk Score				
	N/A				
Recommended action	No further action required				
Surveyor comments	Non-Asbestos lino to timber.

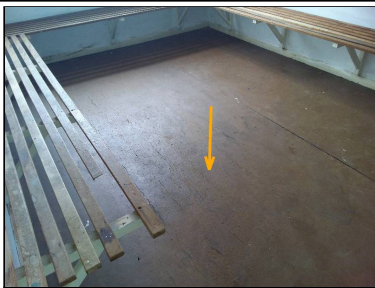
Survey Date:	Lead Surveyor	Survey Type	Floor	Analysis
	12 Jun 2025	Dudley Firkins	Refurbishment & Demolition survey	1st Floor	No Asbestos Detected (0)
	Building	Room	Item	Quantity	
	West Witney Sports Club	Away Changing Room 106	Lino to floor	15m²	
	Sample No (S,SP,P,As)	Product Type	Surface Treatment	Condition	Accessibility
	As DF005675 (SP)	Vinyl floor tiles (1)	Completely Sealed (0)	Low Damage (1)	Occasionally likely to be disturbed
	Material Risk Score				
	N/A				
Recommended action	No further action required				
Surveyor comments	Non-Asbestos lino to timber.

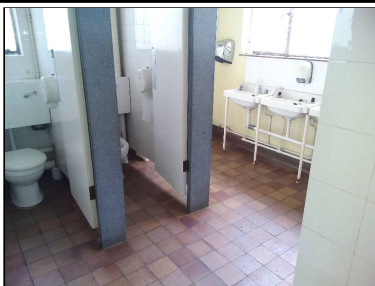
Survey Date:	Lead Surveyor	Survey Type	Floor	Analysis
	12 Jun 2025	Dudley Firkins	Refurbishment & Demolition survey	1st Floor	N/A
	Building	Room	Item	Quantity	
	West Witney Sports Club	Toilets 107	No materials to the solid walls, solid flooring and plasterboard ceiling of the toilets were suspected of containing asbestos	N/A	
	Sample No (S,SP,P,As)	Product Type	Surface Treatment	Condition	Accessibility
	Visual (P)	N/A	N/A	N/A	N/A
	Material Risk Score				
	N/A				
	Recommended action	No further action required			
Surveyor comments	No Suspect Materials. Plastic cisterns.

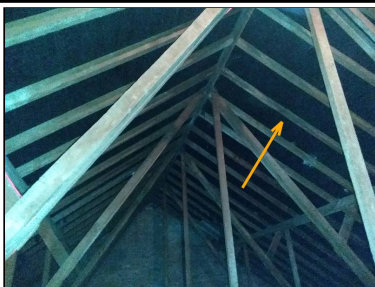
Survey Date:	Lead Surveyor	Survey Type	Floor	Analysis
	12 Jun 2025	Dudley Firkins	Refurbishment & Demolition survey	1st Floor	No Asbestos Detected (0)
	Building	Room	Item	Quantity	
	West Witney Sports Club	Roof Void 108	Felt to underside of roof	Throughout	
	Sample No (S,SP,P,As)	Product Type	Surface Treatment	Condition	Accessibility
	DF005676 (S)	Bituminous (1)	Completely Sealed (0)	Low Damage (1)	Occasionally likely to be disturbed
		Material Risk Score			
	N/A				
Recommended action	No further action required				
Surveyor comments	Non-Asbestos felt to underside of roof.

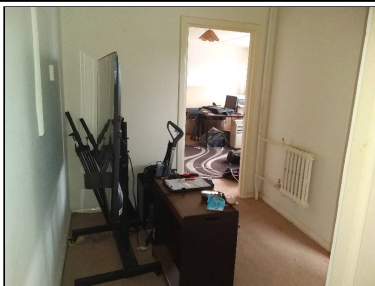
Survey Date:	Lead Surveyor	Survey Type	Floor	Analysis
	12 Jun 2025	Dudley Firkins	Refurbishment & Demolition survey	1st Floor	N/A
	Building	Room	Item	Quantity	
	West Witney Sports Club	Lobby 109	No materials to the solid walls, timber flooring and timber ceiling with polystyrene tiles of the lobby were suspected of containing asbestos	N/A	
	Sample No (S,SP,P,As)	Product Type	Surface Treatment	Condition	Accessibility
	Visual (P)	N/A	N/A	N/A	N/A
	Material Risk Score				
	N/A				
Recommended action	No further action required				
Surveyor comments	No Suspect Materials.

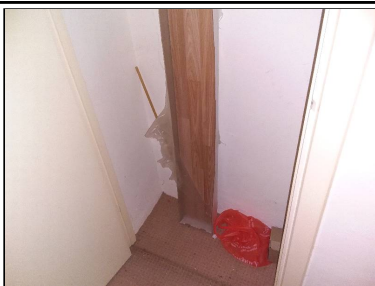
Survey Date:	Lead Surveyor	Survey Type	Floor	Analysis
	12 Jun 2025	Dudley Firkins	Refurbishment & Demolition survey	1st Floor	N/A
	Building	Room	Item	Quantity	
	West Witney Sports Club	Store 110	No materials to the solid walls, timber flooring and plasterboard ceiling with polystyrene tiles of the store were suspected of containing asbestos	N/A	
	Sample No (S,SP,P,As)	Product Type	Surface Treatment	Condition	Accessibility
	Visual (P)	N/A	N/A	N/A	N/A
	Material Risk Score				
	N/A				
Recommended action	No further action required				
Surveyor comments	No Suspect Materials.

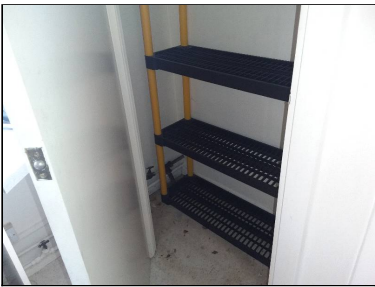
Survey Date:	Lead Surveyor	Survey Type	Floor	Analysis
	12 Jun 2025	Dudley Firkins	Refurbishment & Demolition survey	1st Floor	N/A
	Building	Room	Item	Quantity	
	West Witney Sports Club	Store 112	No materials to the solid walls, timber flooring and plasterboard ceiling with polystyrene tiles of the store were suspected of containing asbestos	N/A	
	Sample No (S,SP,P,As)	Product Type	Surface Treatment	Condition	Accessibility
	Visual (P)	N/A	N/A	N/A	N/A
	Material Risk Score				
Recommended action		No further action required			
Surveyor comments		No Suspect Materials.

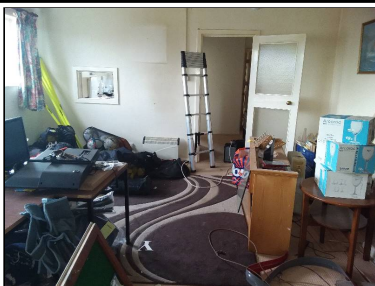
Survey Date:	Lead Surveyor	Survey Type	Floor	Analysis
	12 Jun 2025	Dudley Firkins	Refurbishment & Demolition survey	1st Floor	N/A
	Building	Room	Item	Quantity	
	West Witney Sports Club	Living Room 113	No materials to the solid walls, timber flooring and fibreboard ceiling of the living room were suspected of containing asbestos	N/A	
	Sample No (S,SP,P,As)	Product Type	Surface Treatment	Condition	Accessibility
	Visual (P)	N/A	N/A	N/A	N/A
	Material Risk Score				
	N/A				
Recommended action	No further action required				
Surveyor comments	No Suspect Materials.

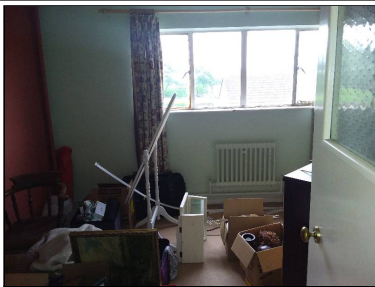
Survey Date:	Lead Surveyor	Survey Type	Floor	Analysis
	12 Jun 2025	Dudley Firkins	Refurbishment & Demolition survey	1st Floor	N/A
	Building	Room	Item	Quantity	
	West Witney Sports Club	Bedroom 116	No materials to the solid walls, timber flooring and fibreboard ceiling of the bedroom were suspected of containing asbestos	N/A	
	Sample No (S,SP,P,As)	Product Type	Surface Treatment	Condition	Accessibility
	Visual (P)	N/A	N/A	N/A	N/A
	Material Risk Score				
	N/A				
	Recommended action	No further action required			
Surveyor comments	No Suspect Materials.

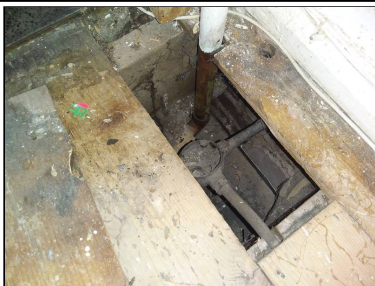
Survey Date:	Lead Surveyor	Survey Type	Floor	Analysis
	12 Jun 2025	Dudley Firkins	Refurbishment & Demolition survey	1st Floor	N/A
	Building	Room	Item	Quantity	
	West Witney Sports Club	Floor Voids 117	No materials to the floor voids (where inspected) were suspected of containing asbestos	N/A	
	Sample No (S,SP,P,As)	Product Type	Surface Treatment	Condition	Accessibility
	Visual (P)	N/A	N/A	N/A	N/A
	Material Risk Score				
	N/A				
Recommended action	No further action required				
Surveyor comments	No Suspect Materials

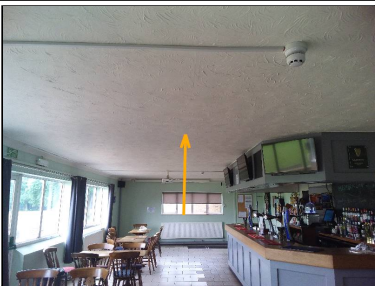
Survey Date:	Lead Surveyor	Survey Type	Floor	Analysis
	12 Jun 2025	Dudley Firkins	Refurbishment & Demolition survey	Ground Floor	No Asbestos Detected (0)
	Building	Room	Item	Quantity	
	West Witney Sports Club	Bar Area G02	Textured Coating to ceiling	84m <sup>2</sup>	
	Sample No (S,SP,P,As)	Product Type	Surface Treatment	Condition	Accessibility
	DF005669 (S)	Textured Coating (1)	Surface Sealed (1)	Low Damage (1)	Occasionally likely to be disturbed
	Material Risk Score				
Recommended action		No further action required			
Surveyor comments		Non-Asbestos textured coating to solid ceiling.

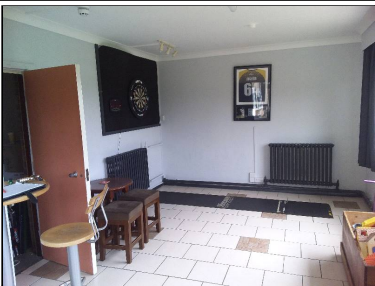
Survey Date:	Lead Surveyor	Survey Type	Floor	Analysis
	12 Jun 2025	Dudley Firkins	Refurbishment & Demolition survey	Ground Floor	N/A
	Building	Room	Item	Quantity	
	West Witney Sports Club	Darts Room G03	No materials to the solid walls, solid flooring and solid ceiling of the darts room were suspected of containing asbestos	N/A	
	Sample No (S,SP,P,As)	Product Type	Surface Treatment	Condition	Accessibility
	Visual (P)	N/A	N/A	N/A	N/A
Material Risk Score					
N/A					
Recommended action	No further action required				
Surveyor comments	No Suspect Materials.

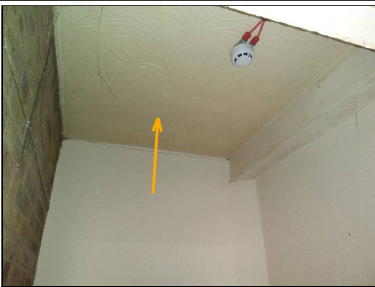
Survey Date:	Lead Surveyor	Survey Type	Floor	Analysis
	12 Jun 2025	Dudley Firkins	Refurbishment & Demolition survey	Ground Floor	No Asbestos Detected (0)
	Building	Room	Item	Quantity	
	West Witney Sports Club	Store G04	Textured Coating to ceiling	3.5m²	
	Sample No (S,SP,P,As)	Product Type	Surface Treatment	Condition	Accessibility
	As DF005669 (SP)	Textured Coating (1)	Surface Sealed (1)	Low Damage (1)	Occasionally likely to be disturbed
Material Risk Score					
N/A					
Recommended action	No further action required				
Surveyor comments	Non-Asbestos textured coating to solid ceiling.

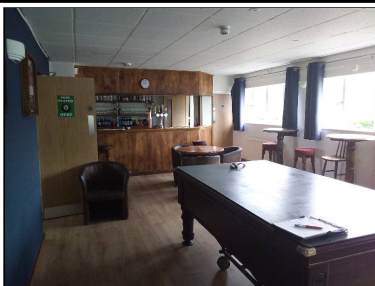
Survey Date:	Lead Surveyor	Survey Type	Floor	Analysis
	12 Jun 2025	Dudley Firkins	Refurbishment & Demolition survey	Ground Floor	N/A
	Building	Room	Item	Quantity	
	West Witney Sports Club	Lounge/Pool Room G05	No materials to the solid walls, timber flooring and suspended ceiling of the lounge were suspected of containing asbestos	N/A	
	Sample No (S,SP,P,As)	Product Type	Surface Treatment	Condition	Accessibility
	Visual (P)	N/A	N/A	N/A	N/A
	Material Risk Score				
	N/A				
Recommended action	No further action required				
Surveyor comments	No Suspect Materials.

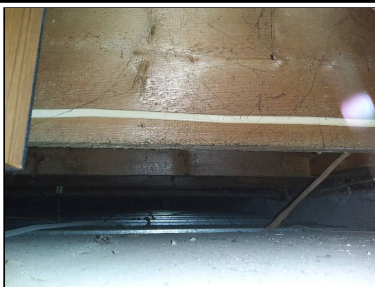
Survey Date:	Lead Surveyor	Survey Type	Floor	Analysis
	12 Jun 2025	Dudley Firkins	Refurbishment & Demolition survey	Ground Floor	N/A
	Building	Room	Item	Quantity	
	West Witney Sports Club	Ceiling Void G06	No materials to the ceiling void were suspected of containing asbestos	N/A	
	Sample No (S,SP,P,As)	Product Type	Surface Treatment	Condition	Accessibility
	Visual (P)	N/A	N/A	N/A	N/A
	Material Risk Score				
	N/A				
Recommended action	No further action required				
Surveyor comments	No Suspect Materials. Timber ceiling.

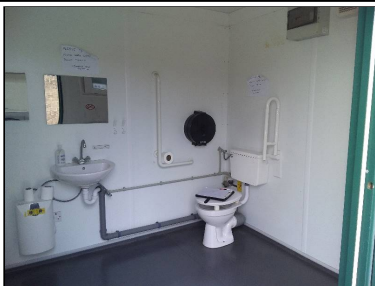
Survey Date:	Lead Surveyor	Survey Type	Floor	Analysis
	12 Jun 2025	Dudley Firkins	Refurbishment & Demolition survey	Ground Floor	N/A
	Building	Room	Item	Quantity	
	West Witney Sports Club	Toilet G07	No materials to the plastic walls, flooring with modern lino and plastic ceiling of the disabled toilet were suspected of containing asbestos	N/A	
	Sample No (S,SP,P,As)	Product Type	Surface Treatment	Condition	Accessibility
	Visual (P)	N/A	N/A	N/A	N/A
	Material Risk Score				
N/A					
Recommended action	No further action required				
Surveyor comments	No Suspect Materials.

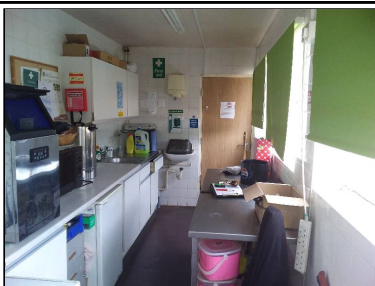
Survey Date:	Lead Surveyor	Survey Type	Floor	Analysis
	12 Jun 2025	Dudley Firkins	Refurbishment & Demolition survey	Ground Floor	N/A
	Building	Room	Item	Quantity	
	West Witney Sports Club	Kitchen G08	No materials to the solid walls, solid flooring with modern lino and plasterboard ceiling of the kitchen were suspected of containing asbestos	N/A	
	Sample No (S,SP,P,As)	Product Type	Surface Treatment	Condition	Accessibility
	Visual (P)	N/A	N/A	N/A	N/A
	Material Risk Score				
	N/A				
Recommended action	No further action required				
Surveyor comments	No Suspect Materials. Modern acoustic pads to sink.

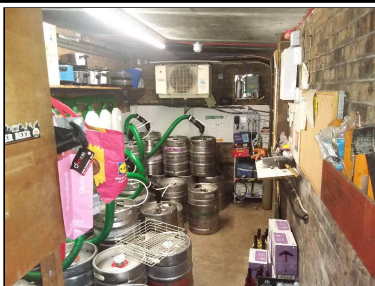
Survey Date:	Lead Surveyor	Survey Type	Floor	Analysis
	12 Jun 2025	Dudley Firkins	Refurbishment & Demolition survey	Ground Floor	N/A
	Building	Room	Item	Quantity	
	West Witney Sports Club	Cellar G09	No materials to the solid walls, solid flooring and timber ceiling of the cellar were suspected of containing asbestos	N/A	
	Sample No (S,SP,P,As)	Product Type	Surface Treatment	Condition	Accessibility
	Visual (P)	N/A	N/A	N/A	N/A
	Material Risk Score				
N/A					
Recommended action	No further action required				
Surveyor comments	No Suspect Materials.

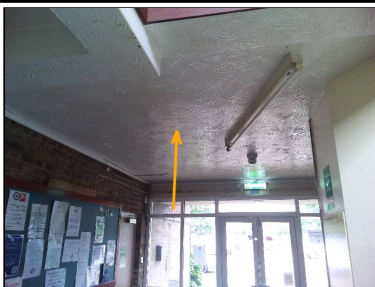
Survey Date:	Lead Surveyor	Survey Type	Floor	Analysis
	12 Jun 2025	Dudley Firkins	Refurbishment & Demolition survey	Ground Floor	No Asbestos Detected (0)
	Building	Room	Item	Quantity	
	West Witney Sports Club	Entrance Lobby G10	Textured Coating to ceiling	28m²	
	Sample No (S,SP,P,As)	Product Type	Surface Treatment	Condition	Accessibility
	As DF005669 (SP)	Textured Coating (1)	Surface Sealed (1)	Low Damage (1)	Occasionally likely to be disturbed
	Material Risk Score				
N/A					
Recommended action	No further action required				
Surveyor comments	Non-Asbestos textured coating to solid ceiling.

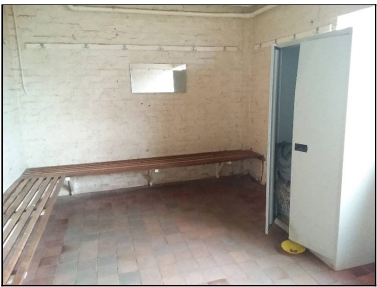
Survey Date:	Lead Surveyor	Survey Type	Floor	Analysis
	12 Jun 2025	Dudley Firkins	Refurbishment & Demolition survey	Ground Floor	N/A
	Building	Room	Item	Quantity	
	West Witney Sports Club	Away Changing Room G13	No materials to the solid walls, solid flooring (tiled) and plasterboard ceiling of the changing room were suspected of containing asbestos	N/A	
	Sample No (S,SP,P,As)	Product Type	Surface Treatment	Condition	Accessibility
	Visual (P)	N/A	N/A	N/A	N/A
	Material Risk Score				
Recommended action		No further action required			
Surveyor comments		No Suspect Materials.

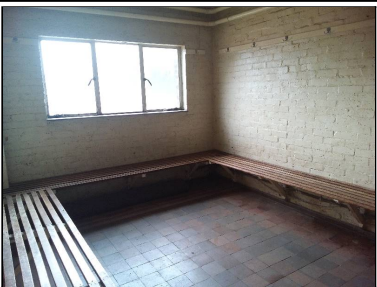
Survey Date:	Lead Surveyor	Survey Type	Floor	Analysis
	12 Jun 2025	Dudley Firkins	Refurbishment & Demolition survey	Ground Floor	N/A
	Building	Room	Item	Quantity	
	West Witney Sports Club	Members Changing Room G14	No materials to the solid walls, solid flooring (tiled) and plasterboard ceiling of the changing room were suspected of containing asbestos	N/A	
	Sample No (S,SP,P,As)	Product Type	Surface Treatment	Condition	Accessibility
	Visual (P)	N/A	N/A	N/A	N/A
	Material Risk Score				
Recommended action		No further action required			
Surveyor comments		No Suspect Materials.

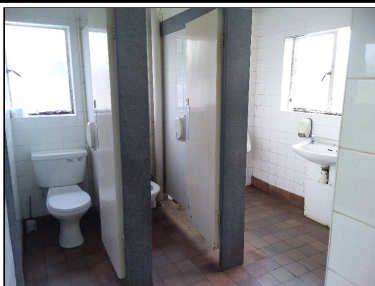
Survey Date:	Lead Surveyor	Survey Type	Floor	Analysis
	12 Jun 2025	Dudley Firkins	Refurbishment & Demolition survey	Ground Floor	N/A
	Building	Room	Item	Quantity	
	West Witney Sports Club	Toilets G15	No materials to the solid walls, solid flooring (tiled) and solid ceiling of the toilets were suspected of containing asbestos	N/A	
	Sample No (S,SP,P,As)	Product Type	Surface Treatment	Condition	Accessibility
	Visual (P)	N/A	N/A	N/A	N/A
	Material Risk Score				
	N/A				
Recommended action	No further action required				
Surveyor comments	No Suspect Materials. Timber boxing, ceramic cisterns.

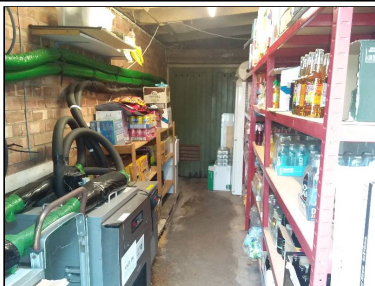
Survey Date:	Lead Surveyor	Survey Type	Floor	Analysis
	12 Jun 2025	Dudley Firkins	Refurbishment & Demolition survey	Ground Floor	N/A
	Building	Room	Item	Quantity	
	West Witney Sports Club	Store G17	No materials to the solid walls, solid flooring and timber ceiling of the store were suspected of containing asbestos	N/A	Accessibility
	Sample No (S,SP,P,As)	Product Type	Surface Treatment	Condition	
	Visual (P)	N/A	N/A	N/A	
	Material Risk Score				
N/A					
Recommended action	No further action required				
Surveyor comments	No Suspect Materials.

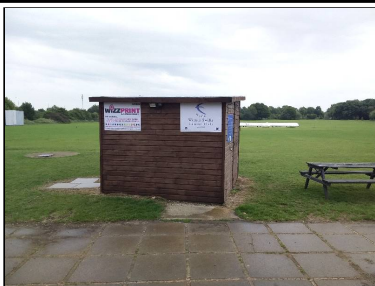
Survey Date:	Lead Surveyor	Survey Type	Floor	Analysis
	12 Jun 2025	Dudley Firkins	Refurbishment & Demolition survey	Ground Floor	N/A
	Building	Room	Item	Quantity	
	West Witney Sports Club	Shed G18	No materials to the timber shed were suspected of containing asbestos	N/A	
	Sample No (S,SP,P,As)	Product Type	Surface Treatment	Condition	Accessibility
	Visual (P)	N/A	N/A	N/A	N/A
	Material Risk Score				
	N/A				
Recommended action	No further action required				
Surveyor comments	No Suspect Materials.

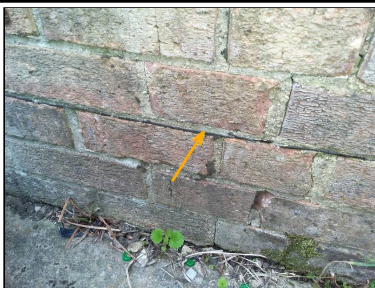
Survey Date:	Lead Surveyor	Survey Type	Floor	Analysis
	12 Jun 2025	Dudley Firkins	Refurbishment & Demolition survey	External	No Asbestos Detected (0)
	Building	Room	Item	Quantity	
	West Witney Sports Club	External Elevations E01	Damp Proof Course to walls	Throughout	
	Sample No (S,SP,P,As)	Product Type	Surface Treatment	Condition	Accessibility
	DF005678 (S)	Bituminous (1)	Completely Sealed (0)	Low Damage (1)	Occasionally likely to be disturbed
	Material Risk Score				
N/A					
Recommended action	No further action required				
Surveyor comments	Non-Asbestos damp proof course to perimeter walls.

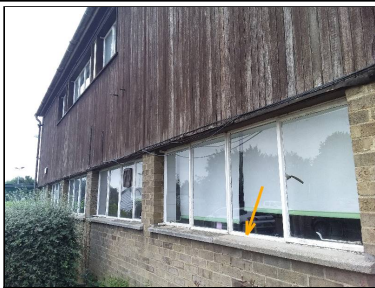
Survey Date:	Lead Surveyor	Survey Type	Floor	Analysis
	12 Jun 2025	Dudley Firkins	Refurbishment & Demolition survey	External	No Asbestos Detected (0)
	Building	Room	Item	Quantity	
	West Witney Sports Club	External Elevations E01	Putty to windows	Throughout	
	Sample No (S,SP,P,As)	Product Type	Surface Treatment	Condition	Accessibility
	DF005680 (S)	Mastic (1)	Completely Sealed (0)	Low Damage (1)	Occasionally likely to be disturbed
	Material Risk Score				
	N/A				
Recommended action	No further action required				
Surveyor comments	Non-Asbestos putty between glazing and frame to all similar windows.

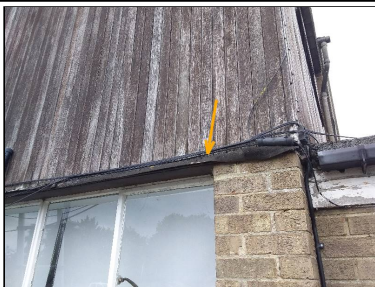
Survey Date:	Lead Surveyor	Survey Type	Floor	Analysis
	12 Jun 2025	Dudley Firkins	Refurbishment & Demolition survey	External	No Asbestos Detected (0)
	Building	Room	Item	Quantity	
	West Witney Sports Club	External Elevations E01	Felt behind timber cladding	20lm	
	Sample No (S,SP,P,As)	Product Type	Surface Treatment	Condition	Accessibility
	DF005682 (S)	Bituminous (1)	Completely Sealed (0)	Low Damage (1)	Occasionally likely to be disturbed
	Material Risk Score				
	N/A				
Recommended action	No further action required				
Surveyor comments	Non-Asbestos felt to base of timber cladding.
