TLC Environmental Services Ltd

Asbestos Refurbishment survey Report

15th October 2018

**West Bergholt Parish Council
(Orpen & John Lampon Hall Loft Space)
Lexden Road
CO6 3BW**

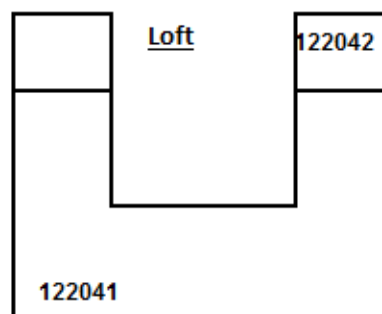
Photo 1

Location	Risk Assessment	Recommendations
Stage-ceiling	Low	Repair/remove

SN1-Slight damage to ceiling. Recommend repair/removal
