ASBESTOS MANAGEMENT SURVEY REPORT

**Roman Business Centre
Le Neubourg Way
Gillingham
Dorset
SP8 4DN**

Project / Job Number: J114211

Survey Date(s): 6 Jan 2022

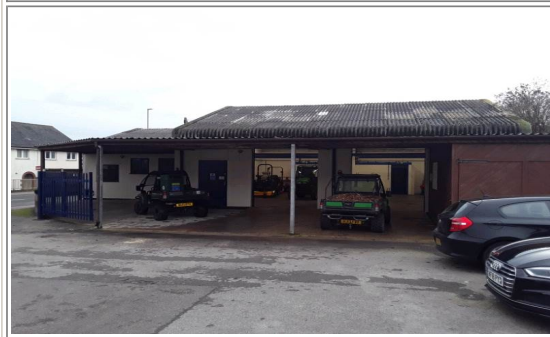
Photo No. 37 - Corrugated roof sheets (curved profile) to roof of extension to east side of building and associated edge capping panels to gable end

External			
Identified			
No Asbestos Detected		No Action Required	
Material Assessment	N/A	Priority Assessment	N/A
N/A
