**ASBESTOS REFURBISHMENT SURVEY
FIRST FLOOR - BREGENZ HOUSE
QUAY STREET
BANGOR
BT20 5ED**

1.0 SUMMARY
PROJECT NUMBER A-05609
1.1 REPORT SUMMARY

| Survey Type: | Refurbishment Survey |
| Site Address | FIRST FLOOR - BREGENZ HOUSE QUAY STREET BANGOR BT20 5ED |

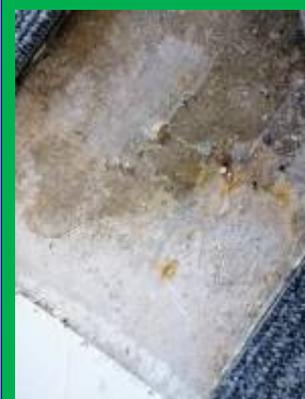
| Floor | Location | Position | Product Type | Sample No | Photograph |
|---|---|---|---|---|---|
| 1st Floor | 003 Conference room | Coating to Floor | Adhesive | ID007 | |
