Asbestos Management Survey Report

Job Ref No: **526967**, Account Ref No: **24359**, Contract Ref No: **79905**

Wellingborough Library and registration office 7 Pebble Ln, Wellingborough NN8 1AS

Title: Management survey of library and registration office, **Property refurbishment Works Scope:** Management survey to entire property

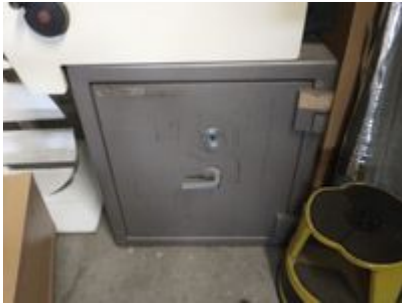
Building	Level	Location	Item / Product Examined	Accessibility	Access Comments	Photograph
Wellingborough Library	0	001/loading bay	Safe	No Access

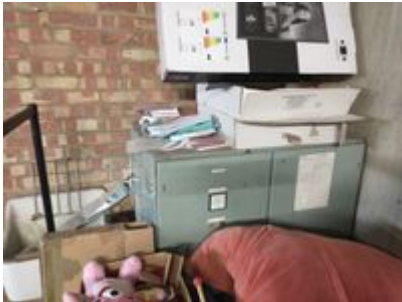
Wellingborough Library	0	001/loading bay	Electrics	No Access	Live service supply

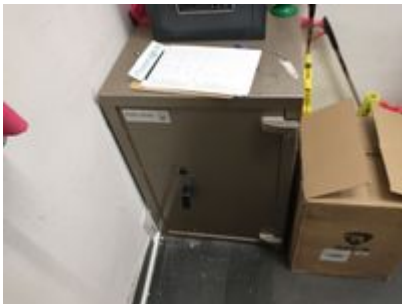
Wellingborough Library	0	002/book store	Safe	No Access

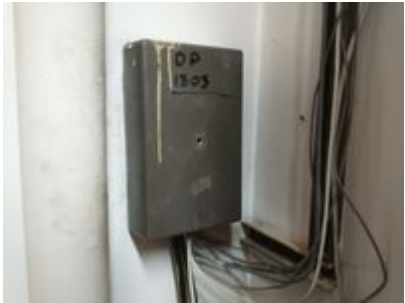
Building	Level	Location	Item / Product Examined	Accessibility	Access Comments	Photograph
Wellingborough Library	0	002/book store	Electrics	No Access	Live service supply

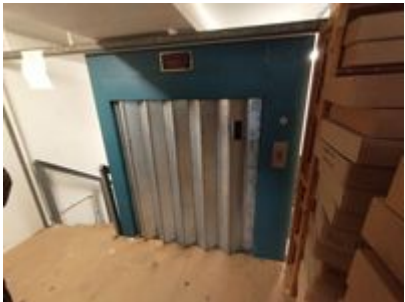
Wellingborough Library	0	002/book store	Lift shaft	No Access	Lift engineer required to assist

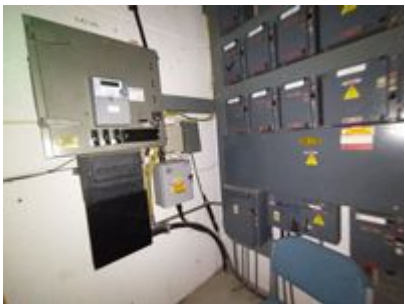
Wellingborough Library	0	003/electrics cupboard	Electrics	No Access	Live service supply

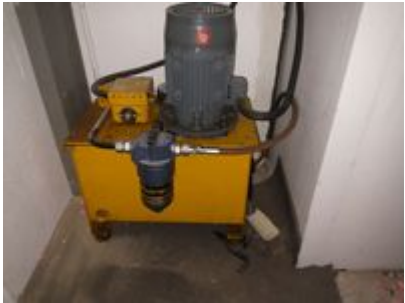
Building	Level	Location	Item / Product Examined	Accessibility	Access Comments	Photograph
Wellingborough Library	0	003/electrics cupboard	Lift motor	No Access	Live service supply

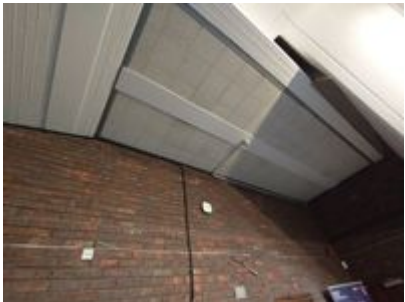
Wellingborough Library	0	004/entrance	Suspended ceiling	No Access	Reasons of height

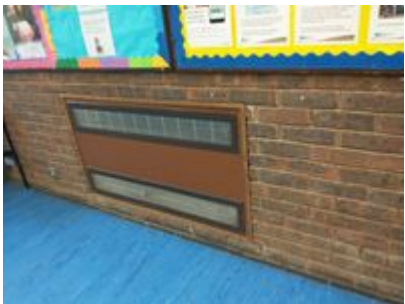
Wellingborough Library	0	004/entrance	Heater	No Access	Live service supply

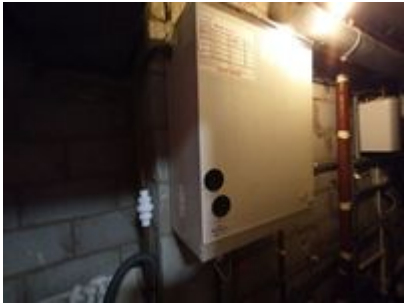
Building	Level	Location	Item / Product Examined	Accessibility	Access Comments	Photograph
Wellingborough Library	1	001/wc and duct	Heater	No Access	Live service supply

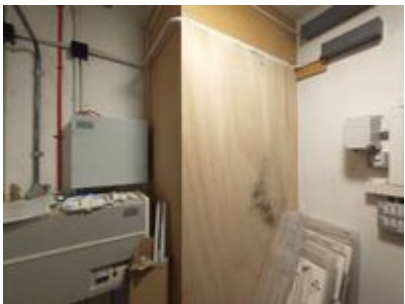
💬 Celmac toilet seats x2. known to be potentially asbestos containing composites	
Wellingborough Library	1	003/electrics cupboard	Behind wooden boxing	No Access

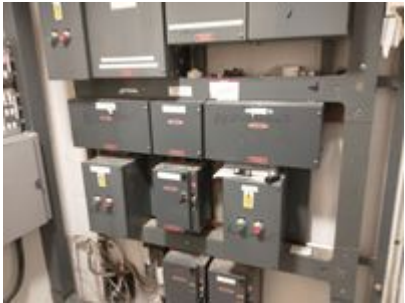
Building	Level	Location	Item / Product Examined	Accessibility	Access Comments	Photograph
Wellingborough Library	1	003/electrics cupboard	Within electrics and loose fuses	No Access	Live service supply

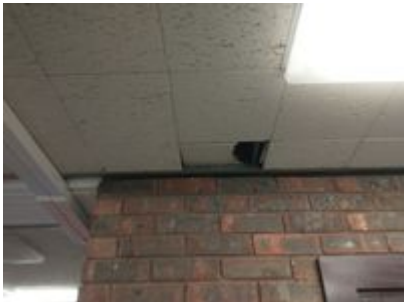
Wellingborough Library	1	004/children's area	Suspended ceiling	Limited Access	Only able to move tiles to far edge

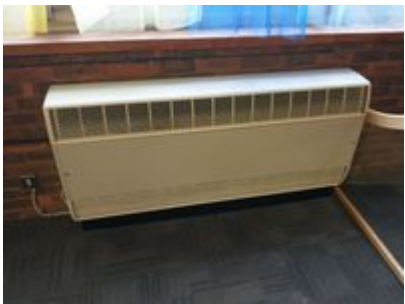
Wellingborough Library	1	004/children's area	Within electric heater	No Access	Live service supply

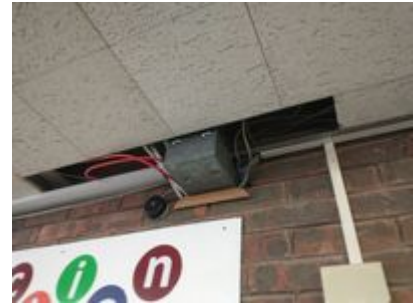
Building	Level	Location	Item / Product Examined	Accessibility	Access Comments	Photograph
Wellingborough Library	1	005/main library	Suspended ceiling	No Access

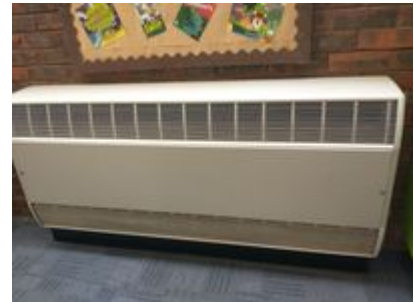
🗨️ Only able to access partially at far edges	
Wellingborough Library	1	005/main library	Within heaters	No Access	Live service supply

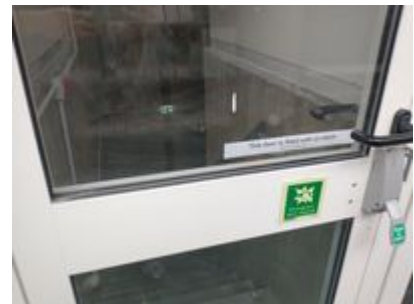
Wellingborough Library	1	005/main library	Fire escape	Limited Access	Unable to deactivate alarm, most of fire escape visible through glass and surveyed visually

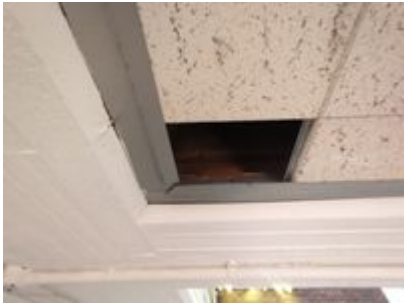
Building	Level	Location	Item / Product Examined	Accessibility	Access Comments	Photograph
Wellingborough Library	1	006/corridor	Suspended ceiling	Limited Access	Only able to partially access from tile to edge

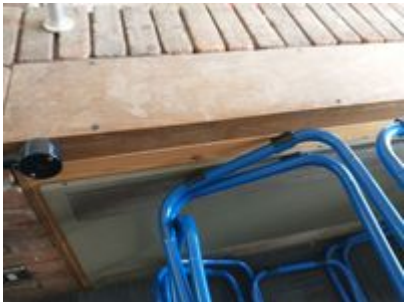
Wellingborough Library	1	006/corridor	Within heater	No Access	Live service supply

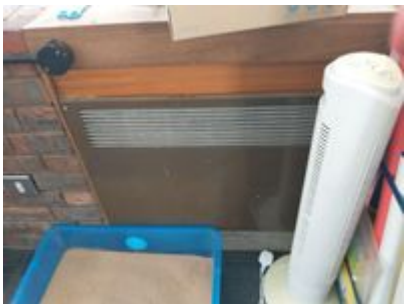
Wellingborough Library	2	001/mezzanine	Within heaters	No Access	Live service supply

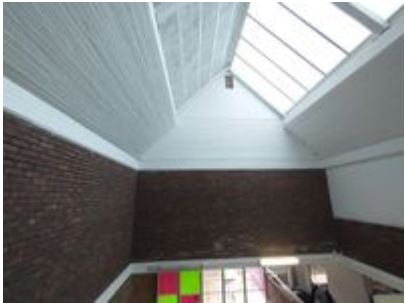
Building	Level	Location	Item / Product Examined	Accessibility	Access Comments	Photograph
Wellingborough Library	2	002/stairwell	Cladding to high level partitions	No Access	Reasons of height

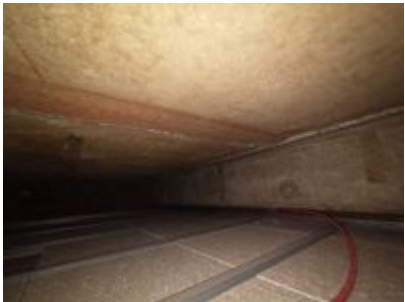
🗨 Visually consistent with wooden cladding, unable to physically access to assess	
Wellingborough Library	2	002/stairwell	Suspended ceiling	Limited Access

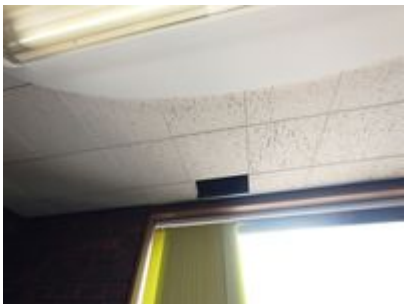
🗨 Unable to move any tiles other than to far edge	
Wellingborough Library	2	003/staff office	Suspended ceiling	Limited Access	Only able to move tiles to far edge

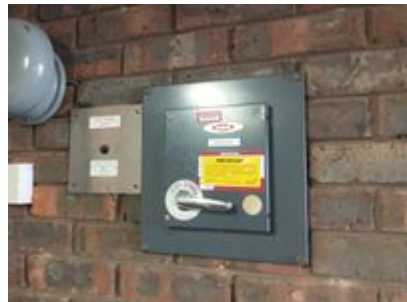
🗨 Not accessible during survey, however presumed to be consistent with AIB panel found to same hoist on floor directly below.		
Wellingborough Library	2	003/staff office	Within electrics	No Access	Live service supply

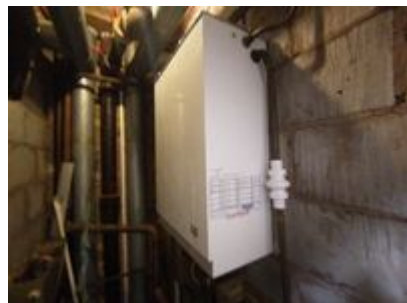
Wellingborough Library	2	007/boiler cupboard	Heater	No Access	Live service supply

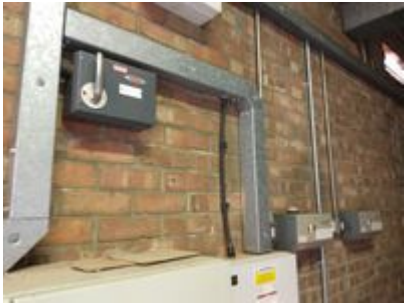
Building	Level	Location	Item / Product Examined	Accessibility	Access Comments	Photograph
Wellingborough Library	3	001/plant room	Within electrics	No Access	Live service supply

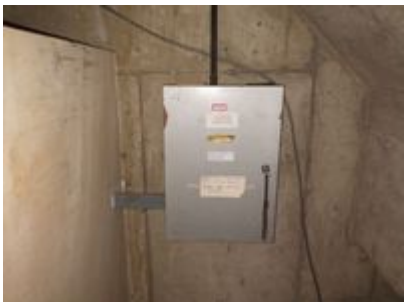
Wellingborough Library	3	004/stairwell	Within electrics	No Access	Live service supply
