BUILDING SURVEY

1 and 2 Marlborough
Square
Coalville
LE67 3WD

Richard Leigh

Wednesday 25th April 2018

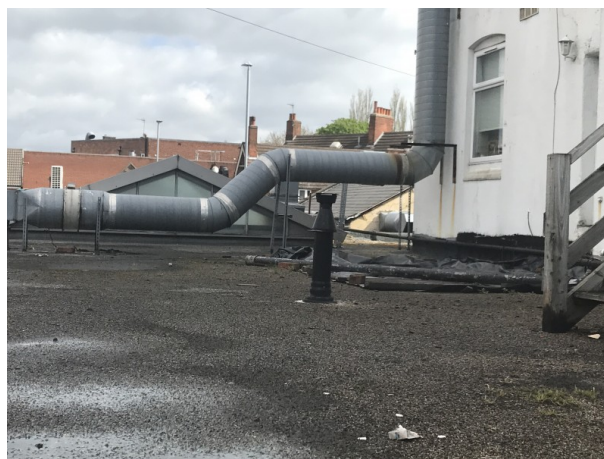
Photo - 3

It was not possible to make a close inspection of roof coverings. The front parapet was too high for our 3m ladder and we were only able to view the roof from a distance at the rear as it was unsafe to climb on to the roof from the ladder. There is a pitched roof over part of the property and the pitched roof is covered with asbestos cement slates with a clay ridge bedded in sand cement mortar. The pitched roof is surrounded by flat roof areas which were not visible to us. There are numerous leaks evident from inside the property and we would suspect that the roof is leaking through the flat roof coverings although this can only be confirmed by closer inspection and further investigation. The flat roof coverings extend over the passageway which leads to the rear of the property and your legal advisers should clarify responsibility for this area as the flat roof coverings are common and continuous over the adjacent property. It should also be noted that there are first floor exits from the flats above which open onto the flat roof area. Foot traffic from the flats has the potential for causing damage. We would also be concerned about liability for persons who may access the roof from the flats as there is no edge protection to the roof or no obvious means of descending down from the roof area.

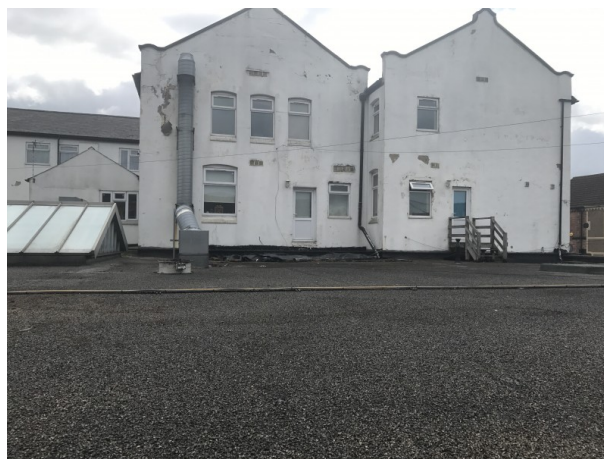
Photo - 5

Photo - 4
Pitched roof is behind glazed roof which is over the neighbouring property

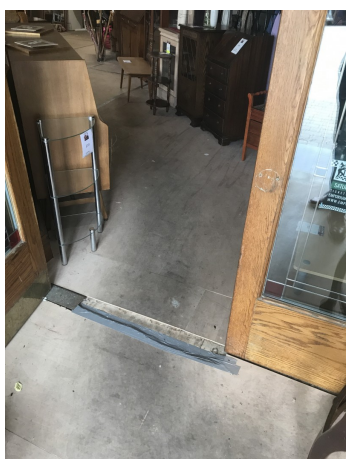
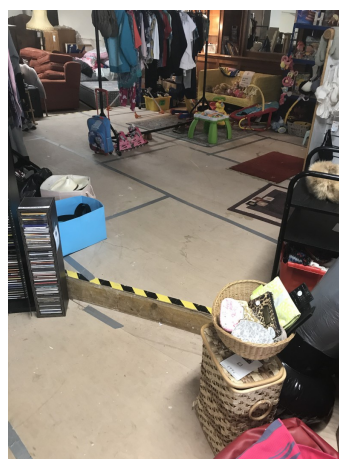
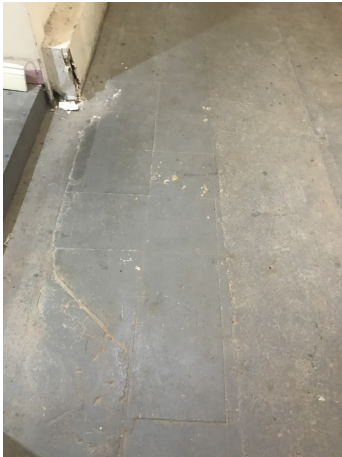
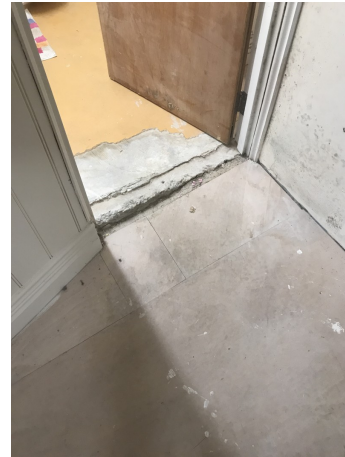
Floors throughout the property are covered with unfinished plywood sheets with taped joints. We are unable to comment on the condition of the floor below the plywood except to say that it is almost certainly a solid floor construction. There is a raised floor area to the right of the shop. The raised area appears to be a lightweight construction and should be relatively easy to remove although again the condition of the subfloor is undeterminable. The WC is situated at a higher level and approached by a ramp although there is a step from the ramp into the toilet area. You will need to improve the ramped access into this WC to remove the slight step or consider reducing the floor level in the toilet area down to a level which is consistent with the remainder of the building. This work would be subject to depth of drains below the floor. Please note that there is a risk of asbestos containing tiles below the plywood floor coverings.

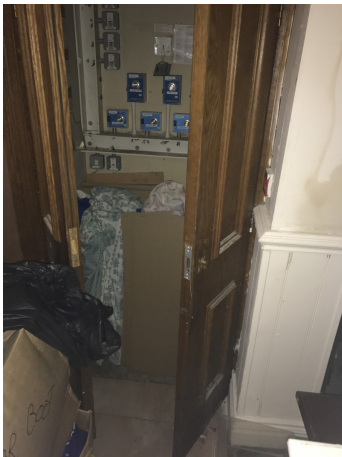
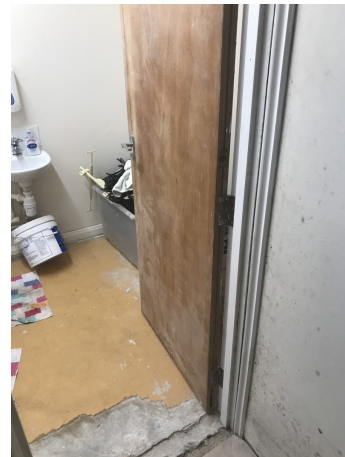
Internal joinery features are limited. There are lightweight and poorly constructed stud walls to screen off the staff office at the rear of the property. Some wall areas are panelled to dado height.

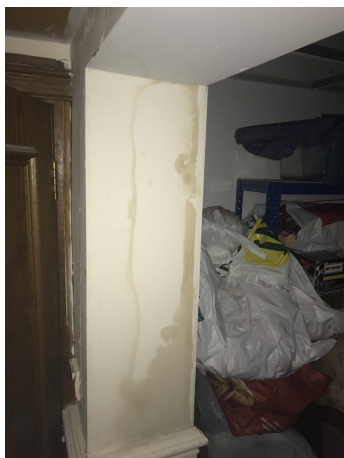
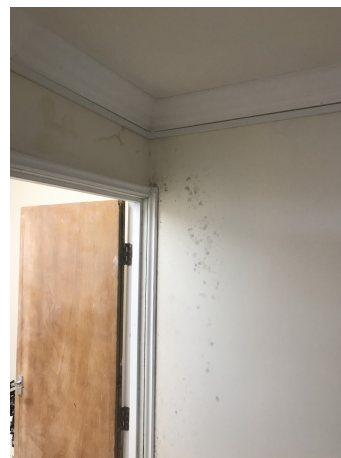
Internal decorative condition is generally fair although the decorations have clearly been affected in areas where there has been significant water penetration and damp.

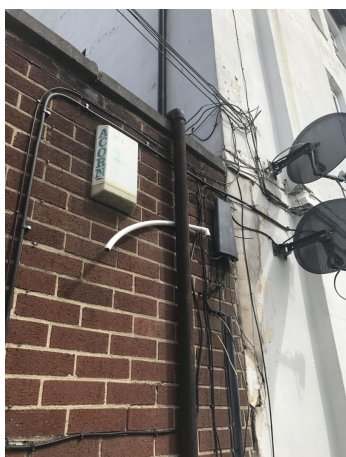
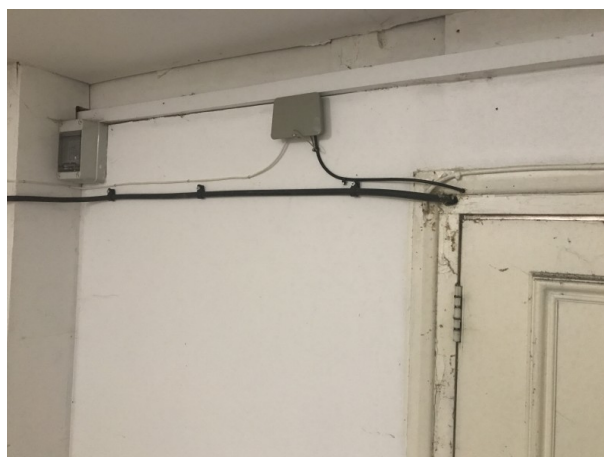
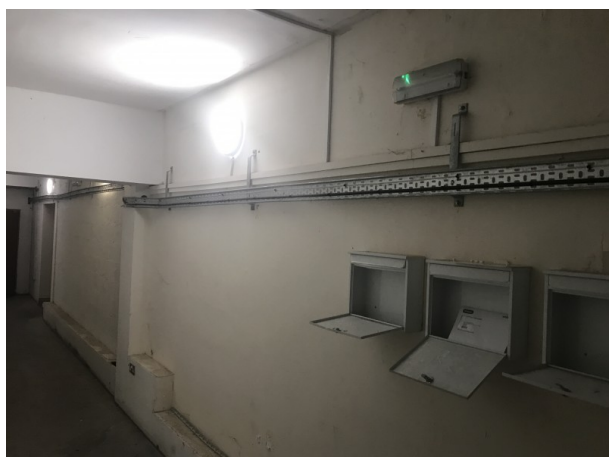
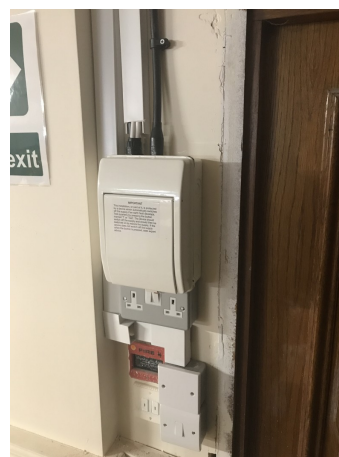
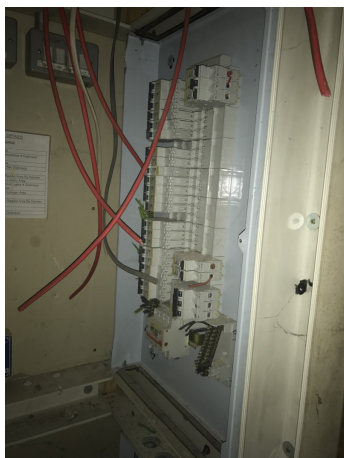
We were unable to locate the electricity meter for the property. It does appear that the power supply to the shop consists of a steel wire armoured cable which runs from the back of the property on Owen Street and along passageway via steel cable tray to a distribution board at the rear of the shop. The three-way distribution board with residual current device and mini circuit breakers serve 1 nr lighting circuit and 2 nr ring mains for general power. We would envisage that a new power supply will be required to the property. We also assume that a full rewire is required to suit the proposed change of use. There is a redundant distribution board in a service cupboard next to the store area with old switchgear which all needs stripping out. The fire detection system has also been disconnected so that manual call points (break glasses) which are situated around the building will not work. Emergency lighting units are also disconnected. Internal lighting is limited to 4 ft fluorescent strip fittings which are surface mounted with surface mounted wiring.

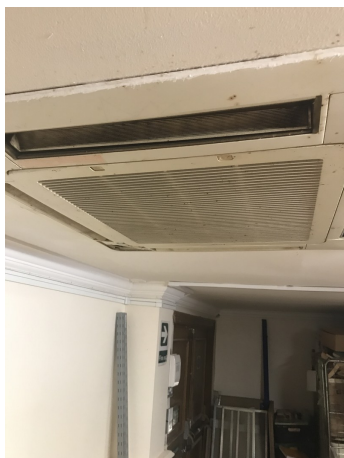
Photo - 48

The only form of heating to the property is a number of Daikin split AC cassette units. We have been unable to identify the location of the compressors which serve the split air conditioning units and believe that the cassette units have been decommissioned. In any case, they appear to be in poor condition and is unlikely that they could be brought back into use. There is no hot water.
