## **ASBESTOS REFURBISHMENT SURVEY REPORT**

**Basset Community Centre**  
Basset Road, Camborne TR14 8SL

Merit Report J3070a

Issue Date: 22<sup>nd</sup> February 2023

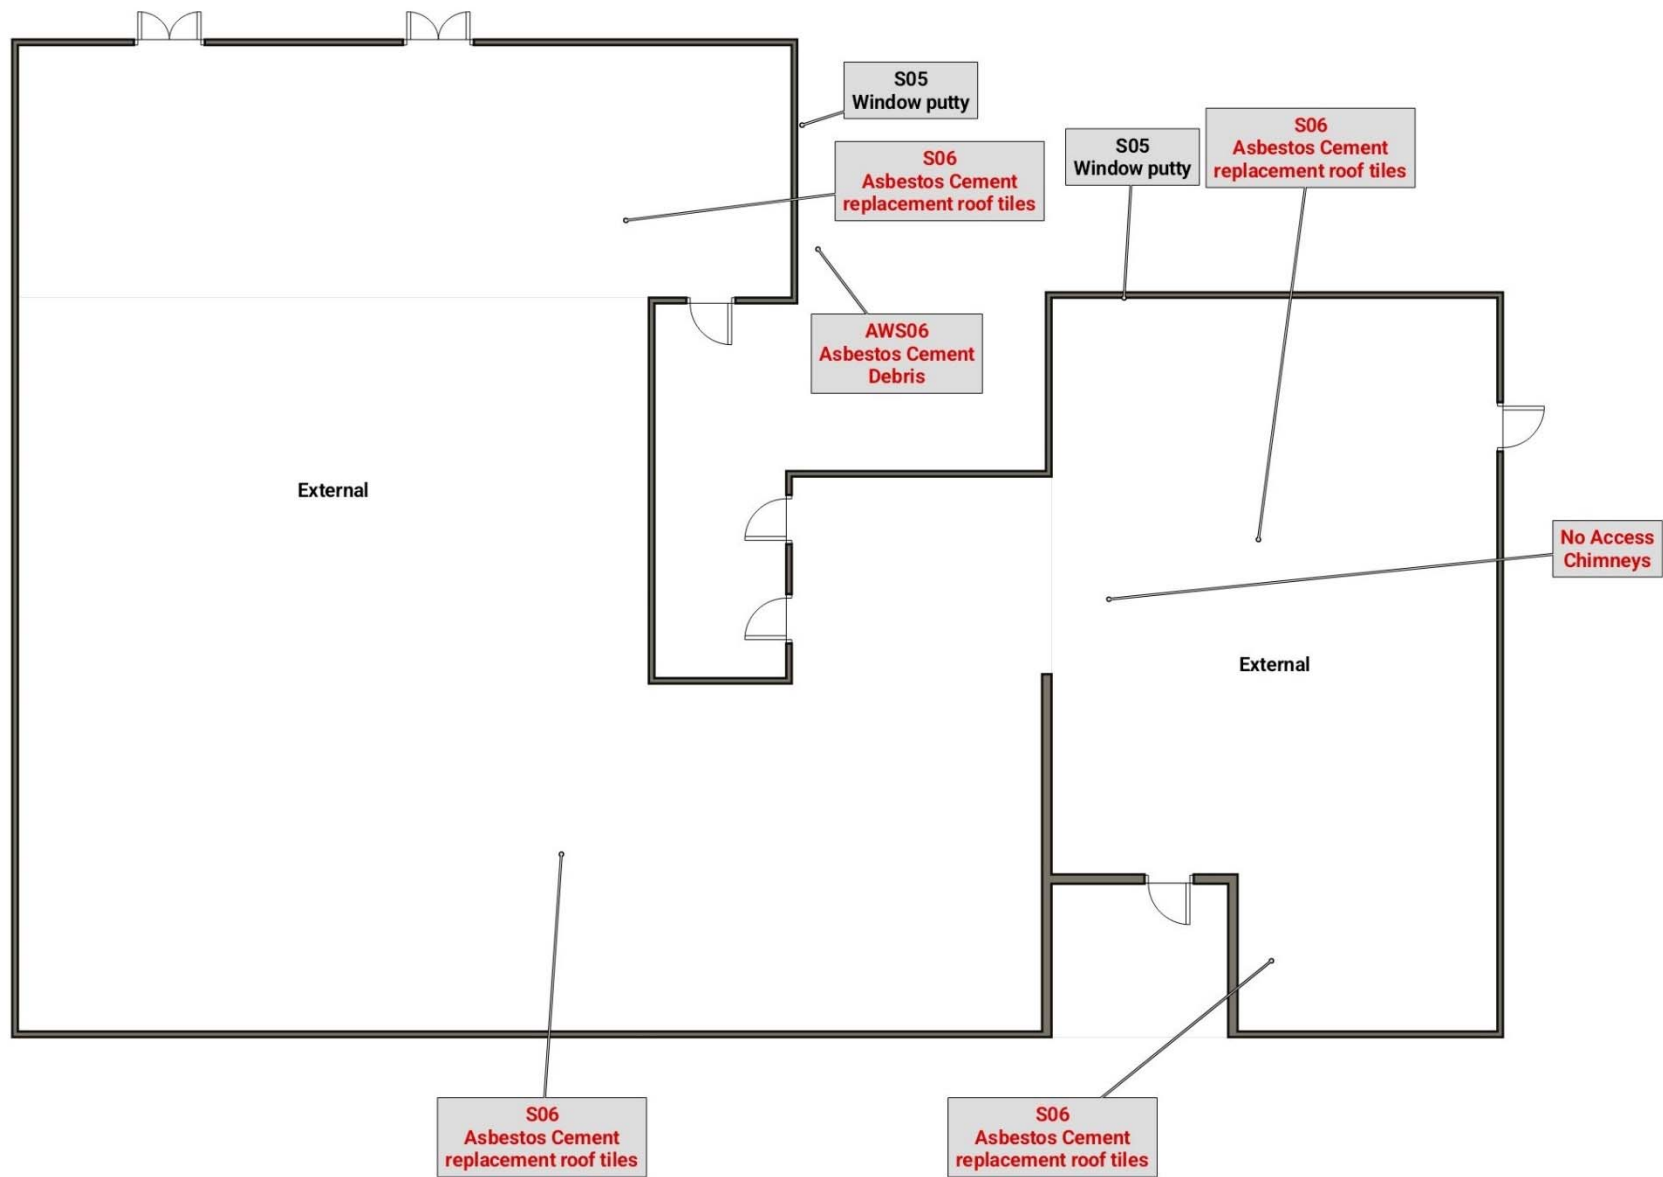
Material	Location
<b>Debris</b>	External – Asbestos Cement roof tile debris
<b>Sprayed Coatings (Flock)</b>	-
<b>Thermal Insulation</b>	-
<b>Asbestos Insulation Board (AIB)</b>	-
<b>Insulation</b>	-
<b>Textiles</b>	-
<b>Gaskets</b>	-
<b>Paper</b>	-
<b>Friction Products</b>	-
<b>Cement Products</b>	External – Replacement Asbestos Cement roof tiles External – Roof tile debris
<b>Textured Coatings</b>	-
<b>Bitumen Products</b>	-
<b>Flooring materials</b>	-
<b>Reinforced PVC</b>	-
<b>Reinforced Plastics &amp; resin composites</b>	-
