Project address: The Horniman Museum and Gardens
 South Boiler Room

Pre Construction Information

Project number	238350
Date	17 August 2017
Client	The Horniman Museum and Gardens

**South Boiler Room Asbestos Removal
PRE CONSTRUCTION INFORMATION**

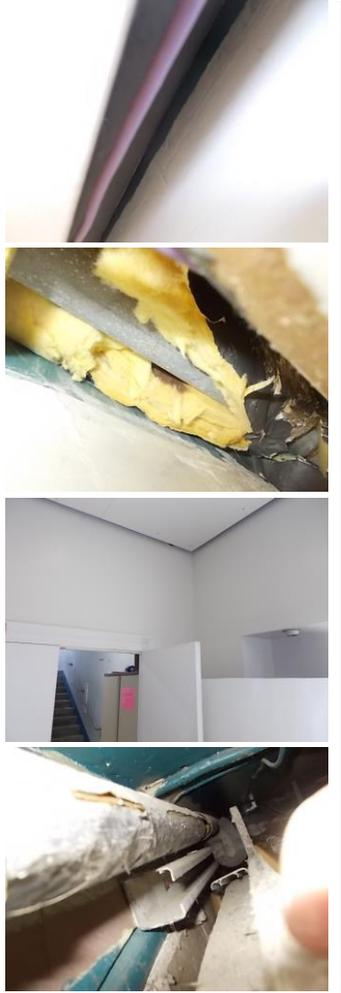
Room/Area	Observation/Comment	Inspection/ Sample No.	Analysis Result	Product	Quantity	Extent of Damage	Surface Treatment	Recommendation	Photo
LG.02 South Hall Entrance	Inspection 06 continued.	06	-	-	-	-	-	-

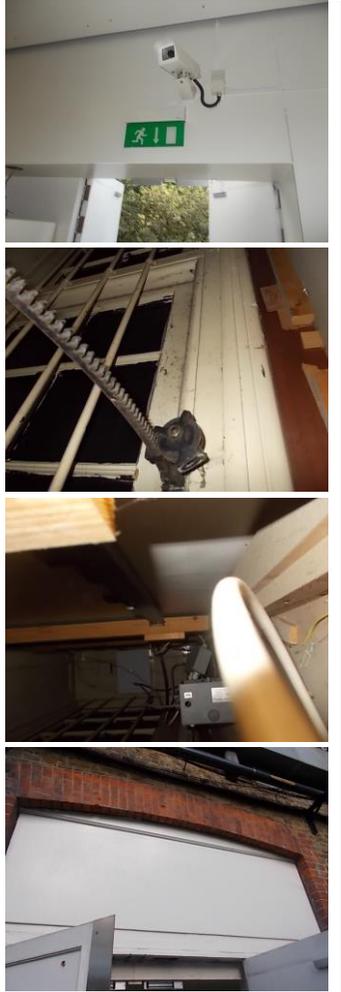
Room/Area	Observation/Comment	Inspection/ Sample No.	Analysis Result	Product	Quantity	Extent of Damage	Surface Treatment	Recommendation	Photo
LG.02 South Hall Entrance	Inspection 06 continued.	06	-	-	-	-	-	-

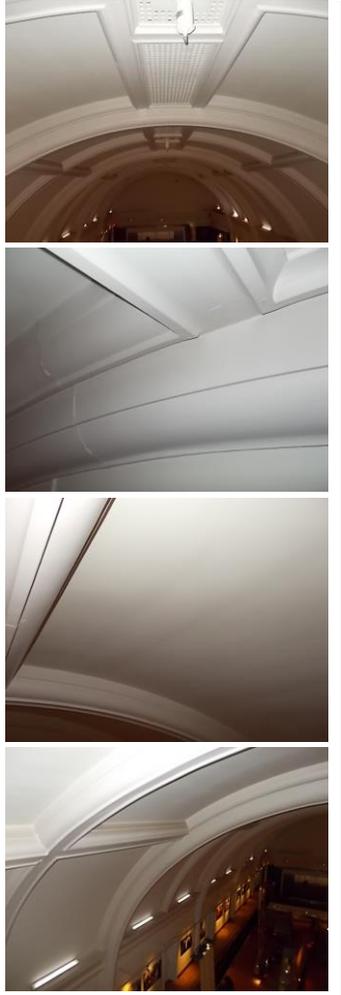
Room/Area	Observation/Comment	Inspection/ Sample No.	Analysis Result	Product	Quantity	Extent of Damage	Surface Treatment	Recommendation	Photo
G.03 Balcony	<p>South Hall Gallery ceiling: Lath and plaster decorative coving with RSJ beams behind. Plasterboard and timber ceiling boards. Lath and plaster grid ceiling panels. Redundant metal lighting pulley with a metal plate. Solid walls. Note: the remaining ceiling is at a higher elevation due to its location. Further investigations will take place once the roof is lifted.</p>	28	-	-	-	-	-	-

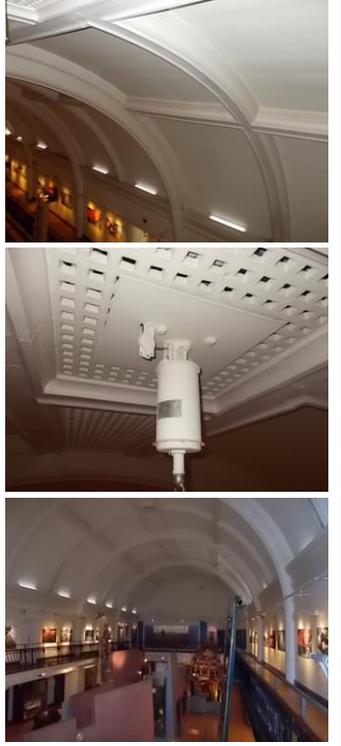
Room/Area	Observation/Comment	Inspection/ Sample No.	Analysis Result	Product	Quantity	Extent of Damage	Surface Treatment	Recommendation	Photo
G.03 Balcony	Inspection 28 continued.	28	-	-	-	-	-	-

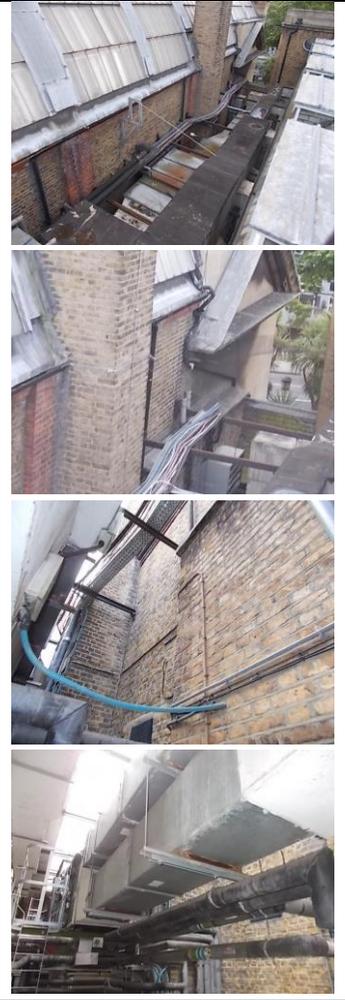
Room/Area	Observation/Comment	Inspection/ Sample No.	Analysis Result	Product	Quantity	Extent of Damage	Surface Treatment	Recommendation	Photo
E.01 Lower Ground Courtyard	Brick walls with a metal grid floor and concrete slab floor. Cast iron gutters and metal down pipes. Bare and MMMF lagged ductwork. Flow and return gas pipes. Black armour wrapped pipes. Air extraction appliances.	16	-	-	-	-	-	-

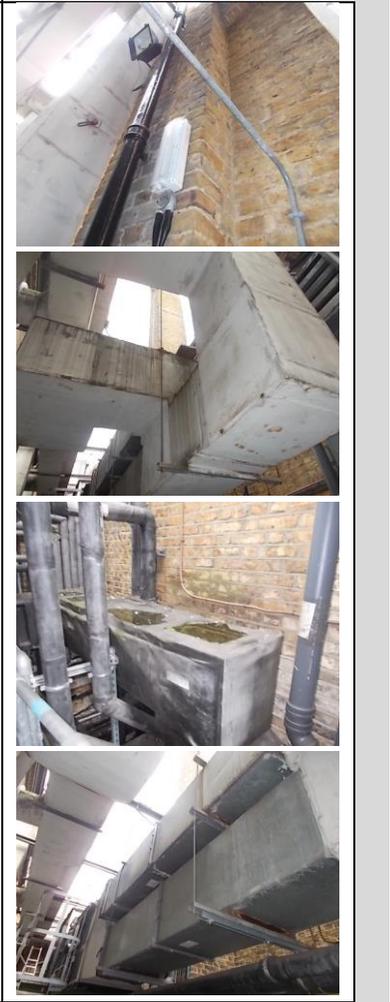
Room/Area	Observation/Comment	Inspection/ Sample No.	Analysis Result	Product	Quantity	Extent of Damage	Surface Treatment	Recommendation	Photo
E.01 Lower Ground Courtyard	Inspection 16 continued.	16	-	-	-	-	-	-

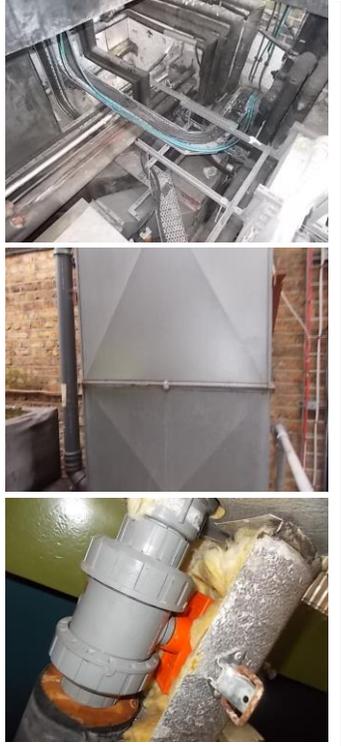
Room/Area	Observation/Comment	Inspection/ Sample No.	Analysis Result	Product	Quantity	Extent of Damage	Surface Treatment	Recommendation	Photo
E.01 Lower Ground Courtyard	Inspection 16 continued.	16	-	-	-	-	-	-

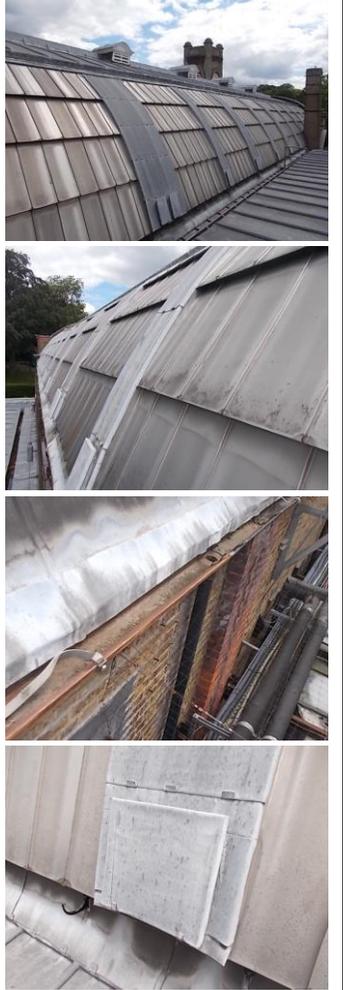
Room/Area	Observation/Comment	Inspection/ Sample No.	Analysis Result	Product	Quantity	Extent of Damage	Surface Treatment	Recommendation	Photo
E.02 Roof	Metal fascia roof covers and lead sheets. Timber and lead pent houses. RSJ beams, and timber joists and battens with hessian insulation fixed to them. Lath and plaster. Aluminium studwork clipped to the metal roof covers. Lead roof covers. Inspections were made through the access points.	23	-	-	-	-	-	-

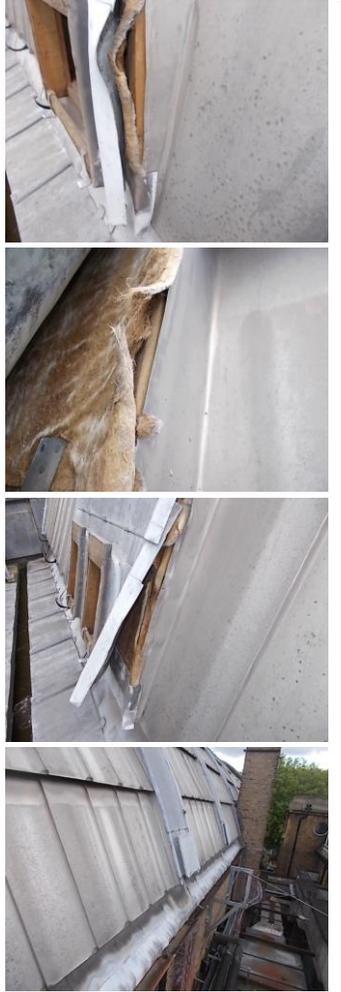
Room/Area	Observation/Comment	Inspection/ Sample No.	Analysis Result	Product	Quantity	Extent of Damage	Surface Treatment	Recommendation	Photo
E.02 Roof	Inspection 23 continued.	23	-	-	-	-	-	-

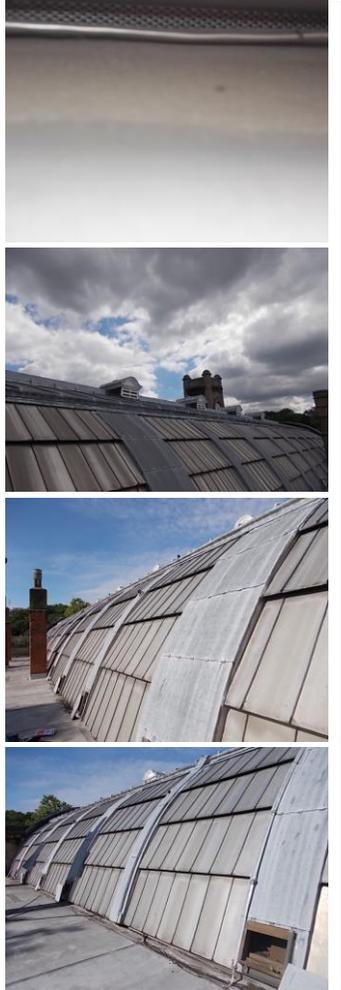
Room/Area	Observation/Comment	Inspection/ Sample No.	Analysis Result	Product	Quantity	Extent of Damage	Surface Treatment	Recommendation	Photo
E.02 Roof	Inspection 23 continued.	23	-	-	-	-	-	-

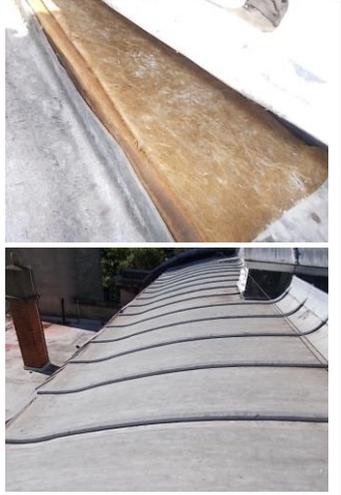
Room/Area	Observation/Comment	Inspection/ Sample No.	Analysis Result	Product	Quantity	Extent of Damage	Surface Treatment	Recommendation	Photo
E.02 Roof	Inspection 38 continued.	38	-	-	-	-	-	-

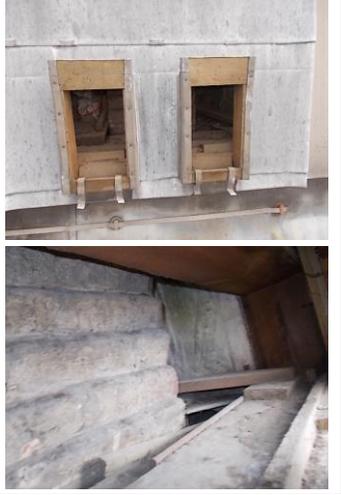
E.03 Roof	Lead access panel. Timber joists and battens, and an RSJ beam. Brick wall and lath and plaster.	24	-	-	-	-	-	-

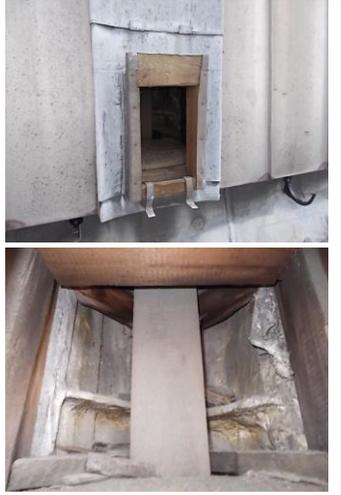
Room/Area	Observation/Comment	Inspection/ Sample No.	Analysis Result	Product	Quantity	Extent of Damage	Surface Treatment	Recommendation	Photo
E.04 Roof	Lead access panel. Timber joists and battens, and an RSJ beam. Brick wall and lath and plaster.	25	-	-	-	-	-	-

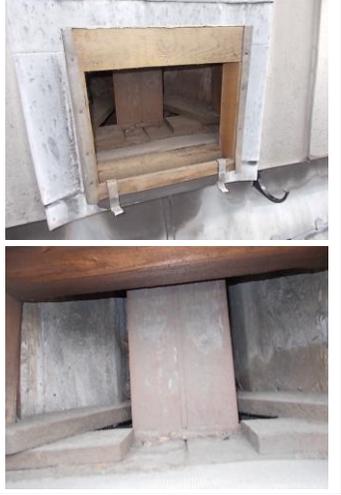
E.05 Roof	Lead access panel. Timber joists and battens, and an RSJ beam. Brick wall and lath and plaster.	26	-	-	-	-	-	-

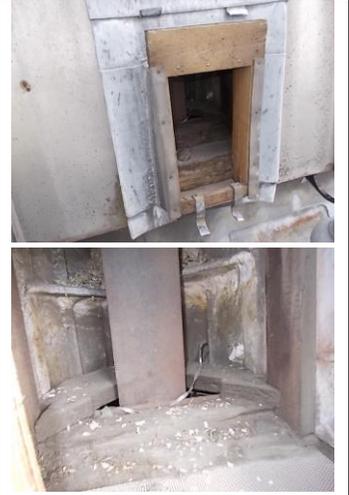
Room/Area	Observation/Comment	Inspection/ Sample No.	Analysis Result	Product	Quantity	Extent of Damage	Surface Treatment	Recommendation	Photo
E.06 Roof	Lead access panel. Timber joists and battens, and an RSJ beam. Brick wall and lath and plaster.	27	-	-	-	-	-	-

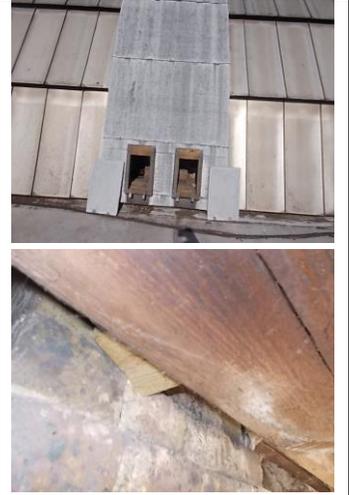
E.07 Roof	Lead access panel. Timber joists and battens, and an RSJ beam. Brick wall and lath and plaster.	29	-	-	-	-	-	-

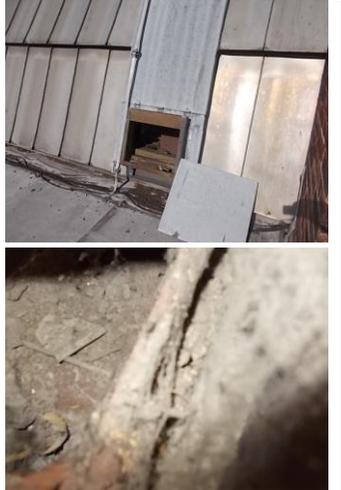
Room/Area	Observation/Comment	Inspection/ Sample No.	Analysis Result	Product	Quantity	Extent of Damage	Surface Treatment	Recommendation	Photo
E.09 Roof	Lead access panel. Timber joists and battens, and an RSJ beam. Brick wall and lath and plaster.	31	-	-	-	-	-	-

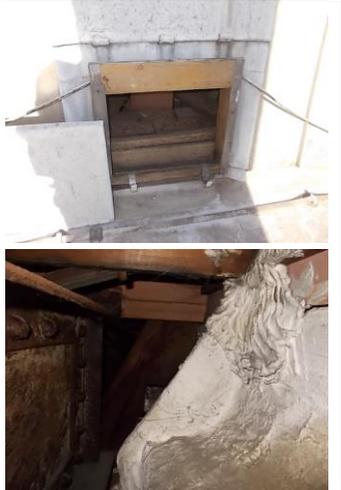
E.10 Roof	Lead access panel. Timber joists and battens, and an RSJ beam. Brick wall and lath and plaster.	32	-	-	-	-	-	-

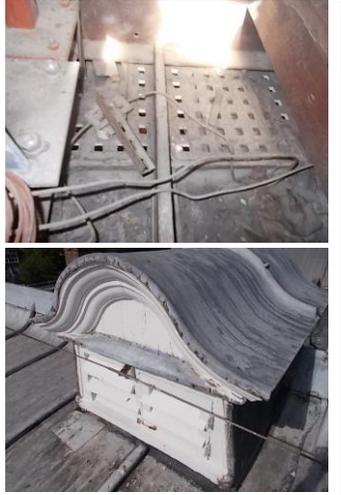
E.12	Timber and lead construction. RSJ beam and a lath and plaster grid ceiling.	34	-	-	-	-	-	-

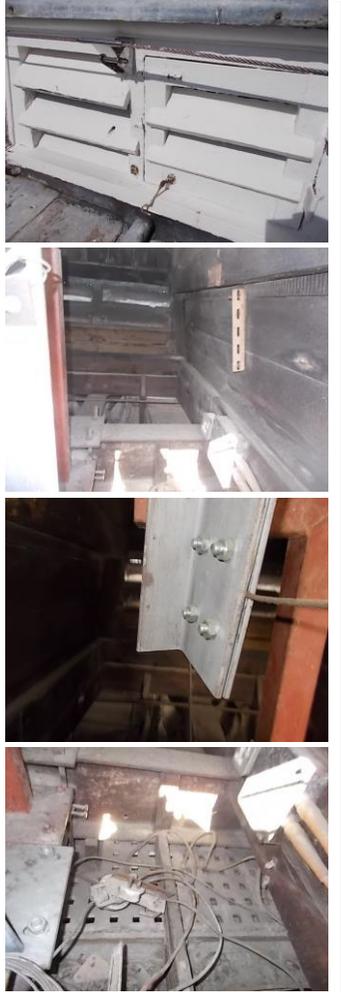
Room/Area	Observation/Comment	Inspection/ Sample No.	Analysis Result	Product	Quantity	Extent of Damage	Surface Treatment	Recommendation	Photo
E.13	Timber and lead construction. RSJ beam and a lath and plaster grid ceiling.	35	-	-	-	-	-	-

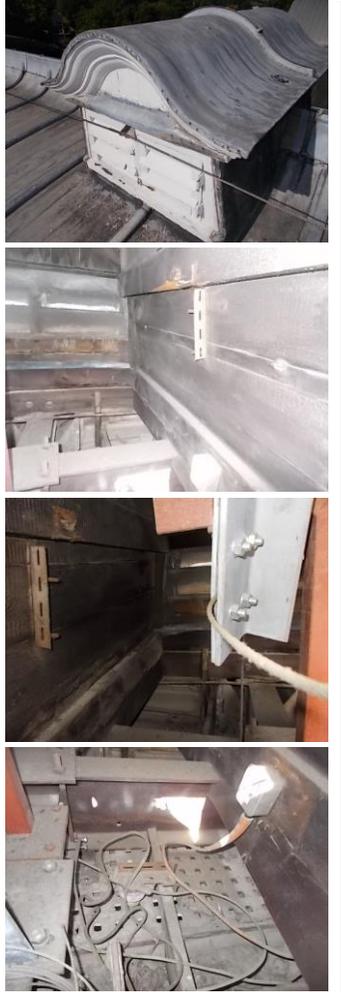
Room/Area	Observation/Comment	Inspection/ Sample No.	Analysis Result	Product	Quantity	Extent of Damage	Surface Treatment	Recommendation	Photo
E.14	Timber and lead construction. RSJ beam and a lath and plaster grid ceiling.	36	-	-	-	-	-	-

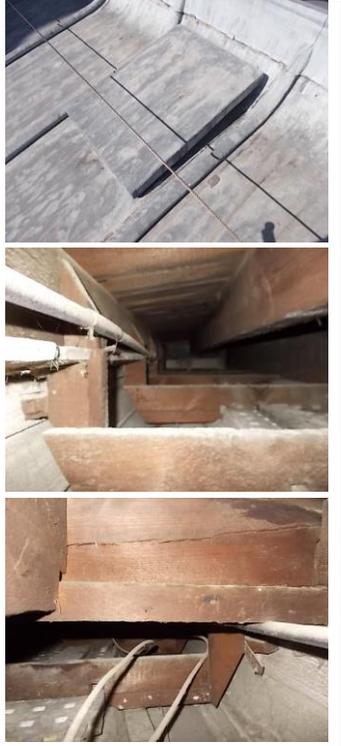
Room/Area	Observation/Comment	Inspection/ Sample No.	Analysis Result	Product	Quantity	Extent of Damage	Surface Treatment	Recommendation	Photo
E.15 Access Cover	Lead access cover. Timber joists and battens. RSJ beams.	37	-	-	-	-	-	-

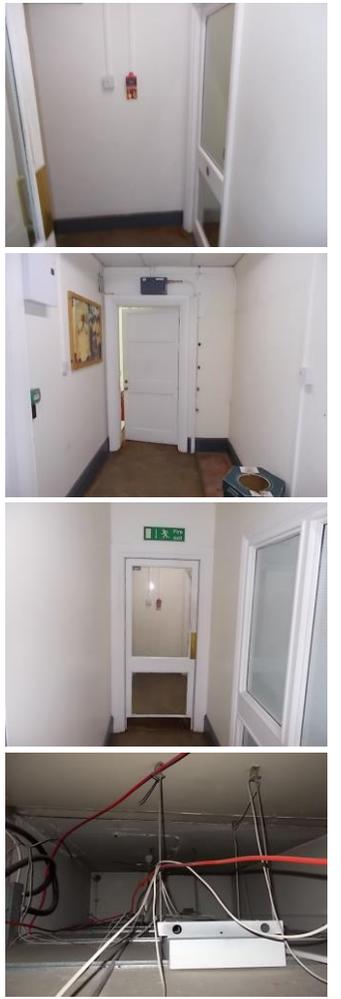
Room/Area	Observation/Comment	Inspection/ Sample No.	Analysis Result	Product	Quantity	Extent of Damage	Surface Treatment	Recommendation	Photo
1.01 Corridor	Solid soffit ceiling and a fibreboard suspended ceiling. Solid casing to the ceiling. Solid and plasterboard walls. Timber parquet floor. Metal conduit electric distribution box unlagged metal pipe with metal collars.	01	-	-	-	-	-	-

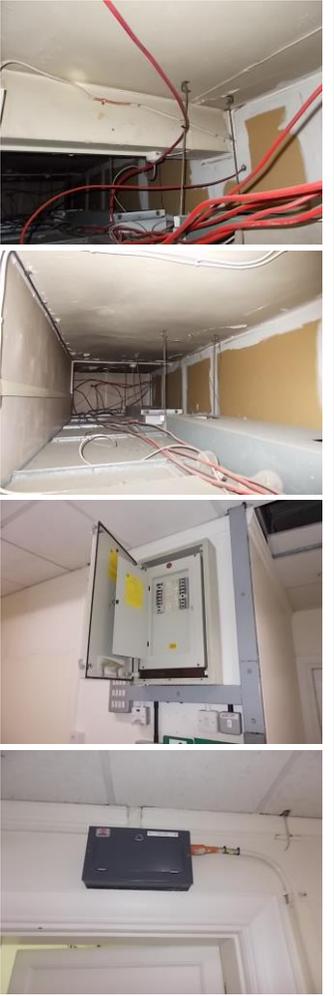
Room/Area	Observation/Comment	Inspection/ Sample No.	Analysis Result	Product	Quantity	Extent of Damage	Surface Treatment	Recommendation	Photo
1.01 Corridor	Inspection 01 continued.	01	-	-	-	-	-	-

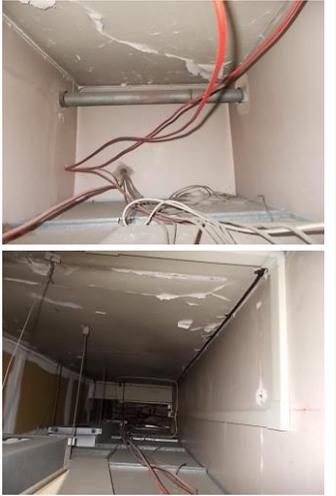
Room/Area	Observation/Comment	Inspection/ Sample No.	Analysis Result	Product	Quantity	Extent of Damage	Surface Treatment	Recommendation	Photo
1.01 Corridor	Inspection 01 continued.	01	-	-	-	-	-	-

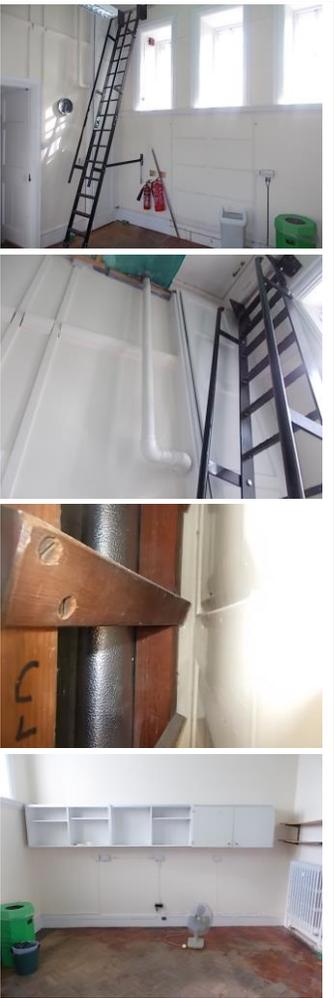
Room/Area	Observation/Comment	Inspection/ Sample No.	Analysis Result	Product	Quantity	Extent of Damage	Surface Treatment	Recommendation	Photo
1.02 Office	Solid soffit ceiling. Solid walls and timber parquet floor. Timber loft hatch door. MMMF lagged metal pipes beneath metal radiators. Unlagged metal pipe. Timber riser boxing with unlagged metal pipes.	04	-	-	-	-	-	-

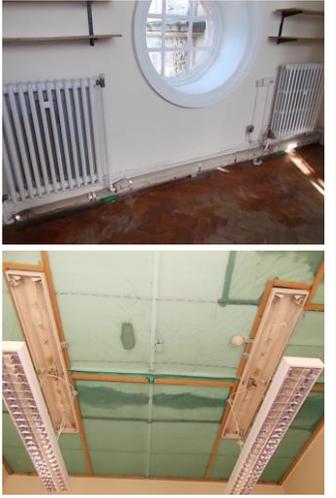
Room/Area	Observation/Comment	Inspection/ Sample No.	Analysis Result	Product	Quantity	Extent of Damage	Surface Treatment	Recommendation	Photo
1.02 Office	Inspection 04 continued.	04	-	-	-	-	-	-

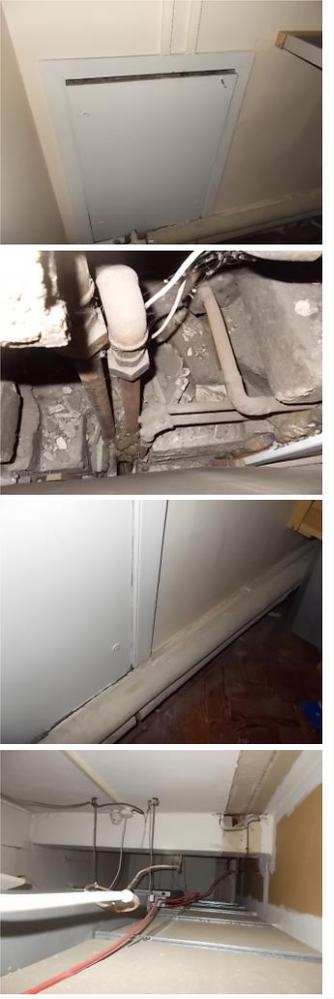
Room/Area	Observation/Comment	Inspection/ Sample No.	Analysis Result	Product	Quantity	Extent of Damage	Surface Treatment	Recommendation	Photo
1.03 Office and Lobby	Inspection 07 continued.	07	-	-	-	-	-	-

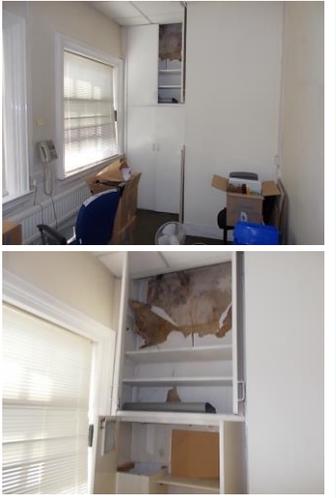
1.04 Office	Solid soffit ceiling and fibreboard suspended ceiling. Solid walls. Carpet over the timber parquet floor. Unlagged metal pipe at high level with a metal collar. Timber cupboard and boxing within, housing unlagged and MMMF lagged metal pipes. Unlagged metal pipes at low level beneath the metal radiator.	10	-	-	-	-	-	-

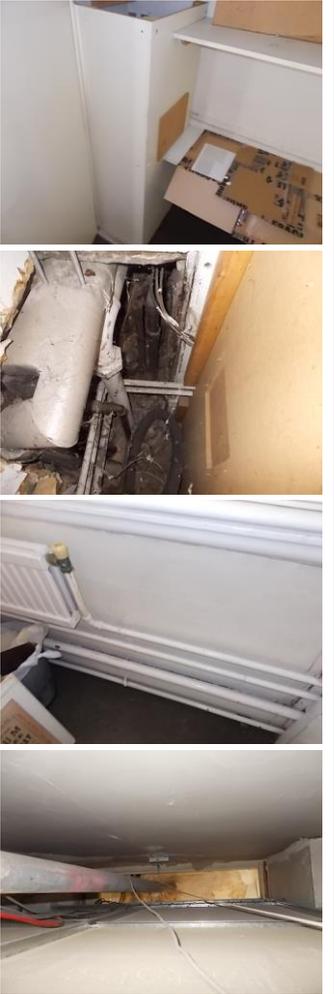
Room/Area	Observation/Comment	Inspection/ Sample No.	Analysis Result	Product	Quantity	Extent of Damage	Surface Treatment	Recommendation	Photo
1.04 Office	Inspection 10 continued.	10	-	-	-	-	-	-

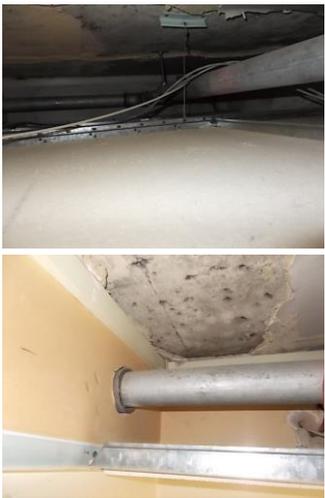
1.04 Office	Clinker to the ceiling.	11	Non- asbestos	Cement	14m ²	Medium	Cement	N/A

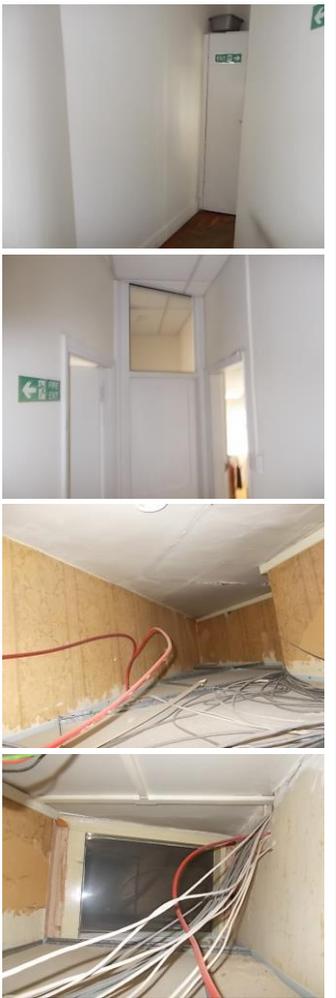
Room/Area	Observation/Comment	Inspection/ Sample No.	Analysis Result	Product	Quantity	Extent of Damage	Surface Treatment	Recommendation	Photo
1.07 Corridor	Residue sampled to the low level pipe located beside the corridor door entrance.	18	Non- asbestos	Residue	<1m	Low	Sealed	N/A

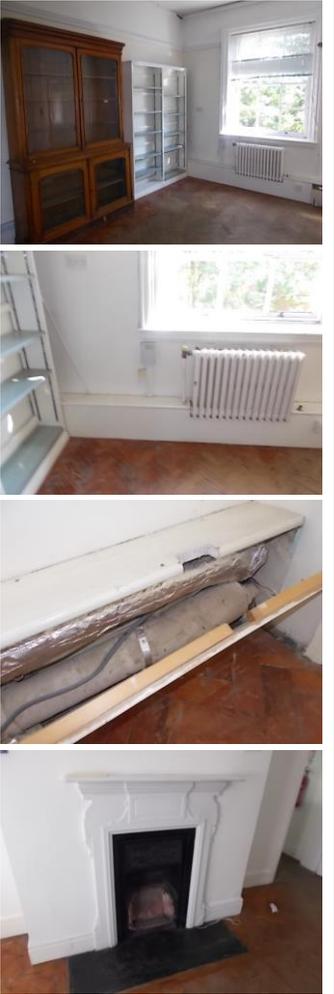
Room/Area	Observation/Comment	Inspection/ Sample No.	Analysis Result	Product	Quantity	Extent of Damage	Surface Treatment	Recommendation	Photo
1.10 Office	Clinker to the ceiling.	26	Non- asbestos	Cement	17m ²	Good Condition	Cement	N/A

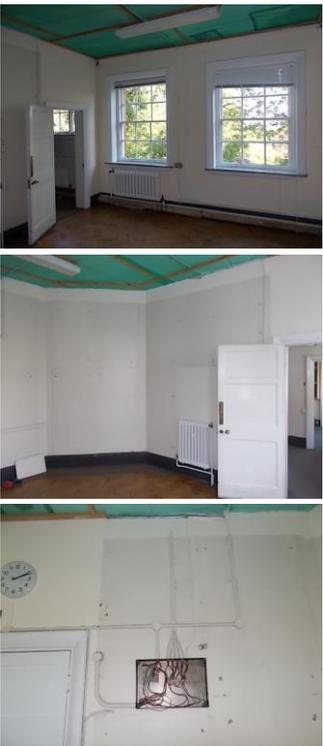
1.11 Office	Clinker to the ceiling.	29	Non- asbestos	Cement	22m ²	Good Condition	Cement	Remove

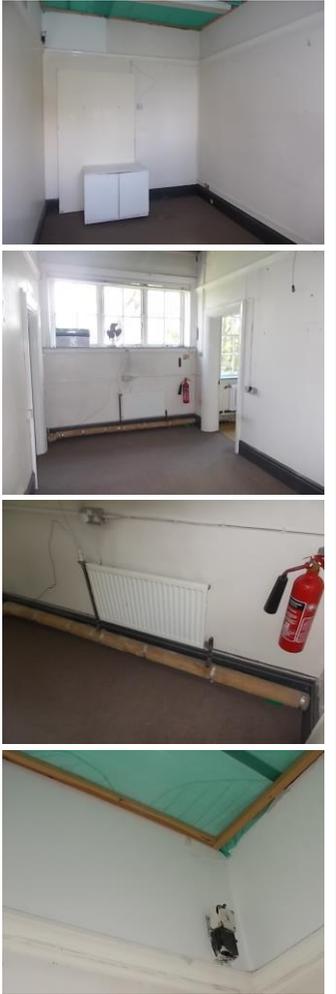
1.12 Office	Clinker to the ceiling.	31	Non- asbestos	Cement	14m ²	Good Condition	Cement	N/A

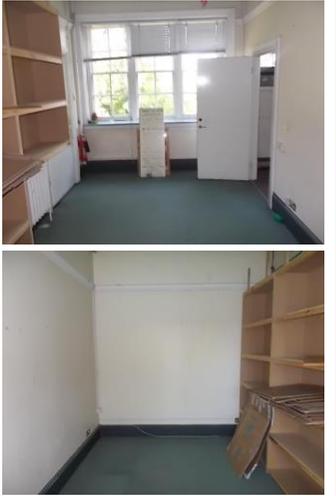
1.13 Office	Clinker to the ceiling.	34	Non- asbestos	Cement	15m ²	Good Condition	Cement	N/A
