Supplementary Geotechnical Investigation

**The Corby Cube
George Street
Corby
NN17 1QG**

**Report No: 19.12.006a
May 2020**

Report Title	Supplementary Geotechnical Investigation Report
Development	Existing Sheet Pile Wall
Project Address	The Corby Cube, George Street, Corby, NN17 1QG
Project Number	19.12.006a
Client	David Smith Associates

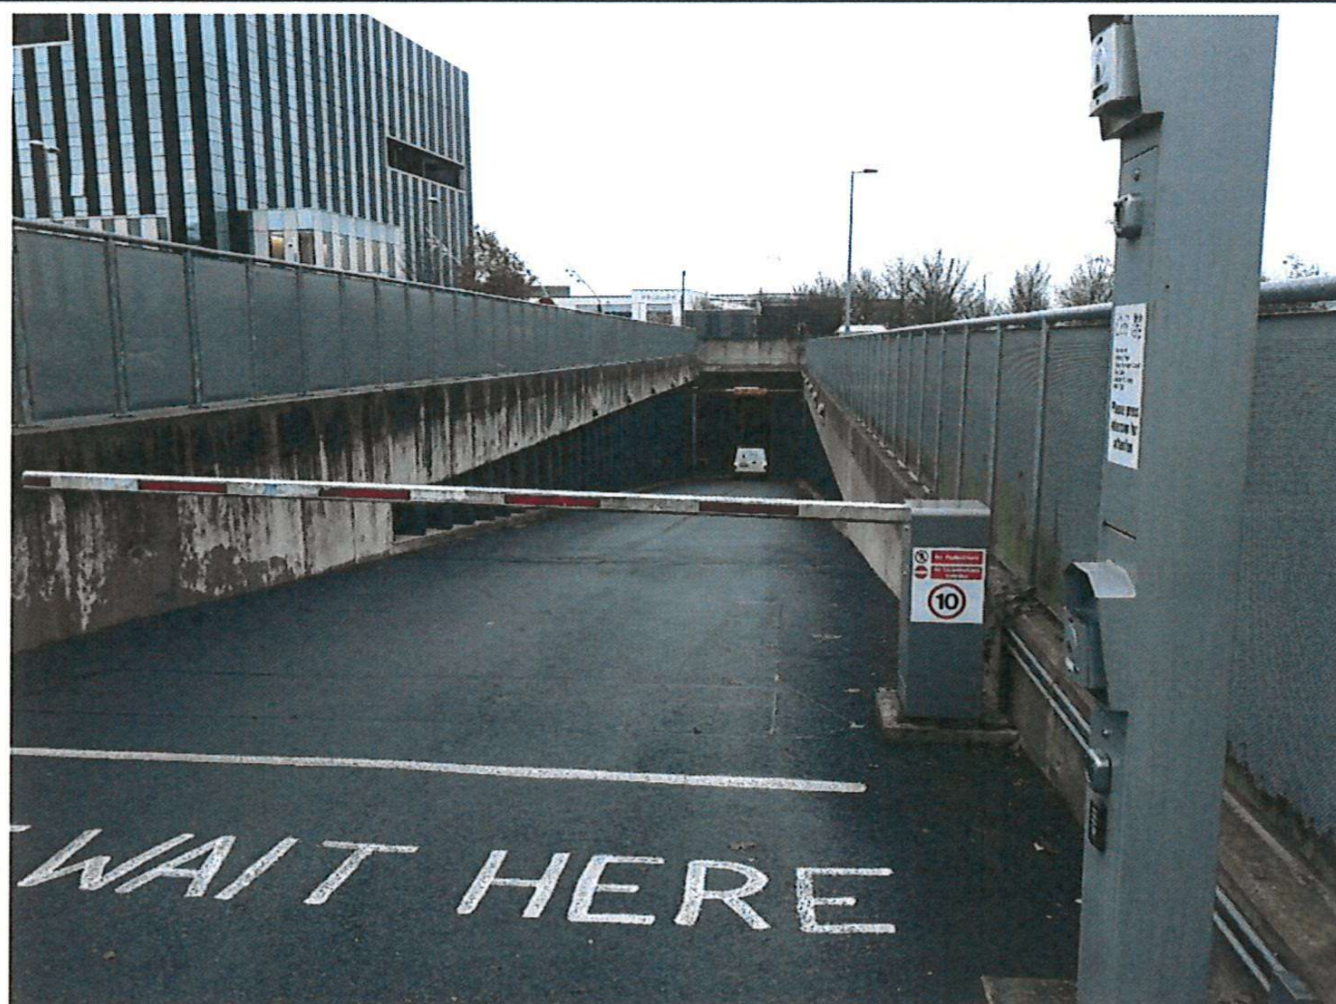
Photo 1: View to the east from the west of the site showing the asphalt ramp down to the basement

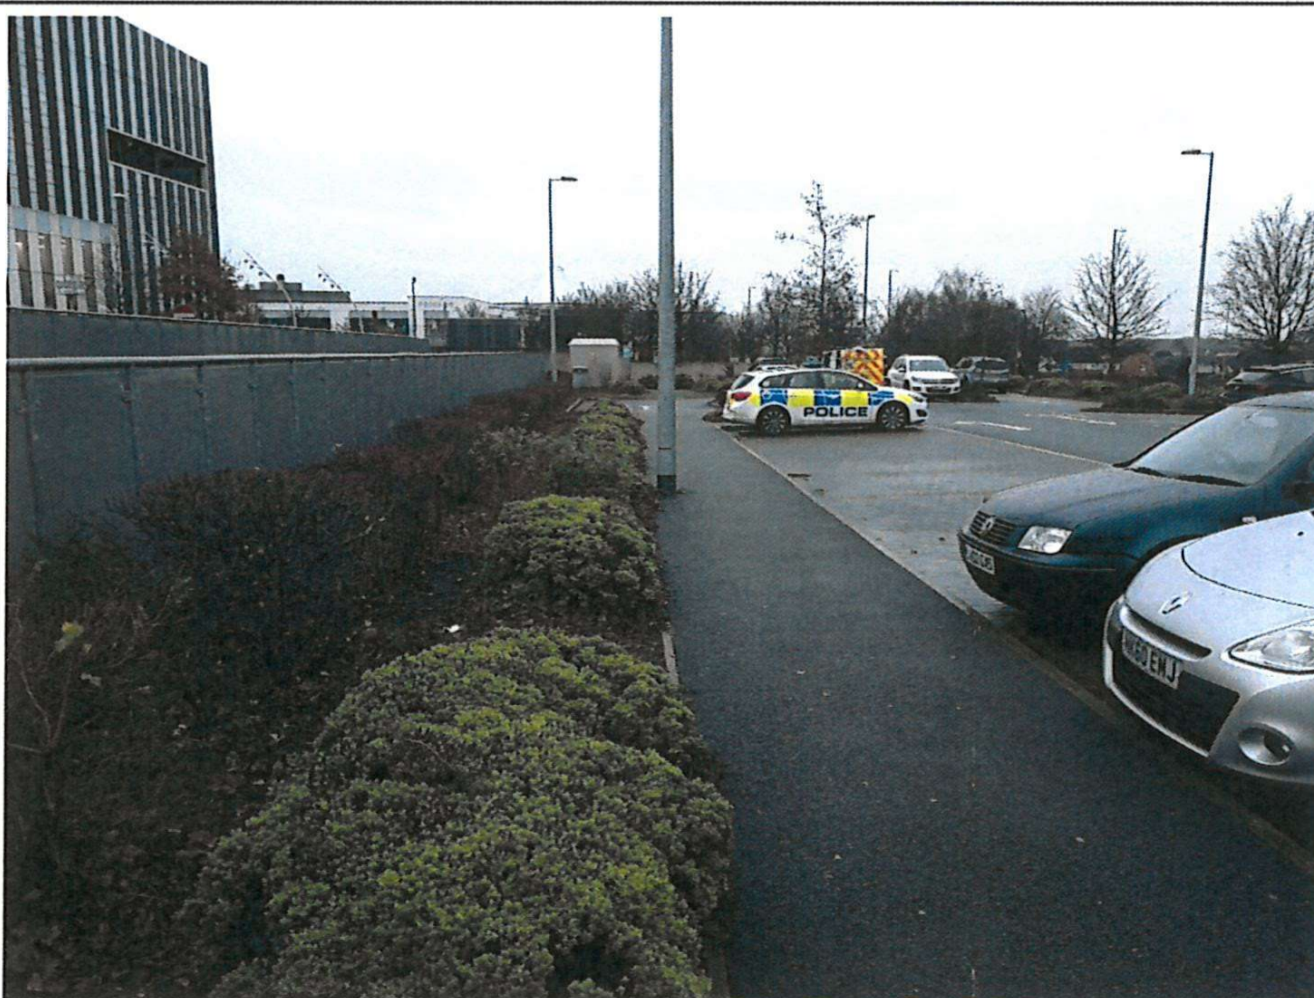
Photo 2: View to the east from in the southwest of the site showing the southern side of the ramp and looking towards the location of TP101 and TP102.

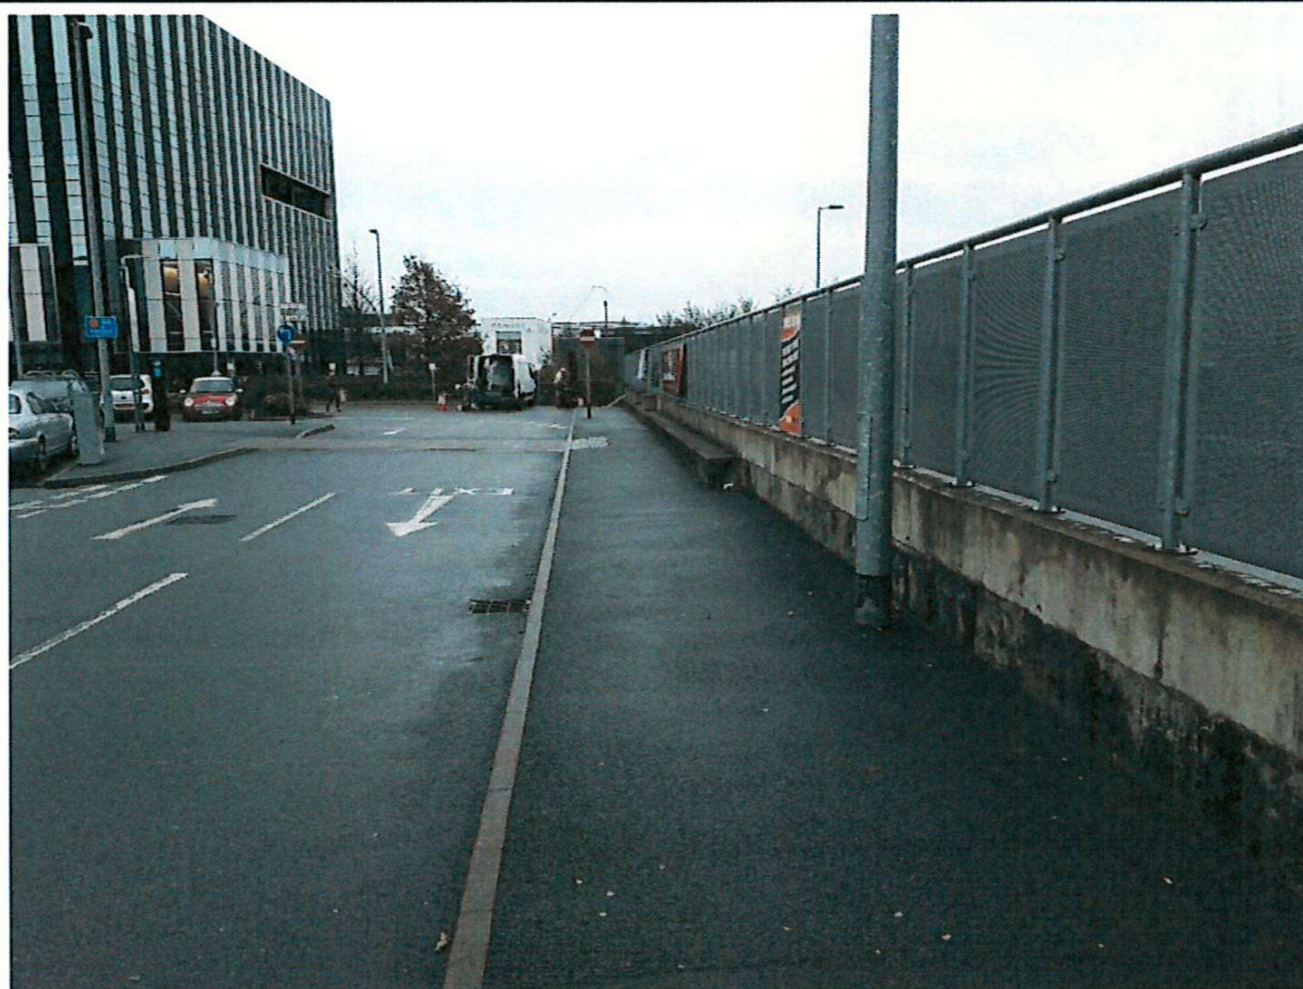
Photo 3: View to the east from in the northwest of the site showing the northern side of the ramp.

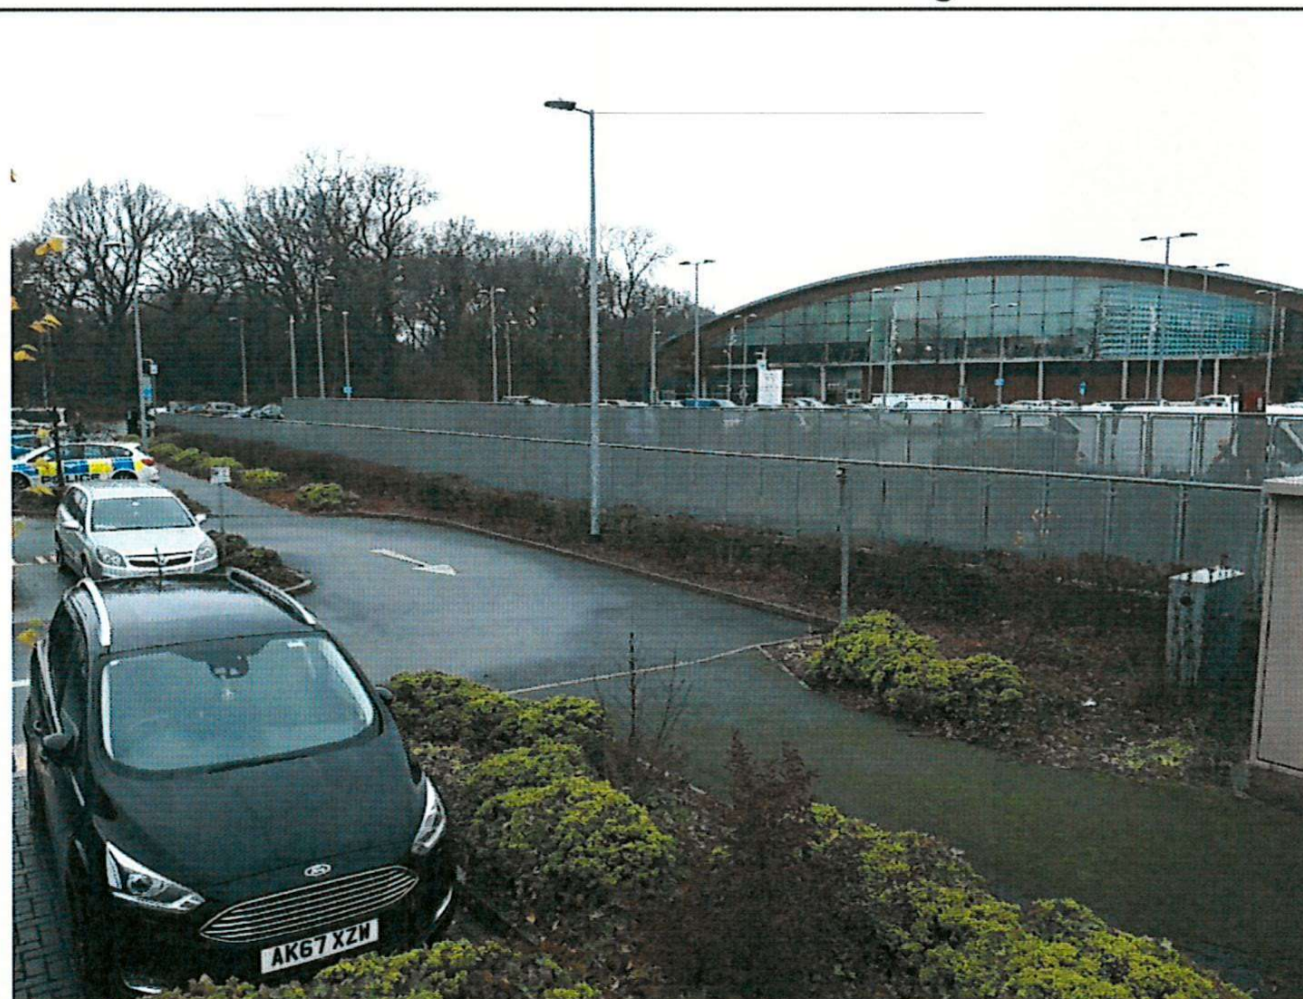
Photo 4: View to the northwest from in the southeast of the site showing the southern side of the ramp and looking towards the location of TP102 (right hand side of the photograph).

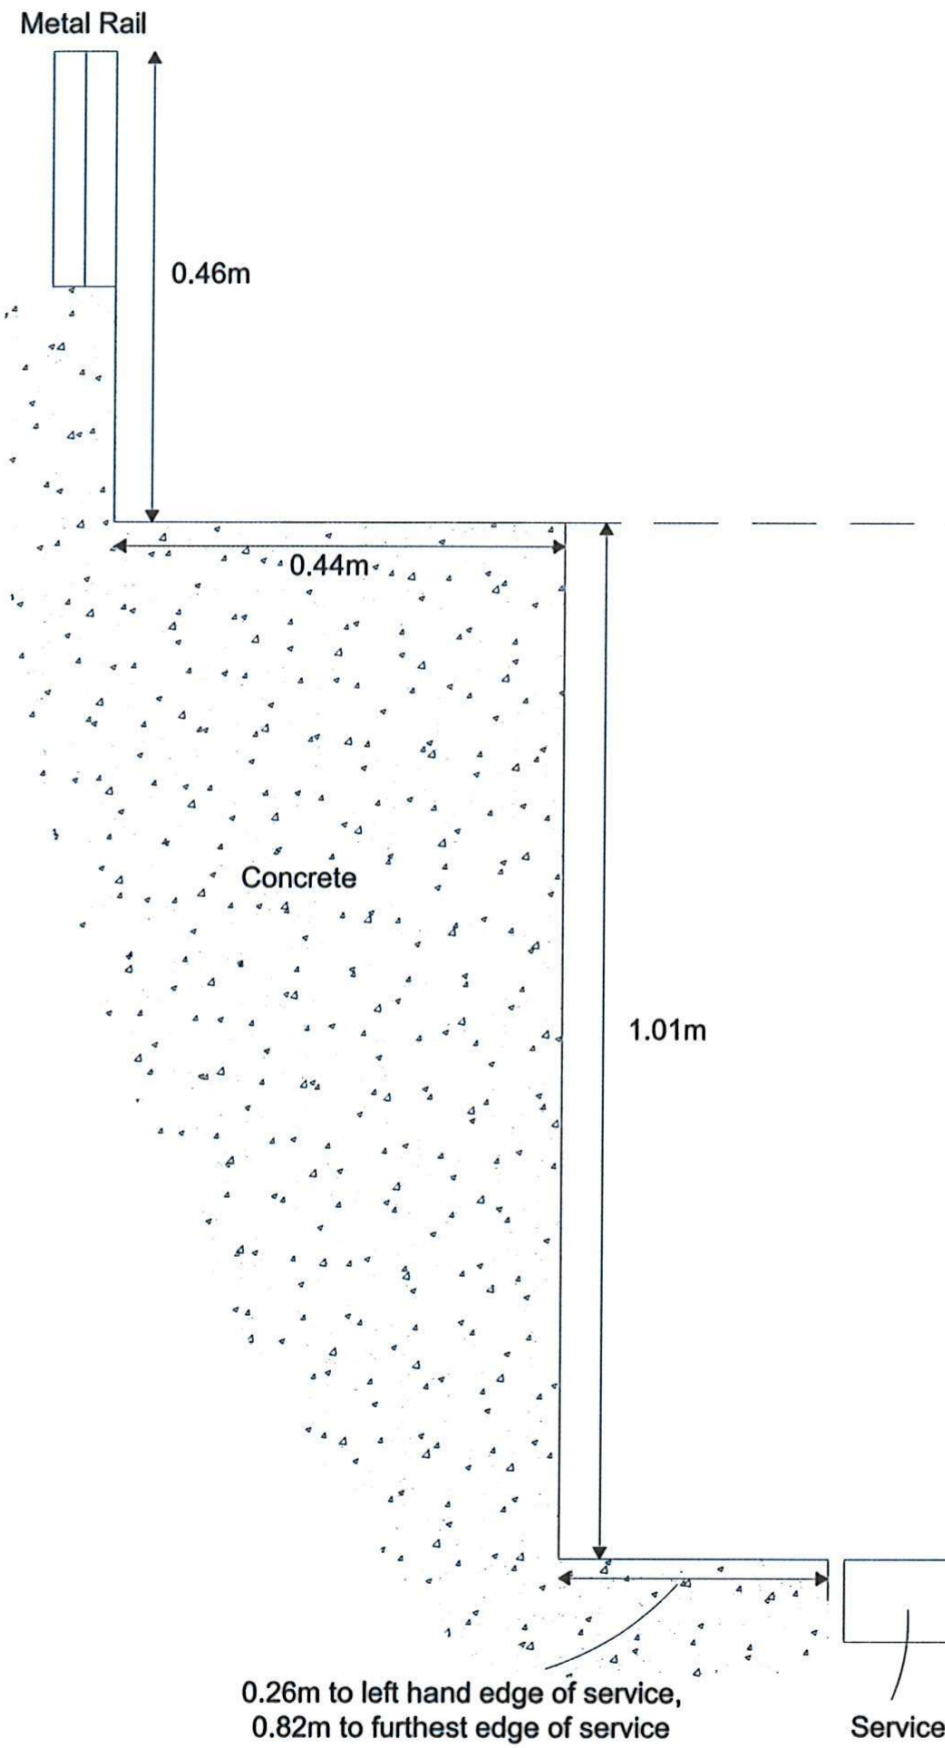
Foundation Profile	Stratum Description	Depth (m)	Legend	Samples

<p>Metal Rail</p> <p>0.46m</p> <p>0.44m</p> <p>Concrete</p> <p>1.01m</p> <p>0.26m to left hand edge of service, 0.82m to furthest edge of service</p> <p>Service</p> <p>End of Trial Pit at 1.05m</p>	TOPSOIL Soft dark brown slightly sandy slightly gravelly orgnaic CLAY with rare roots. Gravel is fine to coarse sub-rounded to angular quaertzite	GL		
	MADE GROUND Medium dense reddish brown very sandy fine to coarse angular GRAVEL	0.20		D - 0.50m
		1.05		D - 1.00m
