## HXH/4a Contract Specification (Masonry Repair and Waterproofing Installation)

**Client name:** National Highways – Historical Railways Estate  
**Project name:** HRE Works Framework  
**Client reference:** HXH/4a  
**Document no:** 0451200  
**Revision no:** 03  
**Date:** May 2023  
**Project no:** B38380DE  
**Project manager:** Nigel Robson  
**Prepared by:** Christopher Doig  
**File name:** HXH 4a NEC ECC

### **HRE WORKS FRAMEWORK HXH/4a 'WHEATLEY VIADUCT' CONTRACT FOR REMEDIAL REPAIRS AND WATERPROOFING**

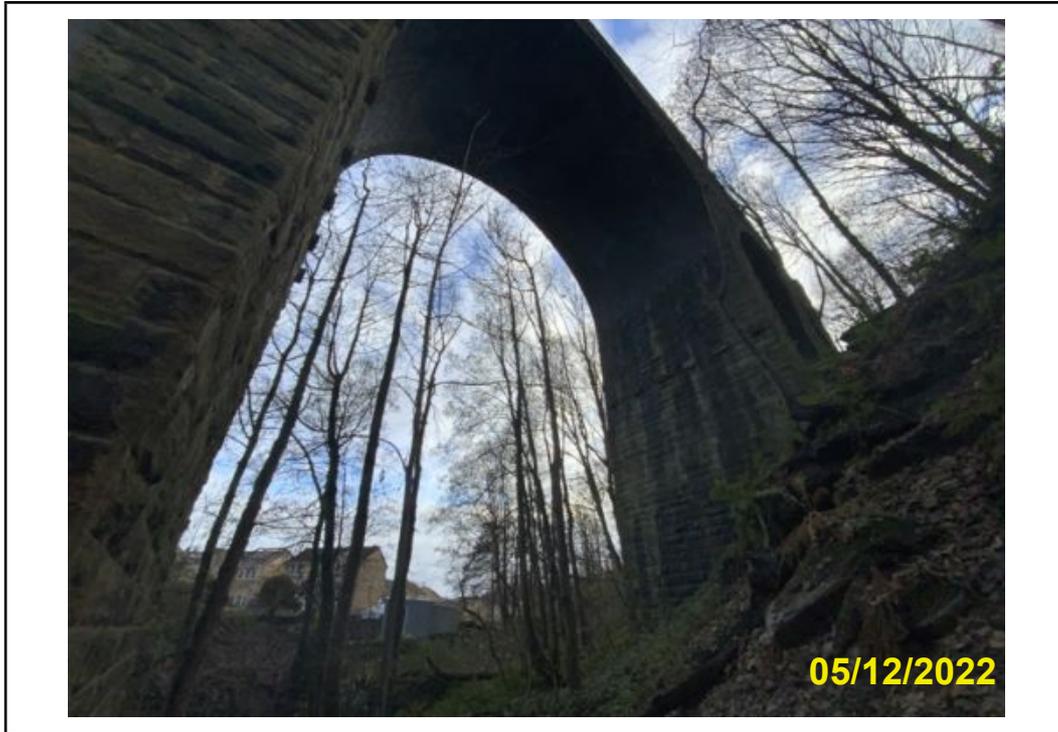
Photo No 13 - HXH - 199m 43chs - 0946yds - 43ch - Structure No - 4A - - 05/12/2022  
General Photo - General view of Span 8.

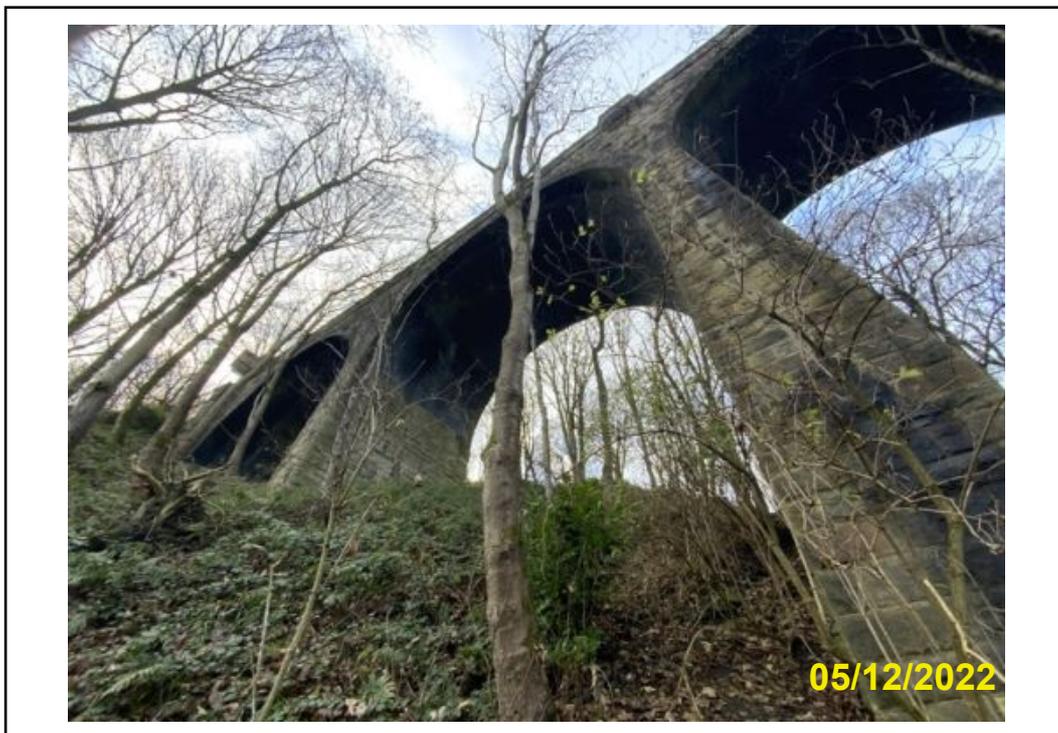
Photo No 14 - HXH - 199m 43chs - 0946yds - 43ch - Structure No - 4A - - 05/12/2022  
General Photo - General view of Span 9.

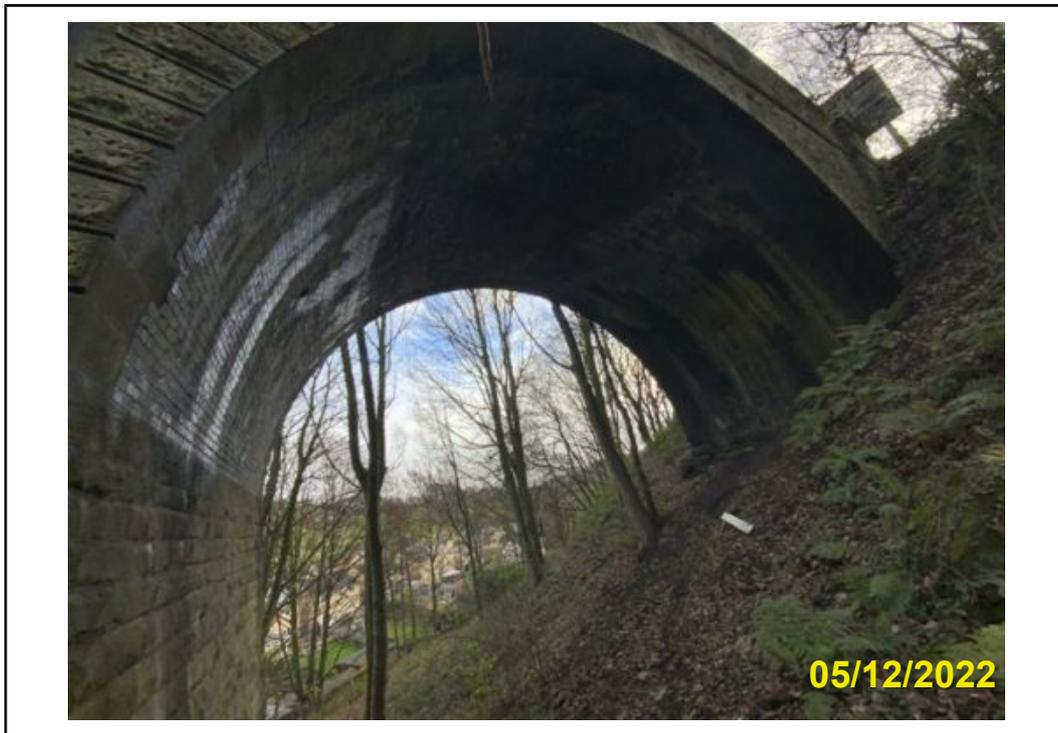
Photo No 15 - HXH - 199m - 0946yds - 43ch - Structure No - 4A - - 05/12/2022  
General Photo - General view of Span 10.

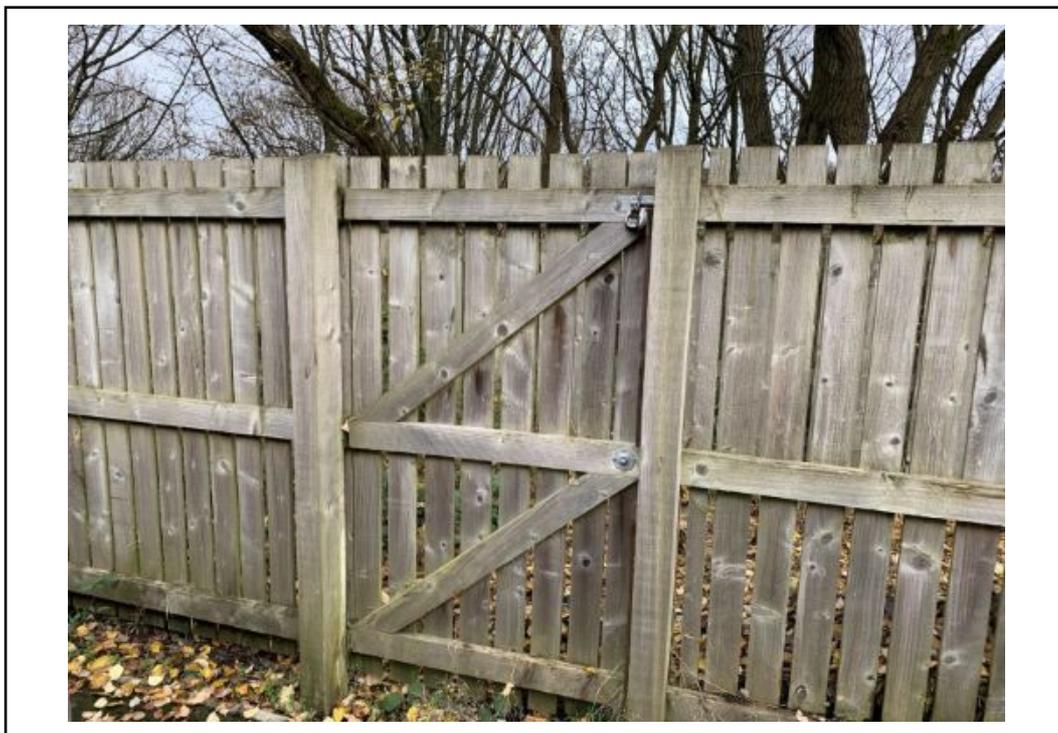
Photo No 16 - HXH - 199m - 0946yds - 43ch - Structure No - 4A - -  
General Photo - Locked gate to topside of structure at South end.

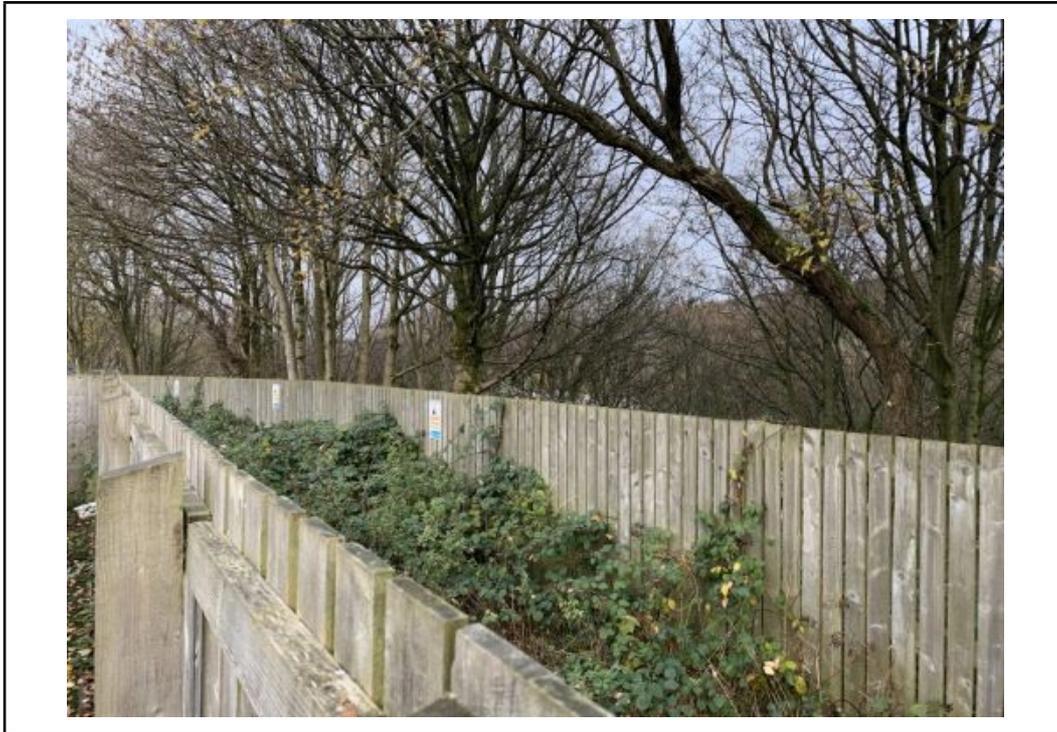
Photo No 17 - HXH - 199m - 0946yds - 43ch - Structure No - 4A - -  
General Photo - Unable to access topside at the South end due to fencing and vegetation.

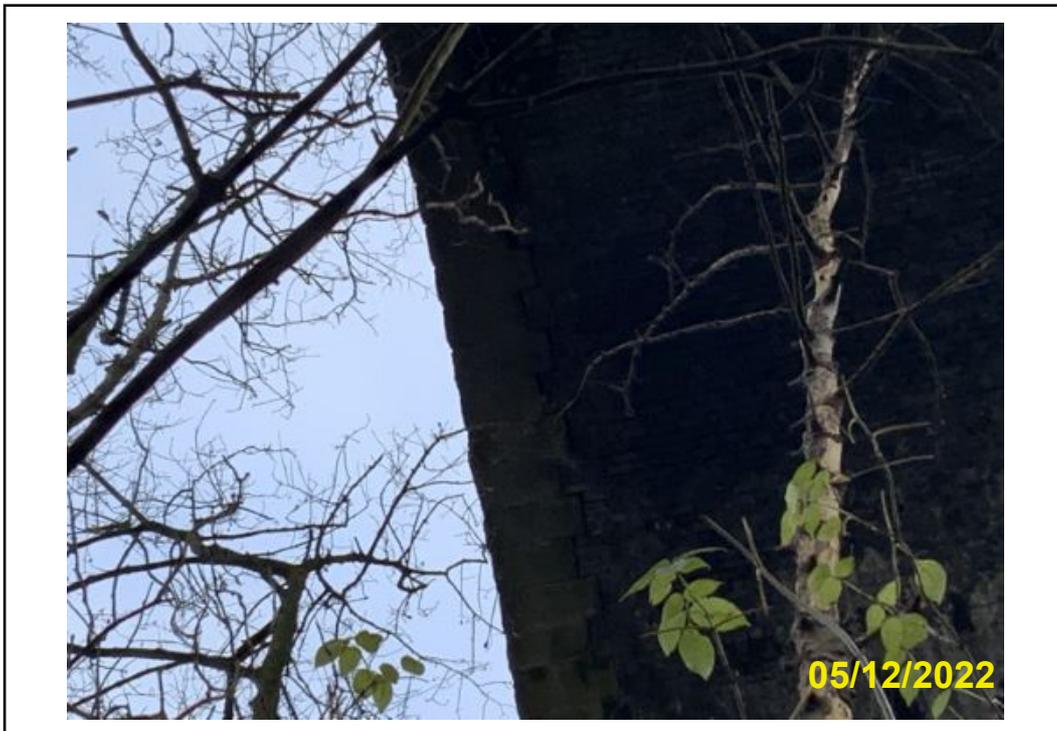
Photo No 18 - HXH - 199m - 0946yds - 43ch - Structure No - 4A - - 05/12/2022  
Defect Tracking - Ref - - Span 4 - Fracture behind West Voussiors with missing brickwork. Appears No further deterioration.

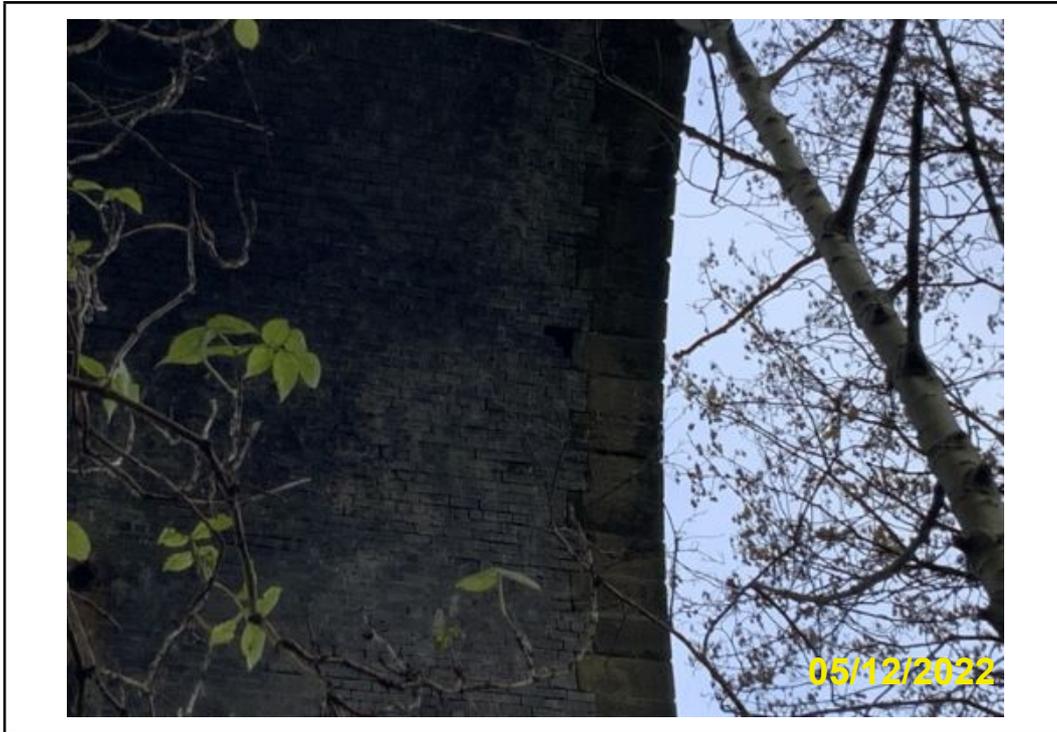
Photo No 19 - HXH - 199m - 0946yds - 43ch - Structure No - 4A - - 05/12/2022  
Defect Tracking - Ref - Span 4 - Missing brickwork to the Soffit.

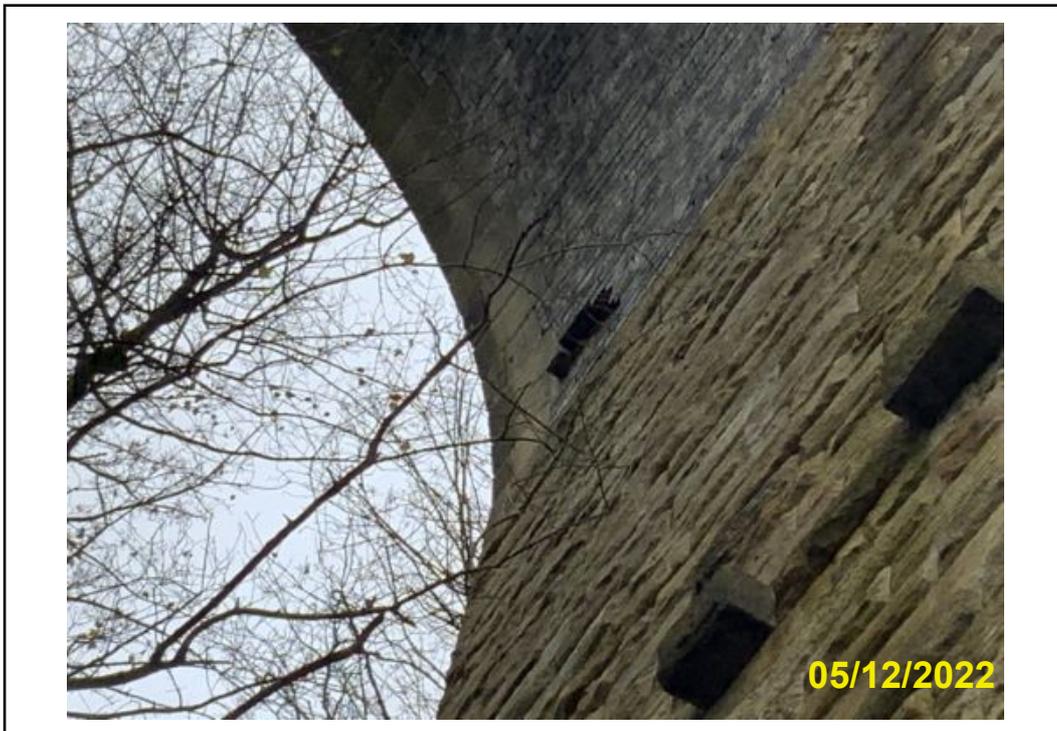
Photo No 20 - HXH - 199m - 0946yds - 43ch - Structure No - 4A - - 05/12/2022  
Defect Tracking - Ref - Span 5 - Missing brickwork to the Soffit.

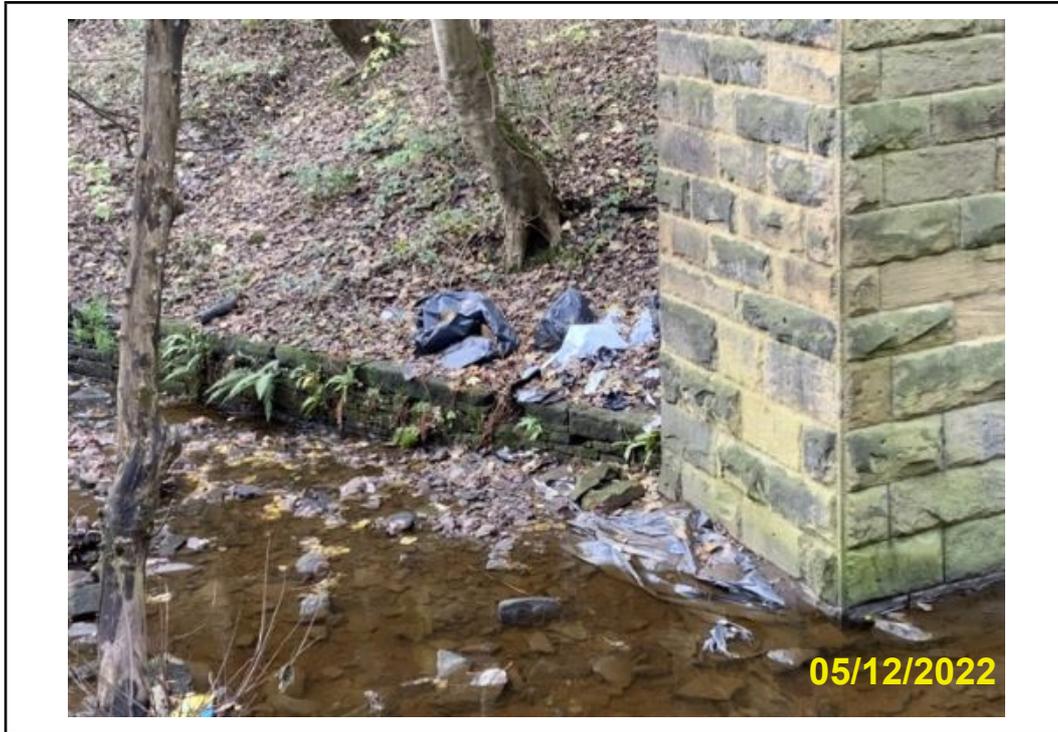
Photo No 21 - HXH - 199m - 0946yds - 43ch - Structure No - 4A - - 05/12/2022  
Defect Tracking - Ref - Rubbish and fly tipping present beneath multiple Spans.

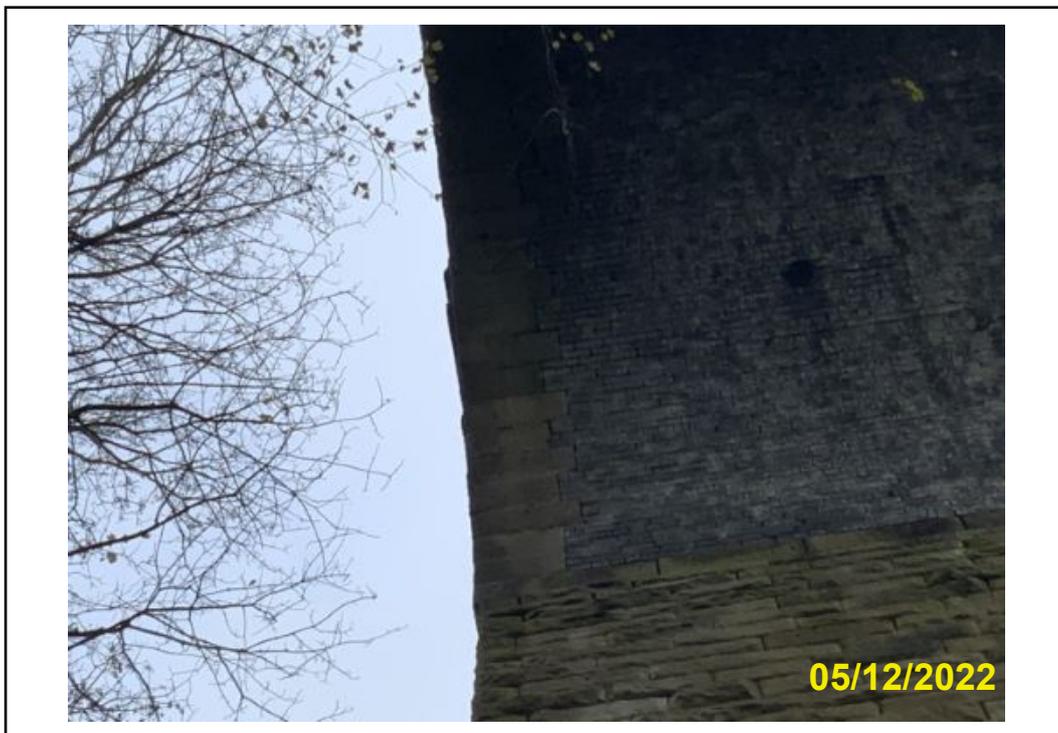
Photo No 22 - HXH - 199m - 0946yds - 43ch - Structure No - 4A - - 05/12/2022  
Defect Tracking - Ref - Span 6 - Fracture behind West Voussoirs is hard to see from ground level.

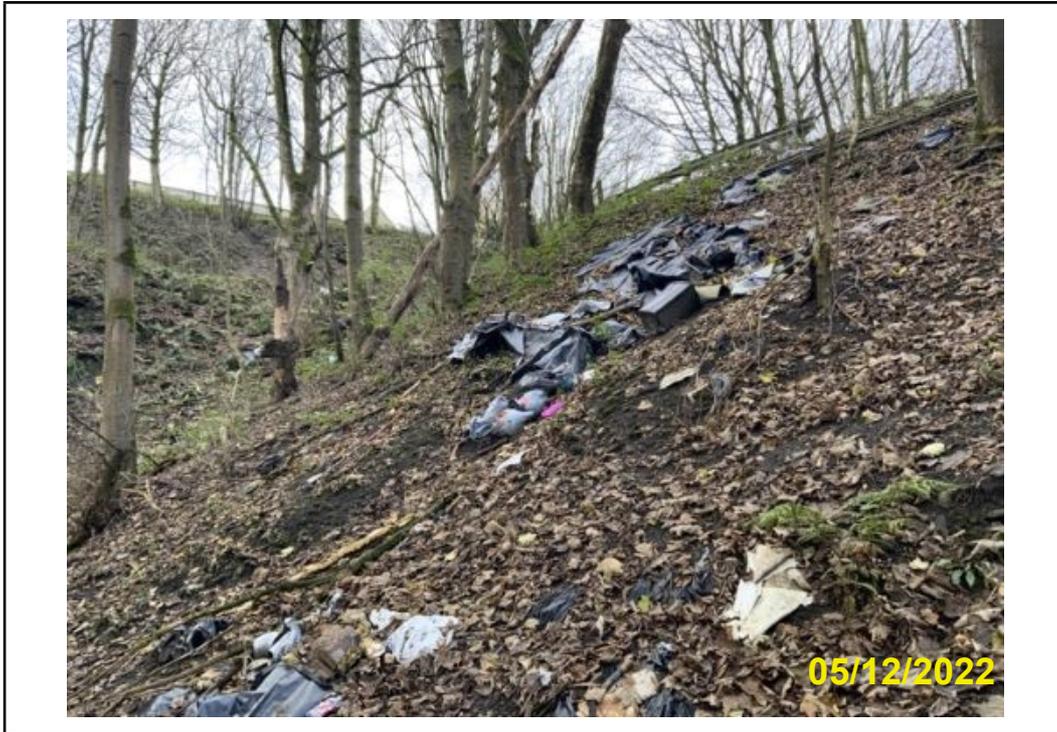
Photo No 23 - HXH - 199m 43chs - 0946yds - 43ch - Structure No - 4A - - 05/12/2022  
Defect Tracking - Ref - Fly tipping to West embankment.

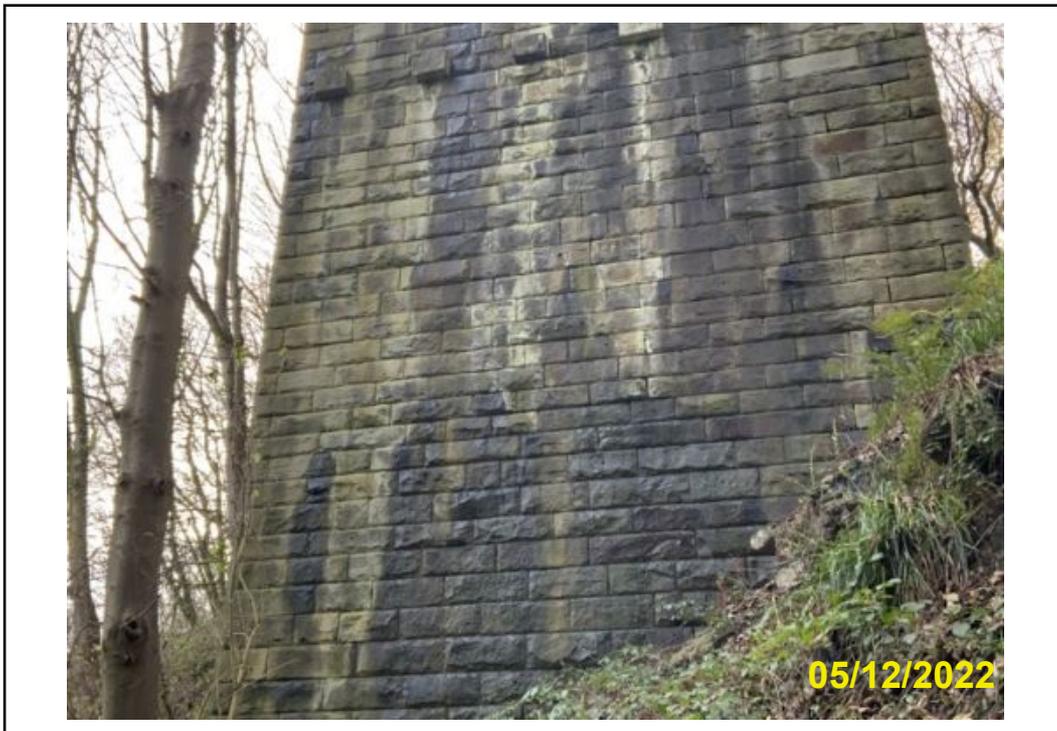
Photo No 24 - HXH - 199m 43chs - 0946yds - 43ch - Structure No - 4A - - 05/12/2022  
Defect Tracking - Ref - Area of wet to Pier below Span 8.

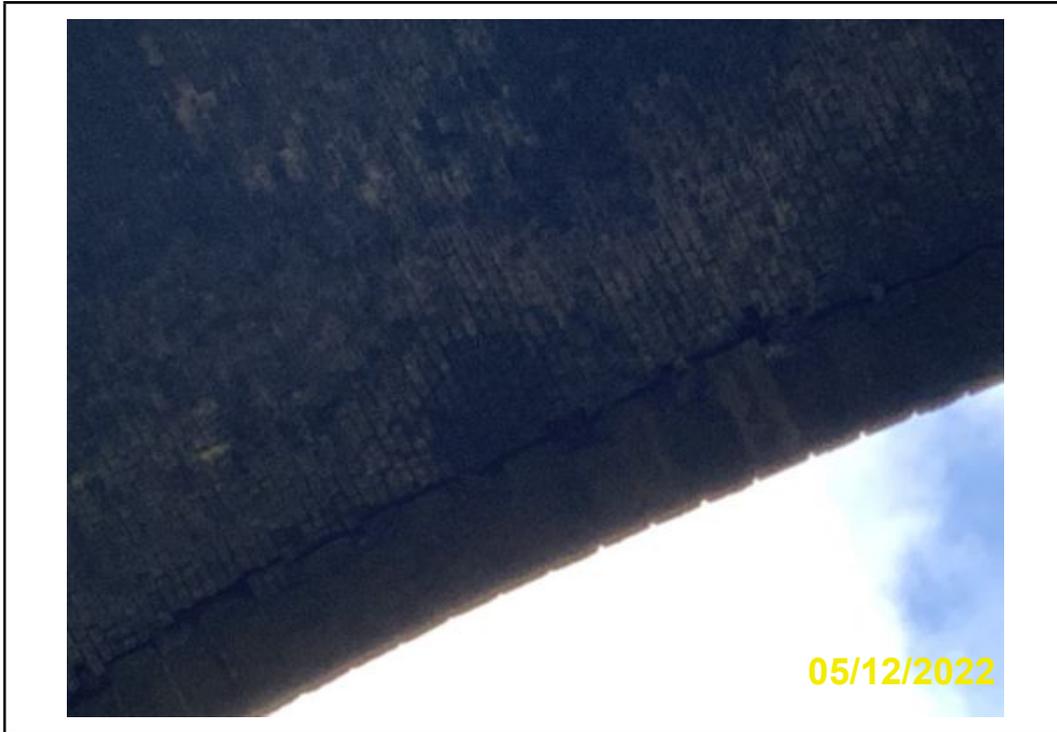
Photo No 25 - HXH - 199mIs - 0946yds - 43ch - Structure No - 4A - - 05/12/2022  
Defect Tracking - Ref- - Span 8 - Longitudinal Fracture behind West Voussiors runs full length x 1-2mm.

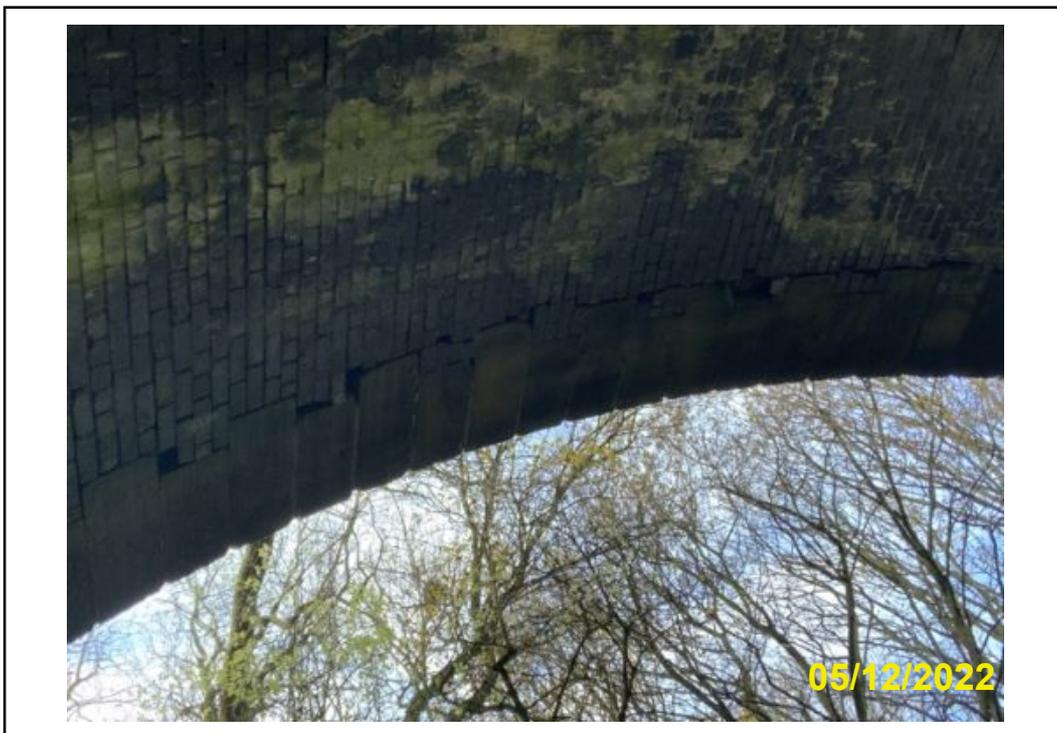
Photo No 26 - HXH - 199mIs - 0946yds - 43ch - Structure No - 4A - - 05/12/2022  
Defect Tracking - Ref- - Span 10 - Longitudinal fracture behind West Voussiors runs full length x 2-3mm.

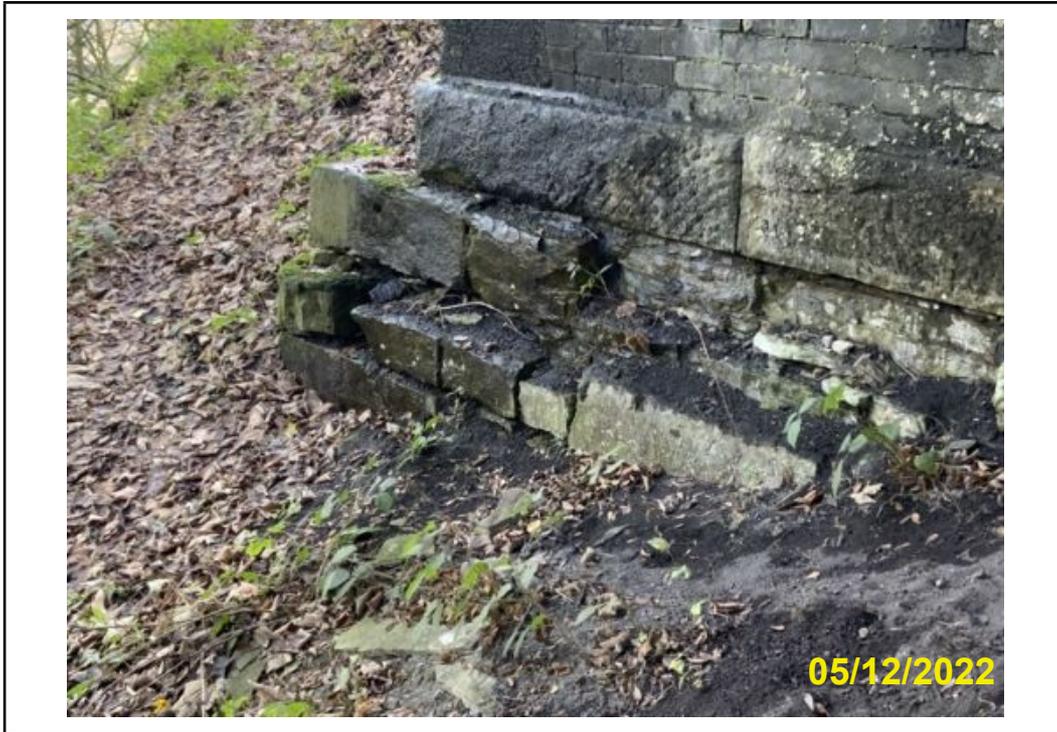
Photo No 27 - HXH - 199m 43chs - 0946yds - 43ch - Structure No - 4A - - 05/12/2022  
Defect Tracking - Ref - East Abutment - Open joints.

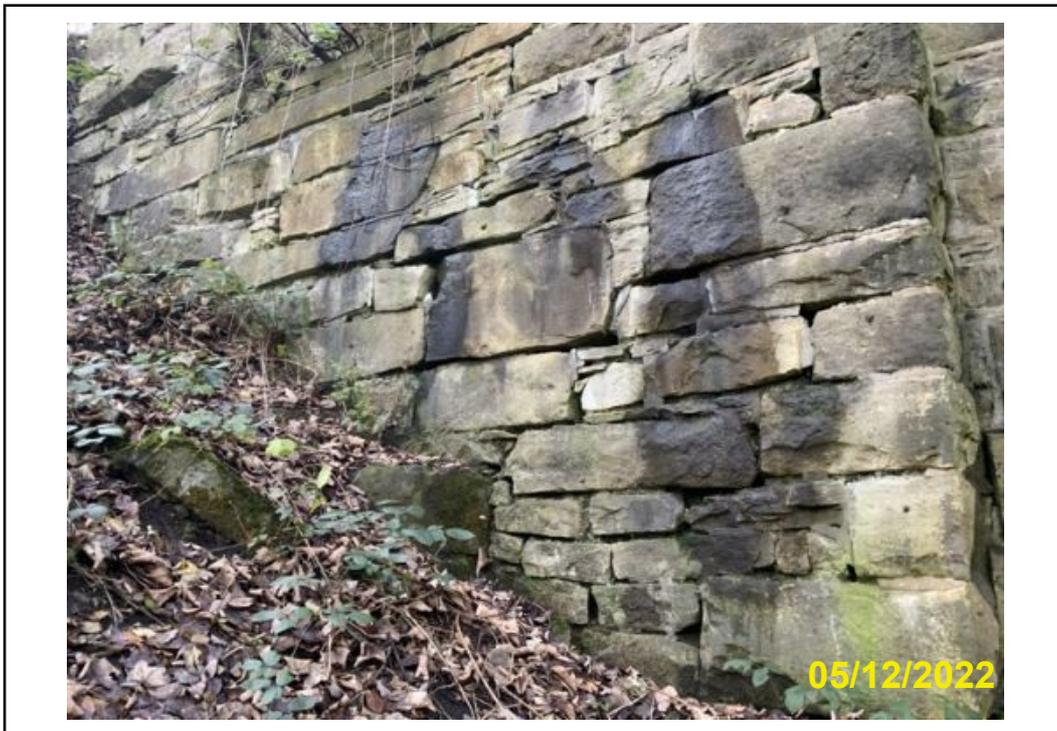
Photo No 28 - HXH - 199m 43chs - 0946yds - 43ch - Structure No - 4A - - 05/12/2022  
Defect Tracking - Ref - South East Wingwall - Open joints 1m<sup>2</sup> x 40mm deep.

Repair odd areas of loose and missing masonry to wingwalls - P2 £6k. - Not actioned.

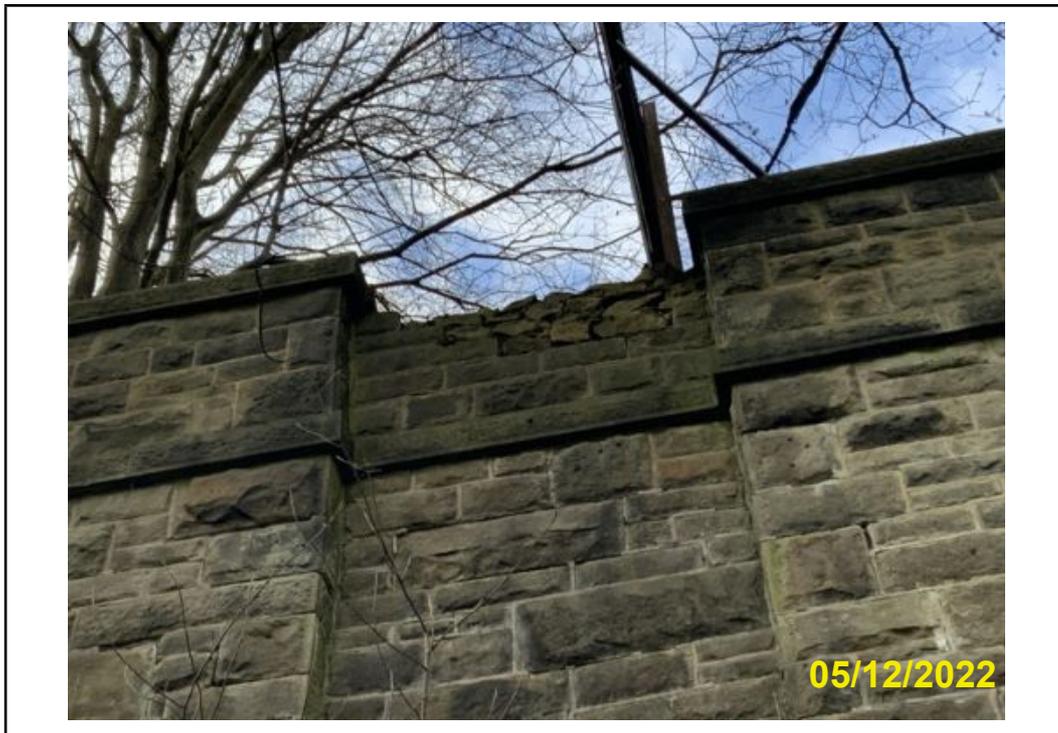
Photo No 29 - HXH - 199m 43chs - 0946yds - 43ch - Structure No - 4A - - 05/12/2022  
Defect Tracking - Ref - Missing capping stones to East Parapet.

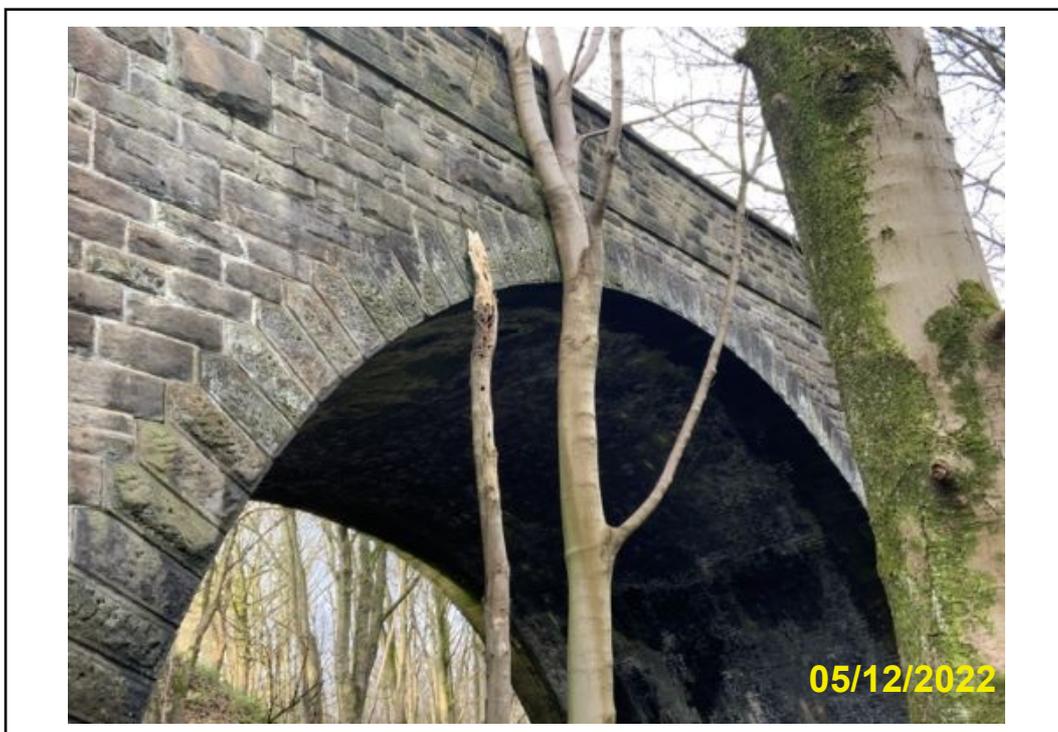
Photo No 30 - HXH - 199m 43chs - 0946yds - 43ch - Structure No - 4A - - 05/12/2022  
Defect Tracking - Ref - Span 10 - Tree growth next to Viaduct.

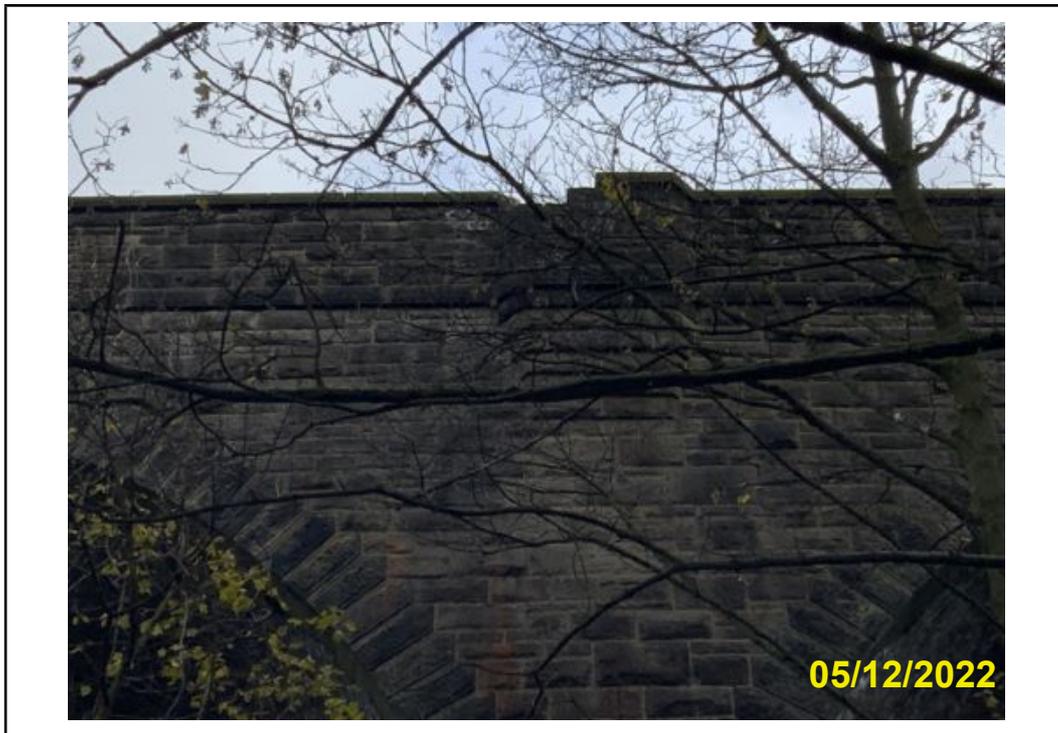
Photo No 31 - HXH - 199m 43chs - 0946yds - 43ch - Structure No - 4A - - 05/12/2022  
Defect Tracking - Ref - Missing capping stones to West Parapet.

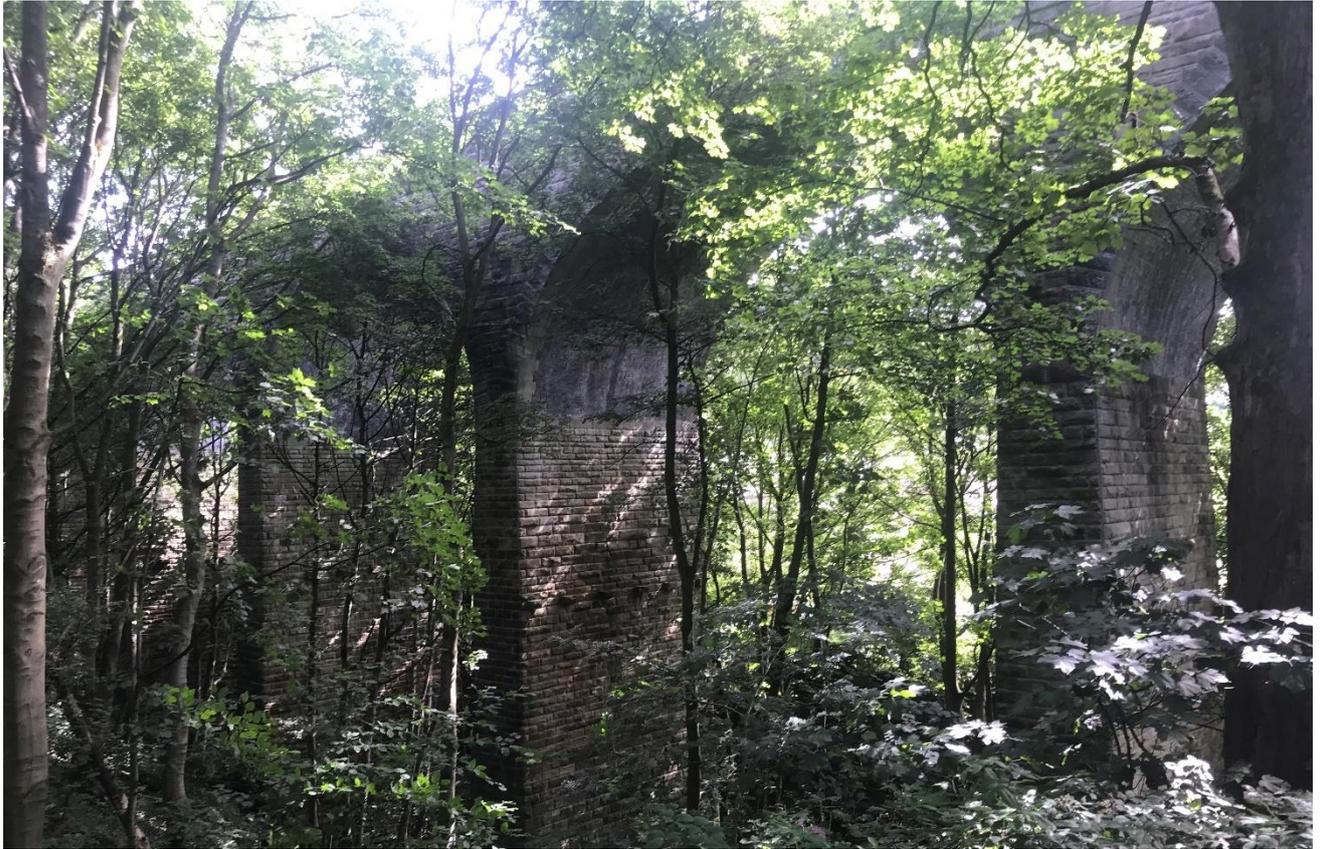
1. West Elevation

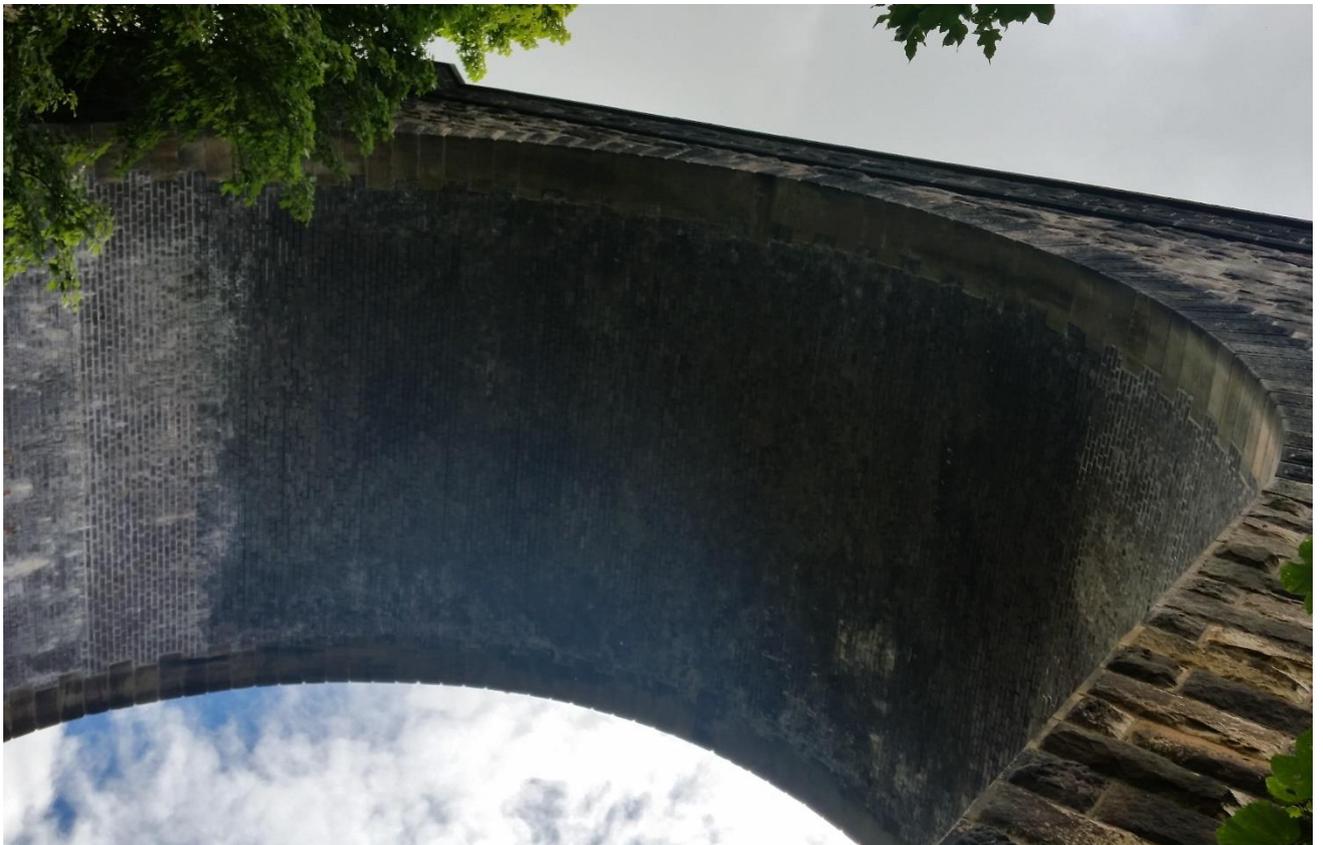
2. Typical arch barrel soffit (Span 5).

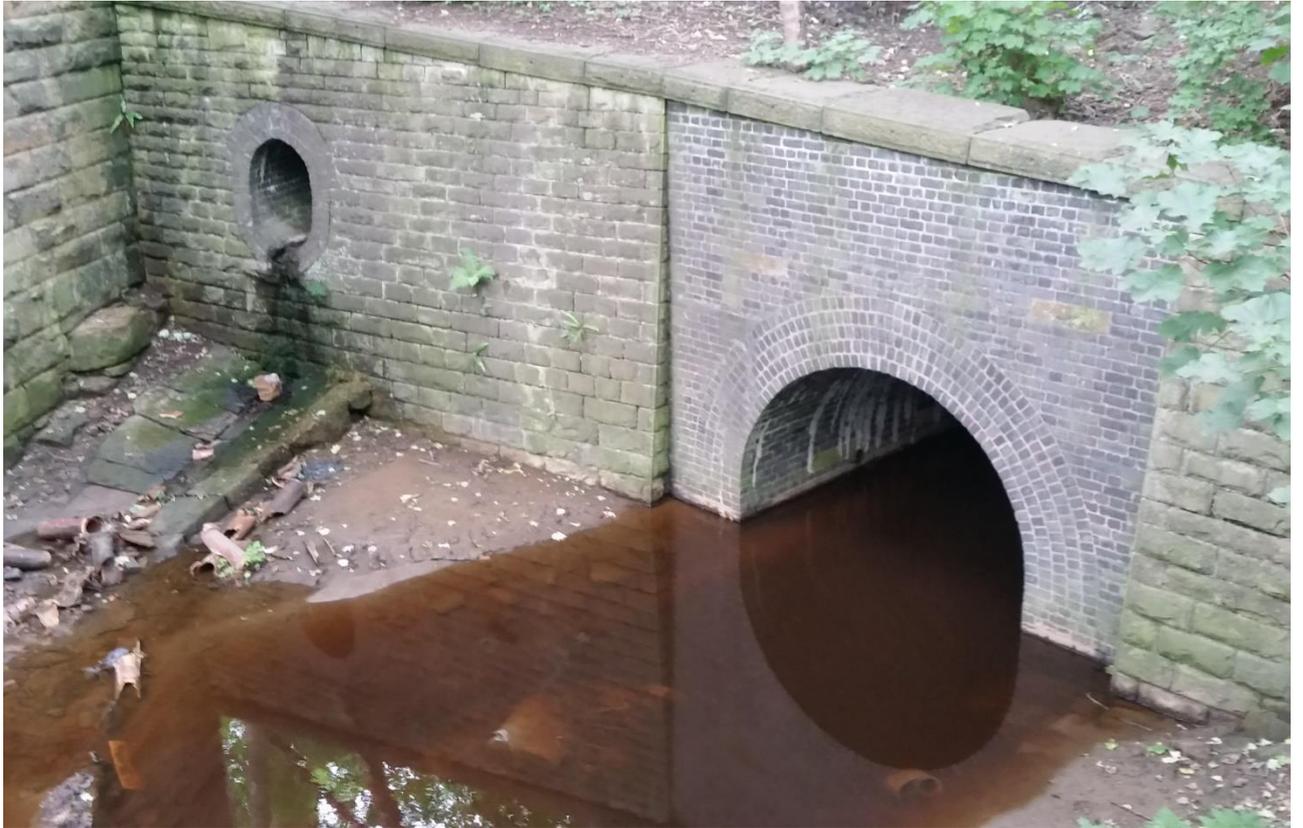
3. Culvert outlet below Span 6.

Make general repairs to the culvert under span 6 - P1 £8k. - Not actioned.

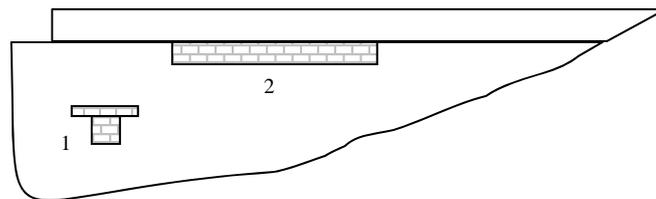
1. Area of spalled masonry, 1500 x 70 x up to 200mm.
2. Area of spalled masonry, 1500 x 200 x up to 200mm.

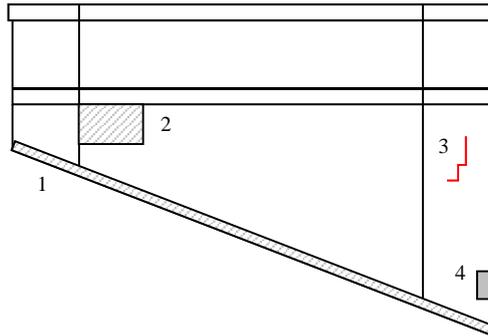
**North Wing Wall**

1. Area of mortar loss of up to 100mm to base of wing wall. **(photo 15)**
2. Area of mortar loss, 1000 x 1000mm x up to 40mm.
3. Vertical stepped fracture through masonry and mortar, 1800 x 1mm. **(photo 16)**
4. Area of fractured and missing masonry, 600 x 350 x up to 120mm. **(photo 17)**

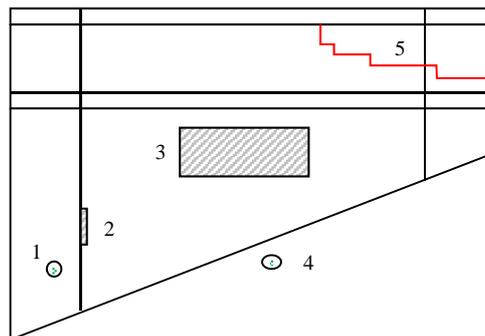
**East Wing Wall**

1. Sapling growing from wing wall, 70mm in diameter.
2. Line of fractured mortar / mortar loss to corner joint, 1800 x up to 50mm. **(photo 18)**
3. Area of mortar loss, 1000 x 500mm.
4. Sapling growing adjacent to wing wall, 130mm in diameter. **(photo 19)**
5. Diagonal stepped fracture through mortar, 2700 x up to 2mm. **(photo 20)**

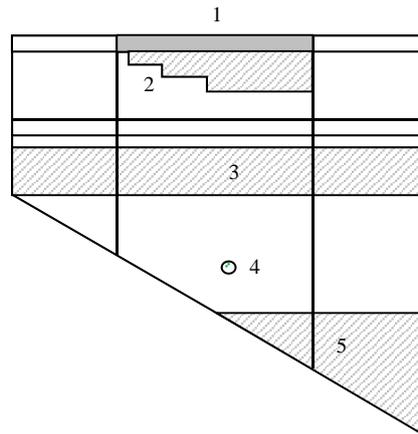
**South Wing Wall**

1. Length of coping, 2000mm, removed for barrier. **(photo 21)**
2. Area of masonry repair in poor condition with mortar loss, 1000 x 1000 x up to 80mm. **(photo 21)**
3. Band of cracked and missing mortar, 1500 x 2500 x up to 40mm. **(photo 22)**
4. Weeds and sapling, 50mm in diameter, growing from wing wall. **(photo 23)**
5. Area of mortar loss, 4000 x 2000 x up to 100mm, with associated seepage. **(photo 24)**

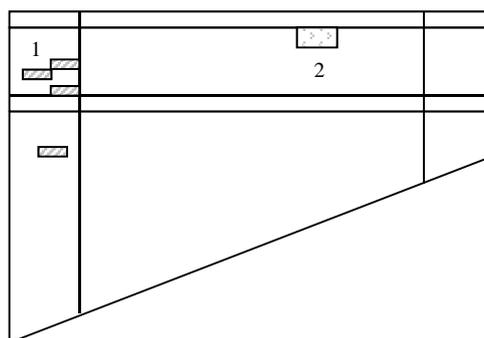
**West Wing Wall**

1. Spot lines of mortar loss totalling 1000 x up to 50mm.
2. Area of mortar loss, 780 x 220 x up to 50mm, 1No. block displaced inwards by 35mm. **(photo 25)**

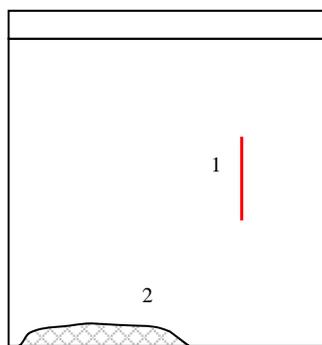
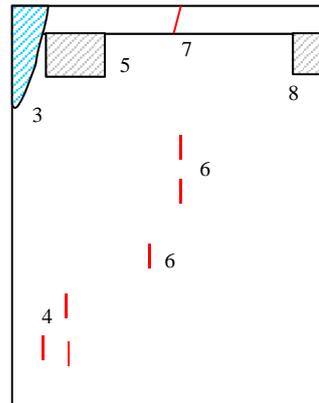
**Pier 1**

There was spot mortar loss of up to 50mm, mainly to the top and sides of the elevation.

1. Vertical hairline fracture through masonry, 900mm in length.
2. Builder's equipment and wood to base of pier. **(photo 26)**
3. Area of seepage, 1000 x 1000mm.
4. 3No. vertical fractures through individual blocks, each 400 x 1mm. **(photo 27)**
5. Area of mortar loss, 2000 x 2000 x up to 30mm. **(photo 28)**
6. 3No. vertical fractures through individual blocks, each 250 x 1mm.
7. Diagonal fracture through spring course block, 400 x 1mm.
8. Area of mortar loss, 1000 x 2000 x up to 30mm.

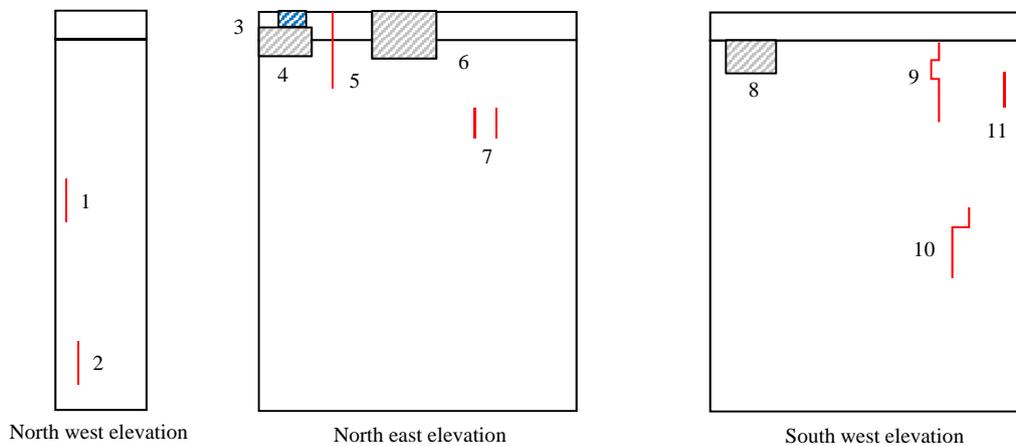
**Pier 2**

There was general weathering to the masonry of up to 40mm depth. Three hairline cracks through individual blocks were noted to the north east elevation. Eight hairline cracks through individual blocks were noted to the south west elevation. There was spot mortar loss to 20mm to horizontal joints and 50% of vertical joints were open to 80mm, mainly in the upper half.

1. Vertical hairline fracture through masonry, 1500mm in length.
2. Vertical fracture through masonry, 1500 x 0.5mm.
3. Area of seepage, 1000 x 500mm.
4. Area of mortar loss, 1000 x 2000 x up to 50mm.
5. Vertical fracture through masonry, 2000 x 1mm.
6. Area of mortar loss, 2000 x 1000mm.
7. 2No. vertical fractures through 1No. masonry block, each 300 x 1mm.
8. Area of mortar loss, 900 x 500 x up to 200mm. **(photo 29)**
9. Vertical stepped fracture through masonry, 2600 x 1.5mm.
10. Vertical stepped hairline fracture through masonry, 1800mm in length.
11. Vertical hairline fracture through masonry, 1000mm in length. **(photo 30)**

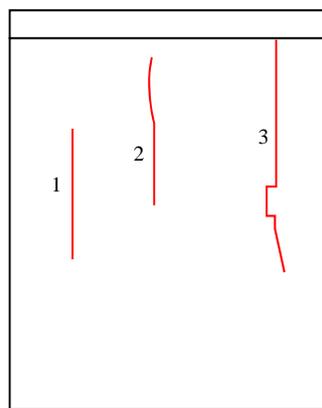
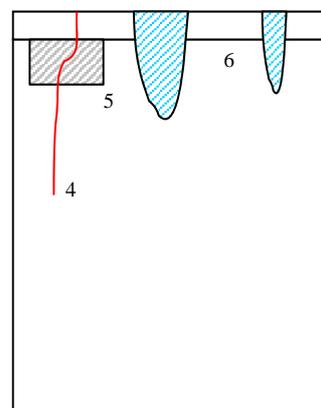
**Pier 3**

Four hairline cracks through individual blocks were noted to the north east elevation. There was spot mortar loss of up to 100mm throughout the elevations, mainly to the top and sides. (photo 31) A mature tree, 600mm in diameter, was growing adjacent to the north west elevation. (photo 32)

1. Vertical hairline fracture through masonry, 3500mm in length.
2. Vertical fracture through masonry, 4000 x 1mm.
3. Vertical stepped fracture through masonry, 6000 x 1mm. (photo 33)
4. Vertical fracture through masonry, 5000 x 1mm. (photo 34)
5. Area of mortar loss, 4000 x 700 x up to 80mm.
6. 2No. areas of seepage totalling 1000 x 2000mm.
7. Area of mortar loss, 1000 x 1000 x up to 30mm.

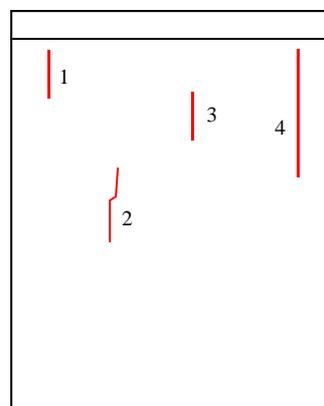
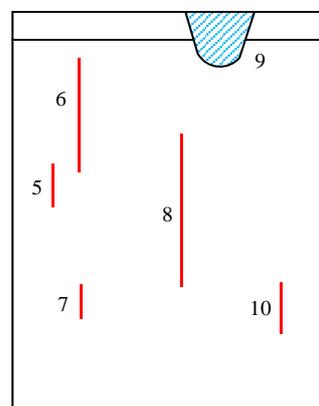
**Pier 4**

There was spot mortar loss of up to 60mm throughout the elevations, mainly to vertical joints. There were occasional vertical hairline fractures to individual blocks to the north west elevation. A culvert under span 5 could carry water from the river and discharge it along the base of the south west elevation, although this was dry at the time of examination. No sign of scour was noted. **(photos 35 & 36)**

1. Vertical fracture through masonry, 1200 x 1mm.
2. Vertical fracture through masonry, 2500 x 0.5mm.
3. Vertical fracture through masonry, 1200 x 0.5mm.
4. Vertical fracture through masonry, 4000 x 1mm.
5. Vertical fracture through masonry, 1000 x 1mm.
6. Vertical fracture through masonry, 2500 x 1mm. **(photo 37)**
7. Vertical fracture through masonry, 1500 x 0.5mm. **(photo 38)**
8. Vertical fracture through masonry, 3500 x 1mm.
9. Area of seepage, 1000 x 500mm, with associated mortar loss of up to 80mm and vegetation growth. **(photo 39)**
10. Vertical fracture through masonry, 1600 x 0.5mm.
11. Vertical fracture through masonry, 1000 x 1mm. **(photo 40)**
12. Vertical fracture through masonry, 1500 x 0.5mm.

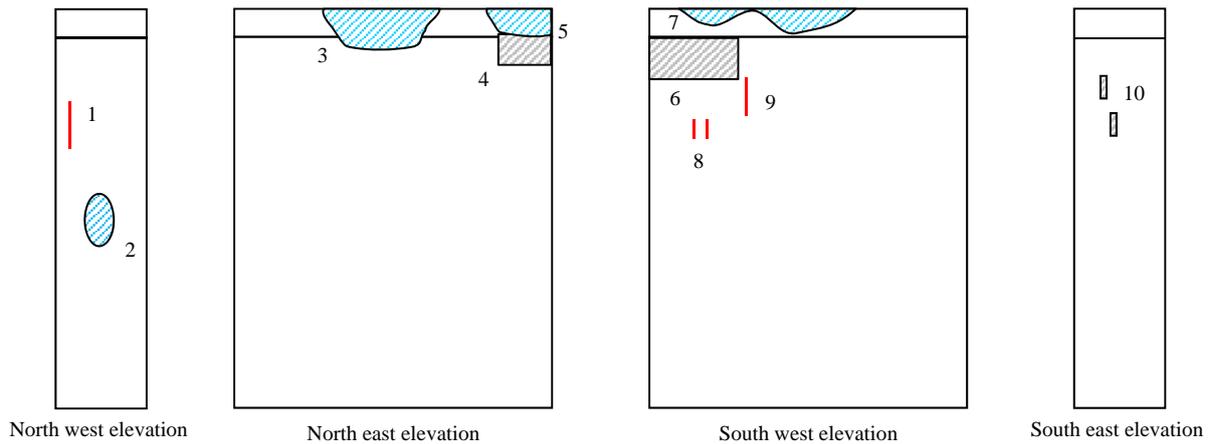
**Pier 5**

1. Vertical fracture through masonry, 500 x up to 2mm. **(photo 41)**
2. Area of seepage, 1000 x 2000mm.
3. Area of seepage, 2000 x 1000, with associated mortar loss of up to 50mm. **(photo 42)**
4. Area of mortar loss, 2000 x 1000 x up to 40mm.
5. Area of seepage, 1000 x 1000mm.
6. Area of mortar loss, 2500 x 2000 x up to 50mm.
7. Area of seepage, 3000 x 500mm.
8. 2No. vertical fractures through 1No. block, each 200 x 1mm.
9. Vertical fracture through masonry, 500 x 1mm.
10. 2No. lines of mortar loss, each 300 x up to 200mm. **(photo 43)**
