## HXH/4a Contract Specification (Masonry Repair and Waterproofing Installation)

**Client name:** National Highways – Historical Railways Estate  
**Project name:** HRE Works Framework  
**Client reference:** HXH/4a  
**Document no:** 0451200  
**Revision no:** 03  
**Date:** May 2023  
**Project no:** B38380DE  
**Project manager:** Nigel Robson  
**Prepared by:** Christopher Doig  
**File name:** HXH 4a NEC ECC

### **HRE WORKS FRAMEWORK HXH/4a 'WHEATLEY VIADUCT' CONTRACT FOR REMEDIAL REPAIRS AND WATERPROOFING**

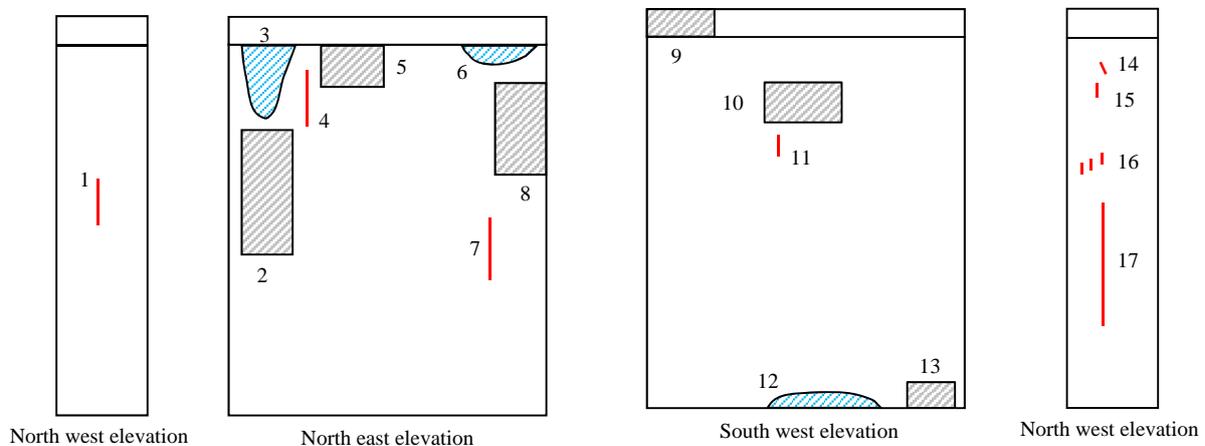
**Pier 6**

The river emerged from two culverts under span 6 and ran along the base of the north east elevation. No sign of scour was noted. (photo 44 & 45) Five hairline cracks through individual blocks were noted to the south west elevation.

1. Vertical fracture through masonry, 600 x 1mm.
2. Area of mortar loss, 2000 x 3000 x up to 30mm.
3. Area of seepage, 1000 x 2000mm. (photo 46)
4. Vertical fracture through masonry, 2000 x up to 2mm. (photo 46)

5. Area of mortar loss, 2000 x 1000 x up to 40mm. (photo 46)
6. Area of seepage, 1000 x 500mm.
7. Vertical fracture through masonry and mortar, 1500 x 1mm. (photo 47)

8. Area of mortar loss, 2000 x 3000 x up to 30mm.
9. Area of mortar loss, 3000 x 1000 x up to 20mm.
10. Area of mortar loss, 3000 x 2000 x up to 30mm.
11. Vertical fracture through masonry, 600 x 1mm.

12. Area of seepage, 3000 x 1000mm.
13. Area of mortar loss, 2000 x 1000 x up to 30mm.
14. Diagonal fracture through 1No. block, 300 x up to 2mm. (photo 48)

15. Vertical fracture through 1No. block, 300 x up to 2mm.
16. 3No. vertical fractures through individual blocks, each 200 x 1mm.
17. Vertical fracture through masonry, 6000 x 1mm.

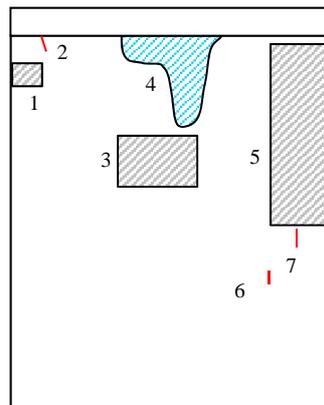
**Pier 7**

There was spot mortar loss of up to 40mm to horizontal joints and 80mm to vertical joints throughout.

1. Area of mortar loss, 2000 x 1000 x up to 150mm. **(photo 49)**
2. Diagonal fracture through 1No. block, 300 x 1mm.
3. Area of mortar loss, 3000 x 2000 x up to 30mm.
4. Area of seepage, 1500 x 1500mm.
5. Area of mortar loss, 2000 x 5000 x up to 30mm.
6. Vertical fracture through masonry, 200 x 1mm.
7. Vertical fracture through masonry, 300 x 1mm.
8. Vertical fracture through masonry, 3000 x 1mm.
9. Vertical fracture through masonry, 2000 x up to 2mm.
10. Vertical fracture through masonry, 4000 x up to 1.5mm.
11. 6No. vertical fractures through individual blocks, each 300 x 1mm.
12. Horizontal fracture through masonry, 600 x 1mm. **(photo 50)**
13. Line of mortar loss, 300 x up to 100mm.
14. Area of mortar loss, 2000 x 1000 x up to 30mm.

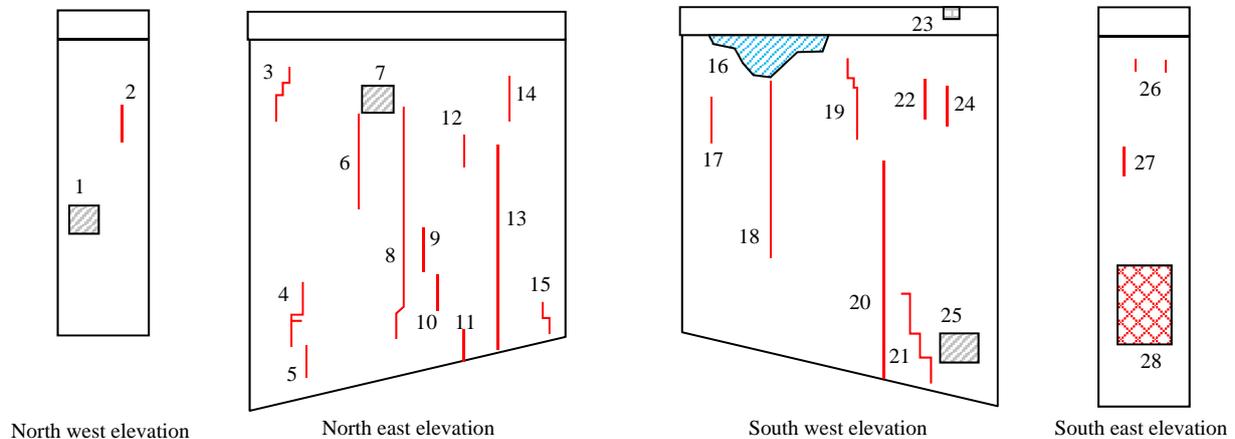
**Pier 9**

There was spot mortar loss of up to 30mm and spot areas of minor seepage throughout.

1. Area of loose, mortarless masonry, 450 x 500mm. **(photo 60)**
2. Vertical fracture through masonry, 1500 x 1mm.
3. Vertical stepped fracture through masonry, 1700 x 1mm.
4. Vertical stepped fracture through masonry, 3000 x 1mm.
5. Vertical fracture through masonry, 1300 x 0.5mm, with associated seepage.
6. Vertical fracture through masonry, 2000 x 1mm.

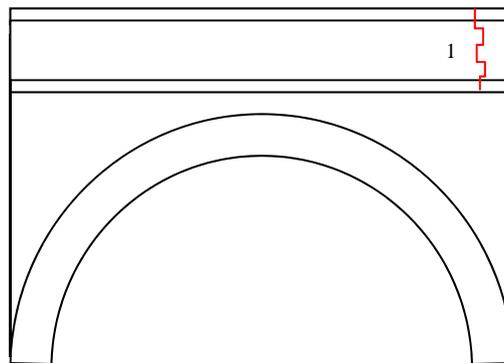
**Span 1 North West Elevation**

There was spot mortar loss of up to 40mm throughout the parapet. 30% of vertical joints to string course had mortar loss of up to 60mm. **(photo 70)** There was spot mortar loss of up to 30mm throughout the spandrel.

1. Vertical toothed fracture through mortar, 1500 x up to 2mm. **(photo 71)**

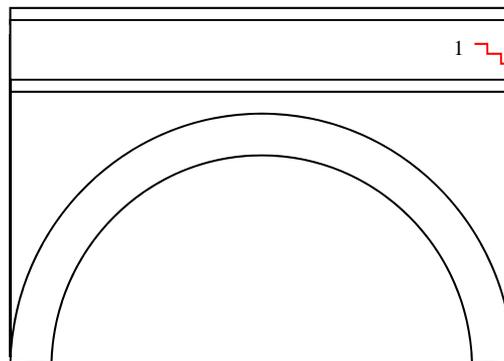
**Span 1 South East Elevation**

There was spot mortar loss of up to 30mm throughout the parapet. There was spot mortar loss of up to 30mm throughout the spandrel. **(photo 72)**

1. Diagonal stepped fracture through mortar, 900 x 1mm.

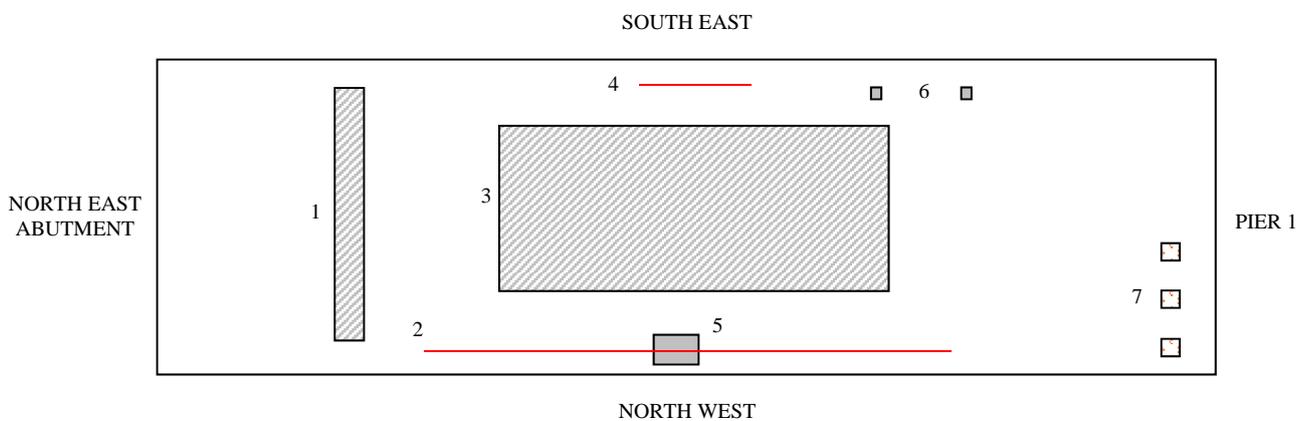
**Span 1 Soffit**

There were spot areas of seepage and leachate deposits from the quarter points to the pier / abutment. There was spot mortar loss behind the voussoirs of up to 80mm. [\(photo 73\)](#)

1. Area of mortar loss, 3000 x 500 x up to 50mm.
2. Longitudinal fracture through brickwork, 8000 x up to 30mm, brickwork along fracture also drummy. [\(photo 74\)](#)
3. Area of mortar loss, 10,000 x 4000 x up to 80mm.
4. Longitudinal fracture through brickwork, 5000 x up to 5mm, brickwork along fracture also drummy. [\(photo 75\)](#)
5. Area of approx. 35No. missing bricks at the crown, 20No. more removed at time of examination. [\(photo 74\)](#)
6. 2No. areas of 3No. missing bricks. [\(photo 76\)](#)
7. 3No. areas of loose to hammer brickwork and mortar loss of up to 80mm, totalling 1000 x 1500mm. [\(photo 77\)](#)

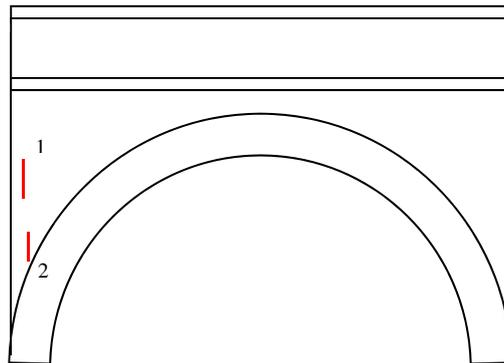
**Span 2 North West Elevation**

There was spot mortar loss of up to 30mm throughout the spandrel.

1. Vertical fracture through masonry, 400 x 1mm. **(photo 78)**
2. Vertical fracture through masonry, 300 x 1mm.

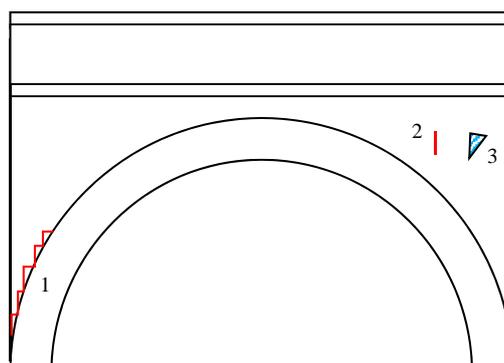
**Span 2 South East Elevation**

There were 7No. individual blocks with vertical hairline fractures to the spandrel over pier 2.

1. Diagonal stepped separation fracture between voussoirs and spandrel, 3000 x 0.5mm. **(photo 79)**
2. Vertical fracture through masonry, 400 x 1mm. **(photo 80)**
3. Area of seepage, 300 x 300mm.

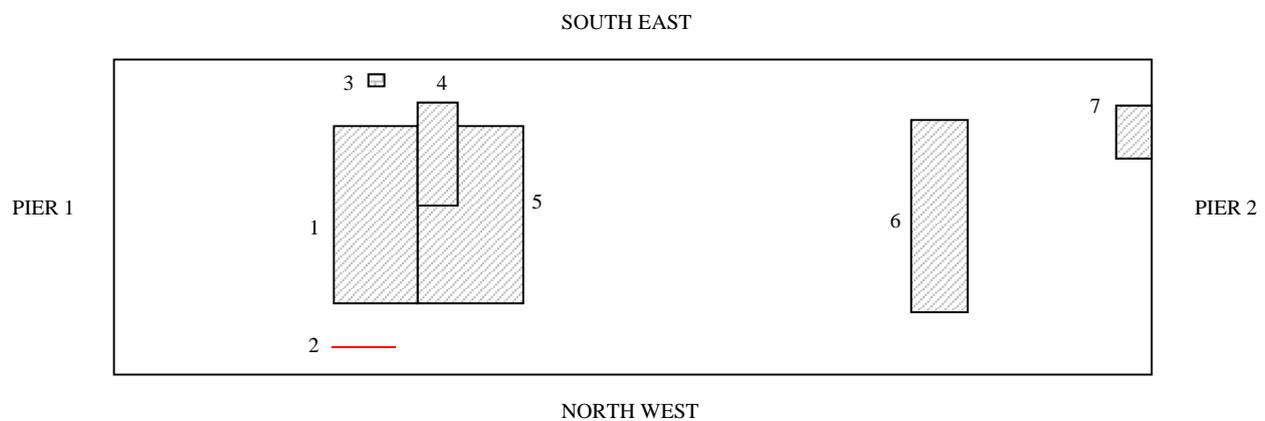
**Span 2 Soffit**

There were spot areas of minor seepage totalling 2m<sup>2</sup> and leachate deposits totalling 15m<sup>2</sup> from the quarter point to pier 1. [\(photo 81\)](#)

1. Area of mortar loss, 3000 x 4000 x up to 90mm. [\(photo 82\)](#)
2. Longitudinal fracture through brickwork, 1500 x up to 4mm. [\(photo 83\)](#)
3. Area of spalled voussoir, 200 x 50 x up to 70mm.
4. Area of heavy mortar loss, 2000 x 800 x up to 110mm. [\(photo 84\)](#)
5. Area of mortar loss, 2500 x 4000 x up to 50mm.
6. Area of mortar loss, 2000 x 4500 x up to 70mm.
7. Area of mortar loss, 1000 x 1000 x up to 70mm.

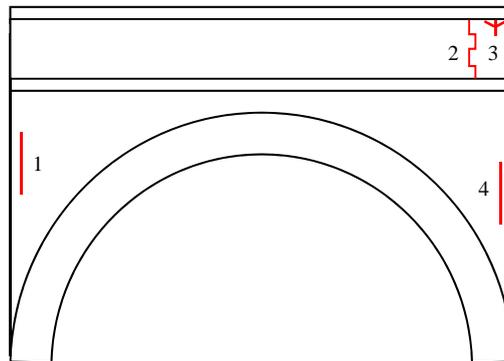
**Span 3 North West Elevation**

There was spot mortar loss of up to 50mm throughout the spandrel. There was spot mortar loss of up to 20mm throughout the parapet.

1. Vertical fracture through masonry, 2700 x 1mm. **(photo 85)**
2. Vertical toothed fracture through mortar, 1500 x 1mm.
3. Multi-directional fractures through 1No. block from old iron fixing, up to 7mm wide. **(photo 86)**
4. Vertical fracture through masonry, 1500 x 0.5mm.

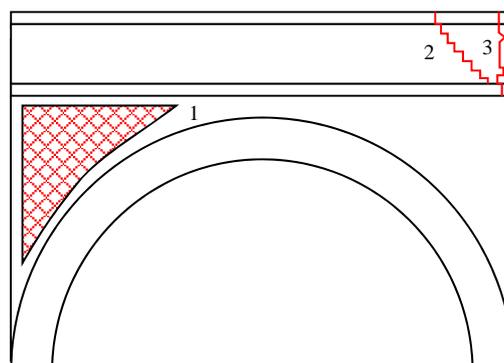
**Span 3 South East Elevation**

1. Area of hairline fractures through mortar and mortar loss of up to 25mm, 1500 x 2000mm, with spot areas of light vegetation growth. **(photo 87)**
2. Diagonal stepped fracture through mortar, 1700 x up to 1.5mm. **(photo 88)**
3. Vertical fracture through mortar, 1500 x 1mm. **(photo 88)**

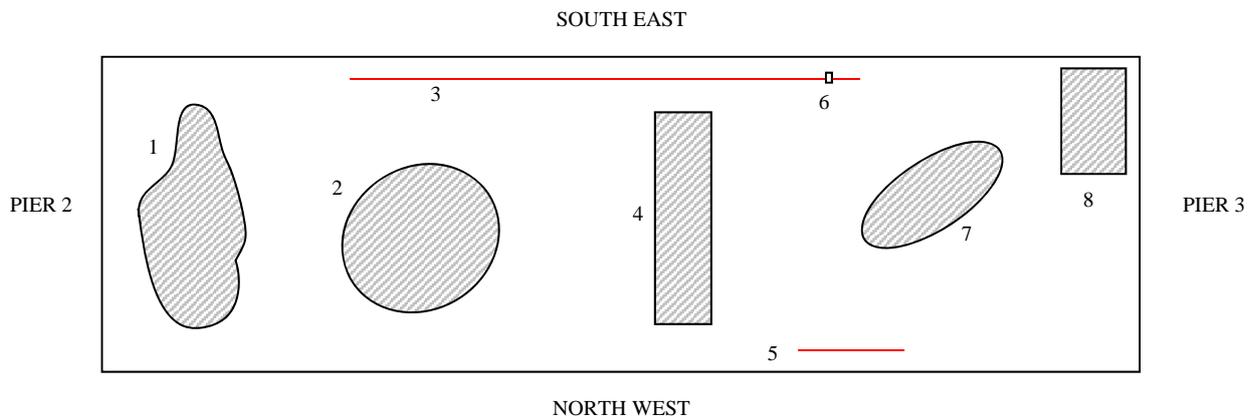
**Span 3 Soffit**

There was spot mortar loss behind the voussoirs of up to 50mm.

1. Area of mortar loss, 3000 x 4000 x up to 40mm. **(photo 89)**
2. Area of mortar loss, 1500 x 2000 x up to 50mm.
3. Longitudinal fracture through brickwork, 6000 x up to 9mm, brickwork and voussoirs to the south east side were lower by up to 7mm with mortar loss of up to 60mm. **(photo 90)**
4. Area of heavy mortar loss to crown, 1000 x 4000 x up to 100mm. **(photo 91)**
5. Longitudinal fracture through brickwork, 1500 x 1mm.
6. 1No. loose brick.
7. Area of mortar loss and seepage, 2000 x 2000 x up to 30mm. **(photo 92)**
8. Area of mortar loss, 1000 x 2000 x up to 35mm.

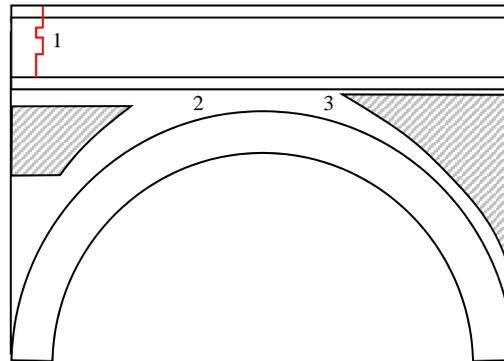
**Span 4 North West Elevation**

1. Vertical stepped fracture through mortar, 1500 x 1mm.
2. Area of mortar loss, 1000 x 500 x up to 30mm.
3. Area of mortar loss, 2000 x 3000 x up to 40mm.

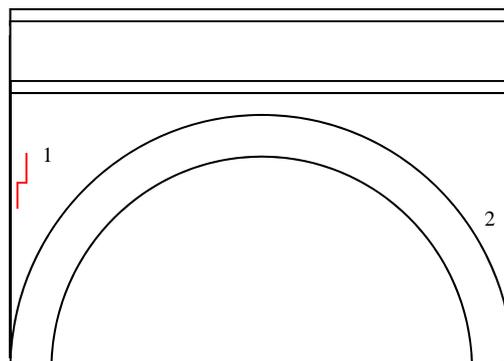
**Span 4 South East Elevation**

There was spot mortar loss of up to 40mm throughout the parapet. There were spot fractures through mortar / mortar loss of up to 30mm and spot light vegetation growth throughout the spandrel. [\(photo 93\)](#)

1. Vertical stepped hairline fracture through mortar and masonry, 1500mm in length. [\(photo 94\)](#)
2. Vertical hairline fracture through mortar and masonry, 1100mm in length.

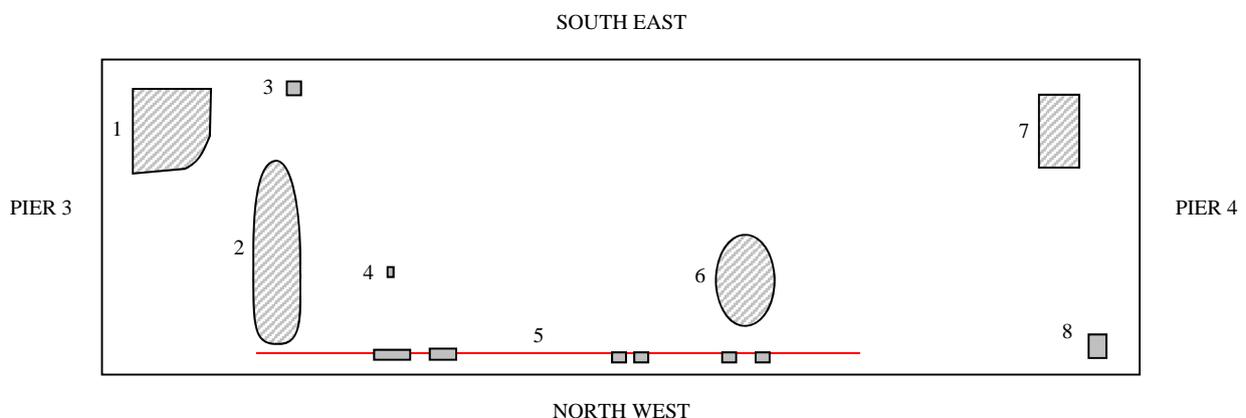
**Span 4 Soffit**

There were spot areas of seepage below the quarter points totalling 6m<sup>2</sup>. There was spot mortar loss of up to 10mm throughout the soffit, with loss of up to 80mm behind the voussoirs.

1. Area of mortar loss, 2000 x 1000 x up to 50mm.
2. Area of mortar loss, 1000 x 5000 x up to 60mm.
3. 3No. missing bricks. [\(photo 95\)](#)
4. 1No. missing brick. [\(photo 96\)](#)
5. Longitudinal fracture through brickwork, 8000 x up to 25mm, approx. 35No. bricks along length of fracture fallen out / removed, usually between fracture and voussoirs. [\(photos 96 & 97\)](#)
6. Area of mortar loss, 1000 x 2000 x up to 60mm.
7. Area of mortar loss, 500 x 1000 x up to 50mm. [\(photo 98\)](#)
8. 6No. missing bricks. [\(photo 99\)](#)

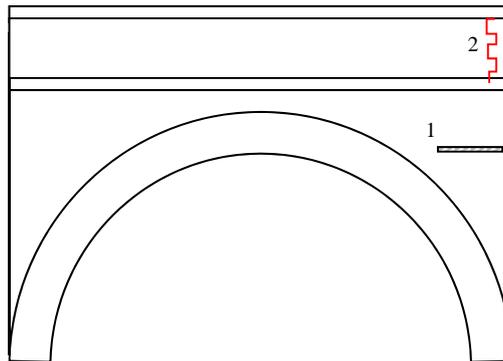
**Span 5 North West Elevation**

1. Line of mortar loss, 600 x up to 80mm.
2. Vertical toothed fracture through mortar, 1500 x up to 1.5mm. [\(photo 100\)](#)

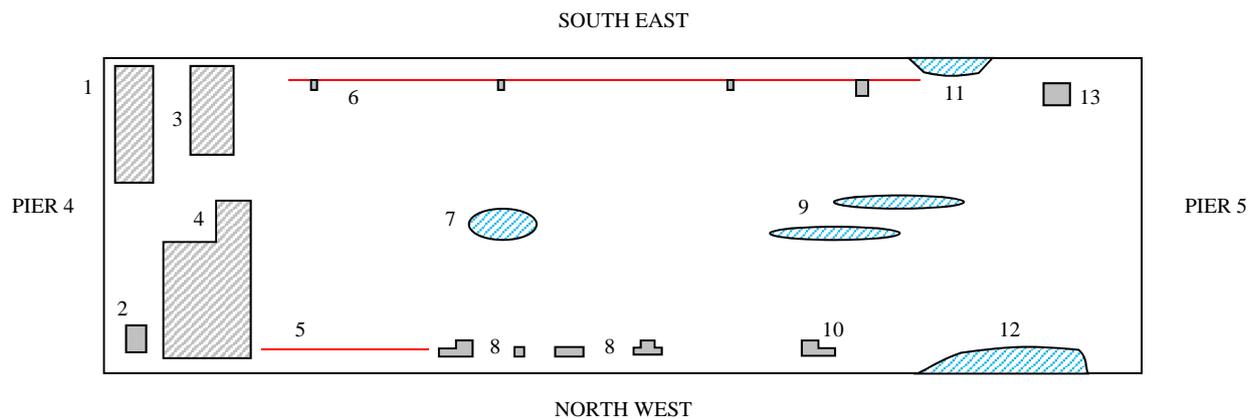
**Span 5 Soffit**

1. Area of mortar loss, 3000 x 800 x up to 50mm, with spot seepage, area also drummy, 1No. loose brick removed. **(photo 101)**
2. Area of missing brickwork, 550 x 800 x 120mm, 5No. further bricks removed. **(photos 102 & 103)**

3. Area of mortar loss, 2000 x 800 x up to 40mm.
4. Area of mortar loss, 2000 x 1500 x up to 30mm. **(photo 104)**
5. Longitudinal fracture through brickwork, 4000 x up to 20mm, approx. 12No. bricks along length of fracture fallen out / removed, usually between fracture and voussoirs. **(photo 105)**

6. Longitudinal fracture through brickwork along voussoir ring, 7000 x up to 15mm, with 4No. areas of missing brickwork, 300 x 250 x 150mm, 300 x 250 x 150mm, 300 x 100 x 150mm and 500 x 200 x 150mm.

7. Area of seepage, 2000 x 1000mm.
8. 4No areas of missing brickwork, approx. 12No. in total, 4No. further bricks removed. **(photo 106)**
9. 2No. areas of seepage, each 2000 x 500mm.

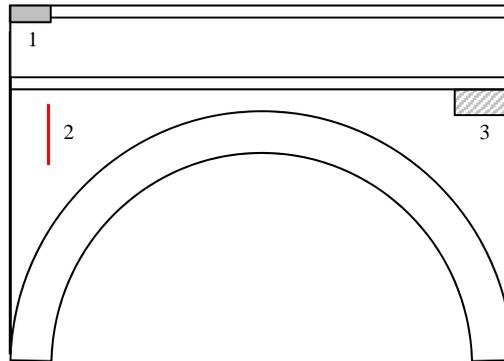
**Span 6 North West Elevation**

1. Area of missing coping, 2000 x 400mm. **(photo 107)**
2. Vertical fracture through masonry, 2000 x 1mm.
3. Area of mortar loss, 2000 x 1000 x up to 20mm. **(photo 108)**

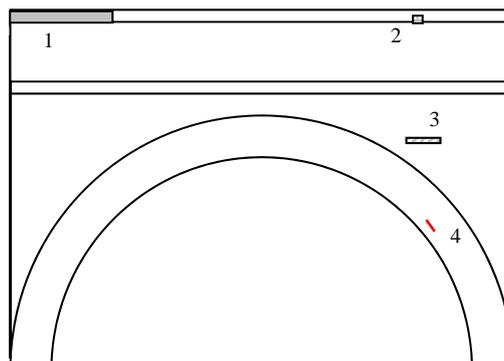
**Span 6 South East Elevation**

1. Area of missing coping, 10,000 x 400mm, continued on to span 7. **(photo 109)**
2. Area of spalling to coping, 200 x 200 x up to 200mm. **(photo 110)**
3. Line of mortar loss, 400 x up to 20mm. **(photo 111)**
4. Diagonal fracture through 1No. voussoir, 200 x 1mm.

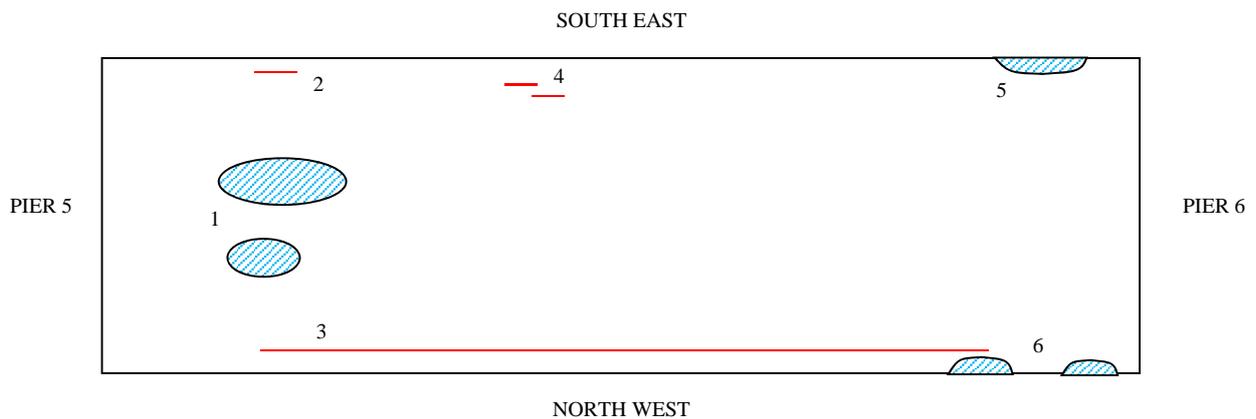
**Span 6 Soffit**

1. 2No. areas of seepage totalling 2000 x 2000mm.
2. Longitudinal fracture through voussoir, 300 x 1mm.
3. Longitudinal fracture through brickwork, 10,000 x up to 40mm, with associated mortar loss of up to 50mm. **(photo 112)**
4. 2No. longitudinal fractures through voussoirs, each 200 x 1mm.
5. Area of seepage, 2000 x 1000mm.
6. 2No. areas of seepage totalling 2000 x 1000mm.

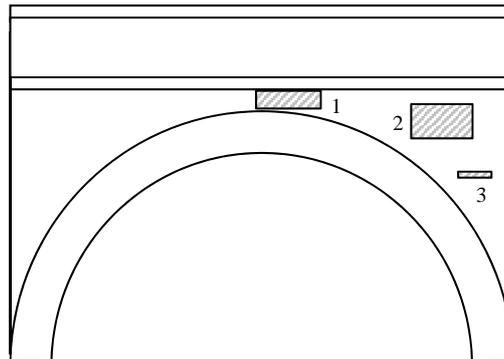
**Span 7 North West Elevation**

1. Area of mortar loss, 2000 x 1000 x up to 30mm. [\(photo 113\)](#)
2. Area of mortar loss, 2000 x 1500 x up to 30mm.
3. Line of mortar loss, 1000 x up to 50mm.

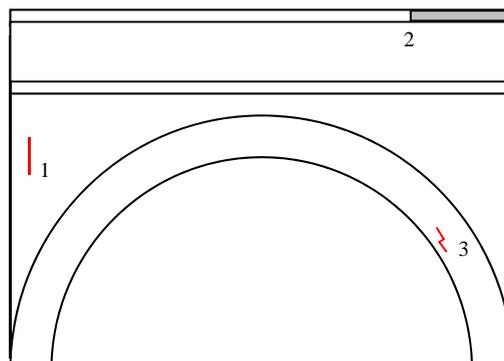
**Span 7 South East Elevation**

1. Vertical fracture through masonry, 1000 x 1mm. [\(photo 114\)](#)
2. Area of missing coping, 10,000 x 400mm, continued on to span 6. [\(photo 109\)](#)
3. Diagonal stepped fracture through voussoirs, 400 x 1mm. [\(photo 115\)](#)

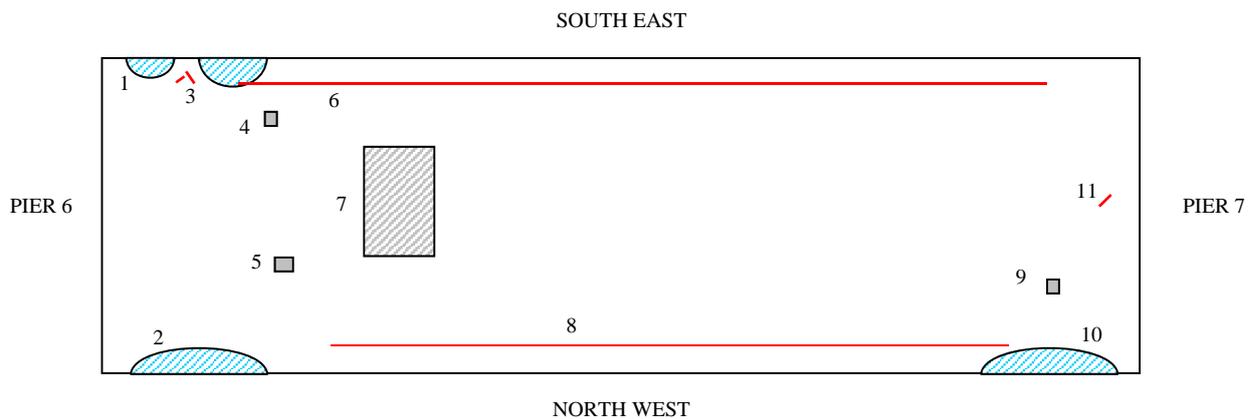
**Span 7 Soffit**

1. 2No. areas of seepage totalling 2000 x 1000mm. **(photo 116)**
2. Area of seepage, 4000 x 1000mm.
3. Diagonal fracture through voussoirs, 600 x 1mm. **(photo 116)**
4. Area of missing brickwork, 400 x 250 x 100mm.
5. Area of missing brickwork, 400 x 400 x 100mm.
6. Longitudinal fracture through brickwork, 10,000 x up to 10mm, with mortar loss of up to 70mm. **(photo 117)**
7. Area of mortar loss, 2000 x 3000 x up to 20mm.
8. Longitudinal fracture through brickwork, 11000 x up to 5mm, with mortar loss of up to 70mm.
9. Area of missing brickwork, 400 x 250 x 100mm.
10. Area of seepage, 4000 x 1000mm.
11. Diagonal fracture through brickwork, 300 x up to 3mm.

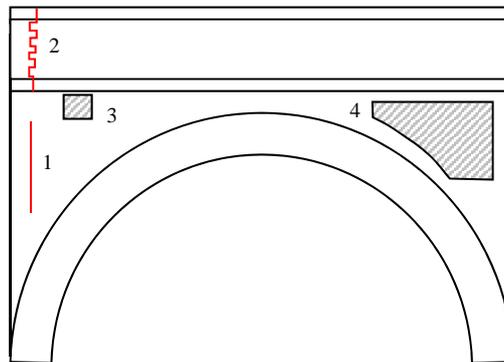
**Span 8 South East Elevation**

There was spot mortar loss of up to 25mm throughout the parapet.

1. Vertical fracture through masonry, 3000 x up to 1.5mm, with associated seepage. **(photo 119)**
2. Vertical toothed fracture through mortar, 1500 x 1mm.
3. Area of mortar loss, 1000 x 1000 x up to 70mm.
4. Area of mortar loss, 2000 x 1000 x up to 40mm.

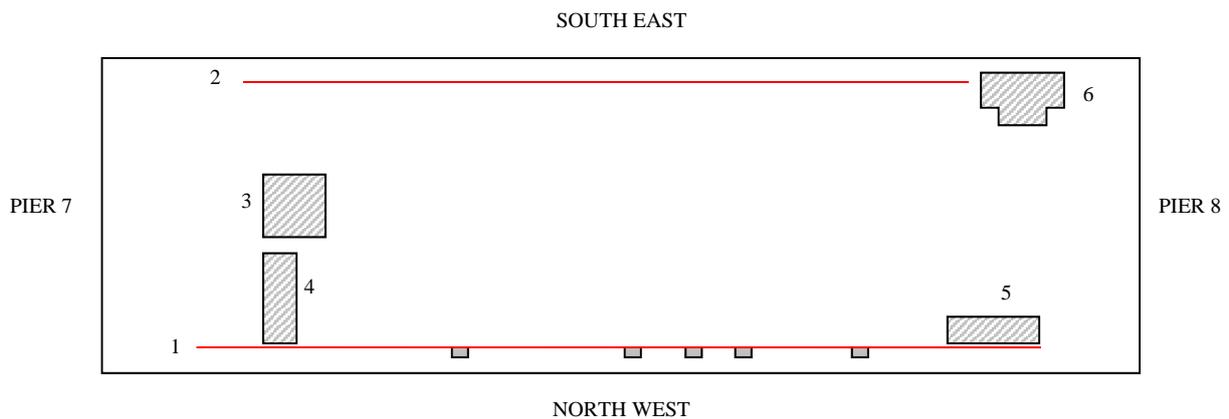
**Span 8 Soffit**

1. Longitudinal fracture through brickwork, 14,000 x up to 45mm, 4No. loose bricks removed, 4No. areas of missing brickwork between fracture and voussoirs: 1No. brick, 1½No. bricks, 3No. bricks, 1No. half brick and 3½No. bricks. [\(photos 120, 121, 122, 123, 124 & 125\)](#)
2. Longitudinal fracture through brickwork, 10,500 x up to 15mm.
3. Area of mortar loss, 2000 x 200 x up to 30mm, with associated seepage. [\(photo 126\)](#)
4. Area of mortar loss, 1000 x 2000 x up to 30mm, with associated seepage.
5. Area of mortar loss, 2000 x 1000 x up to 40mm.
6. Area of mortar loss, 2000 x 1000 x up to 40mm.

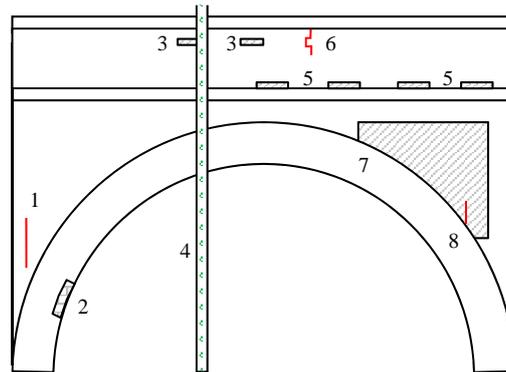
**Span 9 North West Elevation**

1. Vertical fracture through masonry, 900 x 0.5mm. [\(photo 127\)](#)
2. Area of spalled masonry to voussoirs, 700 x 200 x up to 100mm.
3. 2No. lines of mortar loss, each 400 x up to 80mm. [\(photo 128\)](#)
4. Mature tree adjacent to elevation, 500mm in diameter, 30m tall, makes contact with the coping. [\(photo 129\)](#)
5. 4No. lines of mortar loss totalling 3500 x up to 25mm.
6. Vertical stepped hairline fracture through mortar, 600mm in length.
7. Area of mortar loss, 2000 x 2000 x up to 50mm. [\(photo 130\)](#)
8. Vertical hairline fracture through masonry, 750mm in length.

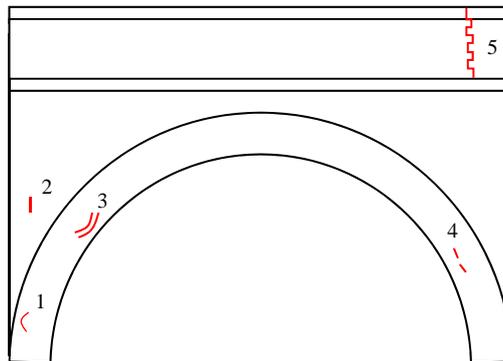
**Span 9 South East Elevation**

There were spot areas of fractured / missing mortar of up to 40mm throughout the spandrel.

1. Diagonal hairline fracture through 2No. voussoirs, 600mm in length.
2. Vertical fracture through masonry, 600 x 1mm, with associated seepage. [\(photo 131\)](#)
3. 2No. diagonal hairline fractures through 2No. voussoirs, each 600mm in length. [\(photo 132\)](#)
4. Diagonal fracture through 2No. voussoirs, 500 x 1mm in length.
5. Vertical toothed fracture through mortar, 1500 x 1mm. [\(photo 133\)](#)

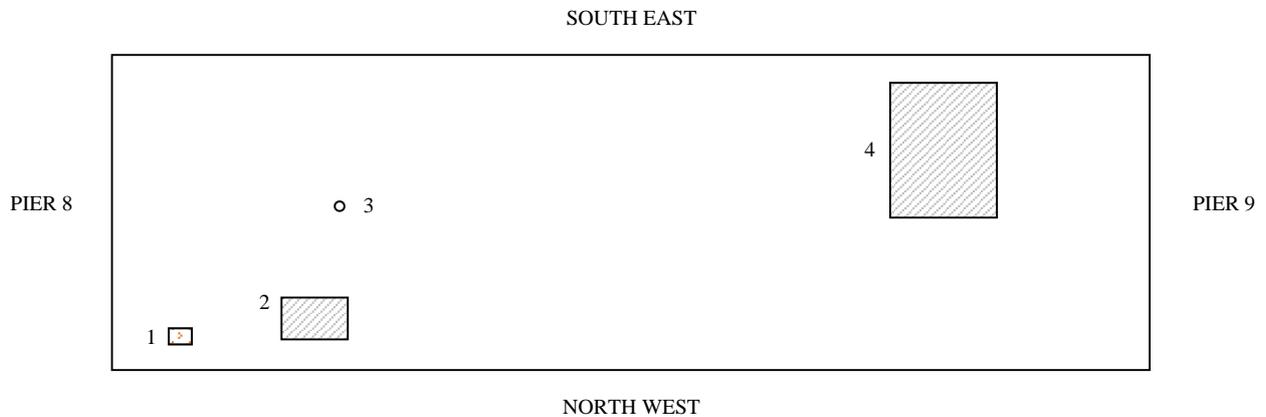
**Span 9 Soffit**

There was mortar loss of up to 40mm between voussoirs and brickwork between the quarter points and piers to both sides of the soffit. There were spot areas of leachate deposits below quarter points, mainly over pier 8. **(photo 134)** There were spot areas of seepage throughout the voussoirs. **(photo 134)**

1. 2No. loose half bricks, 1No. removed. **(photo 135)**
2. Area of mortar loss, 2000 x 1000 x up to 30mm, with associated seepage.
3. Drainage pipe broken but functional.
4. Area of mortar loss, 1500 x 20000 x up to 40mm, with associated seepage. **(photo 136)**

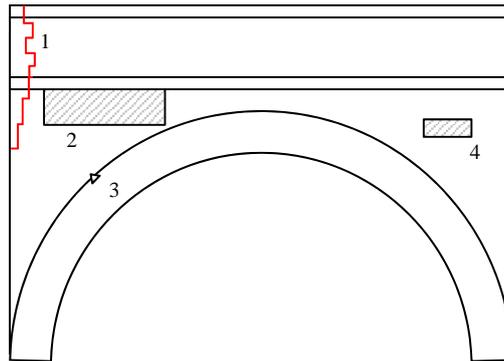
**Span 10 North West Elevation**

1. Vertical stepped fracture through mortar, 2000 x up to 3mm. [\(photo 137\)](#)
2. Area of mortar loss, 2000 x 1500 x up to 50mm, with associated light vegetation growth. [\(photo 138\)](#)
3. Area of spalling to voussoir, 200 x 200 x up to 200mm. [\(photo 139\)](#)
4. Area of mortar loss, 2000 x 1000 x up to 50mm.

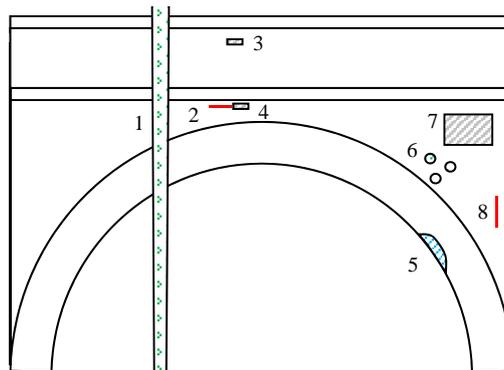
**Span 10 South East Elevation**

1. Mature tree, 400mm in diameter, growing adjacent to elevation in contact with masonry. [\(photo 140\)](#)
2. Horizontal fracture through masonry, 400 x 1mm. [\(photo 141\)](#)
3. Line of mortar loss, 300 x up to 200mm. [\(photo 142\)](#)
4. Line of mortar loss, 300 x up to 30mm.
5. Area of seepage to voussoirs, 1000 x 1000mm.
6. Spot areas of minor vegetation growth. [\(photo 143\)](#)
7. Area of mortar loss, 2000 x 2000 x up to 50mm.
8. Vertical fracture through masonry, 400 x 1mm, with associated seepage.

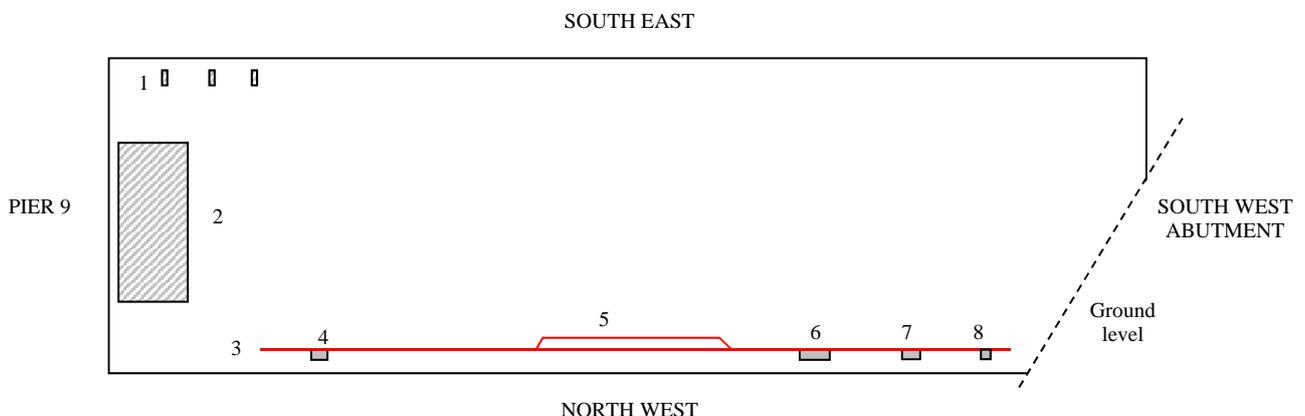
**Span 10 Soffit**

There were spot areas of seepage below the quarter points to both sides of the soffit. There were spot areas of mortar loss of up to 20mm over the pier and abutment and up to 80mm between the voussoirs and brickwork.

1. 3No. lines of mortar loss between voussoirs and brickwork totalling 400 x 15mm.
2. Area of mortar loss, 1000 x 2000 x up to 40mm. [\(photo 144\)](#)
3. Longitudinal fracture through brickwork, 12,000 x up to 15mm, with associated seepage. [\(photos 145 & 146\)](#)
4. Area of missing brickwork between longitudinal fracture and voussoirs, 400 x 100 x 120mm.
5. Longitudinal fracture through brickwork, 2500 x up to 5mm. [\(photo 146\)](#)
6. Area of missing brickwork between longitudinal fracture and voussoirs, 600 x 200 x 120mm. [\(photo 147\)](#)
7. Area of missing brickwork between longitudinal fracture and voussoirs, 400 x 150 x 120mm.
8. Missing half brick between longitudinal fracture and voussoirs. [\(photo 148\)](#)

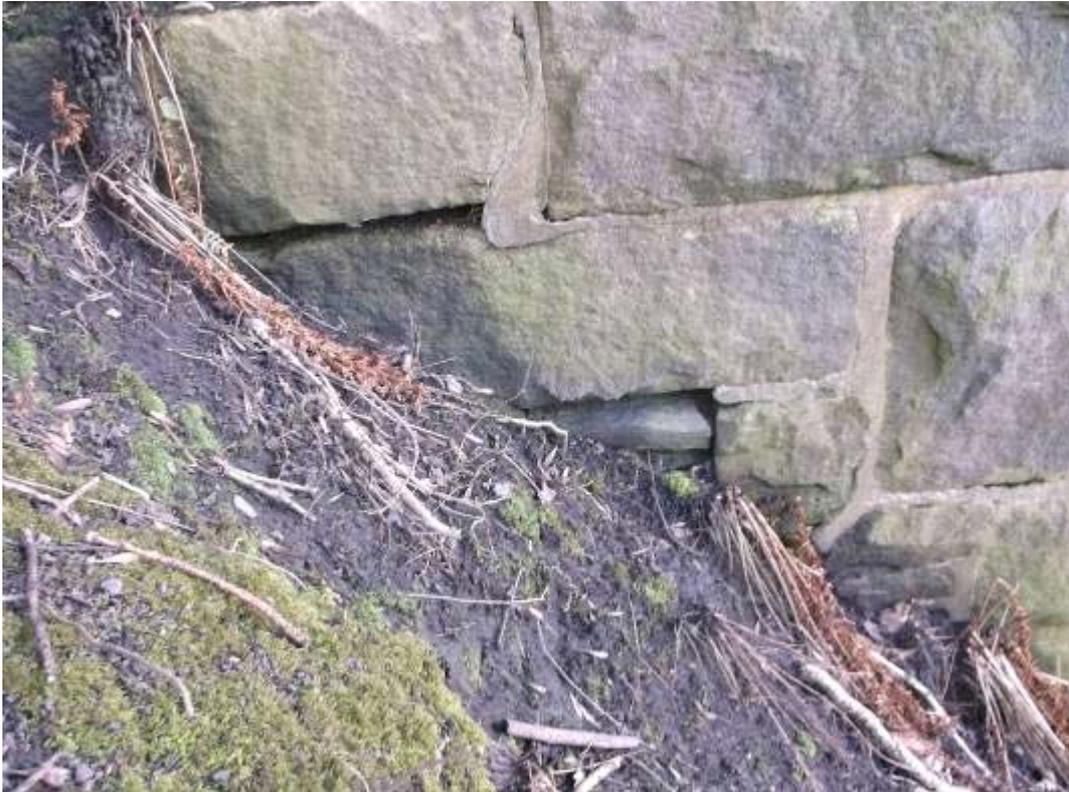
**Photo No. 15: Area of mortar loss to base of north wing wall**

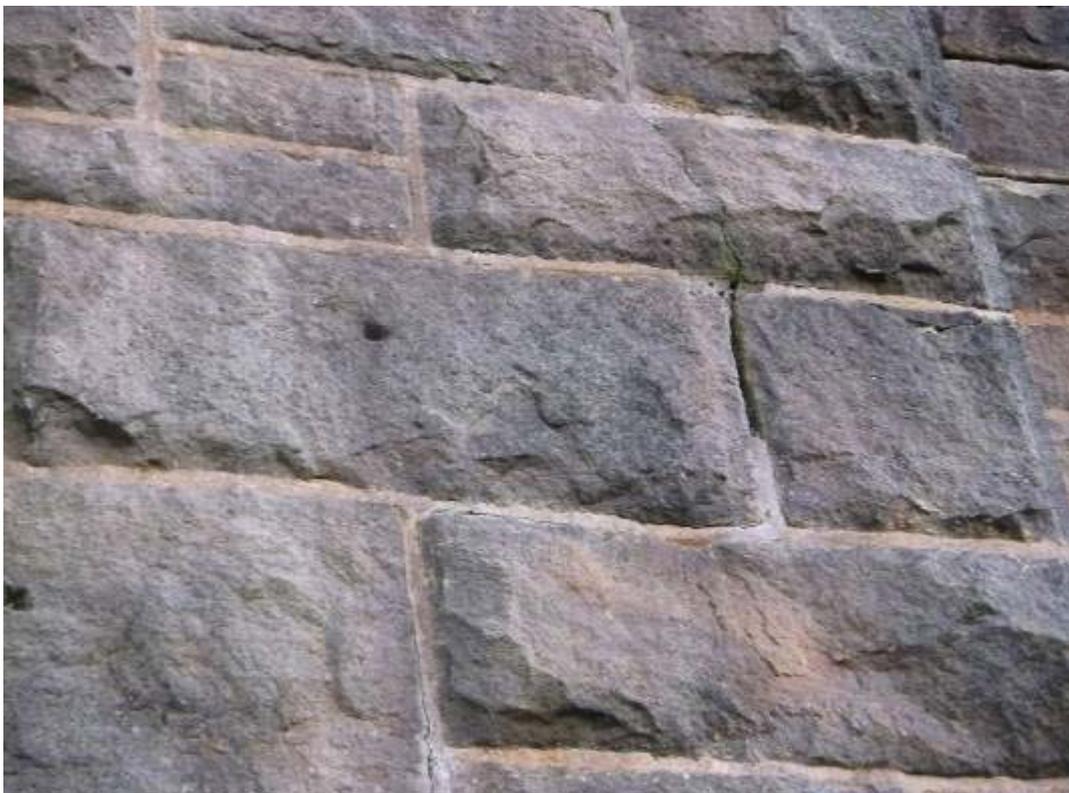
**Photo No. 16: Vertical stepped fracture to north wing wall**

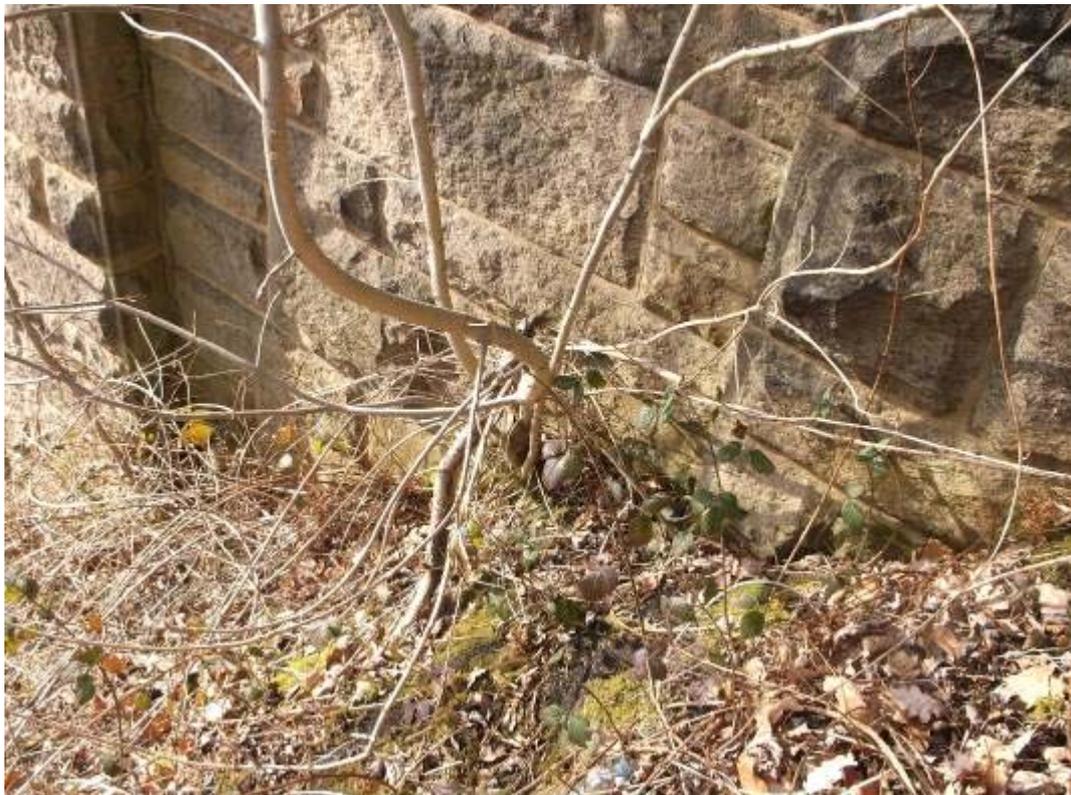
**Photo No. 19: Sapling growing adjacent to east wing wall**

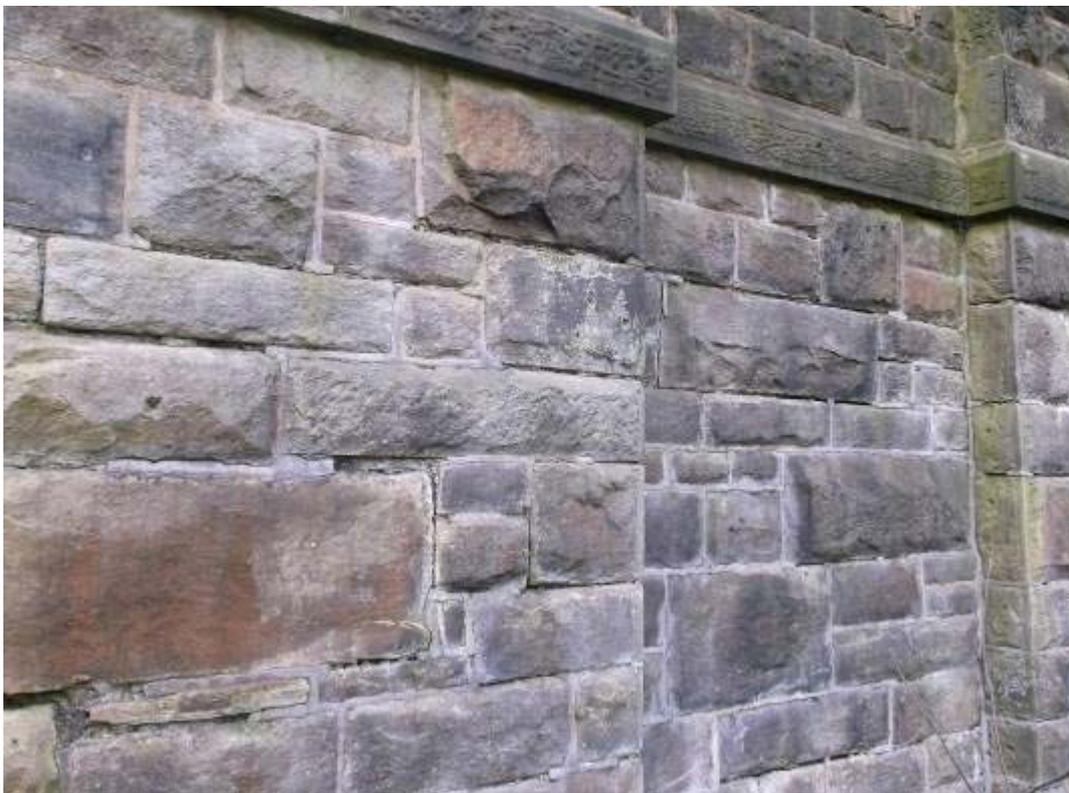
**Photo No. 22: Band of cracked & missing mortar to south wing wall**

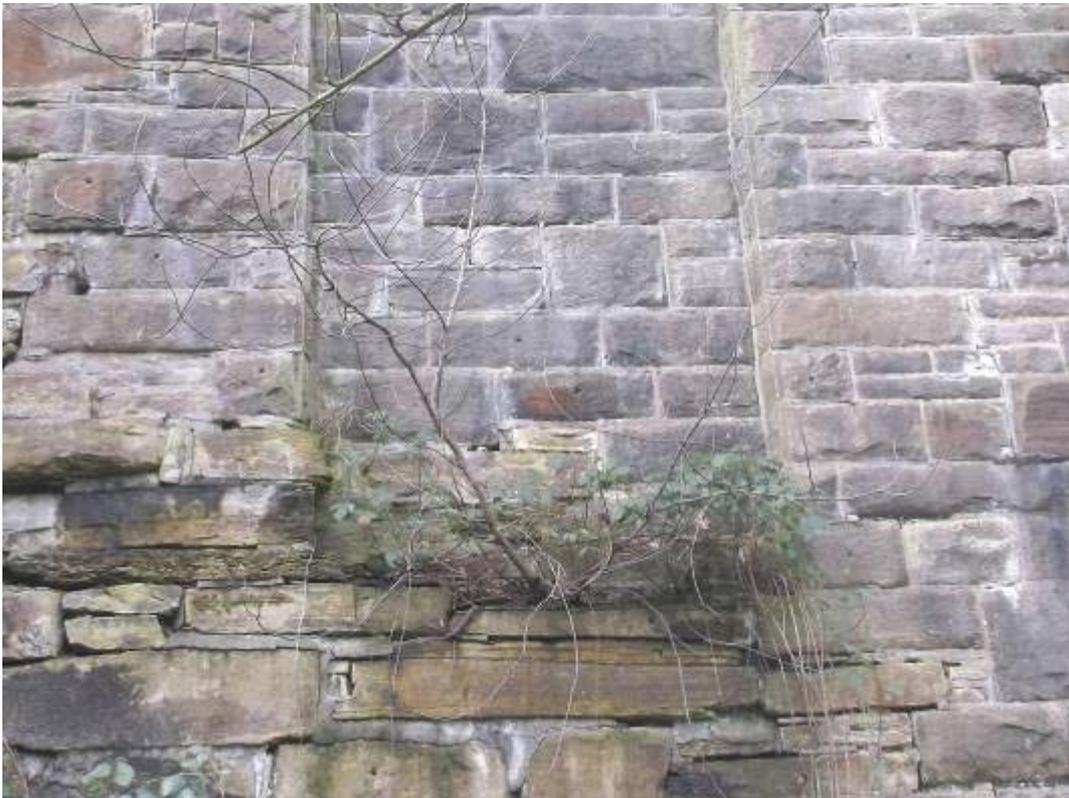
**Photo No. 23: Area of weed & sapling growth to south wing wall**

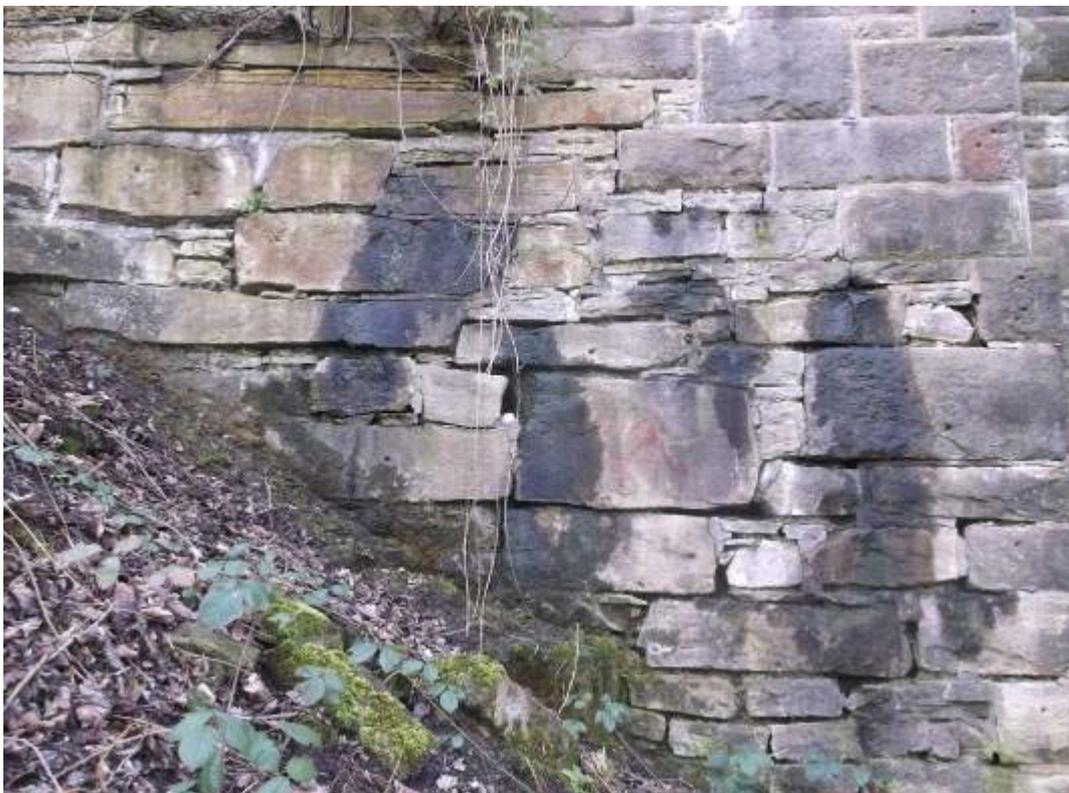
**Photo No. 24: Area of mortar loss & seepage to south wing wall**

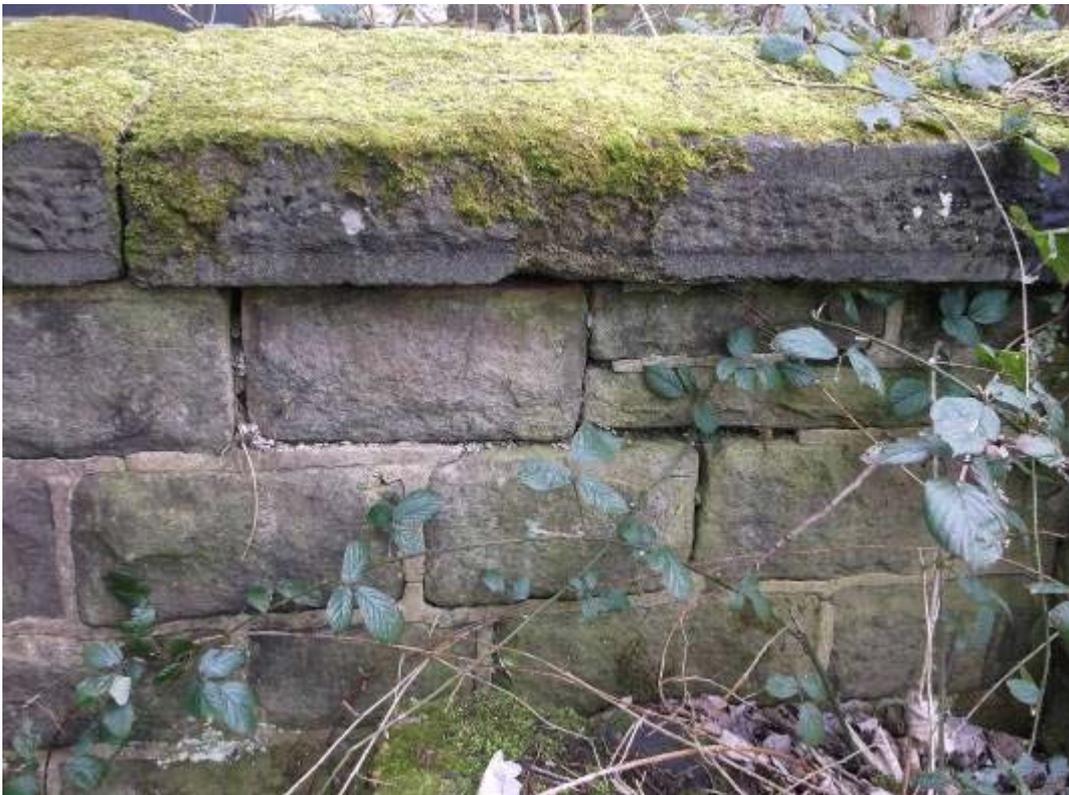
**Photo No. 25: Area of mortar loss & displaced block to west wing wall**

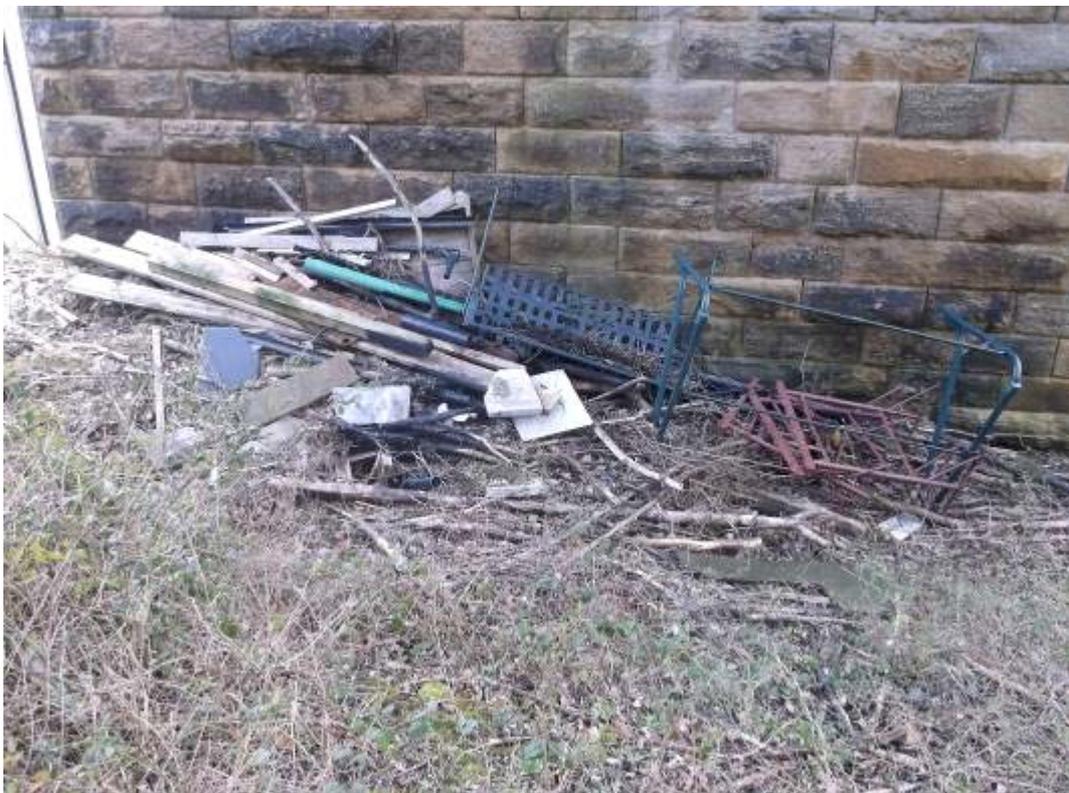
1. Vertical hairline fracture through masonry, 900mm in length.
2. Builder's equipment and wood to base of pier. **(photo 26)**
3. Area of seepage, 1000 x 1000mm.
4. 3No. vertical fractures through individual blocks, each 400 x 1mm. **(photo 27)**
5. Area of mortar loss, 2000 x 2000 x up to 30mm. **(photo 28)**
6. 3No. vertical fractures through individual blocks, each 250 x 1mm.
7. Diagonal fracture through spring course block, 400 x 1mm.
8. Area of mortar loss, 1000 x 2000 x up to 30mm.

**Photo No. 26: Builder's equipment & wood to base of north east elevation of pier 1**

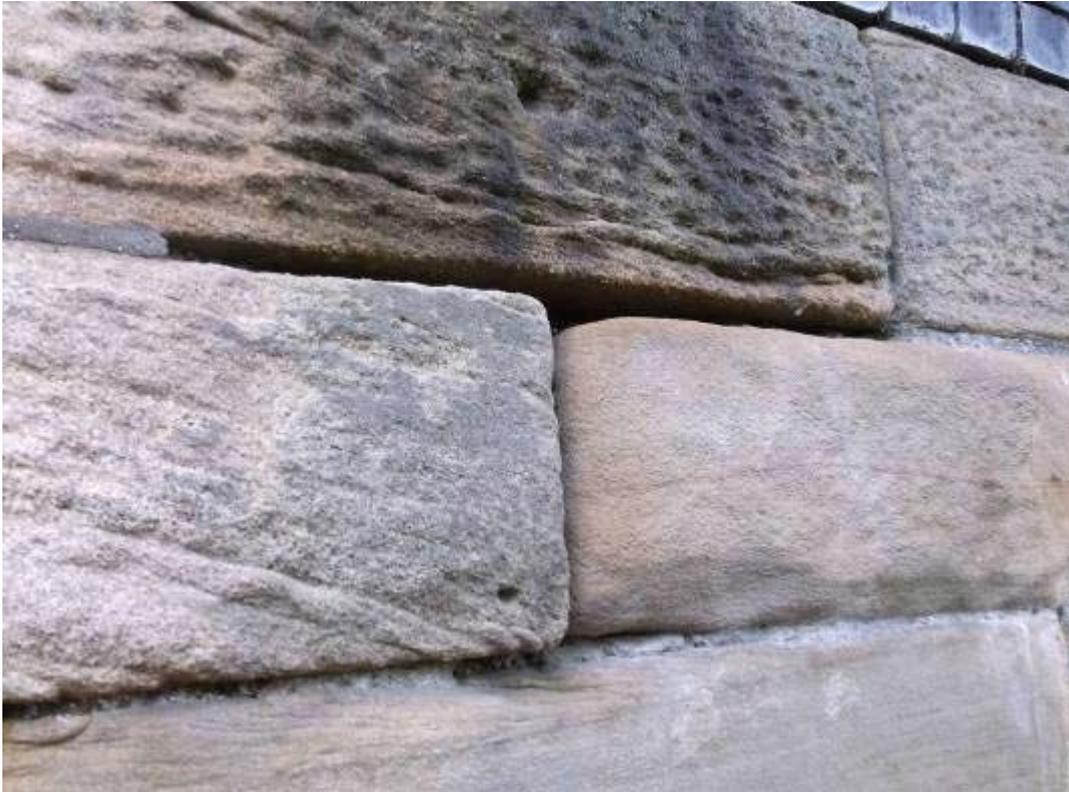
**Photo No. 29: Area of mortar loss to south west elevation of pier 2**
