## HXH/4a Contract Specification (Masonry Repair and Waterproofing Installation)

**Client name:** National Highways – Historical Railways Estate  
**Project name:** HRE Works Framework  
**Client reference:** HXH/4a  
**Document no:** 0451200  
**Revision no:** 03  
**Date:** May 2023  
**Project no:** B38380DE  
**Project manager:** Nigel Robson  
**Prepared by:** Christopher Doig  
**File name:** HXH 4a NEC ECC

### **HRE WORKS FRAMEWORK HXH/4a 'WHEATLEY VIADUCT' CONTRACT FOR REMEDIAL REPAIRS AND WATERPROOFING**

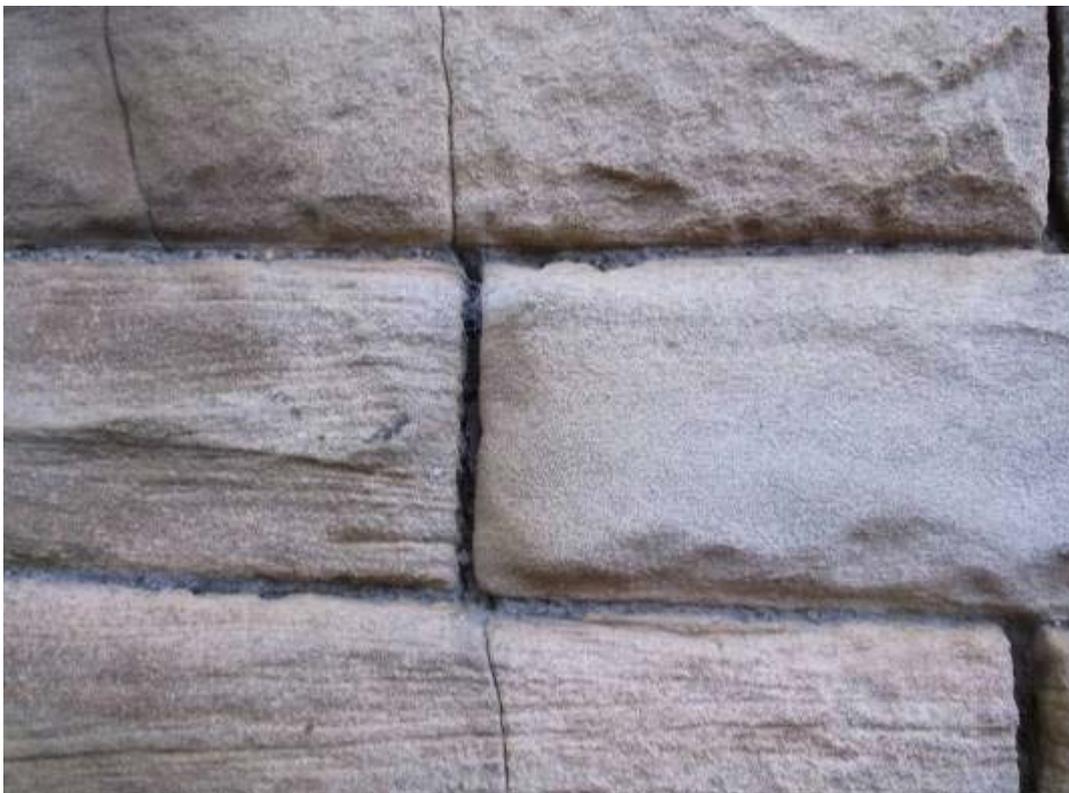
1. Vertical hairline fracture through masonry, 1500mm in length.
2. Vertical fracture through masonry, 1500 x 0.5mm.
3. Area of seepage, 1000 x 500mm.
4. Area of mortar loss, 1000 x 2000 x up to 50mm.
5. Vertical fracture through masonry, 2000 x 1mm.
6. Area of mortar loss, 2000 x 1000mm.
7. 2No. vertical fractures through 1No. masonry block, each 300 x 1mm.
8. Area of mortar loss, 900 x 500 x up to 200mm. **(photo 29)**
9. Vertical stepped fracture through masonry, 2600 x 1.5mm.
10. Vertical stepped hairline fracture through masonry, 1800mm in length.
11. Vertical hairline fracture through masonry, 1000mm in length. **(photo 30)**

**Photo No. 30: Vertical fracture to south west elevation of pier 2**

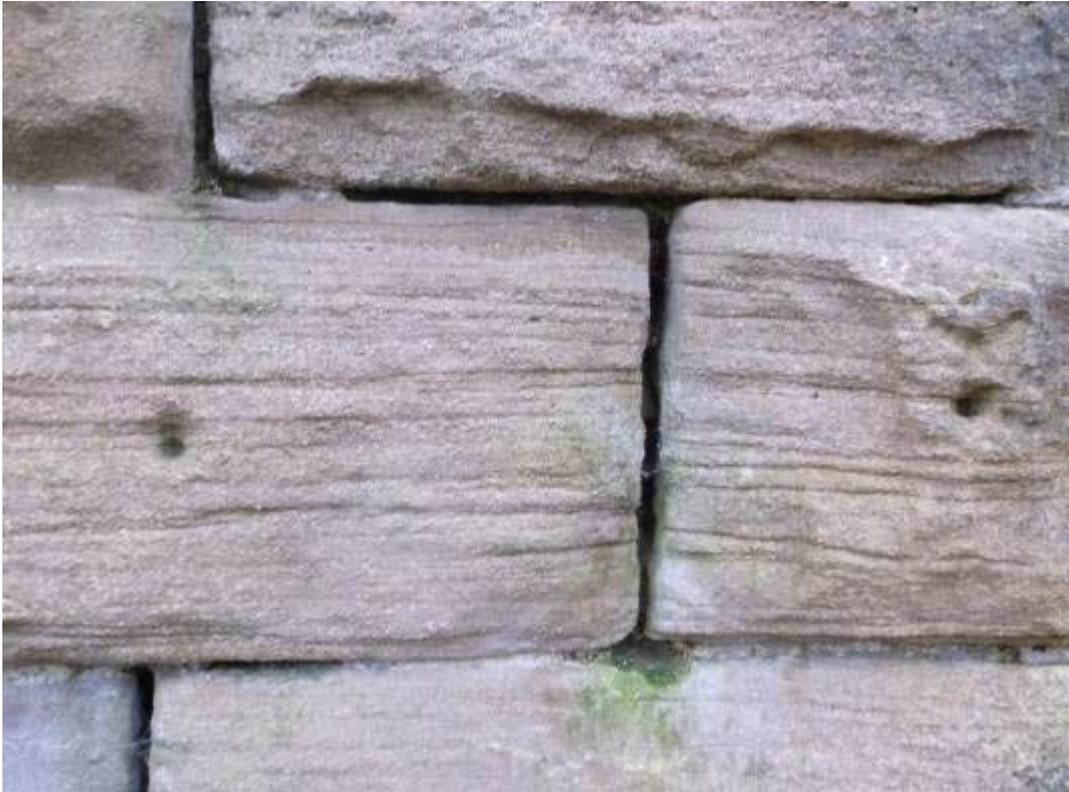
Four hairline cracks through individual blocks were noted to the north east elevation. There was spot mortar loss of up to 100mm throughout the elevations, mainly to the top and sides. (photo 31) A mature tree, 600mm in diameter, was growing adjacent to the north west elevation. (photo 32)

**Photo No. 31: Typical mortar loss to pier 3**

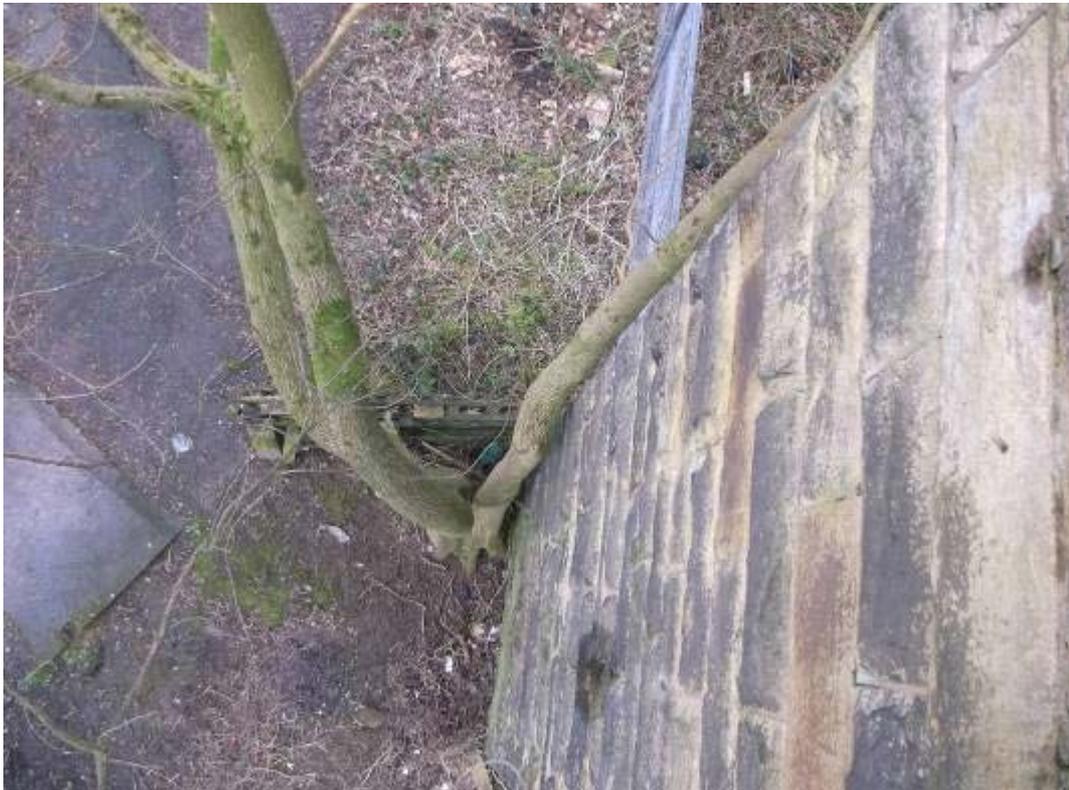
**Photo No. 32: Tree adjacent to north west elevation of pier 3**

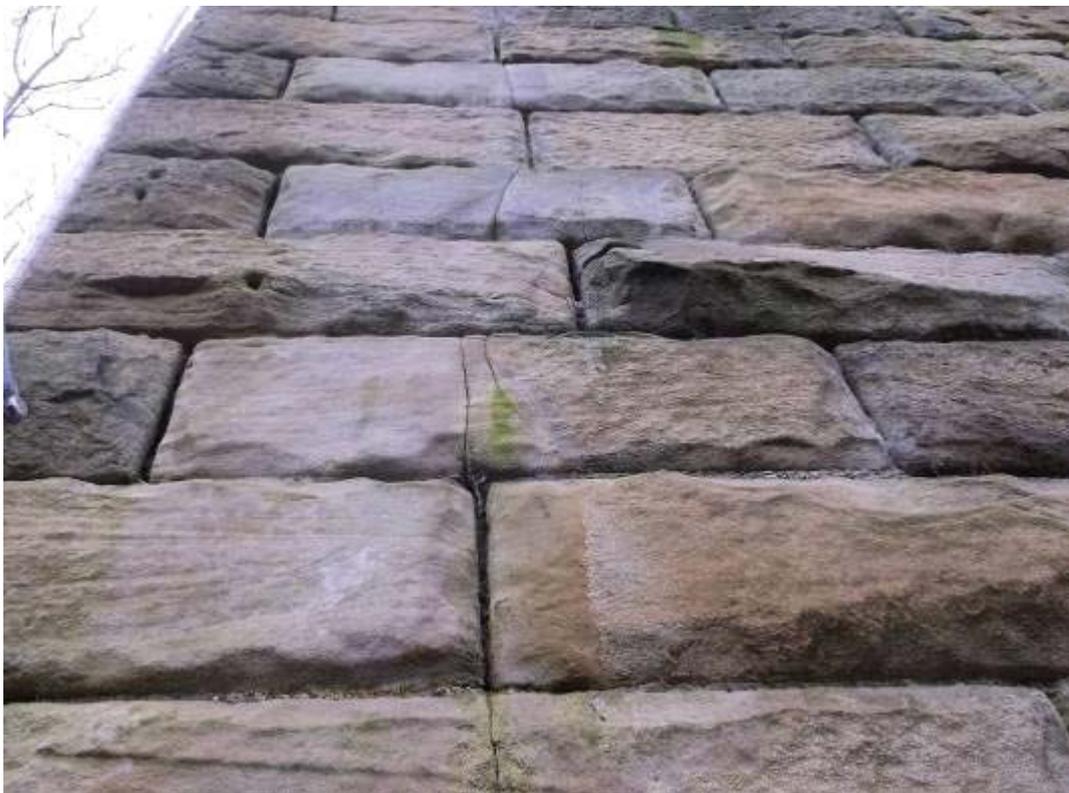
1. Vertical hairline fracture through masonry, 3500mm in length.
2. Vertical fracture through masonry, 4000 x 1mm.
3. Vertical stepped fracture through masonry, 6000 x 1mm. (photo 33)
4. Vertical fracture through masonry, 5000 x 1mm. (photo 34)
5. Area of mortar loss, 4000 x 700 x up to 80mm.
6. 2No. areas of seepage totalling 1000 x 2000mm.
7. Area of mortar loss, 1000 x 1000 x up to 30mm.

**Photo No. 34: Vertical fracture to south west elevation of pier 3**

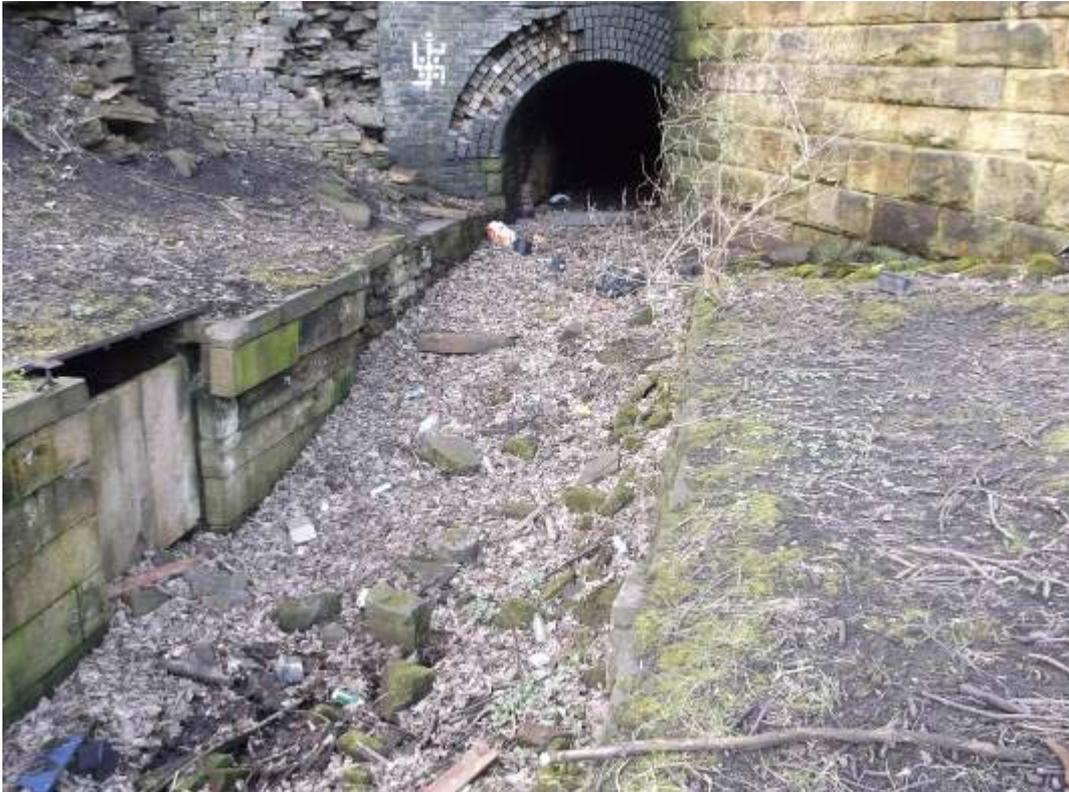
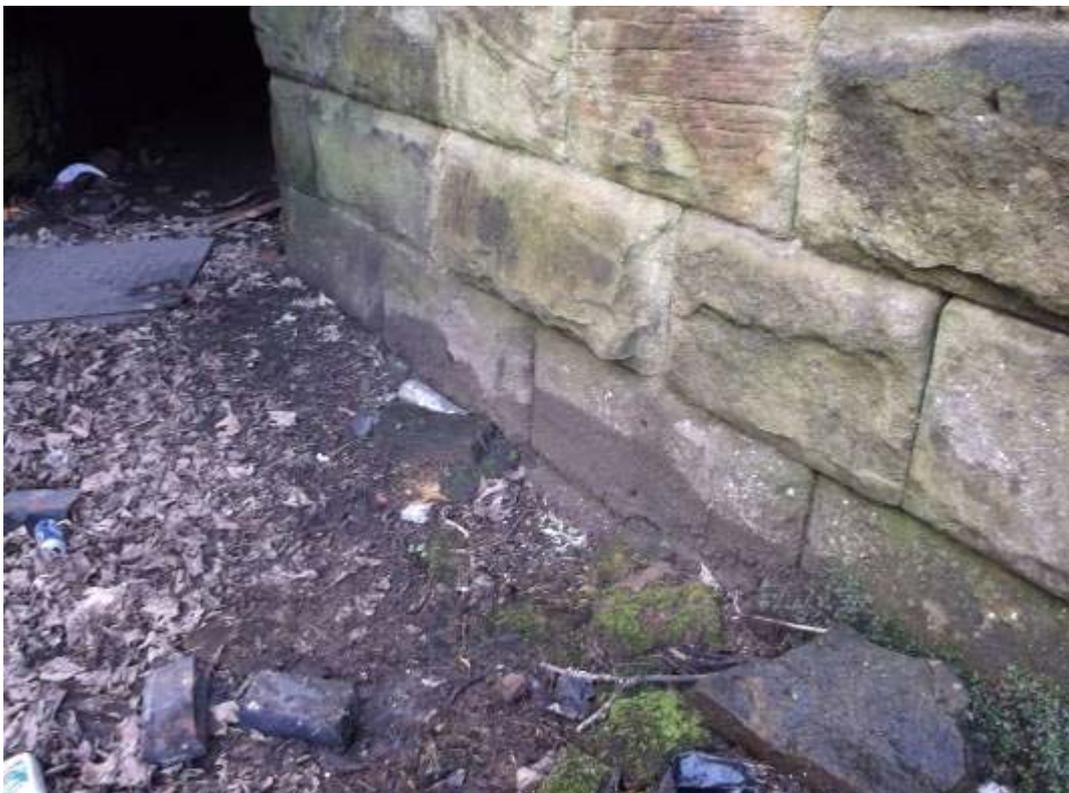
There was spot mortar loss of up to 60mm throughout the elevations, mainly to vertical joints. There were occasional vertical hairline fractures to individual blocks to the north west elevation. A culvert under span 5 could carry water from the river and discharge it along the base of the south west elevation, although this was dry at the time of examination. No sign of scour was noted. **(photos 35 & 36)**

**Photo No. 35: Culvert under span 5, dry at time of examination**

**Photo No. 36: Watercourse from culvert under span 5 running along base of south west elevation of pier 4, dry at time of examination, no evidence of scour noted**

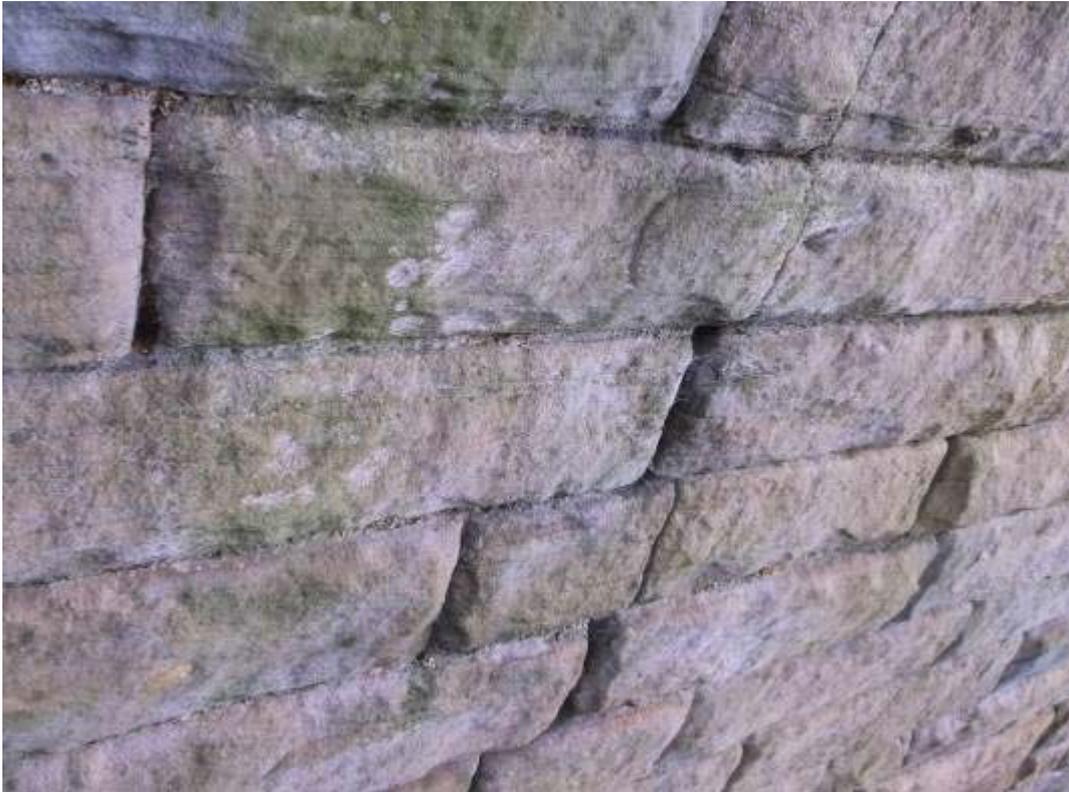
1. Vertical fracture through masonry, 1200 x 1mm.
2. Vertical fracture through masonry, 2500 x 0.5mm.
3. Vertical fracture through masonry, 1200 x 0.5mm.
4. Vertical fracture through masonry, 4000 x 1mm.
5. Vertical fracture through masonry, 1000 x 1mm.
6. Vertical fracture through masonry, 2500 x 1mm. **(photo 37)**
7. Vertical fracture through masonry, 1500 x 0.5mm. **(photo 38)**
8. Vertical fracture through masonry, 3500 x 1mm.
9. Area of seepage, 1000 x 500mm, with associated mortar loss of up to 80mm and vegetation growth. **(photo 39)**
10. Vertical fracture through masonry, 1600 x 0.5mm.
11. Vertical fracture through masonry, 1000 x 1mm. **(photo 40)**
12. Vertical fracture through masonry, 1500 x 0.5mm.

**Photo No. 37: Vertical fracture to south west elevation of pier 4**

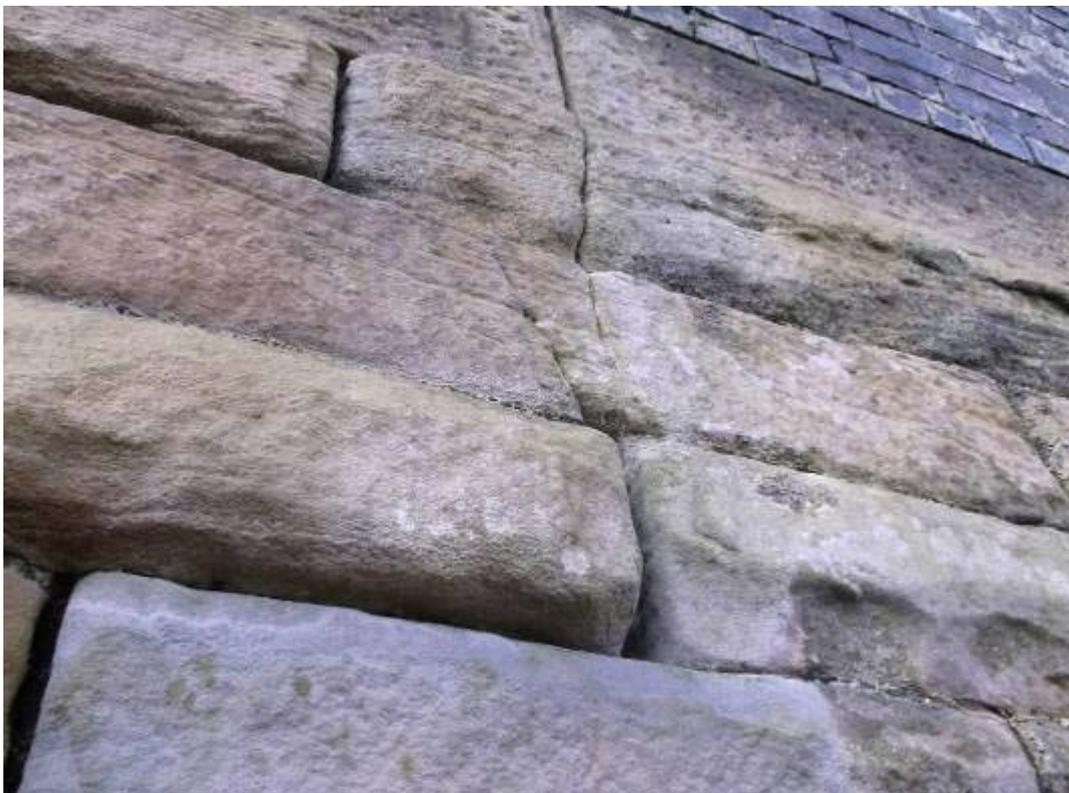
**Photo No. 38: Vertical fracture to south west elevation of pier 4**

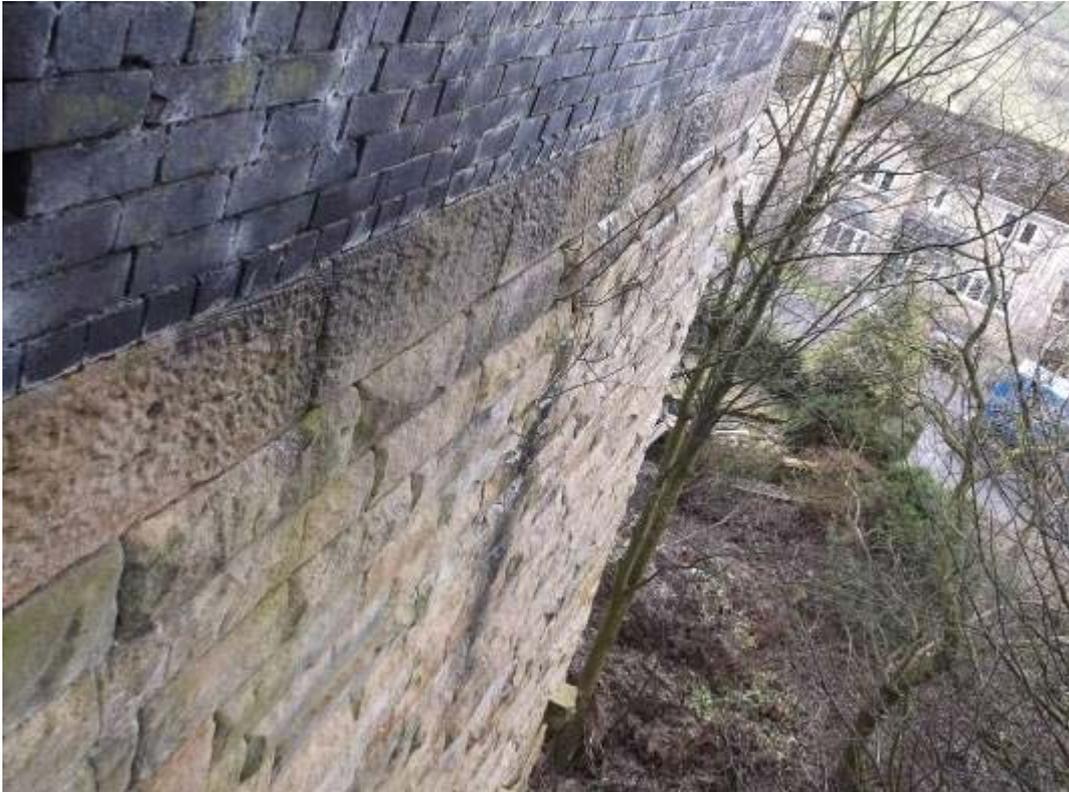
**Photo No. 39: Area of seepage to south west elevation of pier 4**

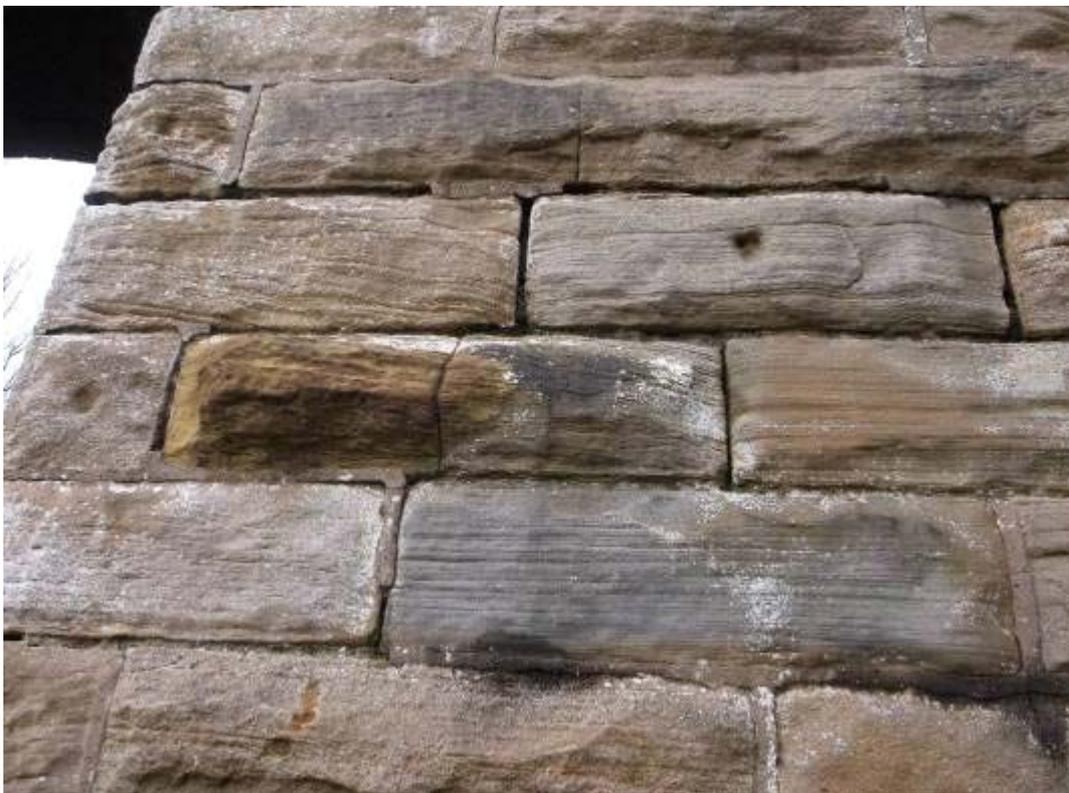
**Photo No. 40: Vertical fracture to south east elevation of pier 4**

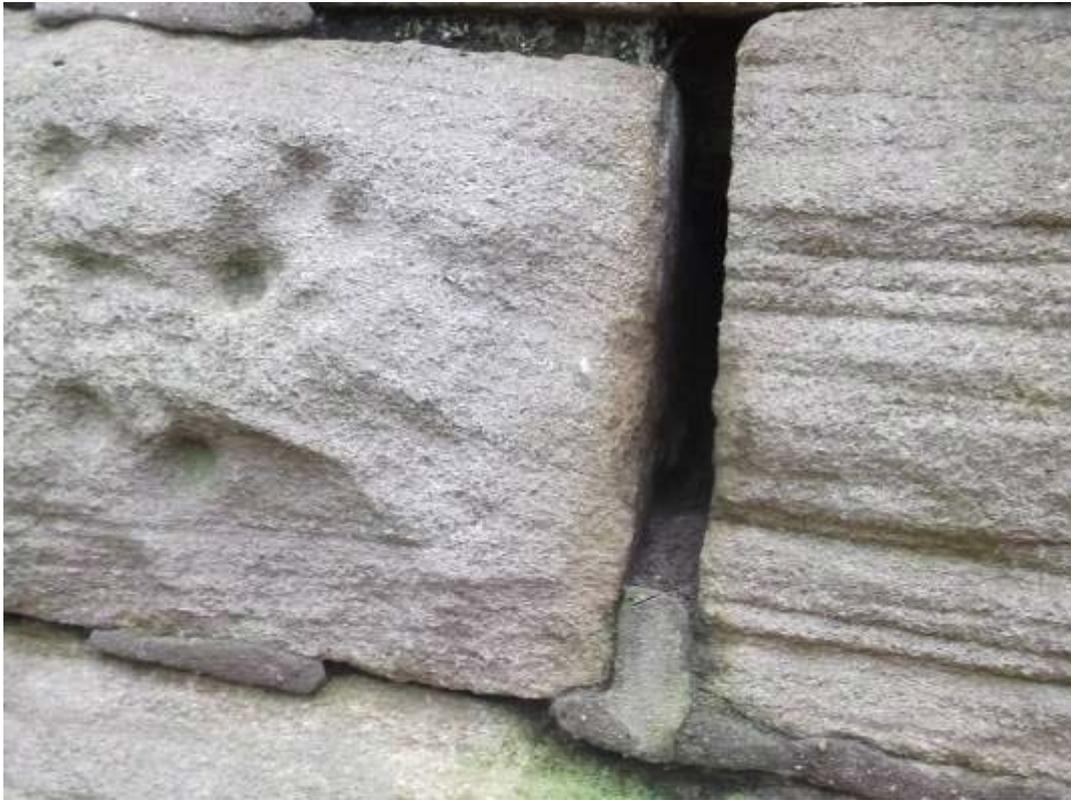
1. Vertical fracture through masonry, 500 x up to 2mm. **(photo 41)**
2. Area of seepage, 1000 x 2000mm.
3. Area of seepage, 2000 x 1000, with associated mortar loss of up to 50mm. **(photo 42)**
4. Area of mortar loss, 2000 x 1000 x up to 40mm.
5. Area of seepage, 1000 x 1000mm.
6. Area of mortar loss, 2500 x 2000 x up to 50mm.
7. Area of seepage, 3000 x 500mm.
8. 2No. vertical fractures through 1No. block, each 200 x 1mm.
9. Vertical fracture through masonry, 500 x 1mm.
10. 2No. lines of mortar loss, each 300 x up to 200mm. **(photo 43)**

**Photo No. 43: Line of mortar loss to south east elevation of pier 5**

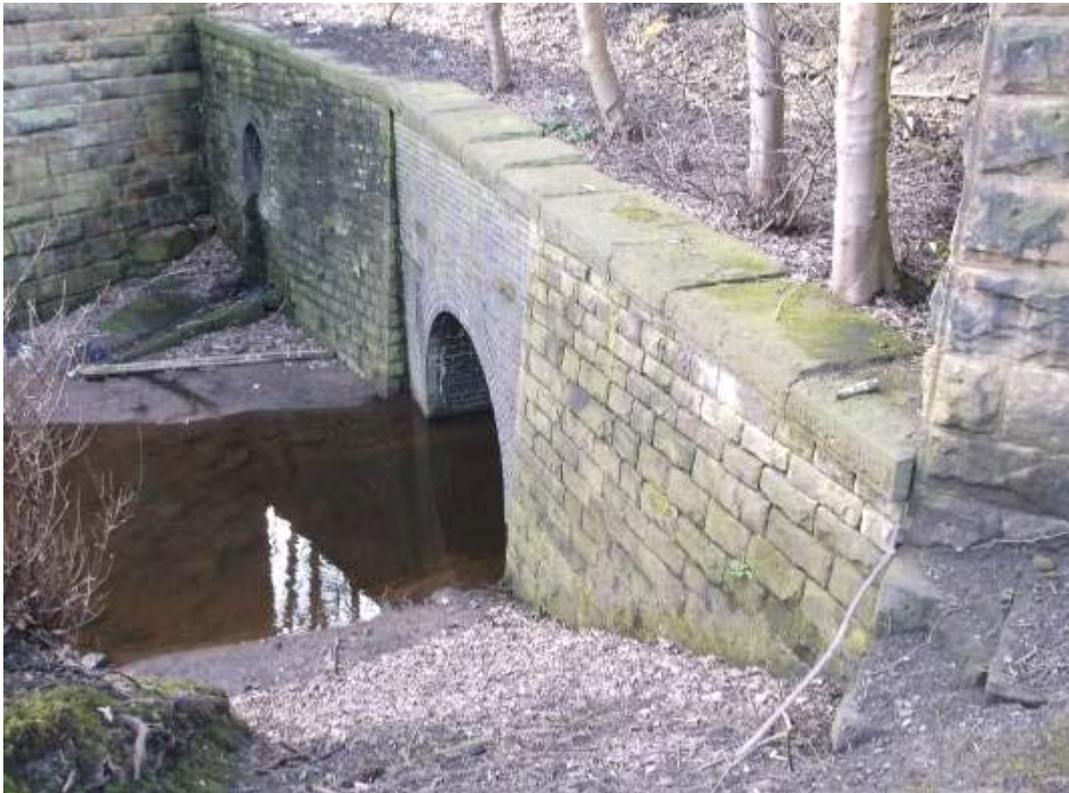
The river emerged from two culverts under span 6 and ran along the base of the north east elevation. No sign of scour was noted. (photo 44 & 45) Five hairline cracks through individual blocks were noted to the south west elevation.

**Photo No. 44: Culverts under span 6**

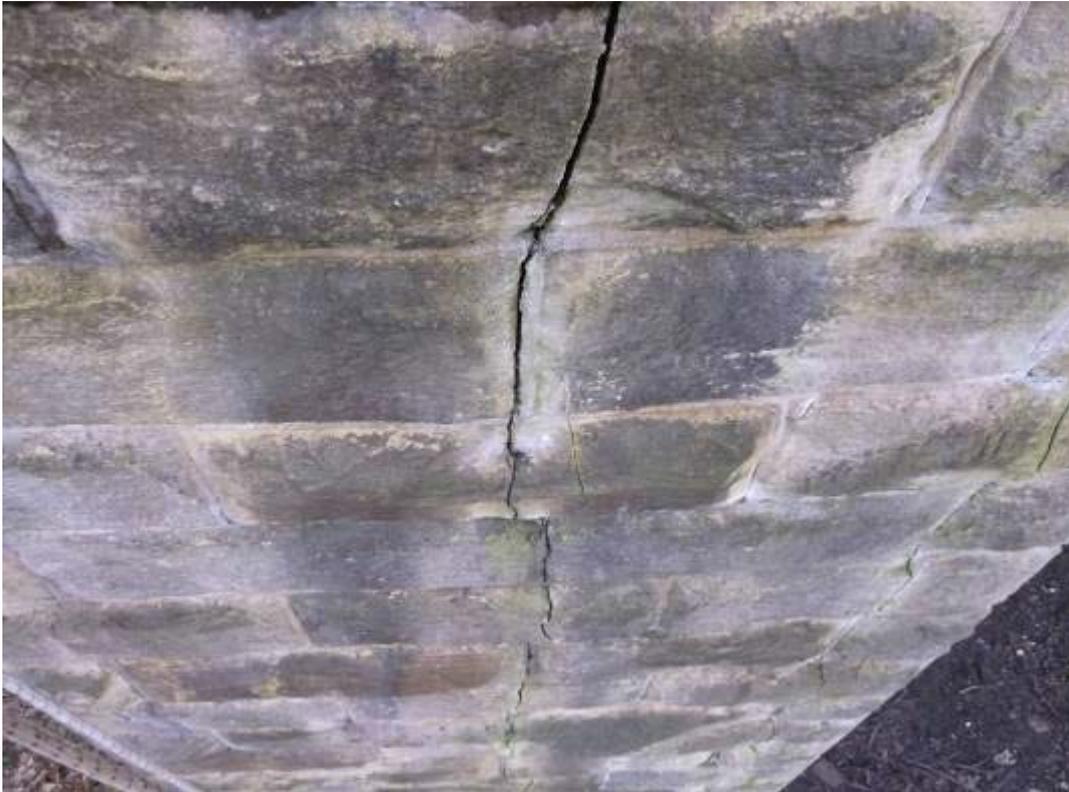
1. Vertical fracture through masonry, 3500 x 1mm, with associated seepage.
2. Vertical fracture through masonry, full height x up to 8mm. **(photo 51)**

**Photo No. 51: Vertical fracture to north west elevation of pier 8**

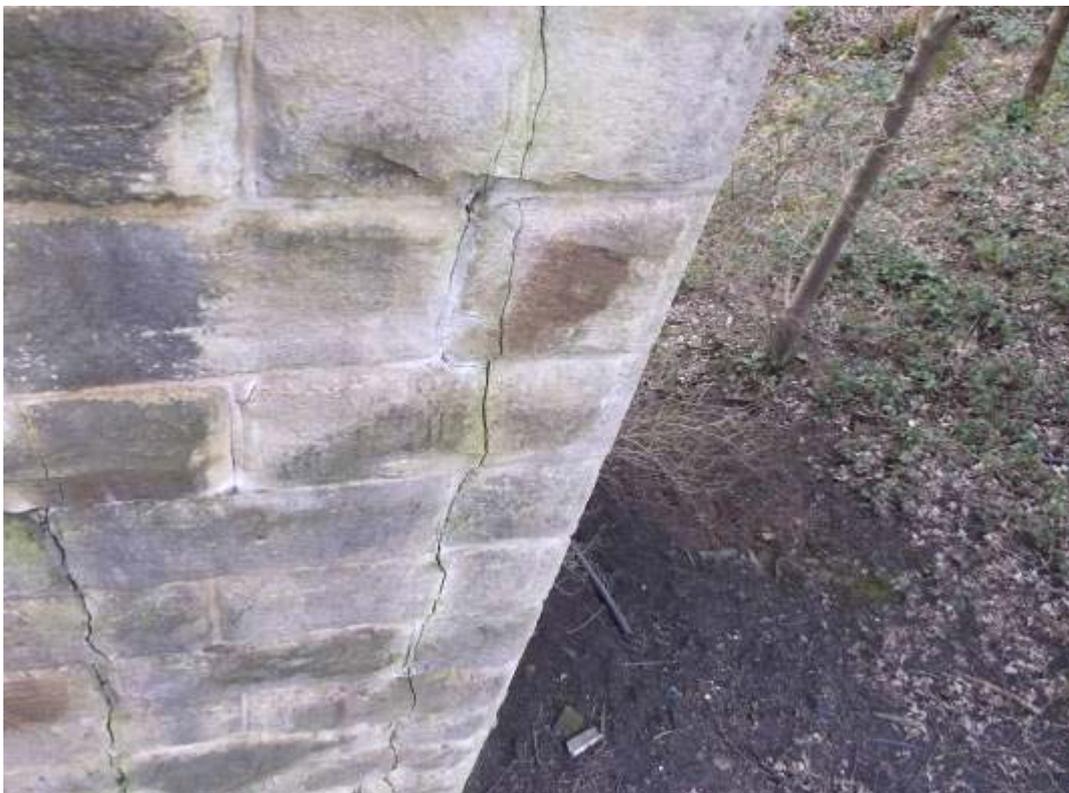
3. Vertical fracture through masonry, 2000 x 1mm, with associated seepage. **(photo 52)**
4. Vertical fracture through masonry, 7000 x up to 6mm. **(photo 52)**

**Photo No. 52: 2No. vertical fractures to north west elevation of pier 8**

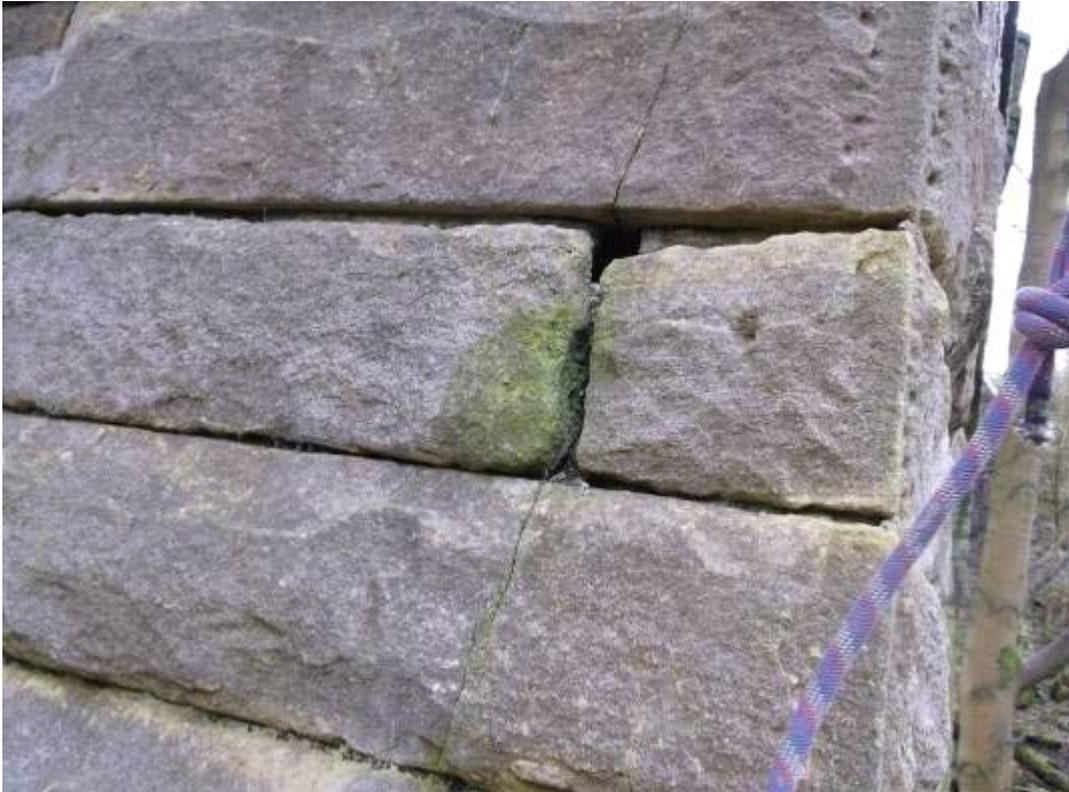
11. Vertical fracture through masonry, 1000 x 1mm. **(photo 55)**
12. Vertical fracture through masonry, 1500 x 0.5mm.
13. Diagonal stepped fracture through masonry, 1800 x 1mm.

**Photo No. 55: Vertical fracture to north east elevation of pier 8**

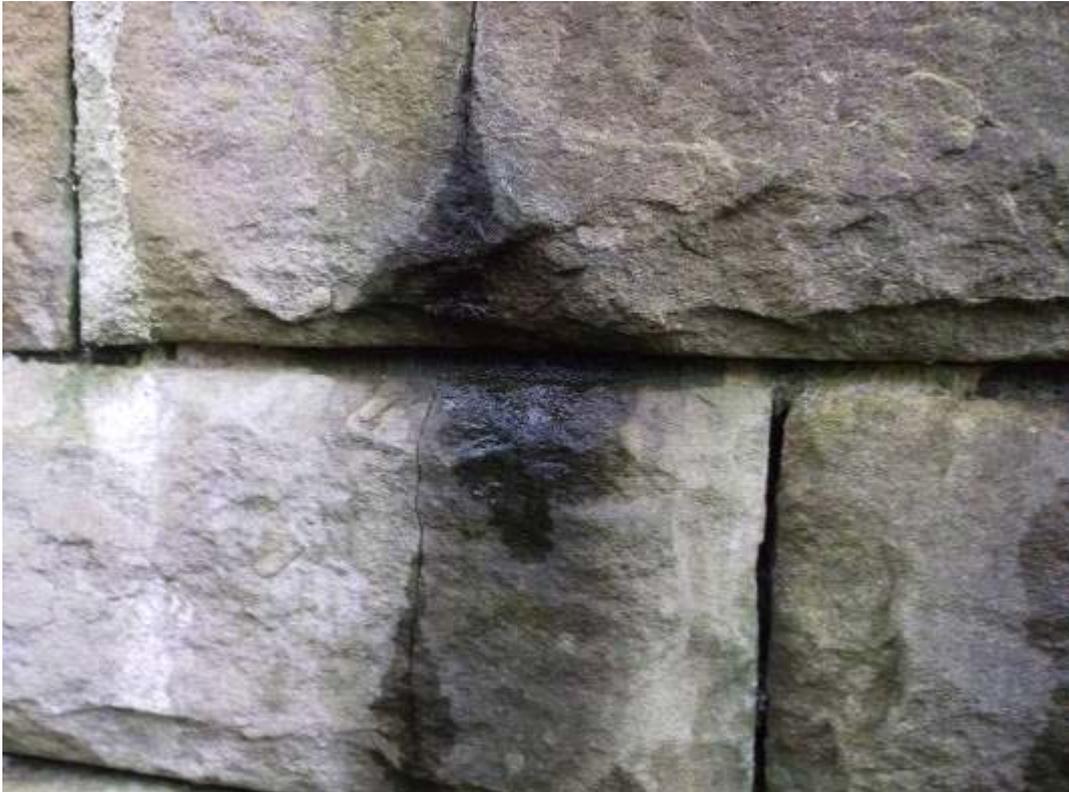
19. Vertical fracture through masonry, 700 x 1mm, with associated seepage. **(photo 57)**
20. Vertical fracture through masonry, 1500 x 1mm.
21. Vertical fracture through masonry, 1700 x 1mm.
22. Vertical fracture through masonry, 6000 x 1mm.
23. 1No. missing block, 800 x 300 x 300mm, vertical fracture to block above, 1mm wide. **(photo 58)**
24. Vertical fracture through masonry, 2000 x 0.5mm.
25. Vertical fracture through masonry, 1400 x 1mm, with associated seepage.
26. Area of seepage, 4000 x 2000mm.
27. Area of fractures through masonry and mortar, 1200 x 700 x up to 3mm. **(photo 59)**
28. Vertical hairline fracture through masonry, 800mm in length.
29. Vertical hairline fracture through masonry, 1100mm in length, with associated seepage.

**Photo No. 57: Vertical fracture to south west elevation of pier 8**

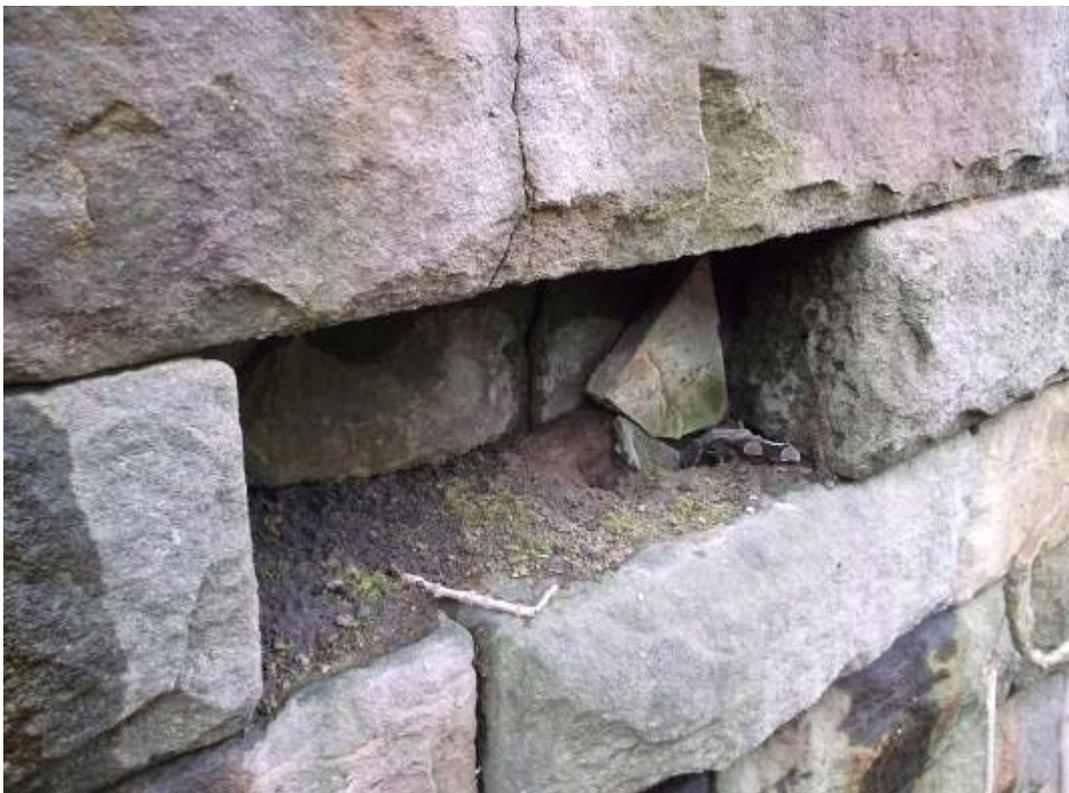
**Photo No. 58: Missing block & vertical fracture to south west elevation of pier 8**

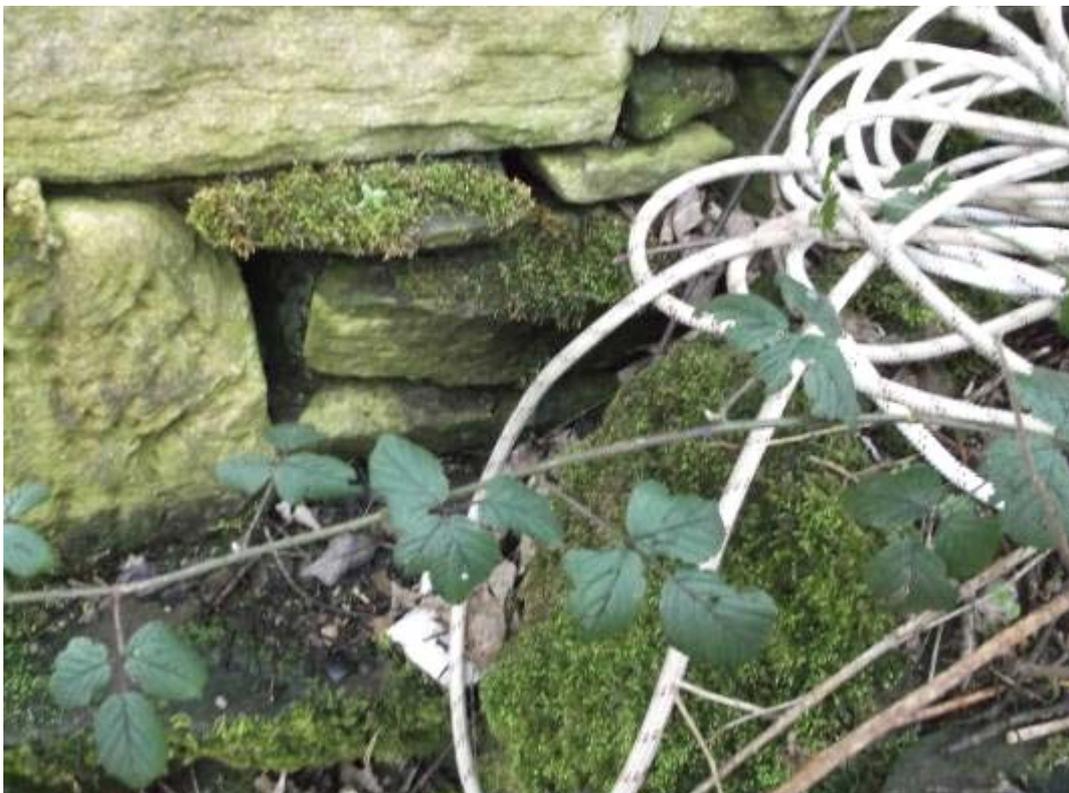
**Photo No. 60: Area of loose, mortarless masonry to north west elevation of pier 9**

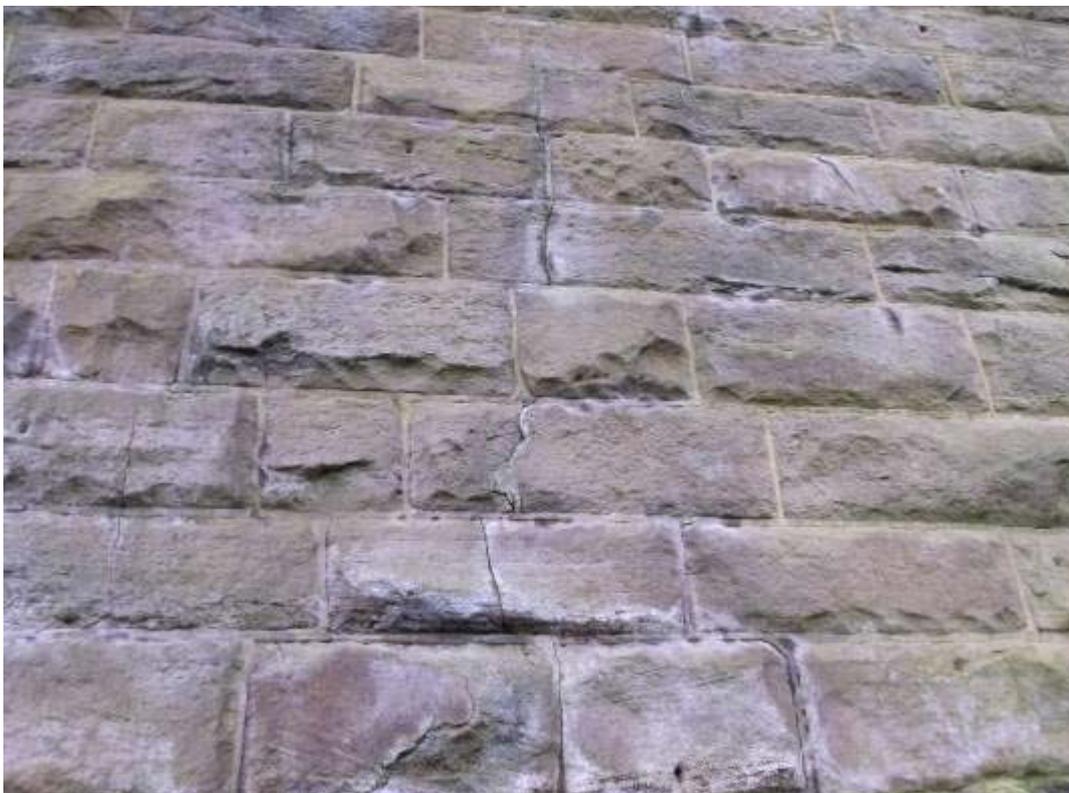
**Photo No. 62: Vertical fracture to north east elevation of pier 9**

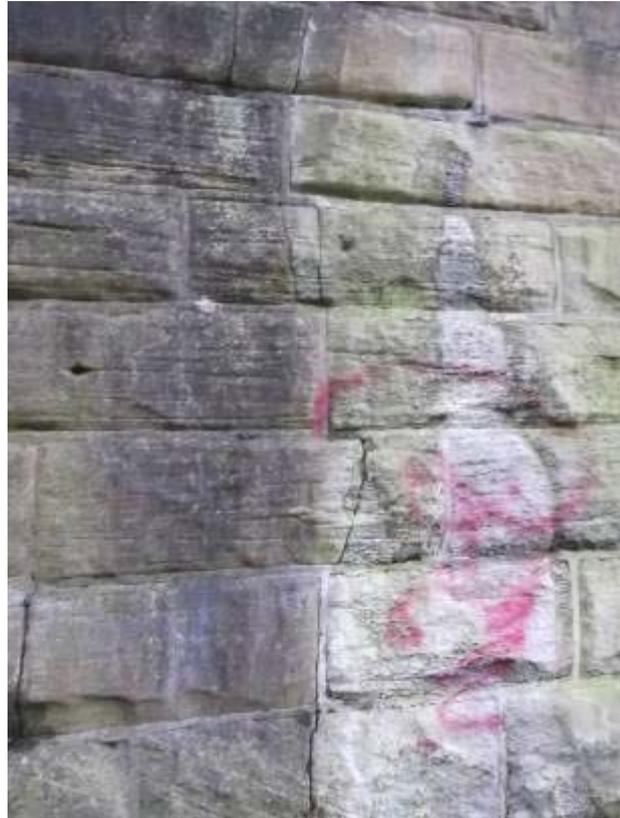
**Photo No. 63: Vertical fracture to south west elevation of pier 9**

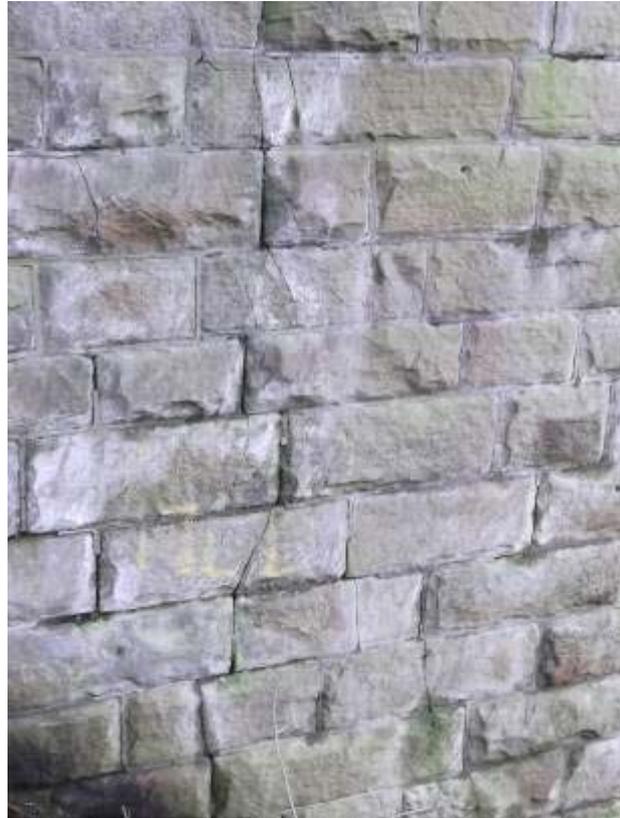
**Photo No. 65: Vertical fracture with seepage to south west elevation of pier 9**

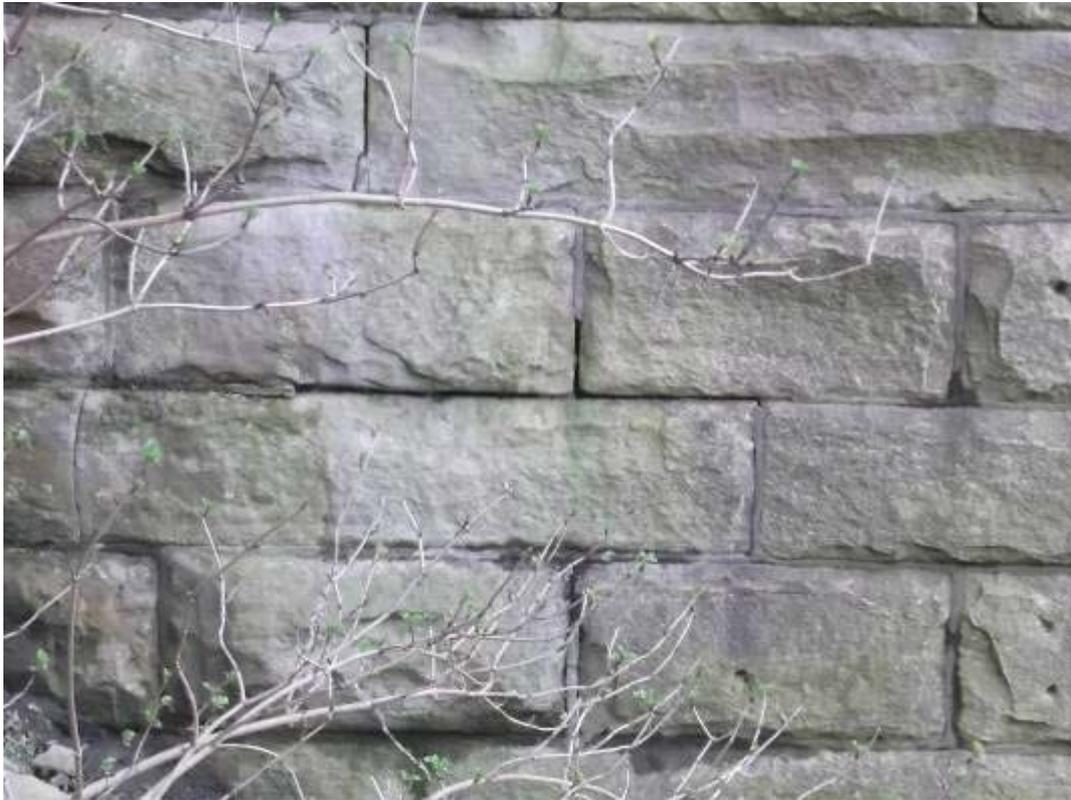
**Photo No. 67: Area of mortar loss to south west elevation of pier 9**

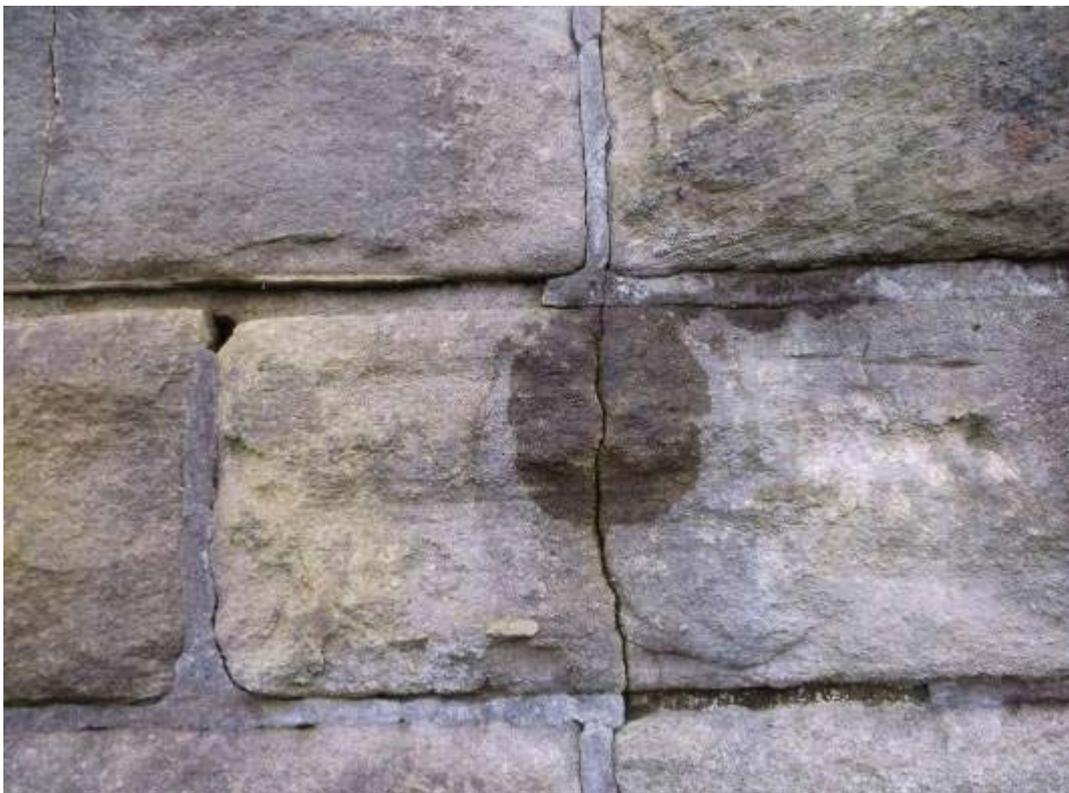
**Photo No. 68: Vertical fracture with seepage to south east elevation of pier 9**

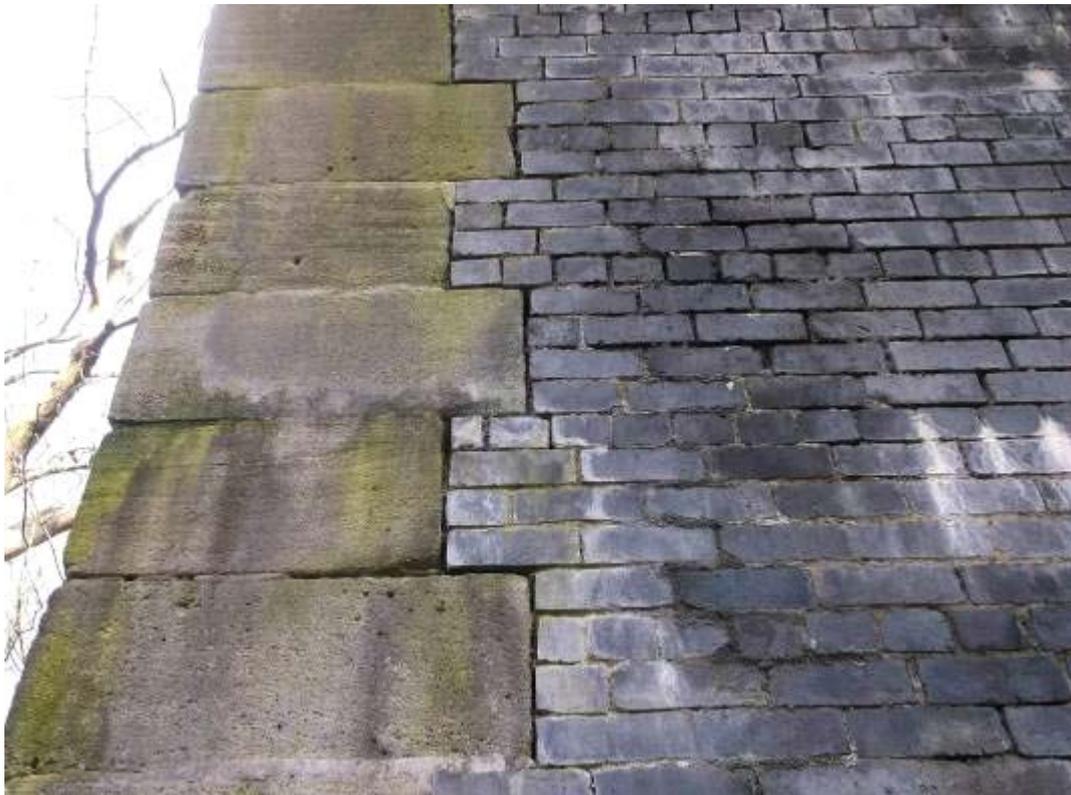
**Photo No. 73: Typical mortar loss behind voussoirs to soffit of span 1**

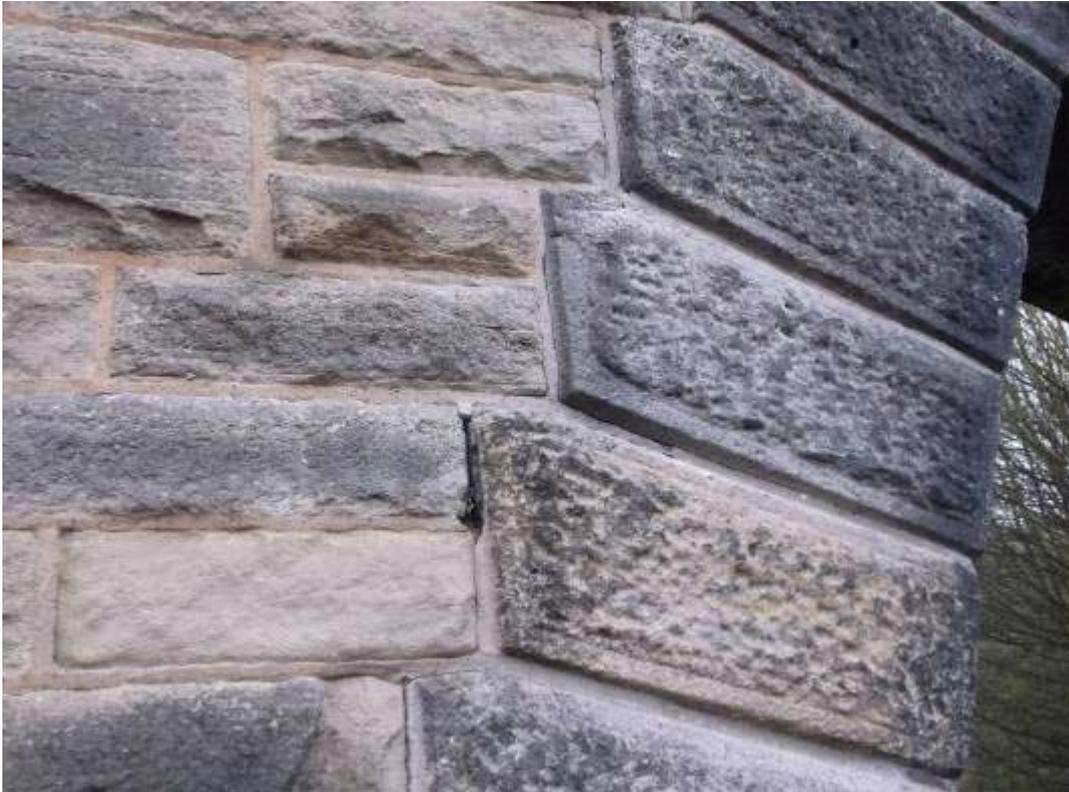
1. Diagonal stepped separation fracture between voussoirs and spandrel, 3000 x 0.5mm. **(photo 79)**
2. Vertical fracture through masonry, 400 x 1mm. **(photo 80)**
3. Area of seepage, 300 x 300mm.

**Photo No. 79: Separation fracture to south east elevation of span 2**
