## HXH/4a Contract Specification (Masonry Repair and Waterproofing Installation)

**Client name:** National Highways – Historical Railways Estate  
**Project name:** HRE Works Framework  
**Client reference:** HXH/4a  
**Document no:** 0451200  
**Revision no:** 03  
**Date:** May 2023  
**Project no:** B38380DE  
**Project manager:** Nigel Robson  
**Prepared by:** Christopher Doig  
**File name:** HXH 4a NEC ECC

### **HRE WORKS FRAMEWORK HXH/4a 'WHEATLEY VIADUCT' CONTRACT FOR REMEDIAL REPAIRS AND WATERPROOFING**

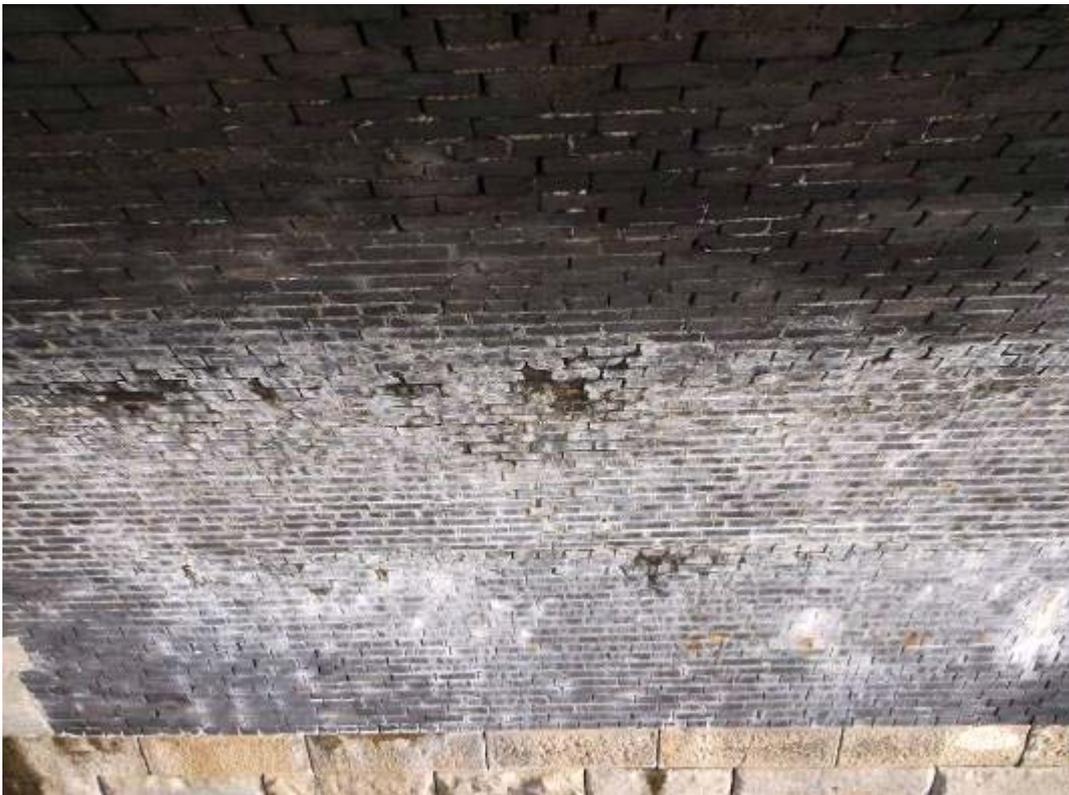
There were spot areas of minor seepage totalling 2m<sup>2</sup> and leachate deposits totalling 15m<sup>2</sup> from the quarter point to pier 1. [\(photo 81\)](#)

**Photo No. 81: Typical seepage & leachate deposits to soffit of span 2**

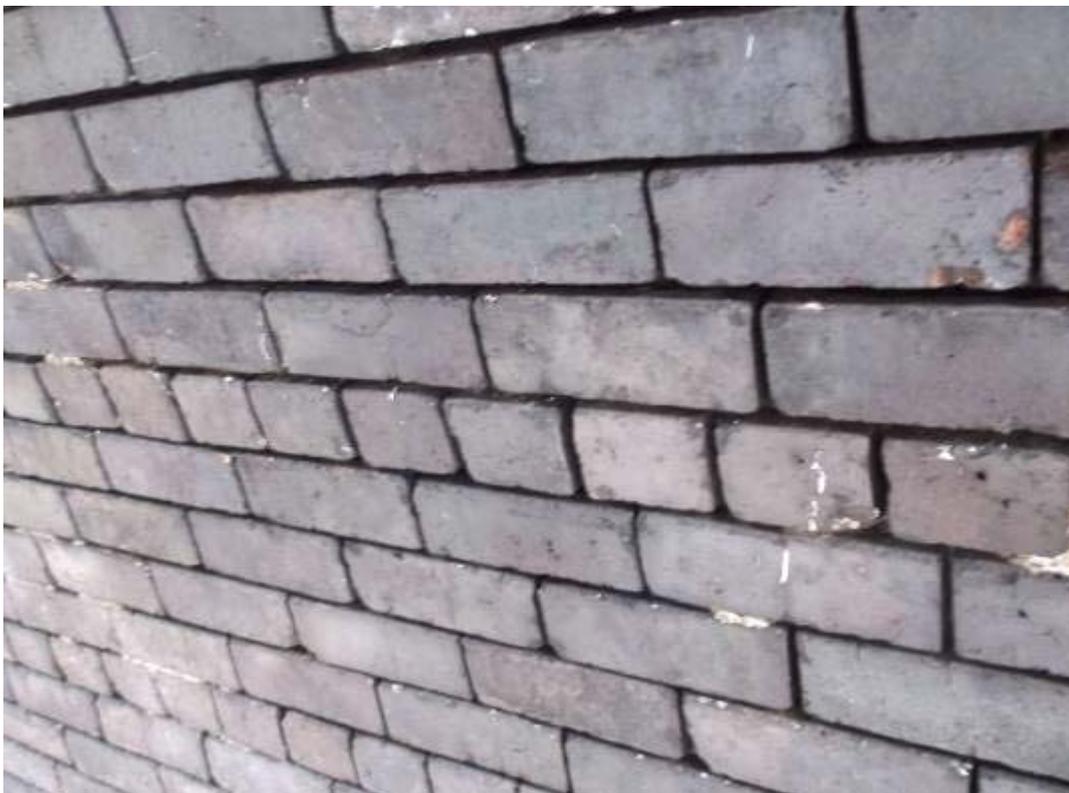
**Photo No. 82: Area of mortar loss to soffit of span 2**

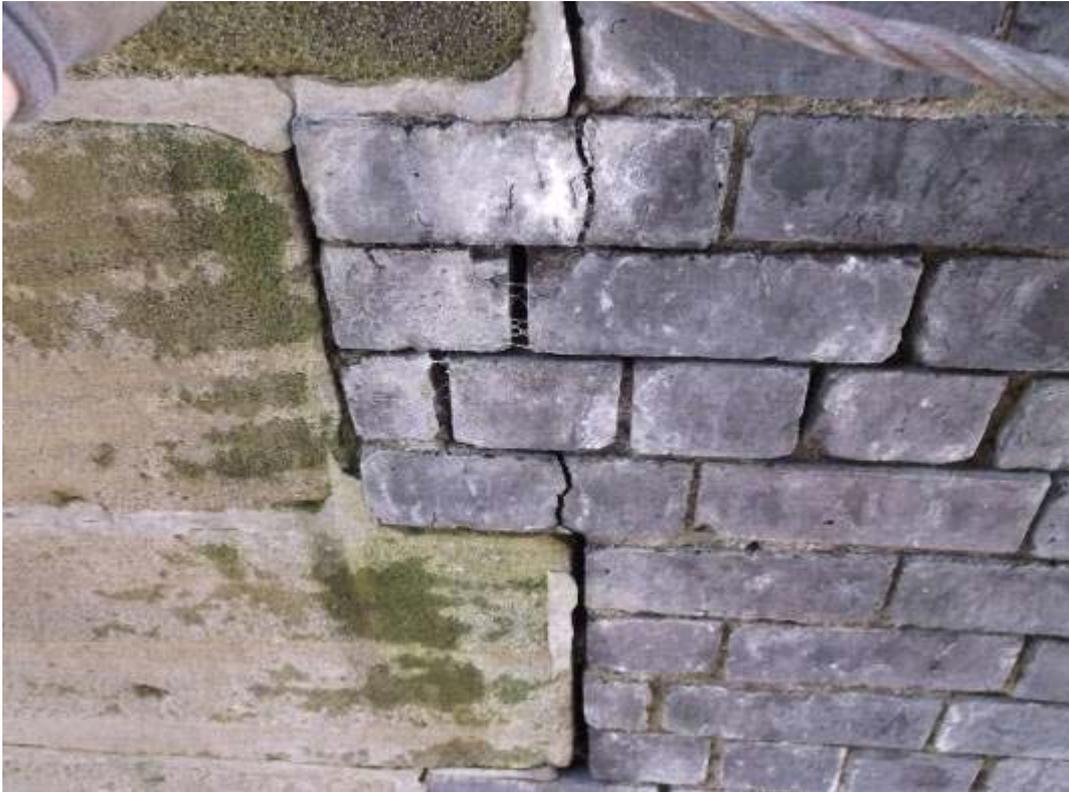
**Photo No. 83: Longitudinal fracture to soffit of span 2**

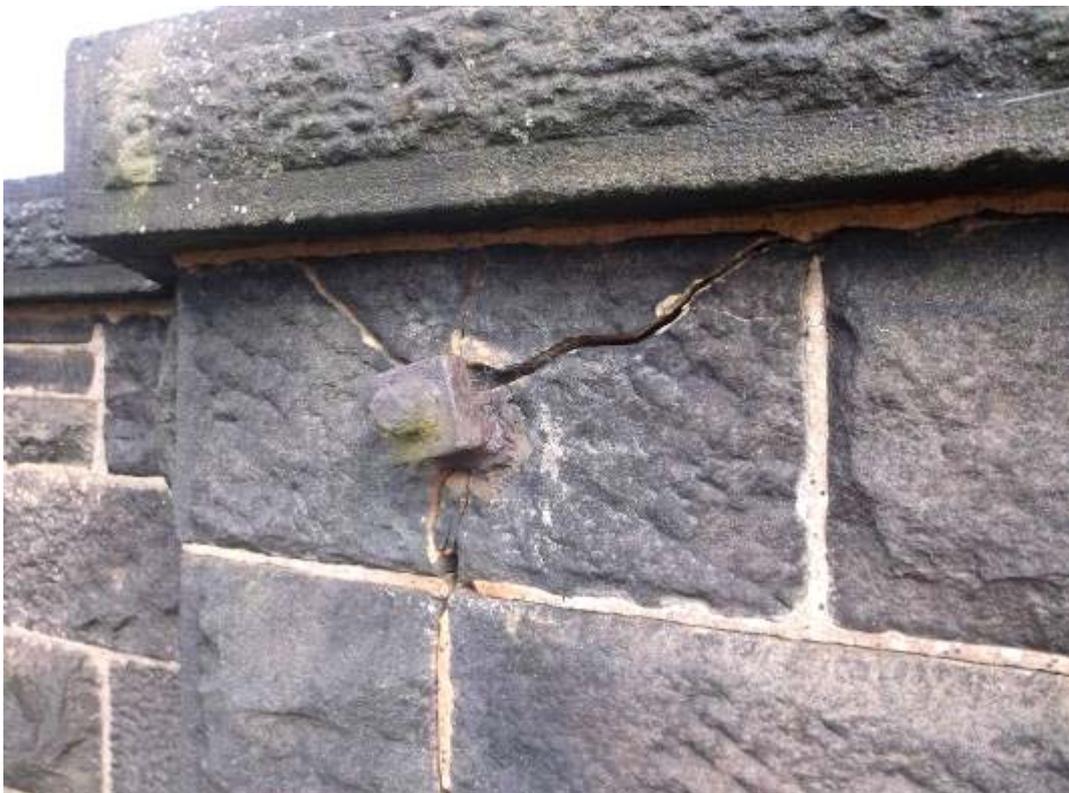
1. Vertical fracture through masonry, 2700 x 1mm. **(photo 85)**
2. Vertical toothed fracture through mortar, 1500 x 1mm.
3. Multi-directional fractures through 1No. block from old iron fixing, up to 7mm wide. **(photo 86)**
4. Vertical fracture through masonry, 1500 x 0.5mm.

**Photo No. 86: Multi-directional fractures to parapet of north west elevation of span 3**

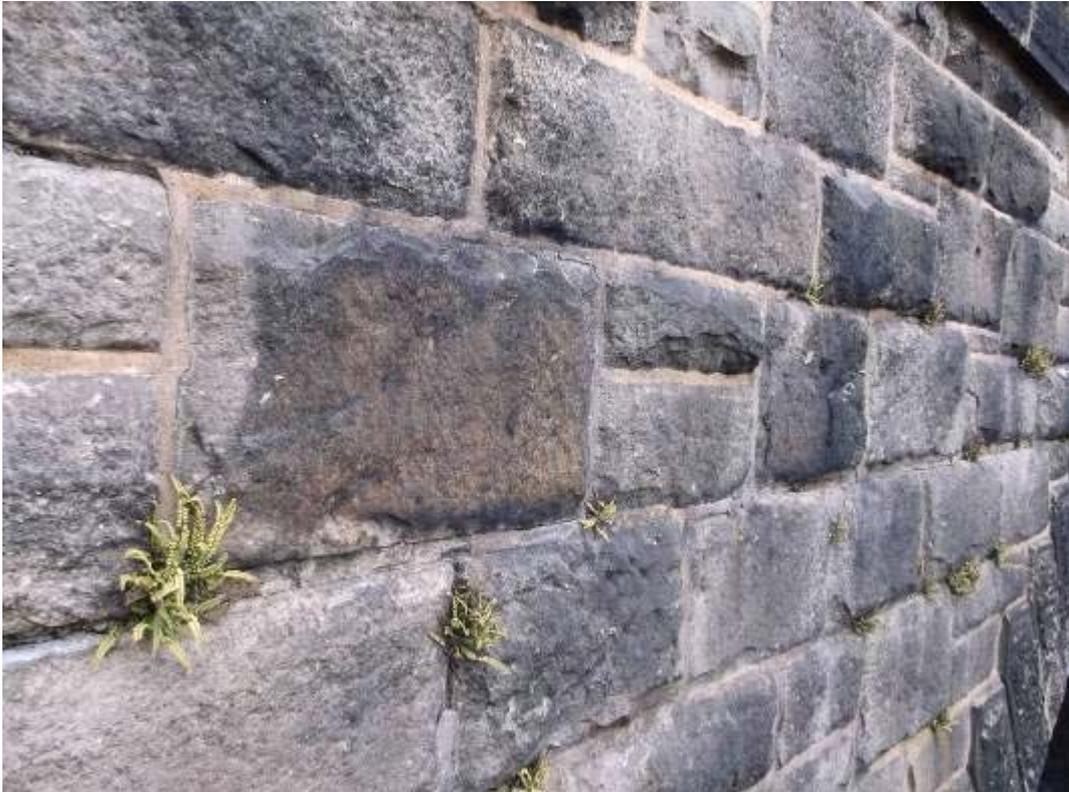
1. Area of hairline fractures through mortar and mortar loss of up to 25mm, 1500 x 2000mm, with spot areas of light vegetation growth. **(photo 87)**
2. Diagonal stepped fracture through mortar, 1700 x up to 1.5mm. **(photo 88)**
3. Vertical fracture through mortar, 1500 x 1mm. **(photo 88)**

**Photo No. 87: Area of hairline fractures, mortar loss & vegetation growth to south east elevation of span 3**

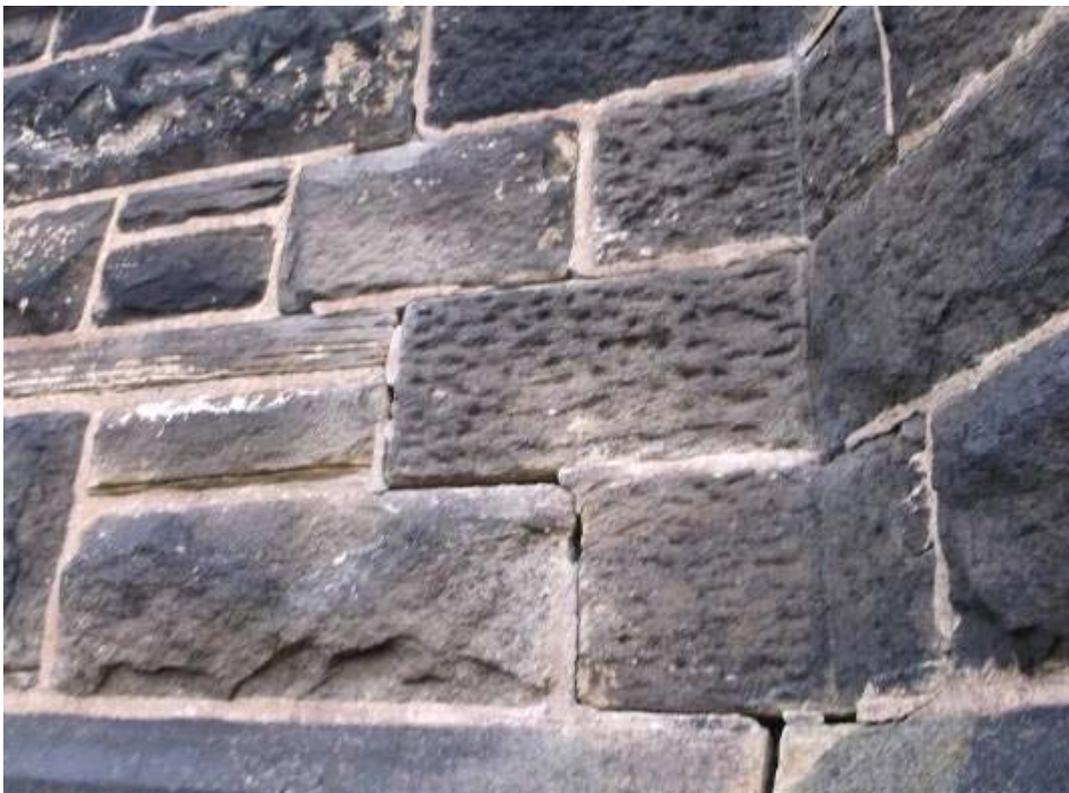
**Photo No. 88: Diagonal stepped & vertical fractures to parapet of south east elevation of span 3**

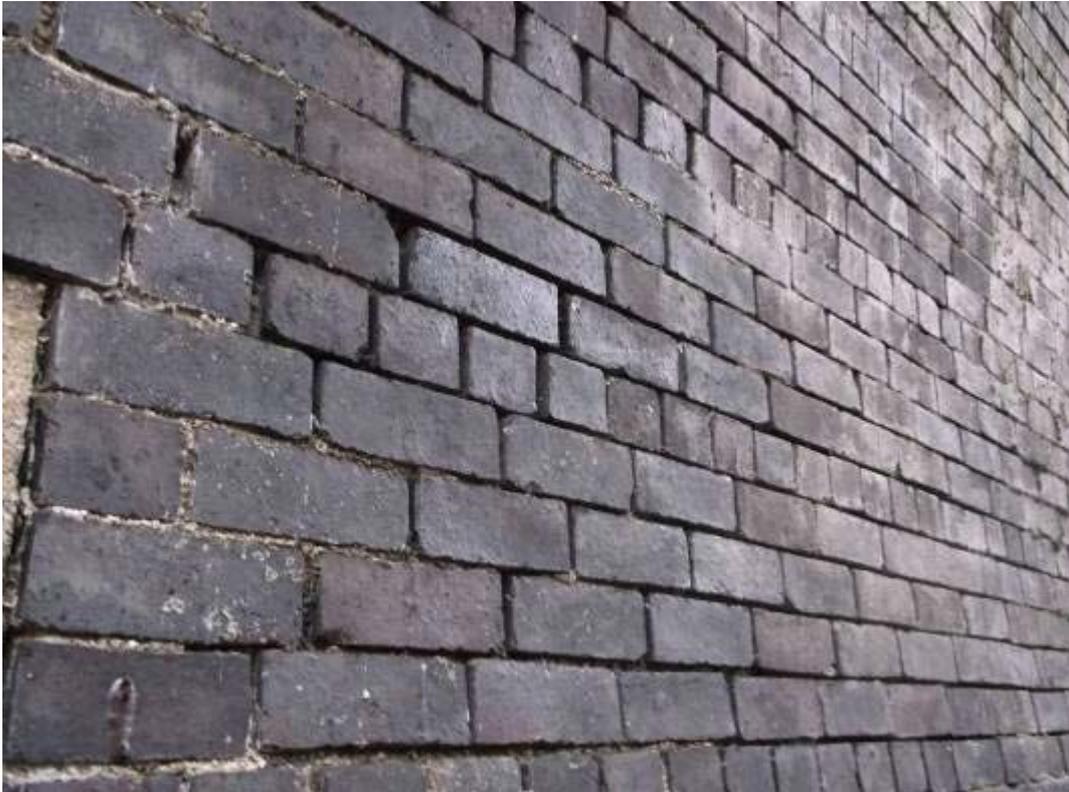
1. Area of mortar loss, 3000 x 4000 x up to 40mm. **(photo 89)**
2. Area of mortar loss, 1500 x 2000 x up to 50mm.
3. Longitudinal fracture through brickwork, 6000 x up to 9mm, brickwork and voussoirs to the south east side were lower by up to 7mm with mortar loss of up to 60mm. **(photo 90)**
4. Area of heavy mortar loss to crown, 1000 x 4000 x up to 100mm. **(photo 91)**
5. Longitudinal fracture through brickwork, 1500 x 1mm.
6. 1No. loose brick.
7. Area of mortar loss and seepage, 2000 x 2000 x up to 30mm. **(photo 92)**
8. Area of mortar loss, 1000 x 2000 x up to 35mm.

**Photo No. 89: Area of mortar loss to soffit of span 3**

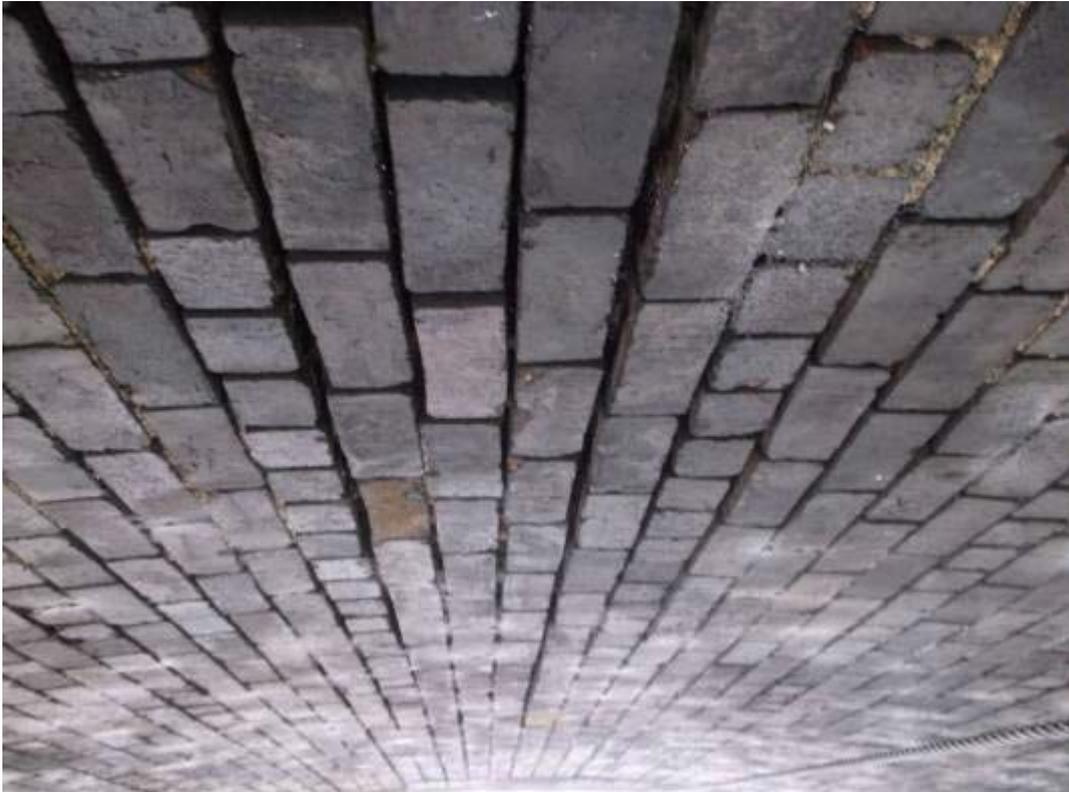
**Photo No. 91: Area of mortar loss to soffit of span 3**

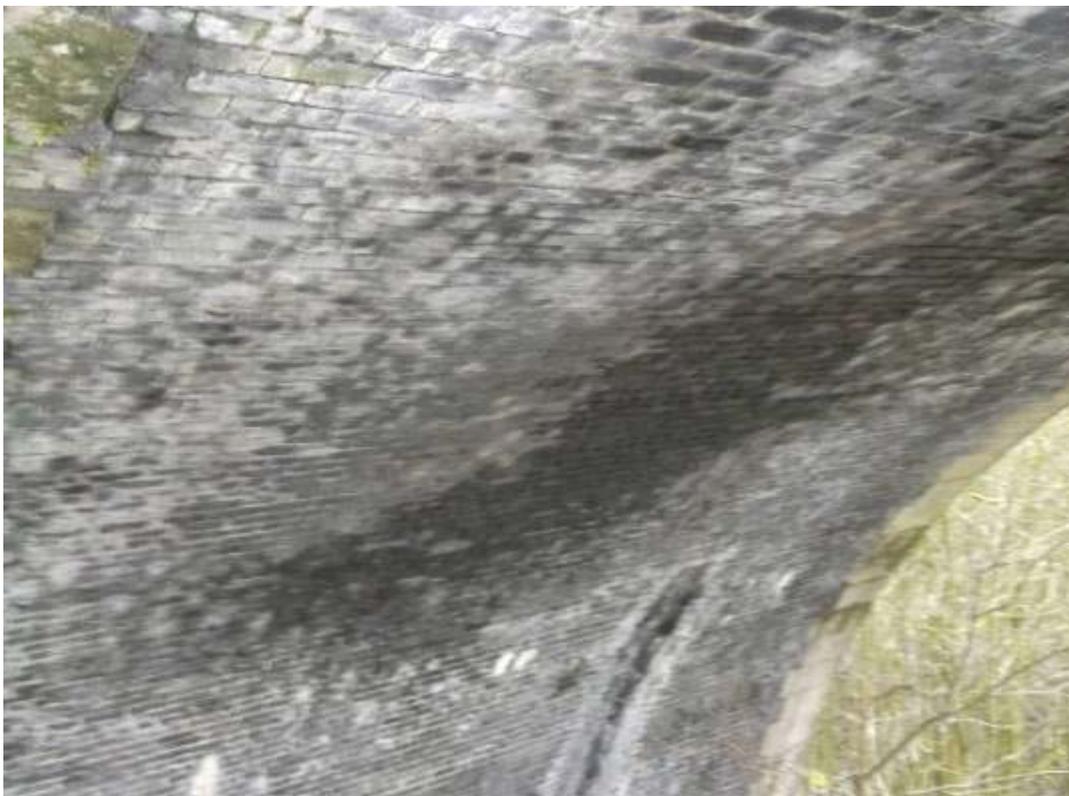
**Photo No. 92: Area of mortar loss & seepage to soffit of span 3**

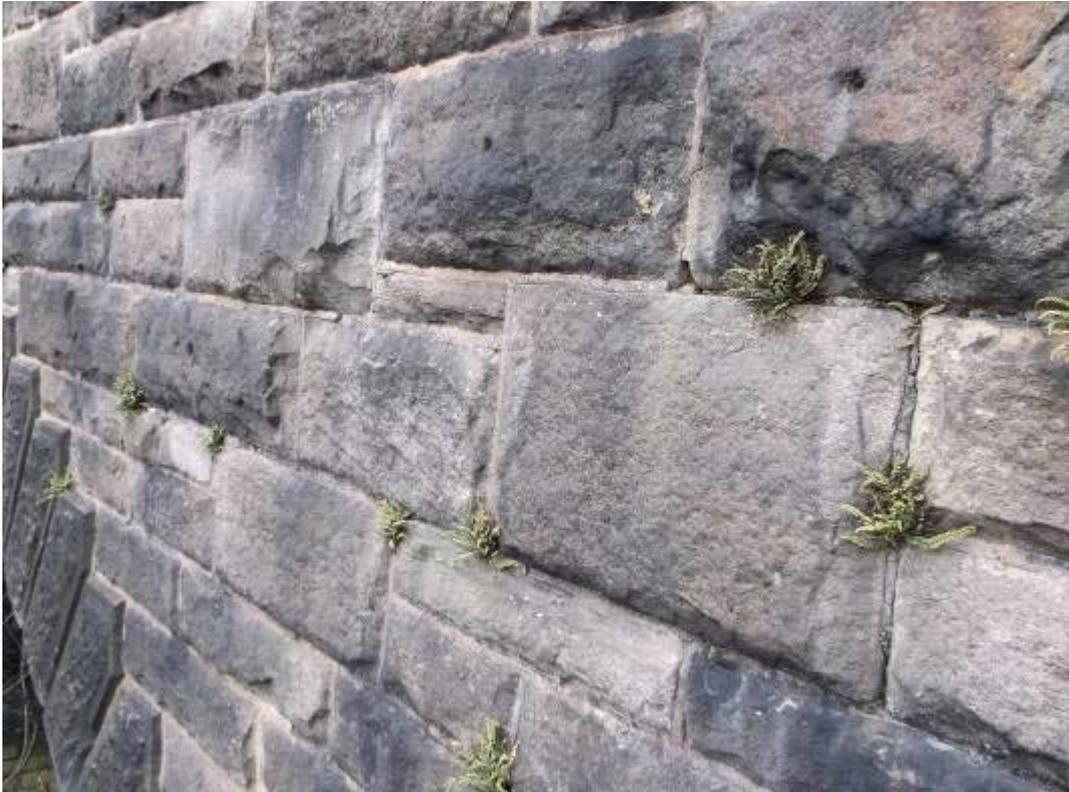
There was spot mortar loss of up to 40mm throughout the parapet. There were spot fractures through mortar / mortar loss of up to 30mm and spot light vegetation growth throughout the spandrel. [\(photo 93\)](#)

**Photo No. 93: Typical spot fractures / mortar loss & vegetation growth to spandrel of south east elevation of span 4**

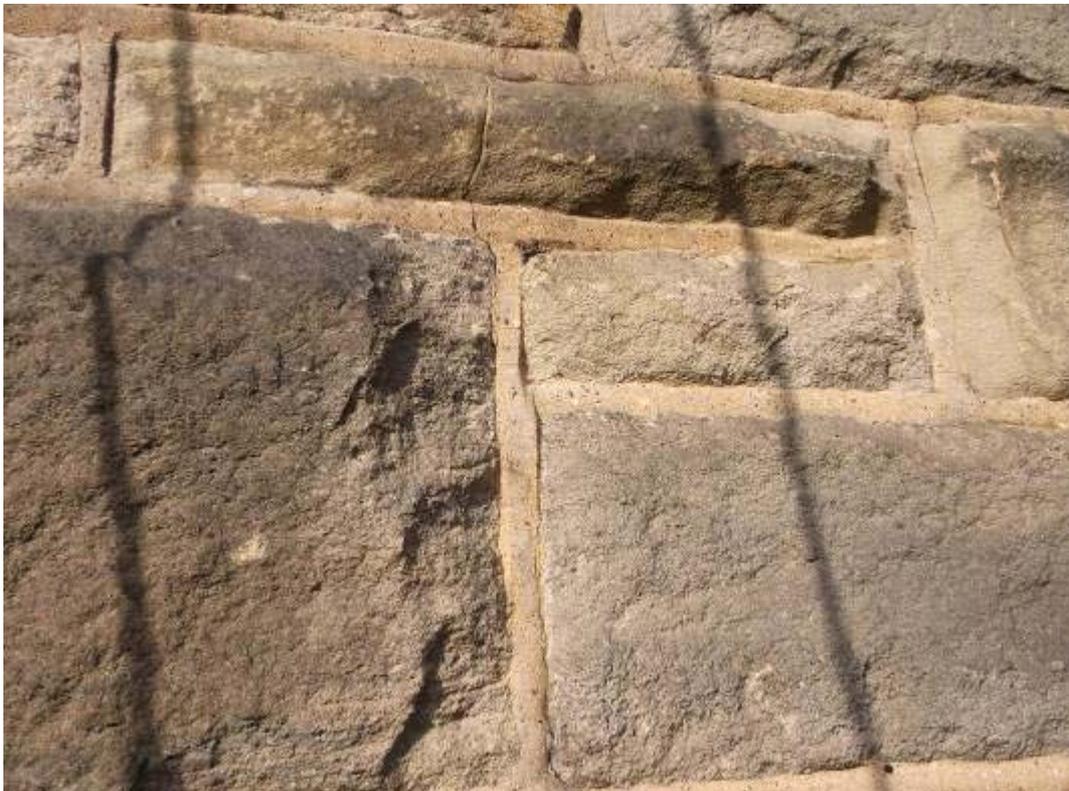
1. Vertical stepped hairline fracture through mortar and masonry, 1500mm in length. [\(photo 94\)](#)
2. Vertical hairline fracture through mortar and masonry, 1100mm in length.

**Photo No. 94: Vertical fracture to spandrel of south east elevation of span 4**

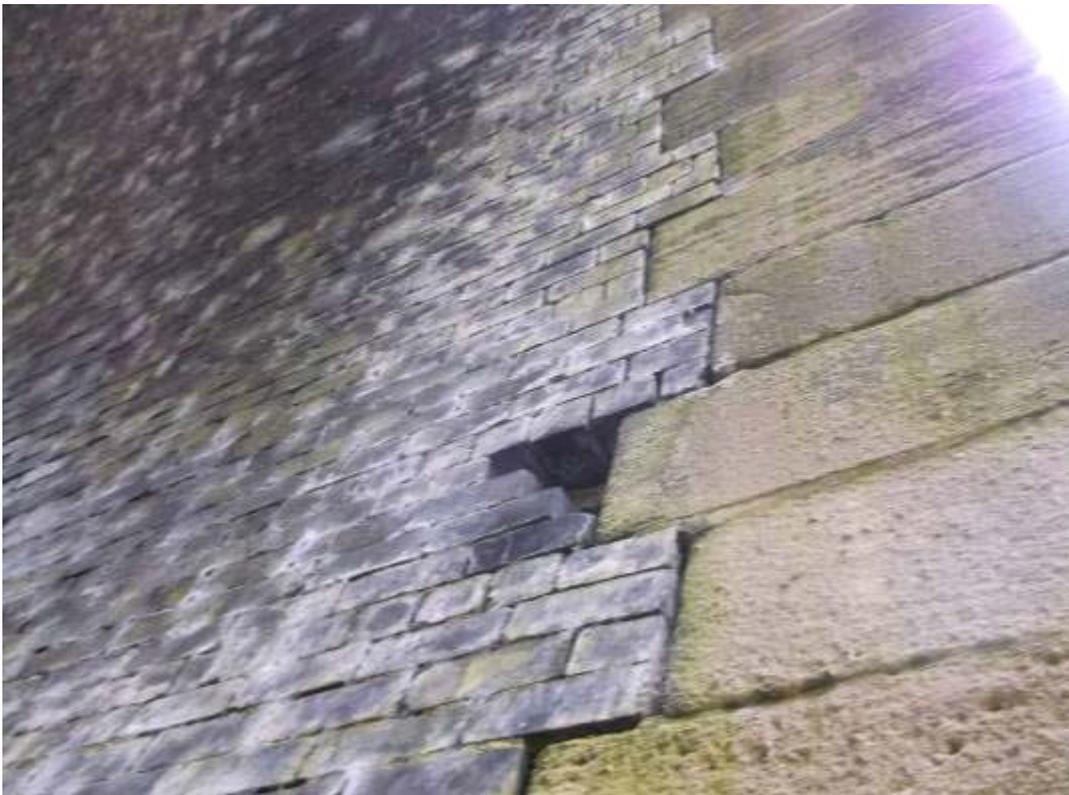
1. Area of mortar loss, 2000 x 1000 x up to 50mm.
2. Area of mortar loss, 1000 x 5000 x up to 60mm.
3. 3No. missing bricks. [\(photo 95\)](#)
4. 1No. missing brick. [\(photo 96\)](#)
5. Longitudinal fracture through brickwork, 8000 x up to 25mm, approx. 35No. bricks along length of fracture fallen out / removed, usually between fracture and voussoirs. [\(photos 96 & 97\)](#)
6. Area of mortar loss, 1000 x 2000 x up to 60mm.
7. Area of mortar loss, 500 x 1000 x up to 50mm. [\(photo 98\)](#)
8. 6No. missing bricks. [\(photo 99\)](#)

**Photo No. 95: Area of missing brickwork to soffit of span 4**

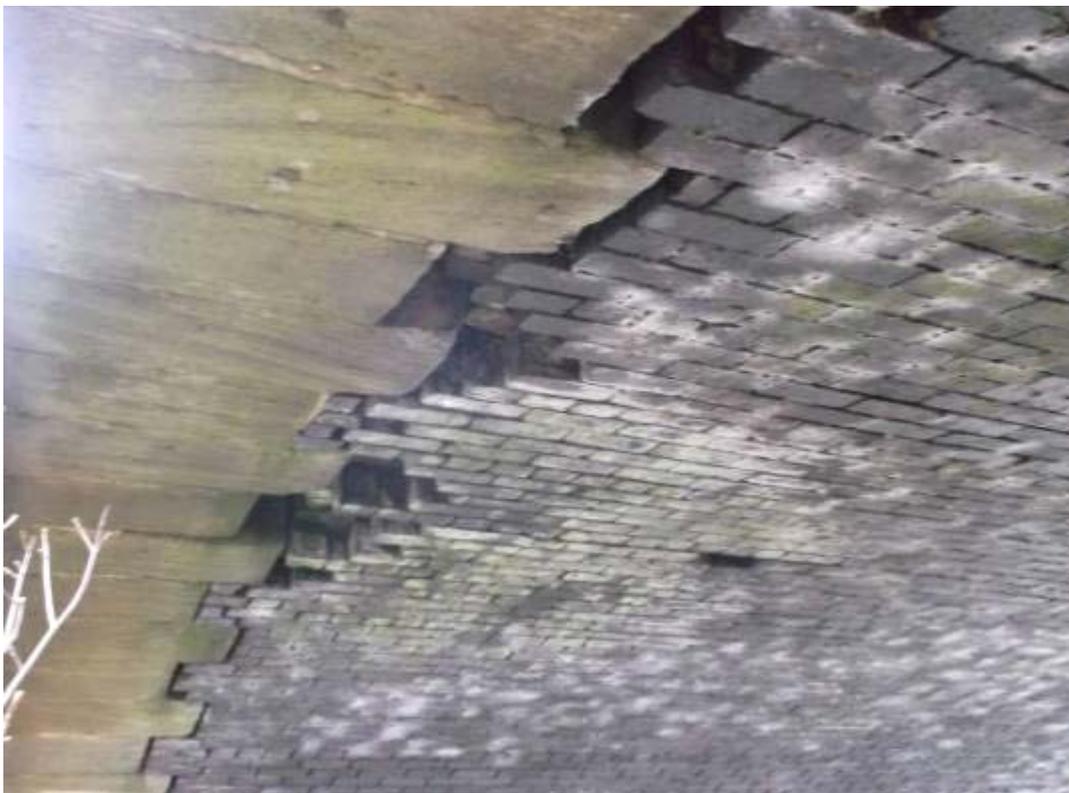
**Photo No. 96: Longitudinal fracture and areas of missing brickwork to soffit of span 4**

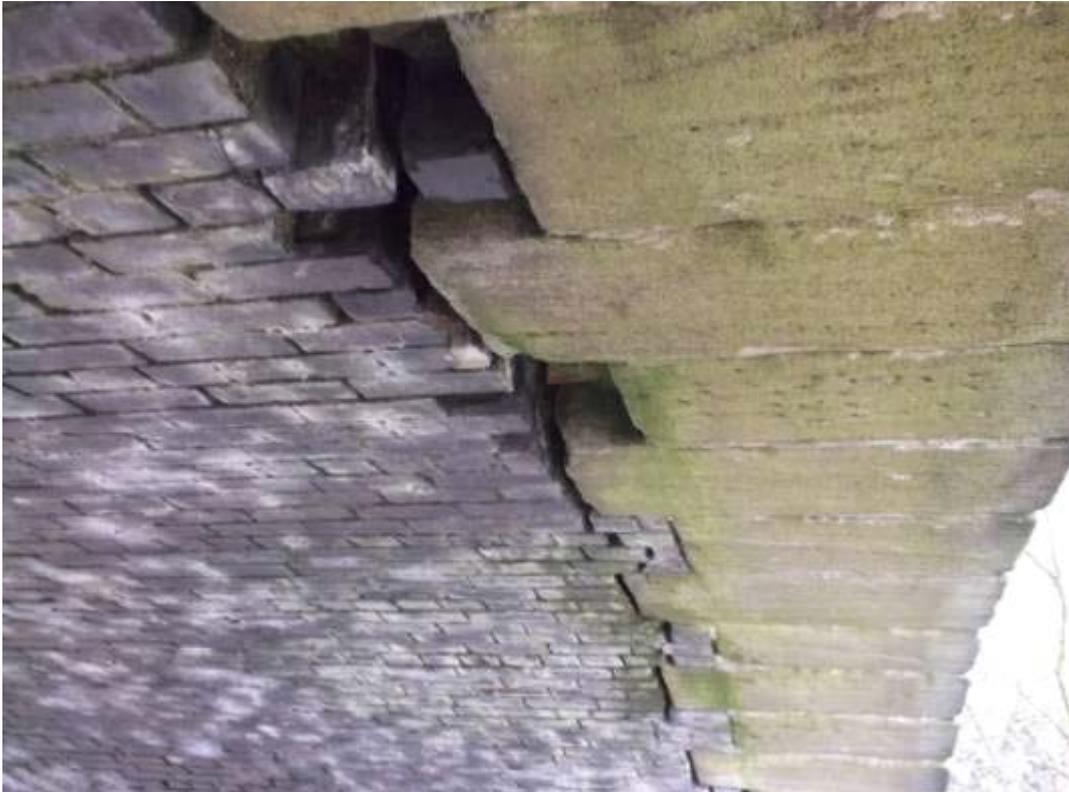
**Photo No. 97: Longitudinal fracture and areas of missing brickwork to soffit of span 4**

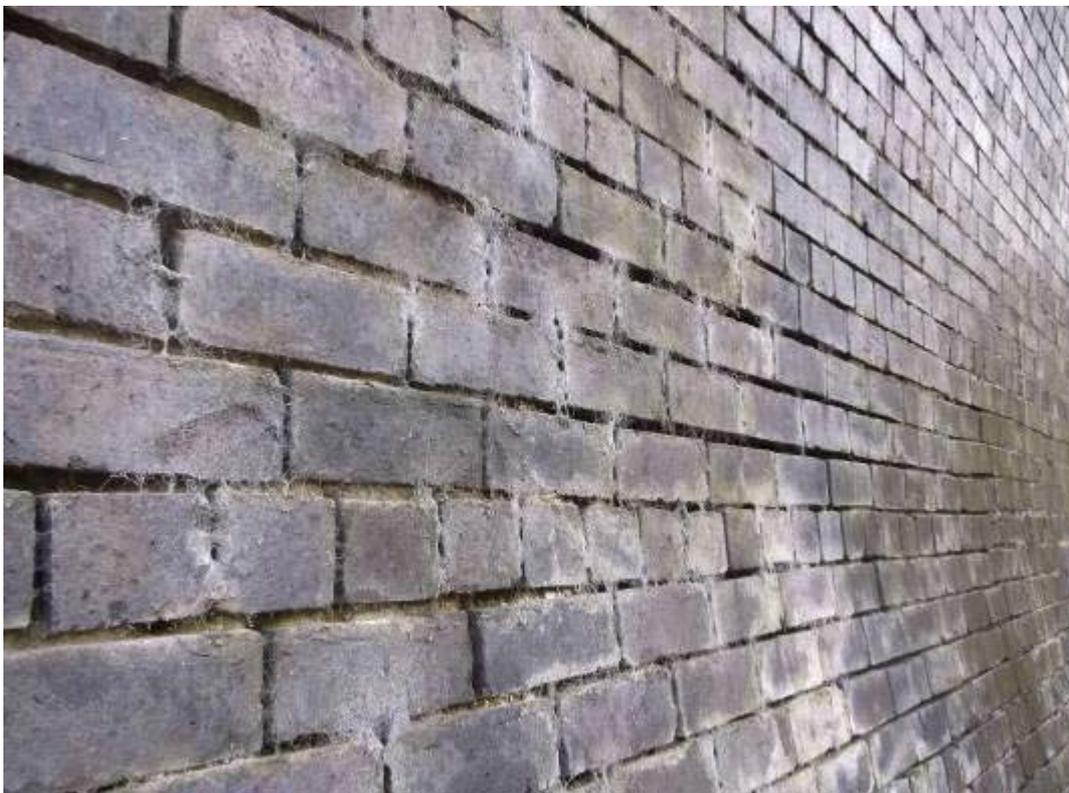
**Photo No. 98: Area of mortar loss to soffit of span 4**

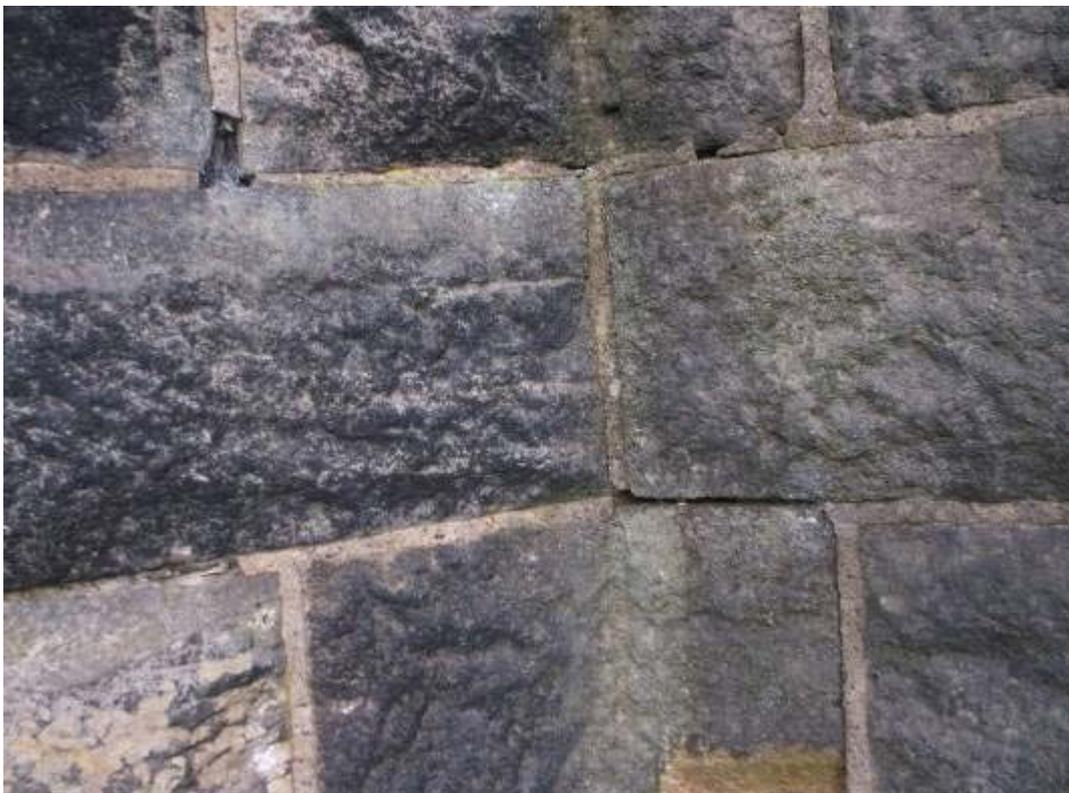
1. Line of mortar loss, 600 x up to 80mm.
2. Vertical toothed fracture through mortar, 1500 x up to 1.5mm. [\(photo 100\)](#)

**Photo No. 100: Vertical toothed fracture to parapet of north west elevation of span 5**

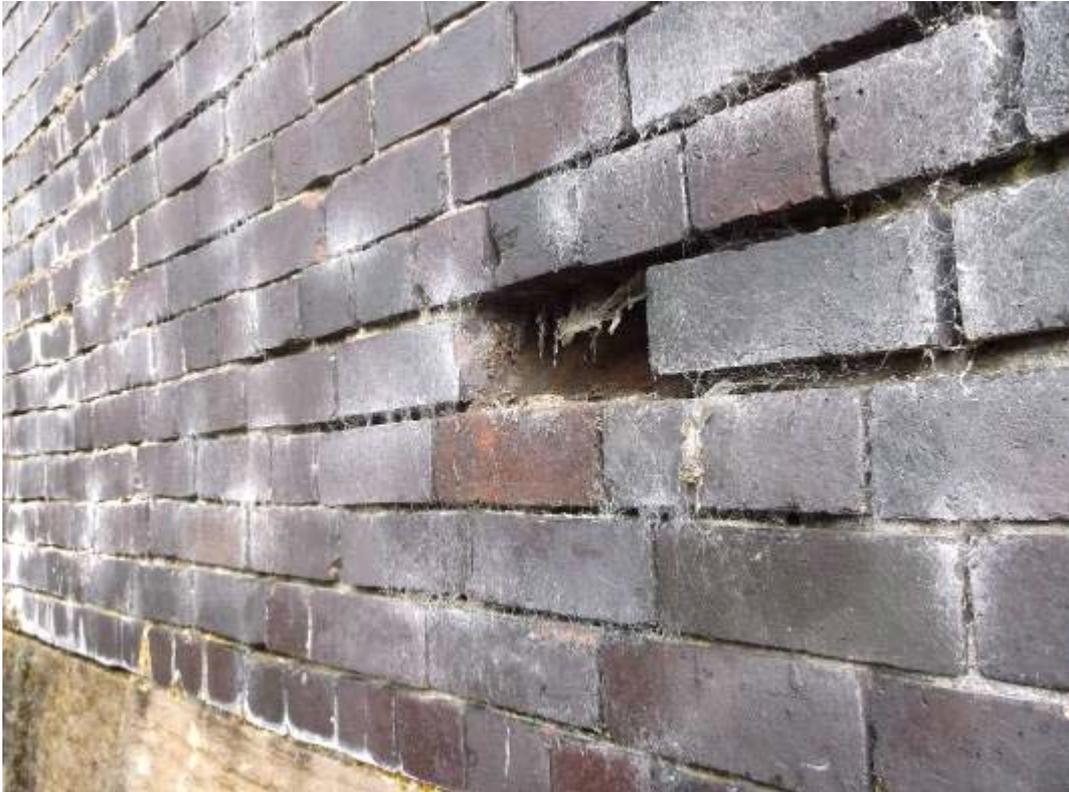
1. Area of mortar loss, 3000 x 800 x up to 50mm, with spot seepage, area also drummy, 1No. loose brick removed. **(photo 101)**
2. Area of missing brickwork, 550 x 800 x 120mm, 5No. further bricks removed. **(photos 102 & 103)**

**Photo No. 101: Area of seepage, mortar loss, drummy brickwork & removed loose brick to soffit of span 5**

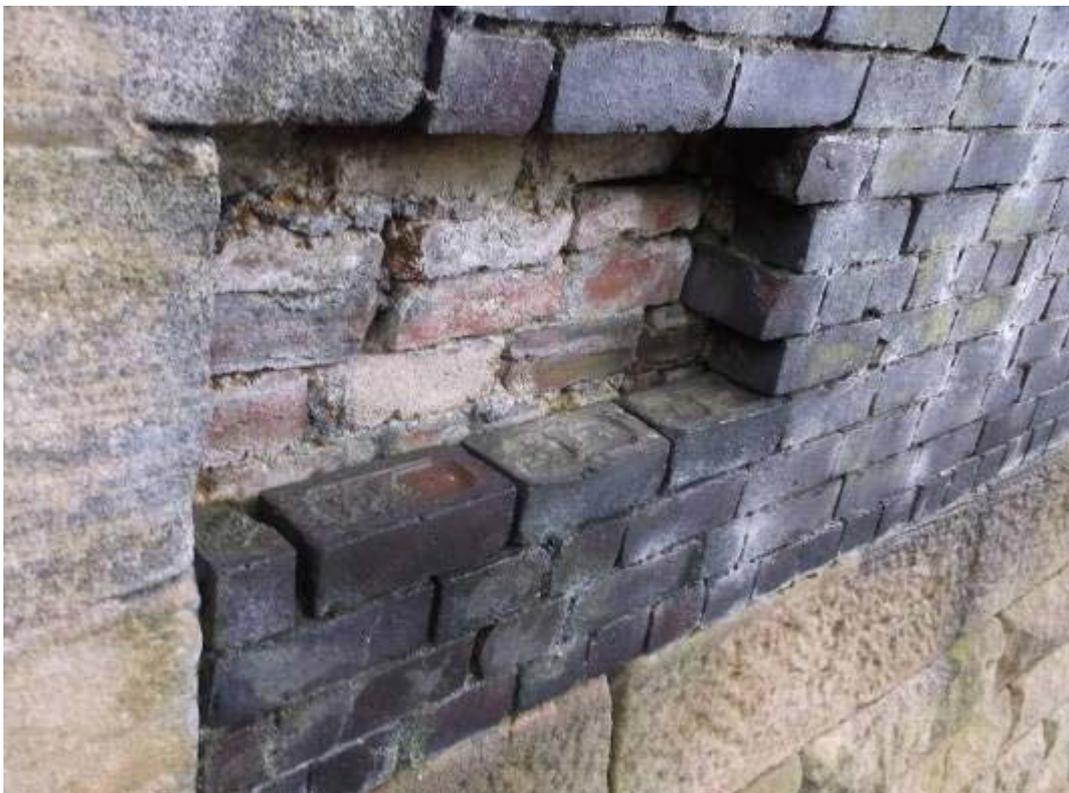
**Photo No. 102: Area of missing brickwork to soffit of span 5**

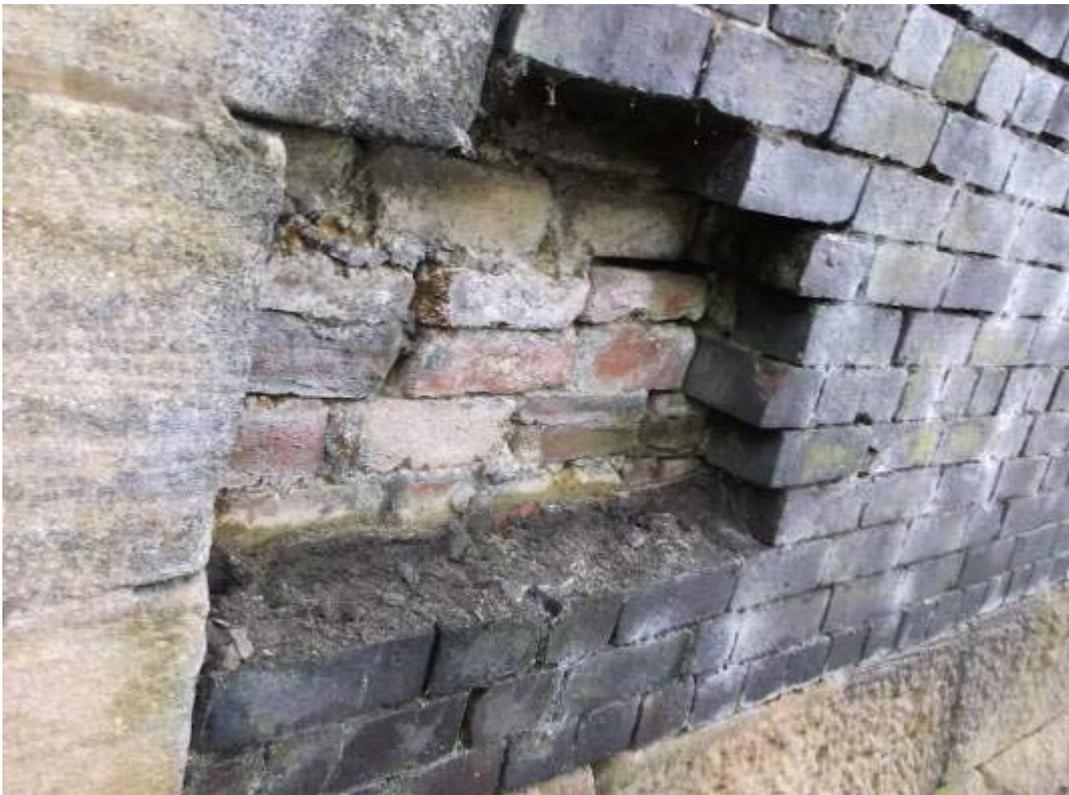
**Photo No. 103: Area of missing brickwork with further loose brickwork removed to soffit of span 5**

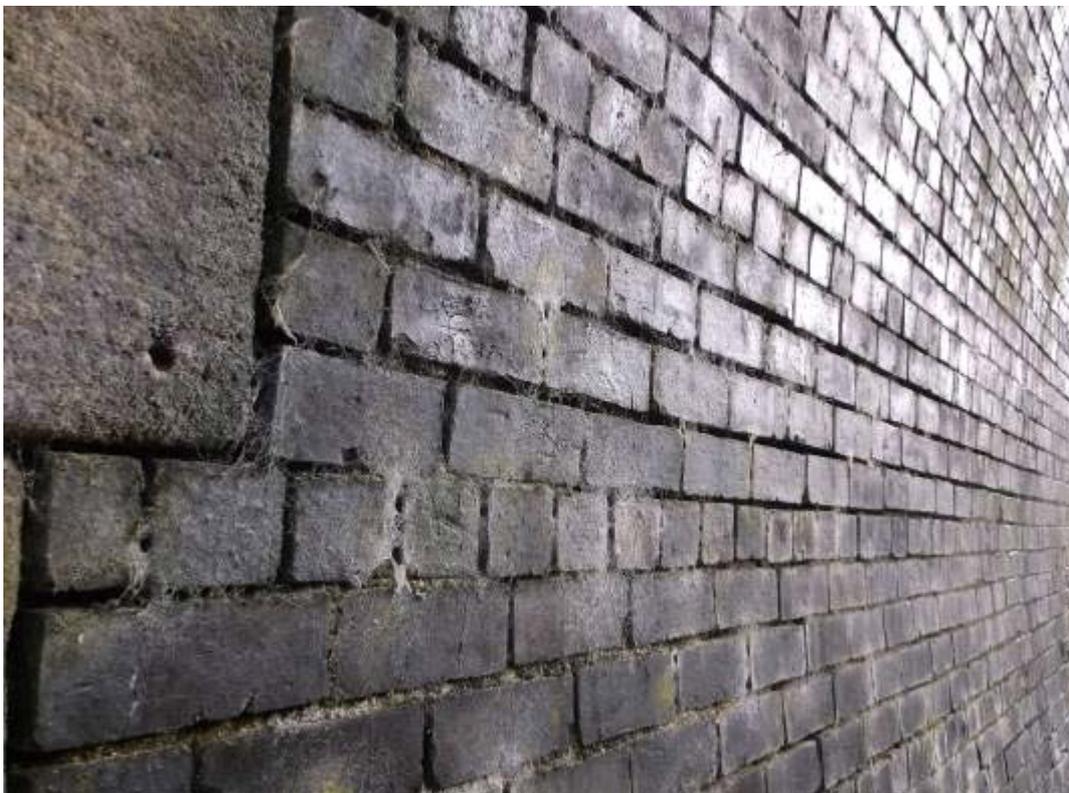
3. Area of mortar loss, 2000 x 800 x up to 40mm.
4. Area of mortar loss, 2000 x 1500 x up to 30mm. **(photo 104)**
5. Longitudinal fracture through brickwork, 4000 x up to 20mm, approx. 12No. bricks along length of fracture fallen out / removed, usually between fracture and voussoirs. **(photo 105)**

**Photo No. 104: Area of mortar loss to soffit of span 5**

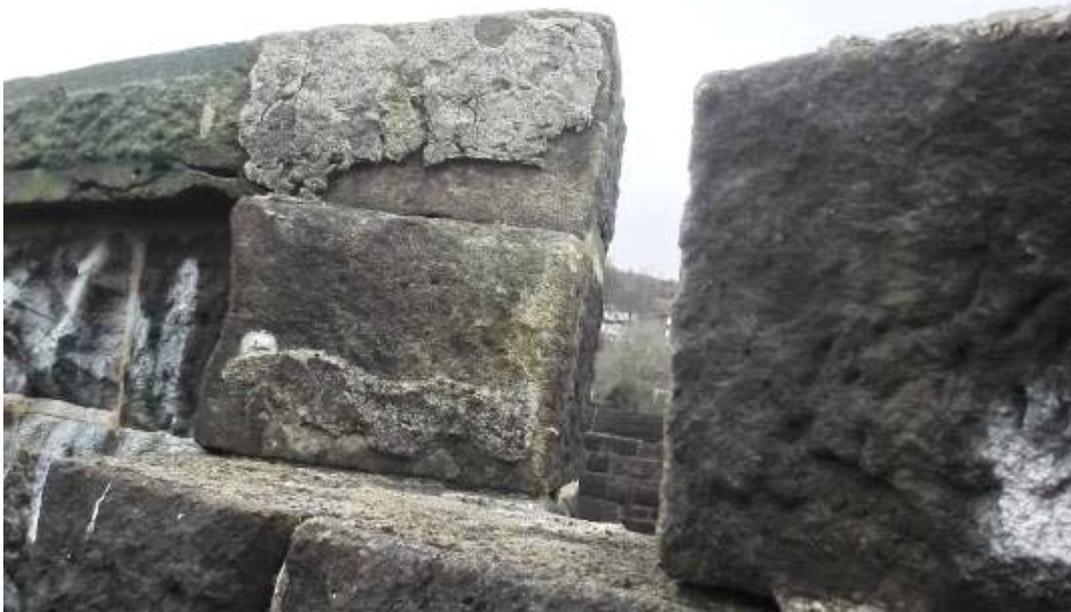
1. Area of missing coping, 2000 x 400mm. **(photo 107)**
2. Vertical fracture through masonry, 2000 x 1mm.
3. Area of mortar loss, 2000 x 1000 x up to 20mm. **(photo 108)**

**Photo No. 107: Area of missing coping to north west elevation of span 6**

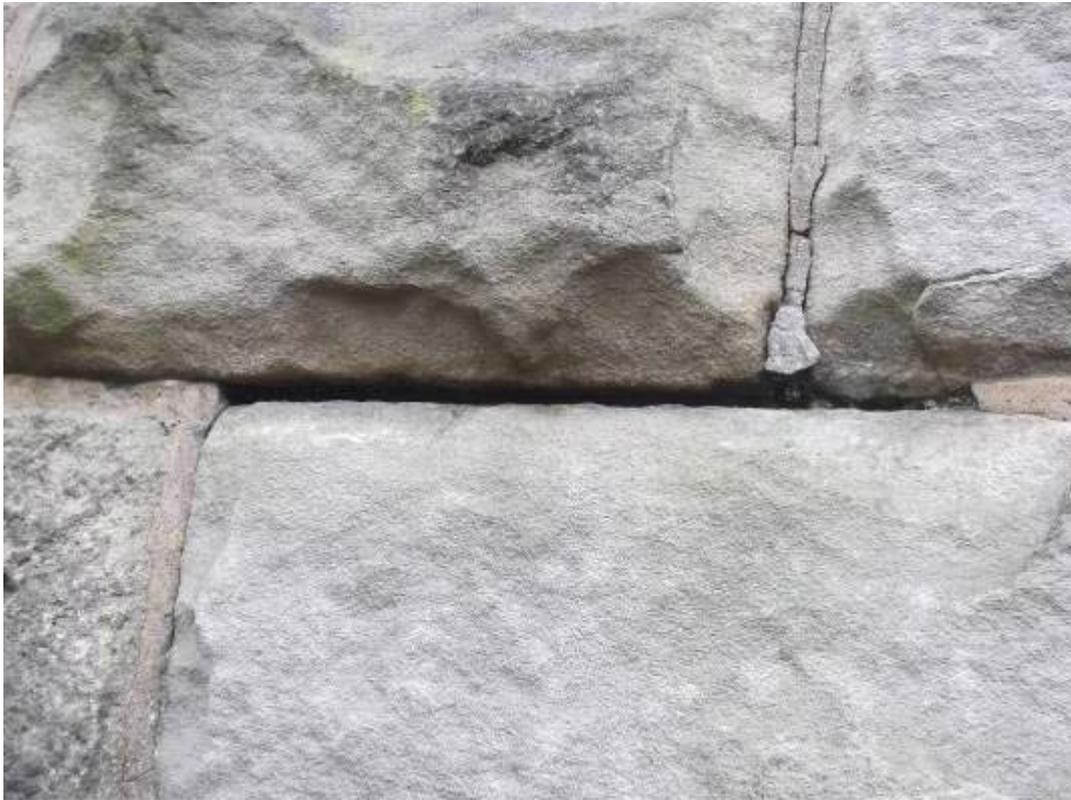
1. Area of missing coping, 10,000 x 400mm, continued on to span 7. **(photo 109)**
2. Area of spalling to coping, 200 x 200 x up to 200mm. **(photo 110)**
3. Line of mortar loss, 400 x up to 20mm. **(photo 111)**
4. Diagonal fracture through 1No. voussoir, 200 x 1mm.

**Photo No. 111: Line of mortar loss to spandrel of south east elevation of span 6**

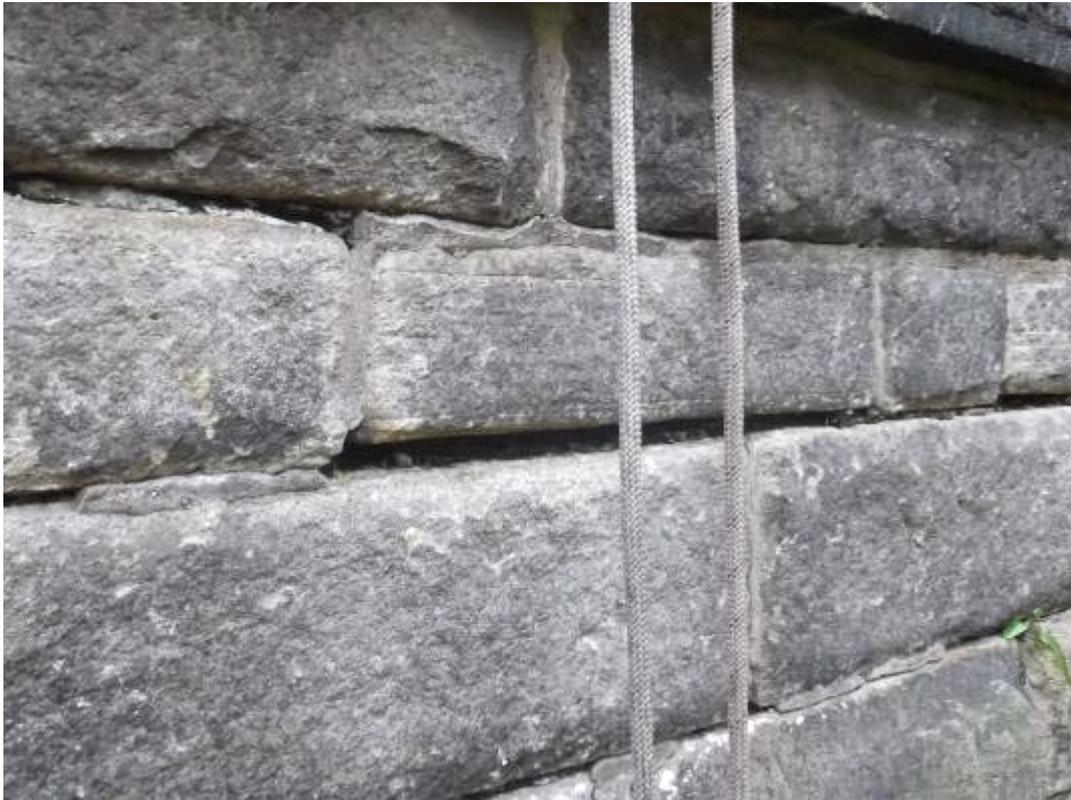
1. Area of mortar loss, 2000 x 1000 x up to 30mm. [\(photo 113\)](#)
2. Area of mortar loss, 2000 x 1500 x up to 30mm.
3. Line of mortar loss, 1000 x up to 50mm.

**Photo No. 113: Area of mortar loss to north west elevation of span 7**

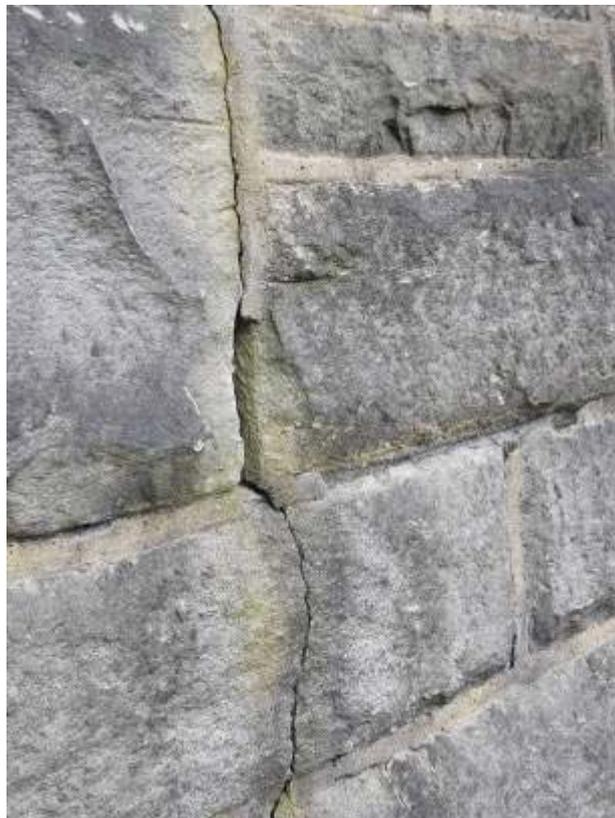
1. Vertical fracture through masonry, 1000 x 1mm. [\(photo 114\)](#)
2. Area of missing coping, 10,000 x 400mm, continued on to span 6. [\(photo 109\)](#)
3. Diagonal stepped fracture through voussoirs, 400 x 1mm. [\(photo 115\)](#)

**Photo No. 114: Vertical fracture to spandrel of south east elevation of span 7**

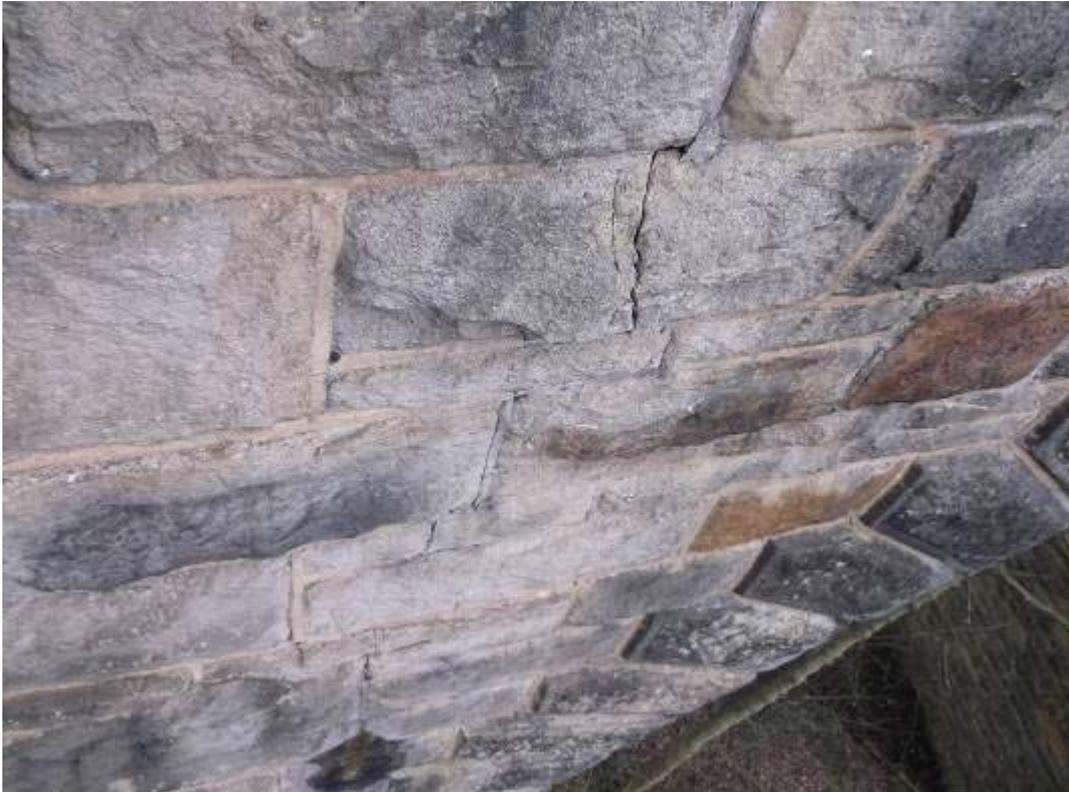
1. Vertical fracture through masonry, 3000 x up to 1.5mm, with associated seepage. **(photo 119)**
2. Vertical toothed fracture through mortar, 1500 x 1mm.
3. Area of mortar loss, 1000 x 1000 x up to 70mm.
4. Area of mortar loss, 2000 x 1000 x up to 40mm.

**Photo No. 119: Vertical fracture to spandrel of south east elevation of span 8**
