## HXH/4a Contract Specification (Masonry Repair and Waterproofing Installation)

**Client name:** National Highways – Historical Railways Estate  
**Project name:** HRE Works Framework  
**Client reference:** HXH/4a  
**Document no:** 0451200  
**Revision no:** 03  
**Date:** May 2023  
**Project no:** B38380DE  
**Project manager:** Nigel Robson  
**Prepared by:** Christopher Doig  
**File name:** HXH 4a NEC ECC

### **HRE WORKS FRAMEWORK HXH/4a 'WHEATLEY VIADUCT' CONTRACT FOR REMEDIAL REPAIRS AND WATERPROOFING**

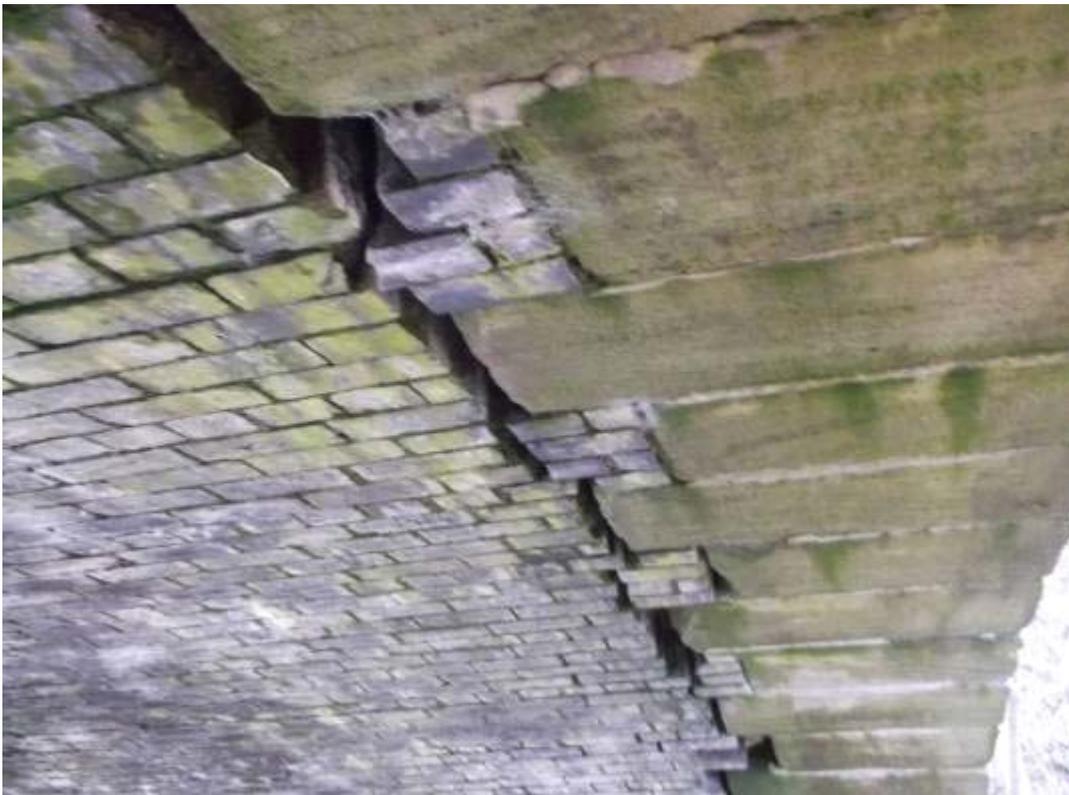
1. Longitudinal fracture through brickwork, 14,000 x up to 45mm, 4No. loose bricks removed, 4No. areas of missing brickwork between fracture and voussoirs: 1No. brick, 1½No. bricks, 3No. bricks, 1No. half brick and 3½No. bricks. [\(photos 120, 121, 122, 123, 124 & 125\)](#)
2. Longitudinal fracture through brickwork, 10,500 x up to 15mm.
3. Area of mortar loss, 2000 x 200 x up to 30mm, with associated seepage. [\(photo 126\)](#)
4. Area of mortar loss, 1000 x 2000 x up to 30mm, with associated seepage.
5. Area of mortar loss, 2000 x 1000 x up to 40mm.
6. Area of mortar loss, 2000 x 1000 x up to 40mm.

**Photo No. 121: Longitudinal fracture with missing brickwork to soffit of span 8**

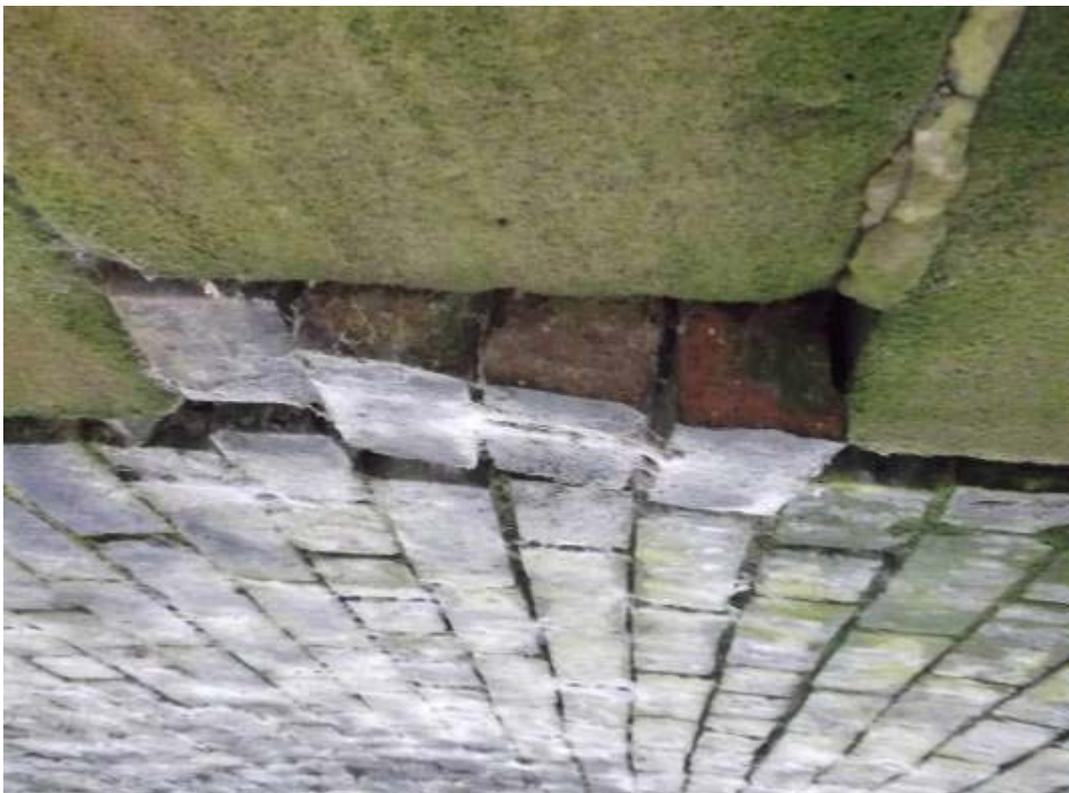
**Photo No. 122: Area of loose brickwork to soffit of span 8**

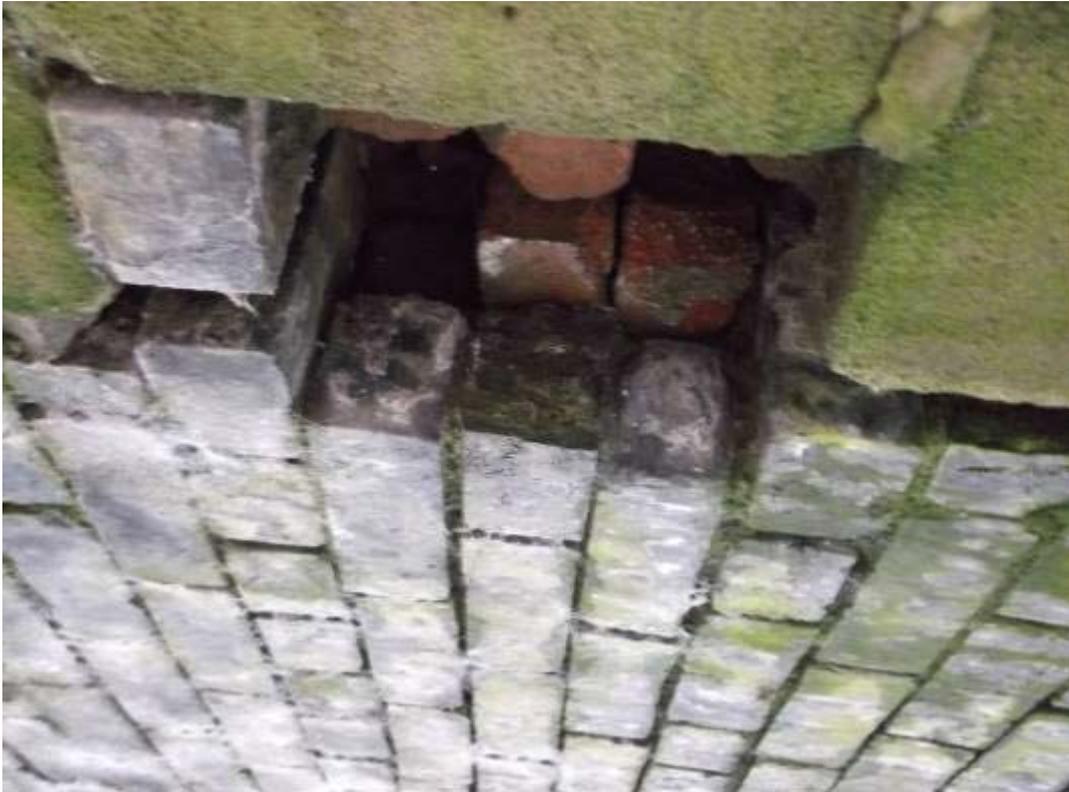
**Photo No. 123: Area of loose brickwork removed to soffit of span 8**

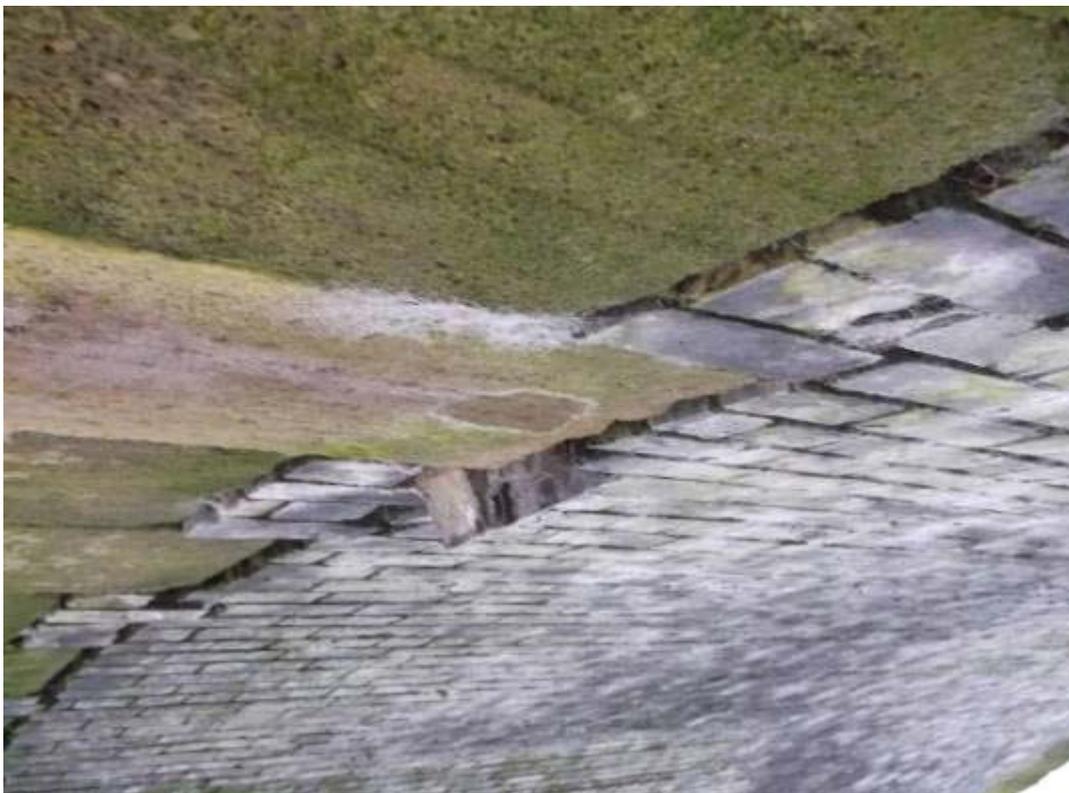
**Photo No. 124: Area of loose brickwork to soffit of span 8**

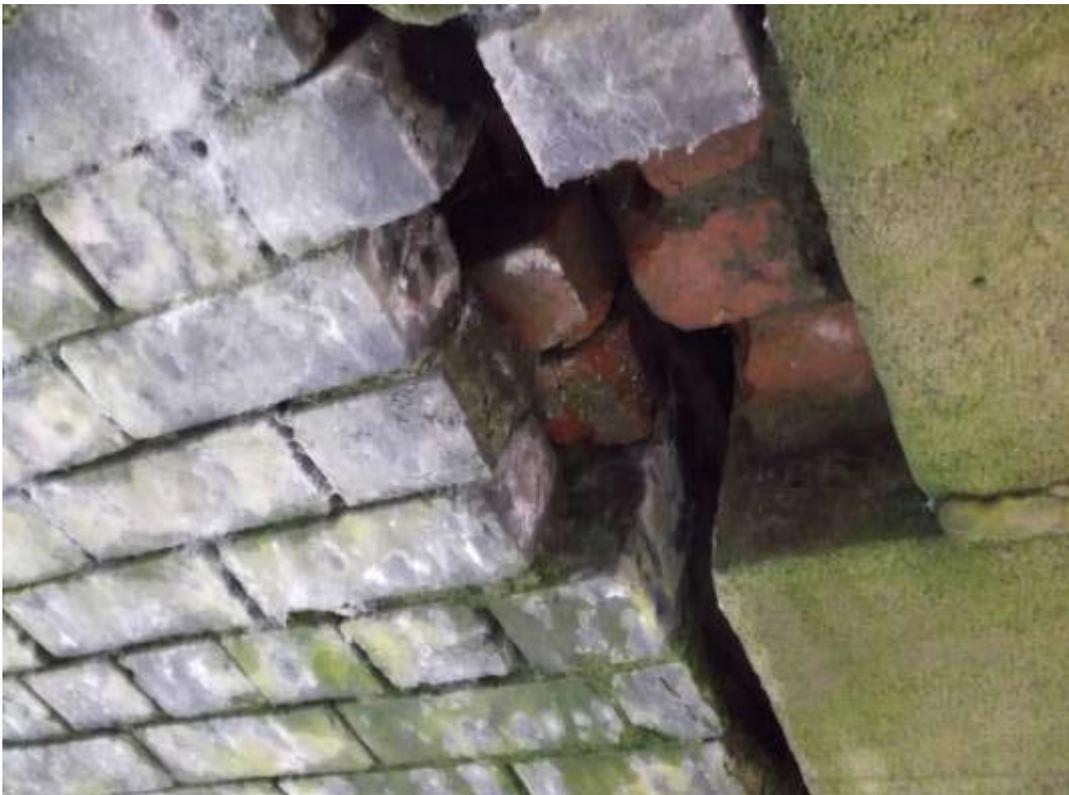
**Photo No. 125: Area of missing brickwork to soffit of span 8**

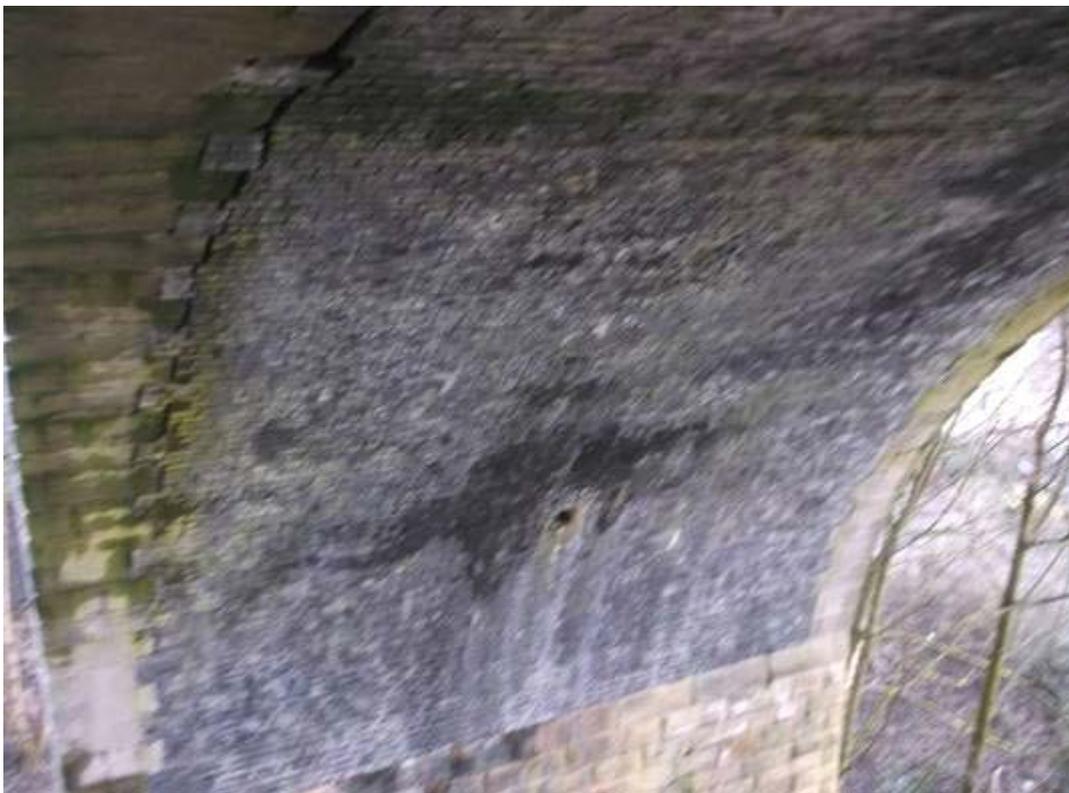
**Photo No. 126: Area of mortar loss & seepage to soffit of span 8**

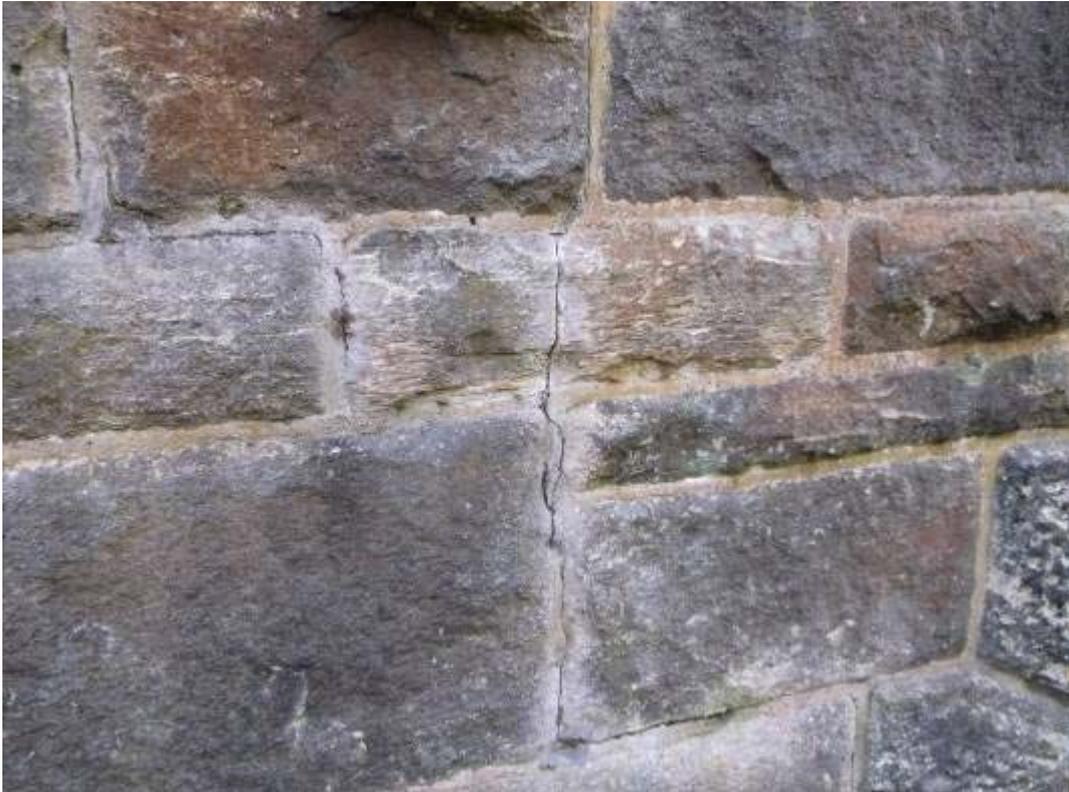
1. Vertical fracture through masonry, 900 x 0.5mm. [\(photo 127\)](#)
2. Area of spalled masonry to voussoirs, 700 x 200 x up to 100mm.
3. 2No. lines of mortar loss, each 400 x up to 80mm. [\(photo 128\)](#)
4. Mature tree adjacent to elevation, 500mm in diameter, 30m tall, makes contact with the coping. [\(photo 129\)](#)
5. 4No. lines of mortar loss totalling 3500 x up to 25mm.
6. Vertical stepped hairline fracture through mortar, 600mm in length.
7. Area of mortar loss, 2000 x 2000 x up to 50mm. [\(photo 130\)](#)
8. Vertical hairline fracture through masonry, 750mm in length.

**Photo No. 127: Vertical fracture to spandrel of north west elevation of span 9**

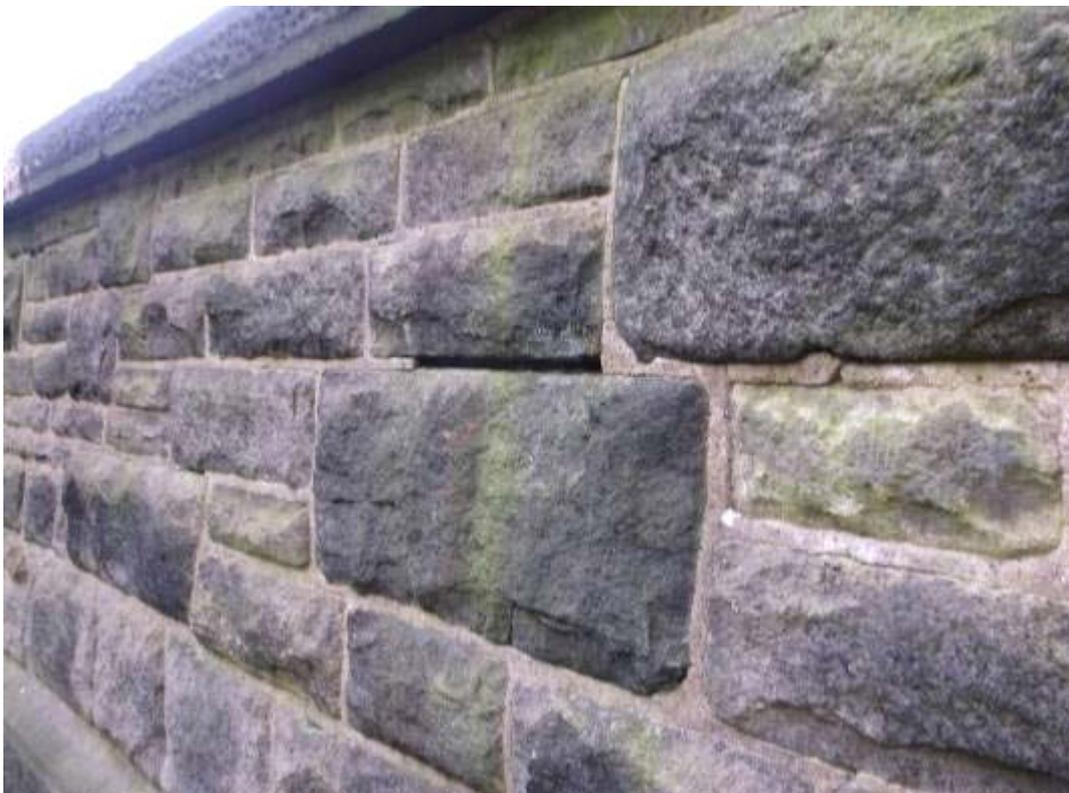
**Photo No. 128: Line of mortar loss to parapet of north west elevation of span 9**

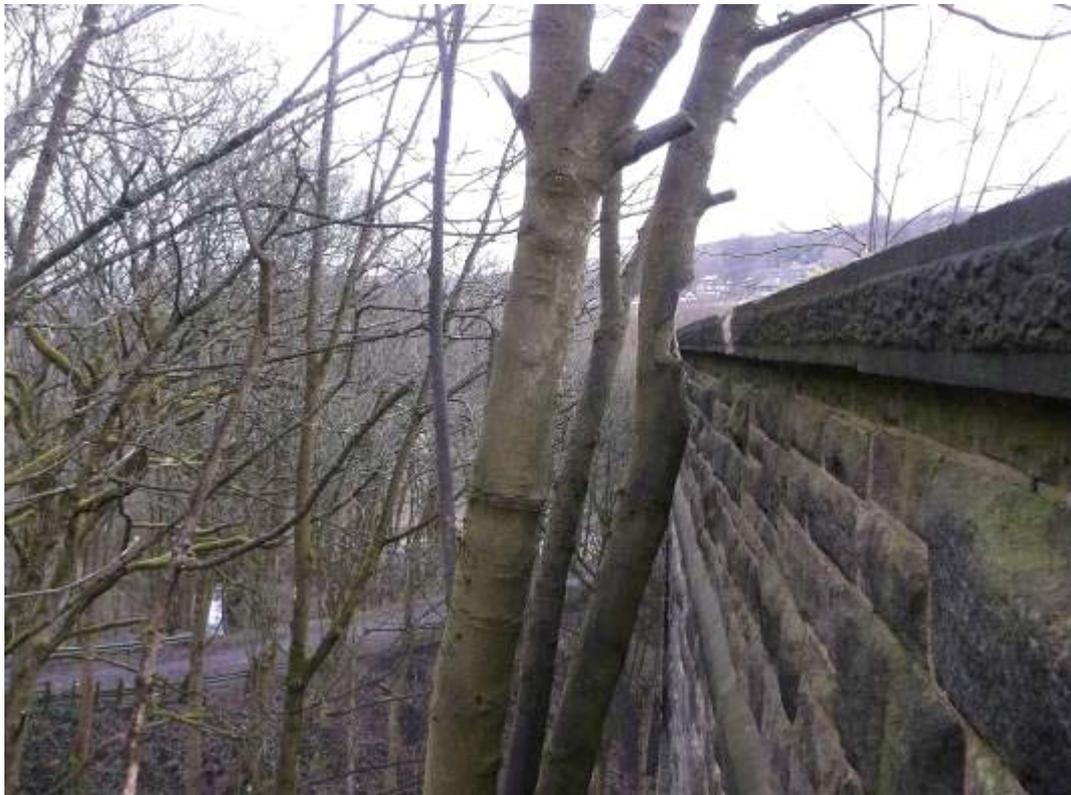
**Photo No. 129: Tree in contact with coping of north west elevation of span 9**

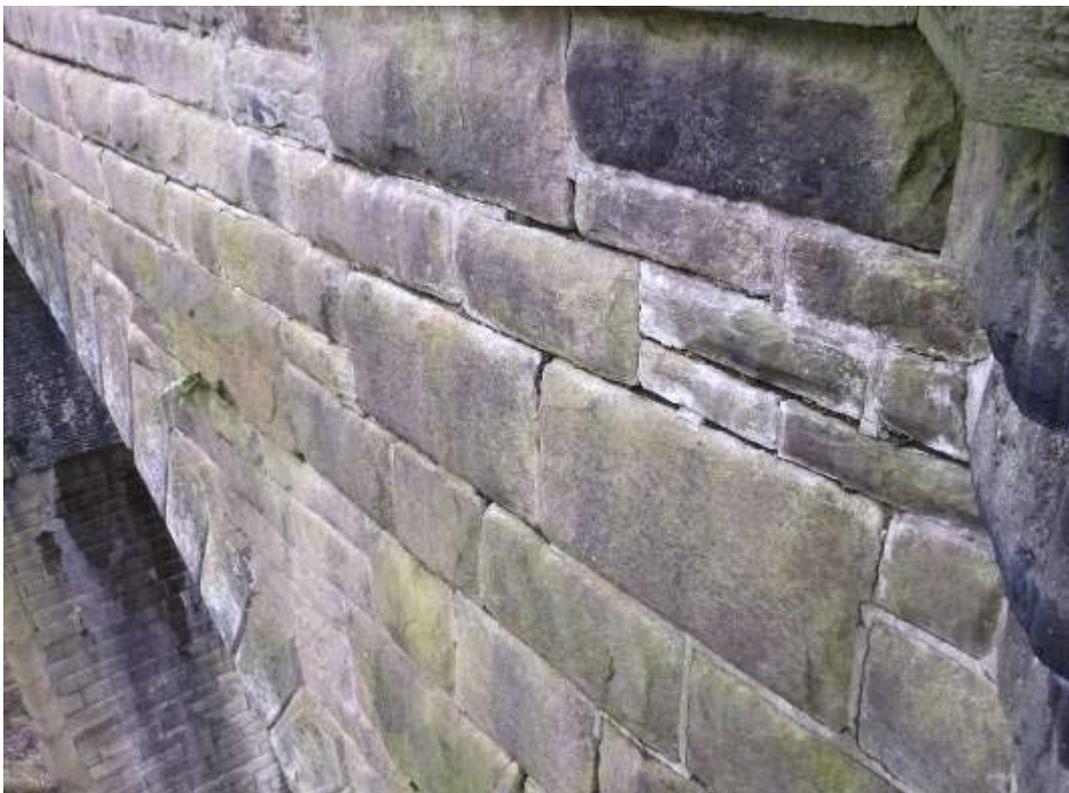
**Photo No. 130: Area of mortar loss to spandrel of north west elevation of span 9**

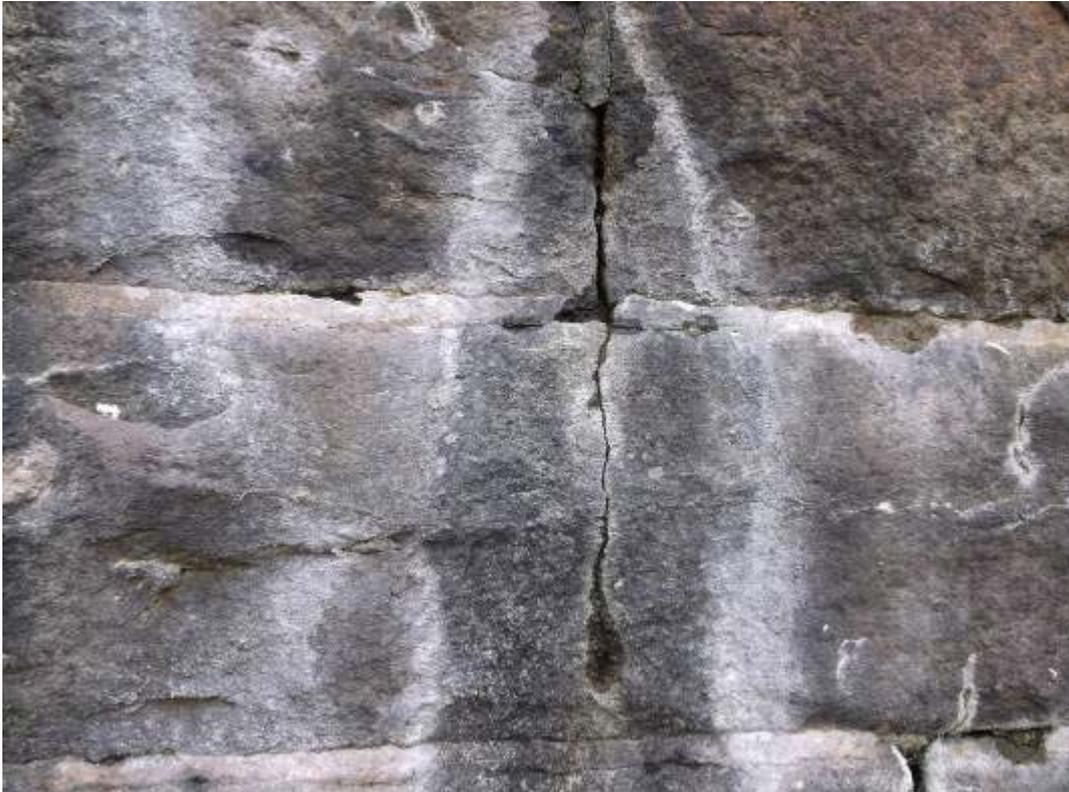
1. Diagonal hairline fracture through 2No. voussoirs, 600mm in length.
2. Vertical fracture through masonry, 600 x 1mm, with associated seepage. [\(photo 131\)](#)
3. 2No. diagonal hairline fractures through 2No. voussoirs, each 600mm in length. [\(photo 132\)](#)
4. Diagonal fracture through 2No. voussoirs, 500 x 1mm in length.
5. Vertical toothed fracture through mortar, 1500 x 1mm. [\(photo 133\)](#)

**Photo No. 131: Vertical fracture to spandrel of south east elevation of span 9**

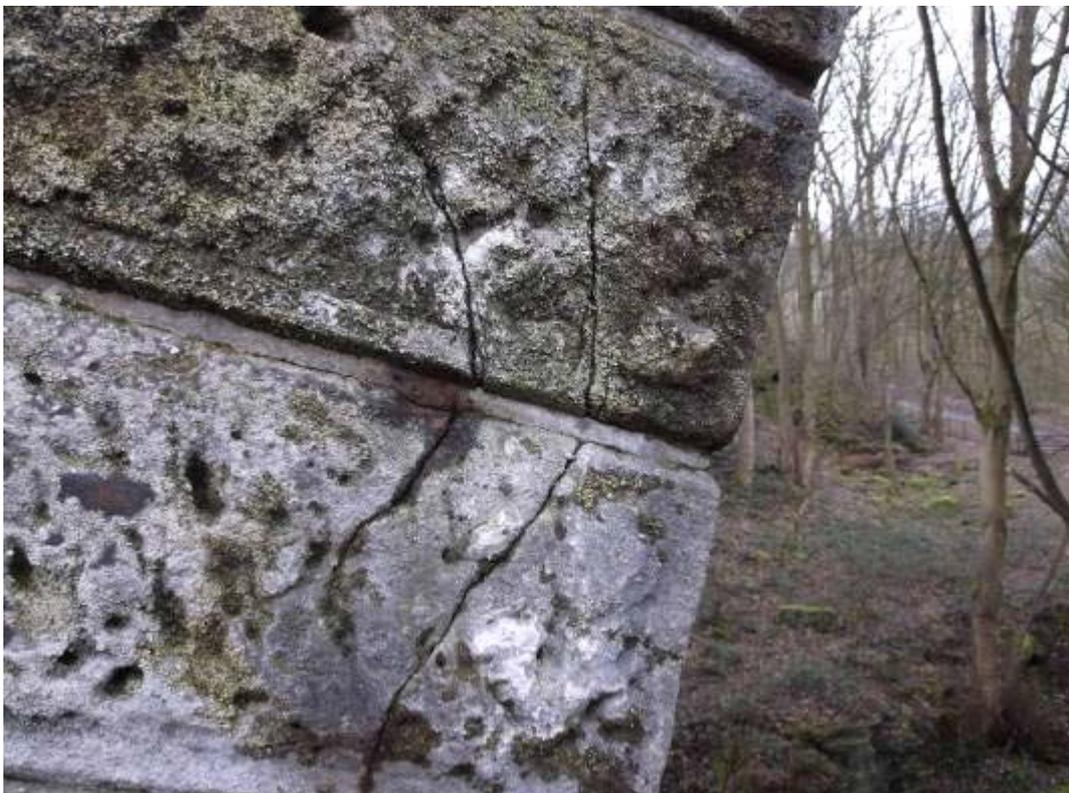
**Photo No. 132: 2No. diagonal fractures to voussoirs of south east elevation of span 9**

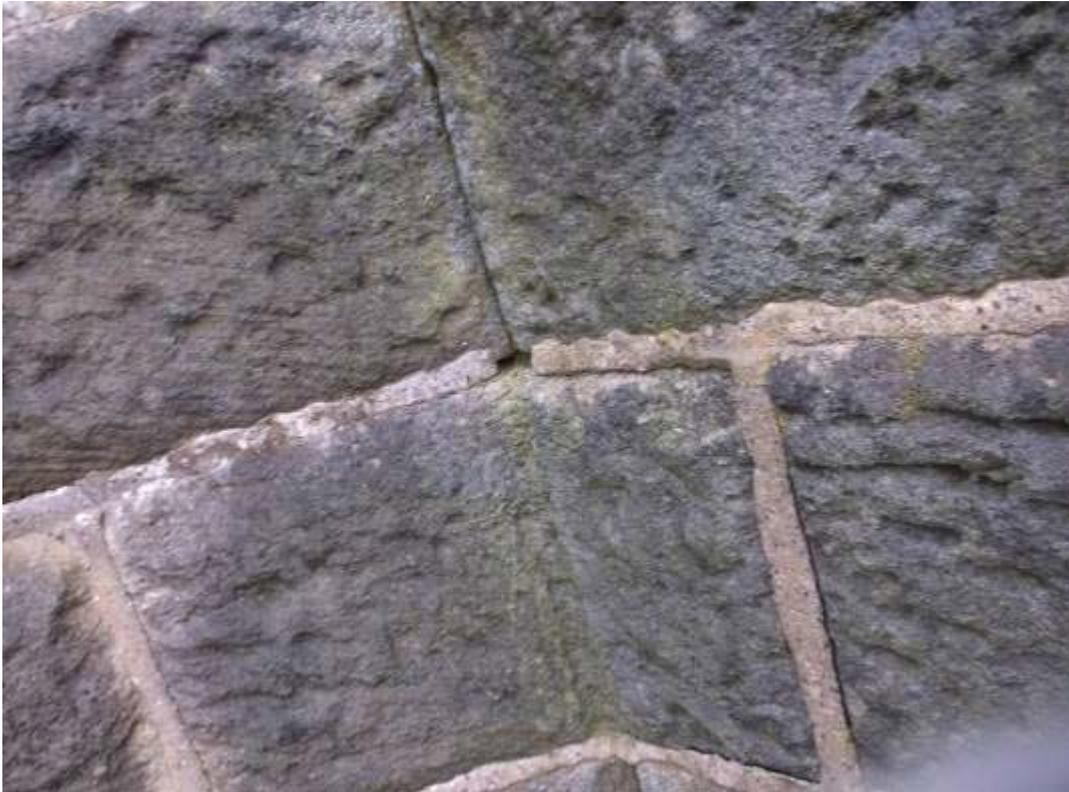
**Photo No. 133: Vertical toothed fracture to parapet of south east elevation of span 9**

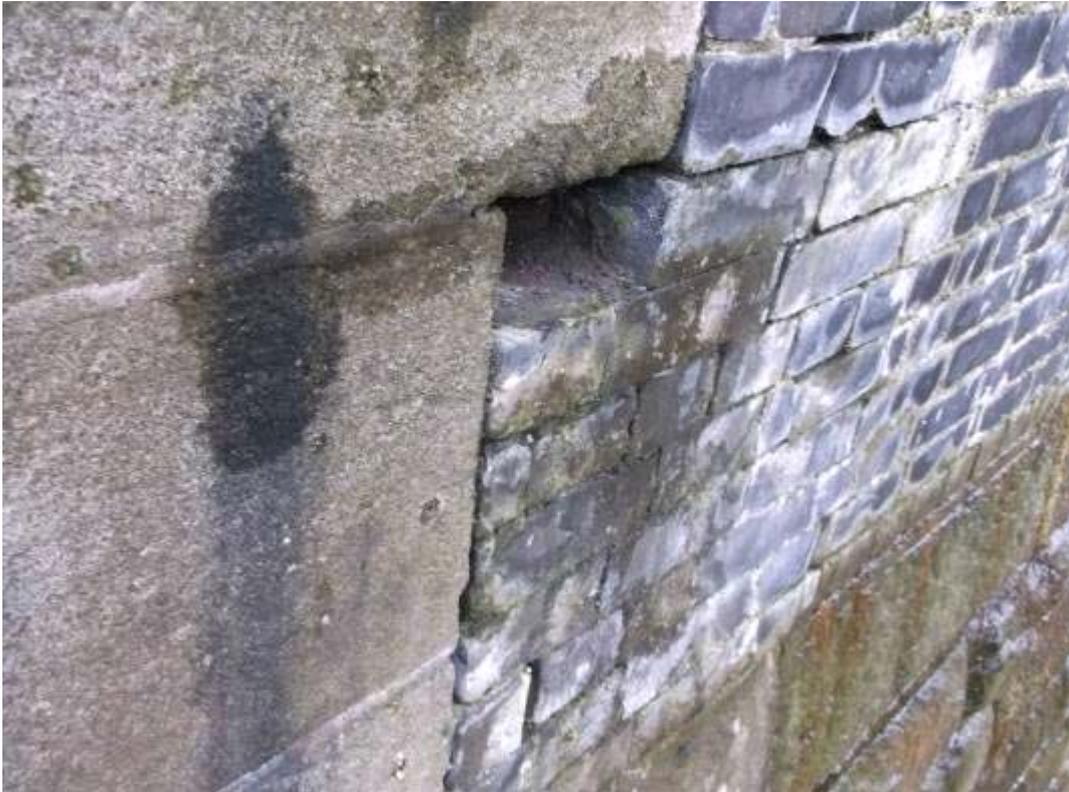
1. 2No. loose half bricks, 1No. removed. **(photo 135)**
2. Area of mortar loss, 2000 x 1000 x up to 30mm, with associated seepage.
3. Drainage pipe broken but functional.
4. Area of mortar loss, 1500 x 20000 x up to 40mm, with associated seepage. **(photo 136)**

**Photo No. 135: Area of loose and removed brickwork to soffit of span 9**

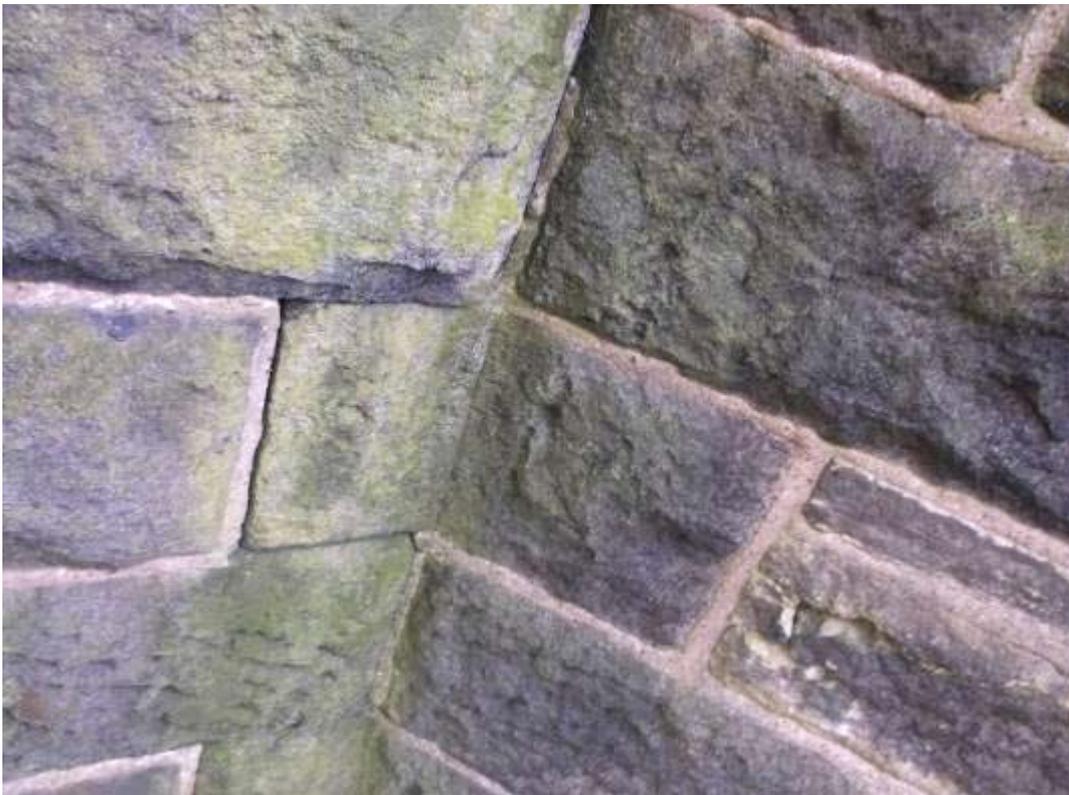
1. Vertical stepped fracture through mortar, 2000 x up to 3mm. [\(photo 137\)](#)
2. Area of mortar loss, 2000 x 1500 x up to 50mm, with associated light vegetation growth. [\(photo 138\)](#)
3. Area of spalling to voussoir, 200 x 200 x up to 200mm. [\(photo 139\)](#)
4. Area of mortar loss, 2000 x 1000 x up to 50mm.

**Photo No. 137: Vertical stepped fracture to parapet of north west elevation of span 10**

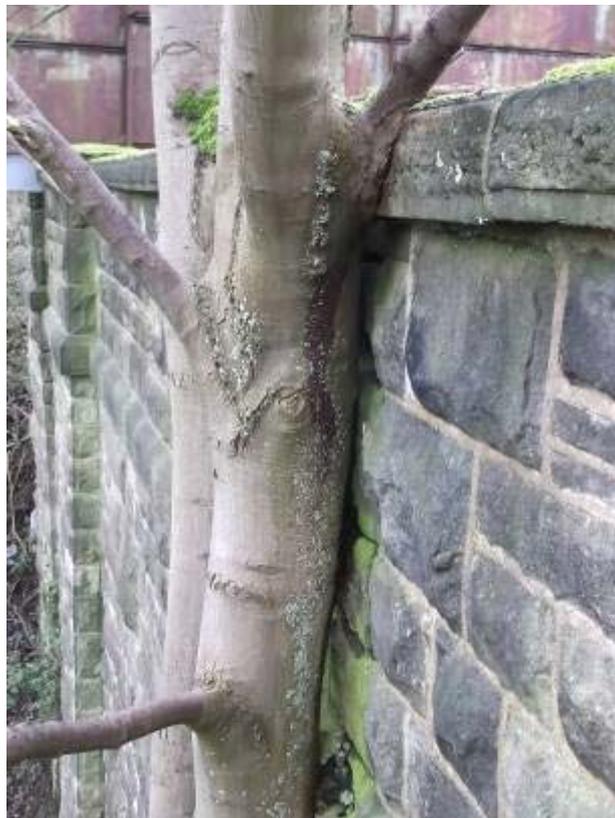
1. Mature tree, 400mm in diameter, growing adjacent to elevation in contact with masonry. [\(photo 140\)](#)
2. Horizontal fracture through masonry, 400 x 1mm. [\(photo 141\)](#)
3. Line of mortar loss, 300 x up to 200mm. [\(photo 142\)](#)
4. Line of mortar loss, 300 x up to 30mm.
5. Area of seepage to voussoirs, 1000 x 1000mm.
6. Spot areas of minor vegetation growth. [\(photo 143\)](#)
7. Area of mortar loss, 2000 x 2000 x up to 50mm.
8. Vertical fracture through masonry, 400 x 1mm, with associated seepage.

**Photo No. 140: Tree in contact with spandrel of south east elevation of span 10**

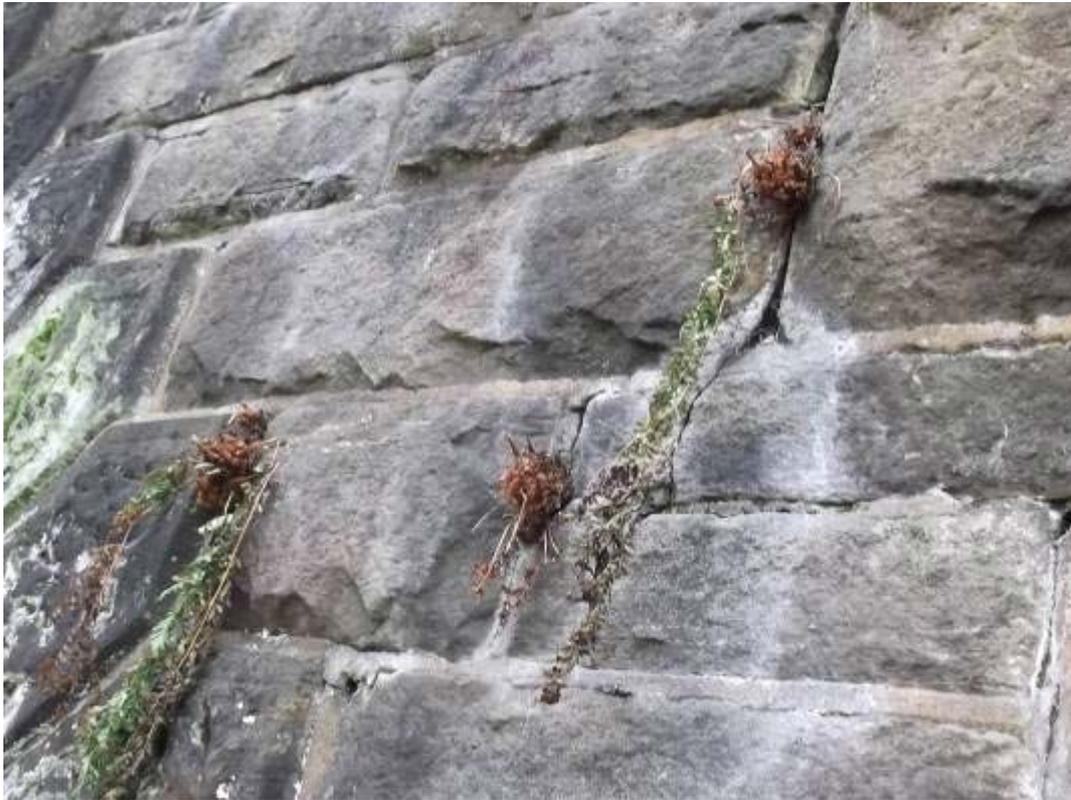
**Photo No. 143: Minor vegetation growth to spandrel of south east elevation of span 10**

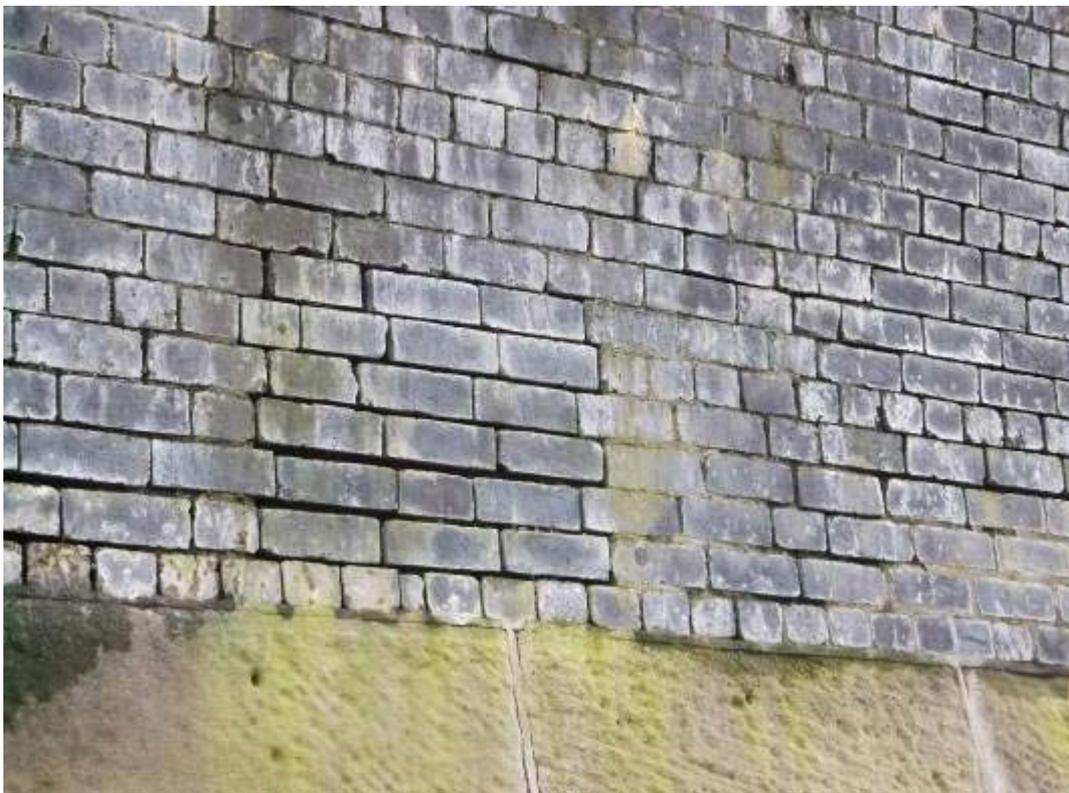
1. 3No. lines of mortar loss between voussoirs and brickwork totalling 400 x 15mm.
2. Area of mortar loss, 1000 x 2000 x up to 40mm. [\(photo 144\)](#)
3. Longitudinal fracture through brickwork, 12,000 x up to 15mm, with associated seepage. [\(photos 145 & 146\)](#)
4. Area of missing brickwork between longitudinal fracture and voussoirs, 400 x 100 x 120mm.
5. Longitudinal fracture through brickwork, 2500 x up to 5mm. [\(photo 146\)](#)
6. Area of missing brickwork between longitudinal fracture and voussoirs, 600 x 200 x 120mm. [\(photo 147\)](#)
7. Area of missing brickwork between longitudinal fracture and voussoirs, 400 x 150 x 120mm.
8. Missing half brick between longitudinal fracture and voussoirs. [\(photo 148\)](#)

**Photo No. 144: Area of mortar loss to soffit of span 10**

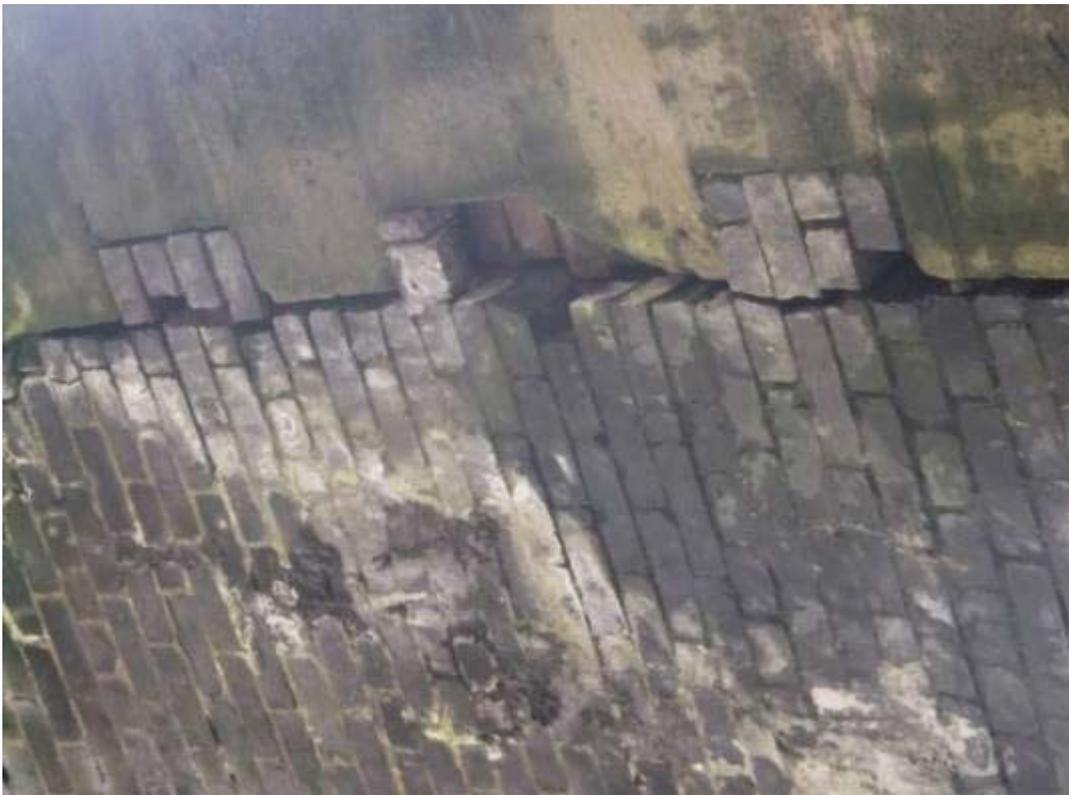
**Photo No. 147: Area of missing brickwork to soffit of span 10**

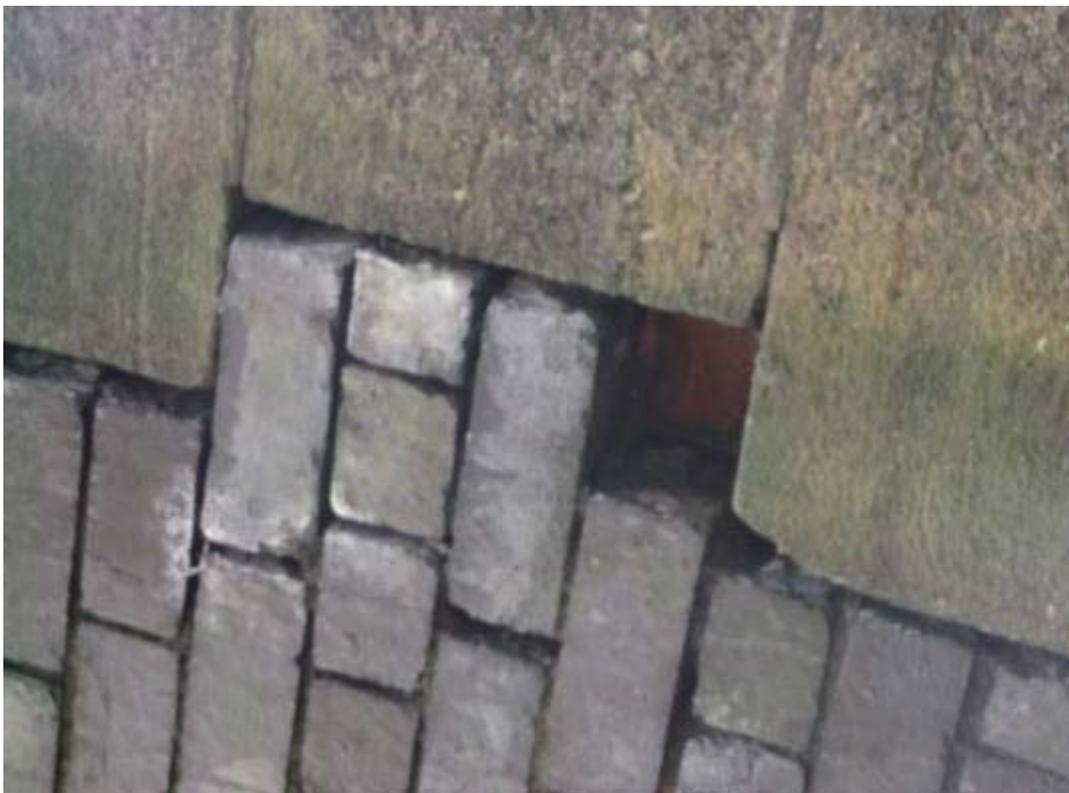
**Photo No. 148: Missing half brick to soffit of span 10**

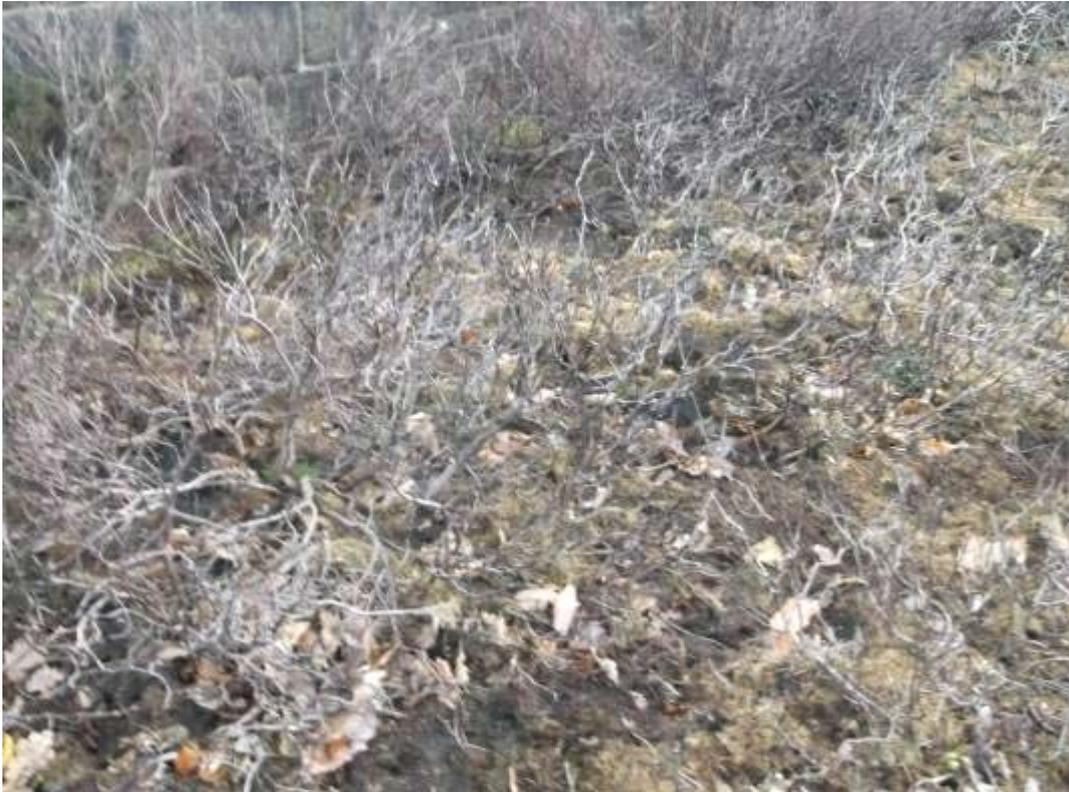
The disused track bed over the structure was overgrown, mainly with heather, which had been on fire recently. **(photo 149)** Occasional saplings were growing throughout. **(photo 150)** 2No. mature trees, 280 and 800mm in diameter, were growing to the north east end of the structure. **(photo 151)**

**Photo No. 149: Typical burned heather to track top**

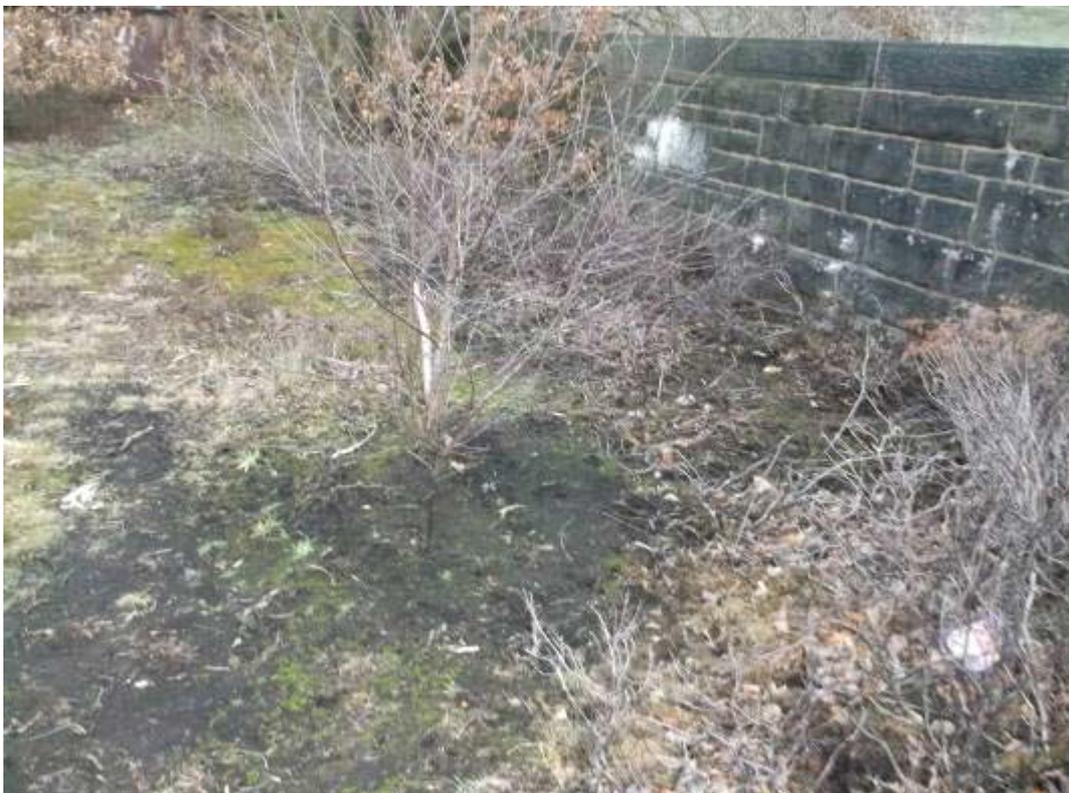
**Photo No. 150: Typical sapling growth to track top**

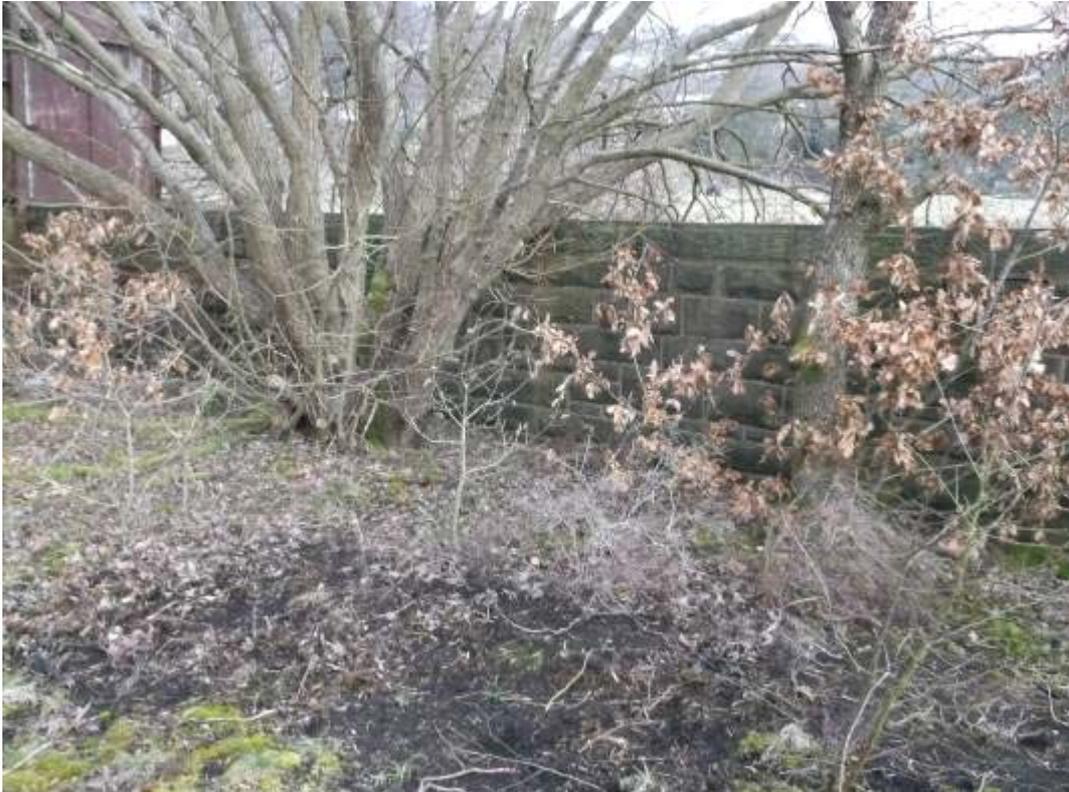
**Photo No. 151: 2No. mature trees growing to track top**

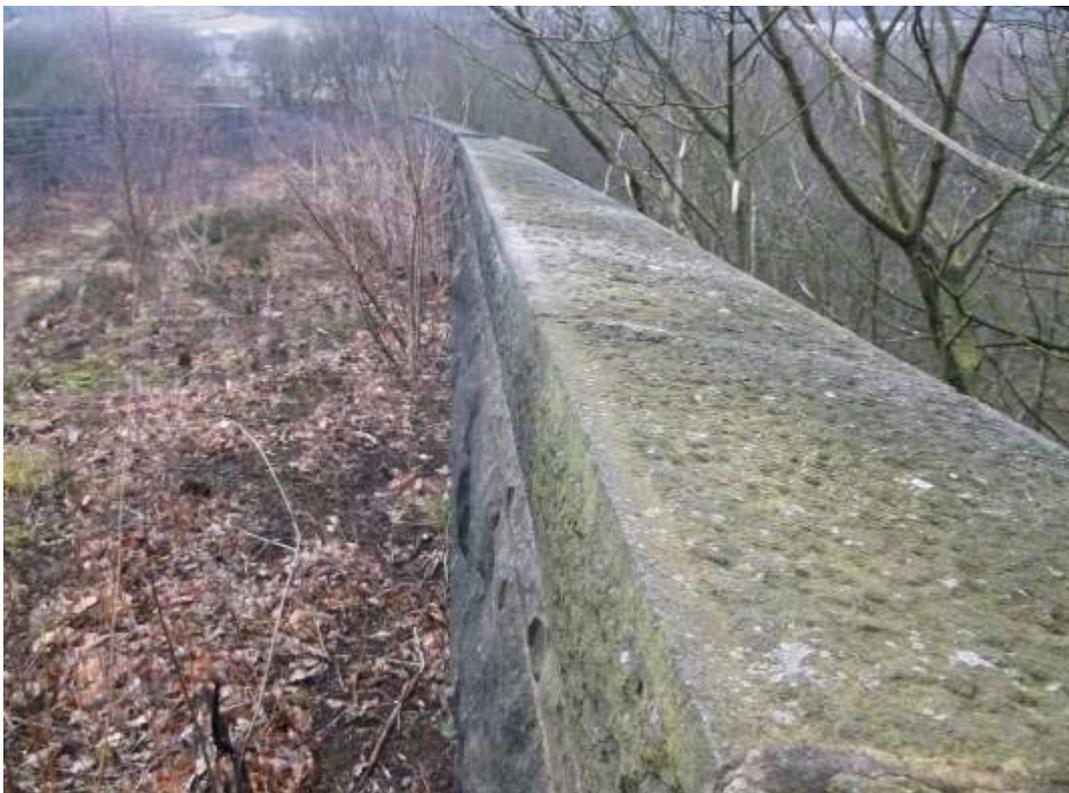
The parapet was leaning outwards by 40 – 60mm. **(photo 152)** There was spot mortar loss of up to 40mm throughout. All refuges had vertical toothed fractures through mortar, full height x av. 1mm, down at least 1No. side. **(photo 153)** There was an area of missing masonry to the top of the refuge over pier 5, 800 x 500 x 300mm. **(photo 154)**

**Photo No. 152: North west parapet leaning outwards**

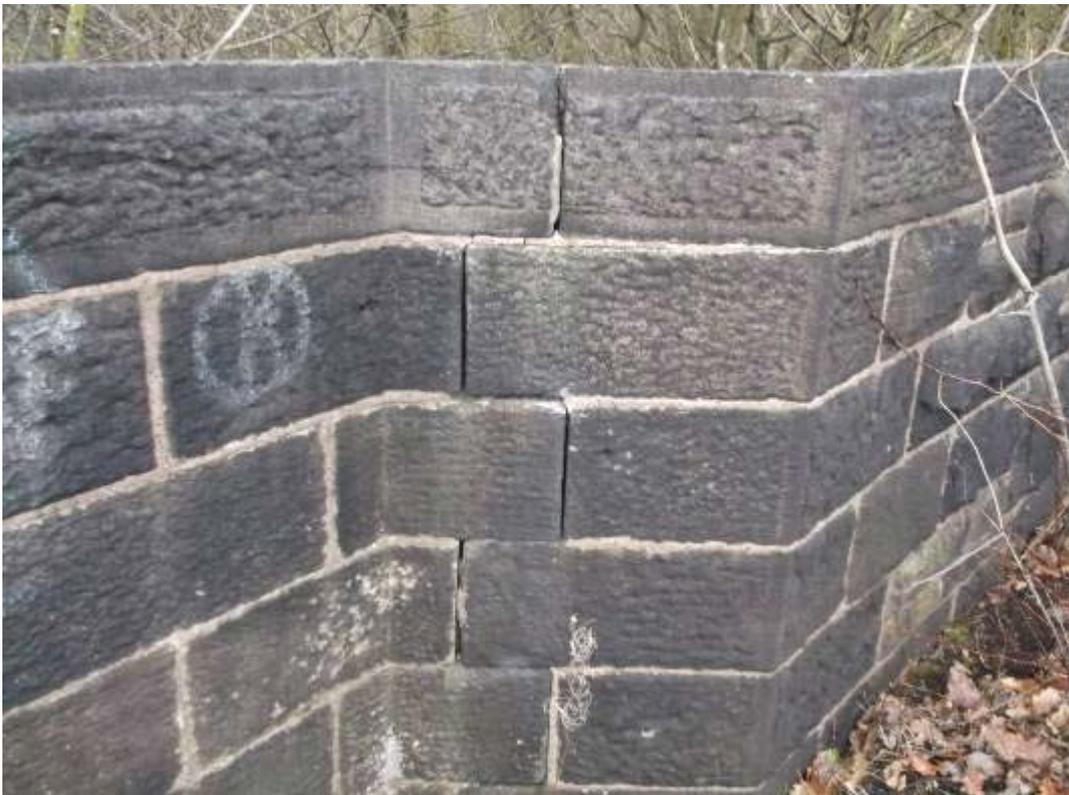
**Photo No. 153: Typical vertical toothed fracture to refuges of north west parapet, internal elevation**
