## HXH/4a Contract Specification (Masonry Repair and Waterproofing Installation)

**Client name:** National Highways – Historical Railways Estate  
**Project name:** HRE Works Framework  
**Client reference:** HXH/4a  
**Document no:** 0451200  
**Revision no:** 03  
**Date:** May 2023  
**Project no:** B38380DE  
**Project manager:** Nigel Robson  
**Prepared by:** Christopher Doig  
**File name:** HXH 4a NEC ECC

### **HRE WORKS FRAMEWORK HXH/4a 'WHEATLEY VIADUCT' CONTRACT FOR REMEDIAL REPAIRS AND WATERPROOFING**

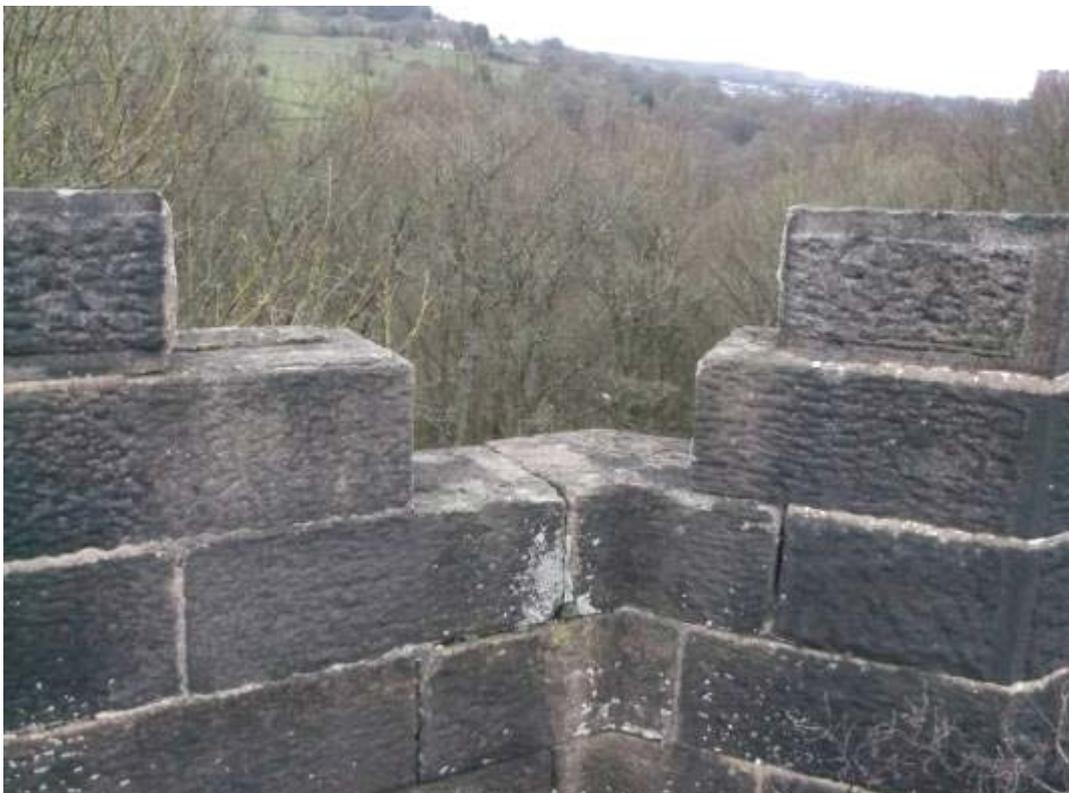
The parapet was leaning outwards by 40 – 60mm. **(photo 152)** There was spot mortar loss of up to 40mm throughout. All refuges had vertical toothed fractures through mortar, full height x av. 1mm, down at least 1No. side. **(photo 153)** There was an area of missing masonry to the top of the refuge over pier 5, 800 x 500 x 300mm. **(photo 154)**

**Photo No. 154: Area of missing masonry to north west parapet, internal elevation**

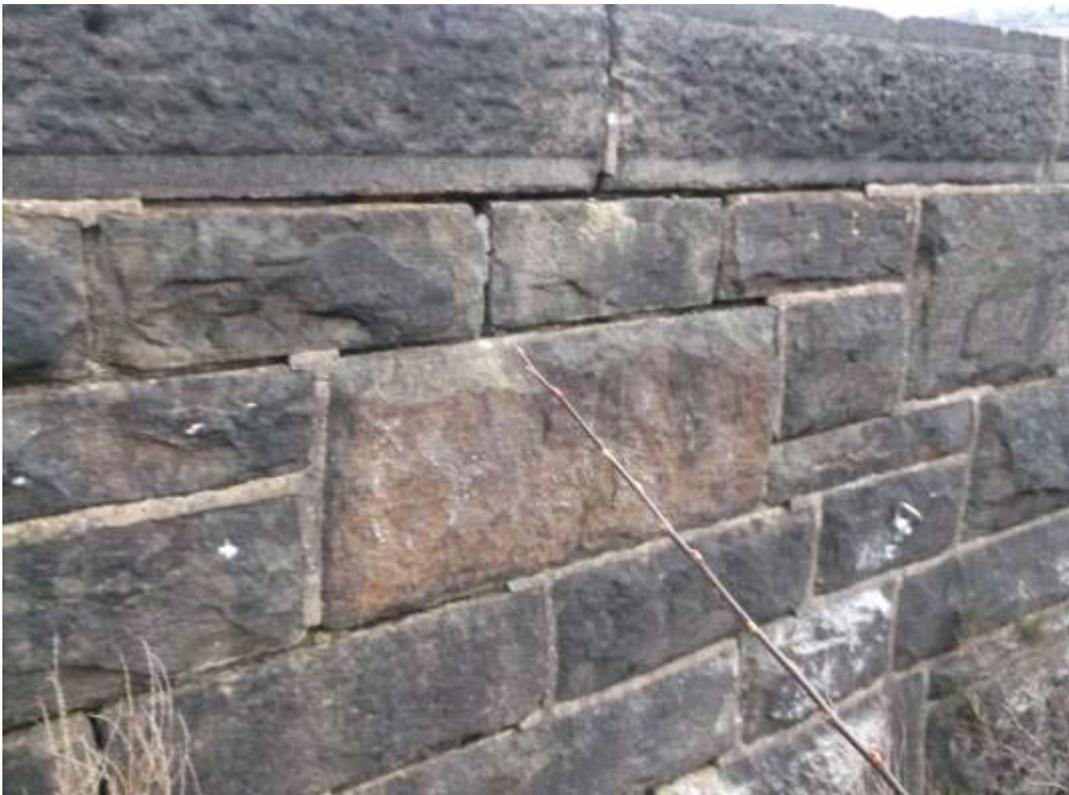
The parapet was leaning outwards by 20 – 40mm. There was spot mortar loss of up to 40mm throughout. **(photo 155)** There was an area of missing masonry to the top of the refuge over pier 6, 6000mm of coping and 1000mm of top course of masonry. **(photo 156)** There was an area of missing masonry to the south west end of the parapet adjacent to the barrier, 500 x 700 x 450mm. **(photo 157)**

**Photo No. 155: Typical spot mortar loss to south east parapet, internal elevation**

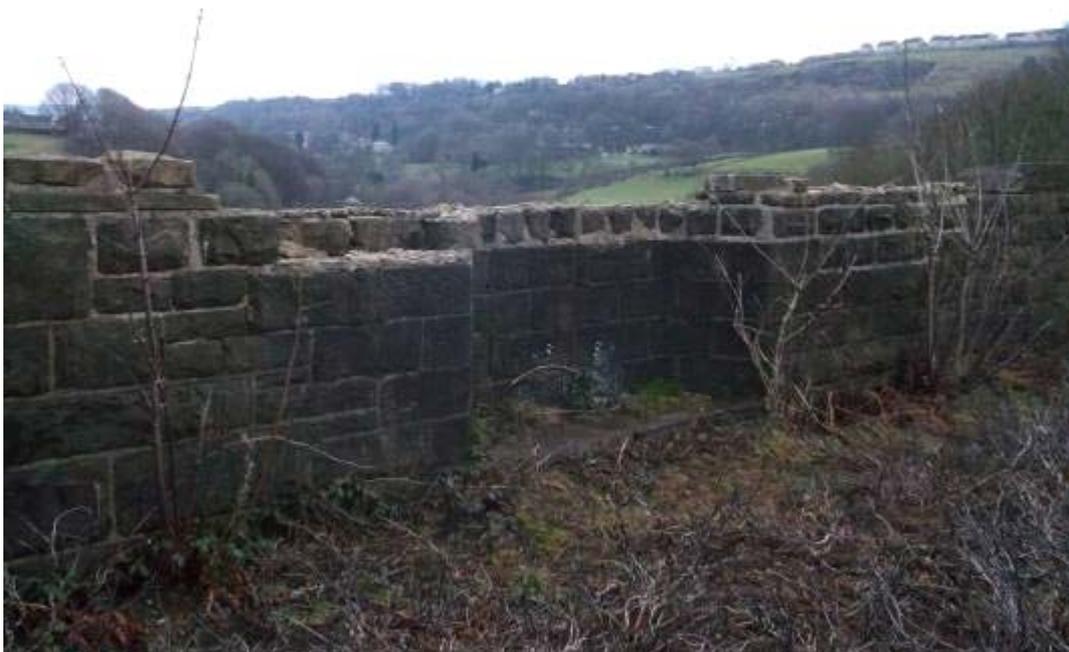
**Photo No. 156: Area of missing masonry to south east parapet, internal elevation**

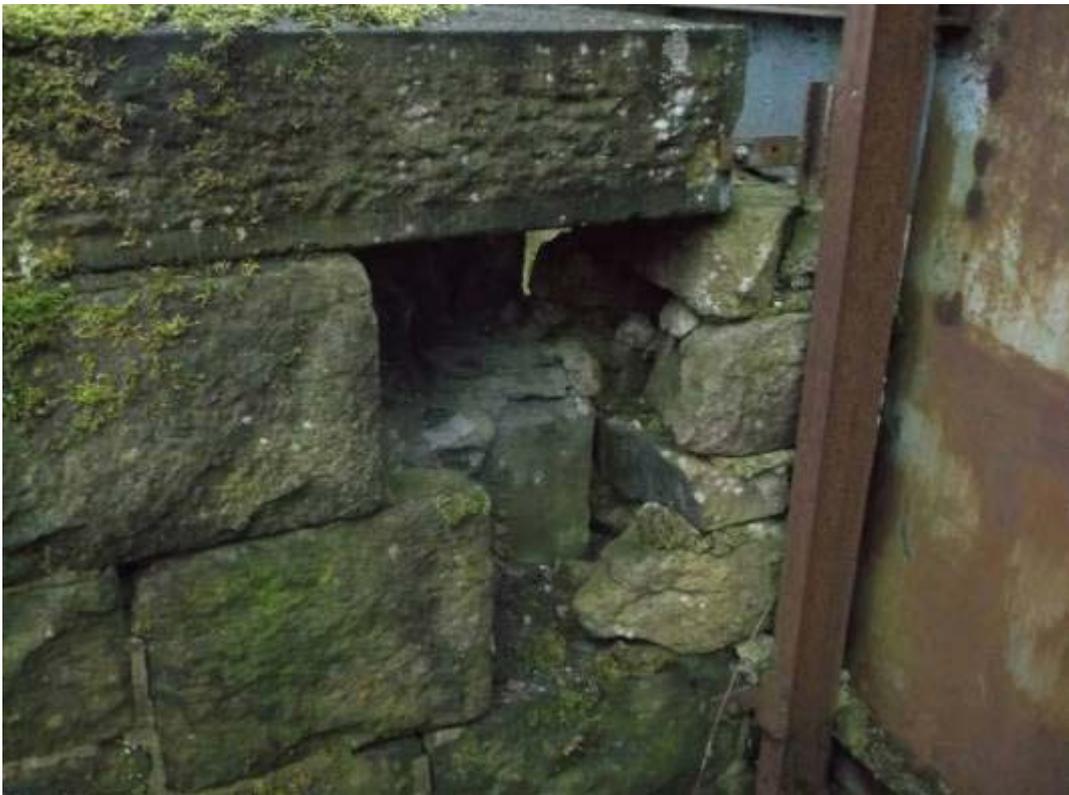
**Photo No. 157: Area of missing masonry to south east parapet, internal elevation**

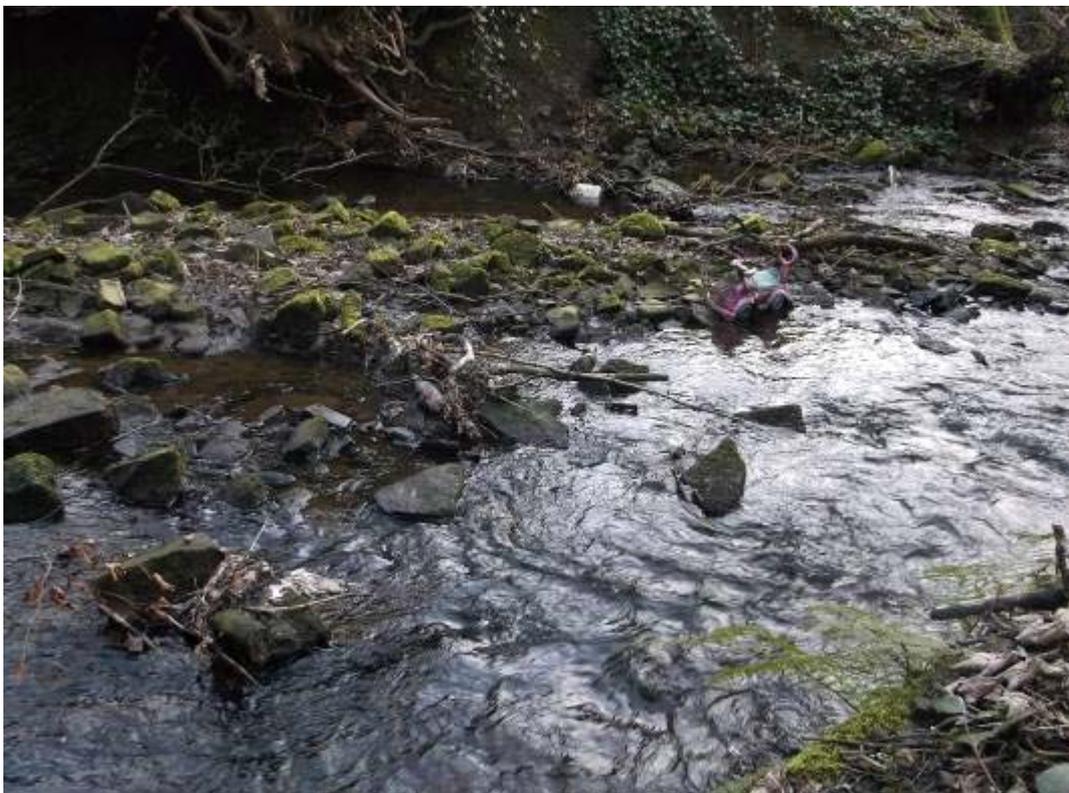
Debris, including fly-tipped material, was noted to the watercourse downstream of the bridge. **(photo 158)** The northern bank of the watercourse downstream of the bridge was heavily eroded, 3No. mature trees (over 30m high) had their roots severely undercut by up to 1500mm. **(photo 159)**

**Photo No. 158: Debris to watercourse downstream of bridge**

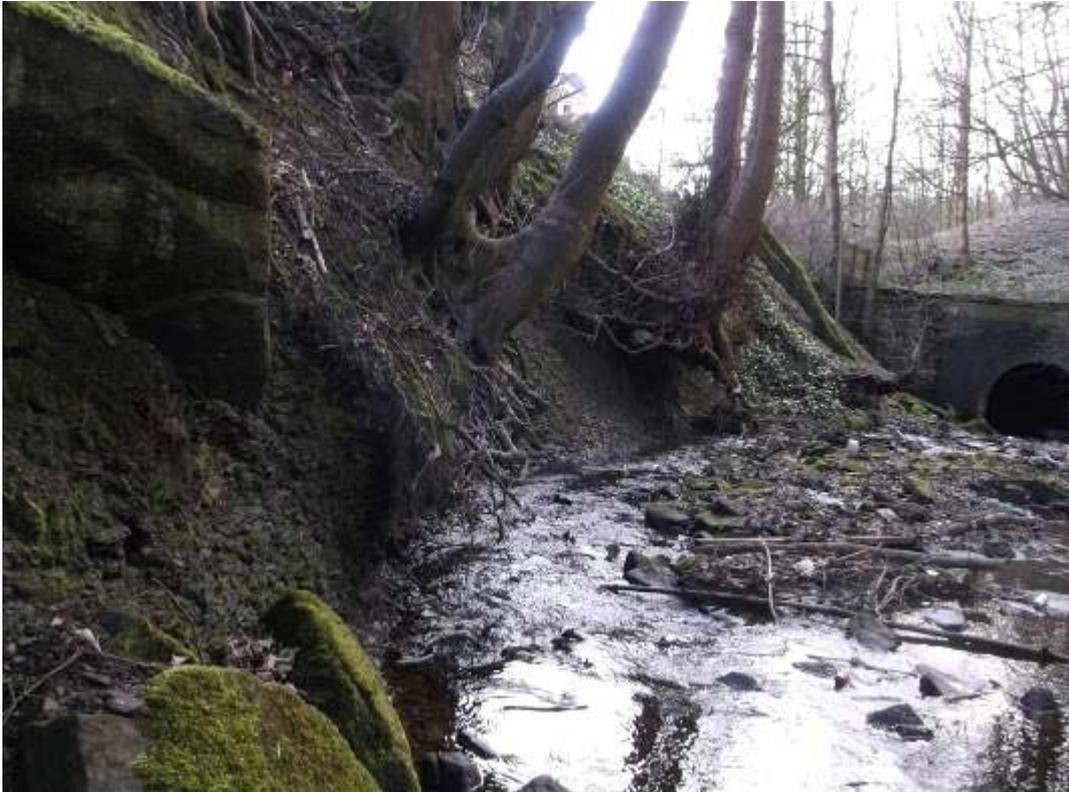
**Photo No. 159: Heavy erosion and undercutting of trees to northern bank of watercourse downstream of bridge**
