**Inspection of: Link Bridge
St. Catherine's College
Priory Road
Eastbourne
BN23 7BL**

Project No: 778
Document Title: Special Inspection
Document No: CRM060619778
Revision: Rev 4.
Date: Tuesday 30th August 2022

Principal Inspection of Link Bridge – St Catherine’s College

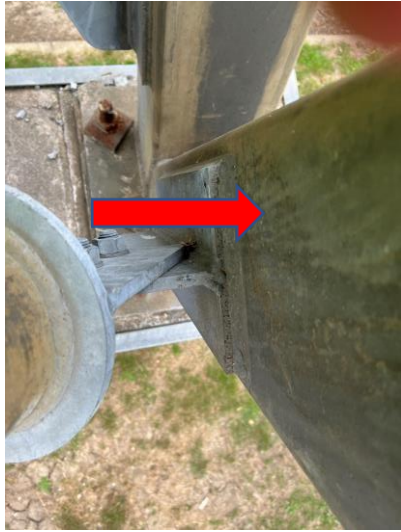
Fig 18: Light corrosion

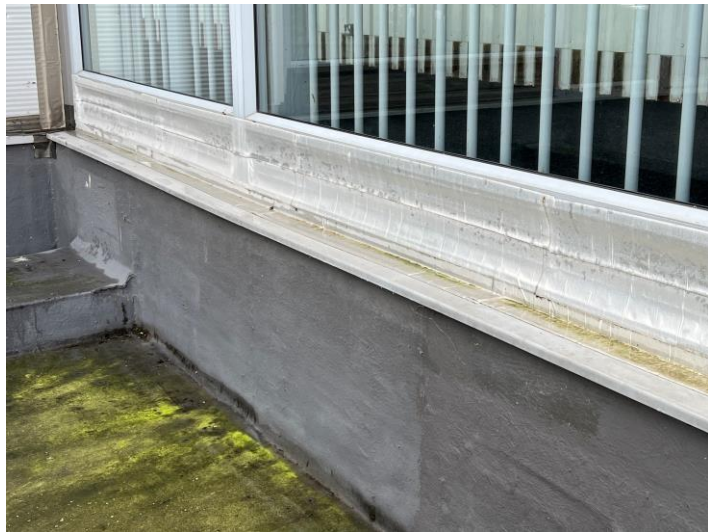
Image 7: Flash band to external cladding
