the **play inspection** company

Annual Inspection

Houghton Regis Town Council

Tithe Farm Recreation Ground

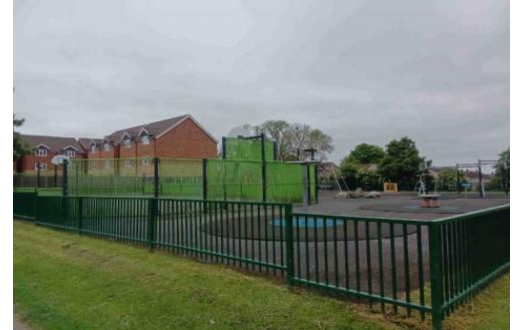
There is algae, silt or moss growth on the surface resulting in slippery conditions - Clean and treat appropriately

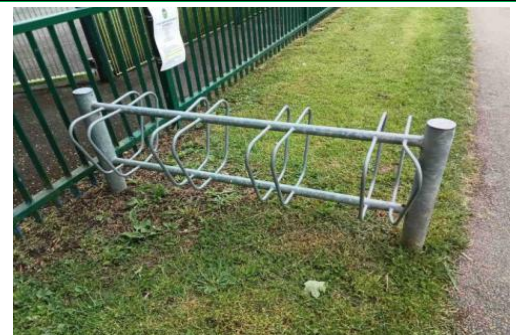
The item has been damaged - Monitor for any further deterioration and replace as required

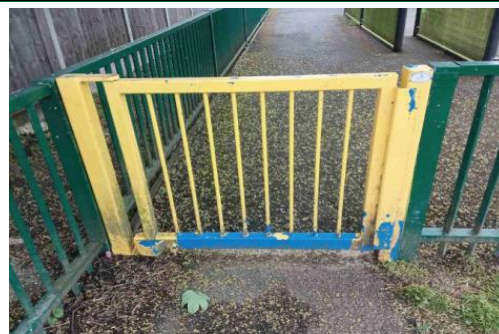
The surface has eroded in some areas and may be slippery in wet conditions - Reinstate the surface

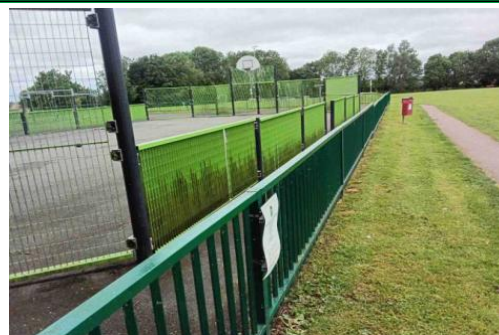
There is some damage to the fence sections - Monitor for any further deterioration and repair as required

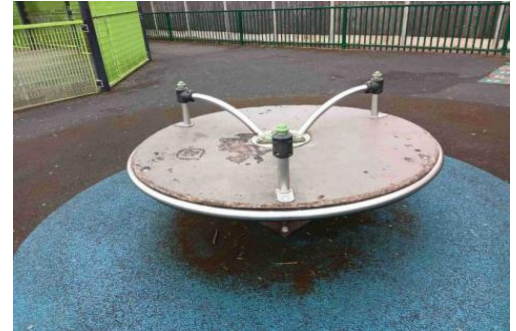
The plywood has delaminated in some places - Remove all rough or splintered edges.

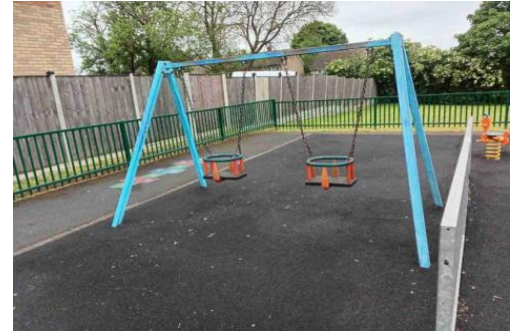
The paintwork on this item has been damaged or worn exposing the metal underneath which is rusting / corroding - Treat affected areas and repaint

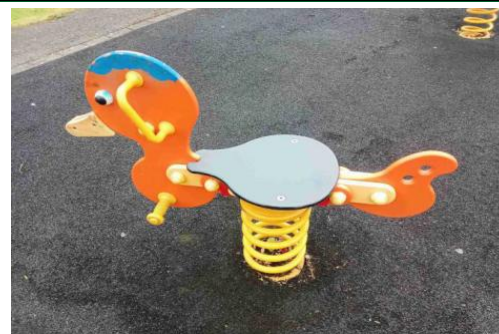
The surface has subsided in some areas - Monitor for any further deterioration and repair as required

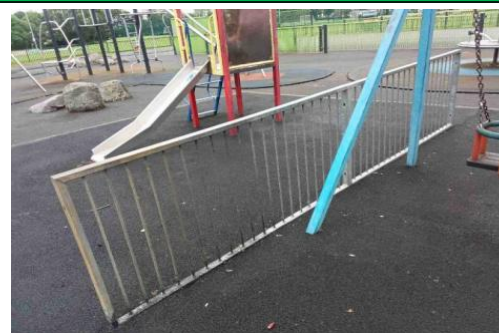
There is some evidence of fire damage to the item - Monitor for any further deterioration and repair as required

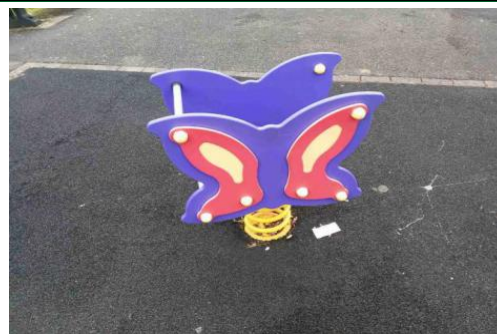
The surface has subsided in some areas - Monitor for any further deterioration and repair as required

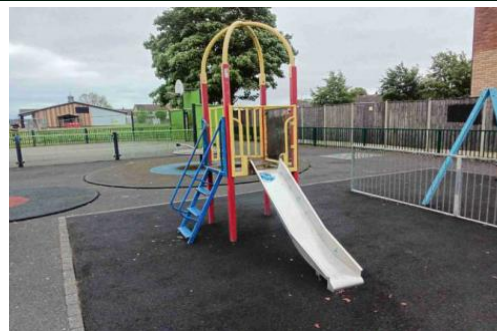
There are a number of dents in the slide surface - Monitor for any further deterioration and repair as required

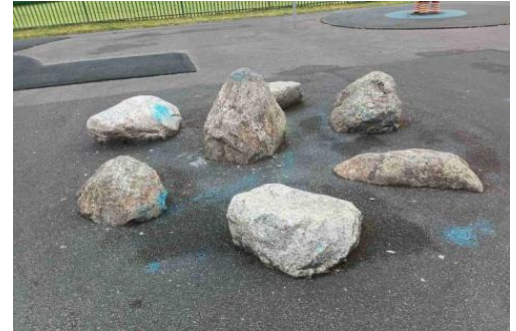
The rocks and/or boulders have moss/algae growth apparent - Clean and maintain

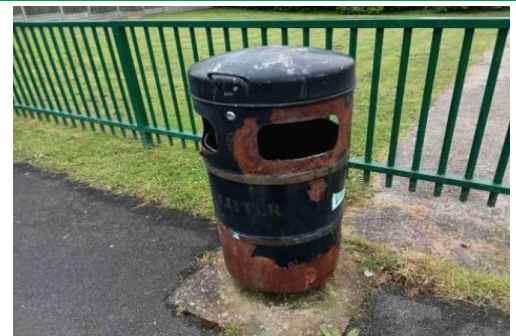
There is some evidence of fire damage to the item - Monitor for any further deterioration and repair as required

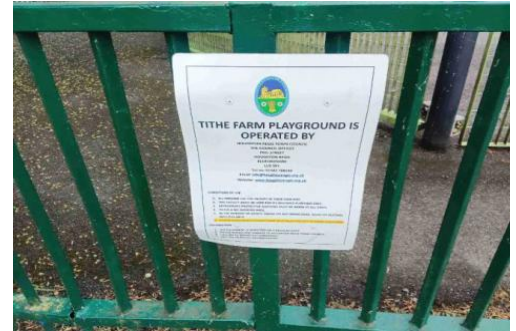
The item has been damaged - Monitor for any further deterioration and replace as required

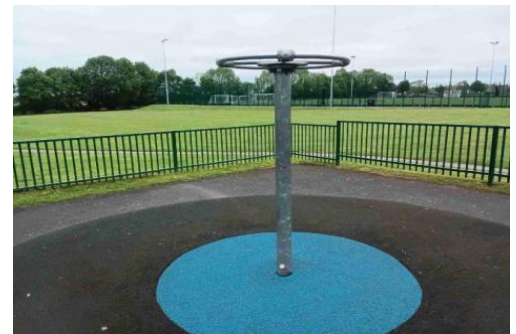
There is some minor damage to the surface - Monitor for any further deterioration and repair as required

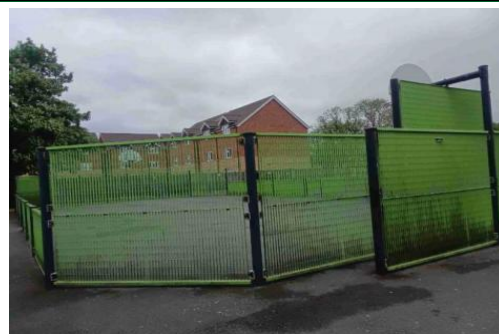
The weld(s) on this item have failed leaving sharp edges - Repair item

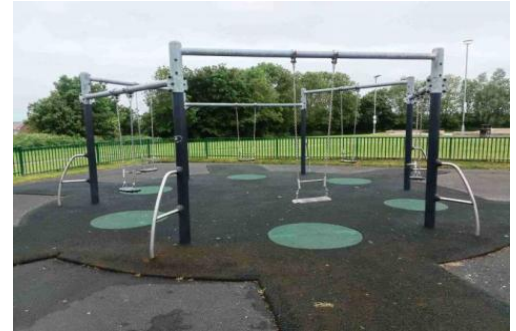
The seat has minor damage or wear - Monitor for any further deterioration and replace as required

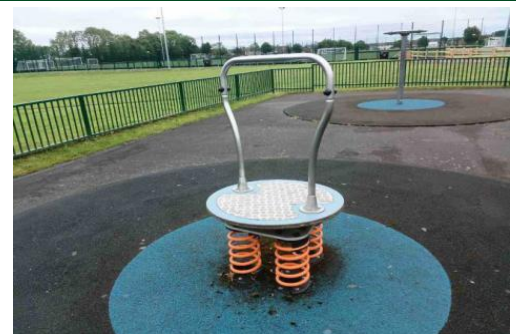
The bearing is worn / damaged and the item is not operating correctly - Repair / replace

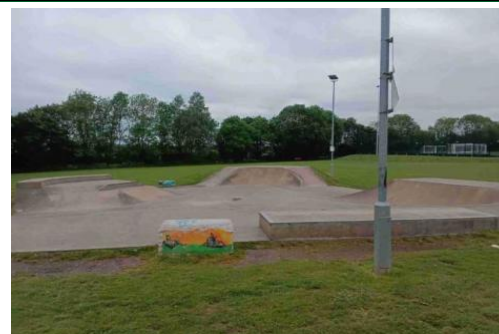
The surface has eroded in some areas and may be slippery in wet conditions - Reinstate the surface

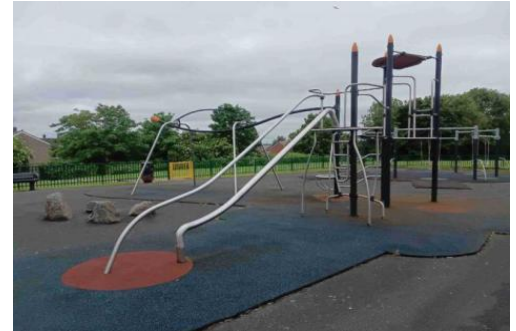
The surfacing dimensions are short and do not meet with the requirements of the current applicable standard - Monitor - no remedial action recommended

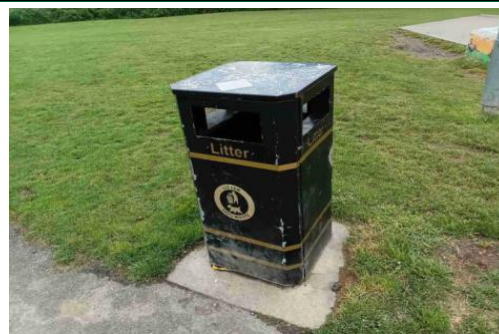
There is some graffiti present - Remove the graffiti

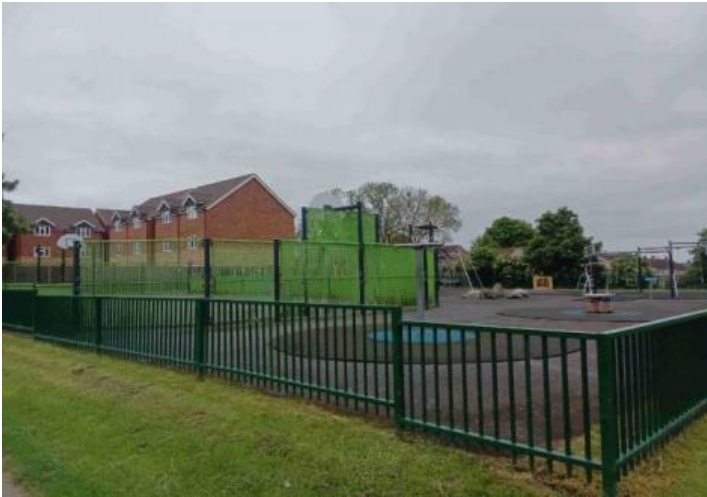
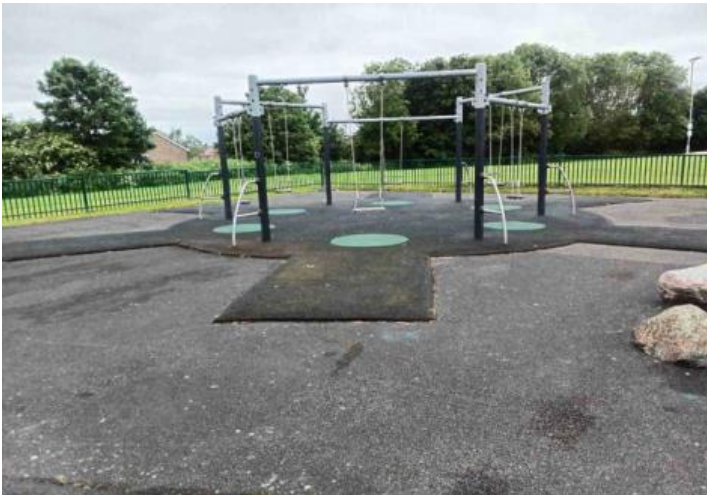
Finding: There is algae, silt or moss growth on the surface resulting in slippery conditions

Action: Clean and treat appropriately

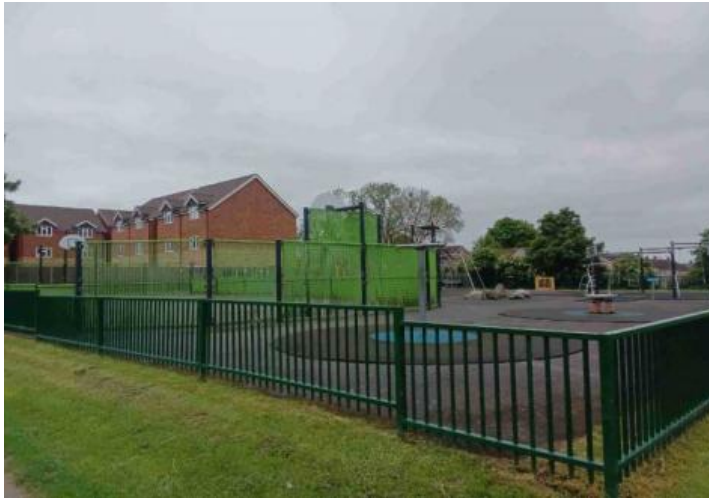
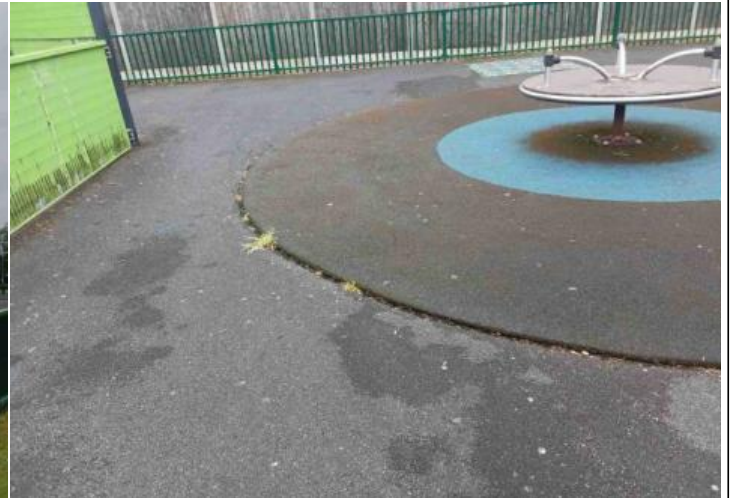
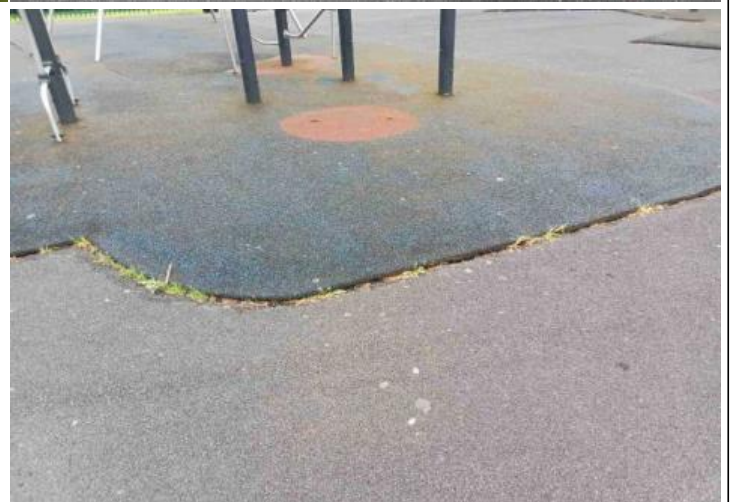
Finding: There is weed / vegetation growth on, between, or around the edges of the surfacing
Action: Remove weed / vegetation growth

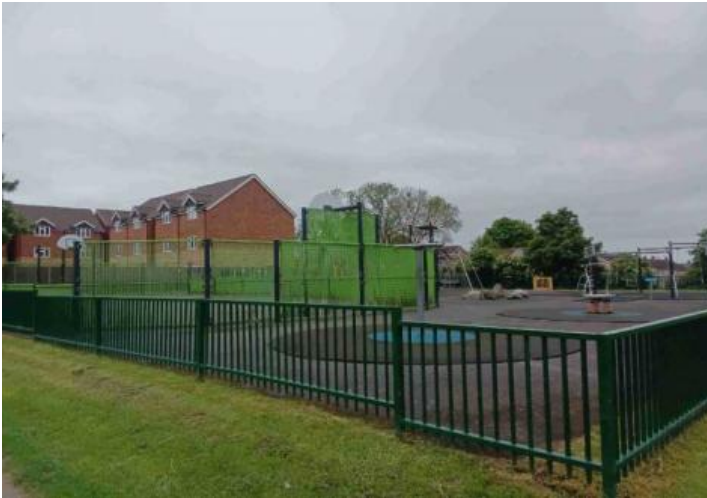
Finding: The surface is lifting at the edges and creating trip points
Action: Repair perimeter of surfacing to remove trip points

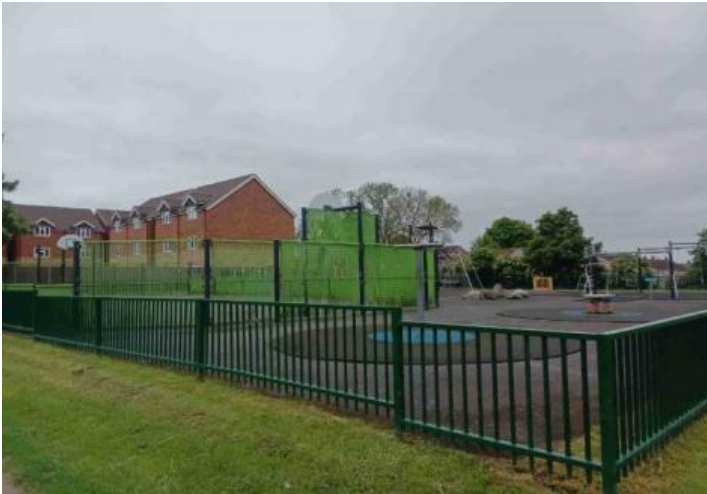
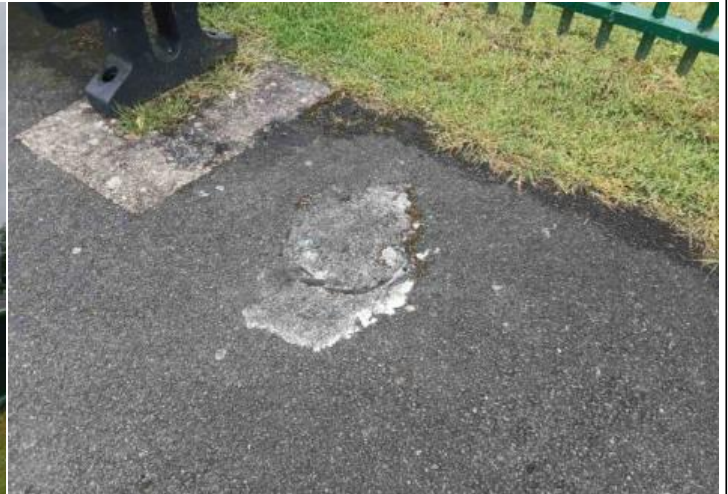
Finding: There is some evidence of fire damage to the surfacing

Action: Monitor for any further deterioration and repair as required

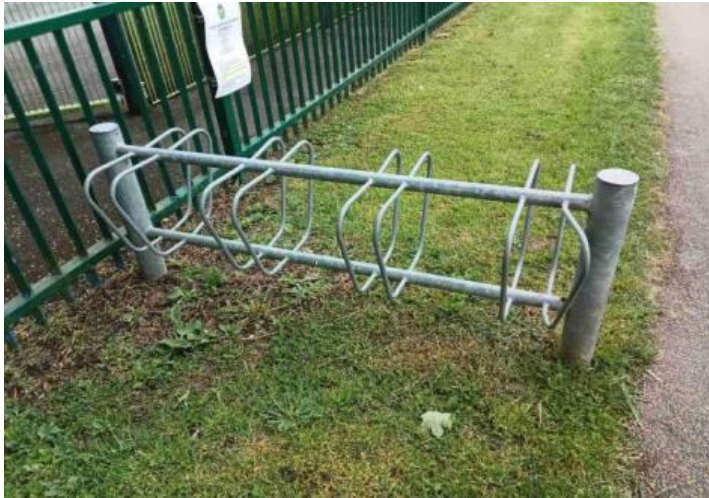
Finding: The item has been damaged

Action: Monitor for any further deterioration and replace as required

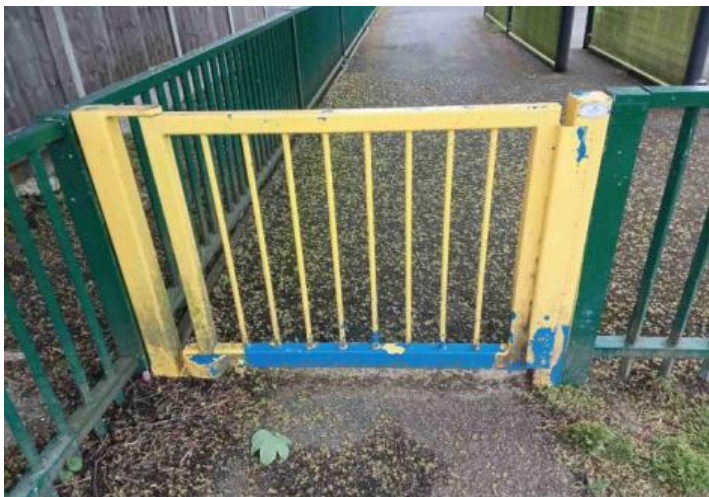
Finding: The surface has eroded in some areas and may be slippery in wet conditions

Action: Reinstate the surface

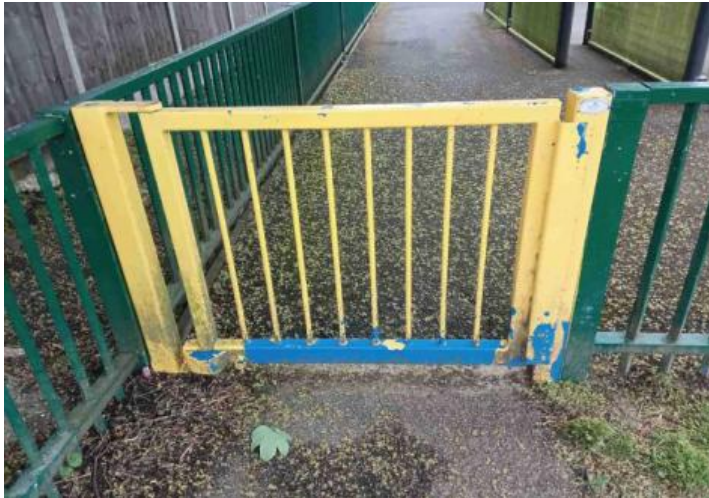
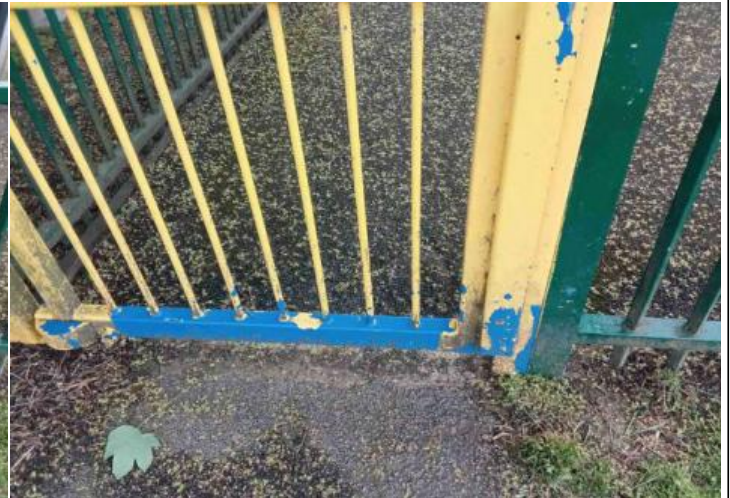
Finding: The paint is flaking off the metalwork

Action: Rub down and re-paint

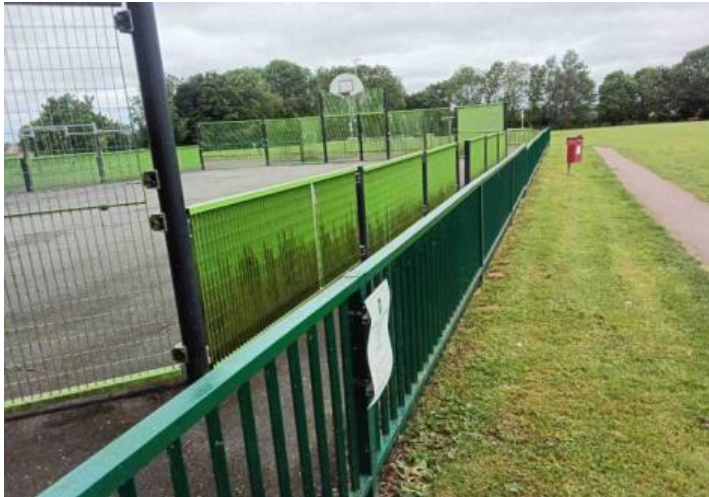
Finding: There is some damage to the fence sections

Action: Monitor for any further deterioration and repair as required

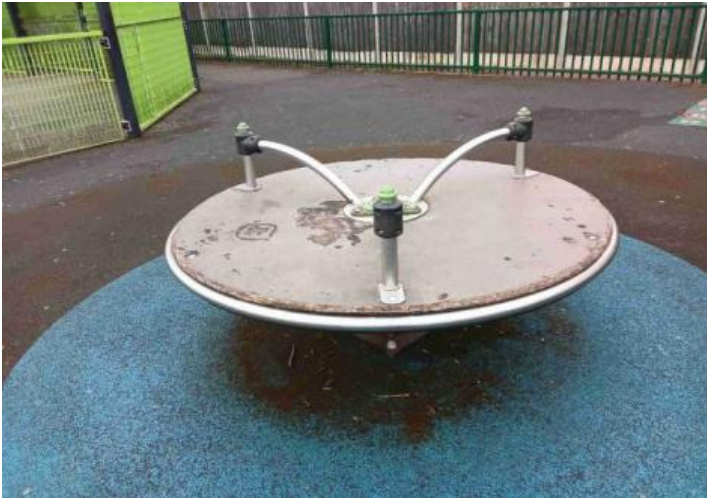
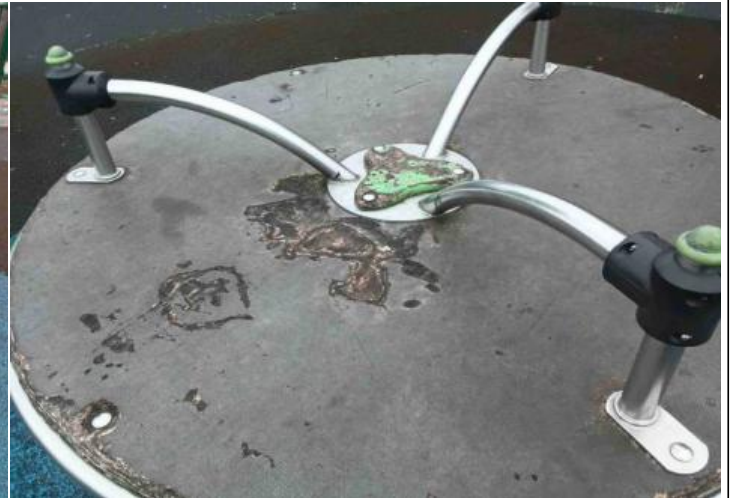
Finding: The plywood has delaminated in some places

Action: Remove all rough or splintered edges.

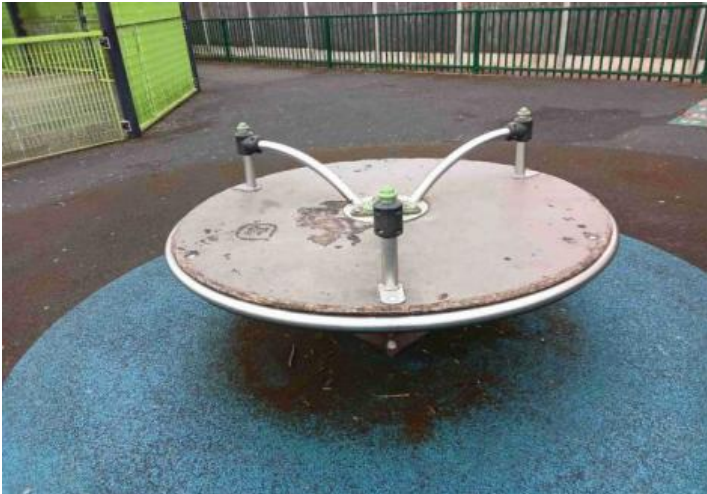
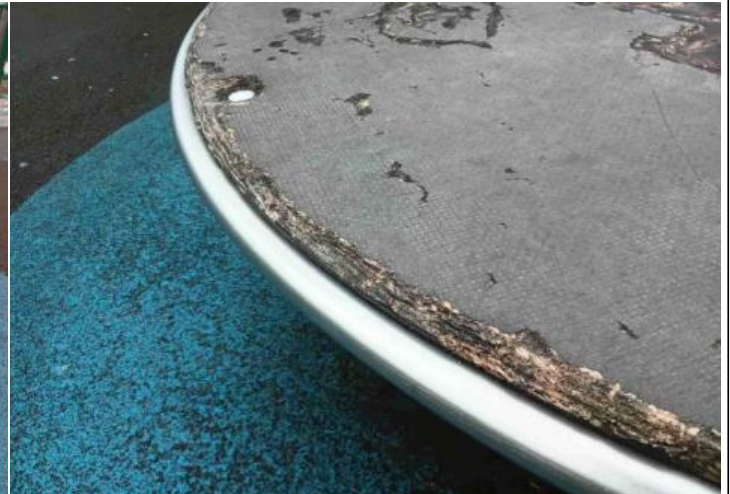
Finding: Parts of the timber are rough or splintered

Action: Remove all rough or sharp edges

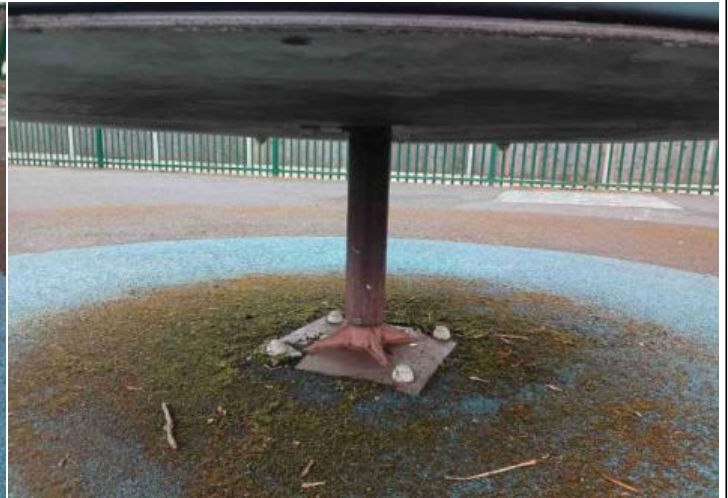
Finding: The bearing on the unit is dry

Action: Service and lubricate the bearing(s)

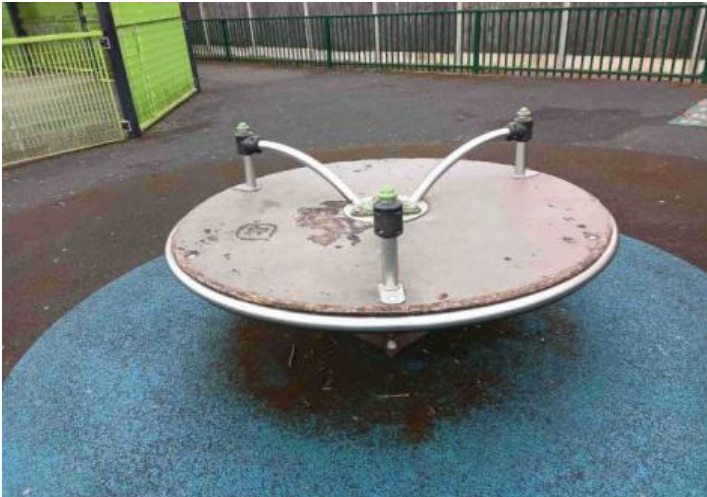
Finding: There is/are bolt cap covers missing or damaged on the item

Action: Replace missing or damaged bolt cap covers

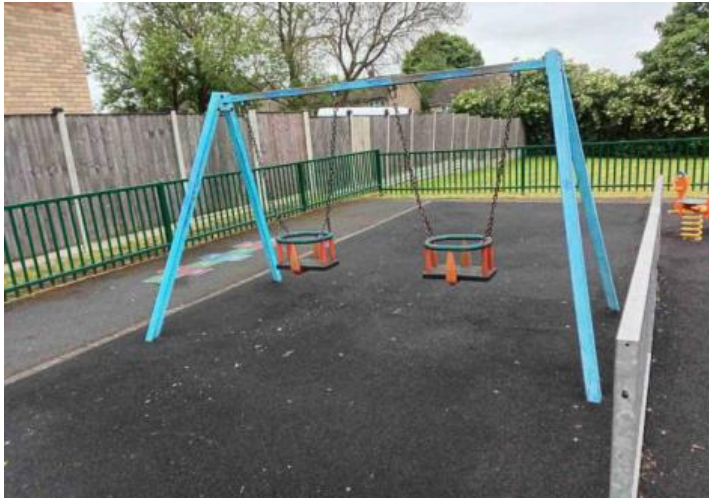
Finding: The paintwork on this item has been damaged or worn exposing the metal underneath which is rusting / corroding

Action: Treat affected areas and repaint

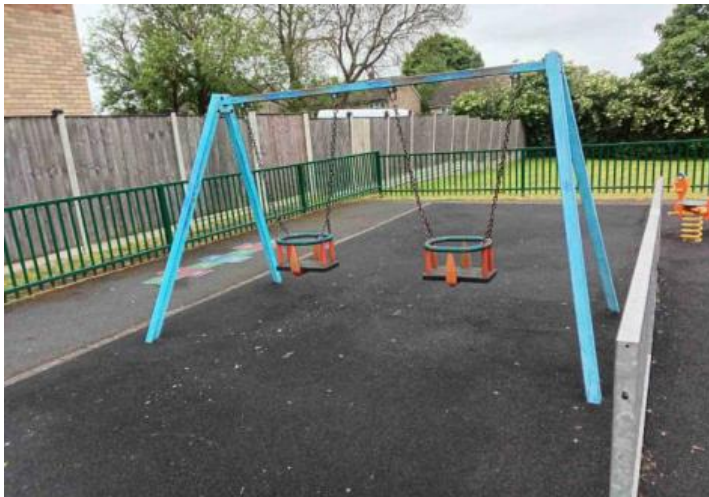
Finding: The safety surface around the area is beginning to wear

Action: Monitor for any further deterioration and repair as required

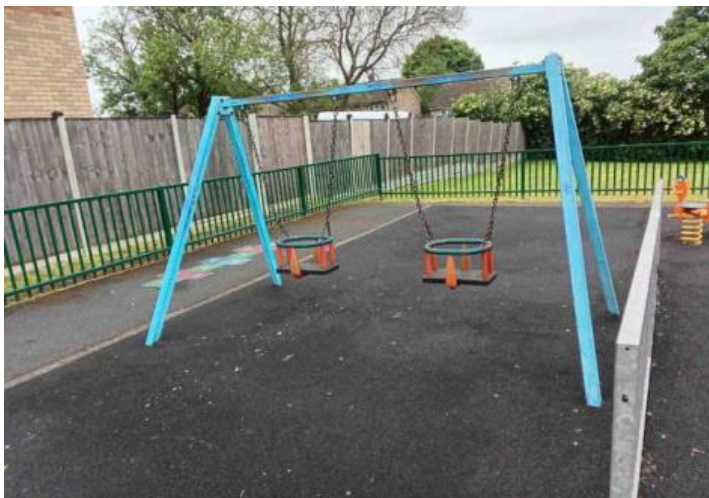
Finding: The bushes are showing signs of wear

Action: Monitor for any further deterioration and replace as required

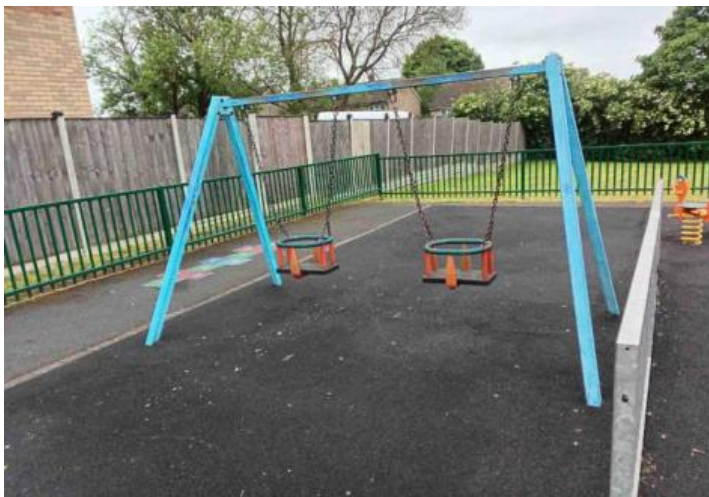
Finding: The chain links are worn excessively and require renewing

Action: Replace worn chains

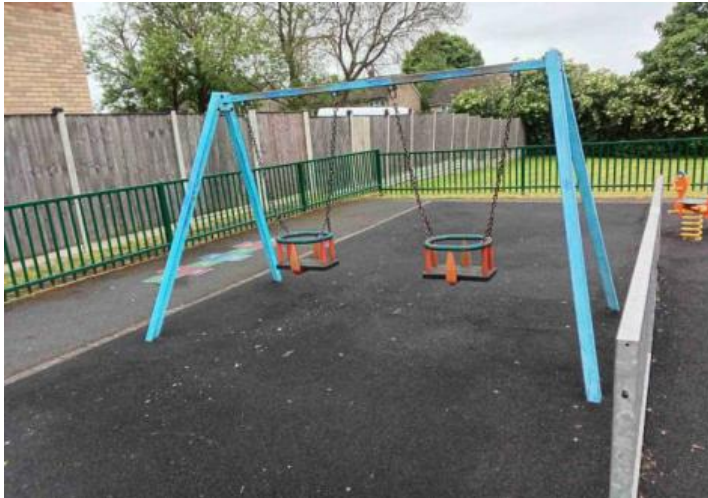
Finding: The chain openings are in excess of the 8.6mm as recommended by BS EN 1176 **Action:** Monitor - No remedial work recommended

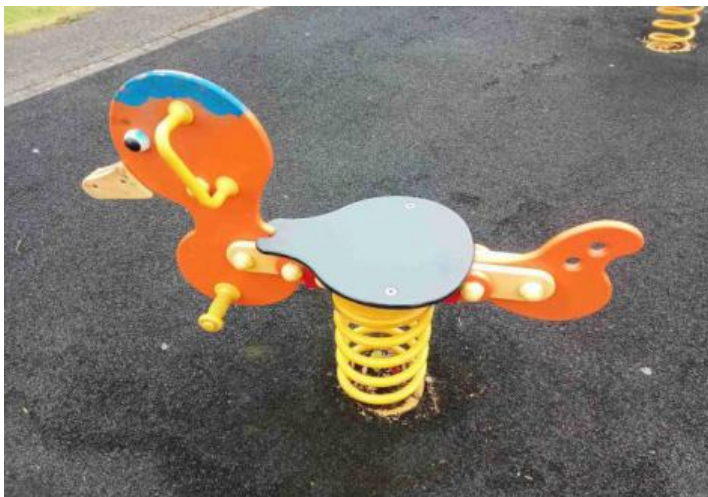
Finding: The surface has subsided in some areas **Action:** Monitor for any further deterioration and repair as required

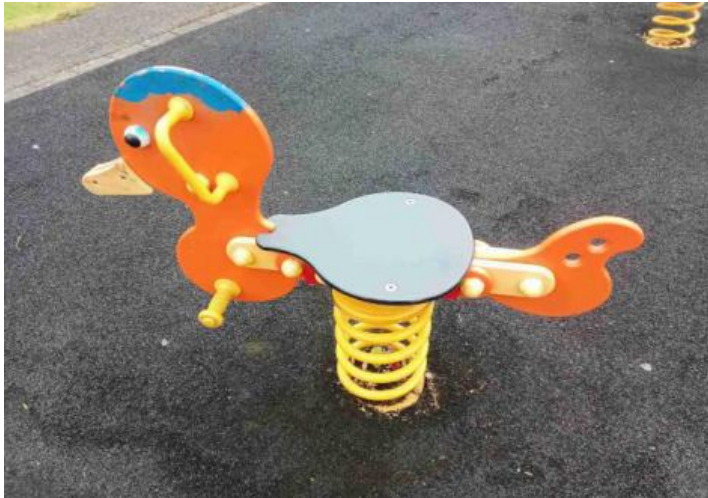
Finding: There is some minor damage to the surface

Action: Monitor for any further deterioration and repair as required

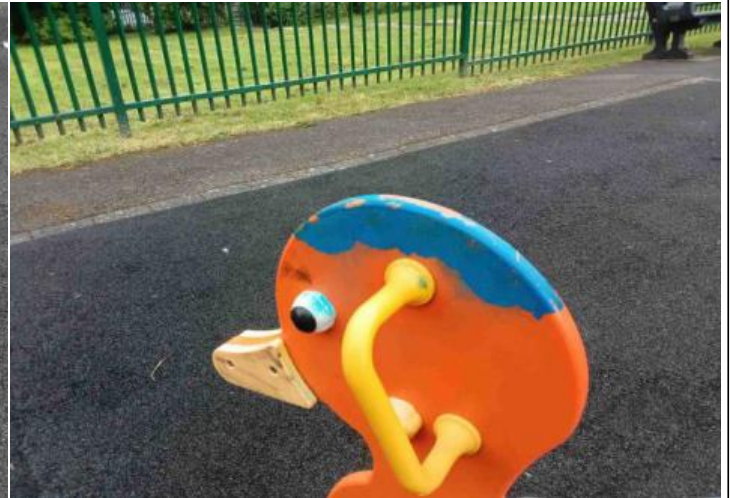
Finding: There is some graffiti present

Action: Remove the graffiti

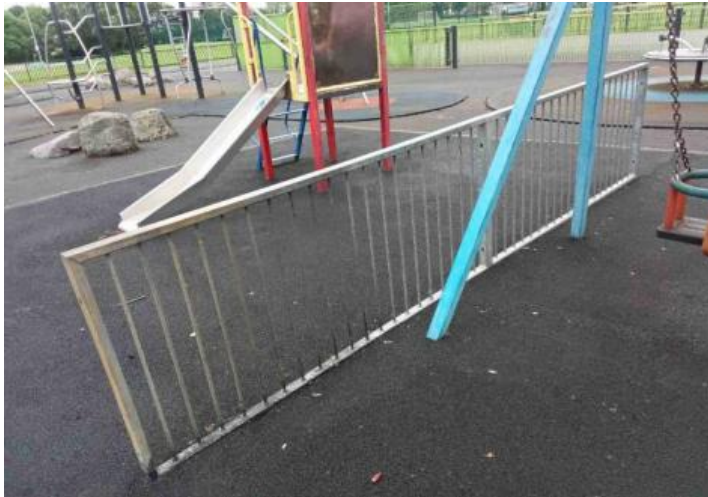
Finding: There is some evidence of fire damage to the item

Action: Monitor for any further deterioration and repair as required

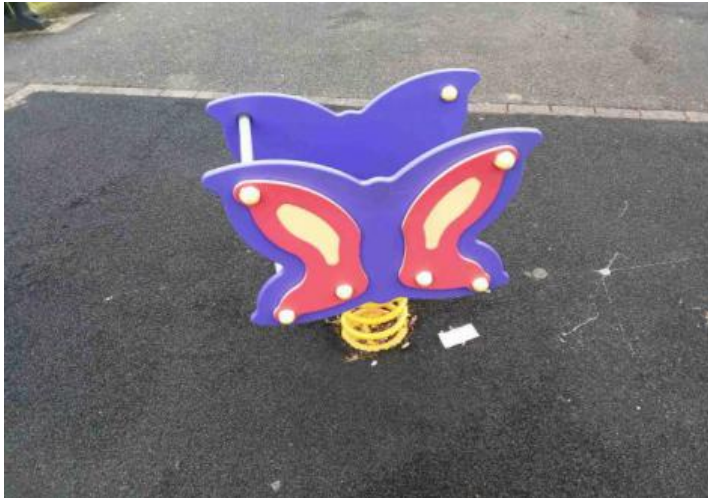
Finding: The surface has subsided in some areas

Action: Monitor for any further deterioration and repair as required

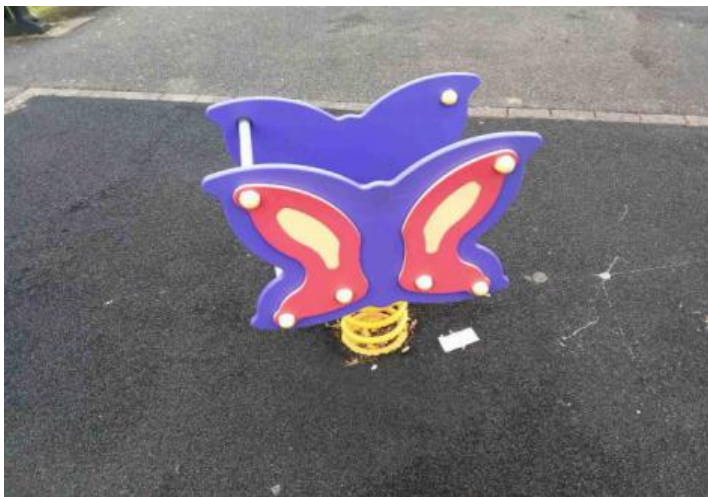
Finding: The Handgrips/Footrests rotate and may cause an unexpected movement for the user

Action: Secure Handgrips/Footrests to prevent rotation.

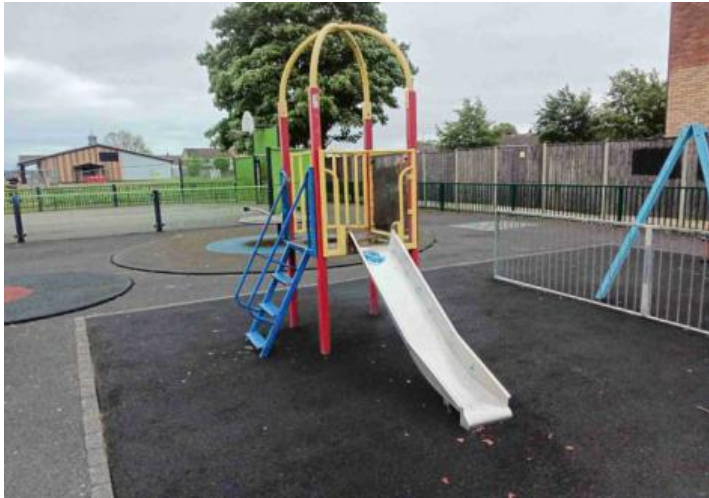
Finding: There are a number of dents in the slide surface

Action: Monitor for any further deterioration and repair as required

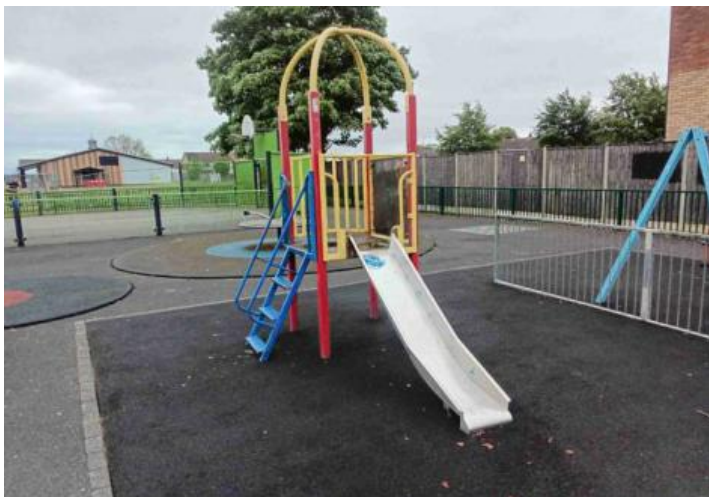
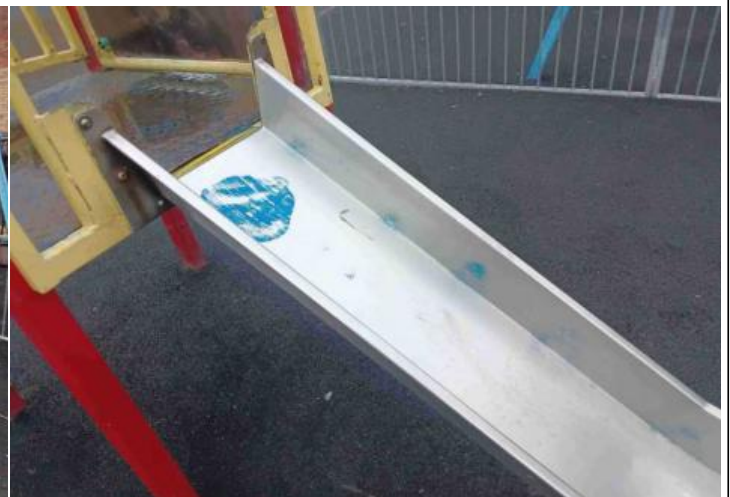
Finding: There is some graffiti present

Action: Remove the graffiti

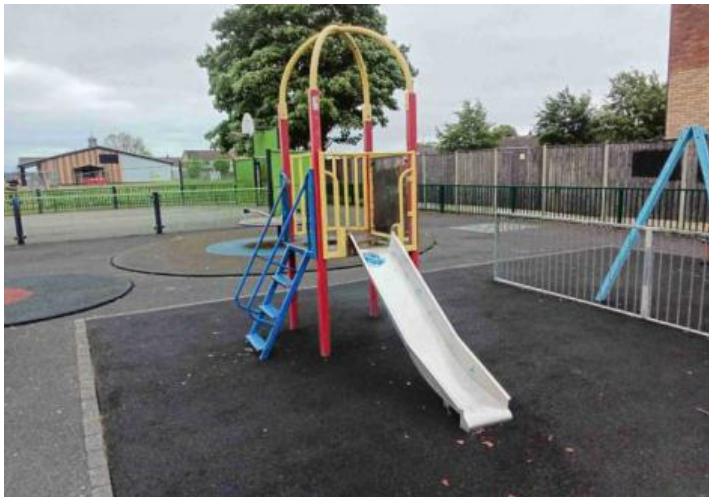
Finding: The paintwork on this item has been damaged or worn exposing the metal underneath which is rusting / corroding

Action: Treat affected areas and repaint

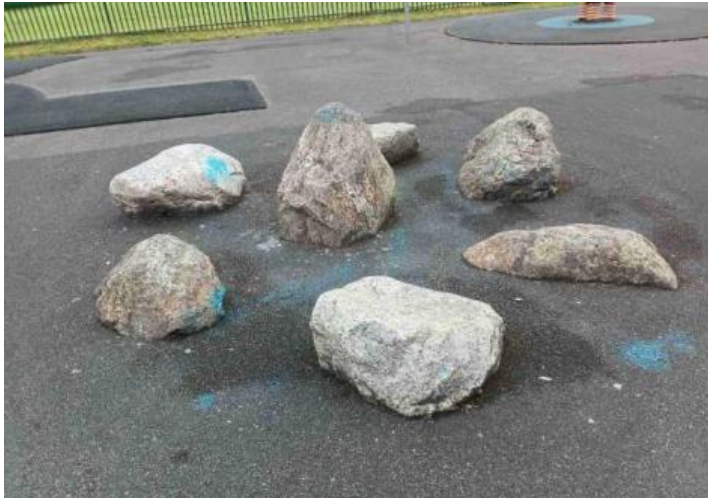
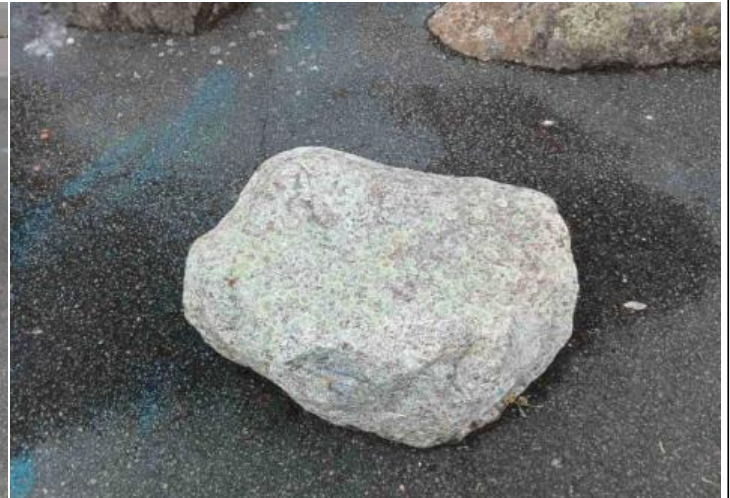
Finding: The rocks and/or boulders have moss/algae growth apparent

Action: Clean and maintain

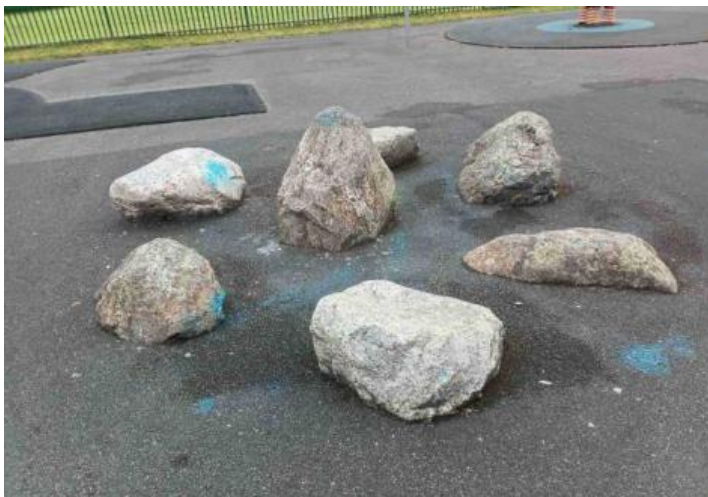
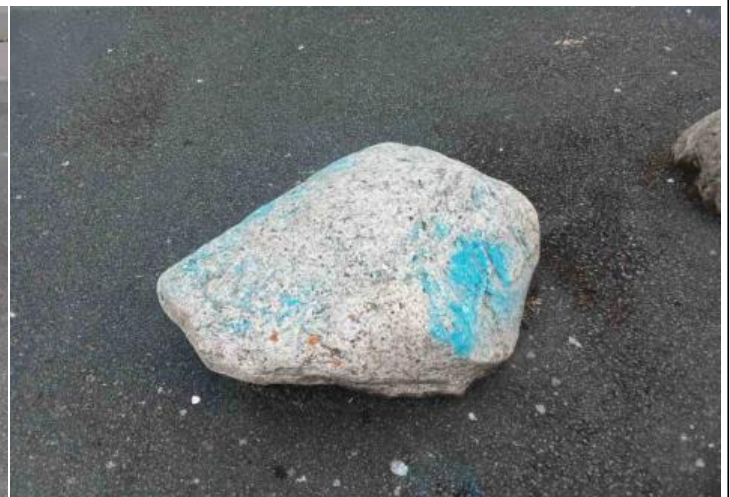
Finding: There is some graffiti present

Action: Remove the graffiti

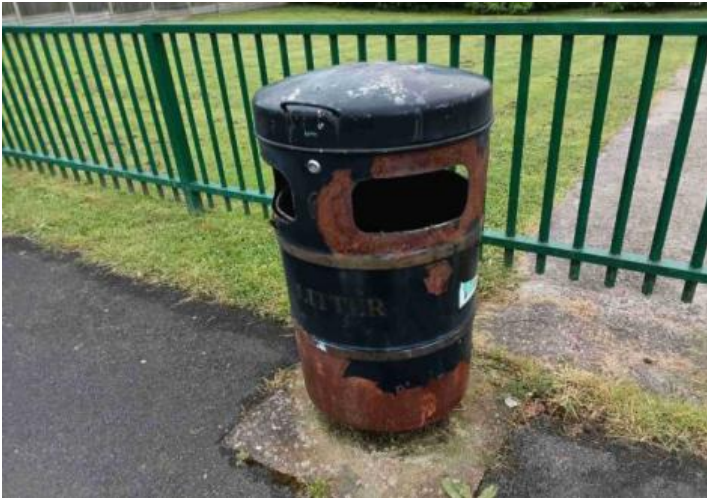
Finding: There is some evidence of fire damage to the item
Action: Monitor for any further deterioration and repair as required

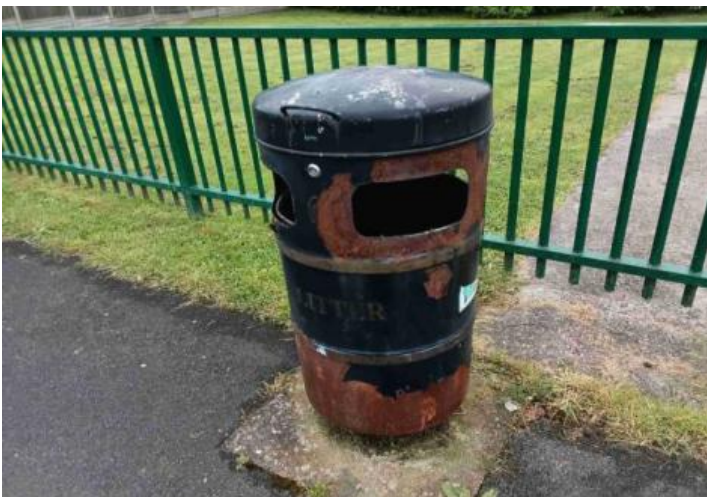
Finding: The paintwork on this item has been damaged or worn exposing the metal underneath which is rusting / corroding
Action: Treat affected areas and repaint

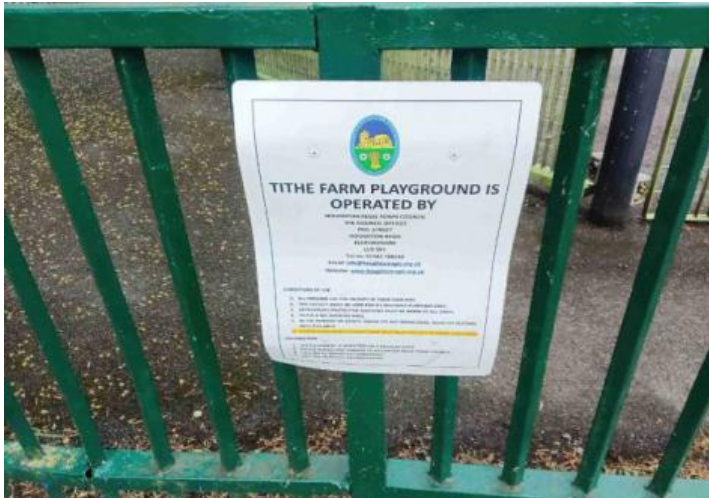
Finding: The item has been damaged

Action: Monitor for any further deterioration and replace as required

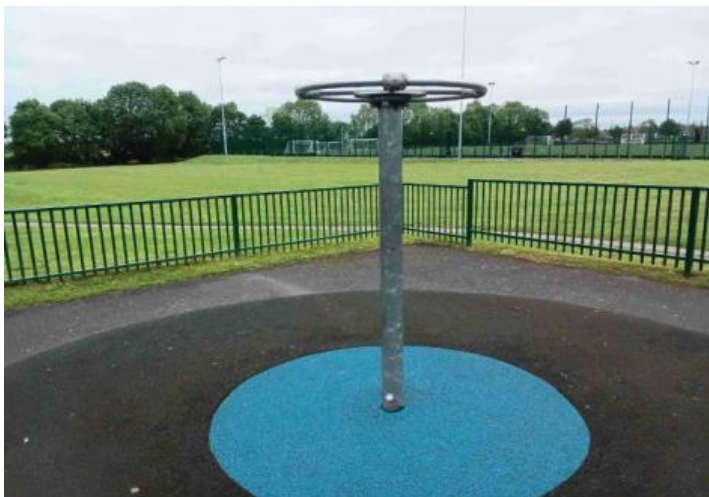
Finding: There is some minor damage to the surface

Action: Monitor for any further deterioration and repair as required

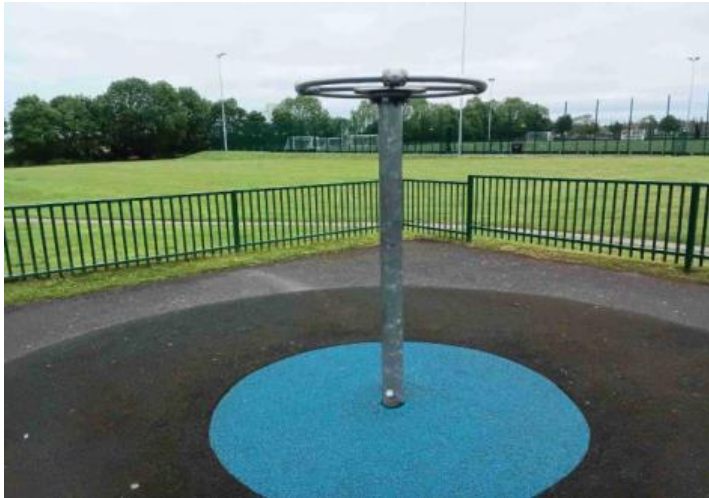
Finding: The bearing is showing signs of wear

Action: Monitor for any further deterioration and replace as required

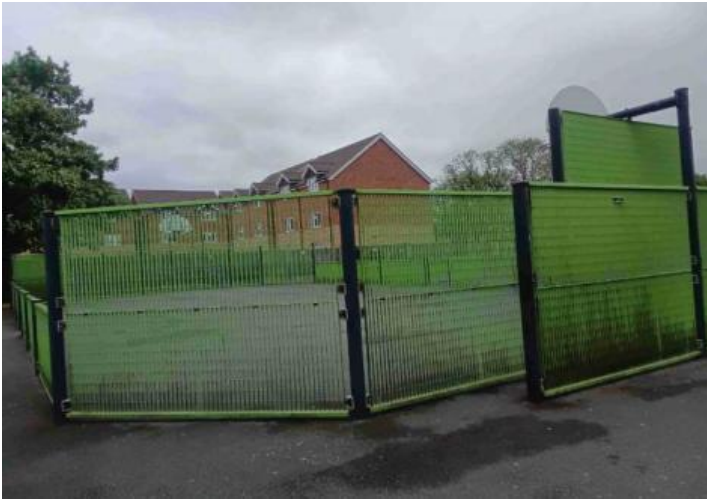
Finding: The weld(s) on this item have failed leaving sharp edges **Action:** Repair item

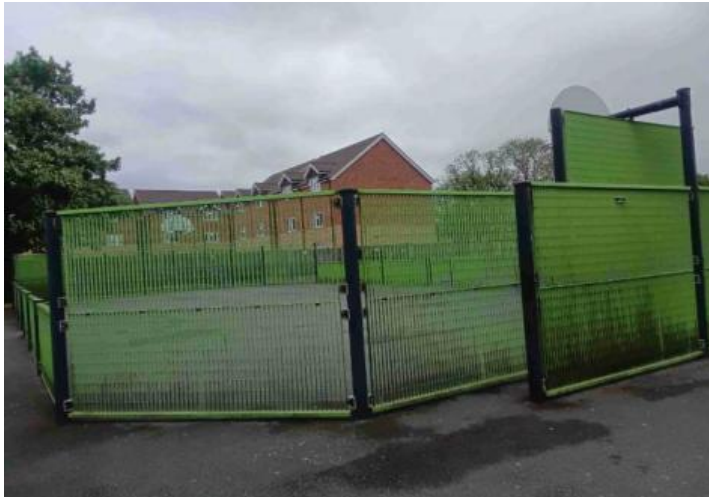
Finding: There are post / end caps missing from the item

Action: Replace missing post caps

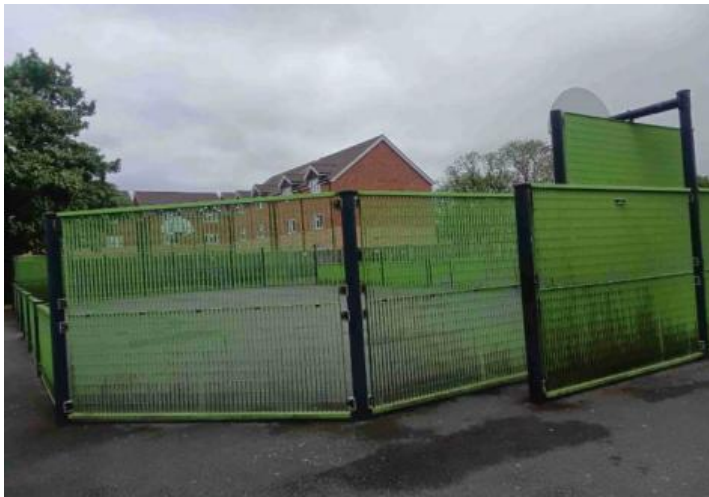
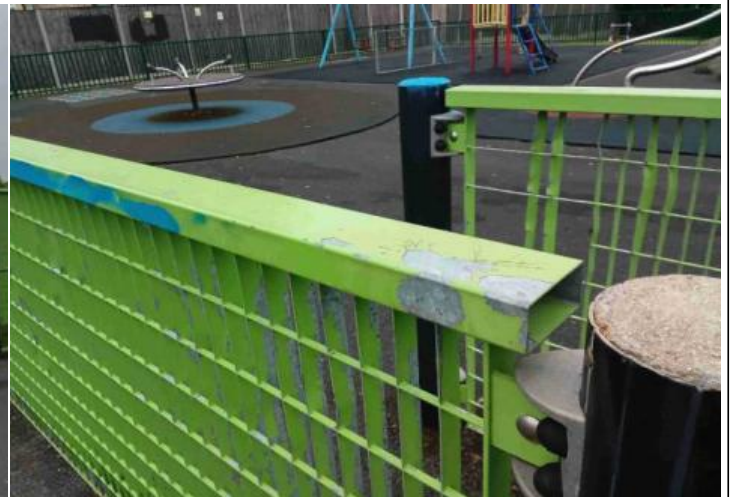
Finding: The paint is flaking off the metalwork

Action: Rub down and re-paint

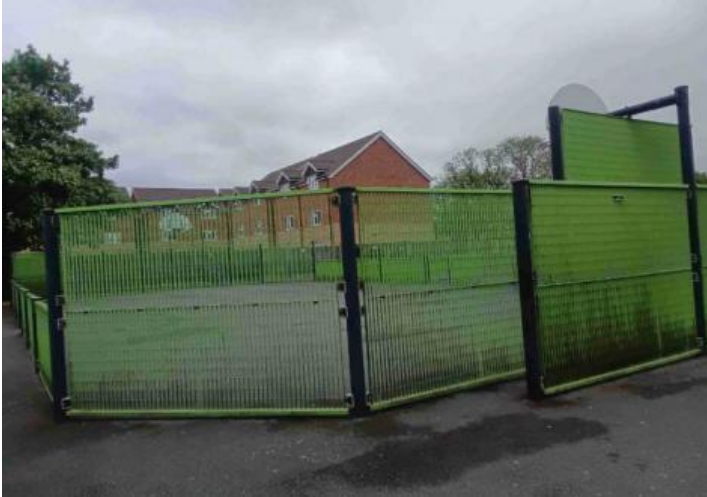
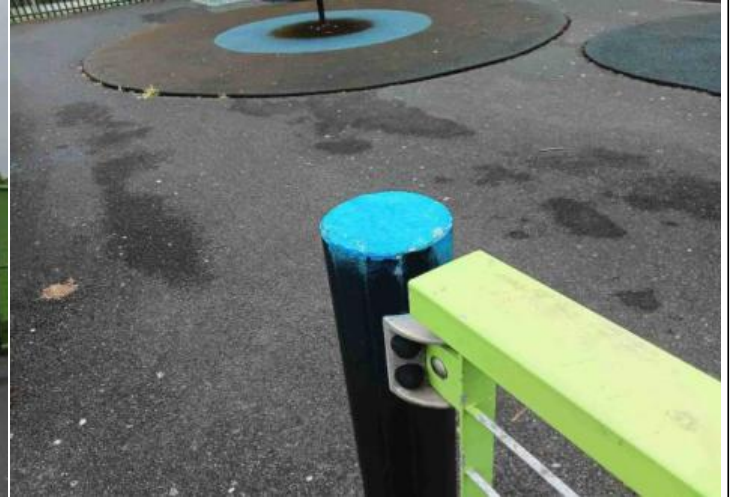
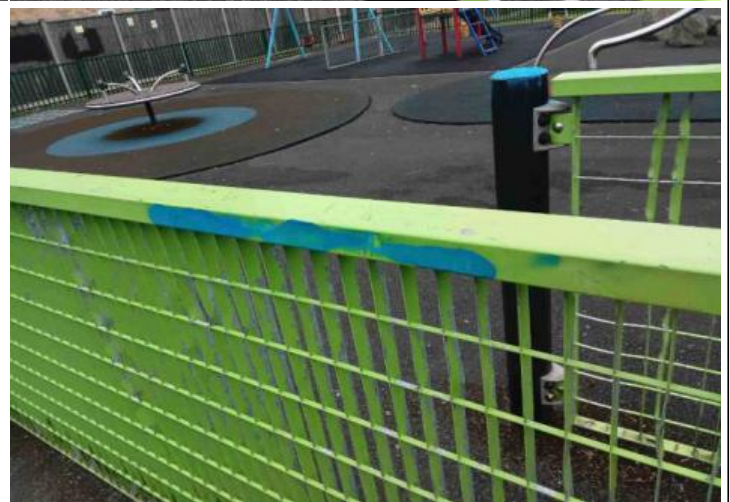
Finding: There is some graffiti present

Action: Remove the graffiti
