the **play inspection** company

Annual Inspection

Houghton Regis Town Council

Tithe Farm Recreation Ground

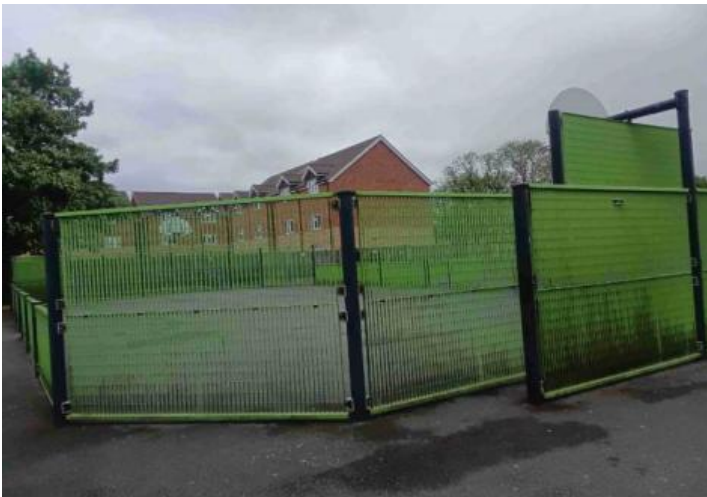
Finding: The item has been damaged

Action: Monitor for any further deterioration and replace as required

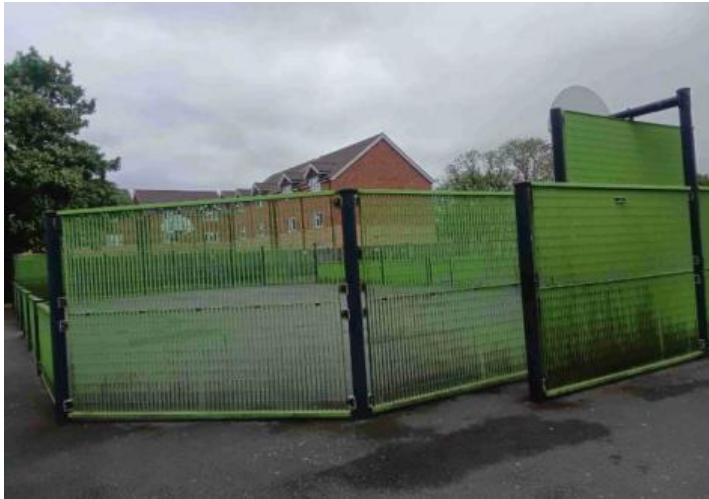
Finding: The backboard is damaged

Action: Monitor for any further deterioration and repair as required

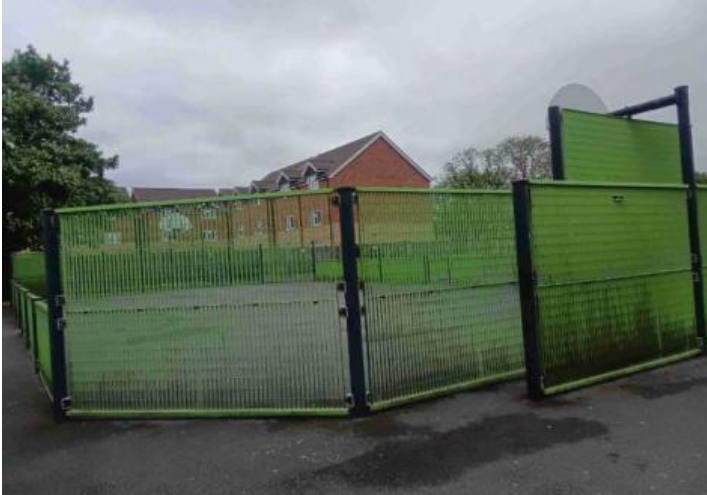
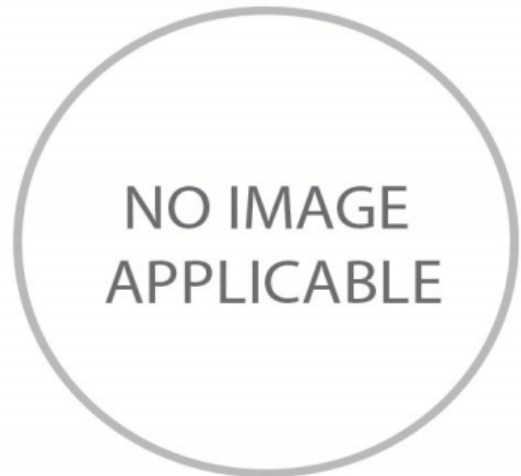
Finding: A clearly visible facility sign should be provided in a prominent position with the wording as detailed BS EN 15312 - the equipment is not intended for children less than 3 years old - the warning - Do not climb on the framework or nets - the warning - Do not hang on the ring (if provided) - the warning - Do not wear rings or other jewellery - name and telephone number of the administrator - number to call in case of accident

Action: Provide signage to BS EN 15312

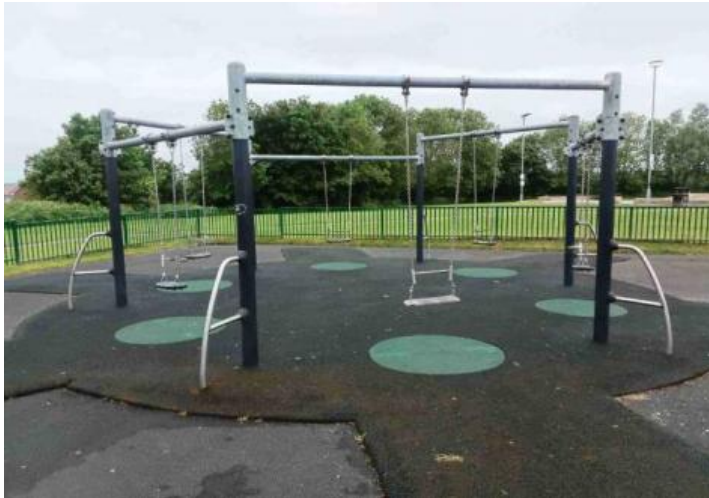
Finding: The seat has minor damage or wear

Action: Monitor for any further deterioration and replace as required

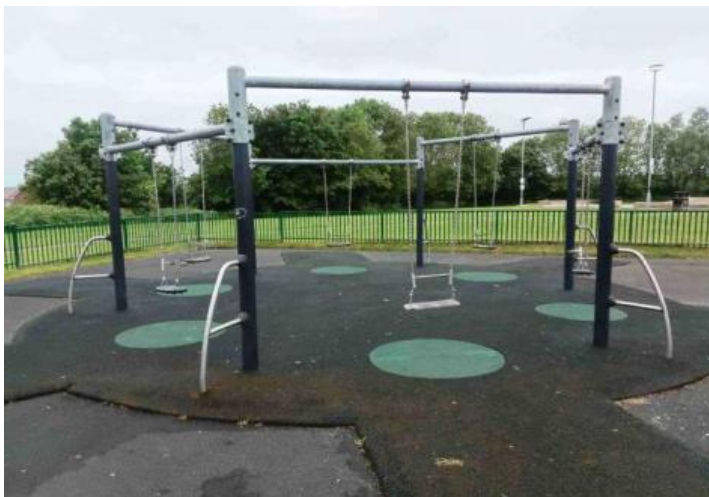
Finding: The item has missing component(s) handgrip cover

Action: Replace missing components

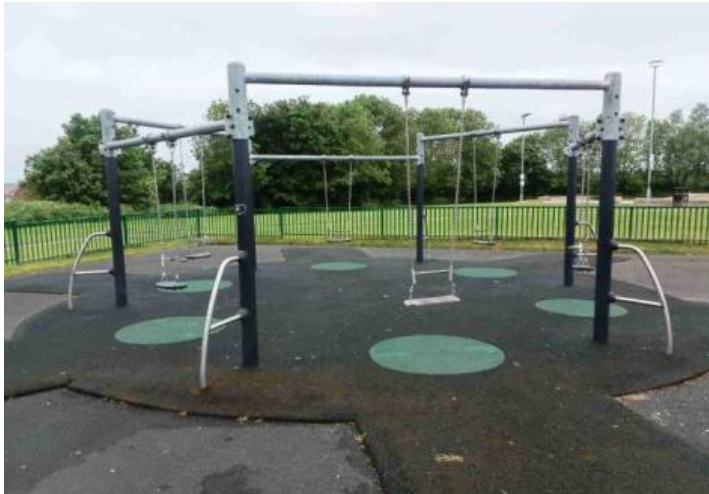
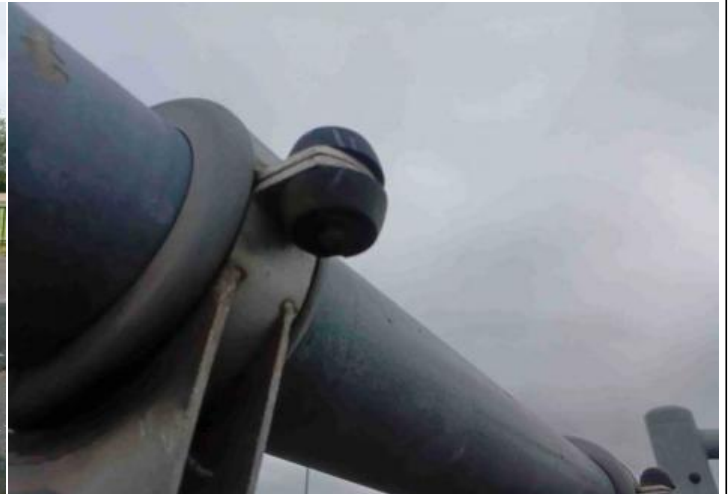
Item: Swings - Contact Swing - Type 4
Manufacturer: Proludic

Risk Level: V - Very Low Risk
Surface: Wet Pour

Finding: There is/are bolt cap covers missing or damaged on the item

Action: Replace missing or damaged bolt cap covers

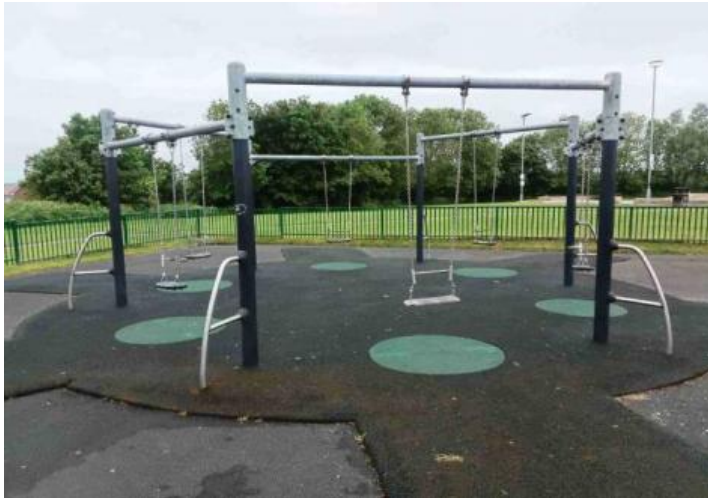
Item: Swings - Contact Swing - Type 4
Manufacturer: Proludic

Risk Level: V - Very Low Risk
Surface: Wet Pour

Finding: The bushes are showing signs of wear

Action: Monitor for any further deterioration and replace as required

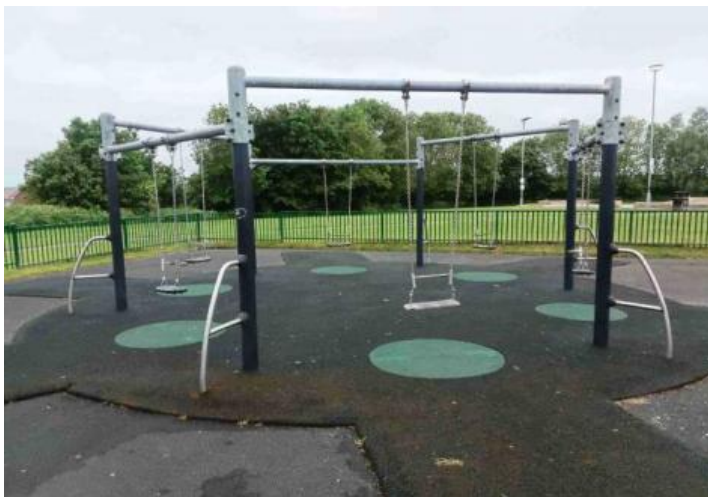
Item: Swings - Contact Swing - Type 4
Manufacturer: Proludic

Risk Level: L - Low Risk
Surface: Wet Pour

Finding: There is some notable evidence of chain wear

Action: Monitor for any further deterioration and replace when 40% worn

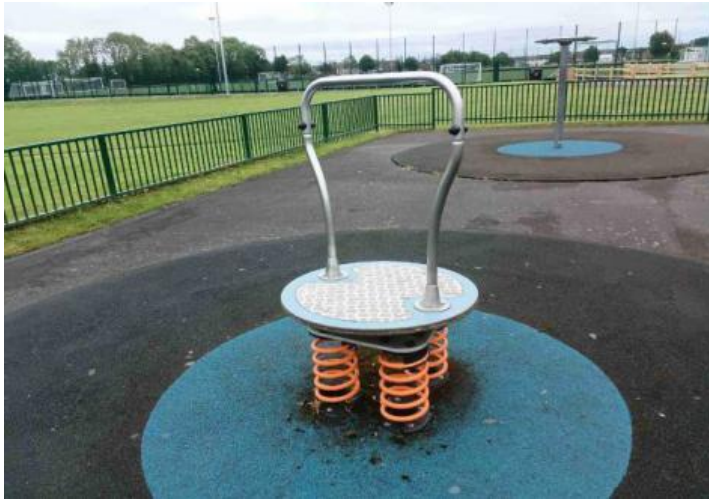
Item: Rocking Equipment - Rotating Spring Board
Manufacturer: Proludic

Risk Level: L - Low Risk
Surface: Wet Pour

Finding: The bearing is worn / damaged and the item is not operating correctly
Action: Repair / replace

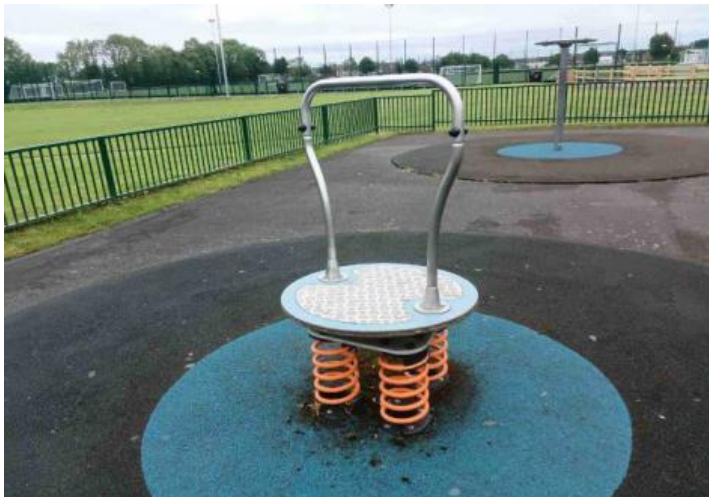
Item: Rocking Equipment - Rotating Spring Board
Manufacturer: Proludic

Risk Level: L - Low Risk
Surface: Wet Pour

Finding: The item has missing component(s) handgrip
Action: Consider replacing missing components

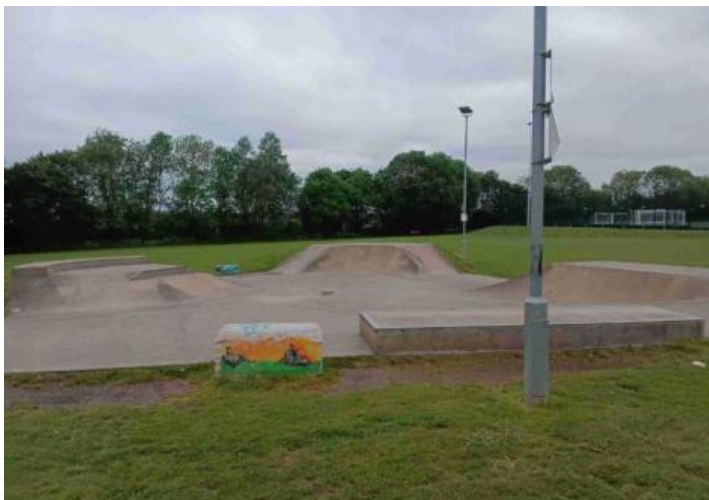
Item: Wheeled Sports - Concrete Skate Park
Manufacturer: Not Identified

Risk Level: L - Low Risk
Surface: Concrete

Finding: The surface has eroded in some areas and may be slippery in wet conditions

Action: Reinstate the surface

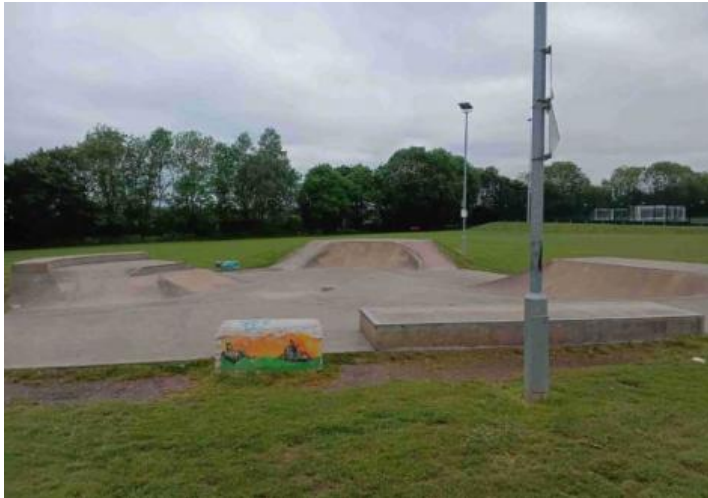
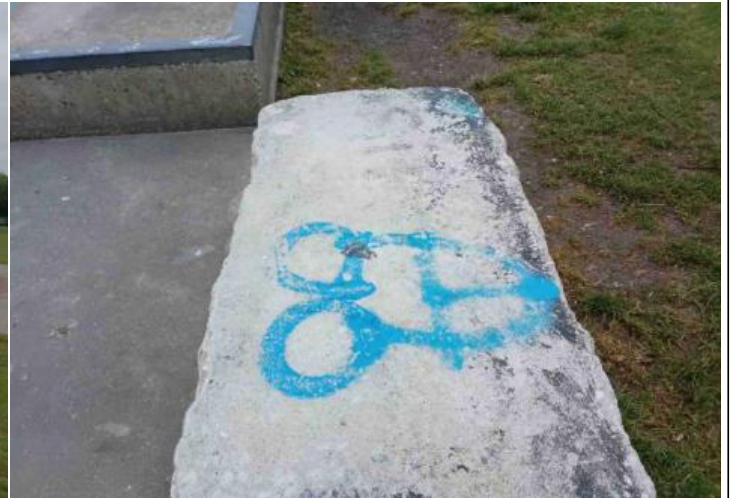
Item: Wheeled Sports - Concrete Skate Park
Manufacturer: Not Identified

Risk Level: N - Risk Assessment not Undertaken
Surface: Concrete

Finding: There is offensive graffiti present

Action: Remove as soon as practicable

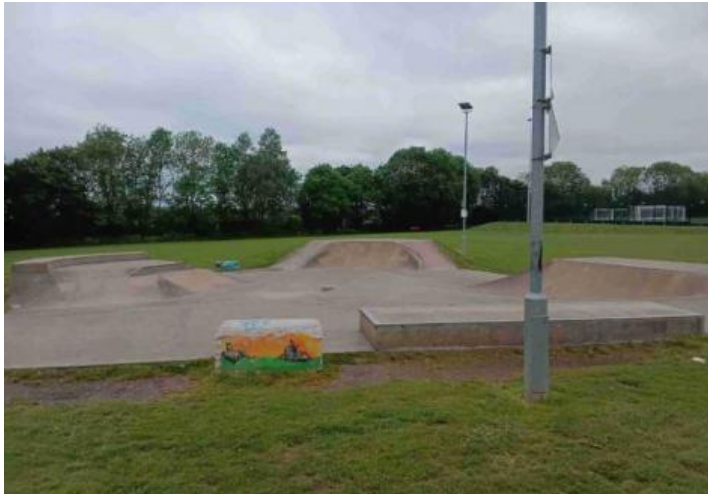
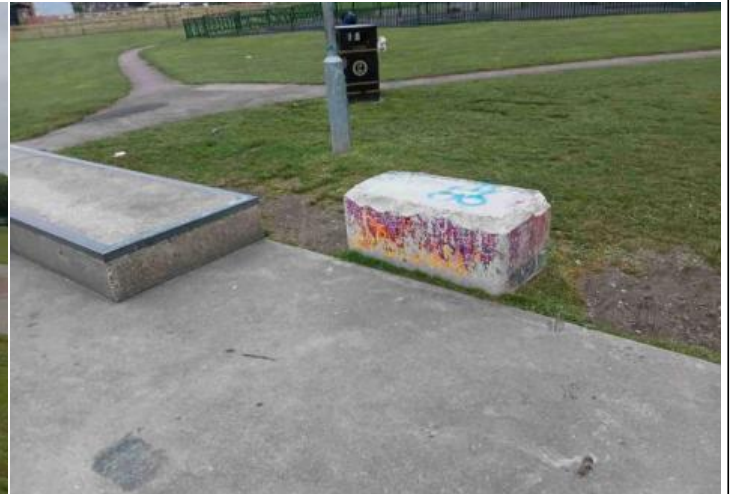
Item: Wheeled Sports - Concrete Skate Park
Manufacturer: Not Identified

Risk Level: L - Low Risk
Surface: Concrete

Finding: The item has insufficient safety zone allowed as required by BS EN 14974 – 6.4. This should equal at least 2.0 metres on this item

Action: Monitor - no reasonably practicable action given the risk assessment

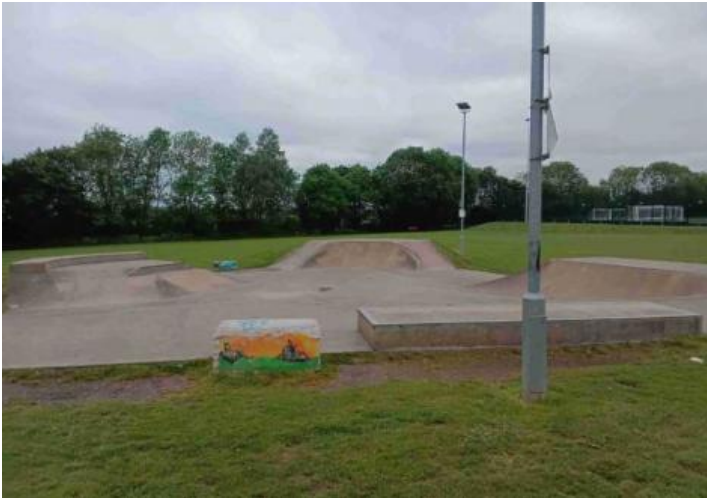
Item: Wheeled Sports - Concrete Skate Park
Manufacturer: Not Identified

Risk Level: L - Low Risk
Surface: Concrete

Finding: There is some evidence of fire damage to the surfacing

Action: Monitor for any further deterioration and repair as required

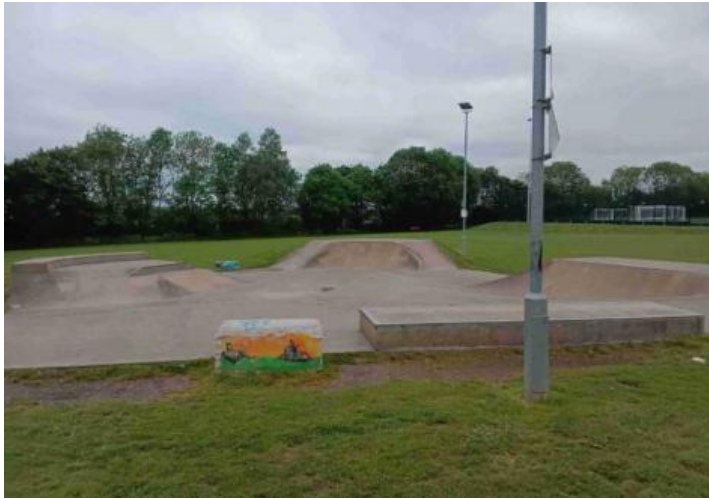
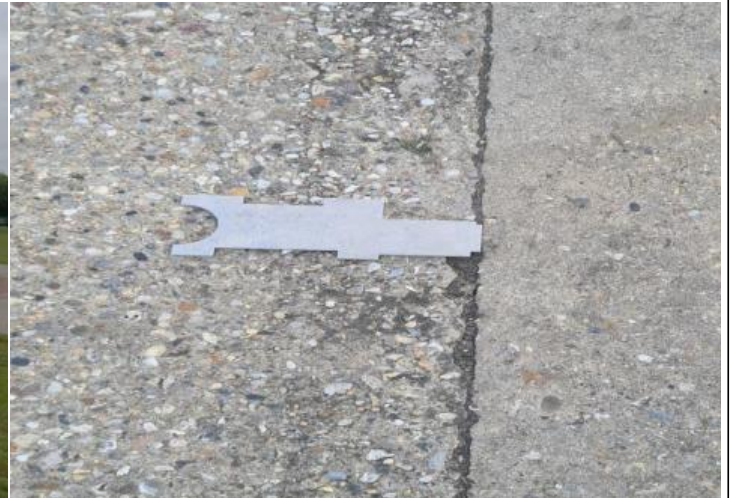
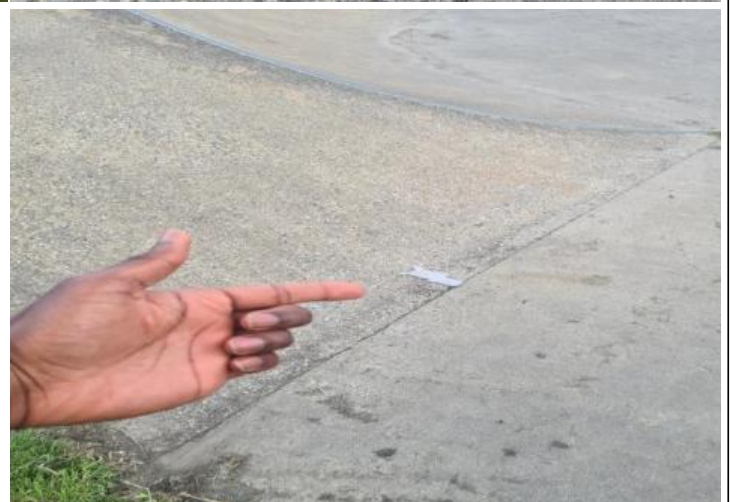
Item: Wheeled Sports - Concrete Skate Park
Manufacturer: Not Identified

Risk Level: V - Very Low Risk
Surface: Concrete

Finding: Joints between the riding / rolling surfaces shall not be greater than 5mm in contravention of the requirements of BS EN 14974 – 6.2.4
Action: Take corrective action to ensure that the gaps between the joints do not exceed 5mm

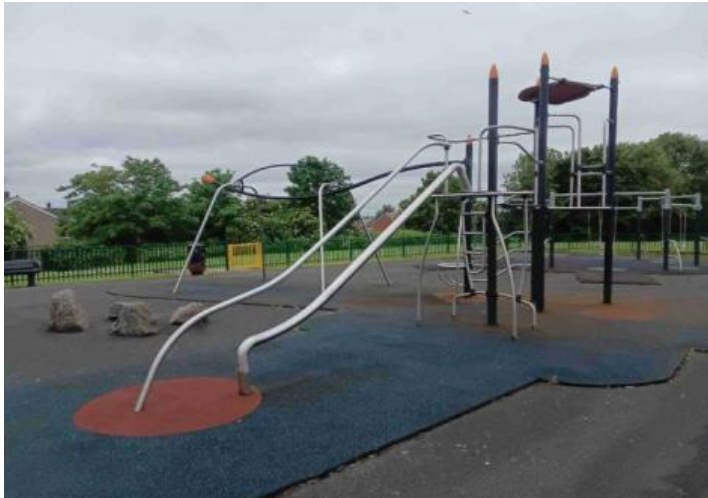
Item: Activity Equipment - Multi Play (Senior)
Manufacturer: Proludic

Risk Level: V - Very Low Risk
Surface: Wet Pour

Finding: The surfacing dimensions are short and do not meet with the requirements of the current applicable standard

Action: Monitor - no remedial action recommended

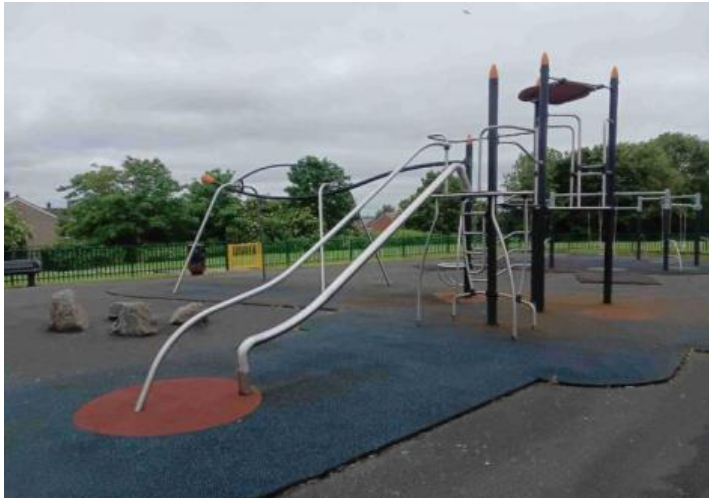
Item: Activity Equipment - Multi Play (Senior)
Manufacturer: Proludic

Risk Level: V - Very Low Risk
Surface: Wet Pour

Finding: There is/are bolt cap covers missing or damaged on the item

Action: Replace missing or damaged bolt cap covers

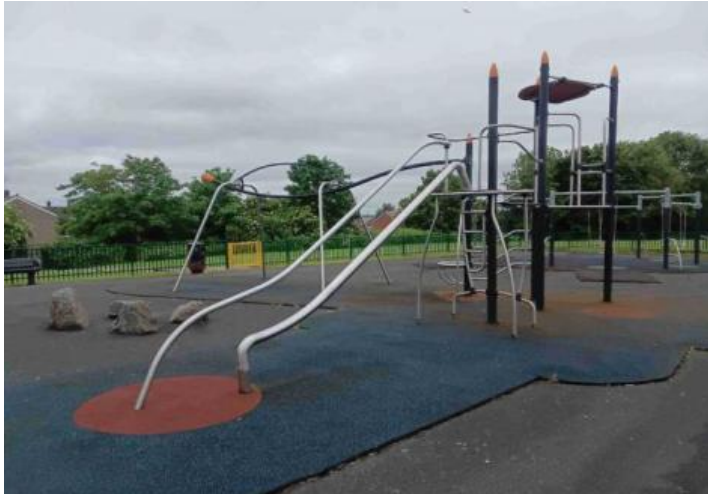
Item: Activity Equipment - Multi Play (Senior)
Manufacturer: Proludic

Risk Level: M - Moderate Risk
Surface: Wet Pour

Finding: The platform has been damaged

Action: Replace the platform

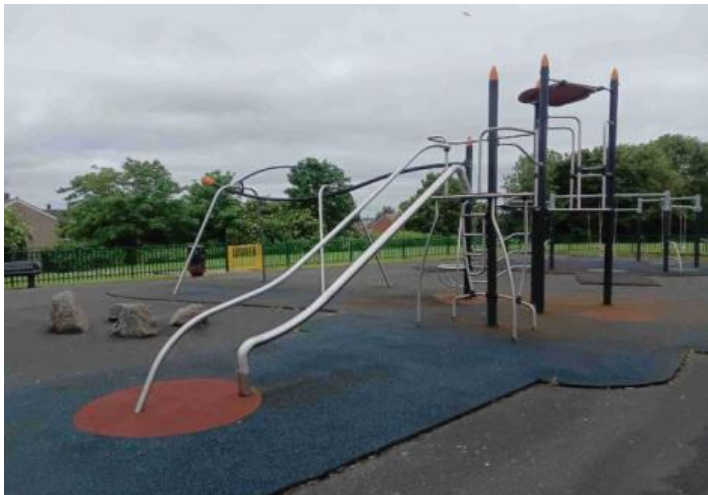
Item: Activity Equipment - Multi Play (Senior)
Manufacturer: Proludic

Risk Level: V - Very Low Risk
Surface: Wet Pour

Finding: There is/are inserts missing

Action: Replace missing inserts

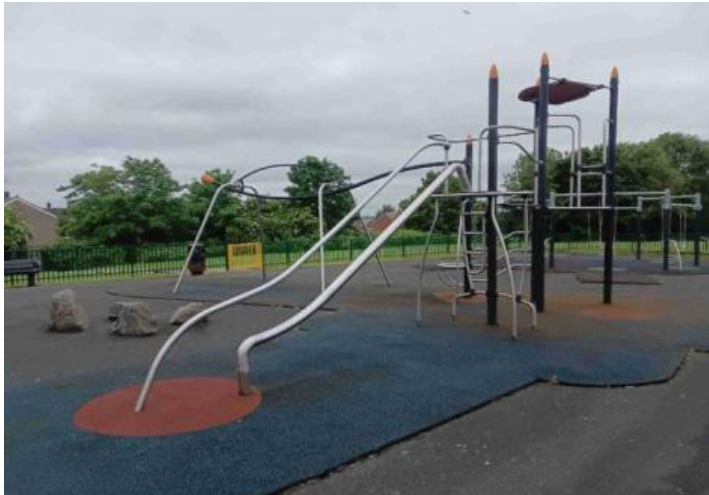
Item: Activity Equipment - Multi Play (Senior)
Manufacturer: Proludic

Risk Level: L - Low Risk
Surface: Wet Pour

Finding: The ropes/nets are worn/damaged in places

Action: Monitor for any further deterioration and repair or replace as required

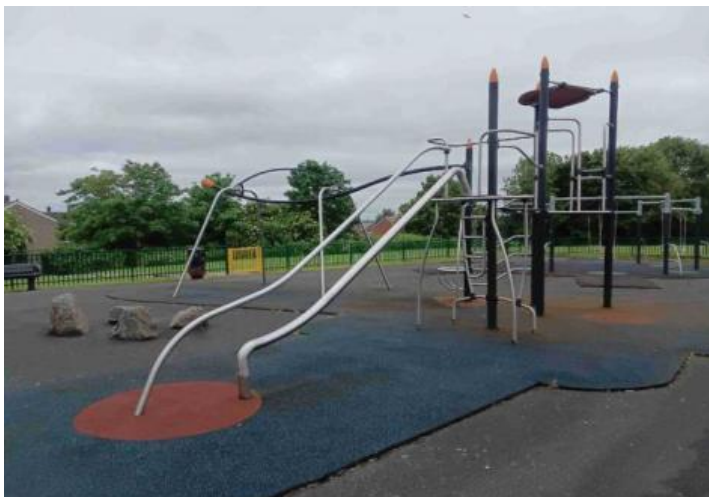
Item: Activity Equipment - Multi Play (Senior)
Manufacturer: Proludic

Risk Level: L - Low Risk
Surface: Wet Pour

Finding: The item has missing component(s)

Action: Consider replacing missing components

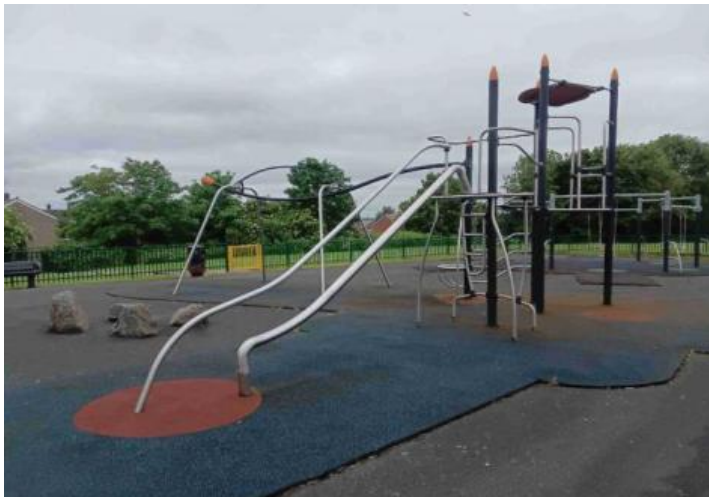
Item: Activity Equipment - Multi Play (Senior)
Manufacturer: Proludic

Risk Level: V - Very Low Risk
Surface: Wet Pour

Finding: There is some minor damage to the surface

Action: Monitor for any further deterioration and repair as required

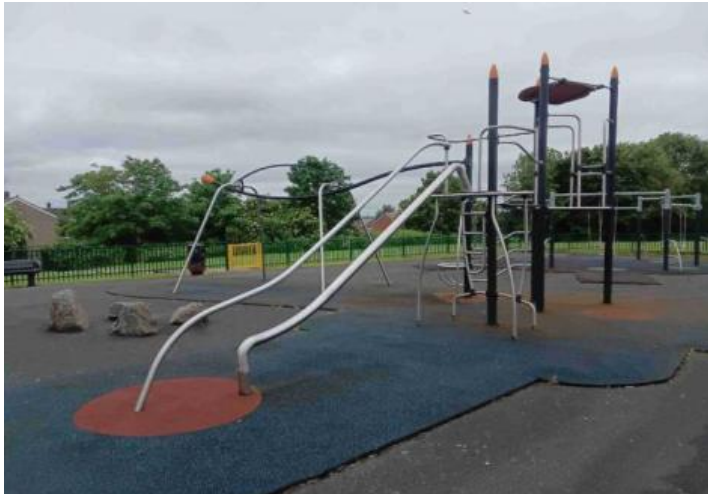
Item: Activity Equipment - Multi Play (Senior)
Manufacturer: Proludic

Risk Level: L - Low Risk
Surface: Wet Pour

Finding: The item has been damaged

Action: Monitor for any further deterioration and replace as required

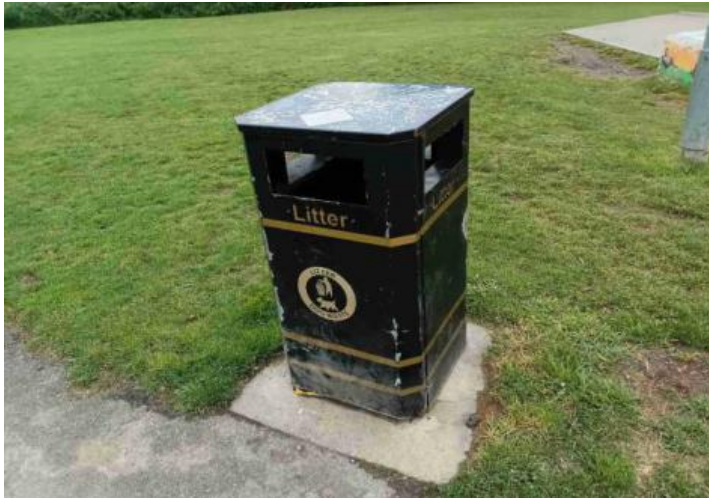
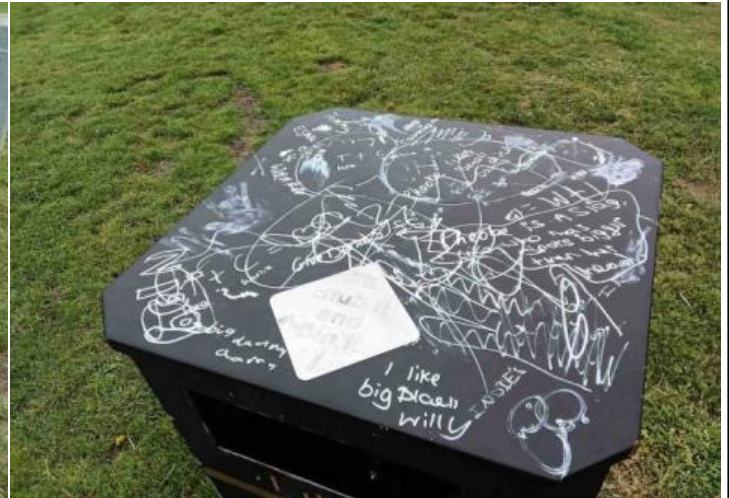
Item: Ancillary Items - Litter Bin
Manufacturer: Not Identified

Risk Level: N - Risk Assessment not Undertaken
Surface: Grass

Finding: There is some graffiti present

Action: Remove the graffiti

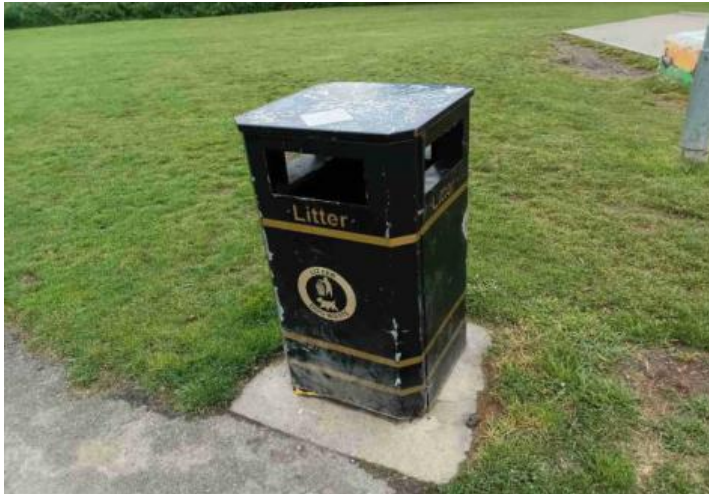
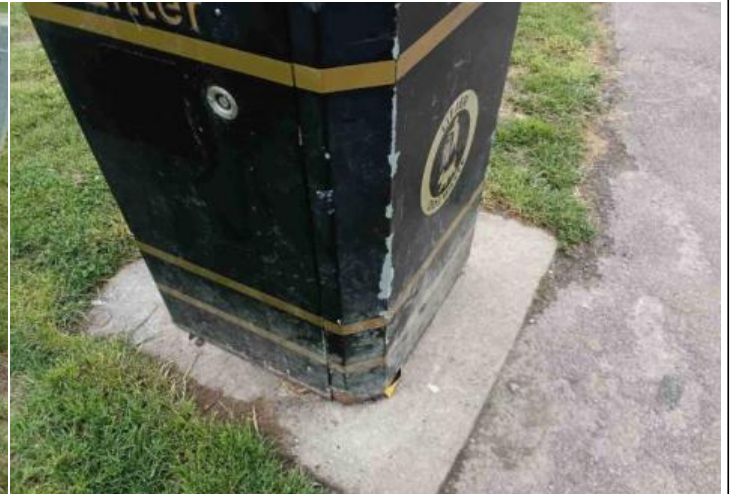
Item: Ancillary Items - Litter Bin
Manufacturer: Not Identified

Risk Level: L - Low Risk
Surface: Grass

Finding: The paint is flaking off the metalwork

Action: Rub down and re-paint
