J P Chick & Partners Limited

ST PETER'S CHURCH, THETFORD

STRUCTURAL INSPECTION REPORT

**ST PETER'S CHURCH
THETFORD
CLIENT: THETFORD TOWN COUNCIL**

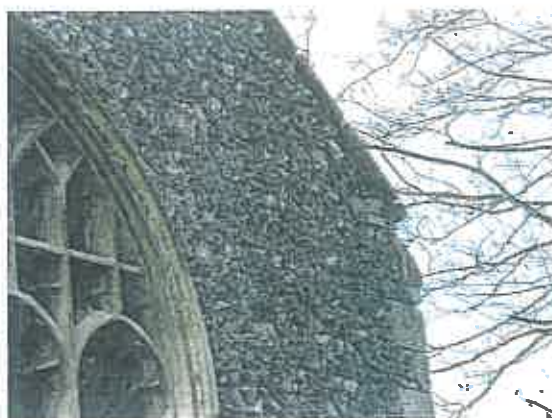
Chancel – East Elevation

- 6.1.1.1 The east elevation of the chancel is largely obscured by the later flat roofed structure, which is built in close proximity to it. From that which is visible it can be noted that the majority of the flint work to the top of the arch height of the window has been undertaken in common and un-knapped flints, giving a lighter appearance. Immediately beneath the south facing window brickwork is evident, which is considered possibly to have been undertaken as later works. All flint work appears to be relatively stable with no obvious movement or damage, although some loss or erosion of lime mortar can be noted at high level.

- 6.1.1.2 At high level to the window the arch to the north is noted to have suffered degradation to the projecting stonework. Coping stones to the parapet detail all appear secure with weathering and long term degradation to the jointing, especially on the northern slope.

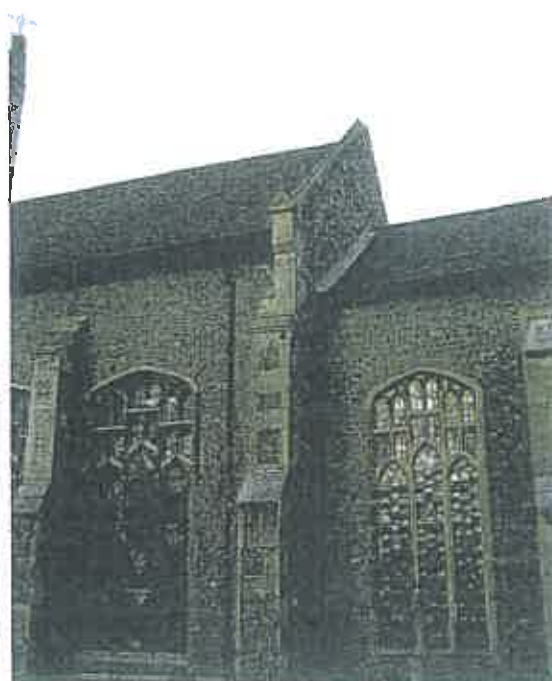
Chancel / Nave – South Elevation

6.1.1.6 Buttreassing to the south have lead flashings, which appear in reasonable condition. Cracking is noted to the interface of the same between key stones and the flints, which were noted to continue full height and are a maximum of 1mm in width. Similarly at the plinth level the limestone to all buttresses appears to have longstanding cracks which have weathered and worn accordingly. Central buttresses have suffered some outward rotation considered to be in the region of 30 – 40mm over their height. Low level stonework making up the plinth is seen to be weathered in places. The tiled roof would appear to be in good condition with flashings intact, no slipped tiles and a consistent ridge level. The south facing perpendicular windows both appear in good condition with no obvious indications of significant movement or deterioration.

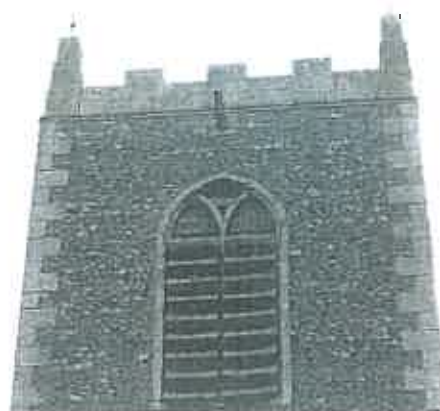
Tower - North

6.1.3.1 Stepped buttresses to the west tower all remain plumb with cracking noted only to the north eastern side abutment, which occurs above the northern aisle at the interface of the key stones and the knapped flints. This runs to full height where the buttress diminishes at belfry level. The flint work and the pointing to the same appears in good condition, although the limestone quoining is suffering weathering to all four corners, which has caused surface spalling to relatively widespread areas. Minor cracking is also noted at the interface between the stone quoining and the flint work at first floor to the south west abutment typically no more than 1mm in width occurring in an isolated 1m length. The faces of the diagonal buttresses have cracking existing between the quoining and the inset knapped flints, which typically exists to the lower staging only. The bases of the exposed abutments have suffered some weathering, especially those that extend on to the pavement of White Hart Street. Typically, stonework within the 'splash zone' has seen significant deterioration to the face and subsequent patch repairs, which have been made over time are again falling.
