# HMS WARRIOR - Recommendations for Survey and Maintenance of Mooring Arrangements

Reference: DSL/38651/006852/2

Date: January 2019

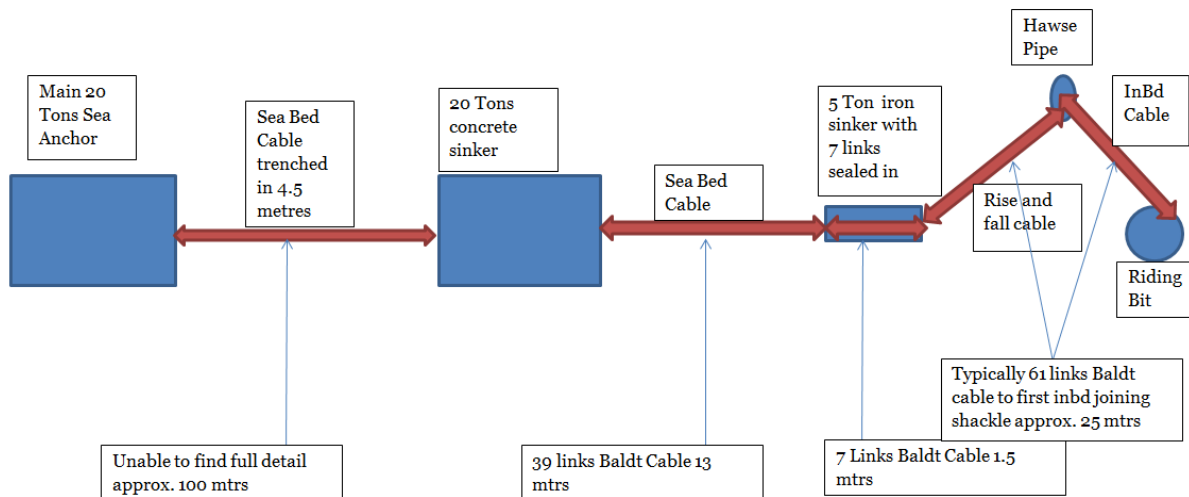
**Figure 1 Schematic of Mooring Arrangements (1 of 8 chains)**

1.2.2 A generic representation of one of the 8 in number chain arrangements is shown below (credit NMRN). Following the surge failures, the Baldt cable from the 20 ton sinkers to inboard of HMS WARRIOR was replaced with Flash Butt Welded Cable.

1.2.3 The chain between the sea anchors 20 ton concrete sinkers (termed sea bed cable) is heavy duty 3 inch square link and this was installed in 1985. From the 20 ton sinkers to inboard of HMS WARRIOR, the cable is flash butt welded installed in 2016 following the surge failures.
