# **National Asset Delivery Technical Surveys and Testing**

## **569243 - A46 NB SB Sixhills Geotech – Water Erosion**

The contract is A46 NB SB Sixhills Geotech – Water Erosion

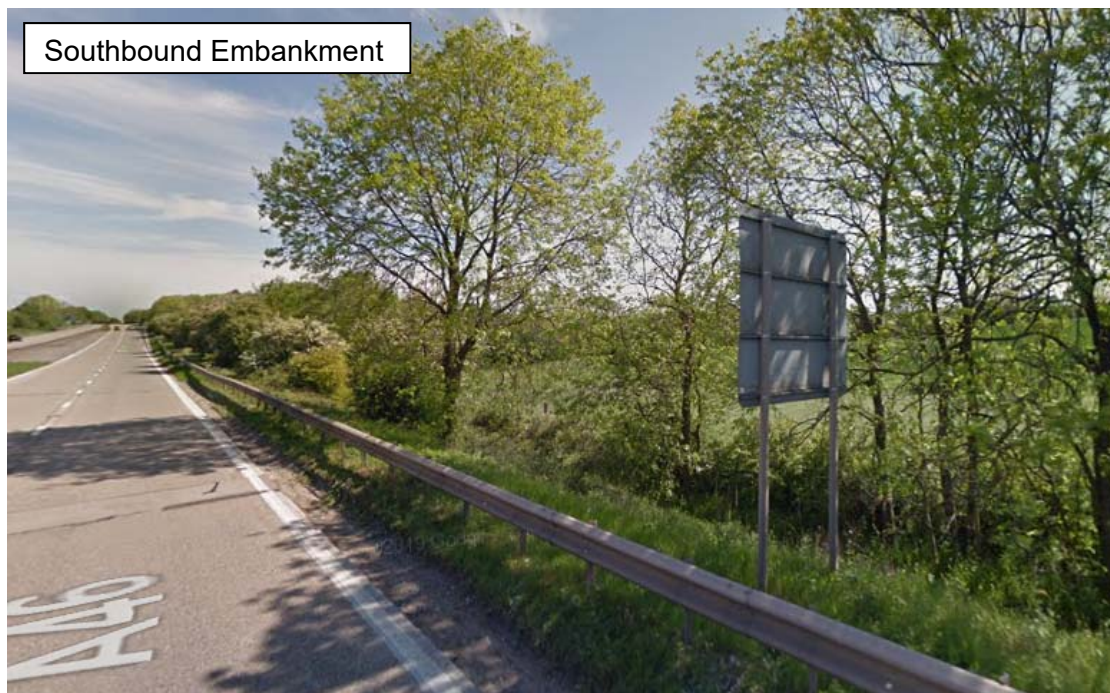
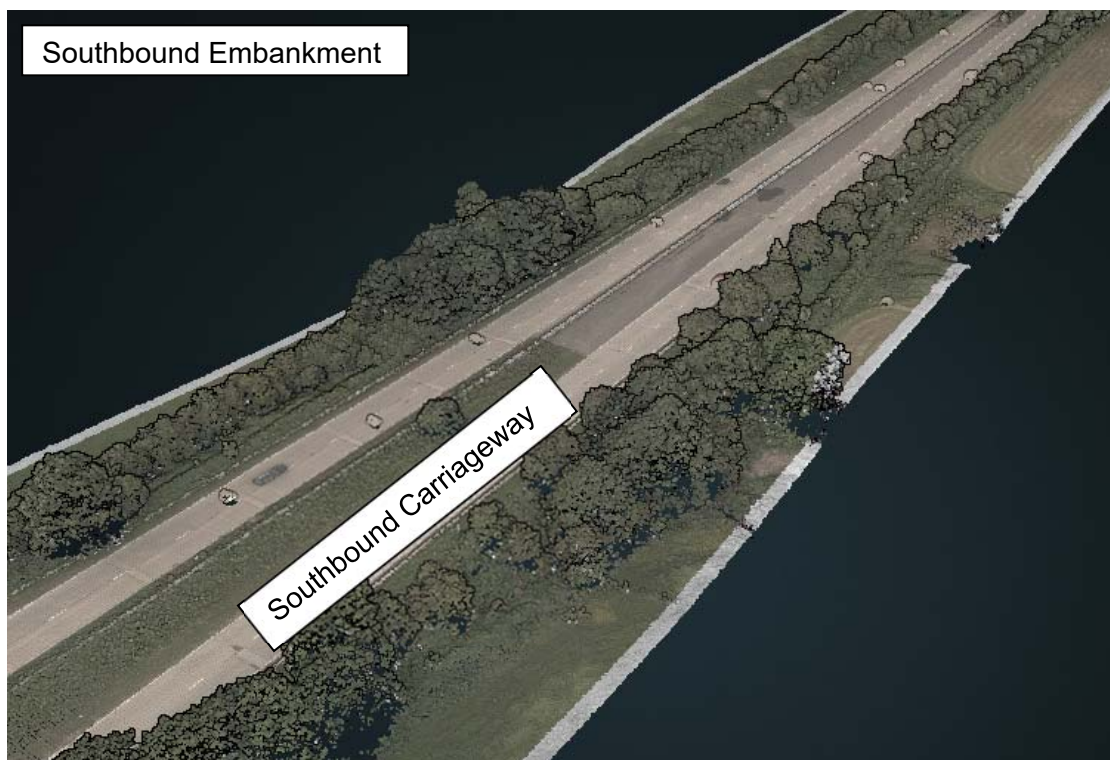
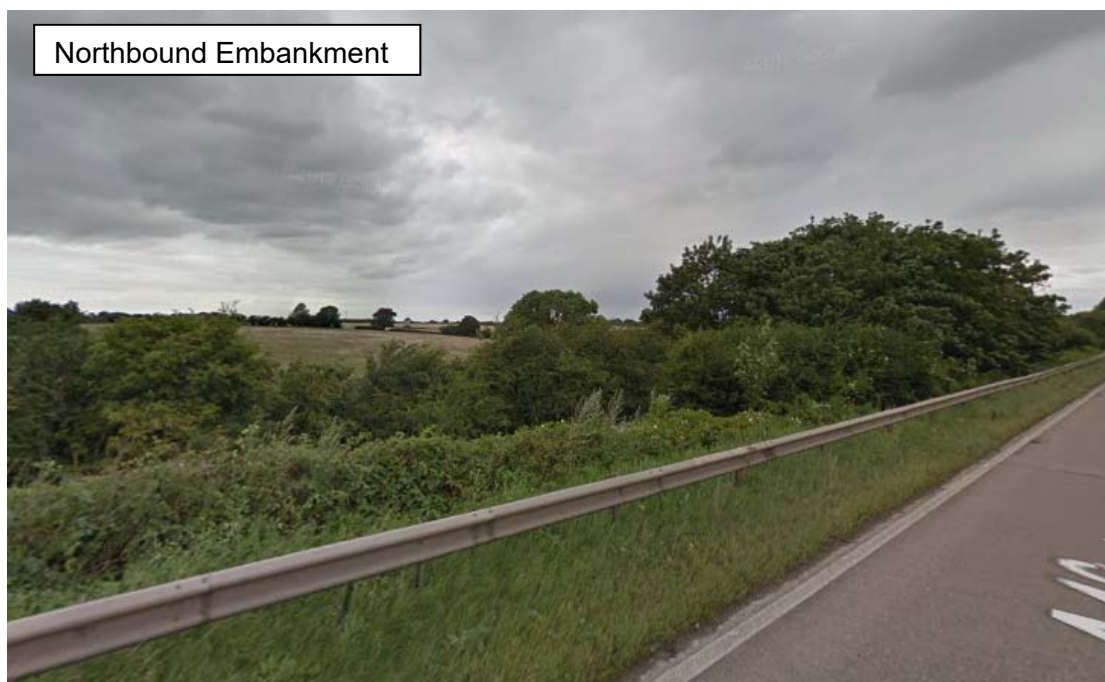
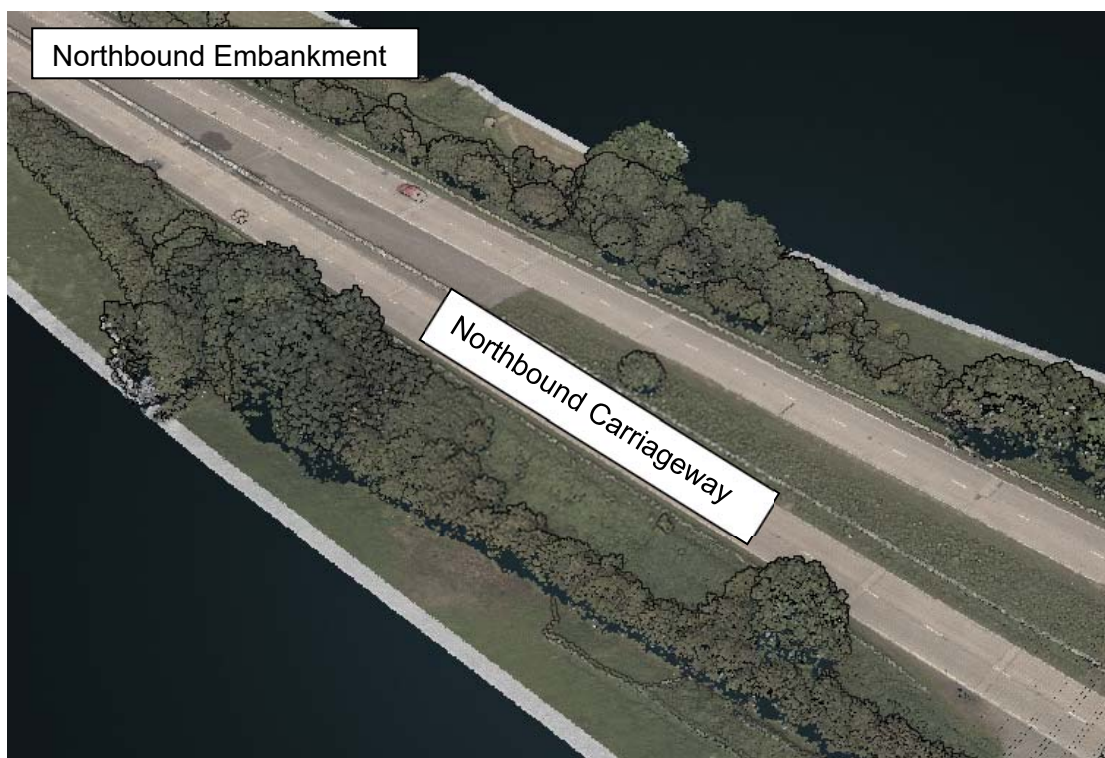
Figure 2-5: A46 Sixhills Site View

The major defects on both earthwork are situated in close proximity to a culvert that is thought to be a major factor in the defects development due to the constant flow of water being carried by the culvert. The most prominent are outlined on drawing number HE569243-KIER-HSC-A46 SixHills-DR-EN-0600\_02.

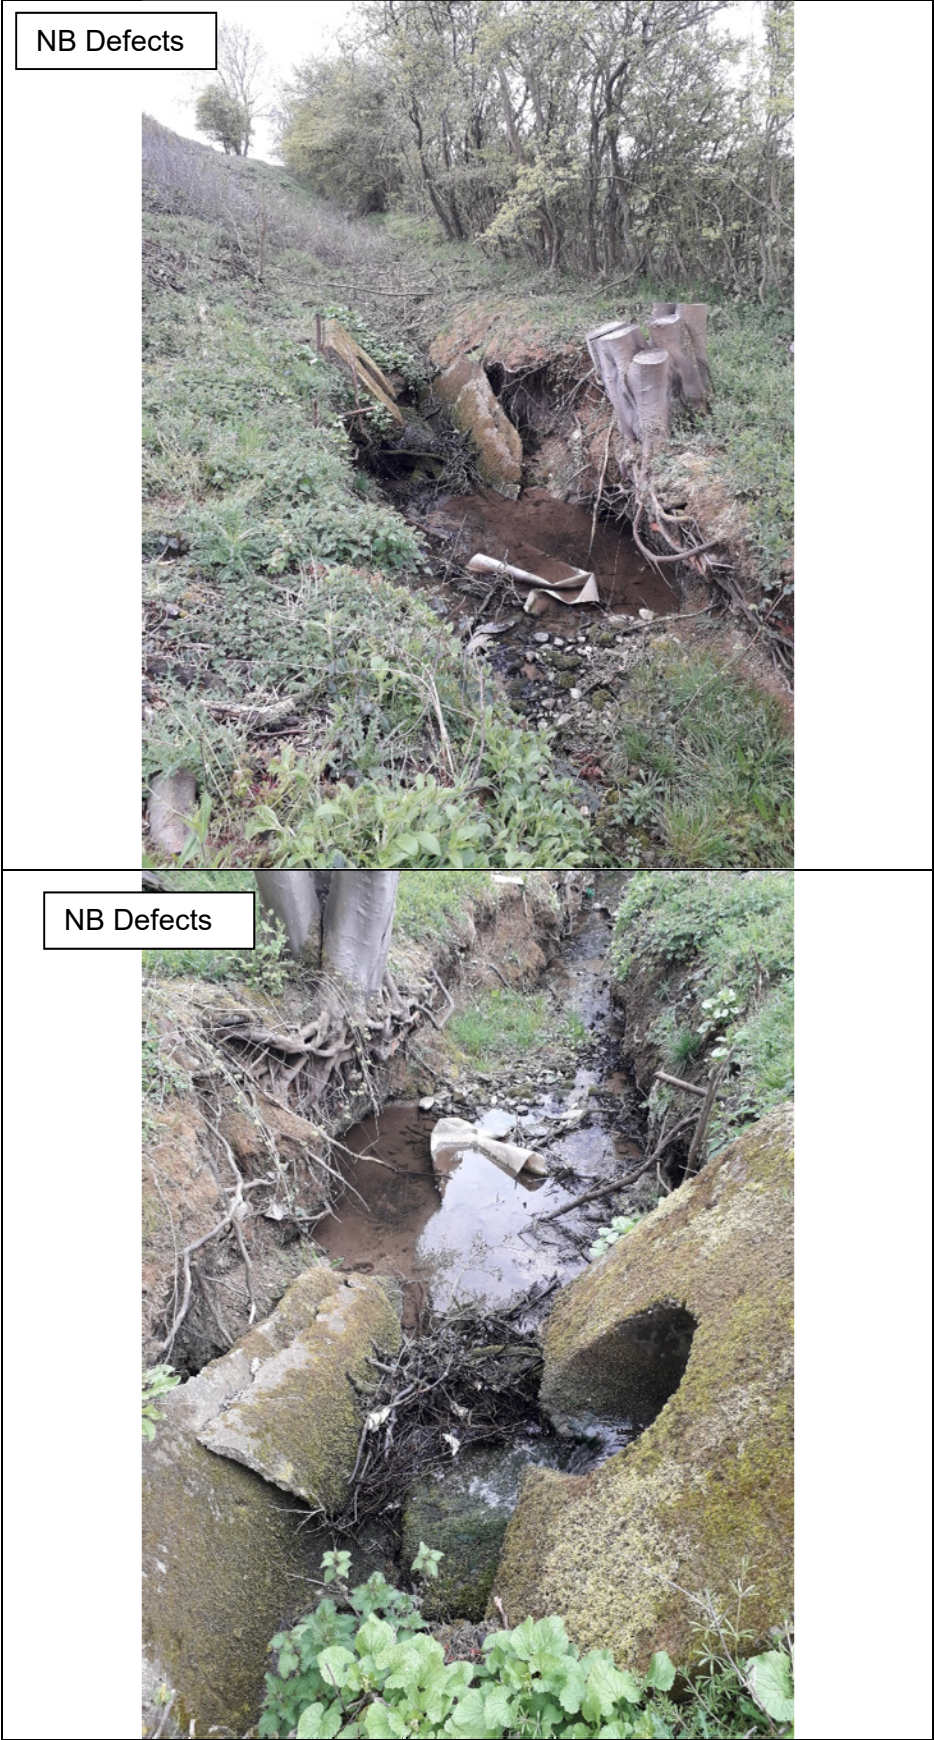
Figure 6-12: Photographs of major defects (Ratcliffe)

The northbound embankment hosts two significant earthwork defects. The first main defect relates to the defective drainage associated to the earthwork. A culvert outlet headwall has become undermined through water erosion due to the constant flow of a stream through the culvert that runs perpendicular to the earthwork, projecting the stream water directly onto the unlined ditch. Subsequently, the unlined ditch has become severely undermined on either side and resulted in the earthwork toe overhanging the ditch. The second main defect pertains to clay pipe drainage existing on the earthwork slope and has been subject to freeze-thaw over the years and shattered. The drainage water now flows out onto the earthwork toe and has resulted in a large gorge developing. The earthwork hosts geotechnical defects such as a soil bulge at the toe of the slope and substantial subsidence across the earthworks mid slope. It is not yet conclusive whether these defects have developed due to the defective drainage associated to the earthwork. Dense vegetation obscures the earthwork making the full extent of the defects uncertain.

The southbound embankment hosts two significant earthwork defects. Both defects consist of large 1m soil slips near the crest with the addition of tension cracks, animal burrows and soil bulging. The defects are located in close proximity to the culvert, which has caused issues on the northbound earthwork, and has therefore raised questions as to whether the southbound earthwork is in a similar condition which can only be investigated once vegetation is cleared. Historic observations of an “undermined pipe” have been recorded on the earthwork but could not be elaborated upon or confirmed whether it relates to the culvert inlet due to dense vegetation. There are also a number of observations relating to water erosion channels down the earthwork face.
