C129/JULY/2017

STRUCTURAL INSPECTION

**AT
JANE PIT, MOSSBAY ROAD, WORKINGTON**

**FOR
WORKINGTON TOWN COUNCIL**

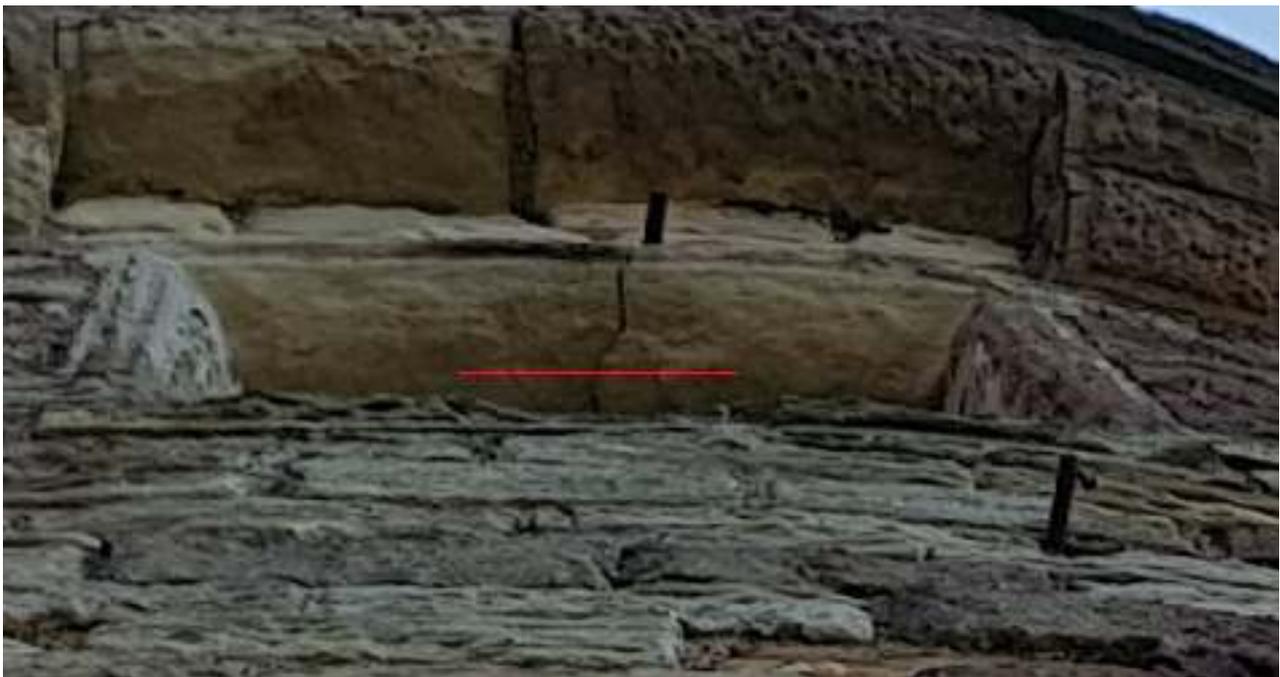
There is a crack through the lintel over the West elevation, upper right hand window. There is a steel rod above this which must be removed. The lintel should be repaired in accordance with the attached specification including bonding the crack and introducing an epoxy resin bonded stitch bar installed into a discreet chase cut under the soffit of the lintel (see image below). The crack above should be repaired also in accordance with the Specification incorporating stitching.
