Report and Register on Management Asbestos Survey

**The Explosion Museum
Priddy's Hard
Gosport
Hampshire**

Ref: 12.7352

January 2013

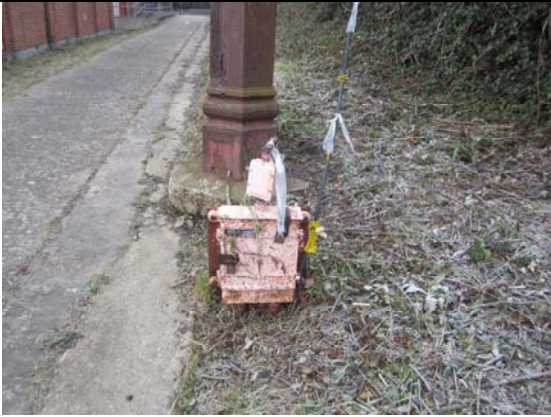
Photo 113

Ref	Int/ Ext	Zone/ Building	Description	Photo	Asbestos	Type	Quantity Extent	Comment
56	Int	Building 314	Vinyl floor tile and adhesive	112 113	Asbestos Reinforced Composite	Chrysotile	20m ²	Some damaged tiles
A	Ext	Through out site	Flash guards to fuse and junction boxes	114	Asbestos Textile	Chrysotile		Fuse and junction boxes located through out site
B	Ext	Through out site	Flash guards to lamp post fuses	174 175	Asbestos Textile	Chrysotile		To older lamp posts through out site.
C	Ext	Through out site	Bituminous board to junction boxes	176 177	Asbestos Reinforced Compound	Chrysotile
