**St. Osyth Priory, Essex.
Repairs and Alterations
To the
Tithe Barn, Dairy and Cart Lodge**

Enabling Works Schedule

September 2022
Carden & Godfrey
33 Clerkenwell Close
London EC1R 0AU

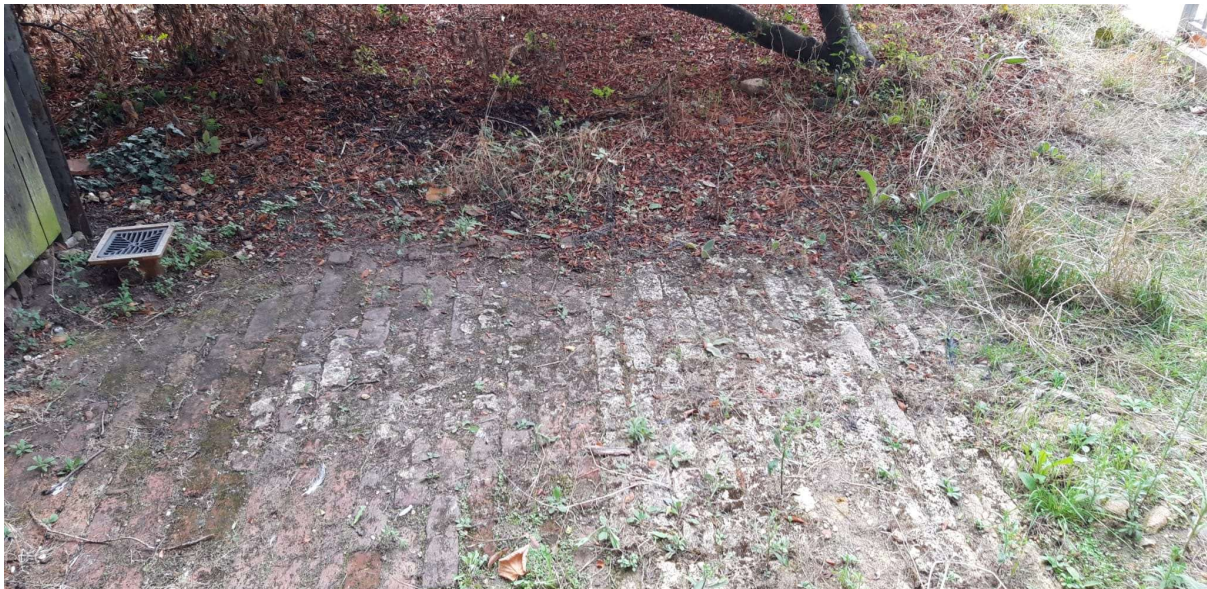
- 3.1.1 East of the middle South Mistry/Cart Entrance, carry out limited shallow excavation adjacent to the Boiler House lean-to south wall, to establish the line and remains of the brick and stone footing of the lost wall thought to have continued the south frame westward up to the middle of the mistry.

(Note: the brick floor survives, therefore the dig should be just along its perimeter).

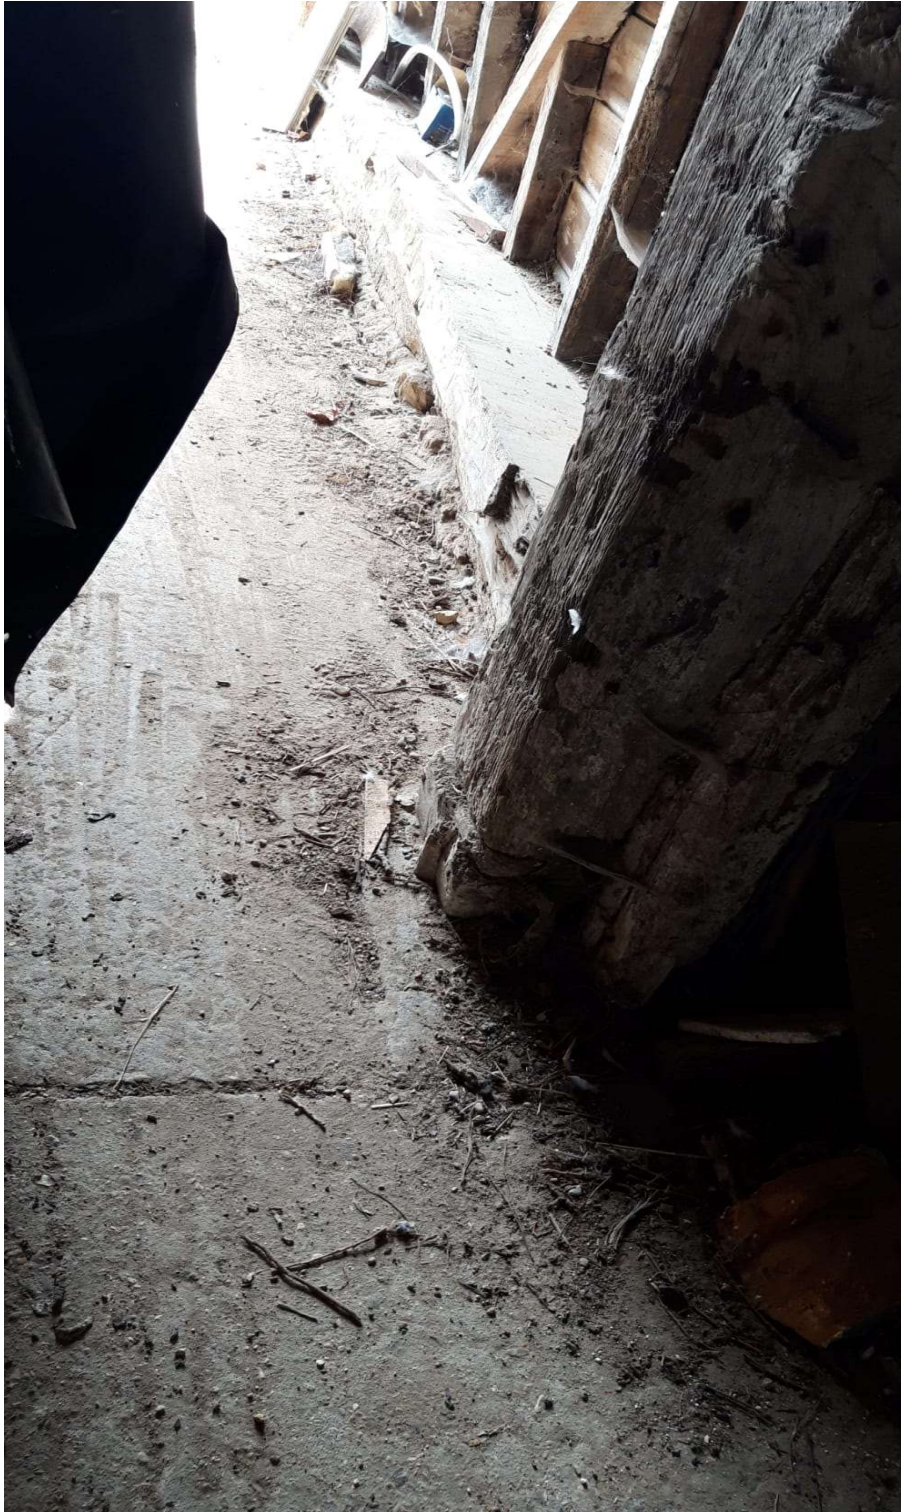
- 3.1.2 Within the lower (eastern) floor level of the Barn, drill out and excavate a small area of concrete floor to locate the nature of the sub-base, its material, condition and depth below the finished surface of the concrete.

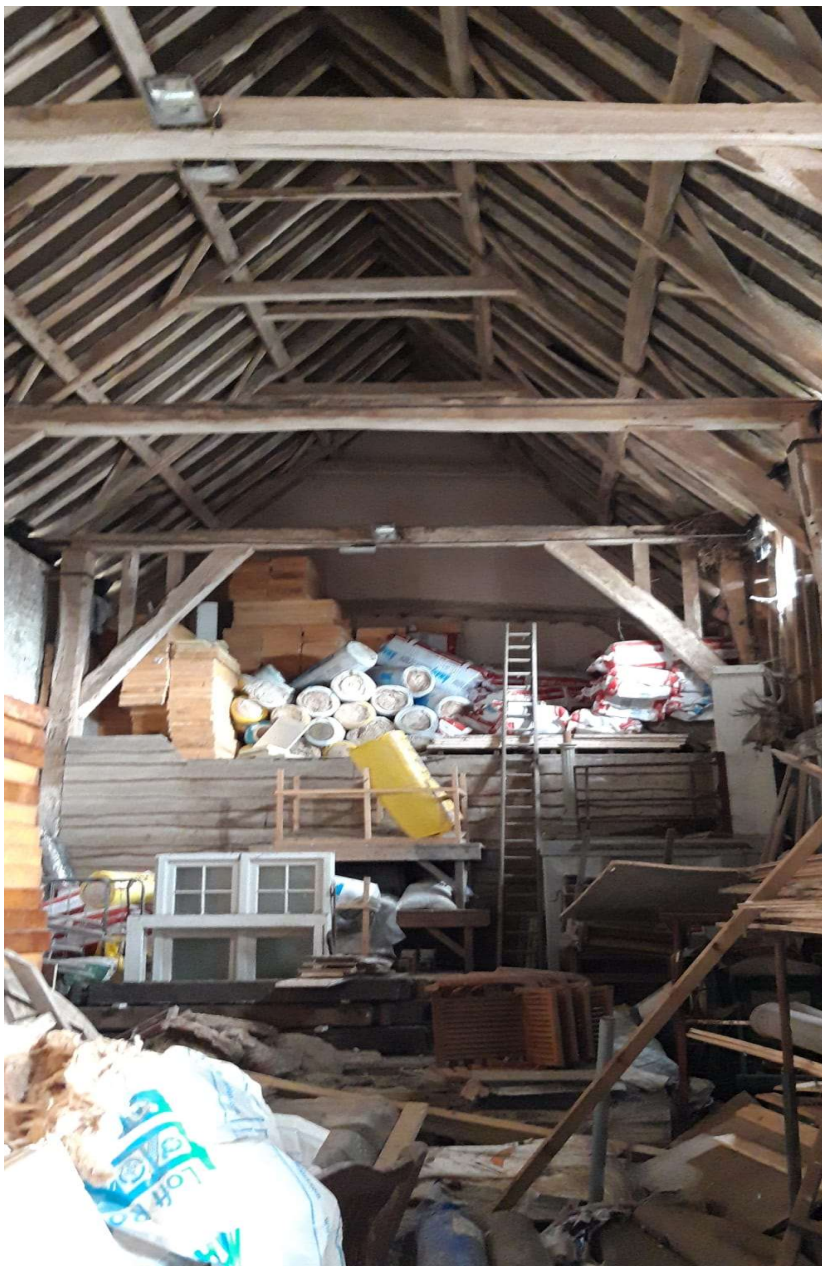
- 3.1.3 Survey the construction of the Waney-boarded platform at east end of the Barn, whether it is historically significant or can be removed without damage to the barn's interior integrity, and whether both concrete floors have the same level either side of the boarded screen.

Also ascertain the construction and condition of the seemingly plastered east end wall of the Barn, full-height and width, and that it provides sufficient fire protection between the Barn and the Cottage next door.

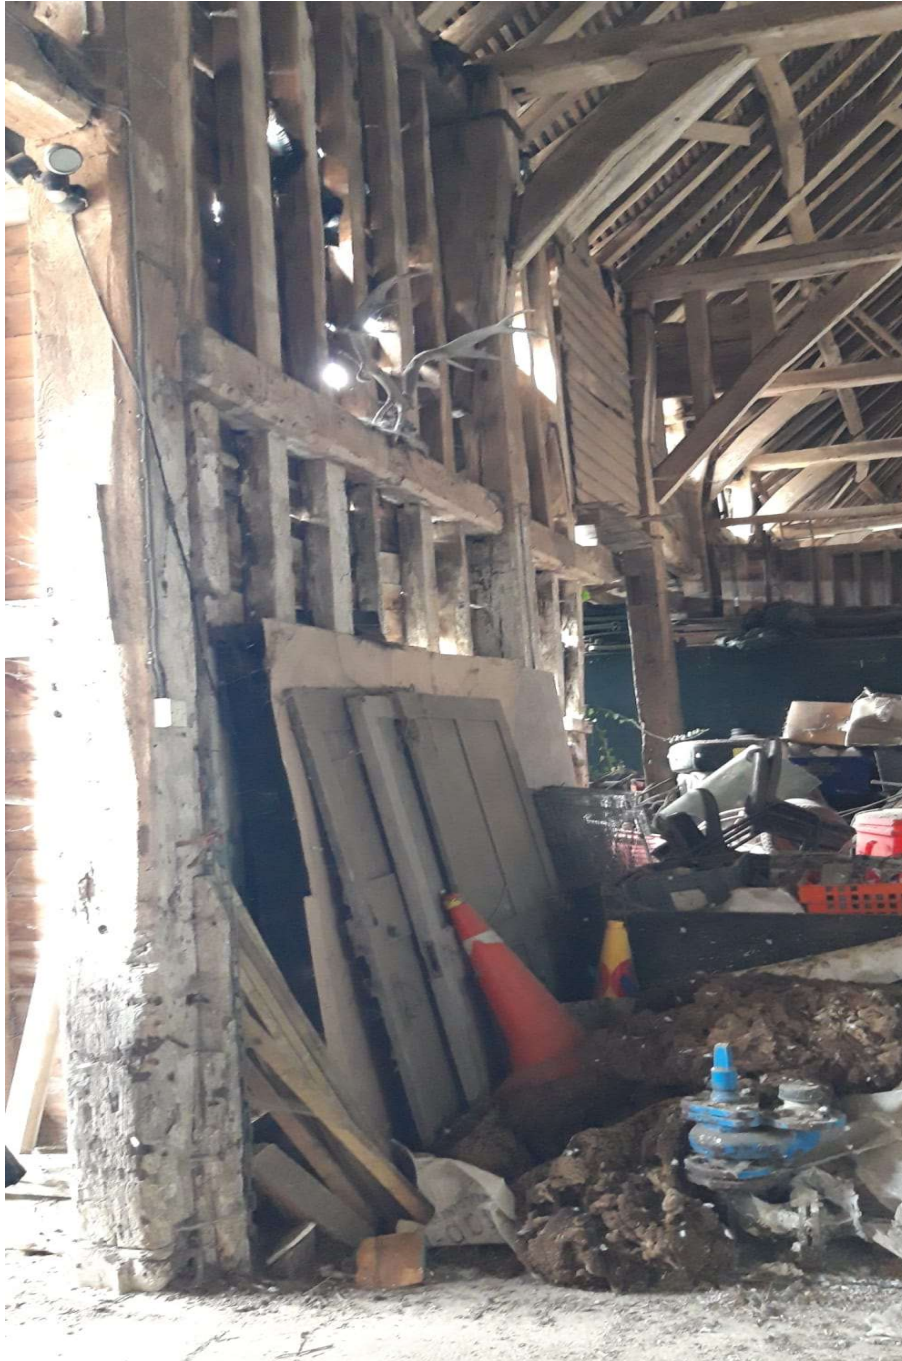
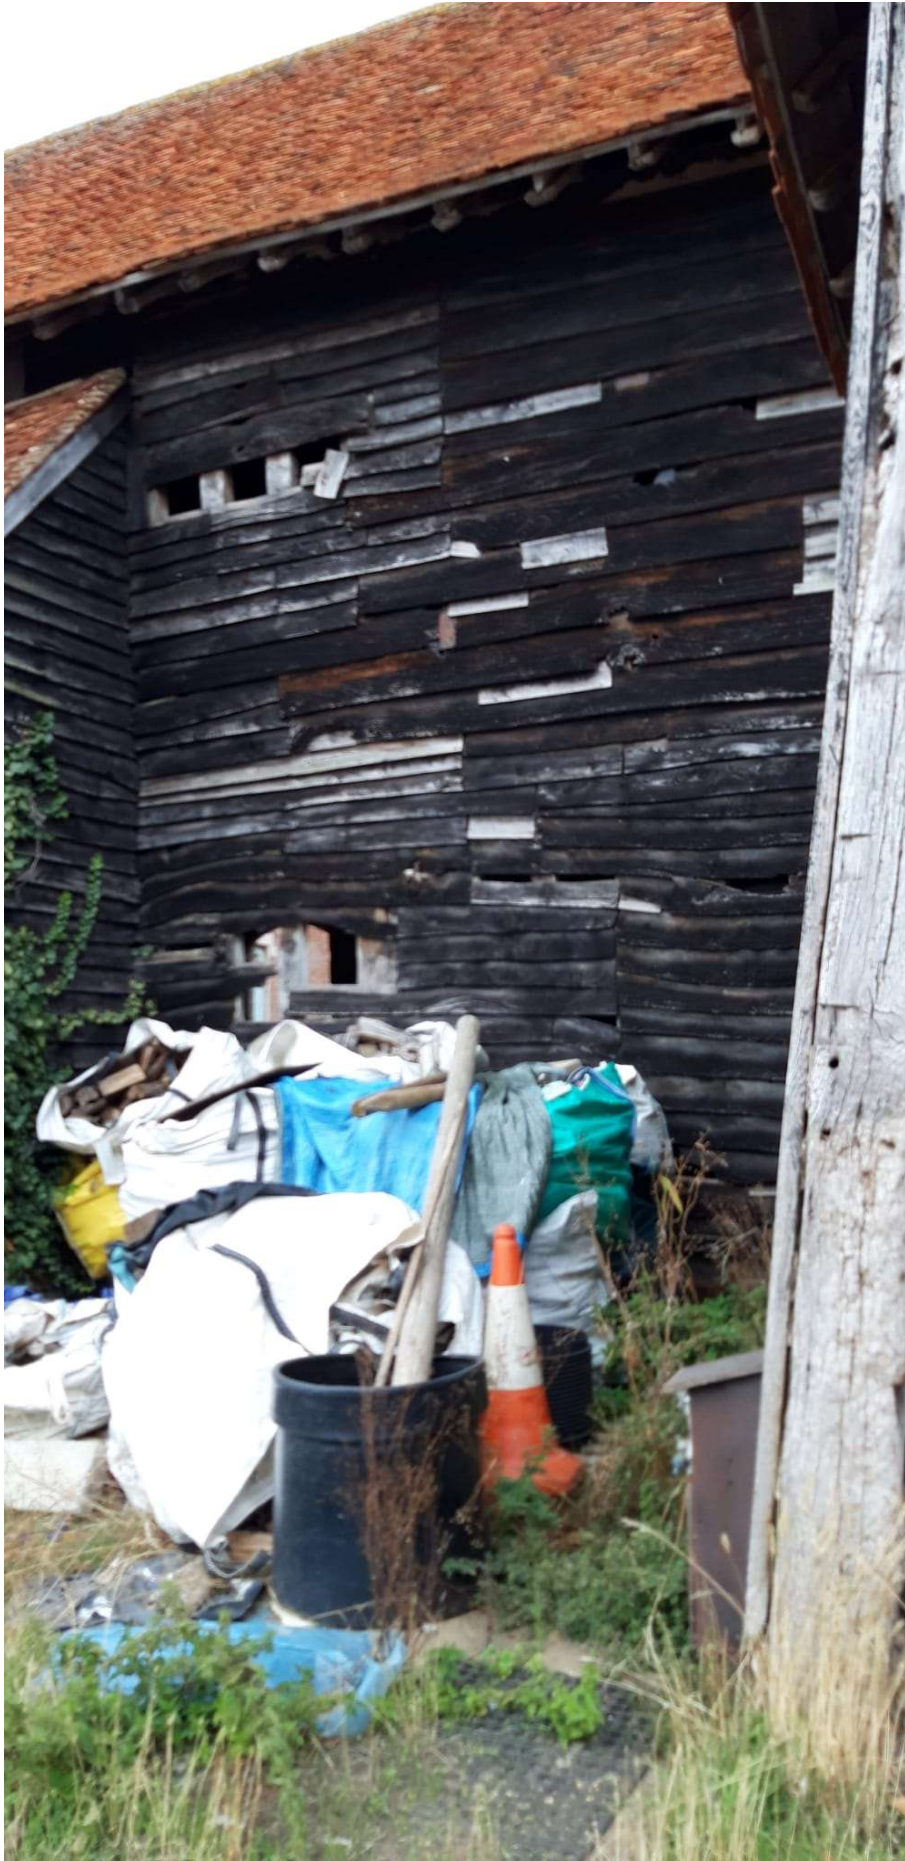
- 3.1.4 To the exterior and the interior, clear debris and storage away from the Base of the walls and around the Barn, in order to enable proper condition surveys (and temporary propping) preparatory to the detailed repair drawings and Schedule of Work.

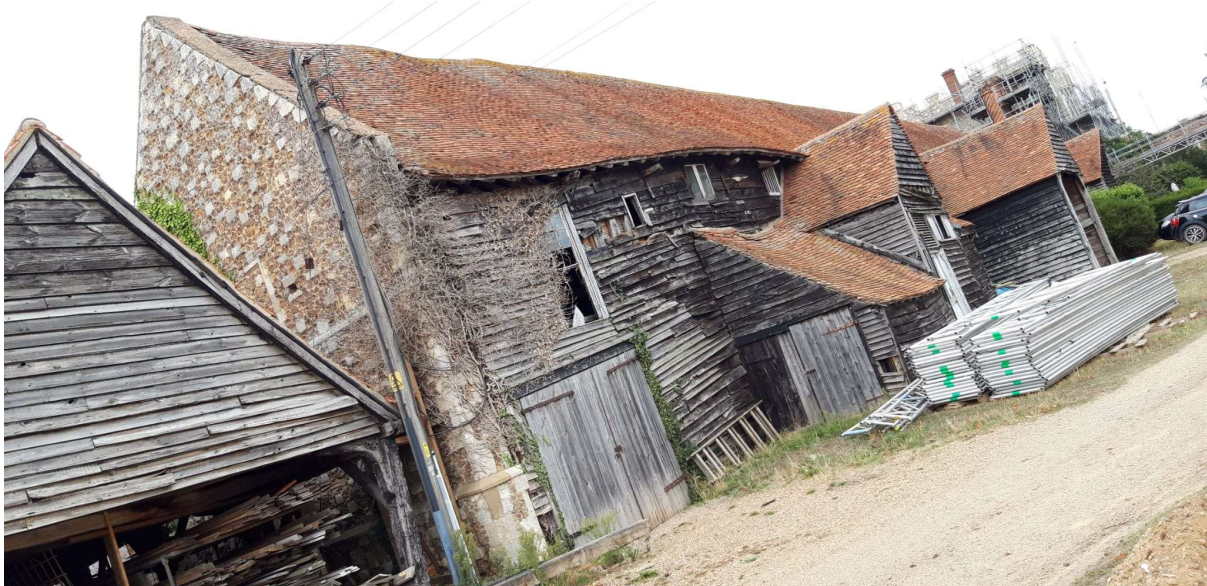
- 3.1.8 Survey and assemble a Schedule of Existing Historic Materials, including roof tiles, bricks, dressed stone, stone rubble, pavers, frame members and weatherboards, with sizes sources, likely origins and current availability.

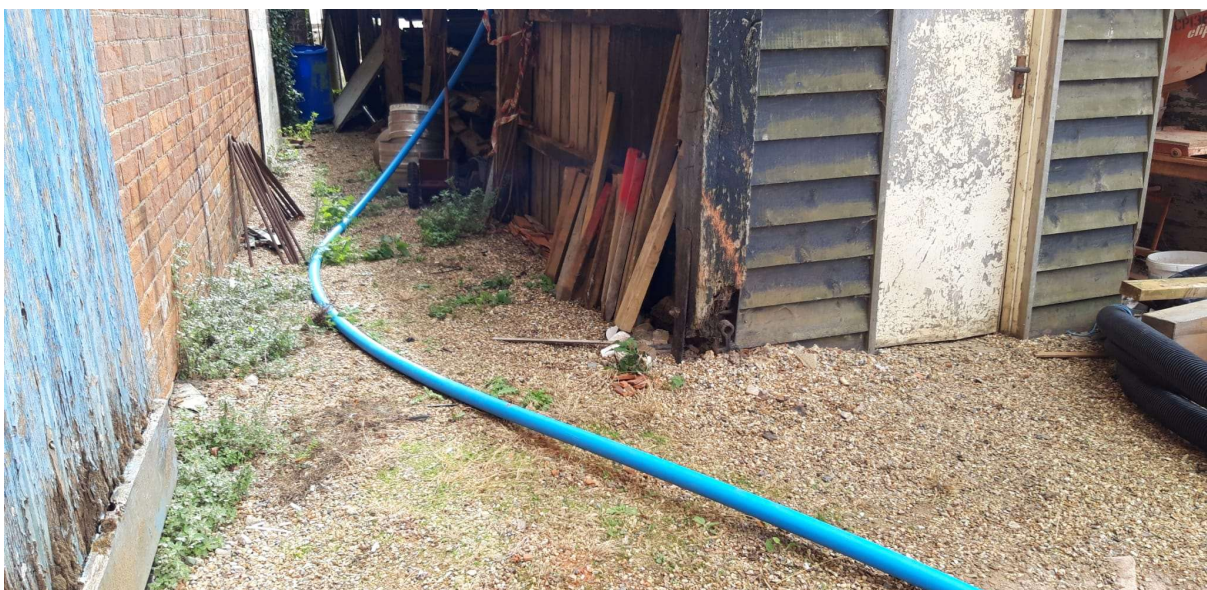
- 3.2.1 Carry out a levels survey to relate to the ground floor of the Dairy Workshop and Lobby with the western ground floor of the Barn and with the western ground floor of the Barn and with the approx.) sub-base and sole plate level of the Cart Lodge.

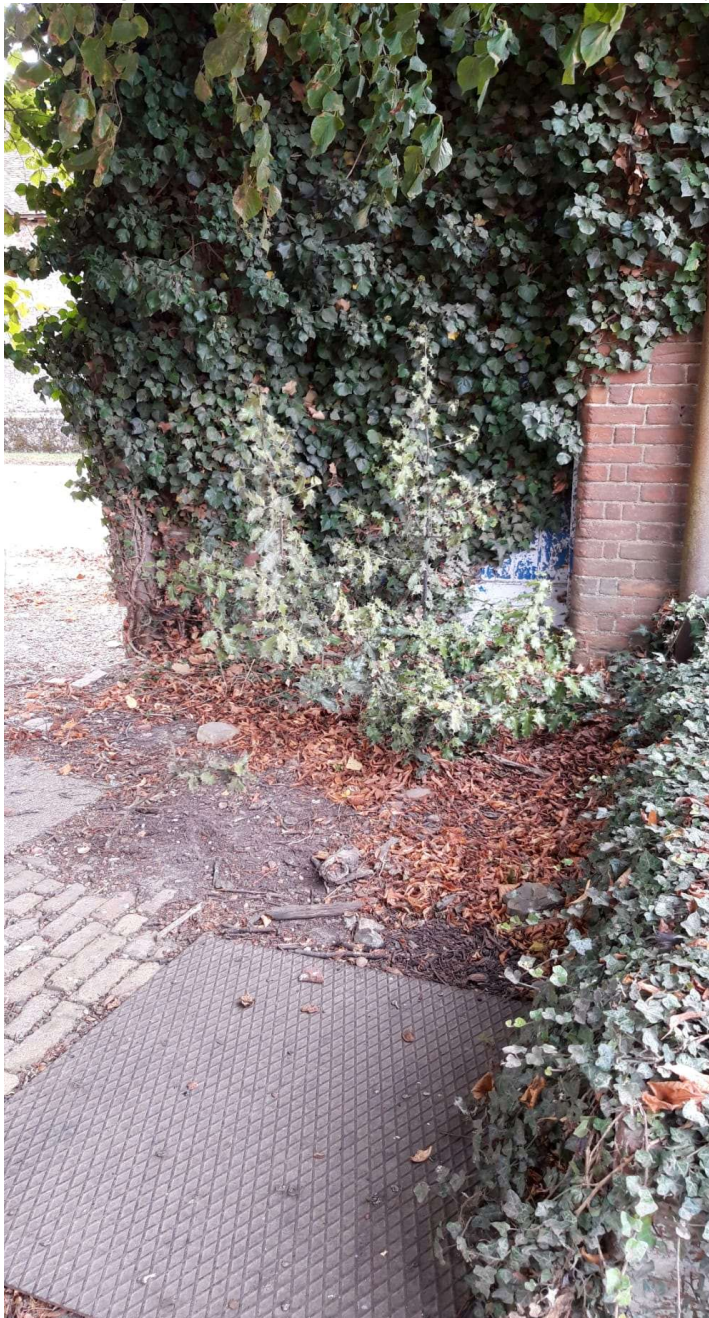
- 3.2.2 In conjunction with the Barn, trace and audit/make safe the electrical installation retaining only mains power and lighting to the ground floor workshop.
- 3.2.3 As Barn, establish a Schedule of materials, sources, sizes and Significance.
- 3.2.4 Test the viability and detail of opening-up the long-blocked northeast ground floor external door. Remove ivy.

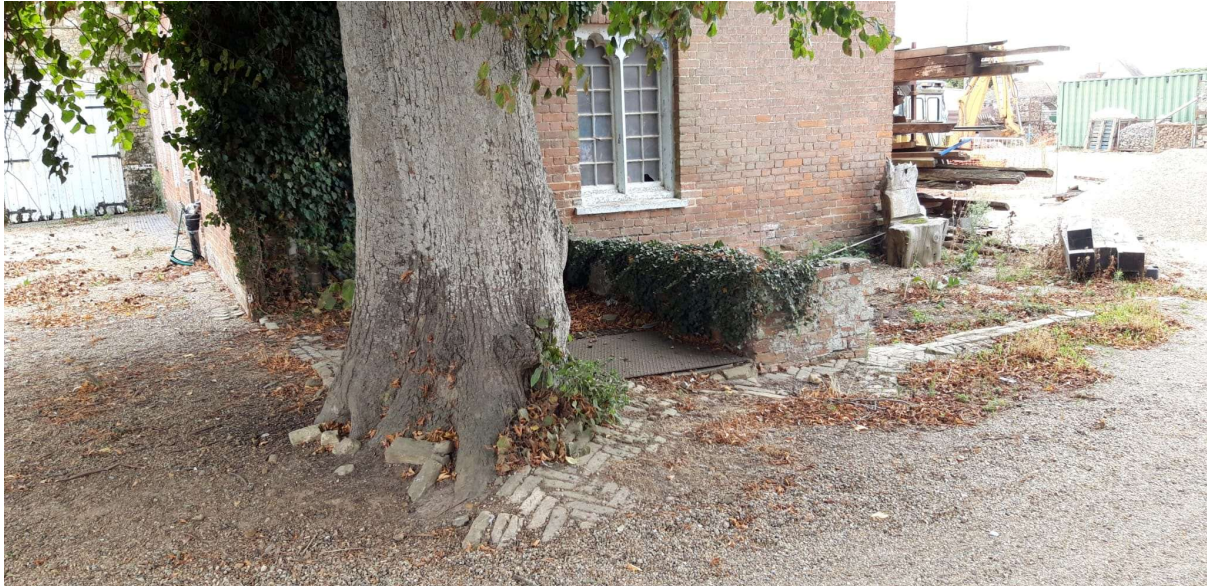
- 3.2.5 Shallow excavation of modern gravel around the external wall base to discover and record the nature and condition of the brickwork (some is missing at ground level), and to find the remains of any surviving paving or other ground surface materials.

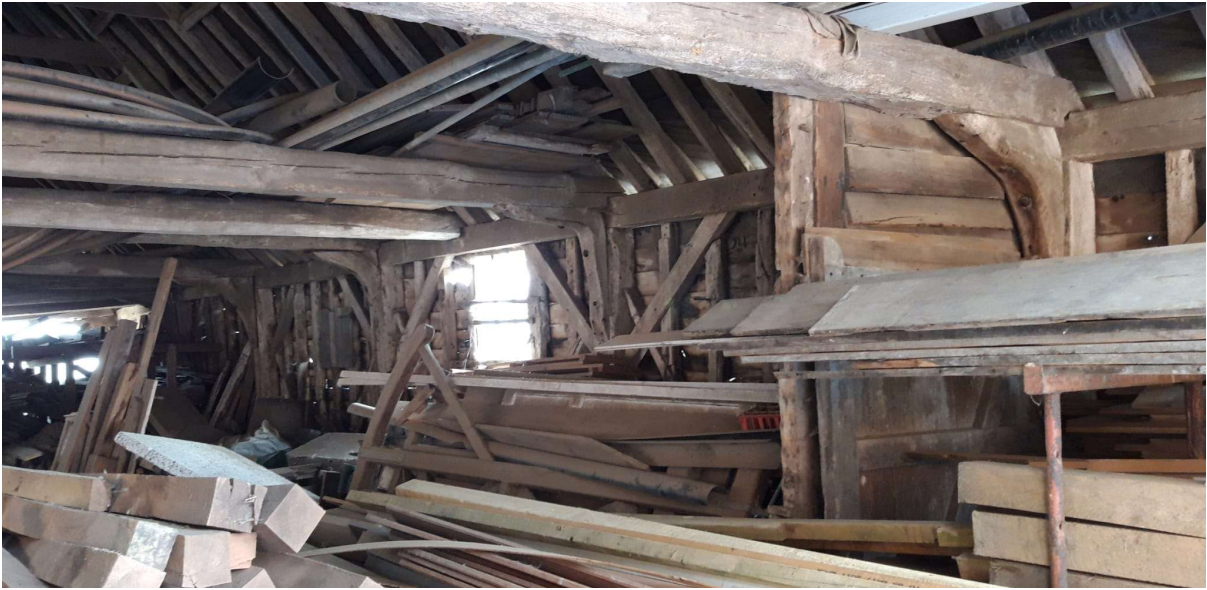
- 3.3.1 As above, survey and establish a compendium of historic materials including roof tiles, footing masonry/brickwork, timbers sources/species and sizes.
- 3.3.2 As for Barn, attempt to clean debris and storage at least from the base of the wall frames and brick plinth, in order to ascertain construction and condition, and prepare to schedule repairs.
- 3.3.3 Internally, clear local area of ground to dig shallow trench in search of any possible remains of brick or other paving, screed or over-site.
- 3.3.4 Similarly make sufficient space through the timber storage to facilitate eventual detailed condition survey, drawings, specification and carpentry repair schedules, all in conjunction with developing the designs for alteration and change of use.

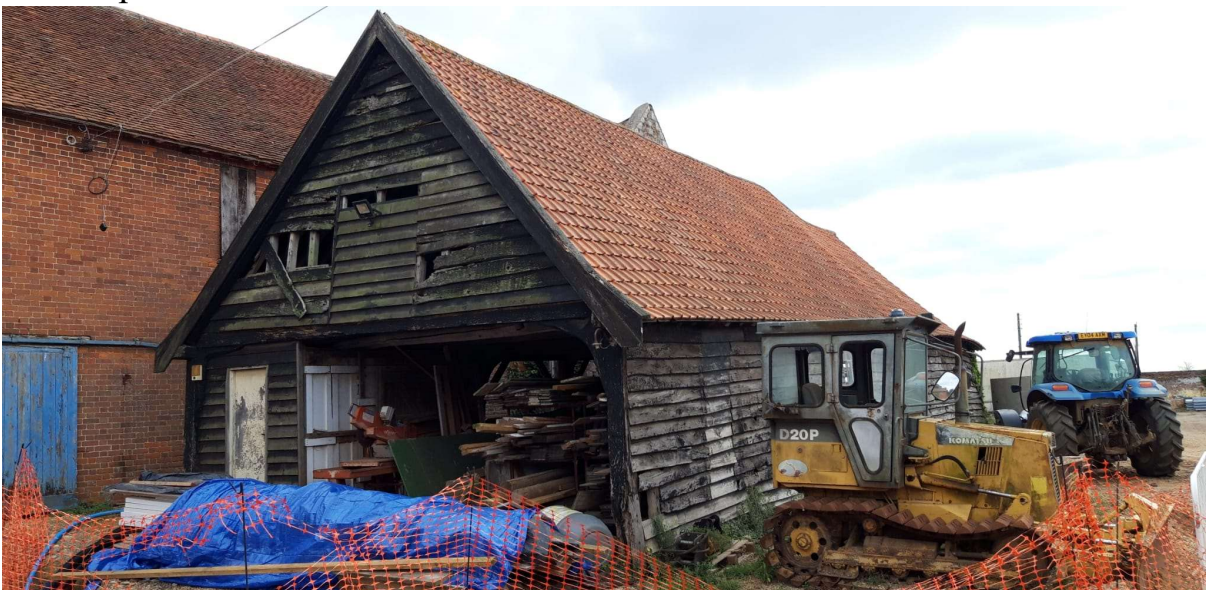
3.3.5 Research archive for images and descriptions of past appearances etc. of the Cart House, including from before it was moved to its current spot.

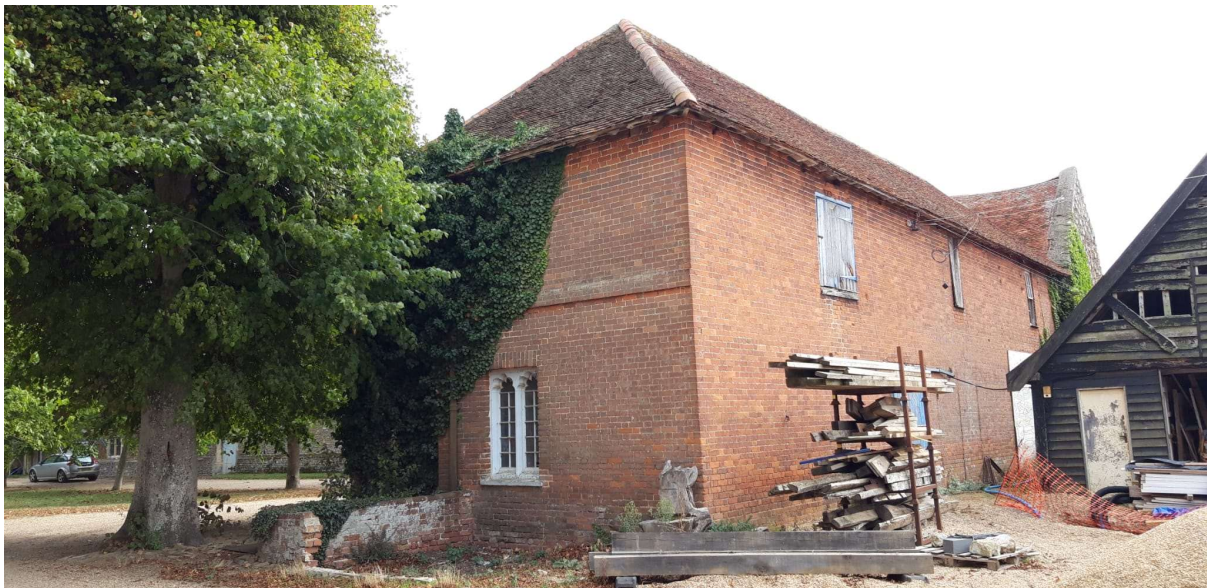
- 3.4.1 Established optimum finished ground levels on the driveways and footpaths in order to co-ordinate with the three buildings internal floor levels, and most importantly, with the levels of the timber frame sole plates and plinths, to avoid any jeopardising of the floors and sole/base plates by higher external ground.
- 3.4.2 Cut back encroaching vegetation and establish an acceptable regime for pruning trees in the vicinity of buildings.

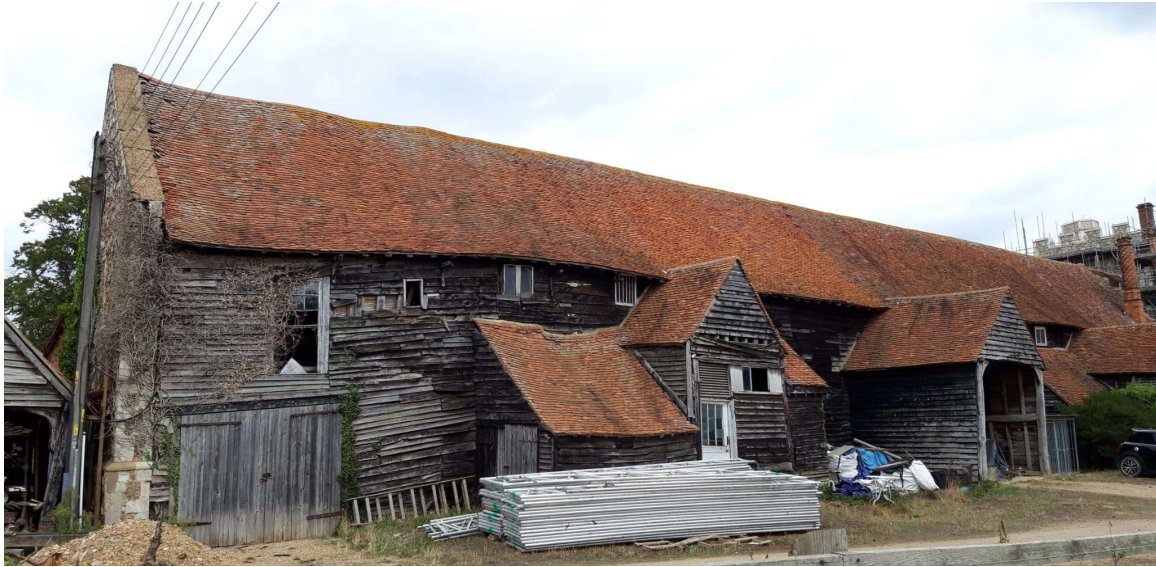
- 3.4.3 Survey modern site drainage invert levels and relate them to the ground floor levels in the building in relation to kitchen and W.C's drainage.
- 3.4.4 Conclude viability or otherwise of trenching the electrical supply into the Barn at the southwest corner, and removing the last pole and overhead cables.

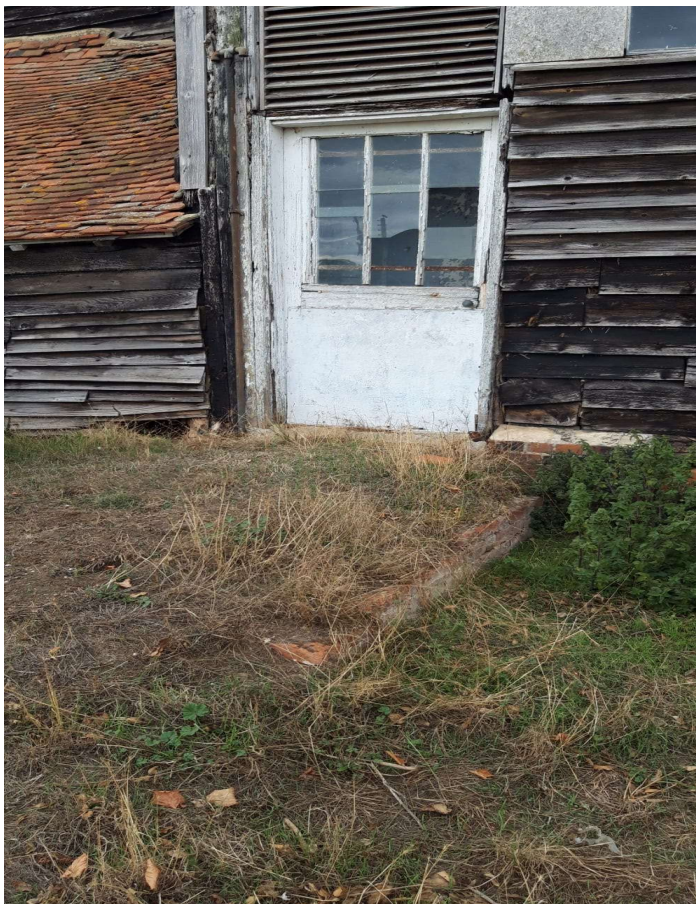
- 3.4.5 Dig shallow trial holes to chart possible previous ground materials south of the Tithe Barn, including brick or stone paving, and including to survey the extent of brick paving and side walls to the central ramp that extends south from the single doorway in the infilled western mistrey.
