# Asbestos Inspection Report

Forestry Commission

Warren Cottage, Lynford, Thetford

## Refurbishment Survey

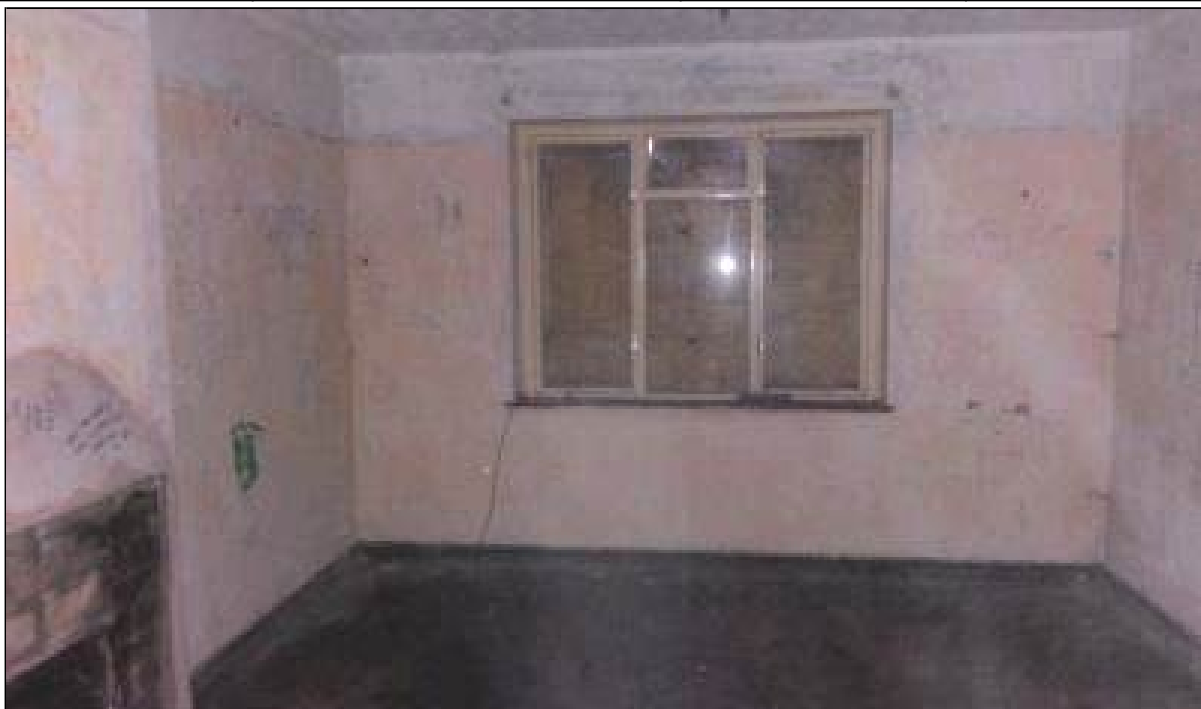
<b>SAMPLE REFERENCE</b>	Item No: 1	<b>ASBESTOS</b>	<b>N/A</b>
<b>PRESUMPTION REFERENCE</b>	N/A	<b>RISK LEVEL</b>	<b>N/A</b>

<b>AREA</b>	Internal	<b>MATERIAL ASSESSMENT</b>	
<b>FLOOR</b>	Ground Floor	<b>PRODUCT TYPE</b>	N/A
<b>UNIQUE ROOM IDENTIFIER</b>	Living room	<b>DAMAGE</b>	N/A
<b>DESCRIPTION OF SAMPLE TAKEN OR PRESUMPTION</b>	plasterboard ceiling, plaster finish to brick and block walls, concrete floor, plaster and brick fire place with no suspect materials behind, empty cavity in walls below windows	<b>SURFACE TREATMENT</b>	N/A
<b>EXTENT</b>	N/A	<b>ASBESTOS TYPE</b>	N/A
<b>ACCESSIBILITY</b>	N/A	<b>MATERIAL ASSESSMENT SCORE</b>	N/A
<b>LEVEL OF IDENTIFICATION</b>	N/A	<b>POTENTIAL TO RELEASE FIBRES</b>	N/A
<b>RECOMMENDATIONS</b> <b>No Further Action Required</b>		<b>COMMENTS</b> <b>No Asbestos Containing Materials Found</b>

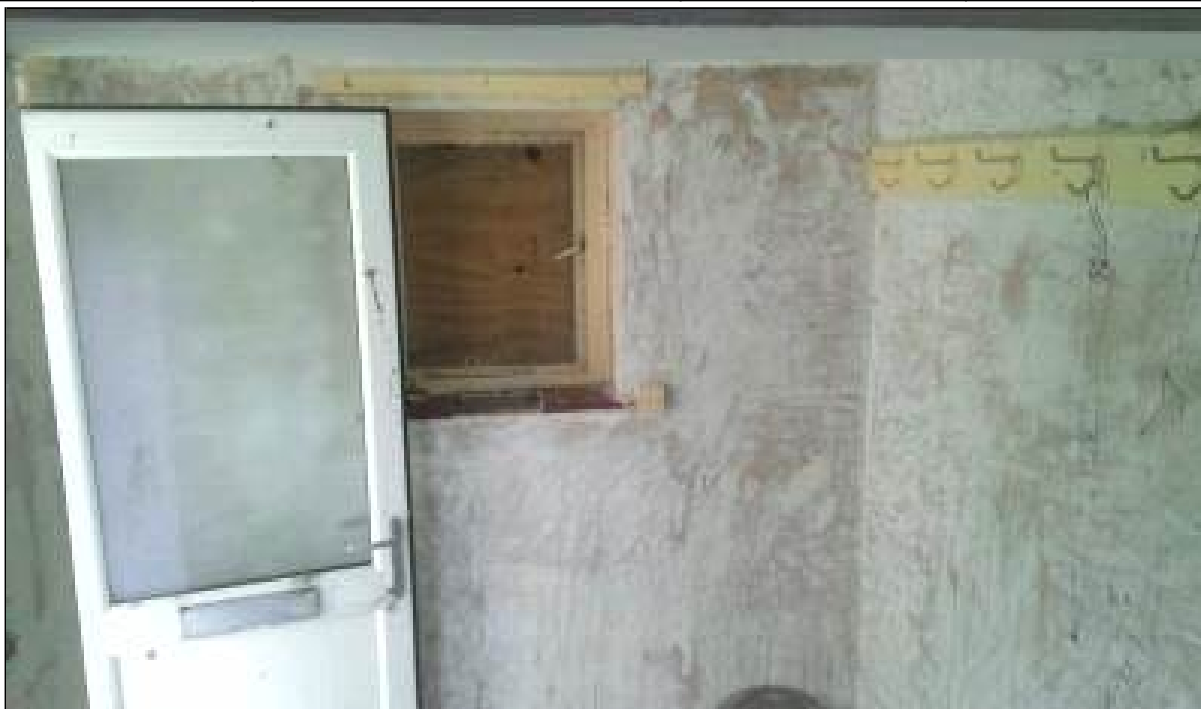
<b>SAMPLE REFERENCE</b>	Item No: 4	<b>ASBESTOS</b>	<b>N/A</b>
<b>PRESUMPTION REFERENCE</b>	N/A	<b>RISK LEVEL</b>	<b>N/A</b>

<b>AREA</b>	Internal	<b>MATERIAL ASSESSMENT</b>	
<b>FLOOR</b>	Ground Floor	<b>PRODUCT TYPE</b>	N/A
<b>UNIQUE ROOM IDENTIFIER</b>	Entrance Porch Hall	<b>DAMAGE</b>	N/A
<b>DESCRIPTION OF SAMPLE TAKEN OR PRESUMPTION</b>	plasterboard ceiling, plaster finish to brick and block walls, concrete floor, empty cavity in walls below windows	<b>SURFACE TREATMENT</b>	N/A
<b>EXTENT</b>	N/A	<b>ASBESTOS TYPE</b>	N/A
<b>ACCESSIBILITY</b>	N/A	<b>MATERIAL ASSESSMENT SCORE</b>	N/A
<b>LEVEL OF IDENTIFICATION</b>	N/A	<b>POTENTIAL TO RELEASE FIBRES</b>	N/A
<b>RECOMMENDATIONS</b> <b>No Further Action Required</b>		<b>COMMENTS</b> <b>No Asbestos Containing Materials Found</b>

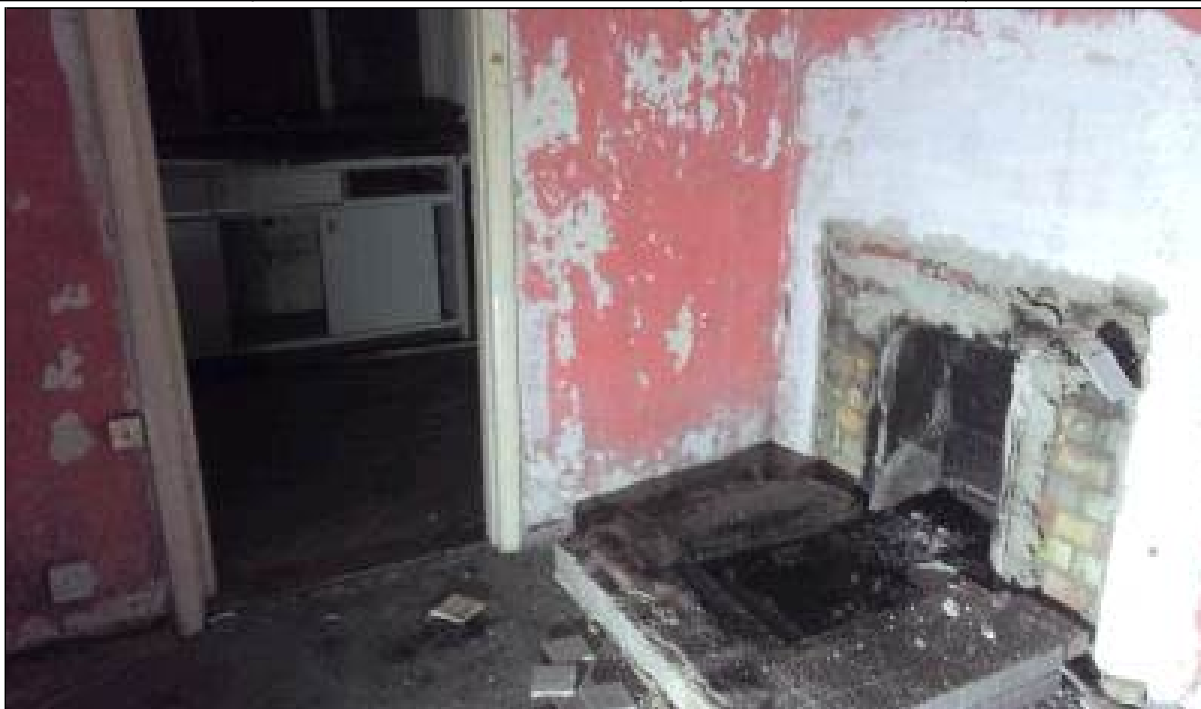
<b>SAMPLE REFERENCE</b>	Item No: 7	<b>ASBESTOS</b>	<b>N/A</b>
<b>PRESUMPTION REFERENCE</b>	N/A	<b>RISK LEVEL</b>	<b>N/A</b>

<b>AREA</b>	Internal	<b>MATERIAL ASSESSMENT</b>	
<b>FLOOR</b>	Ground Floor	<b>PRODUCT TYPE</b>	N/A
<b>UNIQUE ROOM IDENTIFIER</b>	Dinning Room	<b>DAMAGE</b>	N/A
<b>DESCRIPTION OF SAMPLE TAKEN OR PRESUMPTION</b>	plasterboard ceiling, plaster finish to brick and block walls, concrete floor, empty cavity in walls below windows, brick and plaster fire place with no suspect materials behind	<b>SURFACE TREATMENT</b>	N/A
<b>EXTENT</b>	N/A	<b>ASBESTOS TYPE</b>	N/A
<b>ACCESSIBILITY</b>	N/A	<b>MATERIAL ASSESSMENT SCORE</b>	N/A
<b>LEVEL OF IDENTIFICATION</b>	N/A	<b>POTENTIAL TO RELEASE FIBRES</b>	N/A
<b>RECOMMENDATIONS</b> <b>No Further Action Required</b>		<b>COMMENTS</b> <b>No Asbestos Containing Materials Found</b>

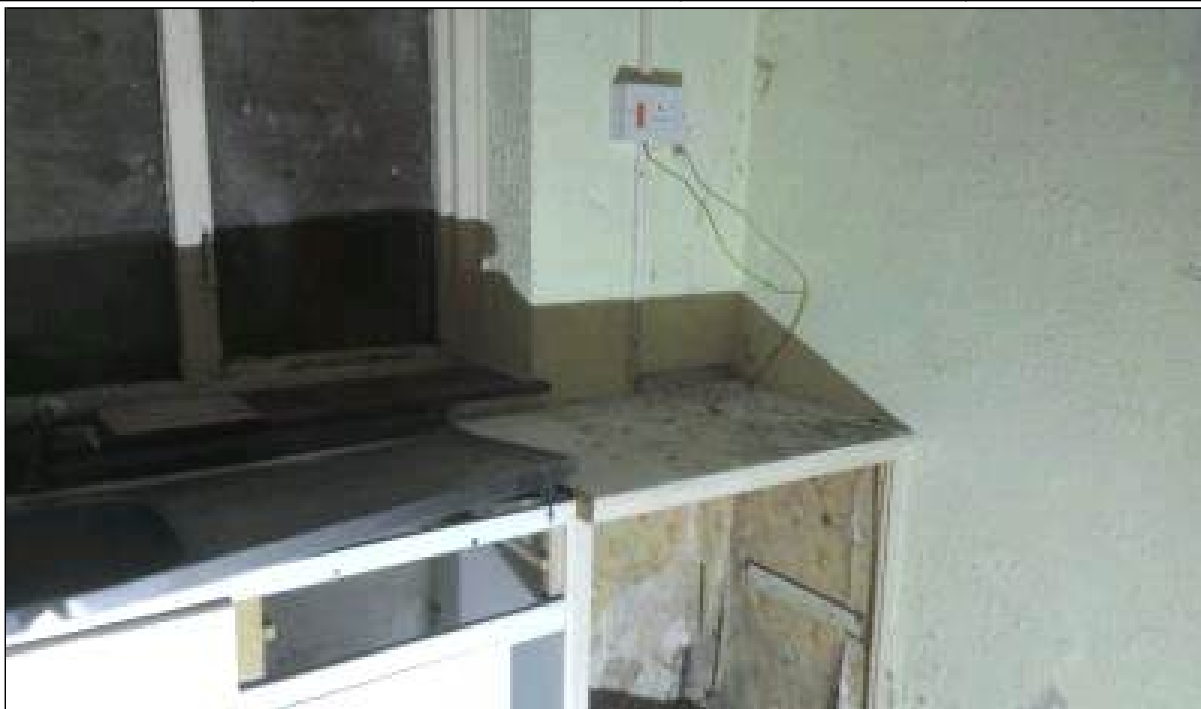
<b>SAMPLE REFERENCE</b>	Item No: 10	<b>ASBESTOS</b>	<b>N/A</b>
<b>PRESUMPTION REFERENCE</b>	N/A	<b>RISK LEVEL</b>	<b>N/A</b>

<b>AREA</b>	Internal	<b>MATERIAL ASSESSMENT</b>	
<b>FLOOR</b>	Ground Floor	<b>PRODUCT TYPE</b>	N/A
<b>UNIQUE ROOM IDENTIFIER</b>	Kitchen and 2 Cpd	<b>DAMAGE</b>	N/A
<b>DESCRIPTION OF SAMPLE TAKEN OR PRESUMPTION</b>	plasterboard ceiling with timber floor above, plaster finish to brick and block walls, concrete floor, empty cavity in walls below windows, modern electrics	<b>SURFACE TREATMENT</b>	N/A
<b>EXTENT</b>	N/A	<b>ASBESTOS TYPE</b>	N/A
<b>ACCESSIBILITY</b>	N/A	<b>MATERIAL ASSESSMENT SCORE</b>	N/A
<b>LEVEL OF IDENTIFICATION</b>	N/A	<b>POTENTIAL TO RELEASE FIBRES</b>	N/A
<b>RECOMMENDATIONS</b> No Further Action Required		<b>COMMENTS</b> No Asbestos Containing Materials Found

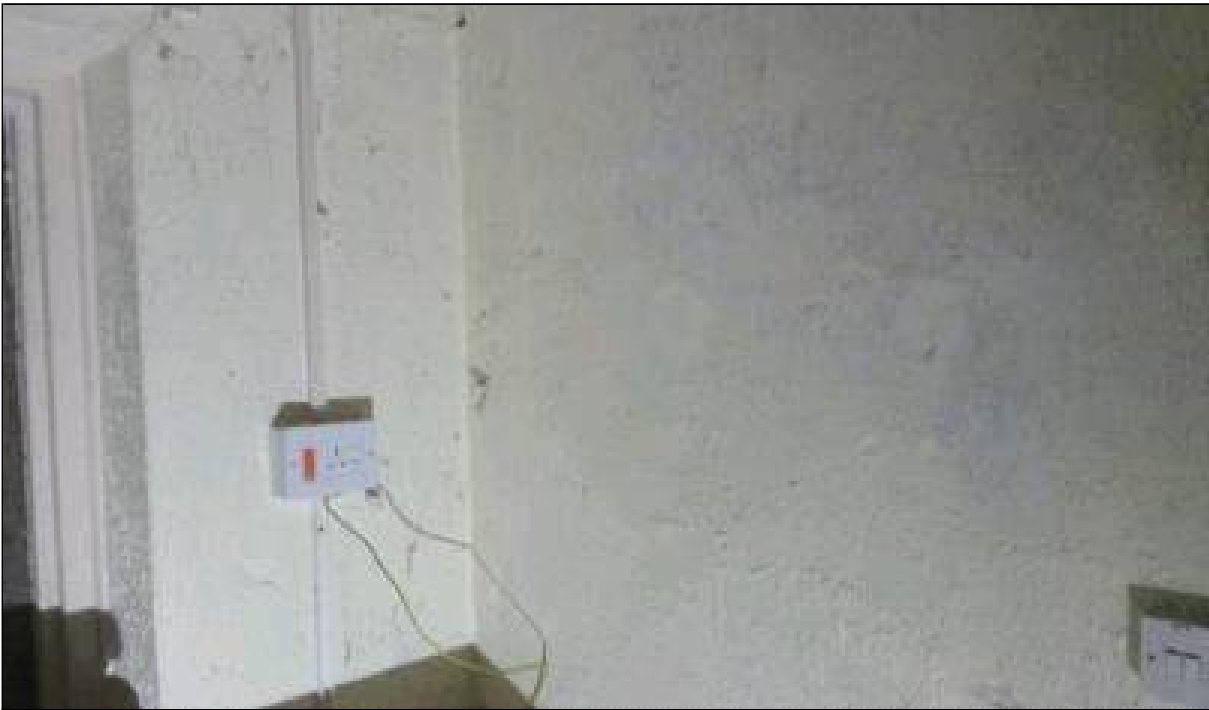
<b>SAMPLE REFERENCE</b>	AE003837	<b>ASBESTOS</b>	<b>NO</b>
<b>PRESUMPTION REFERENCE</b>	N/A	<b>RISK LEVEL</b>	N/A

<b>AREA</b>	Internal	<b>MATERIAL ASSESSMENT</b>	
<b>FLOOR</b>	Ground Floor	<b>PRODUCT TYPE</b>	0 - NADIS
<b>UNIQUE ROOM IDENTIFIER</b>	Kitchen and 2 Cpd	<b>DAMAGE</b>	0 - NADIS
<b>DESCRIPTION OF SAMPLE TAKEN OR PRESUMPTION</b>	textured coating to walls	<b>SURFACE TREATMENT</b>	0 - NADIS
<b>EXTENT</b>	15 Sq. m	<b>ASBESTOS TYPE</b>	0 - NADIS
<b>ACCESSIBILITY</b>	Low	<b>MATERIAL ASSESSMENT SCORE</b>	0
<b>LEVEL OF IDENTIFICATION</b>	Sampled	<b>POTENTIAL TO RELEASE FIBRES</b>	N/A
<b>RECOMMENDATIONS</b> <b>No Further Action Required</b>		<b>COMMENTS</b> <b>No Asbestos Detected in Sample</b>

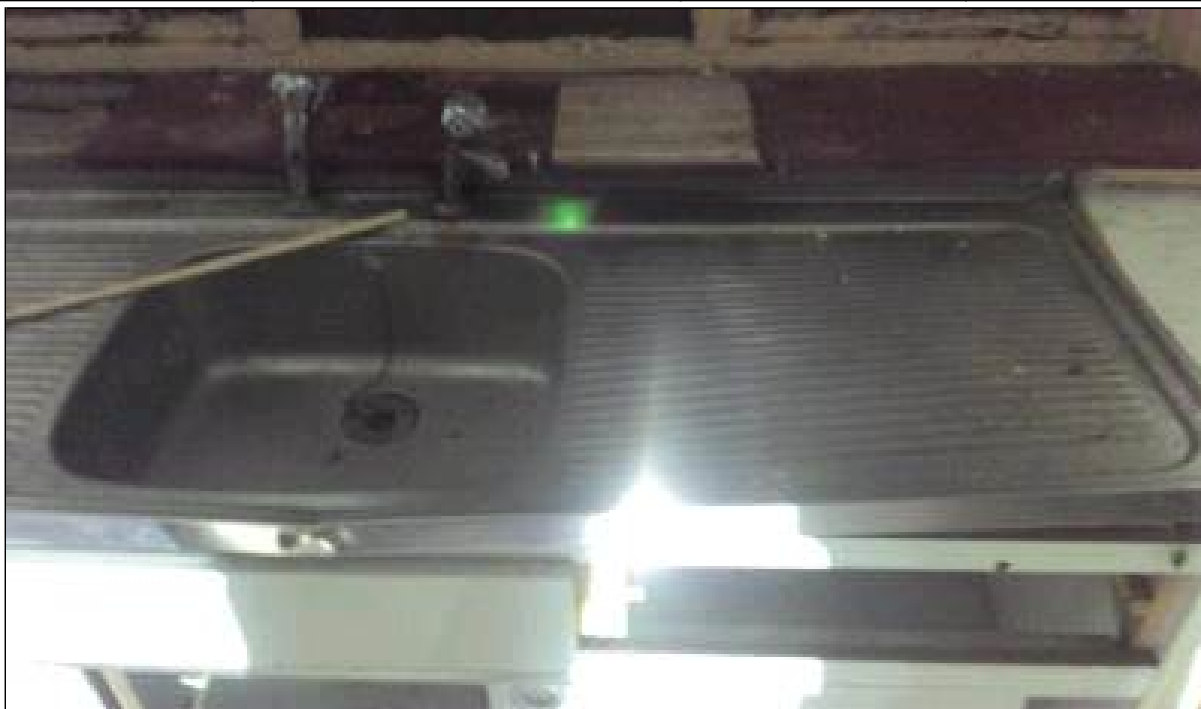
<b>SAMPLE REFERENCE</b>	AE003838	<b>ASBESTOS</b>	<b>NO</b>
<b>PRESUMPTION REFERENCE</b>	N/A	<b>RISK LEVEL</b>	N/A

<b>AREA</b>	Internal	<b>MATERIAL ASSESSMENT</b>	
<b>FLOOR</b>	Ground Floor	<b>PRODUCT TYPE</b>	0 - NADIS
<b>UNIQUE ROOM IDENTIFIER</b>	Kitchen and 2 Cpd	<b>DAMAGE</b>	0 - NADIS
<b>DESCRIPTION OF SAMPLE TAKEN OR PRESUMPTION</b>	Bitumen paint to sink	<b>SURFACE TREATMENT</b>	0 - NADIS
<b>EXTENT</b>	1 Sq. m	<b>ASBESTOS TYPE</b>	0 - NADIS
<b>ACCESSIBILITY</b>	Low	<b>MATERIAL ASSESSMENT SCORE</b>	0
<b>LEVEL OF IDENTIFICATION</b>	Sampled	<b>POTENTIAL TO RELEASE FIBRES</b>	N/A
<b>RECOMMENDATIONS</b> No Further Action Required		<b>COMMENTS</b> No Asbestos Detected in Sample

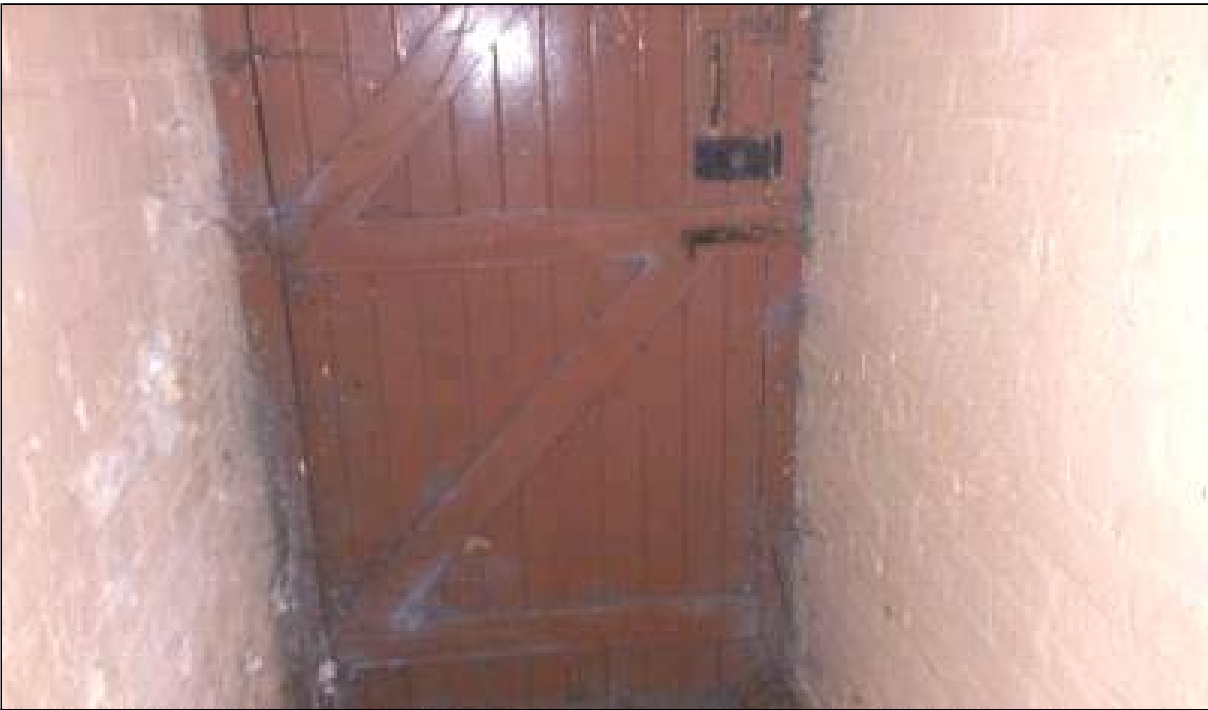
<b>SAMPLE REFERENCE</b>	Item No: 15	<b>ASBESTOS</b>	<b>N/A</b>
<b>PRESUMPTION REFERENCE</b>	N/A	<b>RISK LEVEL</b>	<b>N/A</b>

<b>AREA</b>	Internal	<b>MATERIAL ASSESSMENT</b>	
<b>FLOOR</b>	Ground Floor	<b>PRODUCT TYPE</b>	N/A
<b>UNIQUE ROOM IDENTIFIER</b>	Rear Lobby	<b>DAMAGE</b>	N/A
<b>DESCRIPTION OF SAMPLE TAKEN OR PRESUMPTION</b>	concrete ceiling, brick walls, concrete floor	<b>SURFACE TREATMENT</b>	N/A
<b>EXTENT</b>	N/A	<b>ASBESTOS TYPE</b>	N/A
<b>ACCESSIBILITY</b>	N/A	<b>MATERIAL ASSESSMENT SCORE</b>	N/A
<b>LEVEL OF IDENTIFICATION</b>	N/A	<b>POTENTIAL TO RELEASE FIBRES</b>	N/A
<b>RECOMMENDATIONS</b> <b>No Further Action Required</b>		<b>COMMENTS</b> <b>No Asbestos Containing Materials Found</b>

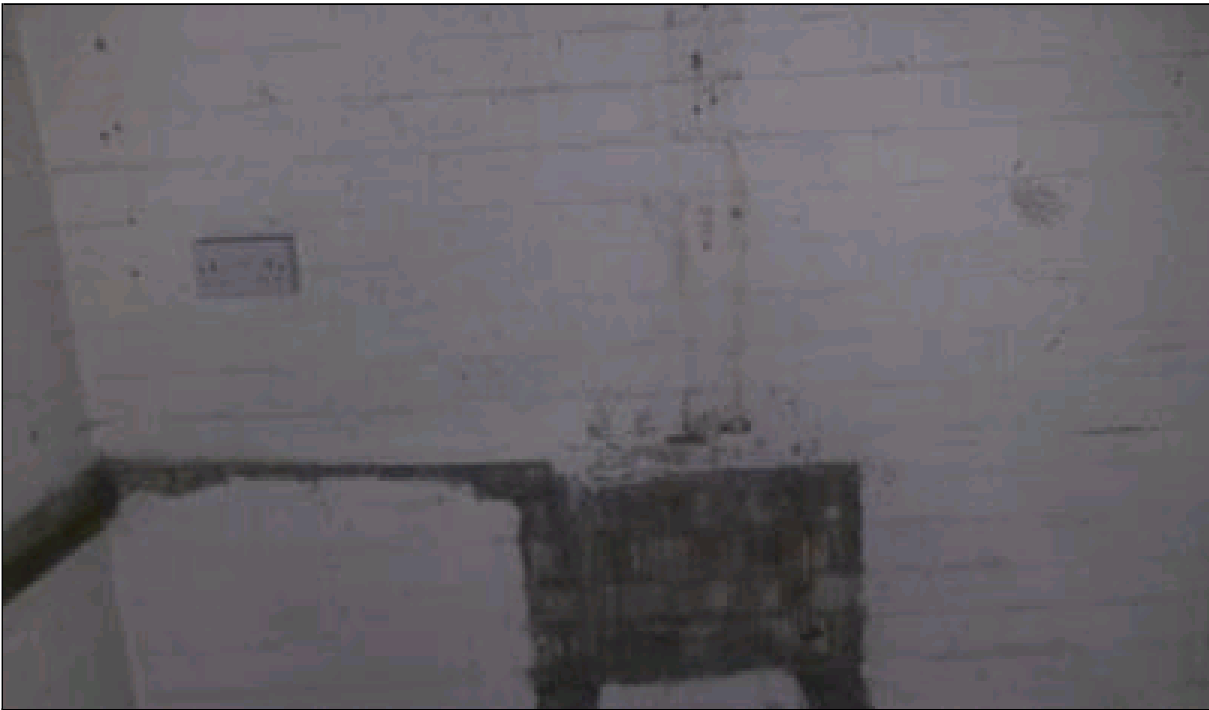
<b>SAMPLE REFERENCE</b>	Item No: 16	<b>ASBESTOS</b>	<b>N/A</b>
<b>PRESUMPTION REFERENCE</b>	N/A	<b>RISK LEVEL</b>	<b>N/A</b>

<b>AREA</b>	Internal	<b>MATERIAL ASSESSMENT</b>	
<b>FLOOR</b>	Ground Floor	<b>PRODUCT TYPE</b>	N/A
<b>UNIQUE ROOM IDENTIFIER</b>	Utility Room	<b>DAMAGE</b>	N/A
<b>DESCRIPTION OF SAMPLE TAKEN OR PRESUMPTION</b>	concrete ceiling above fibre board, brick walls, concrete floor	<b>SURFACE TREATMENT</b>	N/A
<b>EXTENT</b>	N/A	<b>ASBESTOS TYPE</b>	N/A
<b>ACCESSIBILITY</b>	N/A	<b>MATERIAL ASSESSMENT SCORE</b>	N/A
<b>LEVEL OF IDENTIFICATION</b>	N/A	<b>POTENTIAL TO RELEASE FIBRES</b>	N/A
<b>RECOMMENDATIONS</b> <b>No Further Action Required</b>		<b>COMMENTS</b> <b>No Asbestos Containing Materials Found</b>

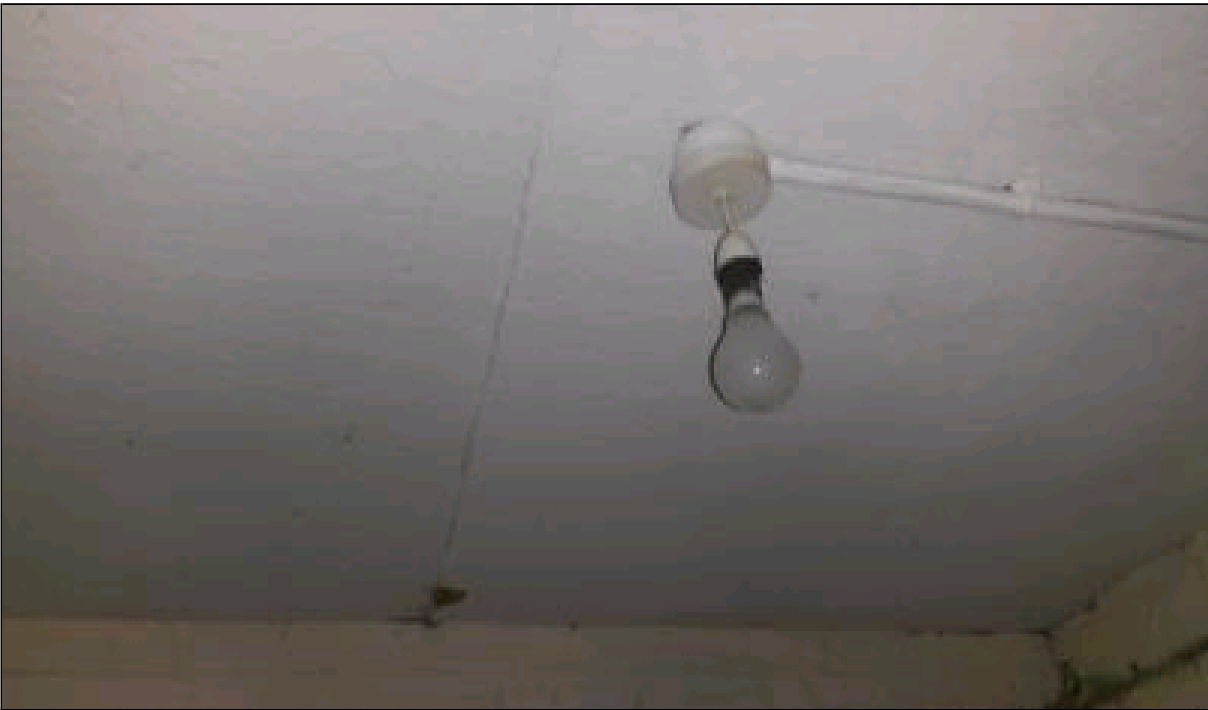
<b>SAMPLE REFERENCE</b>	AE003839	<b>ASBESTOS</b>	<b>NO</b>
<b>PRESUMPTION REFERENCE</b>	N/A	<b>RISK LEVEL</b>	N/A

<b>AREA</b>	Internal	<b>MATERIAL ASSESSMENT</b>	
<b>FLOOR</b>	Ground Floor	<b>PRODUCT TYPE</b>	0 - NADIS
<b>UNIQUE ROOM IDENTIFIER</b>	Utility Room	<b>DAMAGE</b>	0 - NADIS
<b>DESCRIPTION OF SAMPLE TAKEN OR PRESUMPTION</b>	fibre board ceiling	<b>SURFACE TREATMENT</b>	0 - NADIS
<b>EXTENT</b>	6 Sq. m	<b>ASBESTOS TYPE</b>	0 - NADIS
<b>ACCESSIBILITY</b>	Low	<b>MATERIAL ASSESSMENT SCORE</b>	0
<b>LEVEL OF IDENTIFICATION</b>	Sampled	<b>POTENTIAL TO RELEASE FIBRES</b>	N/A
<b>RECOMMENDATIONS</b> No Further Action Required		<b>COMMENTS</b> No Asbestos Detected in Sample

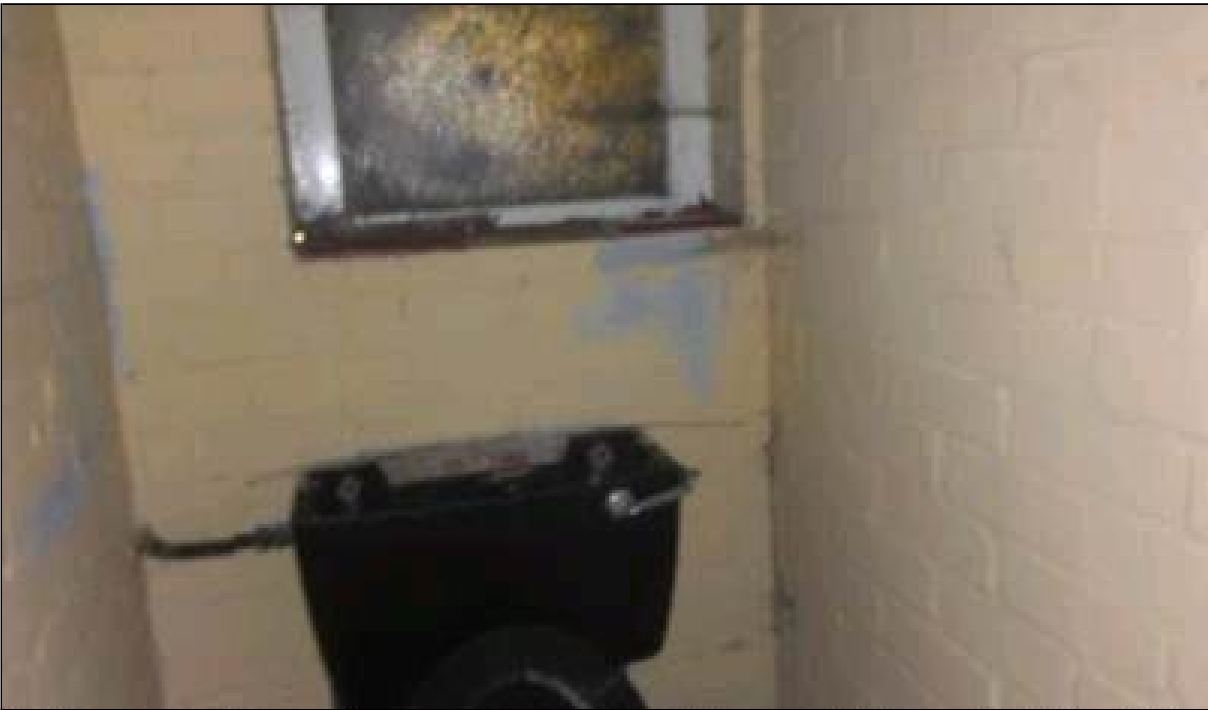
<b>SAMPLE REFERENCE</b>	Item No: 18	<b>ASBESTOS</b>	<b>N/A</b>
<b>PRESUMPTION REFERENCE</b>	N/A	<b>RISK LEVEL</b>	<b>N/A</b>

<b>AREA</b>	Internal	<b>MATERIAL ASSESSMENT</b>	
<b>FLOOR</b>	Ground Floor	<b>PRODUCT TYPE</b>	N/A
<b>UNIQUE ROOM IDENTIFIER</b>	WC 1	<b>DAMAGE</b>	N/A
<b>DESCRIPTION OF SAMPLE TAKEN OR PRESUMPTION</b>	concrete ceiling, brick walls, concrete floor below carpet	<b>SURFACE TREATMENT</b>	N/A
<b>EXTENT</b>	N/A	<b>ASBESTOS TYPE</b>	N/A
<b>ACCESSIBILITY</b>	N/A	<b>MATERIAL ASSESSMENT SCORE</b>	N/A
<b>LEVEL OF IDENTIFICATION</b>	N/A	<b>POTENTIAL TO RELEASE FIBRES</b>	N/A
<b>RECOMMENDATIONS</b> No Further Action Required		<b>COMMENTS</b> No Asbestos Containing Materials Found

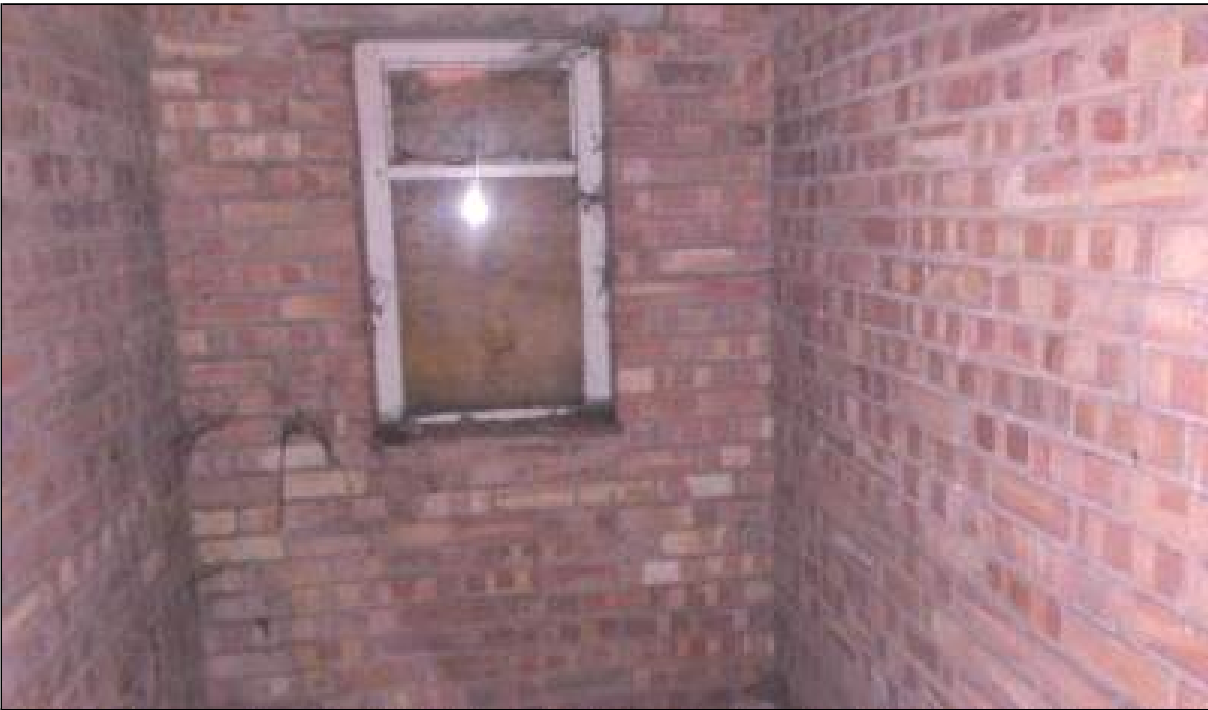
<b>SAMPLE REFERENCE</b>	Item No: 20	<b>ASBESTOS</b>	<b>N/A</b>
<b>PRESUMPTION REFERENCE</b>	N/A	<b>RISK LEVEL</b>	<b>N/A</b>

<b>AREA</b>	Internal	<b>MATERIAL ASSESSMENT</b>	
<b>FLOOR</b>	Ground Floor	<b>PRODUCT TYPE</b>	N/A
<b>UNIQUE ROOM IDENTIFIER</b>	Store	<b>DAMAGE</b>	N/A
<b>DESCRIPTION OF SAMPLE TAKEN OR PRESUMPTION</b>	concrete ceiling, brick walls, concrete floor	<b>SURFACE TREATMENT</b>	N/A
<b>EXTENT</b>	N/A	<b>ASBESTOS TYPE</b>	N/A
<b>ACCESSIBILITY</b>	N/A	<b>MATERIAL ASSESSMENT SCORE</b>	N/A
<b>LEVEL OF IDENTIFICATION</b>	N/A	<b>POTENTIAL TO RELEASE FIBRES</b>	N/A
<b>RECOMMENDATIONS</b> <b>No Further Action Required</b>		<b>COMMENTS</b> <b>No Asbestos Containing Materials Found</b>

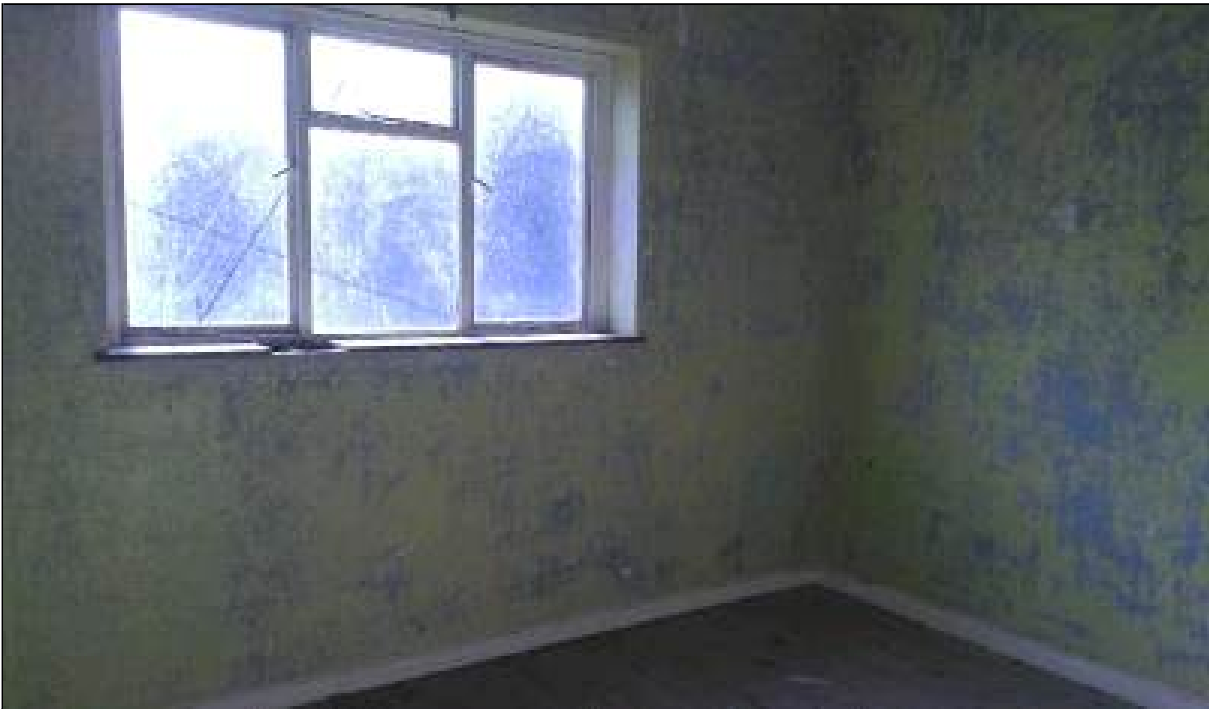
<b>SAMPLE REFERENCE</b>	Item No: 21	<b>ASBESTOS</b>	<b>N/A</b>
<b>PRESUMPTION REFERENCE</b>	N/A	<b>RISK LEVEL</b>	<b>N/A</b>

<b>AREA</b>	Internal	<b>MATERIAL ASSESSMENT</b>	
<b>FLOOR</b>	1st Floor	<b>PRODUCT TYPE</b>	N/A
<b>UNIQUE ROOM IDENTIFIER</b>	Bedroom 2 and Cpd	<b>DAMAGE</b>	N/A
<b>DESCRIPTION OF SAMPLE TAKEN OR PRESUMPTION</b>	lath and plaster ceiling, plaster finish to brick and block walls, timber floor, empty wall cavity below window	<b>SURFACE TREATMENT</b>	N/A
<b>EXTENT</b>	N/A	<b>ASBESTOS TYPE</b>	N/A
<b>ACCESSIBILITY</b>	N/A	<b>MATERIAL ASSESSMENT SCORE</b>	N/A
<b>LEVEL OF IDENTIFICATION</b>	N/A	<b>POTENTIAL TO RELEASE FIBRES</b>	N/A
<b>RECOMMENDATIONS</b> <b>No Further Action Required</b>		<b>COMMENTS</b> <b>No Asbestos Containing Materials Found</b>

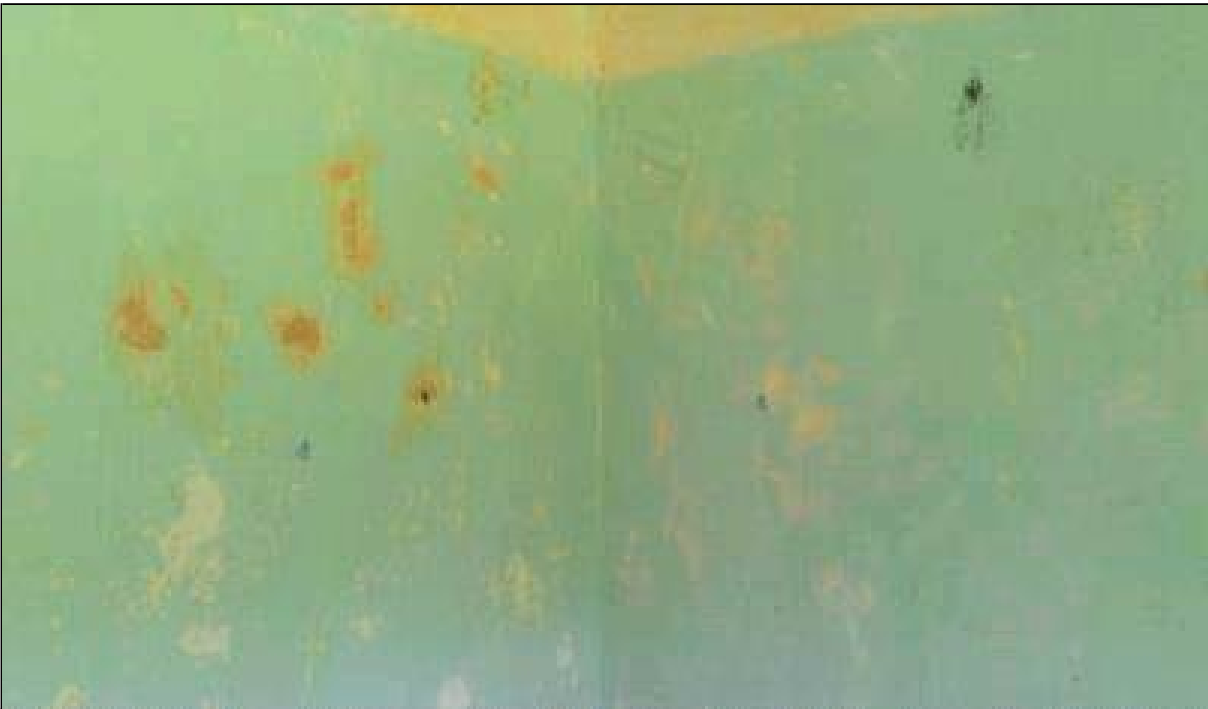
<b>SAMPLE REFERENCE</b>	Item No: 22	<b>ASBESTOS</b>	<b>N/A</b>
<b>PRESUMPTION REFERENCE</b>	N/A	<b>RISK LEVEL</b>	<b>N/A</b>

<b>AREA</b>	Internal	<b>MATERIAL ASSESSMENT</b>	
<b>FLOOR</b>	1st Floor	<b>PRODUCT TYPE</b>	N/A
<b>UNIQUE ROOM IDENTIFIER</b>	Bedroom 3 and Cpd	<b>DAMAGE</b>	N/A
<b>DESCRIPTION OF SAMPLE TAKEN OR PRESUMPTION</b>	plasterboard ceiling, plaster finish to brick and block walls, timber floor, empty wall cavity below window	<b>SURFACE TREATMENT</b>	N/A
<b>EXTENT</b>	N/A	<b>ASBESTOS TYPE</b>	N/A
<b>ACCESSIBILITY</b>	N/A	<b>MATERIAL ASSESSMENT SCORE</b>	N/A
<b>LEVEL OF IDENTIFICATION</b>	N/A	<b>POTENTIAL TO RELEASE FIBRES</b>	N/A
<b>RECOMMENDATIONS</b> <b>No Further Action Required</b>		<b>COMMENTS</b> <b>No Asbestos Containing Materials Found</b>

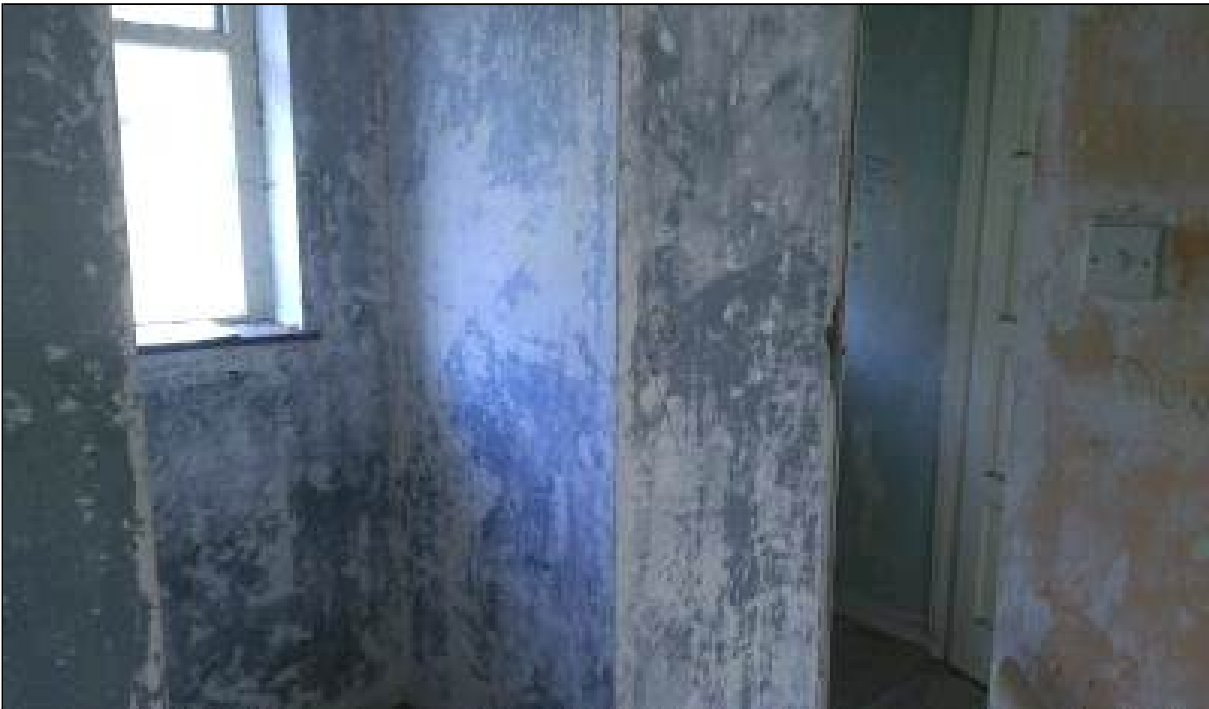
<b>SAMPLE REFERENCE</b>	Item No: 24	<b>ASBESTOS</b>	<b>N/A</b>
<b>PRESUMPTION REFERENCE</b>	N/A	<b>RISK LEVEL</b>	<b>N/A</b>

<b>AREA</b>	Internal	<b>MATERIAL ASSESSMENT</b>	
<b>FLOOR</b>	1st Floor	<b>PRODUCT TYPE</b>	N/A
<b>UNIQUE ROOM IDENTIFIER</b>	Landing	<b>DAMAGE</b>	N/A
<b>DESCRIPTION OF SAMPLE TAKEN OR PRESUMPTION</b>	plasterboard ceiling, plaster finish to brick and block walls, timber floor, empty wall cavity below window, timber built lowered ceiling down the stairs	<b>SURFACE TREATMENT</b>	N/A
<b>EXTENT</b>	N/A	<b>ASBESTOS TYPE</b>	N/A
<b>ACCESSIBILITY</b>	N/A	<b>MATERIAL ASSESSMENT SCORE</b>	N/A
<b>LEVEL OF IDENTIFICATION</b>	N/A	<b>POTENTIAL TO RELEASE FIBRES</b>	N/A
<b>RECOMMENDATIONS</b> No Further Action Required		<b>COMMENTS</b> No Asbestos Containing Materials Found

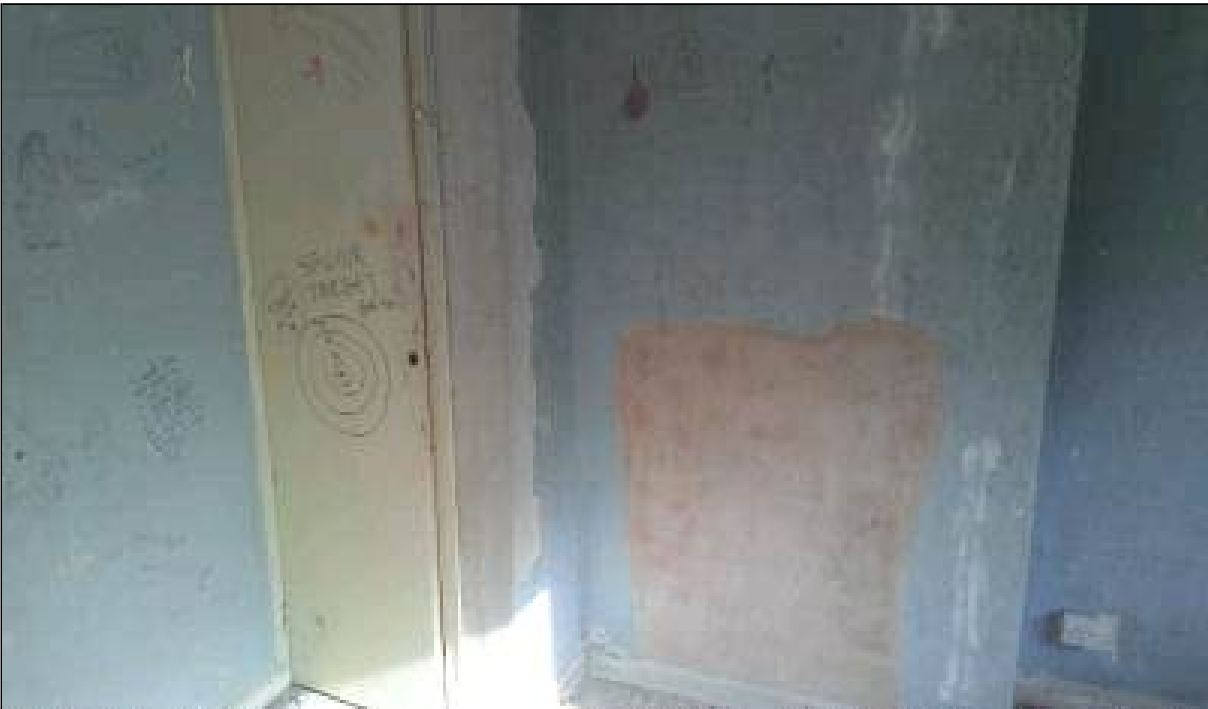
<b>SAMPLE REFERENCE</b>	Item No: 26	<b>ASBESTOS</b>	<b>N/A</b>
<b>PRESUMPTION REFERENCE</b>	N/A	<b>RISK LEVEL</b>	<b>N/A</b>

<b>AREA</b>	Internal	<b>MATERIAL ASSESSMENT</b>	
<b>FLOOR</b>	1st Floor	<b>PRODUCT TYPE</b>	N/A
<b>UNIQUE ROOM IDENTIFIER</b>	Bedroom 1 and Cpd's	<b>DAMAGE</b>	N/A
<b>DESCRIPTION OF SAMPLE TAKEN OR PRESUMPTION</b>	lath and plaster ceiling, plaster finish to brick and block walls, timber floor, empty wall cavity below window	<b>SURFACE TREATMENT</b>	N/A
<b>EXTENT</b>	N/A	<b>ASBESTOS TYPE</b>	N/A
<b>ACCESSIBILITY</b>	N/A	<b>MATERIAL ASSESSMENT SCORE</b>	N/A
<b>LEVEL OF IDENTIFICATION</b>	N/A	<b>POTENTIAL TO RELEASE FIBRES</b>	N/A
<b>RECOMMENDATIONS</b> <b>No Further Action Required</b>		<b>COMMENTS</b> <b>No Asbestos Containing Materials Found</b>

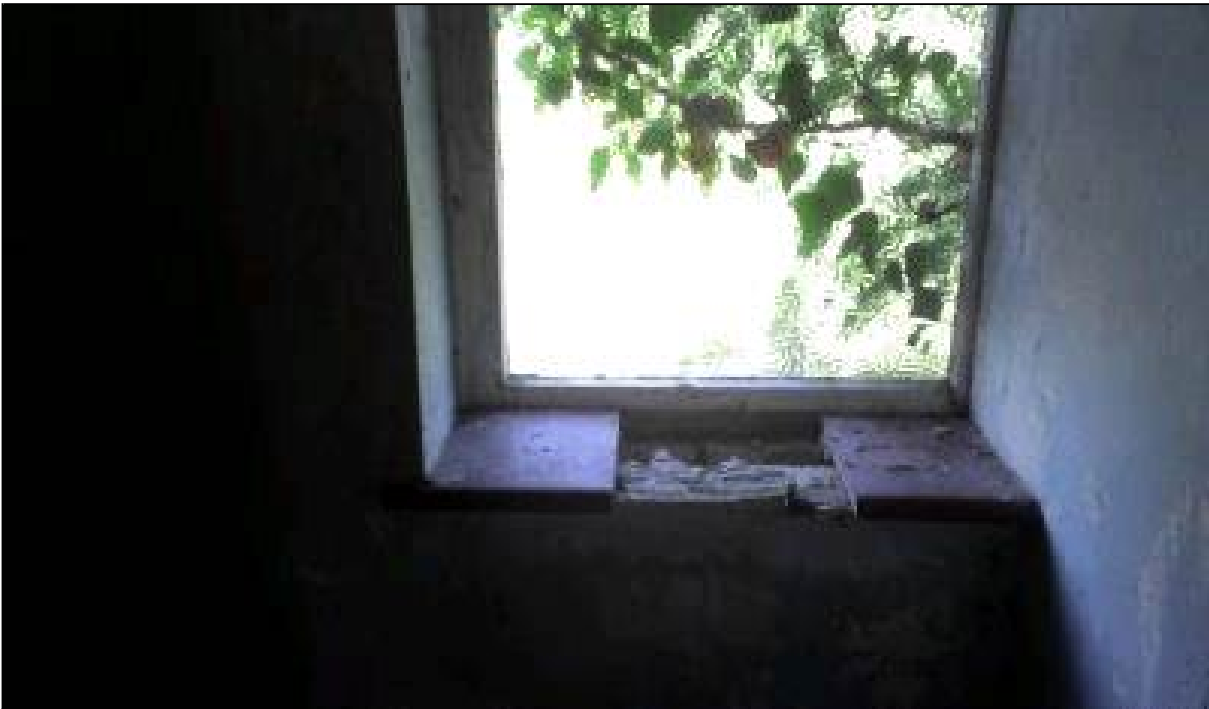
<b>SAMPLE REFERENCE</b>	Item No: 27	<b>ASBESTOS</b>	<b>N/A</b>
<b>PRESUMPTION REFERENCE</b>	N/A	<b>RISK LEVEL</b>	<b>N/A</b>

<b>AREA</b>	Internal	<b>MATERIAL ASSESSMENT</b>	
<b>FLOOR</b>	1st Floor	<b>PRODUCT TYPE</b>	N/A
<b>UNIQUE ROOM IDENTIFIER</b>	WC 2	<b>DAMAGE</b>	N/A
<b>DESCRIPTION OF SAMPLE TAKEN OR PRESUMPTION</b>	plasterboard ceiling, plaster finish to brick and block walls, timber floor, empty wall cavity below window	<b>SURFACE TREATMENT</b>	N/A
<b>EXTENT</b>	N/A	<b>ASBESTOS TYPE</b>	N/A
<b>ACCESSIBILITY</b>	N/A	<b>MATERIAL ASSESSMENT SCORE</b>	N/A
<b>LEVEL OF IDENTIFICATION</b>	N/A	<b>POTENTIAL TO RELEASE FIBRES</b>	N/A
<b>RECOMMENDATIONS</b> <b>No Further Action Required</b>		<b>COMMENTS</b> <b>No Asbestos Containing Materials Found</b>

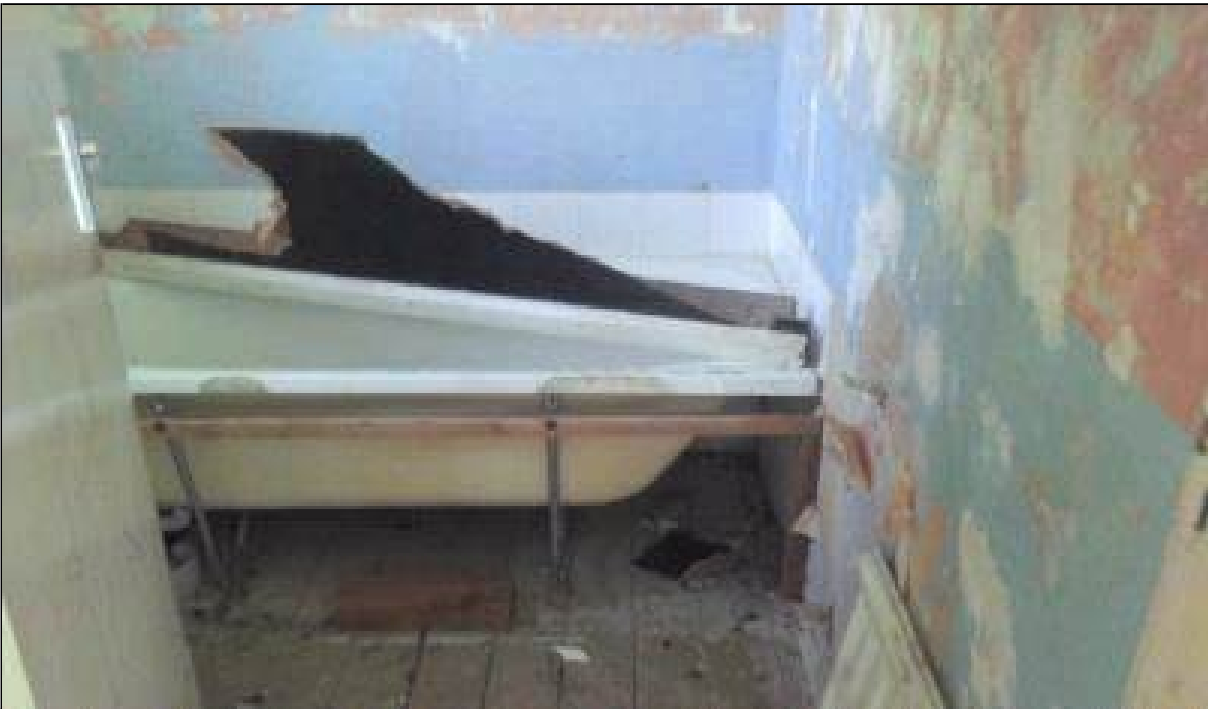
<b>SAMPLE REFERENCE</b>	Item No: 30	<b>ASBESTOS</b>	<b>N/A</b>
<b>PRESUMPTION REFERENCE</b>	N/A	<b>RISK LEVEL</b>	<b>N/A</b>

<b>AREA</b>	Internal	<b>MATERIAL ASSESSMENT</b>	
<b>FLOOR</b>	1st Floor	<b>PRODUCT TYPE</b>	N/A
<b>UNIQUE ROOM IDENTIFIER</b>	Bathroom	<b>DAMAGE</b>	N/A
<b>DESCRIPTION OF SAMPLE TAKEN OR PRESUMPTION</b>	plasterboard ceiling, plaster finish to brick and block walls, timber floor, empty wall cavity below window, timber bath panel	<b>SURFACE TREATMENT</b>	N/A
<b>EXTENT</b>	N/A	<b>ASBESTOS TYPE</b>	N/A
<b>ACCESSIBILITY</b>	N/A	<b>MATERIAL ASSESSMENT SCORE</b>	N/A
<b>LEVEL OF IDENTIFICATION</b>	N/A	<b>POTENTIAL TO RELEASE FIBRES</b>	N/A
<b>RECOMMENDATIONS</b> <b>No Further Action Required</b>		<b>COMMENTS</b> <b>No Asbestos Containing Materials Found</b>

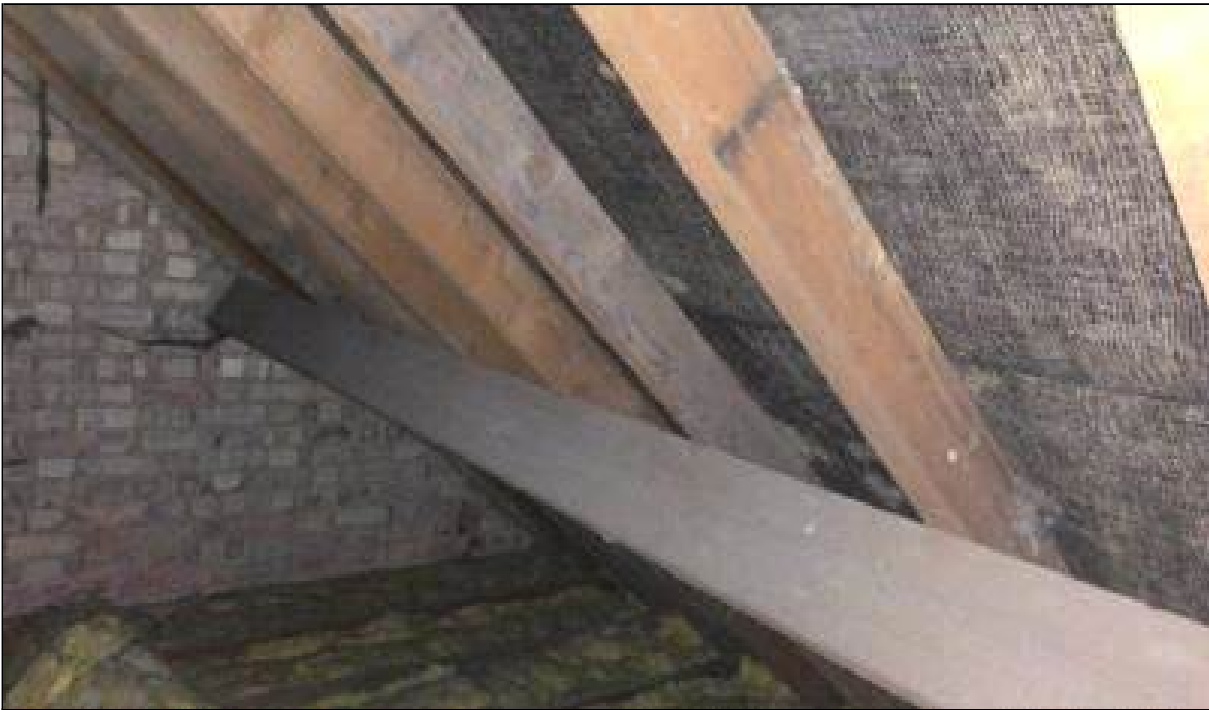
<b>SAMPLE REFERENCE</b>	AE003843	<b>ASBESTOS</b>	<b>NO</b>
<b>PRESUMPTION REFERENCE</b>	N/A	<b>RISK LEVEL</b>	N/A

<b>AREA</b>	Internal	<b>MATERIAL ASSESSMENT</b>	
<b>FLOOR</b>	Roof Void	<b>PRODUCT TYPE</b>	0 - NADIS
<b>UNIQUE ROOM IDENTIFIER</b>	Loft	<b>DAMAGE</b>	0 - NADIS
<b>DESCRIPTION OF SAMPLE TAKEN OR PRESUMPTION</b>	felt lining	<b>SURFACE TREATMENT</b>	0 - NADIS
<b>EXTENT</b>	50 Sq. m	<b>ASBESTOS TYPE</b>	0 - NADIS
<b>ACCESSIBILITY</b>	Low	<b>MATERIAL ASSESSMENT SCORE</b>	0
<b>LEVEL OF IDENTIFICATION</b>	Sampled	<b>POTENTIAL TO RELEASE FIBRES</b>	N/A
<b>RECOMMENDATIONS</b> No Further Action Required		<b>COMMENTS</b> No Asbestos Detected in Sample

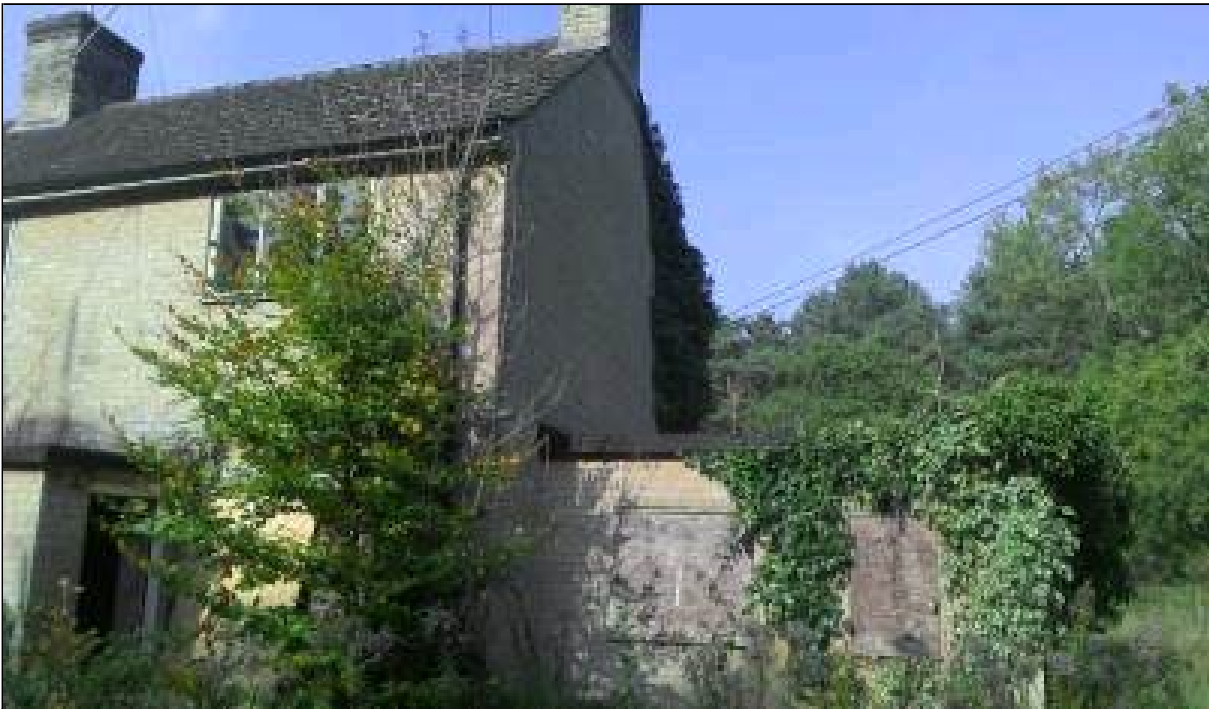
<b>SAMPLE REFERENCE</b>	Item No: 34	<b>ASBESTOS</b>	<b>N/A</b>
<b>PRESUMPTION REFERENCE</b>	N/A	<b>RISK LEVEL</b>	<b>N/A</b>

<b>AREA</b>	External	<b>MATERIAL ASSESSMENT</b>	
<b>FLOOR</b>	External	<b>PRODUCT TYPE</b>	N/A
<b>UNIQUE ROOM IDENTIFIER</b>	External	<b>DAMAGE</b>	N/A
<b>DESCRIPTION OF SAMPLE TAKEN OR PRESUMPTION</b>	clay tiles and felt roofs, brick walls, upvc fascia, cement and concrete soffits, plastic and metal rain water goods, timber windows, upvc and timber doors	<b>SURFACE TREATMENT</b>	N/A
<b>EXTENT</b>	N/A	<b>ASBESTOS TYPE</b>	N/A
<b>ACCESSIBILITY</b>	N/A	<b>MATERIAL ASSESSMENT SCORE</b>	N/A
<b>LEVEL OF IDENTIFICATION</b>	N/A	<b>POTENTIAL TO RELEASE FIBRES</b>	N/A
<b>RECOMMENDATIONS</b> No Further Action Required		<b>COMMENTS</b> No Asbestos Containing Materials Found

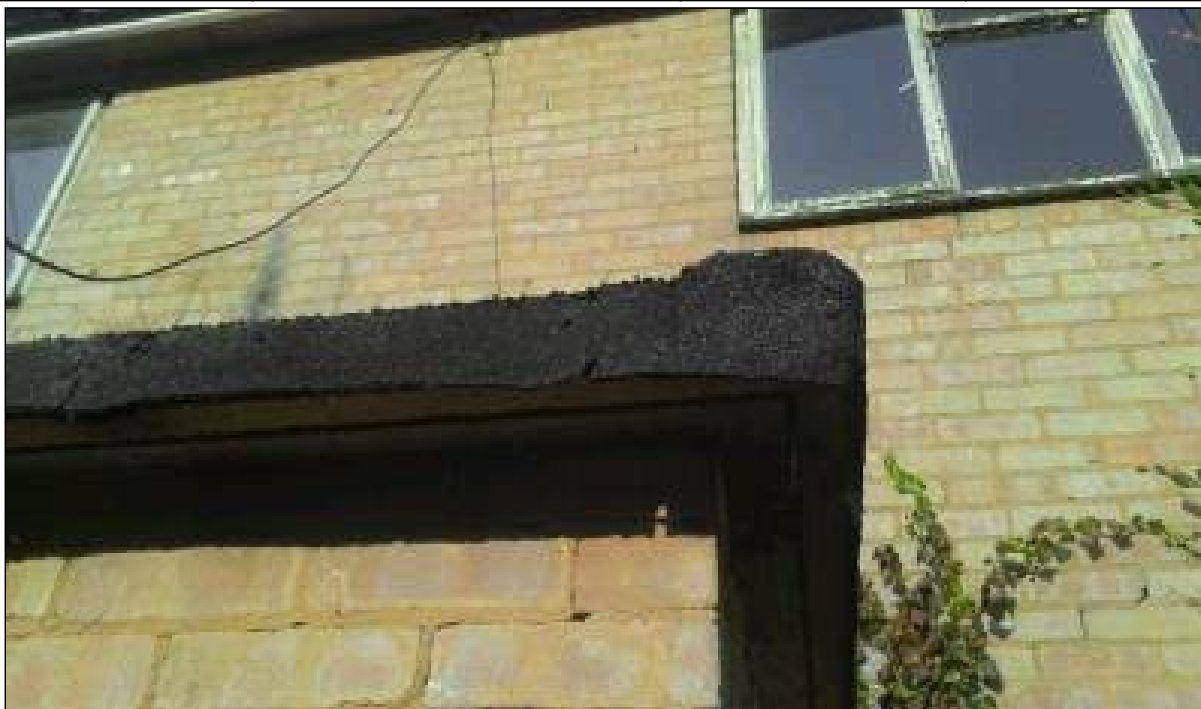
<b>SAMPLE REFERENCE</b>	AE003845	<b>ASBESTOS</b>	<b>NO</b>
<b>PRESUMPTION REFERENCE</b>	N/A	<b>RISK LEVEL</b>	N/A

<b>AREA</b>	External	<b>MATERIAL ASSESSMENT</b>	
<b>FLOOR</b>	External	<b>PRODUCT TYPE</b>	0 - NADIS
<b>UNIQUE ROOM IDENTIFIER</b>	External	<b>DAMAGE</b>	0 - NADIS
<b>DESCRIPTION OF SAMPLE TAKEN OR PRESUMPTION</b>	felt to flat roofs	<b>SURFACE TREATMENT</b>	0 - NADIS
<b>EXTENT</b>	20 Sq. m	<b>ASBESTOS TYPE</b>	0 - NADIS
<b>ACCESSIBILITY</b>	Low	<b>MATERIAL ASSESSMENT SCORE</b>	0
<b>LEVEL OF IDENTIFICATION</b>	Sampled	<b>POTENTIAL TO RELEASE FIBRES</b>	N/A
<b>RECOMMENDATIONS</b> No Further Action Required		<b>COMMENTS</b> No Asbestos Detected in Sample
