# BUILDING SURVEY

Radford House,  
18-20 Effingham Street,  
Ramsgate,  
Kent,  
CT11 9AT.

**Working DRAFT**

Ramsgate Town Council

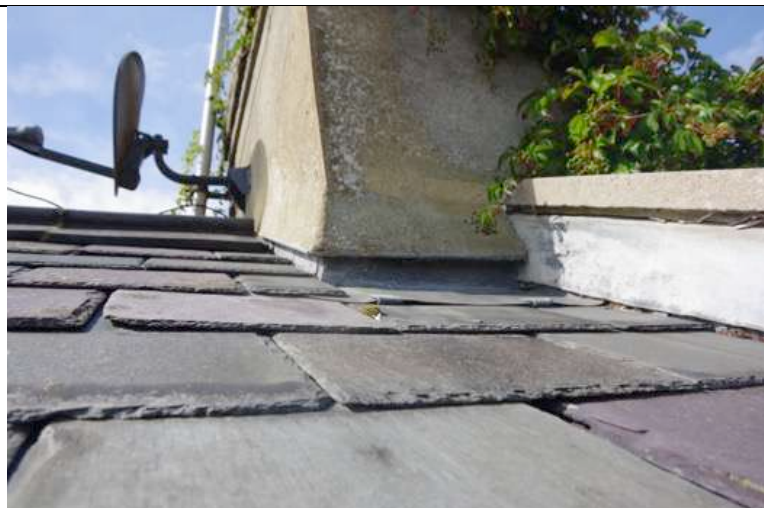
The OPC mortars at the crown areas of the chimney stacks and the flaunching have failed, particularly at the flaunching. The failed mortars need removing and redoing with a specified lime mortar. The flashings under the OPC mortars will need attention or replacement.

Note;  
Cracked and failing OPC mortars

It should be noted that stripping all of the OPC mortars from the parapets and stacks may cause irreversible damage to the bricks where it is firmly attached. Localised repairs would be the initial approach. Some design work needs to go into the repair mortar mix so as to produce a 'harmonised' finish. The flaunching can be done with a NHL 5 (Natural Hydraulic Lime) mortar mix.

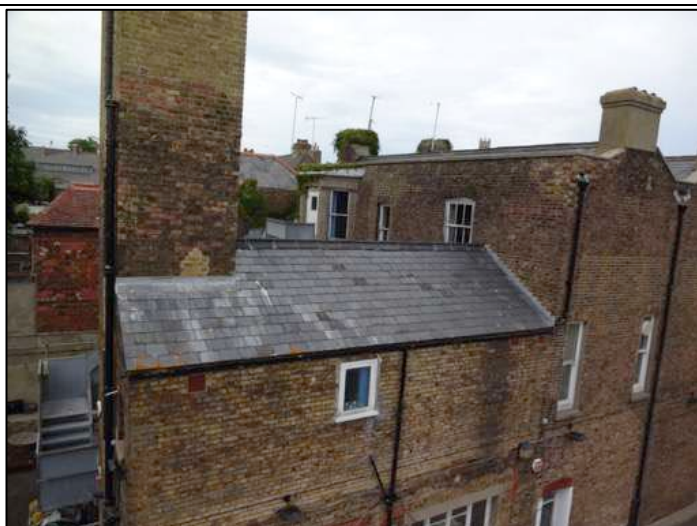
**The left-hand pitch of Rear Wing**

Note; roof cut around training tower

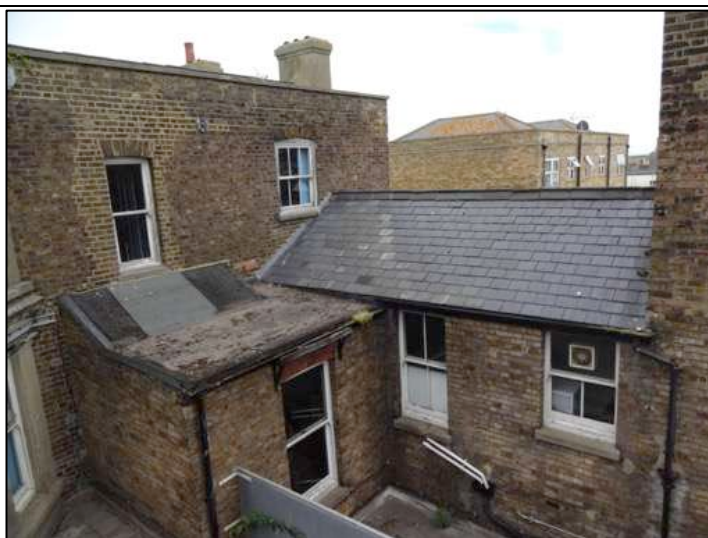
**The right-hand pitch of Rear Wing**

There is some poor detailing where the right-hand pitch meets the building. The roof line is too high, this has led to the flashing clashing with the window cill and attempts to repair/ get over this have been made using OPC mortars. It should be noted that a defective window sill can soak a building's wall; the wall internally has been dry-lined with a plastic sheet incorporated, indicating rainwater penetration. The OPC mortars will need to be stripped from the flashing and the window sill, the lead work inspected and an on-site remedy/ developed.

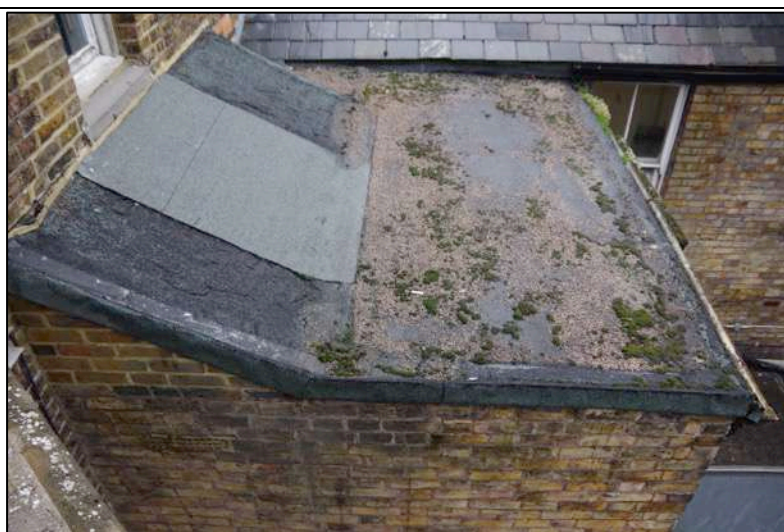
The roofs timber structure has mineral bitumen felt covering. The roof has been patch repaired relatively recently. The roof covering is failing and it's at the end of its life – the roof was found to be leaking after heavy rainfall. The roof needs replacing. Temporary repairs need executing particularly where the felt has been poorly flashed into the wall as there are signs of long term water damage in the ceilings below. The roof was found to be leaking after heavy rainfall in November. This the roof also clashes with the window sill above it.

This roof is what is known as 'cold deck' but there is no provision for cross-flow ventilation. Cross-flow ventilation is essential in this roof type (cold deck) to remove any condensation, which will tend to form on the underside of the decking material and cause problems such as black mould formation and timber decay.

The flat roof over the stair well

When the flat roof covering is replaced, a well designed hybrid warm deck could be used to avoid problems associated with cold decks. See this web page for clear explanations of roof types; <http://www.classicroofing.ie/docs/insulated.html>

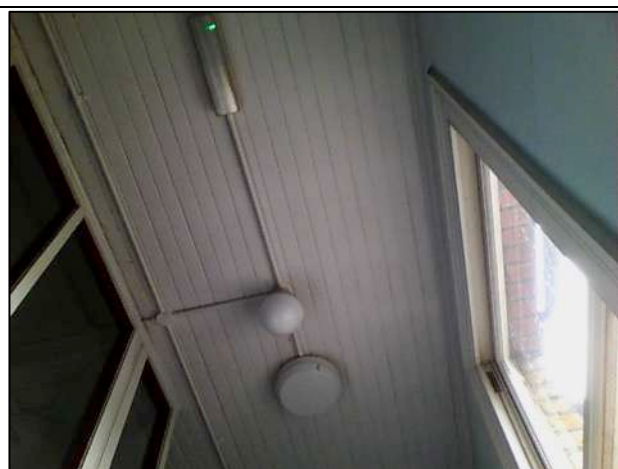
## Comparative Digital Photograph

- Excessive heat gain during the summer seen by the bright colours in the image will translate to excessive heat loss in the winter
- Condensation will be forming on the building fabric inside the roof space

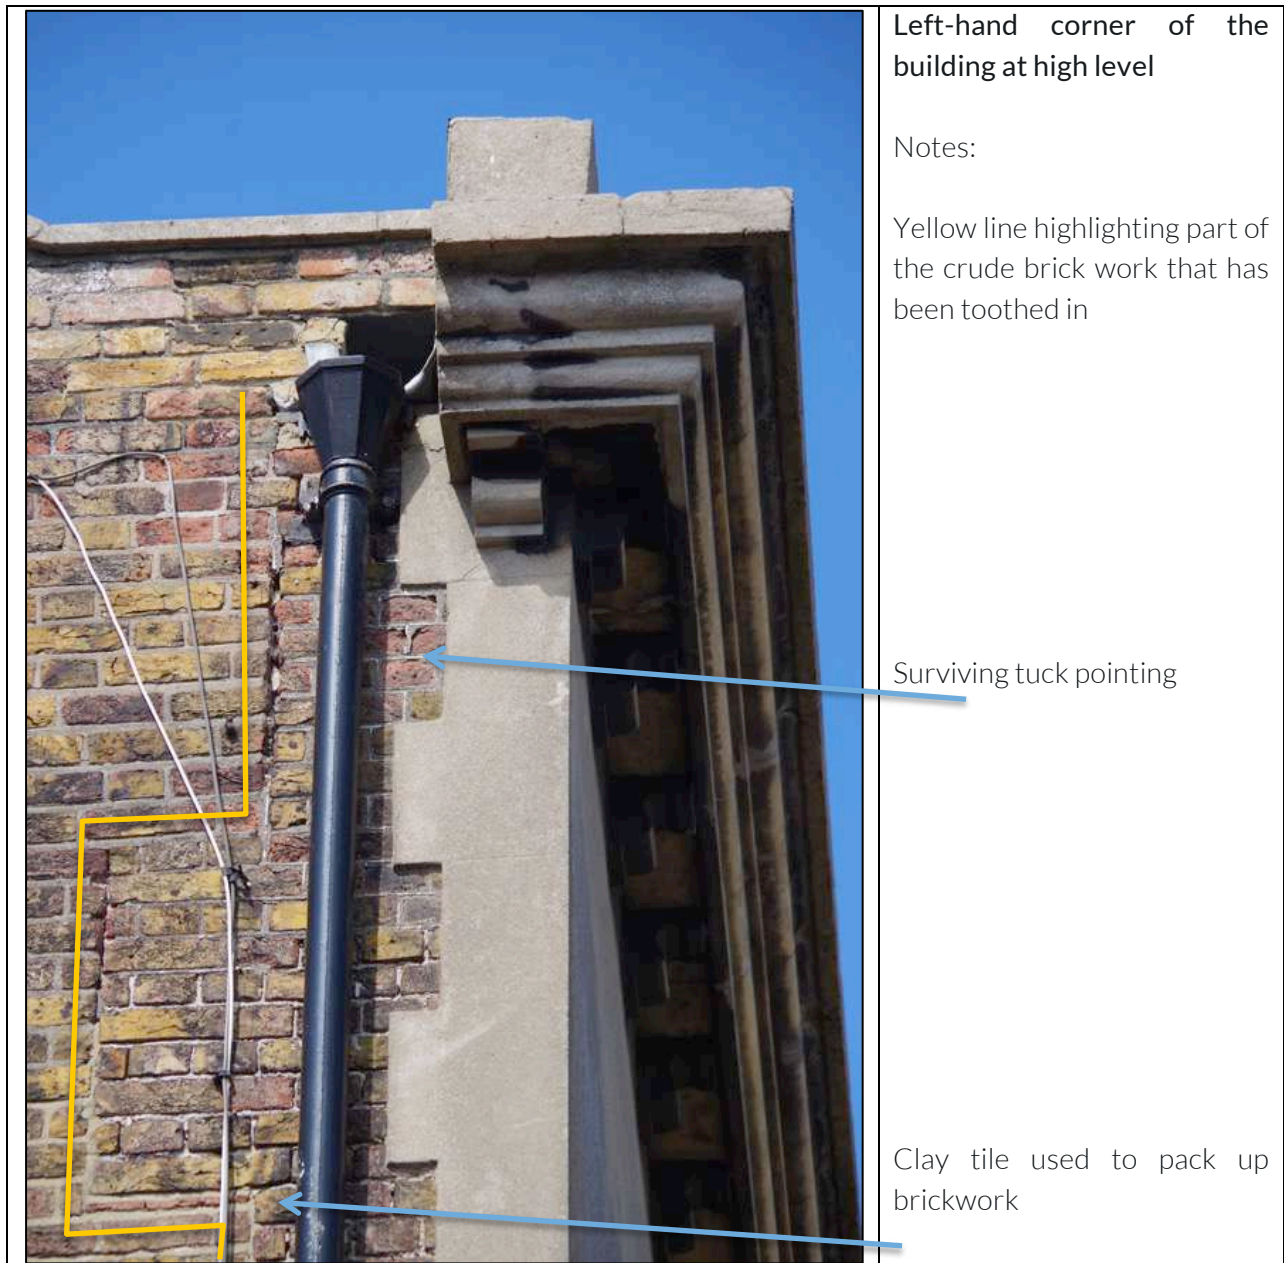
There is cracking all over the render, which is fairly typical as the cements are relatively brittle and do not have the ability to flex with the building as it moves during the seasons.

The top of the masonry/ parapet at the front elevation as explained earlier in this report is missing its coping stones. The render that forms cornice capping has cracked extensively.

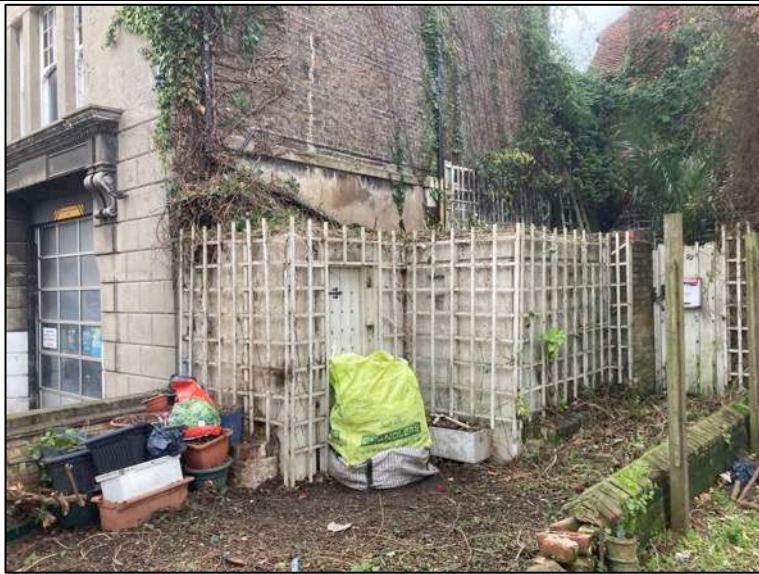
The right-hand flank has had various OPC repairs and the wall has been rendered with a cementitious render up to first floor level but more significantly, a single story structure, with a wall at the neighbouring property at 22 Effingham Street has been built up against the Main Building towards wall at the front of it. The single story structure is in a dilapidated condition and the foliage has exploited the joint between it and the main building, rainwater will be penetrating into the buildings fabric here. The render at the side of the main building has cracked. Accessed inspection is required

The single story structure at 22 Effingham Street

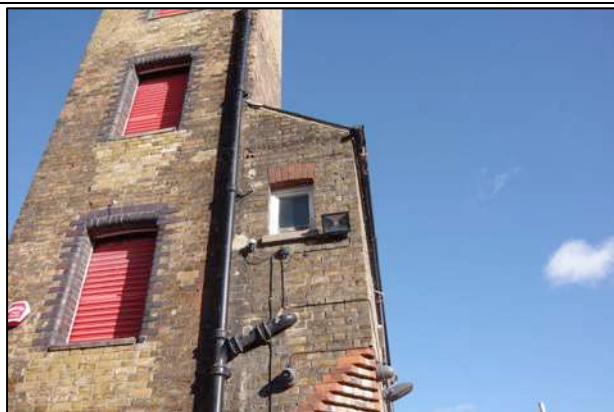
The end of the rear wing where its been built around The Tower

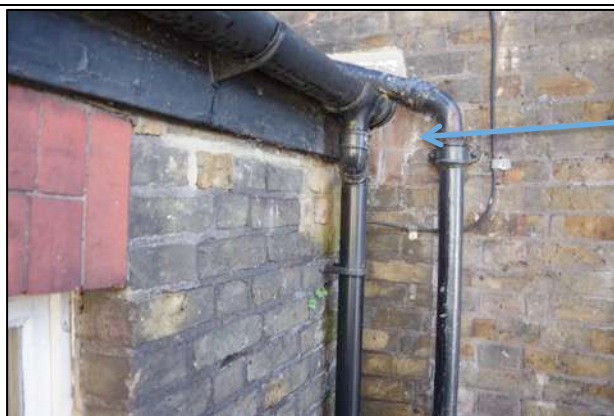
Remains of an arch where the toilet extension has been built onto the rear wing

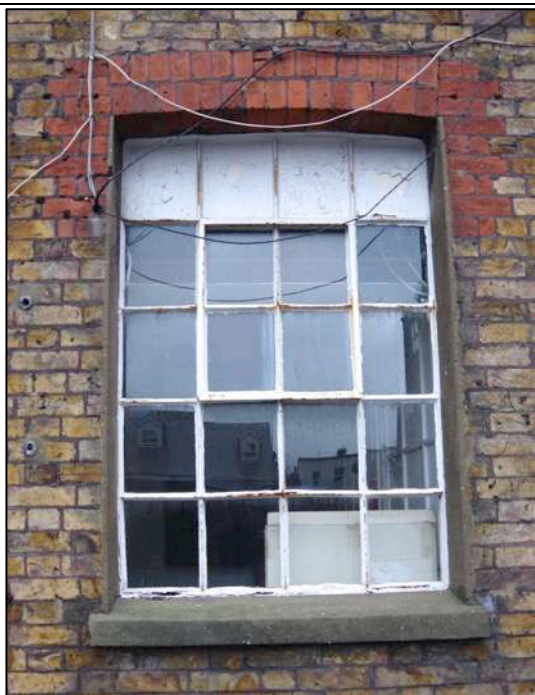
The 'Hopper' window at the rear Watch Room

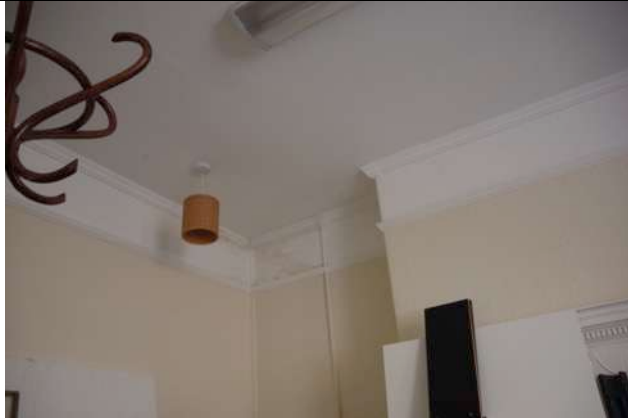
<p>Surviving Georgian cornice inside the cupboard at the front right-hand room</p>

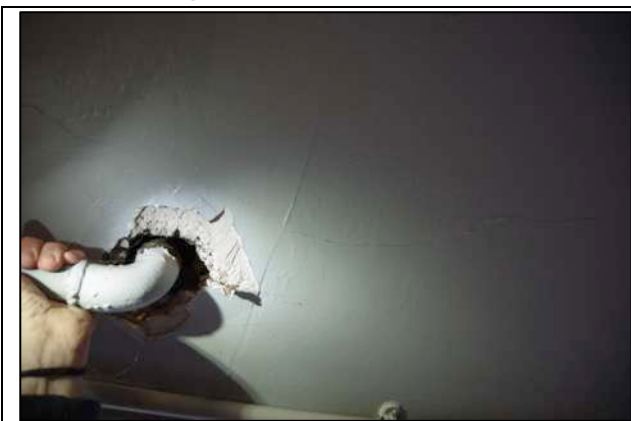
**Holes in ceilings:** Appliance Bay

Note; all the pipes/services etc. that penetrate the fire breaks/fire compartments need to be checked for fire stopping and upgraded where necessary. It should also be noted that none of the buildings pipework's have been sleeved. Any pipe work that penetrates masonry (or concrete) should be sleeved with a material that has the same abrasive resistance as the pipe it protects; this is to protect the pipe from damage caused by chafe and thermal expansion. Any pipes that penetrate masonry without being sleeved are prone to leaks.

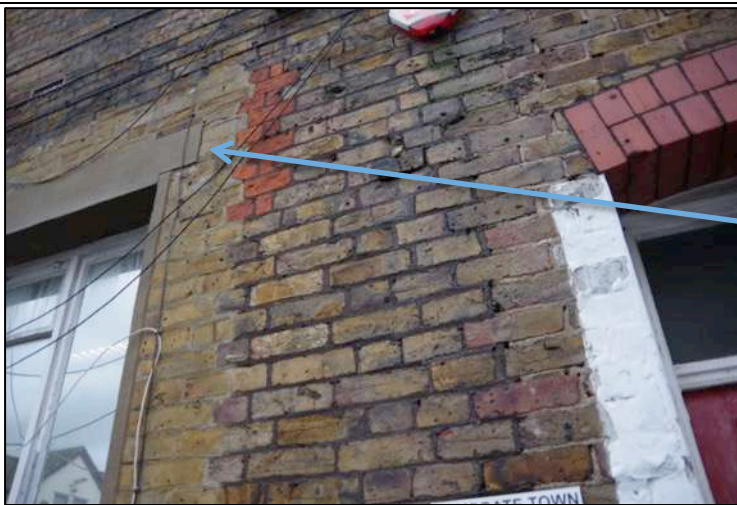
There is damp related damage to the plaster by the structural opening for the main Crital window, to the left, as seen facing. This is being caused by the leaking gutter and excessive rainwater on the masonry below it. The masonry around the window is made up of bricks bedded and pointed with cement, there are gaps in the mortar at the top of the lintel right corner, which will be allowing rainwater penetration. The rainwater is being trapped between the cement work on both sides of the wall causing hydrostatic pressure to build up, which in turn has blown the plaster. It should be noted that hydrostatic pressure can build up to 1 Bar/ 15 PSI in and around masonry that has been covered with impermeable materials. This is enough to 'blow' cement plasters and plastic paints off the wall.

Hydrostatic pressure blowing the impermeable materials off of the wall in the front Watch Room
