Report No **NACS/2939** for

Lombardy Lodge
Portland Road
Toton

ASBESTOS SURVEY REPORT 2939

Name and Address of Client 650	Property Name ,Address & Ref No 4975
Broxtowe Borough Council	Lombardy Lodge
Chief Executive Department	Portland Road
Town Hall, Foster Avenue, Beeston	Toton
Nottingham	Notts
NG9 1AB	
Type of Survey	Related Documents
Type 2 full survey	BS report 8233
Nature of Clients Request	Air report -
Carry Out Type 2 Surveys (communal To Residences)	Plan report 29266v1, 29267v1.
Name of surveyor(s)	Photo file 17515-17521, 20936-20942
SD Smith/I Haney	Register 4078
Survey Limitations	Priority One -
Communal areas	Misc documents
	Survey Date 9.6.2005 Report Date 30.6.2005

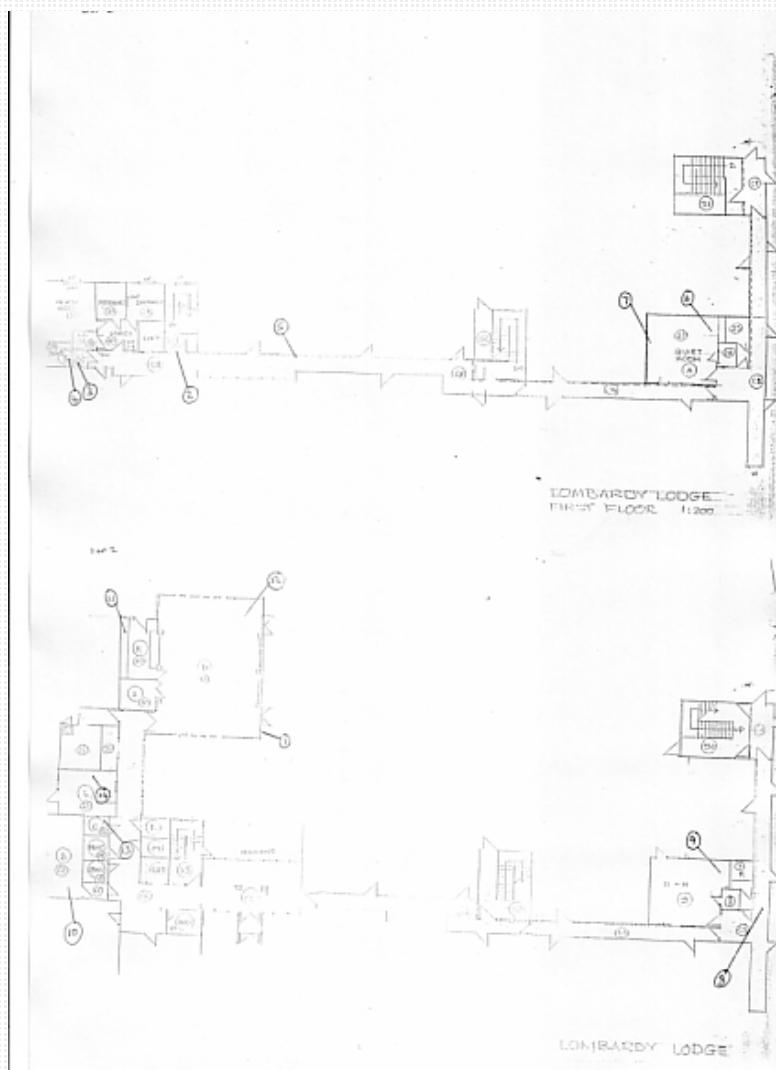
SAMPLING PLAN DIAGRAM

SAMPLES TAKEN AT Lombardy Lodge Portland Road, Toton, Notts,	ON 9.6.2005	SAMPLES TAKEN BY I Haney	SAMPLING STRATEGY NACS
PROJECT NO.	Building I D On This Report Lombardy Lodge		Clients Building Name
