# CONDITION SURVEY

## HOP POLE INN, LIMPLEY STOKE

HBA 345 – 21<sup>st</sup> NOVEMBER 2022

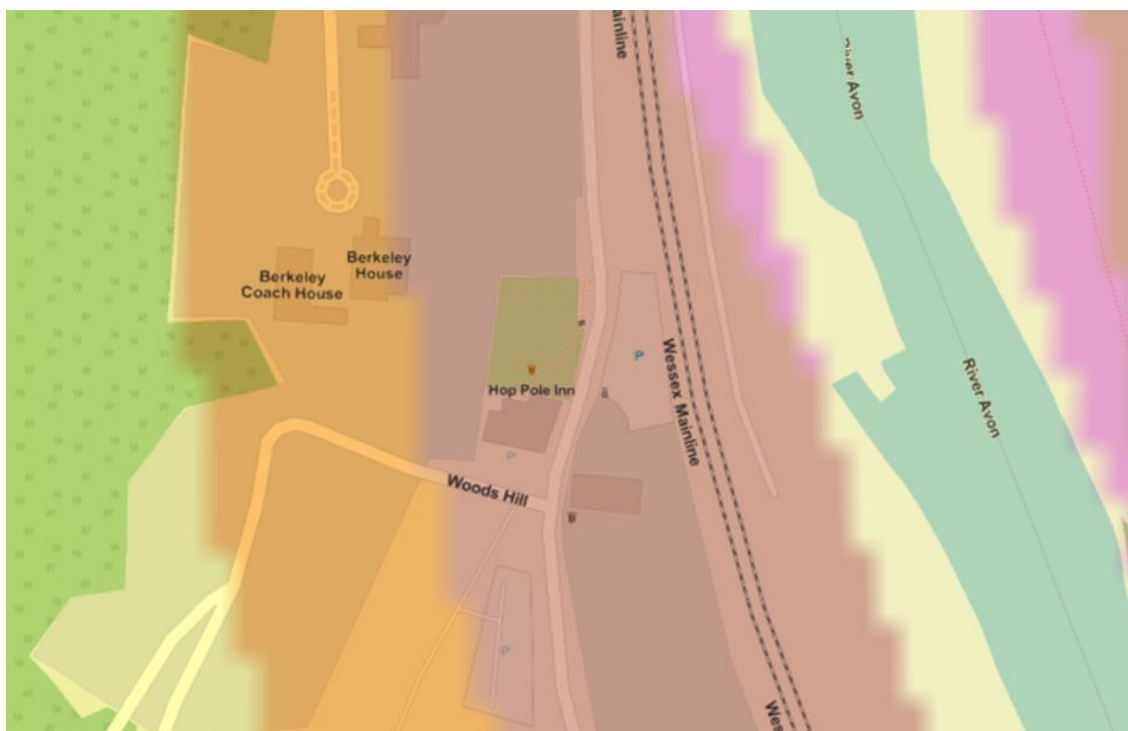
- 2.1.4 There is clearly a major issue at the west end of the building where the building is extremely saturated and has been for a considerable time. The level of saturation is so severe that it can not be reasonably attributed to penetrating or rising damp but has to relate to an active water source. Obvious candidates are services which run in the neighbouring drive but equally likely is a spring and or ground water. The geology on the site suggests that this is a very probable and there are springs locally very nearby. This is most definitely something that has to be tackled outside of the building footprint. Our suspicion is that there was a historical water management system that ran down the back of the building and into the highway that channelled the water away.

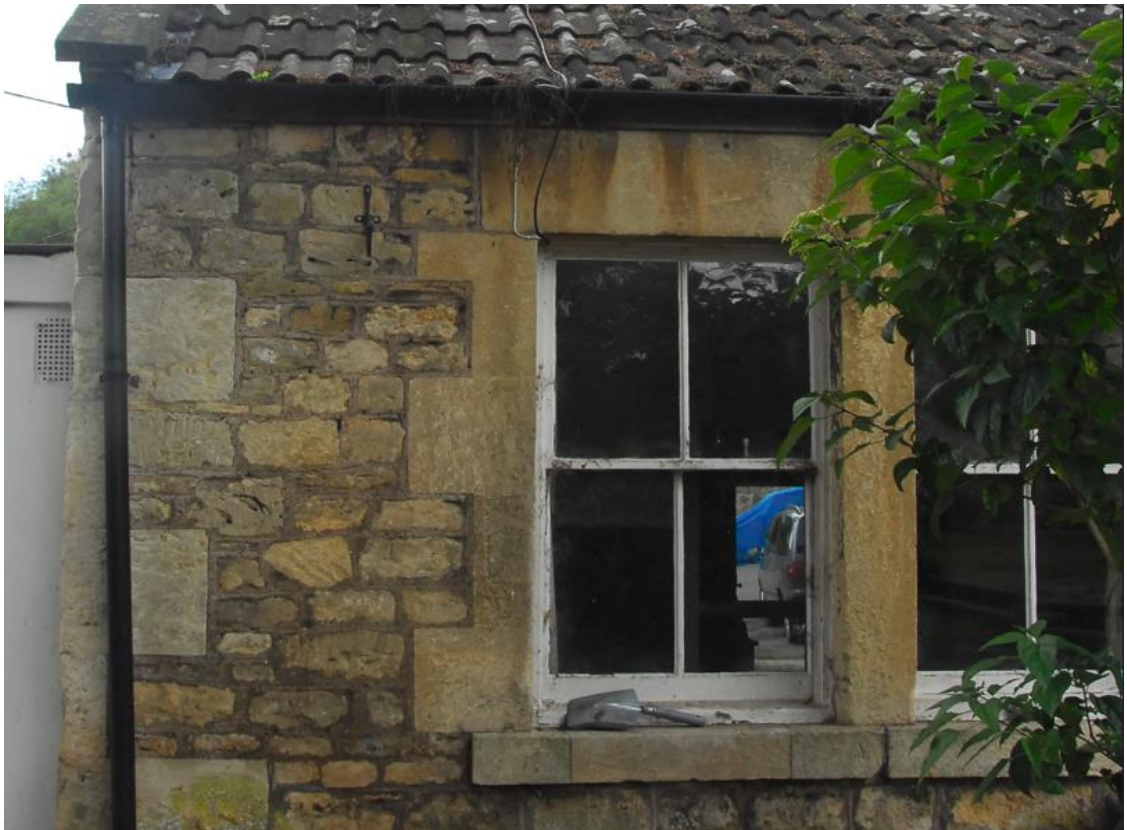
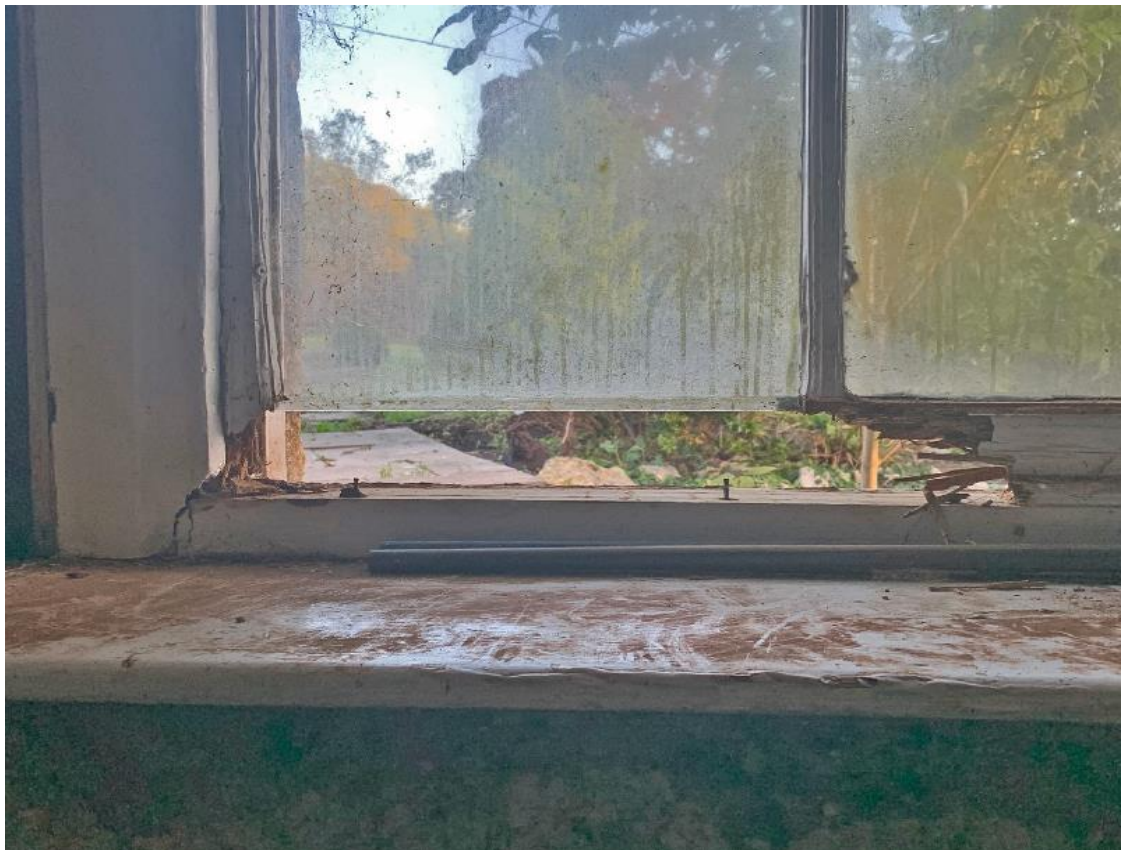
Figure 37 WG4 Metal casement windows

- 8.7.1 WG7 is a pair of Victorian un-horned sash windows with subsills divided by a central rectangular unembellished stone mullion and quoin stones. What is slightly odd about the reveal quoins is that the upper stones either side of the windows are slip stones rather than full height quoins suggesting that these windows may have been adjusted. This is also reflected in the high-level masonry either side of the windows which has been repointed in a different mix to the lower

levels suggesting a possible rebuild. The left hand sill has either been repaired or adjusted as it is formed in three pieces. The stonework is in **GOOD** condition

8.7.2 Each pair of windows to WG7 is a 2/2 pane construction with a fine glazing bar. The upper sashed have been has fixed but the lower sashes are moveable. The lower rail and rails of lower sash to the right-hand window is severely decayed with both insect and fungal activity. This appears to be dry rot and will require removal of this sash. **POOR** condition.

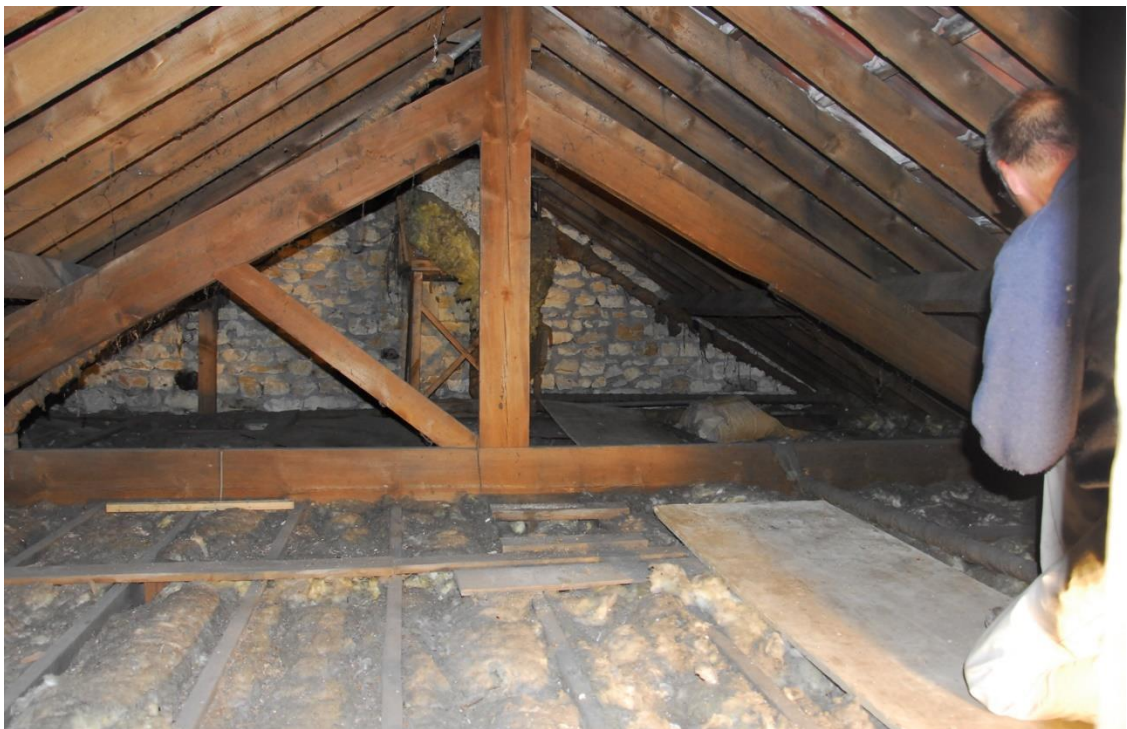
Figure 42 WF5 Timber casement windows

- 9.1.5 The roof appears dry and well insulated with mineral quilt but with the exception of a few local areas has no felt. There are no obvious signs of bats. **GOOD** condition

- 9.1.6 There is a cold water tank at the west end fed by an insulated riser from the beer cellar at the east end.

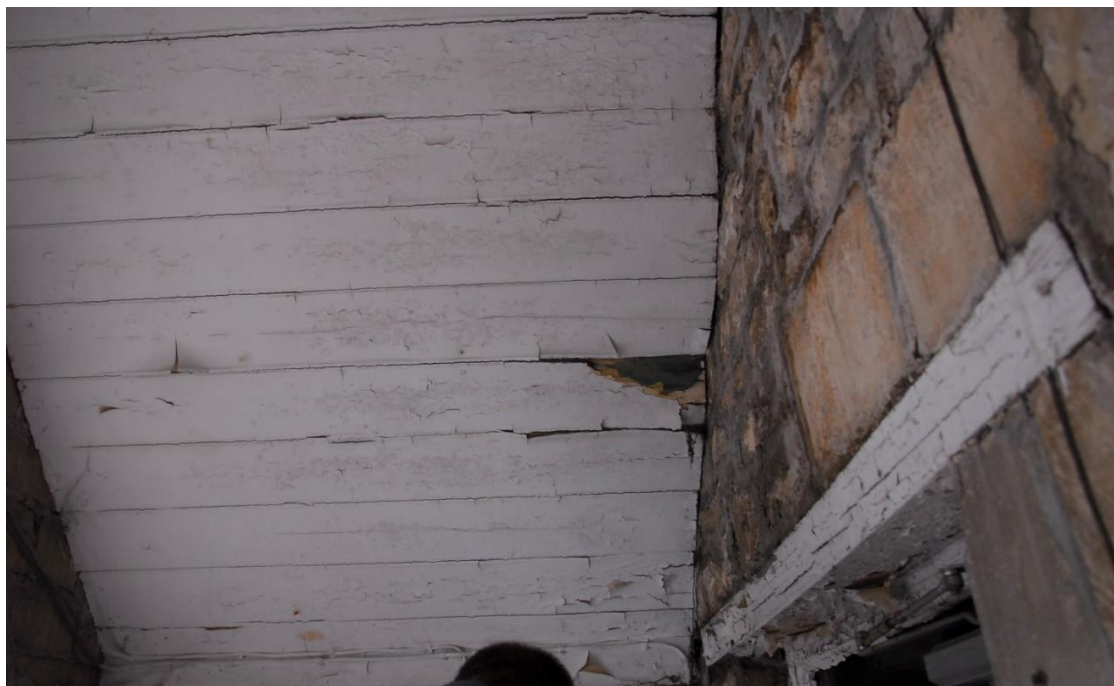
Figure 46 Entrance porch ceiling

9.9.1 The ceiling to the porch is formed from matchboard fixed to the underside of the rafters. There are signs of movement and possibly some decay. The ceiling is painted white over a historic green and is failing. **REASONABLE** condition

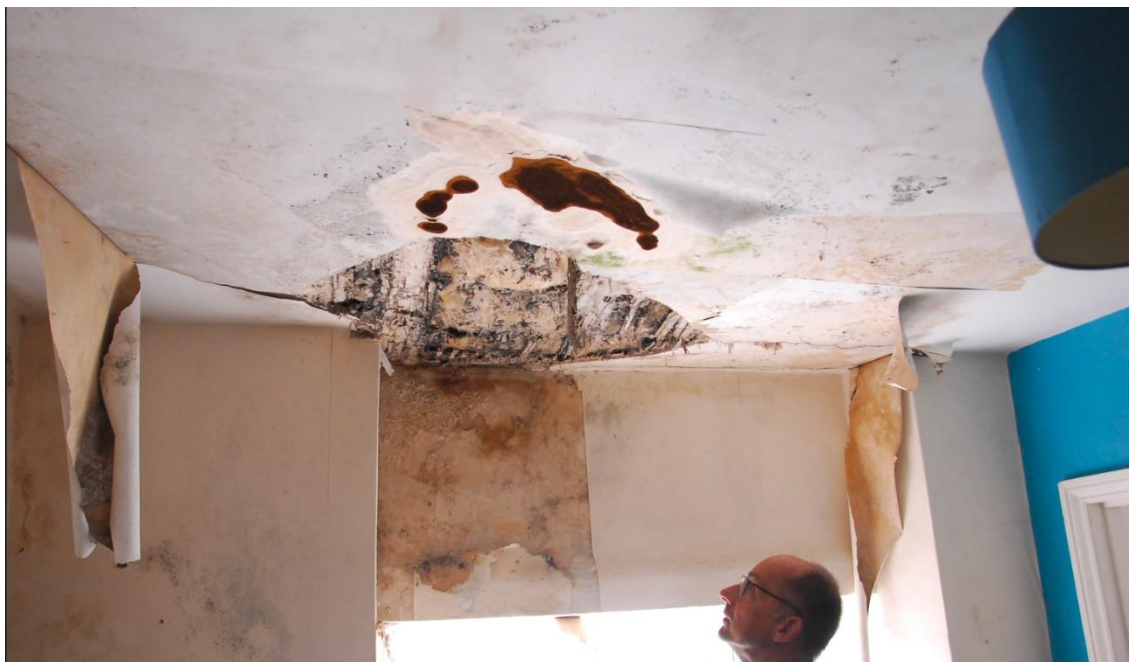
Figure 47 F3 Ceiling

10.13.1 Ceiling is obscured by multiple layers of paper but appears to be lathe and plaster ceiling. There is an area of significant water damage covering 50% of the ceiling and fungal attack immediately adjacent to WF2 these effects both the ceiling and the wall around WF2. The fruiting bodies on the ceiling suggests the fungus is *Serpula Lacrymans*. A section of ceiling plasterwork has been lost revealing severely decayed lathe. **POOR** condition

10.13.2 Remove papering – Cut back decayed areas and carryout localised repairs to ceiling with new lathe and plaster – paint with soft distemper.

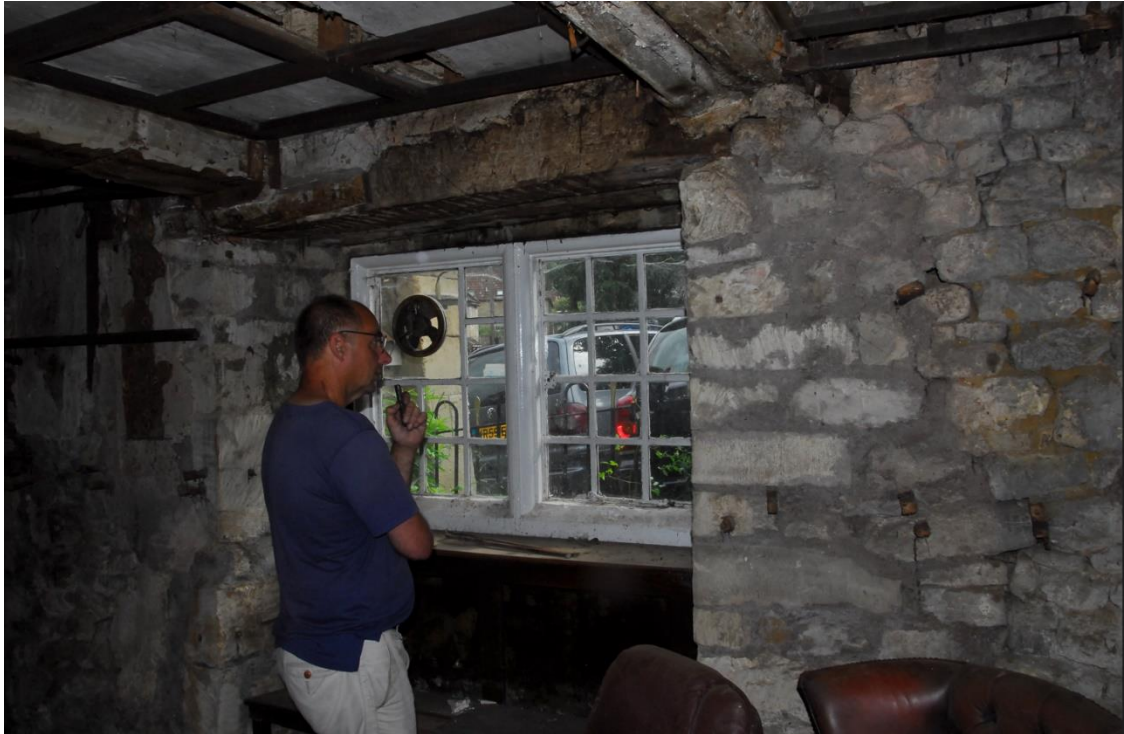
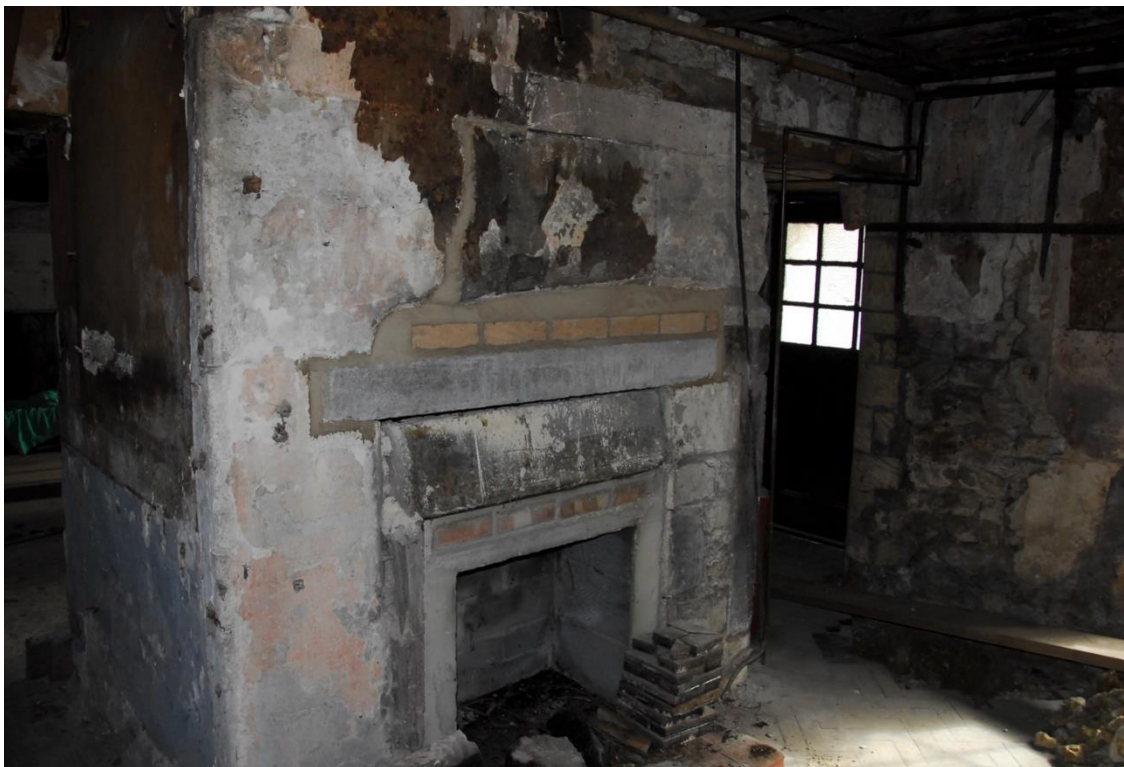
Figure 49 and 50 G2 South and fireplace wall

- 11.2.1 The south wall which contains WG2 has been stripped of all its panelling and plaster to expose a stone wall with an axe hewn finish and set in a lime ash mortar. There is some cracking in the wall extends 50% the height of the wall to the east of the window. The wall appears generally dry. **POOR** condition due to the loss of finishes

- 11.2.2. The east wall is very interesting. It comprises a main chimney stack that serves CH2. This may not be original but a later insertion. The stack has been significantly adjusted but originally appears to have contained a large inglenook style masonry fireplace only part of which remains. The right-hand reveal has been lost as a result of the second access door being cut through the stack in the early 1900's. A further, more recent intervention has been a very crude insertion of a smaller fireplace with concrete lintels that cut into the historic masonry. There is no plaster on this wall. The wall appears dry. **POOR** condition due to loss of finished and damaging interventions

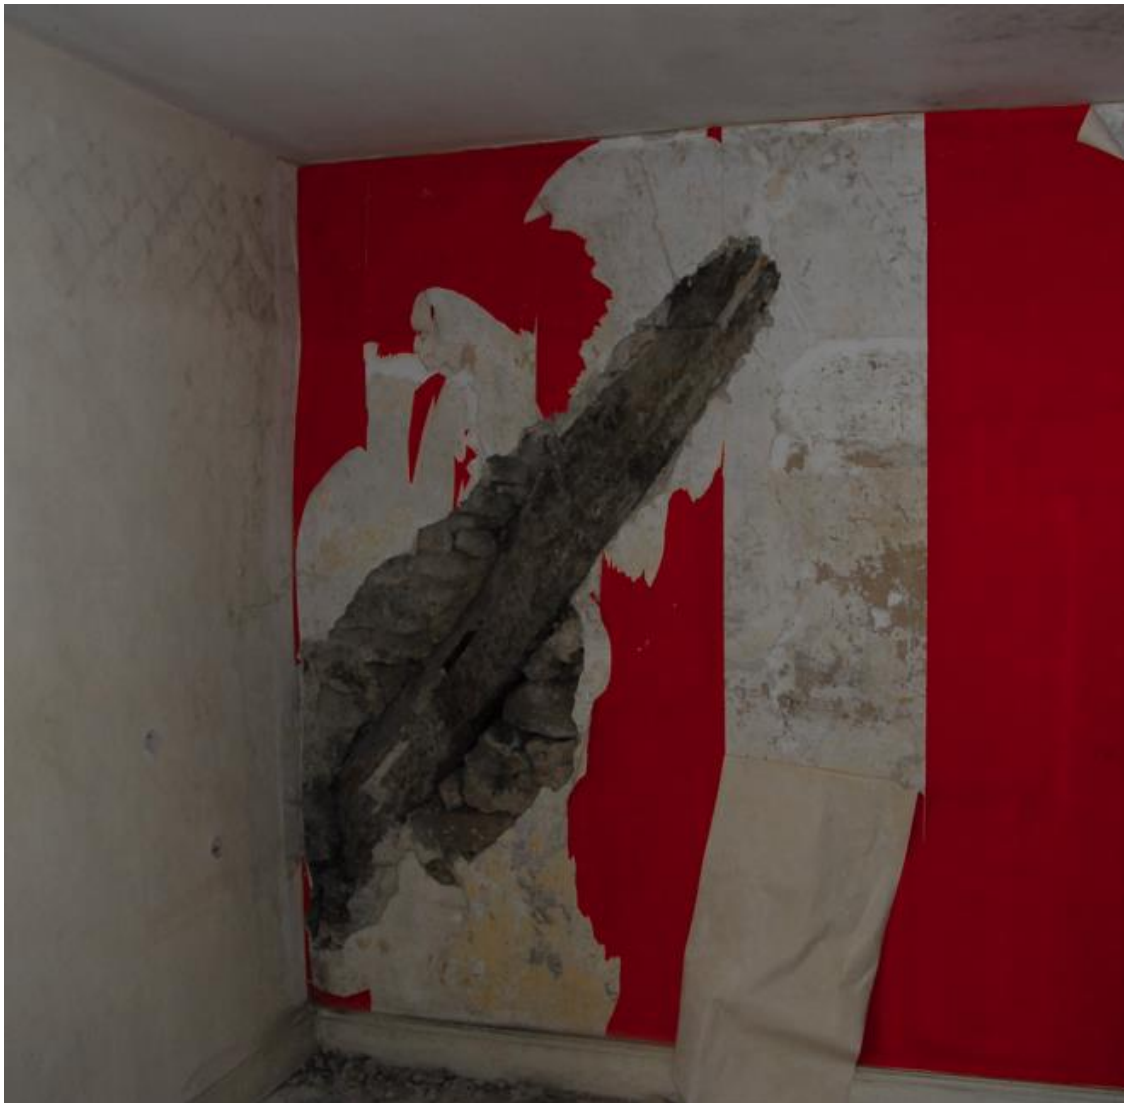
11.14.6 The wall F3/F4 is the chimney masonry to CH2. On the south side this contains a fully imbedded principal rafter (PR) complete with wind brace mortice. The relates to the floor carrier to G3 and is likely to be the original roof line to the building. Several areas of masonry are exposed due to plaster loss but insufficient to determine difference in the fabric makeup above and below the PR. This is a very sensitive part of the building which provide clues to its development. The wall is in **POOR** condition by virtue of the fact that it requires some work.
