## Domestic Services Risk Assessment & Written Scheme for the Control and Prevention of Legionellosis

Carried out at  
**Tendering District Council**  
**Clacton Leisure Centre**  
**Vista Road, Clacton-on-Sea**  
**Essex, CO15 6DB**

**Date of Assessment:** 20<sup>th</sup> January 2022

**Assessment No:** 12717CS

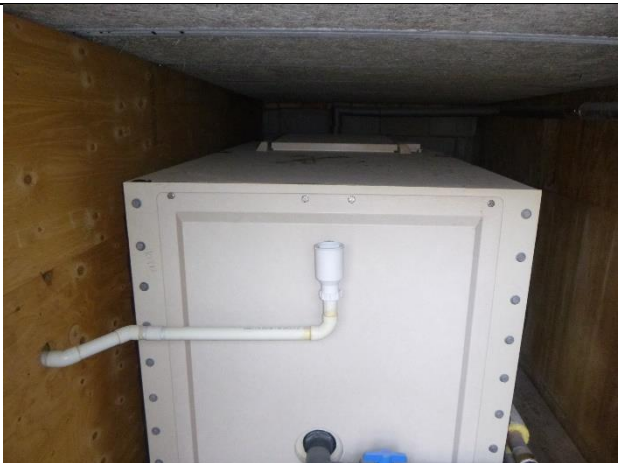
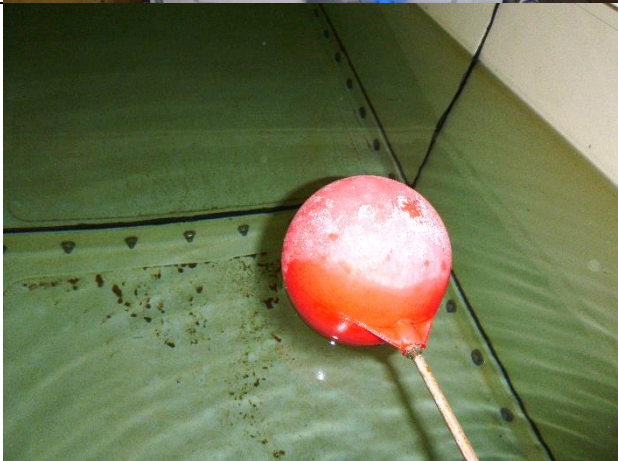
Tank title/asset number	CWST 1
Location	Roof Area Wet Side
Size (m) / volume (m <sup>3</sup> )	2000 litres
Materials of construction	GRP
External Photograph of Tank

Source of water supply to tank	MCW
Process served by tanked water	Cold water Down Services & Calorifier
Is tank easily and safely accessible	Yes
Configuration	Single Tank
If split or duplex, is flow balanced	N/A
Corrosion of internal surfaces	N/A
Deposits on internal surfaces	Light
Flow patterns correct	Yes
Stagnation evident	No
Tank insulation condition	Built in insulation
Distribution insulation condition	Good

Overflow screen fitted	Yes
If no o/f screen – indicate size required and in line or end of line	N/A
Warning pipe fitted	N/A
Lid condition and fit	Good
If no lid – dimensions required	N/A
Lid vent fitted with screen	Yes
Temperature remote from valve - °C	13.4°C
Temperature inlet - °C	11.5°C
Ambient temperature tank room - °C	10.0°C
Date of last clean and disinfection	November 2021
Date of last inspection	January 2022
Inlet & Outlet Opposed	Yes
Hot water services vent returns to cold water storage tank	No
Details for re-routing vent: dimensions, length	N/A
Drain size and location	Not Seen
Make-up size and location	28mm - Top
Services size and location	42mm base
Tank clearly labelled	Yes
Tank nearest sentinel - location & temp °C	Wet Side Toilet Sink 14.0°C
Tank furthest sentinel - location & temp °C	Poolside First Aid Room 14.5°C
Non-compliances with Water Fittings (Water Supply) Regulations 1999/Water Bylaws 2000, Scotland

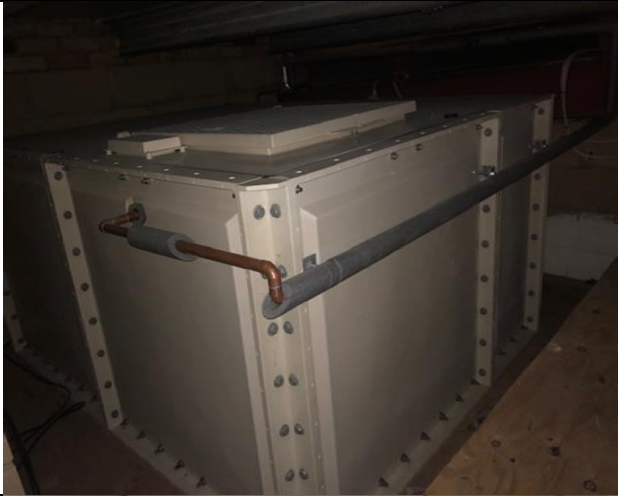
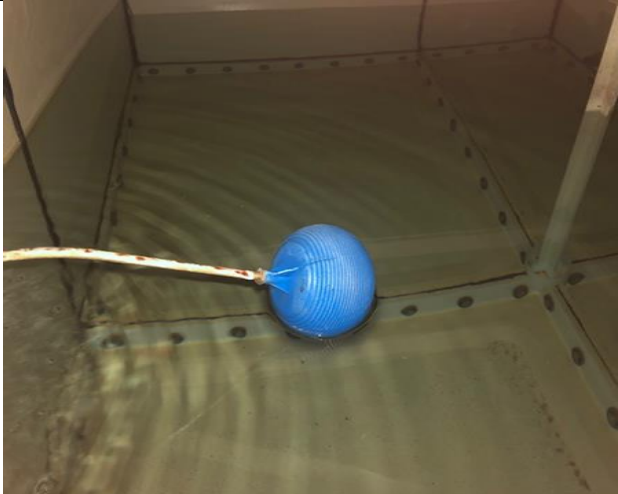
Tank title/asset number	CWST 4
Location	Main Stairwell leading from Reception to 1st Floor (within ceiling void)
Size (m) / volume (m <sup>3</sup> )	3000 litres
Materials of construction	GRP
External Photograph of Tank

Source of water supply to tank	MCW
Process served by tanked water	Down Cold Water Services & Calorifier – Dry Side
Is tank easily and safely accessible	Yes
Configuration	Single Tank
If split or duplex, is flow balanced	N/A
Corrosion of internal surfaces	N/A
Deposits on internal surfaces	None
Flow patterns correct	Yes
Stagnation evident	No
Tank insulation condition	Built in insulation
Distribution insulation condition	Good

Overflow screen fitted	Yes
If no o/f screen – indicate size required and in line or end of line	N/A
Warning pipe fitted	N/A
Lid condition and fit	Good
If no lid – dimensions required	N/A
Lid vent fitted with screen	Yes
Temperature remote from valve - °C	13.0°C
Temperature inlet - °C	11.0°C
Ambient temperature tank room - °C	14°C
Date of last clean and disinfection	November 2021
Date of last inspection	January 2022
Inlet & Outlet Opposed	Yes
Hot water services vent returns to cold water storage tank	No
Details for re-routing vent: dimensions, length	N/A
Drain size and location	Not Seen
Make-up size and location	28mm - Top
Services size and location	42mm base
Tank clearly labelled	Yes
Tank nearest sentinel - location & temp °C	Male Dry Change WC 15.0°C
Tank furthest sentinel - location & temp °C	Female Dry Change WC 15.0°C
Non-compliances with Water Fittings (Water Supply) Regulations 1999/Water Bylaws 2000, Scotland

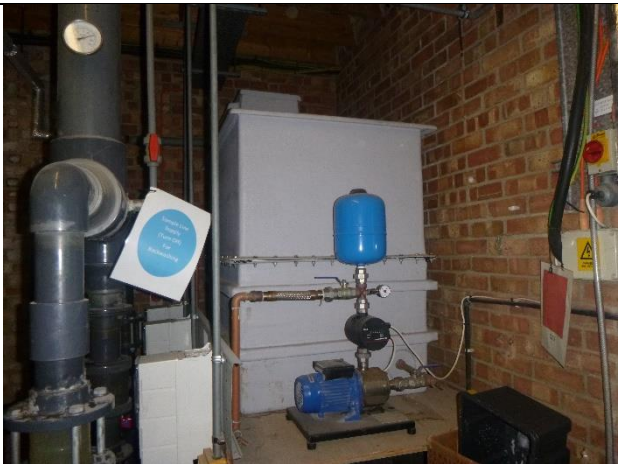
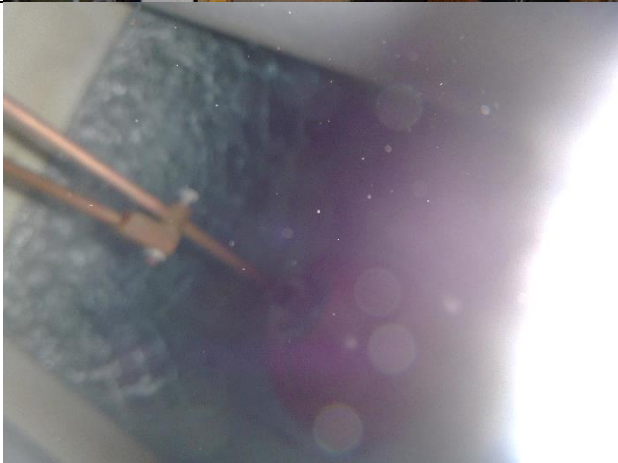
Tank title/asset number	Pool Make-Up Tank
Location	Main Pool Plant Room
Size (m) / volume (m <sup>3</sup> )	1500litres
Materials of construction	GRP
External Photograph of Tank

Source of water supply to tank	MCW
Process served by tanked water	Main Pool Top Up
Is tank easily and safely accessible	Yes
Configuration	Single Tank
If split or duplex, is flow balanced	N/A
Corrosion of internal surfaces	N/A
Deposits on internal surfaces	None
Flow patterns correct	Yes
Stagnation evident	No
Tank insulation condition	Built in insulation
Distribution insulation condition	Good

Overflow screen fitted	Yes
If no o/f screen – indicate size required and in line or end of line	N/A
Warning pipe fitted	N/A
Lid condition and fit	Good
If no lid – dimensions required	N/A
Lid vent fitted with screen	Yes
Temperature remote from valve - °C	10.0°C
Temperature inlet - °C	9.0°C
Ambient temperature tank room - °C	14°C
Date of last clean and disinfection	N/A
Date of last inspection	N/A
Inlet & Outlet Opposed	Yes
Hot water services vent returns to cold water storage tank	No
Details for re-routing vent: dimensions, length	N/A
Drain size and location	Not Seen
Make-up size and location	28mm - Top
Services size and location	28mm base
Tank clearly labelled	Yes
Tank nearest sentinel - location & temp °C	N/A Pool Top Up
Tank furthest sentinel - location & temp °C	
Non-compliances with Water Fittings (Water Supply) Regulations 1999/Water Bylaws 2000, Scotland	
Comments/actions required	
<b>Overall Risk Rating</b>	<b>0</b>

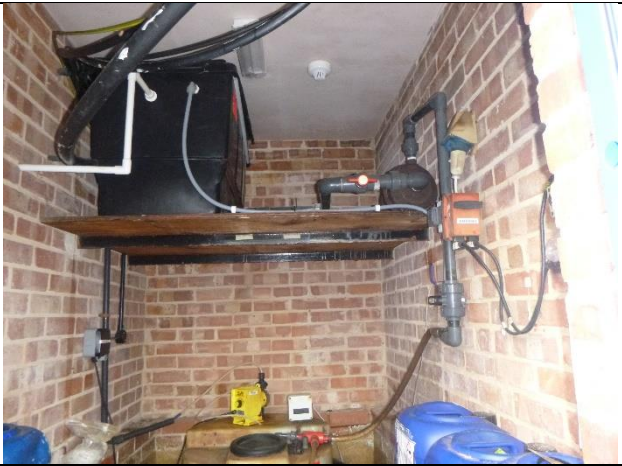
Tank title/asset number	Pool Chemical Break Tank
Location	Acid Store Pool Plant
Size (m) / volume (m <sup>3</sup> )	240 litres
Materials of construction	Plastic
External Photograph of Tank

Internal Photograph of Tank	
Source of water supply to tank	MCW
Process served by tanked water	Chemical Tank Pool
Is tank easily and safely accessible	Yes
Configuration	Single Tank
If split or duplex, is flow balanced	N/A
Corrosion of internal surfaces	N/A
Deposits on internal surfaces	None
Flow patterns correct	Yes
Stagnation evident	No
Tank insulation condition	None
Distribution insulation condition	N/A

Overflow screen fitted	Yes
If no o/f screen – indicate size required and in line or end of line	N/A
Warning pipe fitted	N/A
Lid condition and fit	Good
If no lid – dimensions required	N/A
Lid vent fitted with screen	Yes
Temperature remote from valve - °C	N/A Chemical Break Tank
Temperature inlet - °C	
Ambient temperature tank room - °C	
Date of last clean and disinfection	
Date of last inspection	
Inlet & Outlet Opposed	N/A Pumped
Hot water services vent returns to cold water storage tank	No
Details for re-routing vent: dimensions, length	N/A
Drain size and location	Not Seen
Make-up size and location	22mm - Top
Services size and location	35mm base
Tank clearly labelled	Yes
Tank nearest sentinel - location & temp °C	N/A Break Tank
Tank furthest sentinel - location & temp °C	
Non-compliances with Water Fittings (Water Supply) Regulations 1999/Water Bylaws 2000, Scotland	
Comments/actions required	
<b>Overall Risk Rating</b>	<b>0</b>

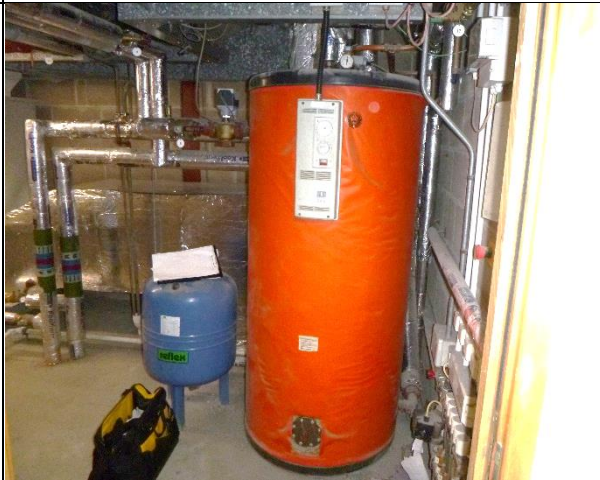
Hot water generator title/asset number	CAL 2			
Location	Gym/Sauna 1 <sup>st</sup> Floor Plant Room			
Stored water Volume	Approx. 400 litres			
Materials of construction	S/Steel			
Photograph of Hot Water Storage Vessel

<b>Comments:</b> - <b>Storage Gauge reads &gt;80°C – actual storage 70°C</b> ensure temp readings are taken from flow pipe to remove confusion.				
Overall Risk Rating	LOW Risk - See comment

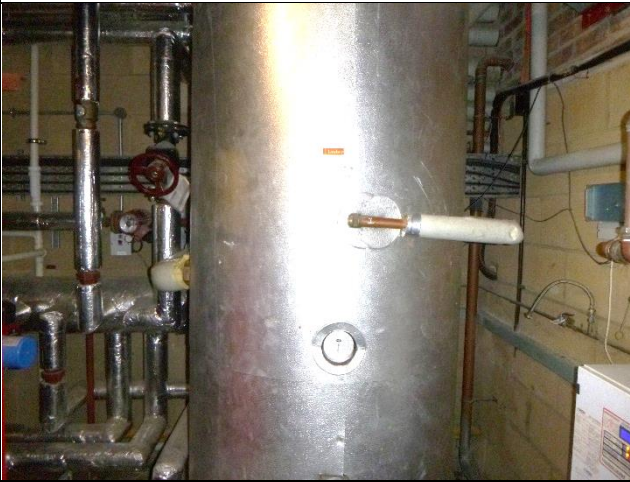
Hot water generator title/asset number	CAL 3		
Location	Dry Side Ext plant Room		
Stored water Volume	Approx. 1000 litres		
Materials of construction	Steel		
Photograph of Hot Water Storage Vessel

Accessible inspection hatch	Yes		
Vessel supplied from	TCWS		
Vessel Feeds	Dry Side Changing Facilities		
Accessible drain fitted on lowest point	Yes		
Heat source	LTHW		
Vessel insulation condition	Good		
Distribution insulation condition	Good		
Expansion type	Vent to drain via tundish		
If pressure vessel fitted, can diaphragm be cleaned	Yes		
HWS recirculation pump fitted	Yes		
Timed destratification pump fitted	Yes		
Immersion temperature gauges fitted	Flow - Yes	Storage - No	Ret – Yes
Temperature °C (Digital thermometer with surface probe)	61.0	>61.0	55.0
Nearest Sentinel Point Temperature	Dry Male Change Pre TMV 68.3°C		
Furthest Sentinel Point Temperature			
<b>Comments: -</b>			
Overall Risk Rating	None

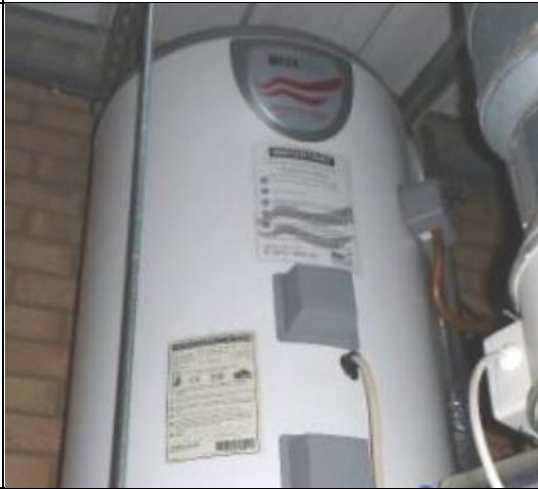
Hot water generator title/asset number	CAL 4		
Location	Kitchen Roof Space		
Stored water Volume	Approx. 220 litres		
Materials of construction	Steel		
Photograph of Hot Water Storage Vessel

Accessible inspection hatch	Yes		
Vessel supplied from	TCWS		
Vessel Feeds	Kitchen & Treatment Rooms		
Accessible drain fitted on lowest point	Yes		
Heat source	LTHW		
Vessel insulation condition	Good		
Distribution insulation condition	Good		
Expansion type	Vent to drain via tundish		
If pressure vessel fitted, can diaphragm be cleaned	Yes		
HWS recirculation pump fitted	Yes		
Timed destratification pump fitted	Yes		
Immersion temperature gauges fitted	Flow - Yes	Storage - No	Ret – Yes
Temperature °C (Digital thermometer with surface probe)	62.0	>62.0	58.0
Nearest Sentinel Point Temperature	Kitchen Wash Up Sink 61.3°C		
Furthest Sentinel Point Temperature	Treatment Room 1 60.7°C		
<b>Comments: -</b>			
<b>Overall Risk Rating</b>	<b>None</b>

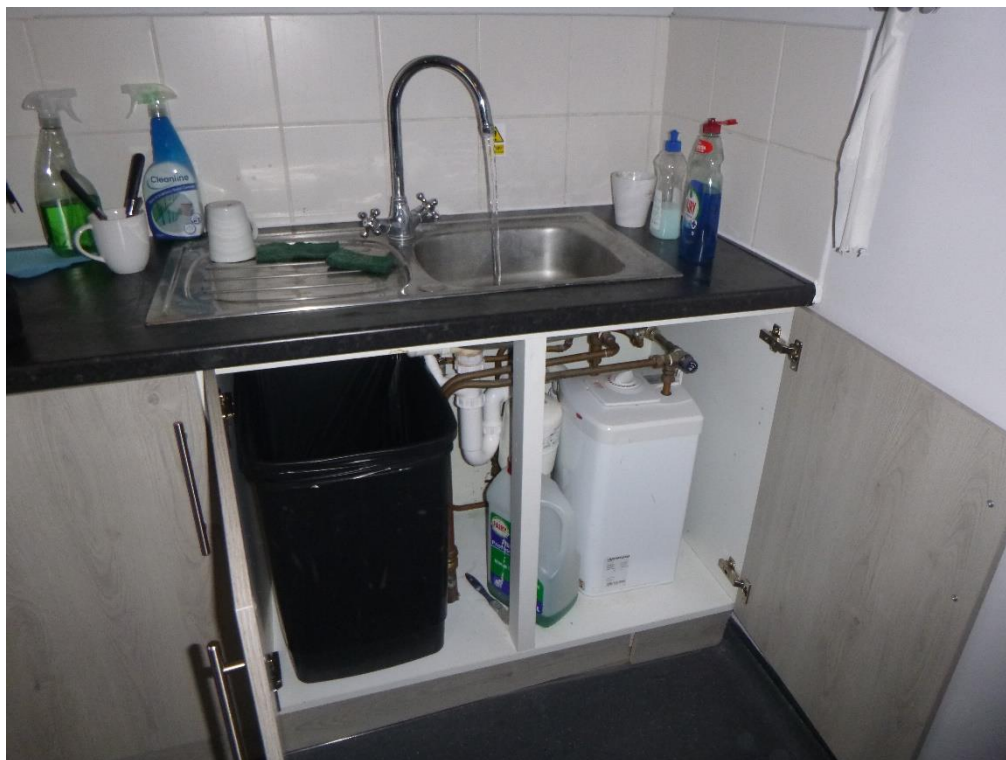
**POU Staffroom**

A single POU is located in the G/F Staffroom. Low storage volume POU water heaters are those that store no more than 15 litres of hot water (see Figure 2.2). These systems generally heat water to a set point that is often variable via a simple dial on the unit. These systems deliver a small volume of stored hot water before they need to be left to recover and bring the temperatures back to the set point. Water heaters should store HW at  $>50^{\circ}\text{C}$  to reduce the risk of legionella growth.

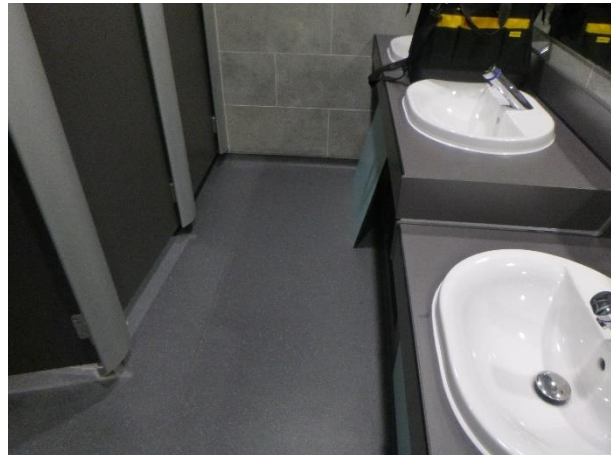
Typical Toilet Sinks

**Spa/Gym Side** - Outlets were found to be in fair condition in line with their age, most of the tap outlets had a degree of limescale build-up. Limescale can provide an ideal environment for legionella and other bacteria and as such should be removed (**remedial action 2 refers**)

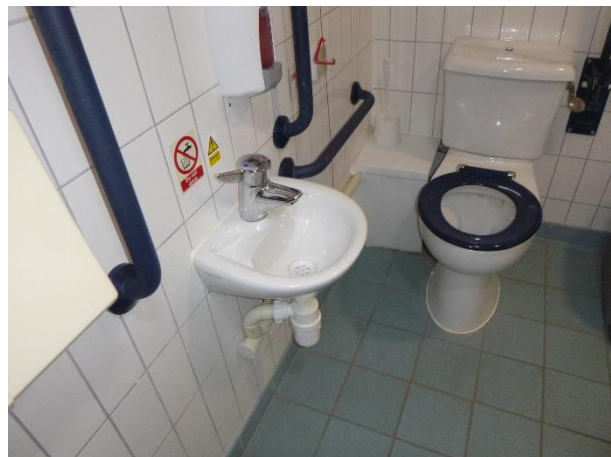
Limescale Building Up

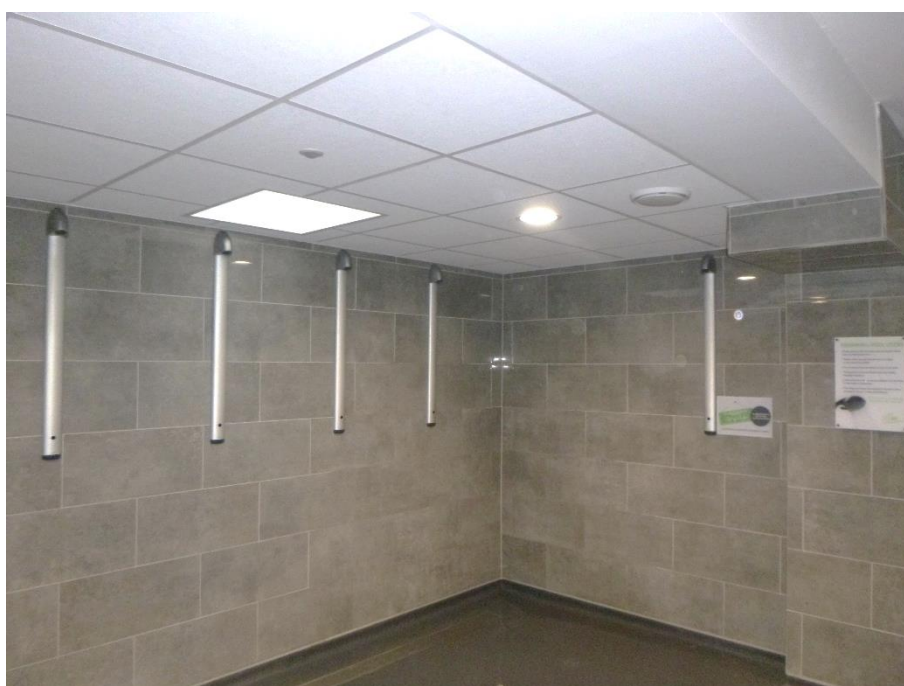
General Information	Risk Comment	Risk
State the Location of the shower/s	Wet Side – Pool Side	0
State Number of Showers	8	0
Is this an emergency shower/s	No	0
Is the shower/s Electric, Thermostatic or Mixer Controlled?	TMV Controlled (8 x TMV)	0
State the cold water supply source to the shower/s	Tank Cold Water	0
State the hot water supply source to the shower/s	Domestic HWS	0
Is the shower-head/s clean & free from scale or mould	Yes (New)	0
Is the shower/s regularly used	Yes	0
Is there a single blender control serving several showers	No	0
Is the showerhead/s regularly cleaned & disinfected	Yes	0
Mixer Inlet Temp Cold	<9.0°C	0
Mixer Inlet Temp Hot	N/A	0
Outlet Temp	37 - 39	0
<b>Overall Risk</b>	<b>0</b>

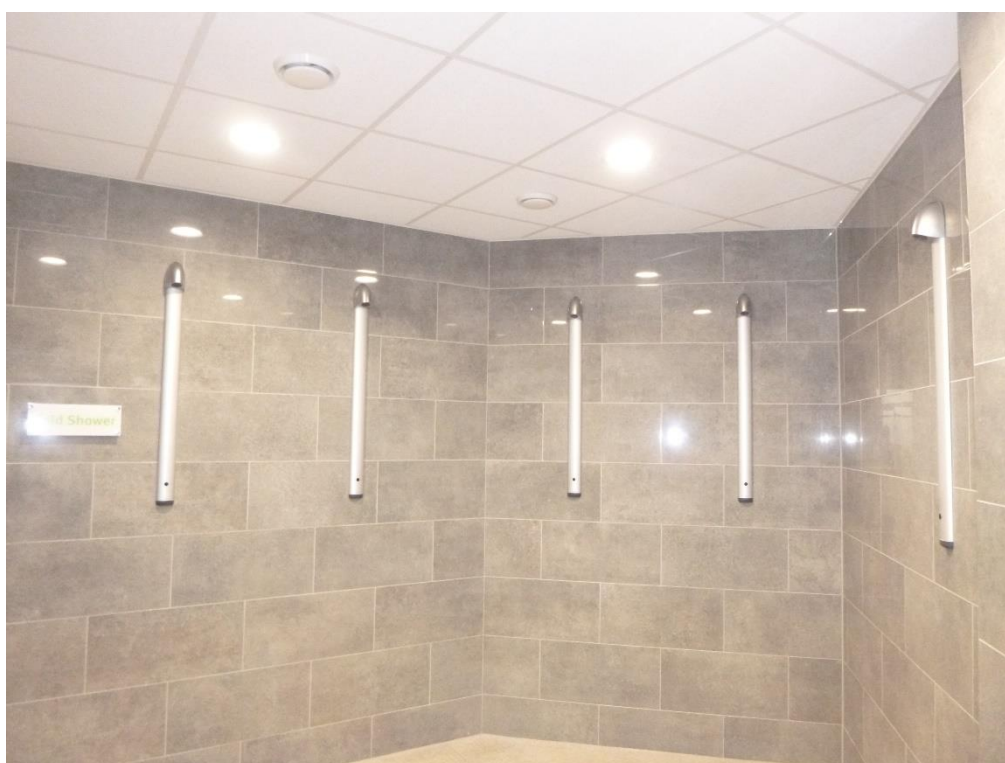
General Information	Risk Comment	Risk
State the Location of the shower/s	Sauna Showers	0
State Number of Showers	4 + 1 Cold	0
Is this an emergency shower/s	No	0
Is the shower/s Electric, Thermostatic or Mixer Controlled?	TMV	0
State the cold water supply source to the shower/s	Cold water Storage Tank (Boosted)	0
State the hot water supply source to the shower/s	Domestic HWS	0
Is the shower-head/s clean & free from scale or mould	Yes	0
Is the shower/s regularly used	Yes	0
Is there a single blender control serving several showers	No	0
Is the showerhead/s regularly cleaned & disinfected	Yes	0
Mixer Inlet Temp Cold	9.5°C	0
Mixer Inlet Temp Hot	61.9°C	0
Outlet Temp	~38°C	0
<b>Overall Risk</b>	<b>0</b>

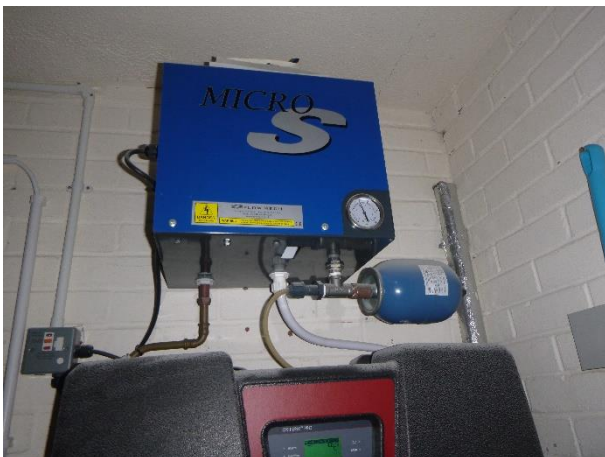
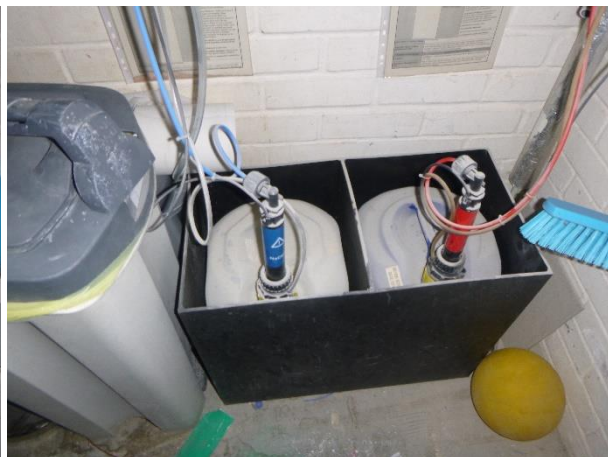
There is a chlorine dioxide unit supplying the domestic water system for the wet side changing facilities. The unit is located in the wet side cleaning storeroom. The unit supplies the make up to the wet side storage tank which in turn supplies the wet side water outlets. Site carry out regular testing of CLo2 and record the readings in the logbook. Beacon Water Treatments are responsible for the regular service visits.

At the time of the survey the CLo2 reading in the storage tank was at 0.2 mg/l. by the time this reaches the outlets it has further diluted to 0.1mg/l. Establishing and maintaining a chlorine dioxide residual (as total oxidant) of 0.1– 0.5 mg/l at an outlet is usually sufficient to control legionella in the system
