Report:	Asbestos Survey
Type:	Two (2)

Site:	Depot, Robinson Way, Kettering, NN16 8PQ
Contract:	CO2064-38
Survey Date:	30 th April 2009
Report Date:	1 st May 2009
Client:	Kettering Borough Council, Municipal Offices, Bowling Green Road, Kettering, NN15 7QX

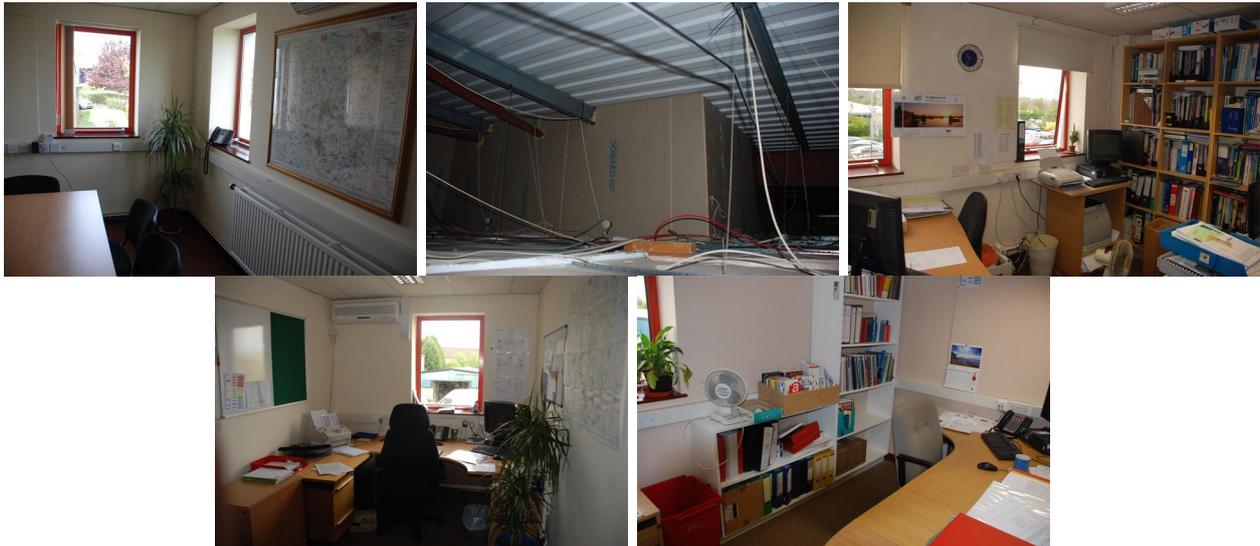
The first floor comprised of offices, toilets and training rooms with a storage section to the rear. The offices were identical in construction with either a carpeted or linoleum covered concrete floor, plaster finished walls and a suspended MMMF tiled ceiling held within a metal grid. The ceiling void was empty and the plaster board partitions could be seen, the original metal sheet roof could be seen and the steel frame supporting the building. All of the doors were timber set in a timber frame and the windows all metal framed.

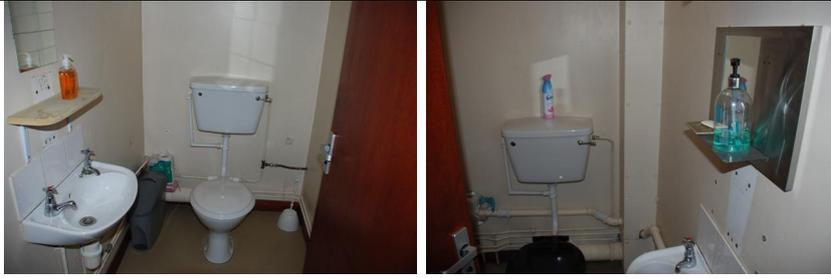
The toilets were identical in construction as the office area and contained a modern linoleum floor and ceramic sanitary ware, to the corner there was a modern cement lining to a service riser.

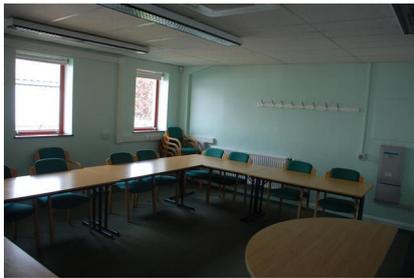
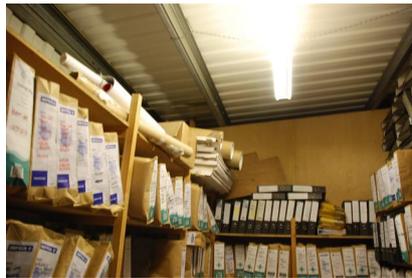
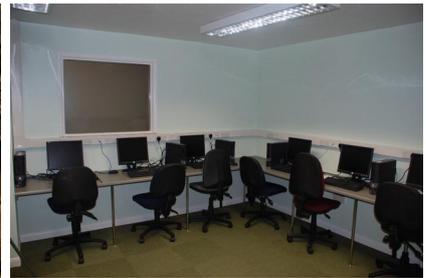
There were two training rooms and associated corridor, the rooms contained a carpeted floor on to concrete, all the walls were plaster finished and the ceilings a mixture of MMF tiles held in a metal grid and plastered ceilings with a textured coated finish. To the rear of the training room there was a corridor leading to a storage room this area had a concrete floor and the ceiling was the original metal lined roof. The corridor was identical in construction with a small area of vinyl tiles on entrance.

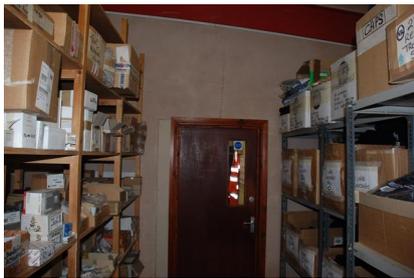
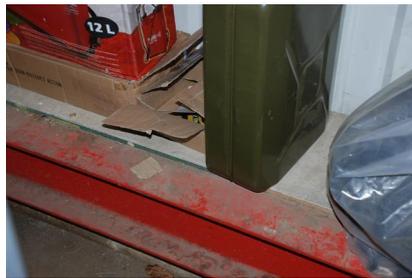
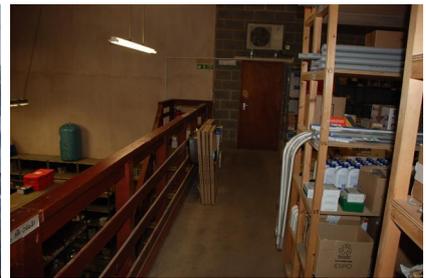
The rear storage area was one large open plan area and contained a small office. This area contained a concrete floor with a metal lined roof, the walls were a mixture of metal sheeting and plaster finished. The office was timber and plaster construction. The main area contained a timber balustrade and timber steps to the ground floor. The steel beams were insulated with modern insulating board and the top section of the wall void also contained a strip of modern insulating board.

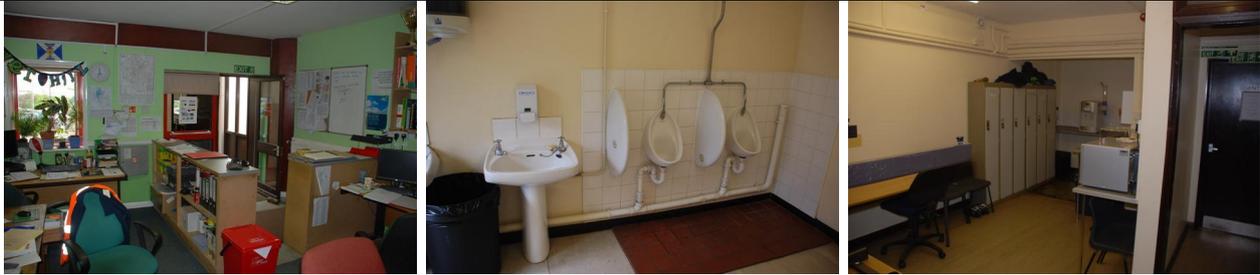
The ground floor contained offices, toilets gas and electric cupboards and the main reception. All area were similar in construction containing either carpeted or linoleum finished floors on to concrete, the walls were a mixture of plaster finished block and board. The ceilings throughout were all plaster finished. The windows were all metal framed and the doors timber. Two of the offices contained a small section of vinyl tiles on entrance to the rooms.

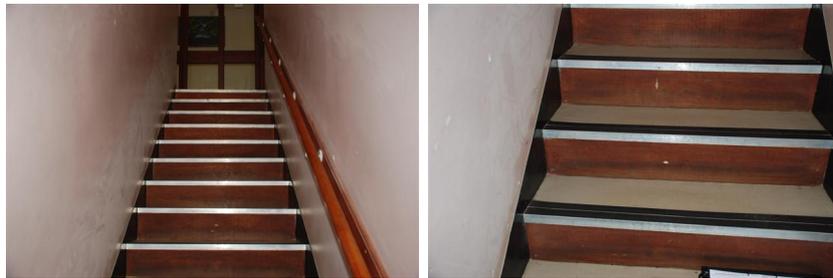
The toilets contained modern ceramic sanitary ware and the kitchen area contained modern units. The stairs from the ground floor to the first were concrete with rubber nosings.

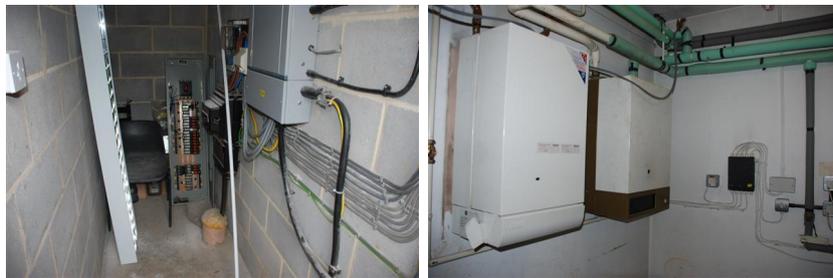
The gas and electric cupboard were block built with modern services, all of the pipe work was foam insulated and the boilers modern.

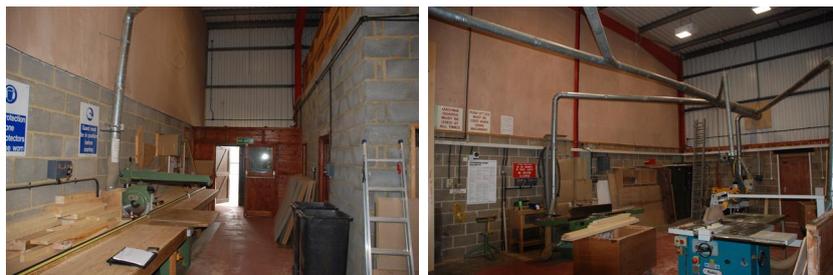
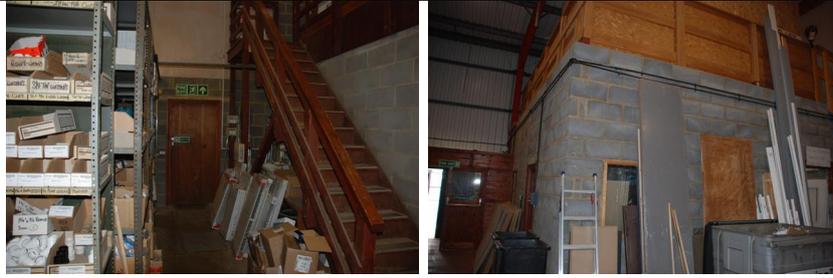
This area contained the carpenters workshop, stores and glass stores. The construction was consistent with a concrete floor, plastered block, metal clad and timber walls with the original metal lined roof and steel frame. The area had a small extraction room to the rear which was timber built.

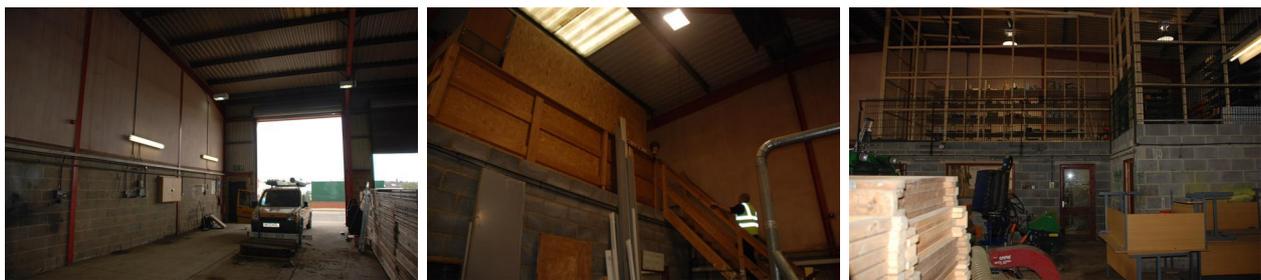
This area contained the vehicle workshop and stores to the rear. The construction was consistent with a concrete floor, plastered block, metal clad and timber walls with the original metal lined roof and steel frame. The area had stores to the rear which were all block built and plaster finished there was a set of timber stairs leading to a timber constructed mezzanine storage area. The main office was block built with plastered ceilings.

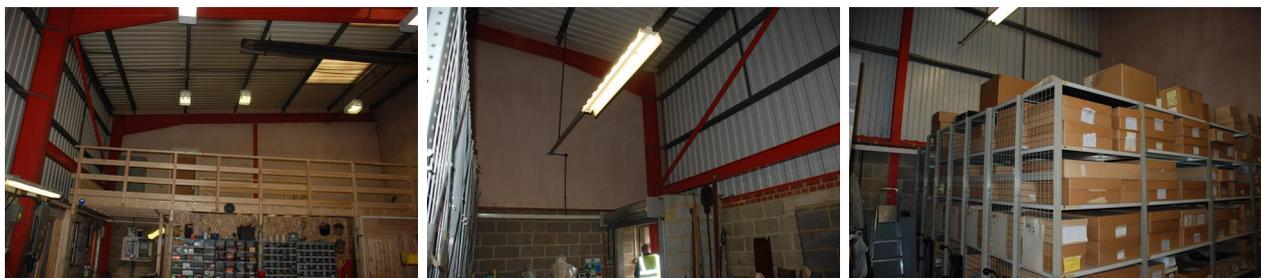
This area contained the vehicle workshop 2 and museum stores. The construction was consistent with a concrete floor, plastered block, metal clad and timber walls with the original metal lined roof and steel frame. The museum store had a block built office to the corner, and the vehicle stores again had a timber constructed mezzanine level.
