Road	M69	Link & Section	2400M69/156	Location	Drawing number - HE601892-KIER-VGN-M69_ML_M1_JN1_B-DE-CH-0000-08				Length (m)	1019	VCS undertaken by	Date	00/00/0000
------	-----	----------------	-------------	----------	--	--	--	--	------------	------	-------------------	------	------------

Visual Survey Key												
Cracking	Reinstatement /patching	Fretting	Crazing	Pothole	Open joint	Construction Joint	Rutting/ depression	Core	Loops	Nodes	G - GULLY OG - OFFSET KG - KERB	Deflectograph

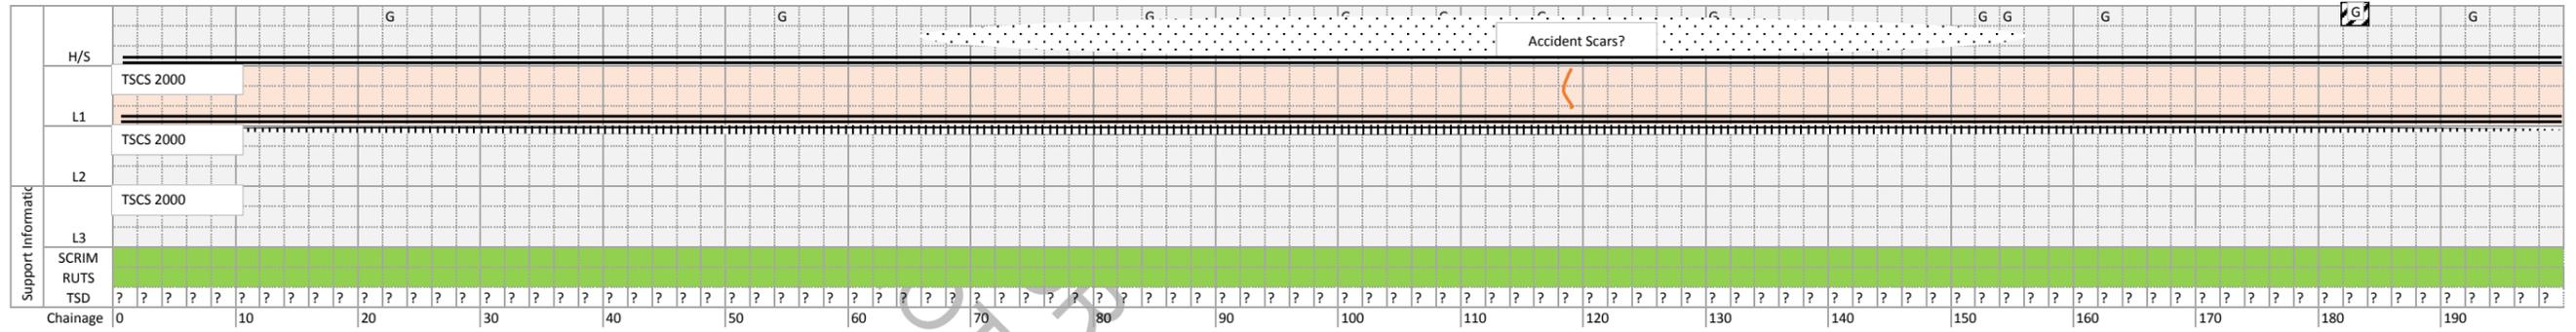
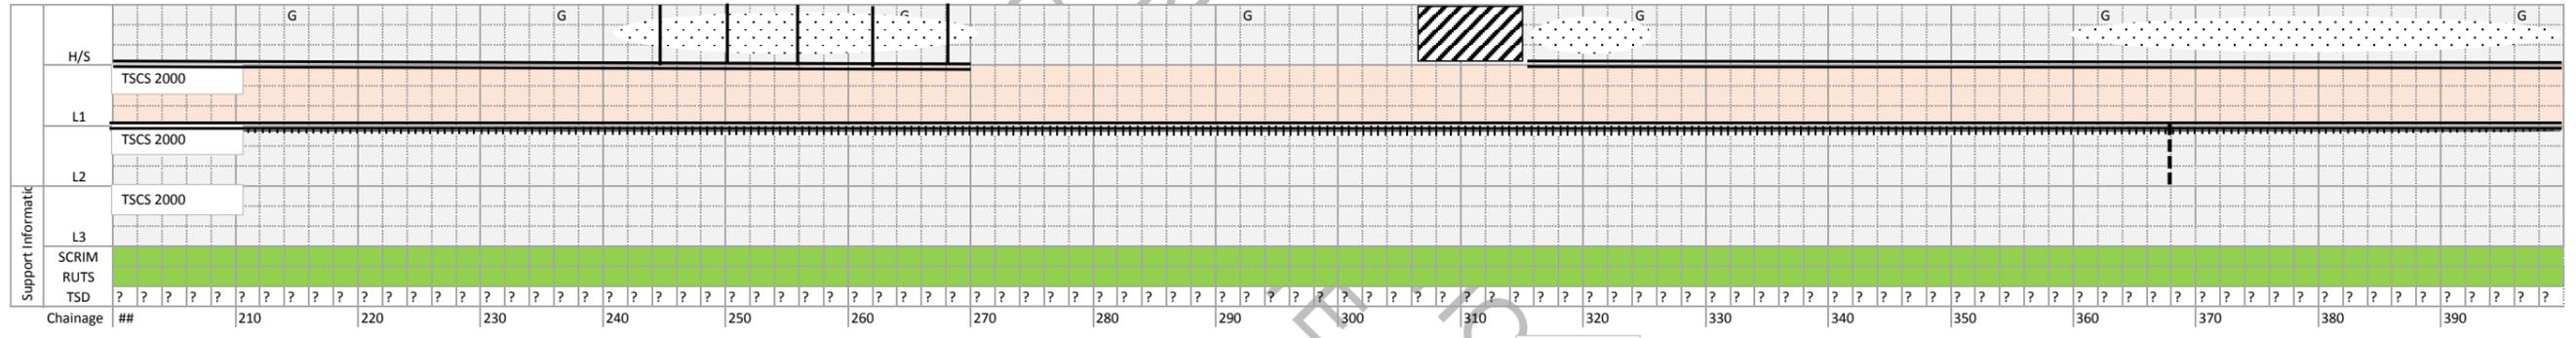
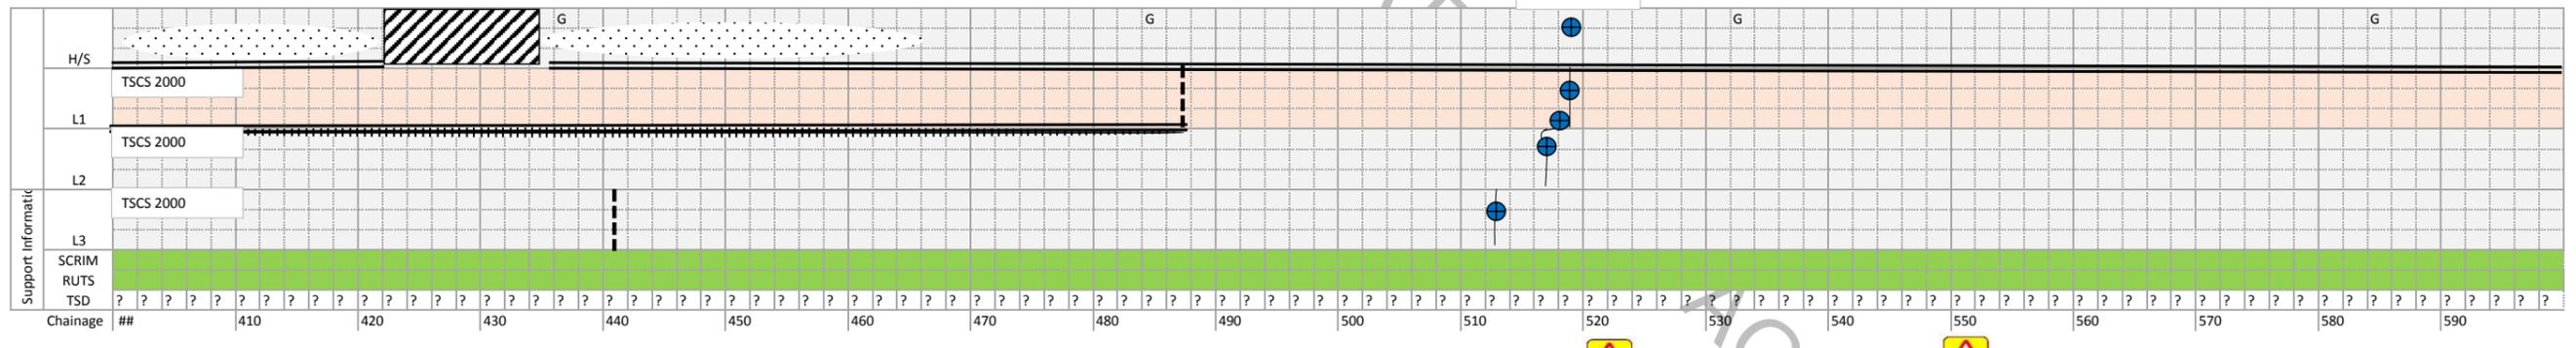
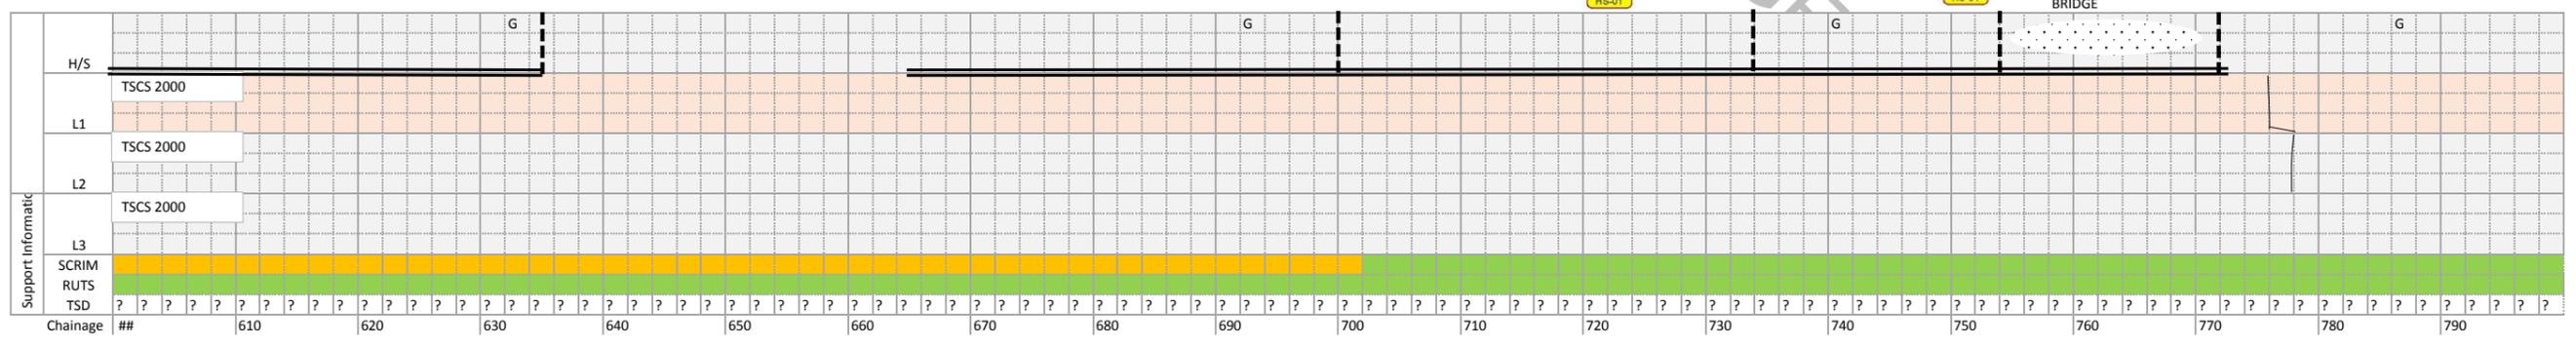
Road	M69	Link & Section	2400M69/146	Location	Drawing number - HE601892-KIER-VGN-M69_ML_M1_JN1_B-DE-CH-0000-09				Length (m)	1031	VCS undertaken by	Date	00/00/0000
------	-----	----------------	-------------	----------	--	--	--	--	------------	------	-------------------	------	------------

C68,69,70,71
,72&73
