STRUCTURAL INSPECTION

**SAXON HALL,
THORPE ST,
RAUNDS,
NN9 6LT.**

Reference: 24 / 55514

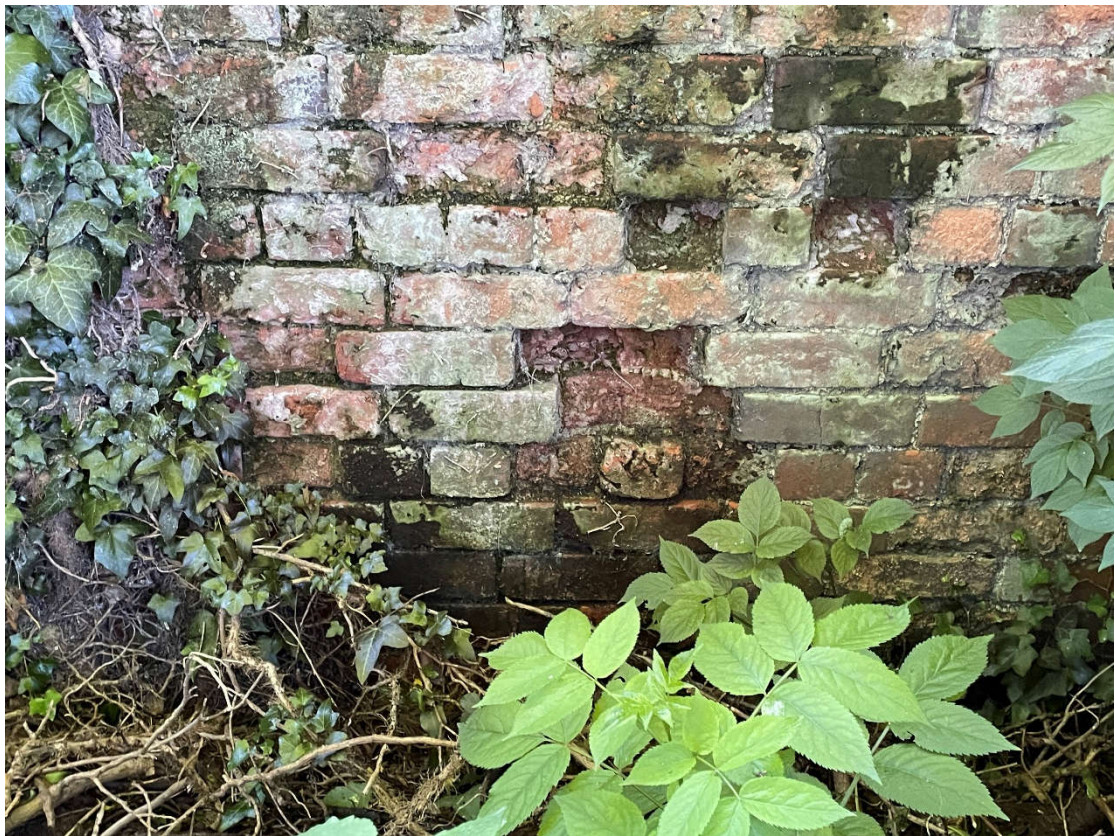
Photograph 15

- 4.2 Lower Level – The lower face of the retaining wall is constructed of solid masonry, a large portion of the lower wall is inaccessible due to vegetation situated at the front of the retaining wall. Refer to Photo 12 - 14 in Appendix A.
- 4.2.1 Where the wall was accessible in the green area / terrace several masonry defects were visible within the wall. The lower portion of the wall had significant staining to the face of the wall. Refer to Photo 15 - 16 in Appendix A.
- 4.2.2 A large bulge was visible within the retaining wall at the midpoint of the upper section of wall. This is situated in the service area behind Saxon Hall. The ivy is of significant size in this area. Refer to Photo 17 - 18 in Appendix A.

- 5.1 In our opinion the defects noted within the report show signs of movement within the wall, specifically in the area where the bulge is located. This area should be propped and the large ivy bush that is situated on the wall removed. This will alleviate some of the stress on the wall.
- 5.2 It is recommended to implement a soil nailing and plating remediation to effectively anchor the wall into the supporting soil behind it.
- 5.3 The defective masonry should be replaced with similar masonry and mortar, where possible.
