ASBESTOS MANAGEMENT PLAN

Danesholme Communicare Centre

Reference Number	Version Number	Date Issued	Review Date	Summary of Amendments	Policy Author
ASB002	1	01/04/15	31/03/16	Initial Issue	M. Warburton
ASB002	2	04/01/17	03/01/18	Re-inspection	M. Warburton

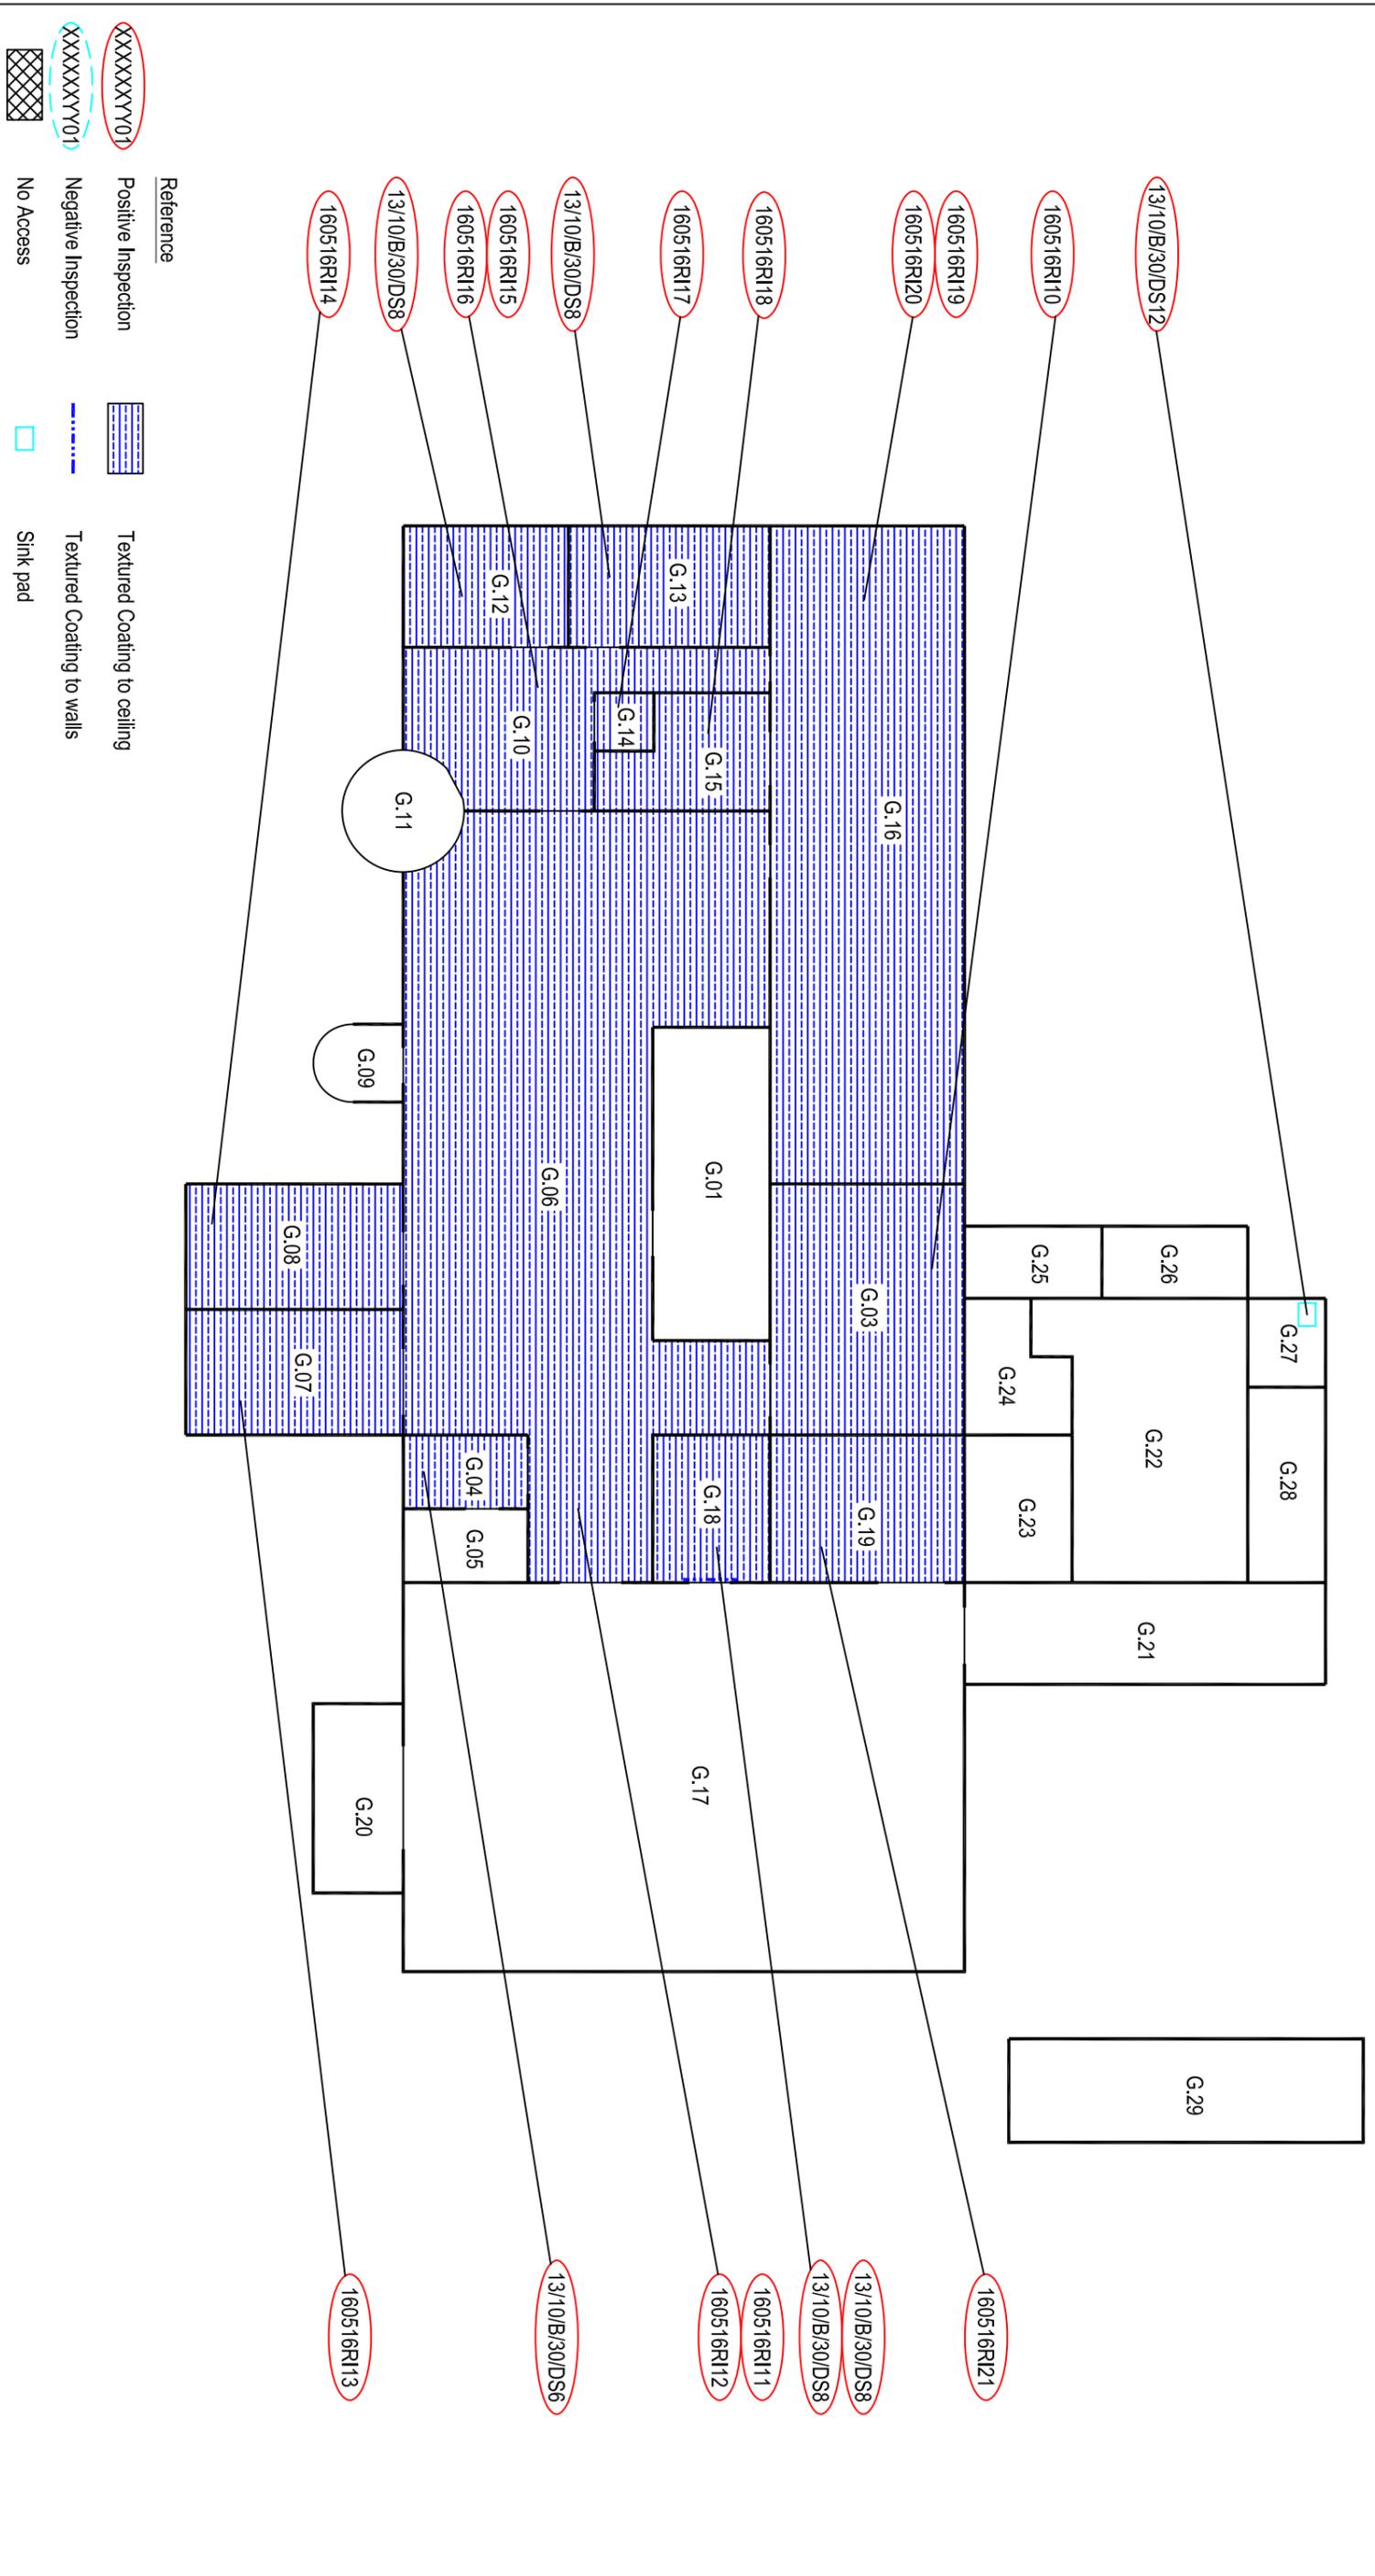
Address: Danesholme Communicare Centre Corby		Drawing Title: Corby Borough Council Asbestos Survey Plan	
Client Address: Depot Fleming Road Earlstree industrial Estate, Corby		Scale: A4 Date: JMO	Drawn By: MW
Ground Floor Plan		Revision: 2

Area	Feature	Material Type - (Friability)	Photo No.	Asbestos Fibre	Condition / Surface Treatment	Extent	Access / Position	Reference Number / (Identification)	Risk Band	Recommendations
Danesholme Communicare Centre, Ground, G.16 Hall	Coating to ceiling	Textured Coating - (Low)	19	Presumed Chrysotile (White Asbestos)	Good / Composite materials, reinforced plastics, resin, vinyl materials	150 sq. m.	Low / Internal	160516R119 (Visual Identification)	Risk Band D Very Low Risk	Reference to sample: 13/10/B/30/DS8
Danesholme Communicare Centre, Ground, G.16 Hall	Coating above walls and doors	Textured Coating - (Low)	20	Presumed Chrysotile (White Asbestos)	Good / Composite materials, reinforced plastics, resin, vinyl materials	100 sq. m.	Low / Internal	160516R120 (Visual Identification)	Risk Band D Very Low Risk	Reference to sample: 13/10/B/30/DS8
Danesholme Communicare Centre, Ground, G.18 Store	Presumed coating to ceiling - No access	Textured Coating - (Low)	22	Presumed Chrysotile (White Asbestos)	Fair / Composite materials, reinforced plastics, resin, vinyl materials	8 sq. m.	Low / Internal	13/10/B/30/DS8 (Visual Identification)	Risk Band D Very Low Risk	Manage in situ via periodic re-inspection

Danesholme Communicare Centre, Ground, G.18 Store	Presumed coating to wall above door	Textured Coating - (Low)	23	Presumed Chrysotile (White Asbestos)	Fair / Composite materials, reinforced plastics, resin, vinyl materials	8 sq. m.	Low / Internal	13/10/B/30/DS8 (Visual Identification)	Risk Band D Very Low Risk	Manage in situ via periodic re-inspection
Danesholme Communicare Centre, Ground, G.19 Store	Coating to ceiling	Textured Coating - (Low)	24	Presumed Chrysotile (White Asbestos)	Good / Composite materials, reinforced plastics, resin, vinyl materials	18 sq. m.	Low / Internal	160516R121 (Visual Identification)	Risk Band D Very Low Risk	Reference to sample: 13/10/B/30/DS8
Danesholme Communicare Centre, Ground, G.27 Kitchen	Presumed sink pad - No access	Bitumen - (Low)	25	Presumed Chrysotile (White Asbestos)	Fair / Composite materials, reinforced plastics, resin, vinyl materials	1 No.	High / Internal	13/10/B/30/DS12 (Visual Identification)	Risk Band D Very Low Risk	Manage in situ via periodic re-inspection
