12016/GL  
27th April 2012

### **DAME ALICE OWEN'S SCHOOL - FLOOD RISK**

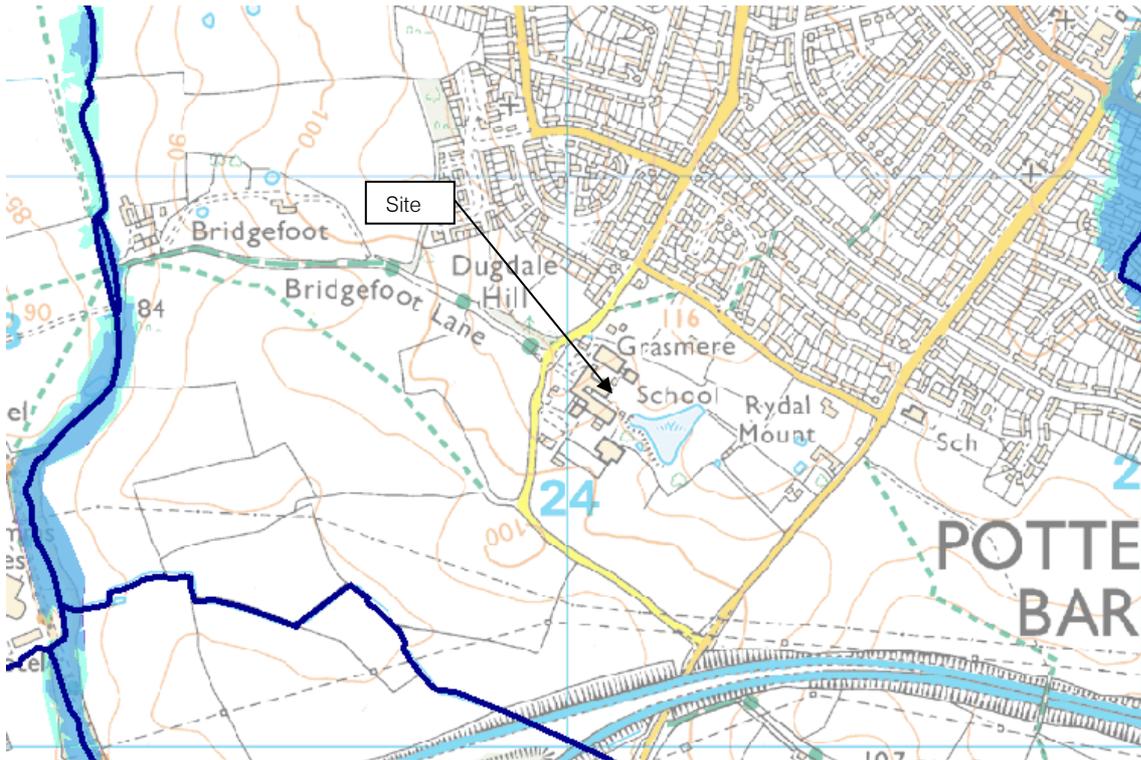
Figure 1 - Environment Agency Flood Zone Map

A reservoir exists to the east of the main school buildings as shown in figure 1 below. Water levels in the reservoir are significantly higher than the existing and proposed school buildings.

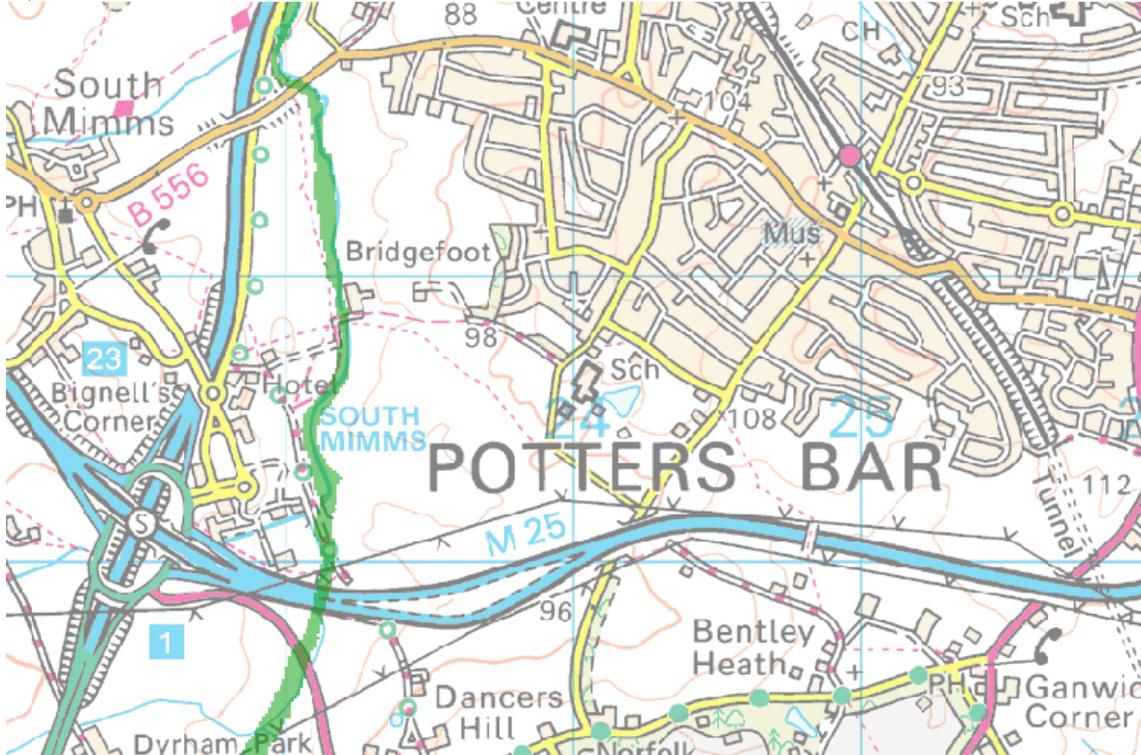
Figure 2 - Environment Agency 'Risk of flooding from Reservoirs'

According to the Environment Agency, the site is not at risk of flooding from artificial waterbodies, as shown in Figure 2. However, the Environment Agency are the enforcement authority for the Reservoirs Act 1975 which only covers large reservoirs that hold over 25,000m<sup>3</sup> of water.
