ANNUAL MAIN INSPECTION REPORT FOR **CLIFFE PARK PLAY AREA**

Site address:-
Callywhite Lane, Dronfield, S18 2XP

Date of inspection:-
9/11/2016

Inspected by:
Gary Watkinson
RPii Certificate No 1041A

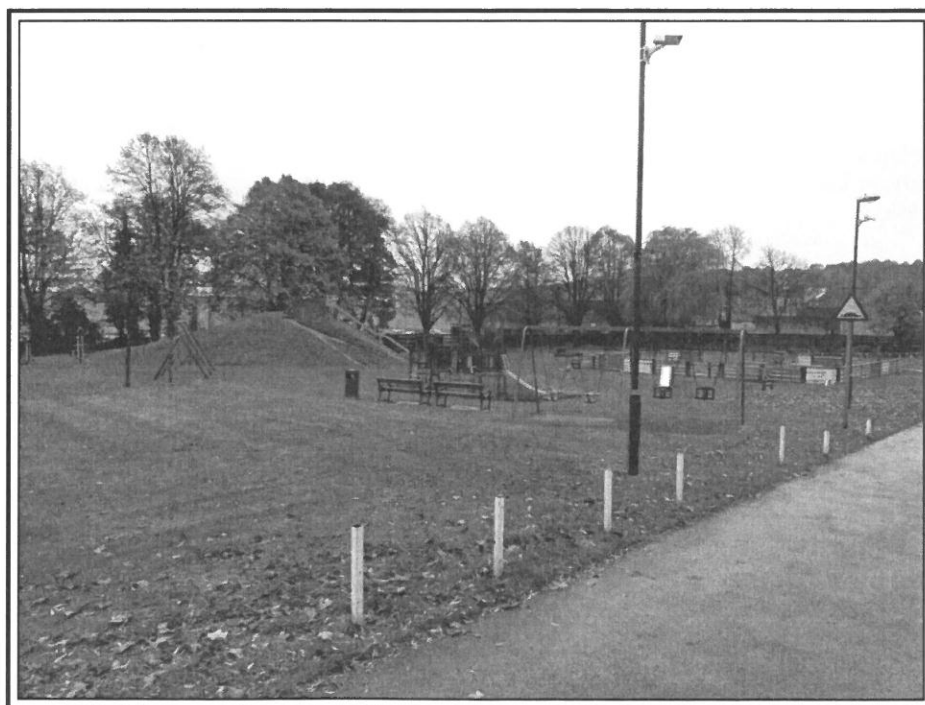
5. Ledon Spring Seesaw Life expectancy: 20 yrs Very Low Risk: 2	Satisfactory	Grass Worn – <u>monitor</u>
6. Unknown Make Junior Multi Unit Life expectancy: nil Medium Risk: 9	BS EN 1176-1, Sec. 4.2.7.2, head trap between bars in barriers; between barriers & platforms; between supports & slide sides BS EN 1176-3, Sec. 4.2, there should be a cross-bar of between 600mm & 900mm high across slide access openings BS EN 1176-1, Sec. 4.2.4.4, opening at top of incline climber wider than 500mm & without guardrail Platforms missing <u>Item taped off</u> REMOVE FROM SERVICE	Wood Chippings Satisfactory

(Missing platforms at taped-off junior multi unit)
