*Sewer Inspection,  
Cleaning and Repair*

***Project ref:TV200234***

# ***CCTV Survey Report***

**SITE: Leybourne Village Hall**

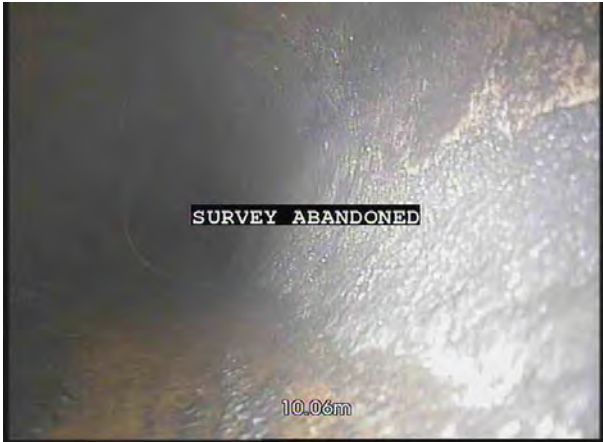
Section	Inspection Direction	PLR	Client's Job Ref	Contractor's Job Ref
19	Upstream	RUN BX	TV200234

1, 00:00:45, 10.06 m  
Survey abandoned, No further survey required

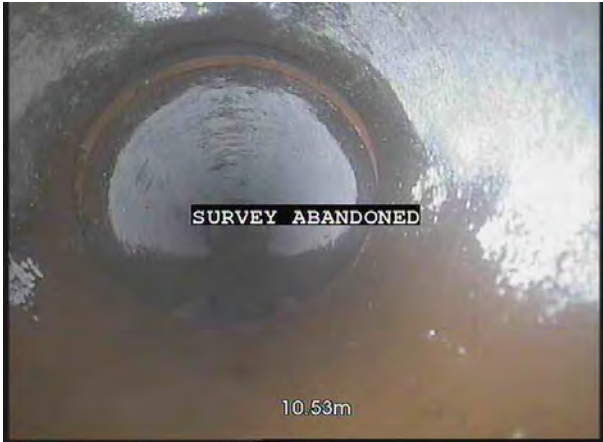
Section	Inspection Direction	PLR	Client's Job Ref	Contractor's Job Ref
20	Upstream	RUN CX	TV200234

1, 00:01:02, 10.53 m  
Survey abandoned, No further survey required

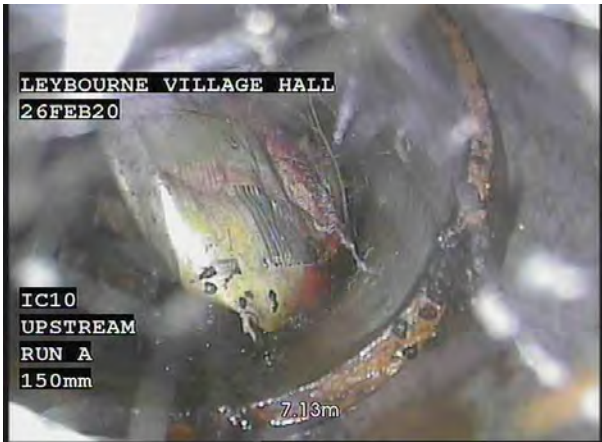
Section	Inspection Direction	PLR	Client's Job Ref	Contractor's Job Ref
25	Upstream	RUN AX	TV200234

1, 00:01:48, 7.13 m  
Settled deposits, coarse, 80% cross-sectional area loss

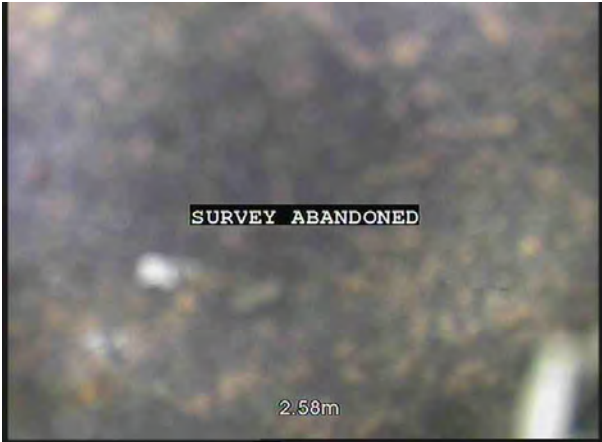
Section	Inspection Direction	PLR	Client's Job Ref	Contractor's Job Ref
26	Upstream	RUN CX	TV200234

1, 00:01:18, 2.58 m  
Survey abandoned, Unable to continue round bend
