# St. Mary's Church, Thornbury

## Churchyard Monument Condition Report

## Report into The Condition of The Churchyard Monuments, St. Mary's Church, Thornbury

Report prepared for  
Thornbury PCC

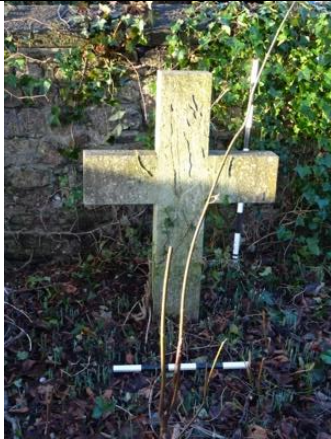
| IDENTIFICATION | CHURCHYARD | St. Mary's, Thornbury BS35 1HQ | GRAVE REFERENCE | 1 |

| | Biological patina. | | Prev. repairs | |

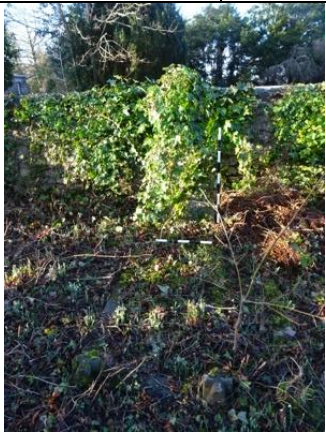
| | The surface is covered with ivy. | | Prev. repairs | |

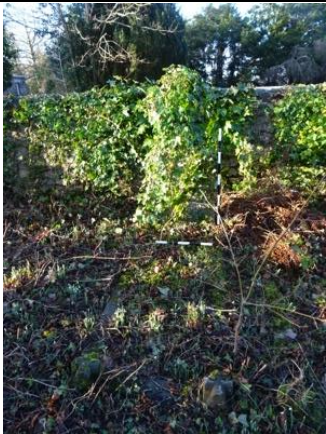
| IDENTIFICATION | CHURCHYARD | St. Mary's, Thornbury BS35 1HQ | GRAVE REFERENCE | 2 |

| | The surface is covered with ivy. | | Prev. repairs | |

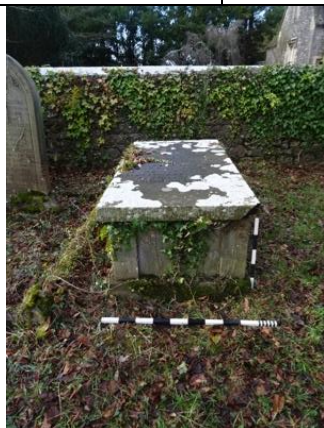
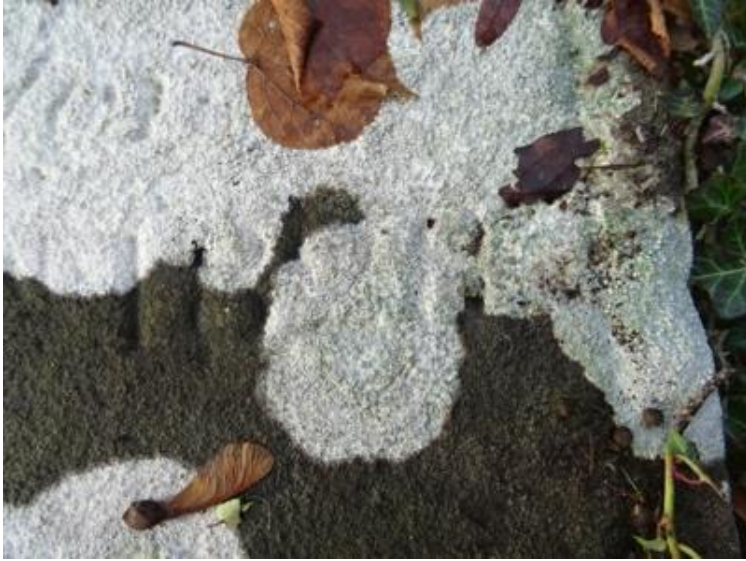
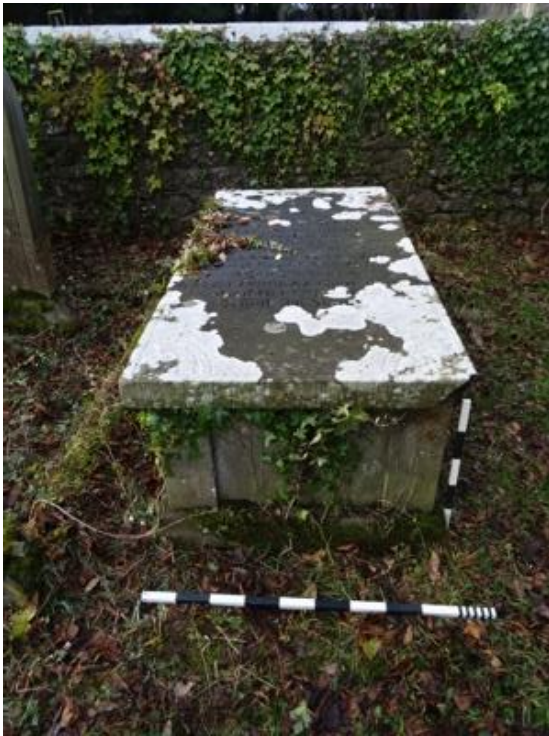
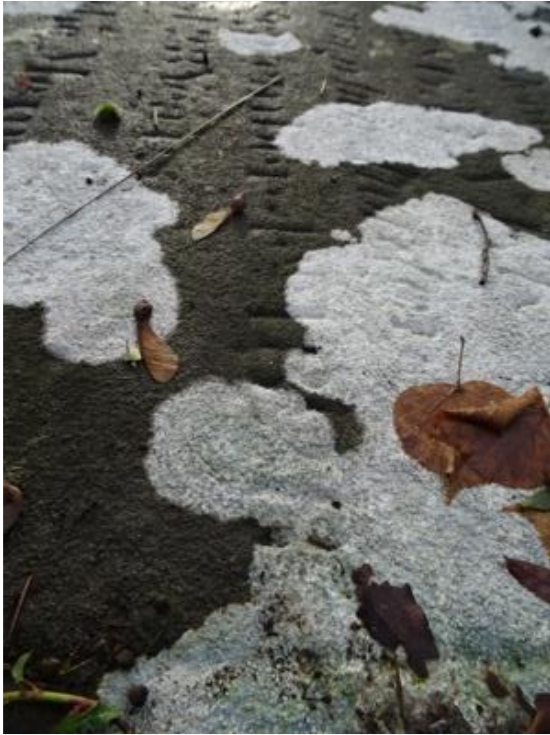
| | The surface has a rich biological patina including large patches of white lichen on the lid. Ivy has started to colonise the tomb. Delamination on the north and south panels. | | Prev. repairs | |

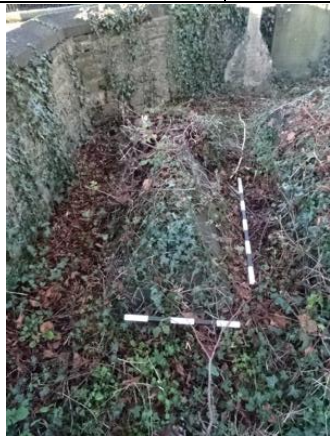
| IDENTIFICATION | CHURCHYARD | St. Mary's, Thornbury BS35 1HQ | GRAVE REFERENCE | 9 |

| | Surface covered by ivy. | | Prev. repairs | |

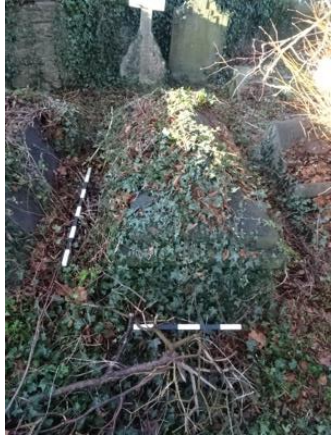
| IDENTIFICATION | CHURCHYARD | St. Mary's, Thornbury BS35 1HQ | GRAVE REFERENCE | 10 |

| | Approximately 40% of the inscription on the north side of the lid is missing. The arrisses on the lid are cracked and splitting at the edges. | | Prev. repairs | |

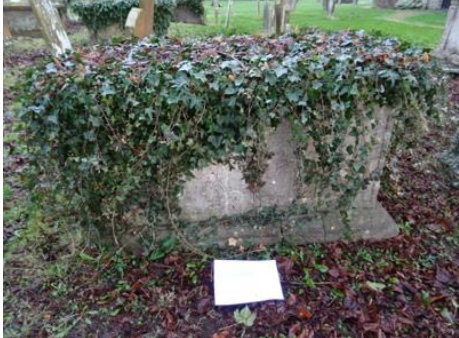
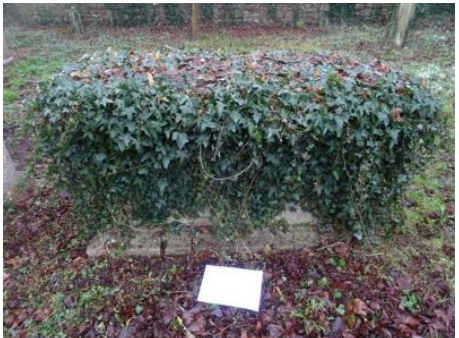
| | The surface is entirely covered in ivy. | | Prev. repairs | |
| | The structure is stable despite having open joints between the moulded base sections underneath the panels. A section of the moulded base is missing at the east end and has been replaced with a brick. | | Unstable | |

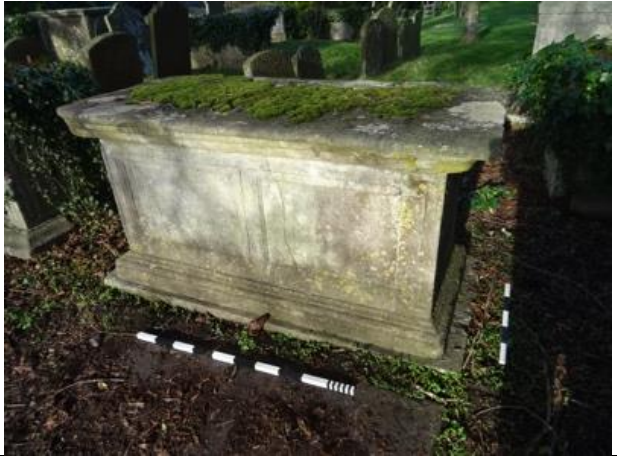
| | <p>The surface has a rich patina of red and green algae plus yellow Xanthoria lichen. The lid is partially covered with moss. Ivy is starting to colonise the north side of the tomb.</p> | | Prev. repairs | |
| | <p>The lid which was originally one piece has been broken at its east end and has been repaired with lead butterfly cramps which have since gone. A section of piecing-in overlaps this at the at the south east corner.</p> | | Unstable | |

| | Remove the ivy. | | | |

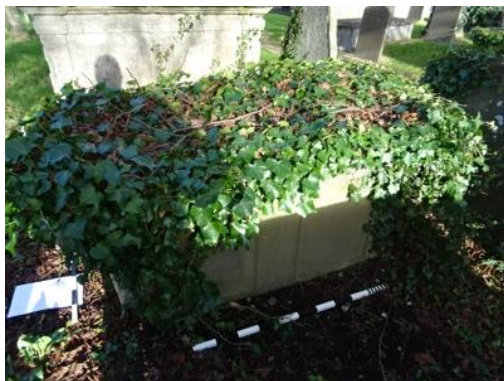
| | The surface is in good condition but some of the arrises on the south elevation are splitting. The inscription panel at the south east end is decaying at the top. The inscription at the south west end is hollow when tapped but the delamination is too thin to grout. Ivy is taking hold in the joints particularly on the north side and could lead to the destruction of the tomb. | | Prev. repairs | |
| | The structure is stable. The west end has its southern corner post missing measuring 150 x 150 x 700mm. The diagonally opposite north east corner has a hole into the tomb where the upper right side of the east end is missing; presumably the result of an expanding corroding cramp. | | Unstable | |

| | Remove ivy cutting out the roots.<br>Repoint all open joints.<br>Piece-in the missing upper right section of the east end to prevent ivy reaching inside the tomb.<br>Add small mortar fillets above the inscription panel on the south elevation to slow down the rate of decay.<br>Consider replacing the corner section that is missing from the west end (150 x 150 x 700mm). The twist in the west end may make piecing-in difficult. | | | |

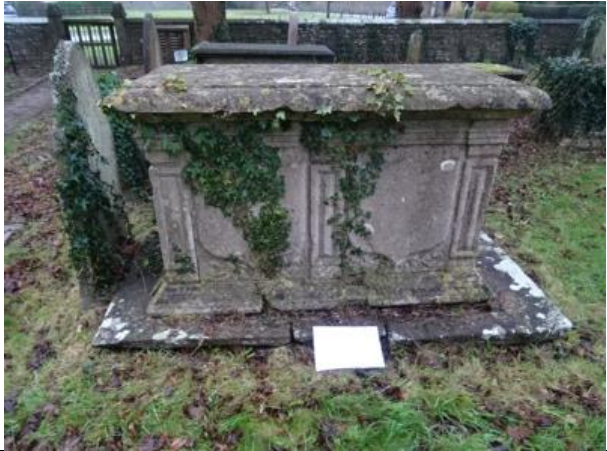
| | The surface has a rich biological patina. | | Prev. repairs | |

| | Remove ivy.<br>Point up all the open joints.<br>Reset the base stone at the east end. | | | |

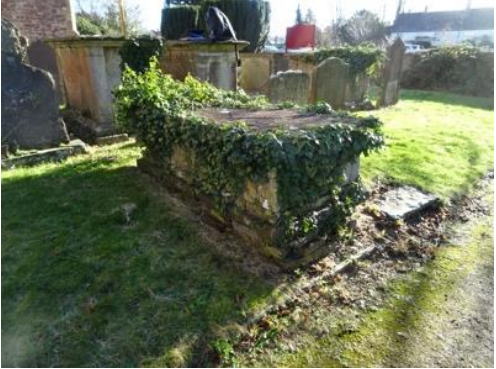
| | The surface has a rich biological patina and is colonised by mature ivy. | | Prev. repairs | |
| | Some of the bricks of the brick base or vault top have become dislodged and have been repointed in their out of line positions. The bricks have open gaps that appear not to fully support the structure. The tomb sits upon three large slabs of which the one at the west end has a crack. | | Unstable | |

| | Remove the ivy.<br>Add brick or tile in the gaps of the vault top to help support the structure above and inhibit ivy growth.<br>Repoint all open joints. | | | |

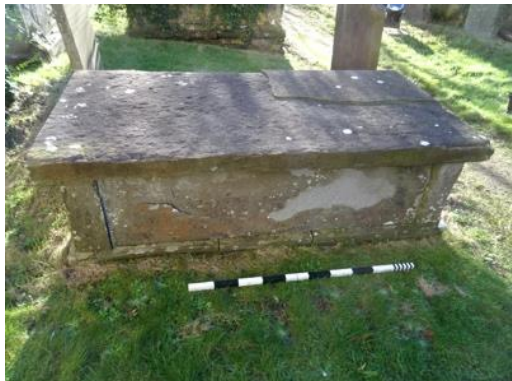
| | Approximately 80% of the inscribed lid surface has been lost except for a patch at the south west corner. The surface remnant is 10mm thick and is firmly in place but hollow when tapped. The void appears to be too thin to grout and any mortar fillets intended to support the edges of the remnant would not survive for long on this sky-facing surface. There are several splits along the edges of the lid that would benefit from grouting to help shed water. Much of the vertical surfaces of the sides and ends have decay due to sandstone delamination. | | Prev. repairs | |

| | Treat the friable decaying stone on the sides and ends with a lime slurry and mortar caps to help shed water. Grout the split edges on the lid with a colour-matched grout. | | | |

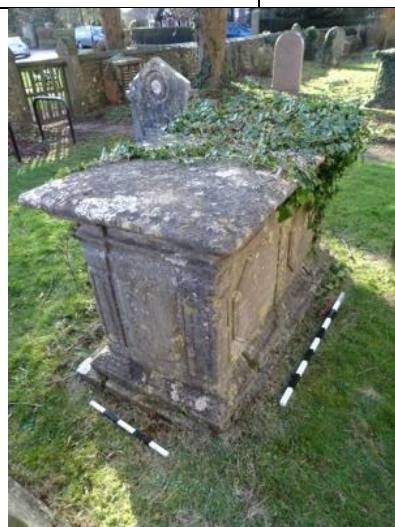
| | The surface of the tomb has a rich biological patina and has become partially overgrown by ivy. | | Prev. repairs | |
| | The west end panel has been pushed out by ivy so that there is now a 28mm gap between this and the two side panels; the joint should be 6-7mm in this instance. The north west corner of the lid had previously been repaired by piecing-in new stone (600 x 400 x 150mm) which has subsequently been lost but the iron fixing cramp for this still remains. The south west corner of the lid is missing too (120 x 120 x 150mm). | | Unstable | |

| | Remove ivy.<br>Reset the west end panel.<br>Piece back the missing northwest and southwest corners of the lid. Alternatively, make good with tile repairs.<br>Point the open joints. | | | |

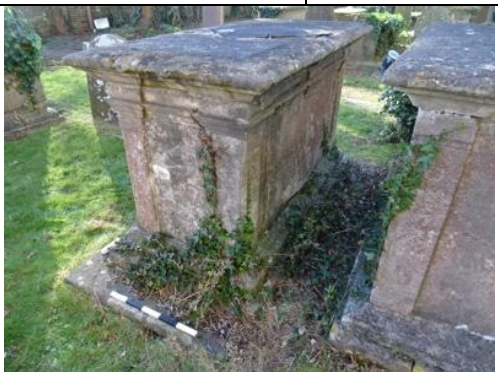
| | The tomb surface has a rich biological patina and has ivy growing around the base. | | Prev. repairs | |

| | Remove ivy.<br>Fill gap under bowing inscription plaque with mortar to shed water.<br>Repoint open joints. | | | |

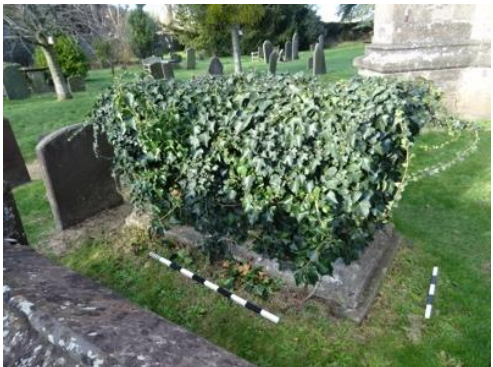
| | The top surfaces are covered by ivy. The south panel decay caused by delamination. | | Prev. repairs | |
| | The box tomb appears to be stable despite ivy having penetrated the structure and dislodging the moulded base stones at the north east corner. The tomb has been constructed on top of a large sandstone slab which has cracked approximately one third the distance from the east end. There are gaps beneath the slab which appears to be unsupported in places. Cramps were detected at the upper corners formed by the side and end panels. | | Unstable | |

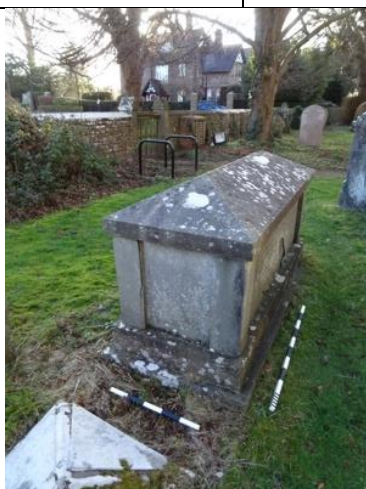
| | The tomb stonework is suffering from delamination which seems too thin to grout without incurring further loss. The corner posts at the east end have developed thin delaminated skins which are curling away from the main body of the stone. | | Prev. repairs | |

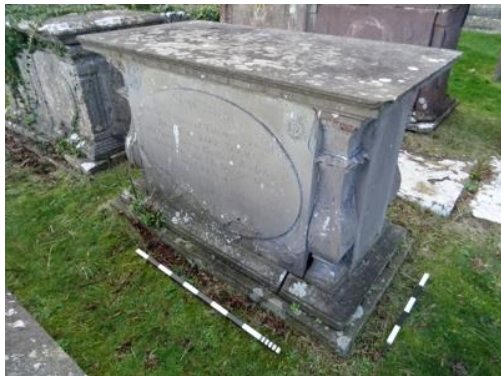
| | Rich biological patina including lichen spots.<br>10% of the south side oval inscription panel is missing. Only one of the raised sunflower motifs survives on the upper right-hand corner of the south panel. | | Prev. repairs | |

| | Remove vegetation and point open joints.<br><br>Grout, slurry and fillet the inscription panel on the south side. | | | |

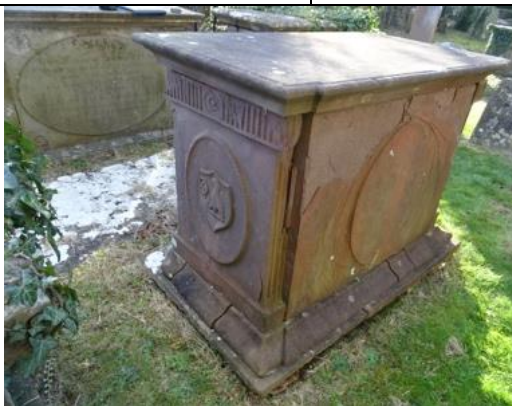
| | The south side inscription panel is very badly delaminated retaining approximately a 10mm x 10mm section of the inscription amidst radiating decay. | | Prev. repairs | |
| | The structure appears to be stable despite detecting only one iron cramp at the north west corner below the lid. The moulded base has a section missing that is now occupied by a fern. | | Unstable | |

| | Lightly defrass the south side panel and support the remaining decayed edges with colour-matched mortar fillets.<br>Remove the fern and fill the gap with a tile repair.<br>Repair the panel on the north side by grouting and mortar capping broken edges.<br>Repoint all open joints.<br>Grout and fillet the broken edges of the east end panel. | | | |

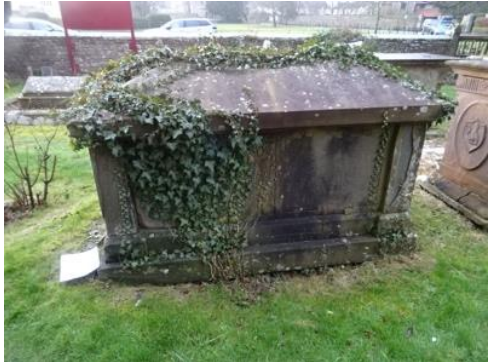
| | <p>The inscription panels on both the north and south sides are hollow when tapped. It was not possible to say if the panels had moved away from the main body of the stone because the ivy has obscured this.</p> | | Prev. repairs | |

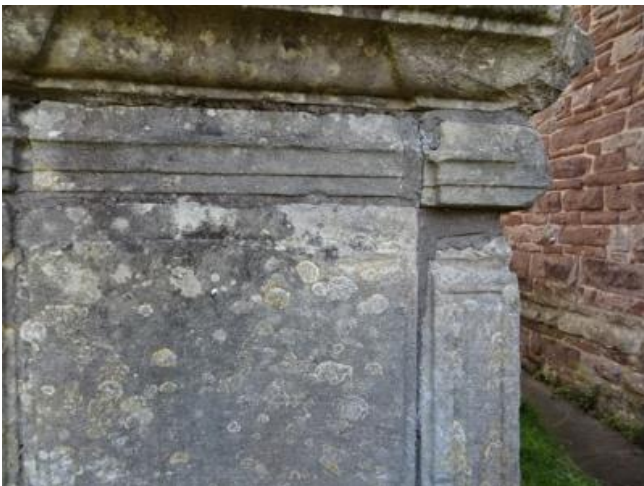
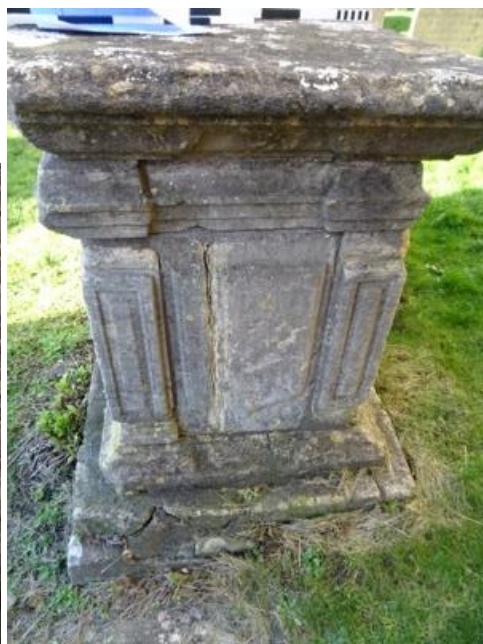
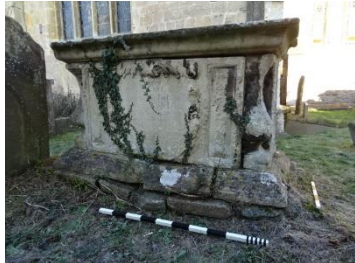
| | The tomb has black calcium sulphate staining at the south east corner on the engaged pilaster. Blistering from sulphation skins can be seen elsewhere on the sheltered parts of the tomb. Ivy appears to have been cut back but is taking hold again. Other biological growth includes moss and lichens on the lid. | | Prev. repairs | | | |
| | The tomb is leaning to the east which has led to some distortion at the joints which is being exploited by ivy growth. Corroding iron cramps at the upper corners has jacked up the lid by as much as 20mm at the south east corner. | | Unstable | | | |

| | Brace the side and end panels prior to lifting the lid and replacing the corroding iron cramps with stainless steel versions. | | | | | |
| | Rake out vegetation and loose pointing from the joints and repoint with lime mortar. | | | | | |

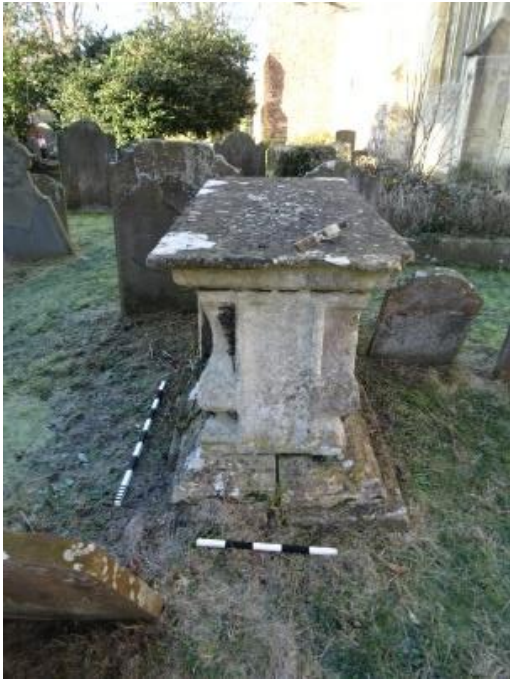
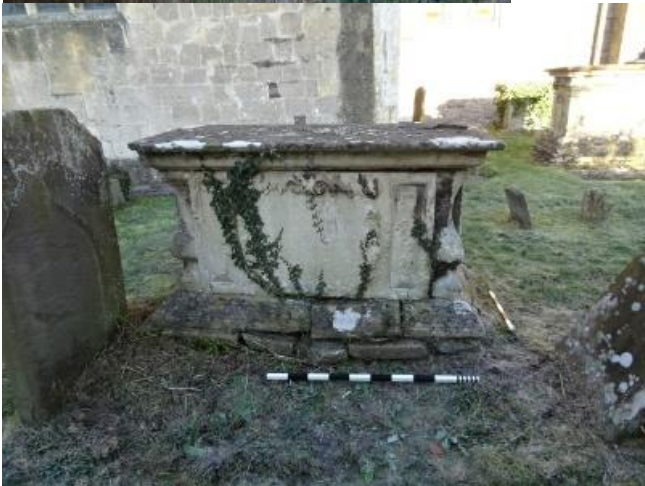
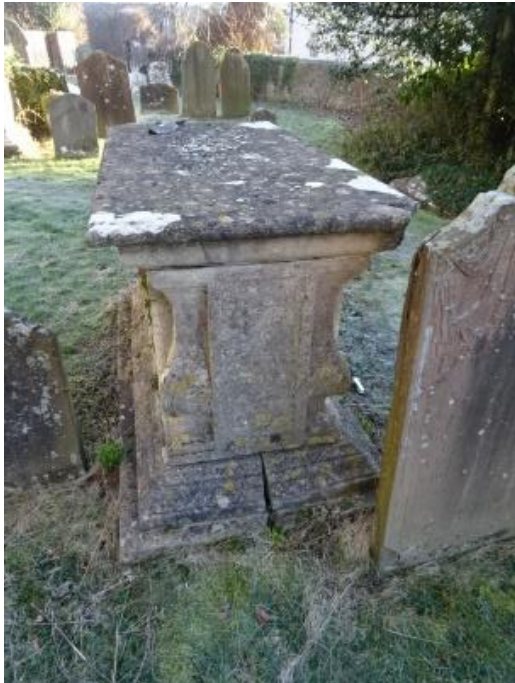
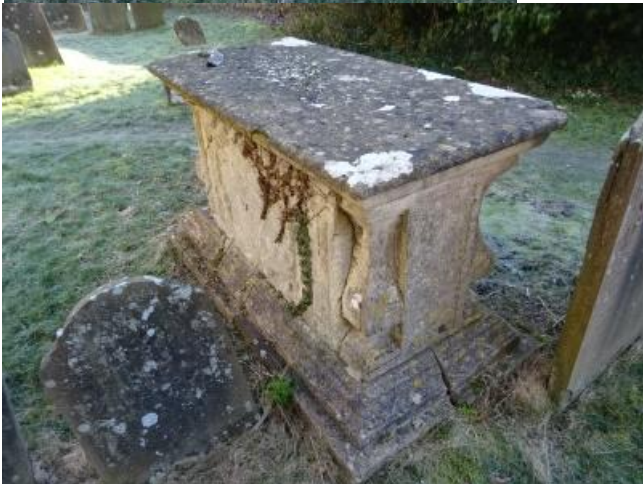
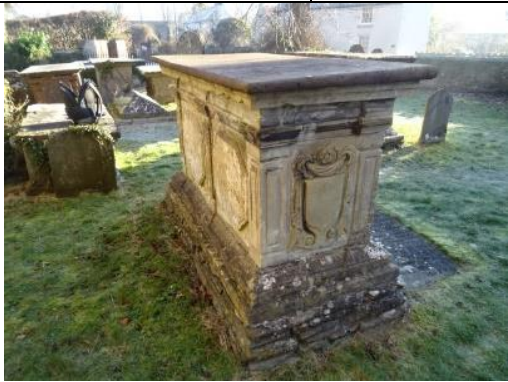
| | Sulphation staining on sheltered areas, rich biological growth on the east end and north side panel. | | Prev. repairs | |
| | The tomb appears in good order and may have been previously restored as no cramps were detected which may indicate they were replaced with stainless steel versions. | | Unstable | |

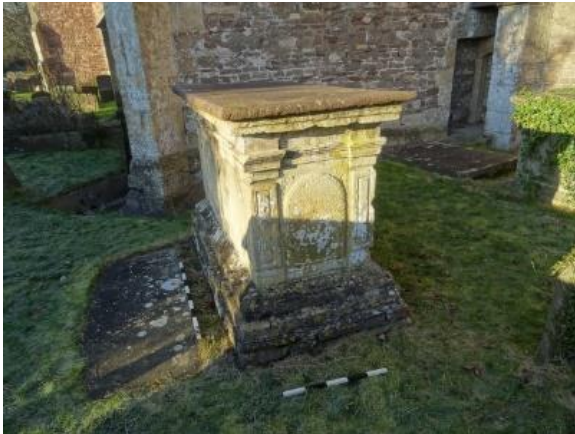
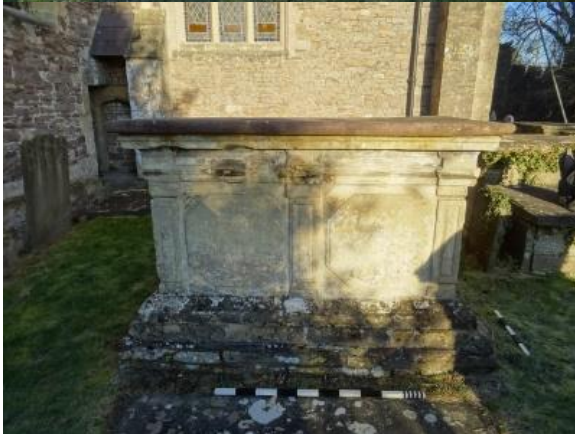
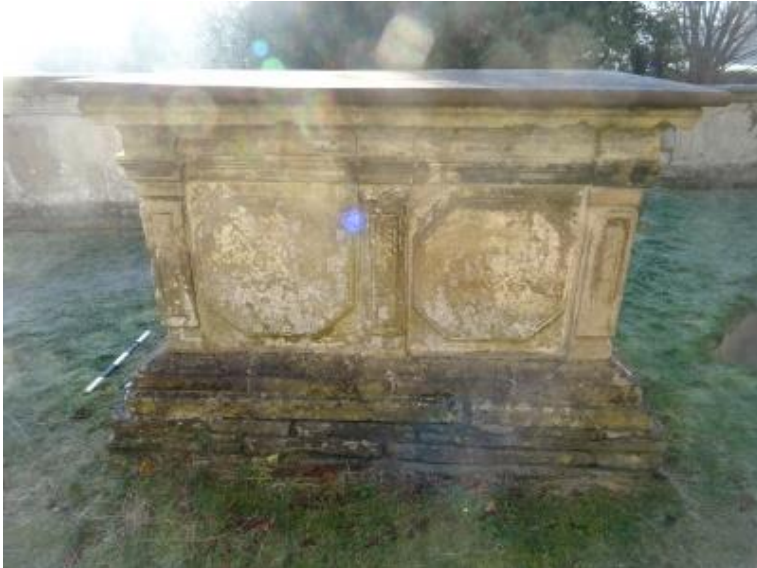
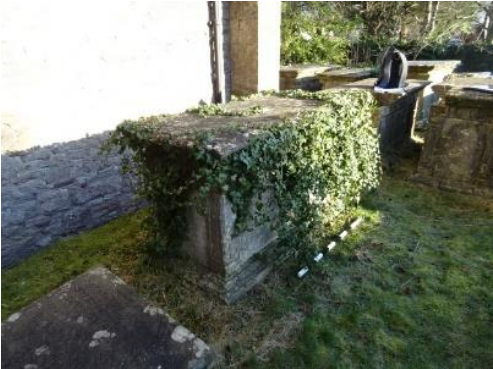
| IDENTIFICATION | CHURCHYARD | St. Mary's, Thornbury BS35 1HQ | GRAVE REFERENCE | 178 |

| | The tomb has been colised by ivy. | | Prev. repairs | |

| | Remove ivy.<br>Attempt to put back corner section without having to lift the lid.<br>Repoint open joints. | | | |

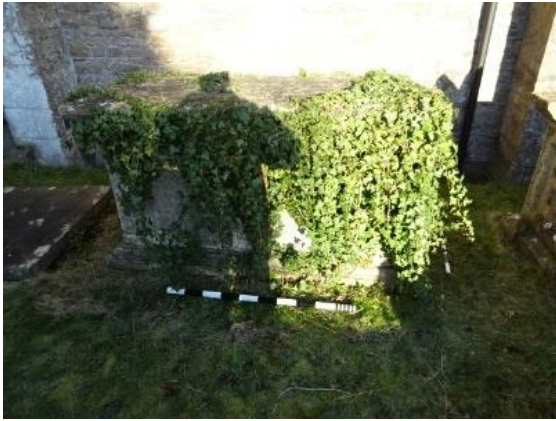
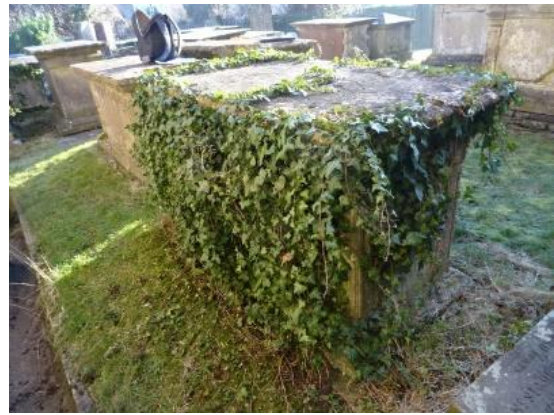
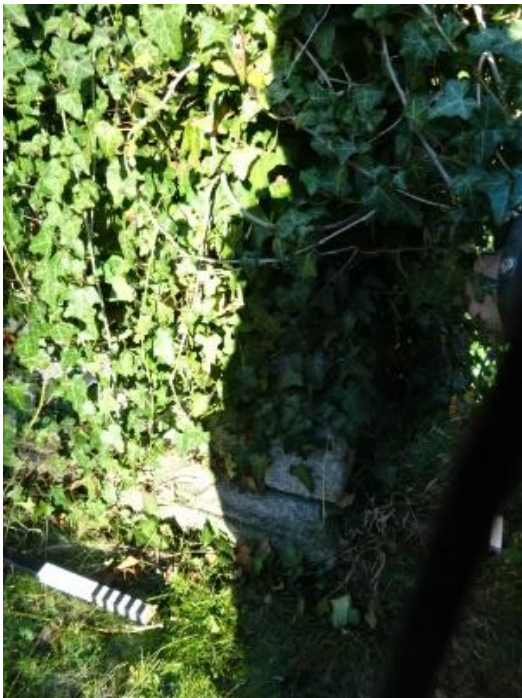
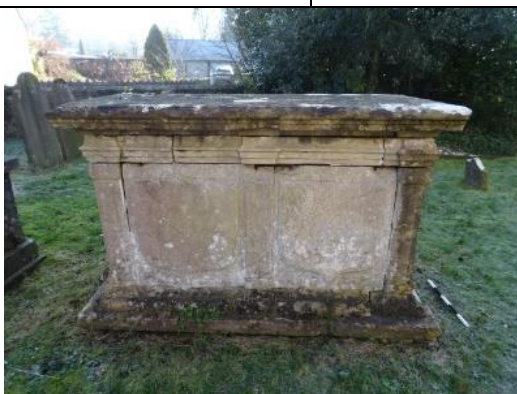
| | The tomb has a rich biological patina and sulphation staining towards the upper south west corner. | | | Prev. repairs | |
| | The tomb appears to be stable with little distortion to the vertical joints apart from the south east corner that is being exploited by brambles and ivy. However, there is an issue with the cramps above and below the architrave course. This has resulted in spalling stone and jacking-up the lid. Areas of spalled stone have exposed the corroding cramps at various points at the top of the side and end panels. The lid has been nudged and overextends at the south west corner. | | | Unstable | |

| | Set up a gantry and remove the lid and the architrave course to replace corroding iron cramps with stainless steel versions (approximately 8 fixings).<br>Remove ivy and brambles.<br>Rebuild tomb and use mortar repairs to make good areas of spalled stone.<br>Repoint open joints. | | | | |

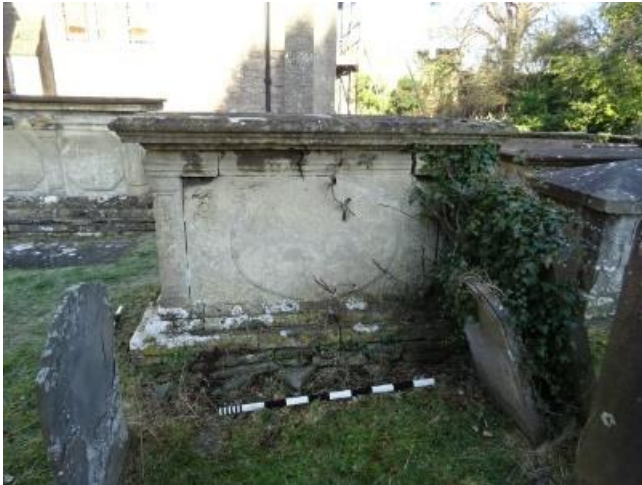
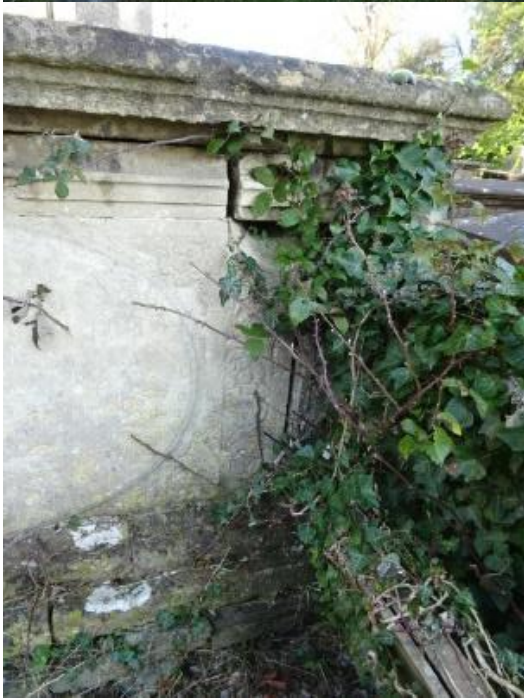
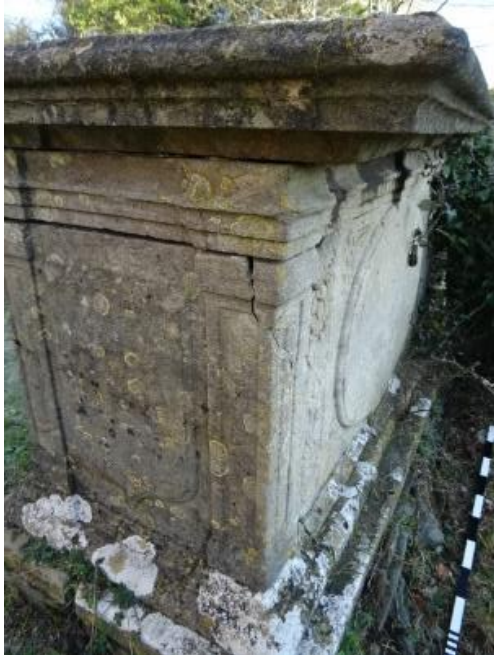
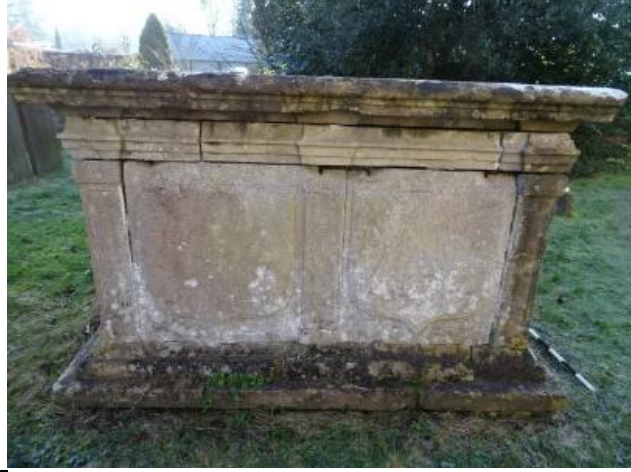
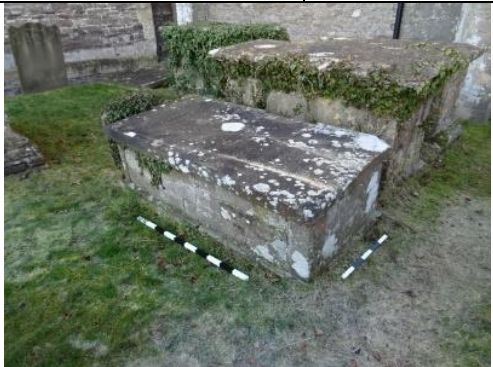
| | <p>The lid has areas of delamination along the northern, southern and east edges. There is also a large hollow area at the south side of the lid one third of the way down from the eastern edge.</p> | | Prev. repairs | |

| | Grout and fillet the broken edges and hollow cavities on the lid. | | | |
| | Repoint ashlar after removal of ivy. | | | |

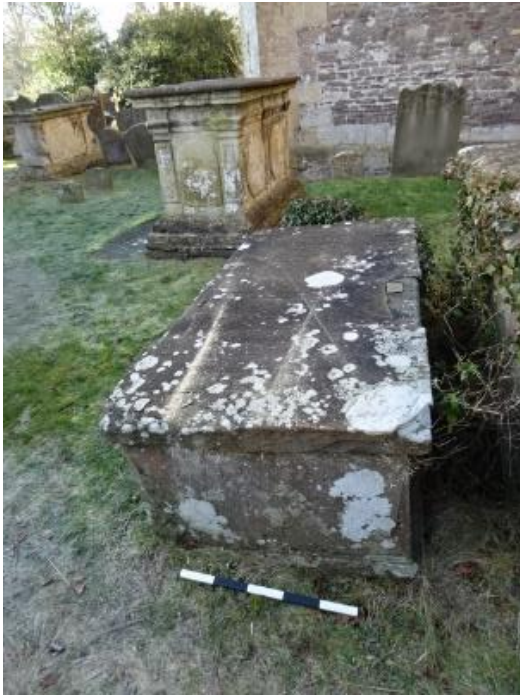
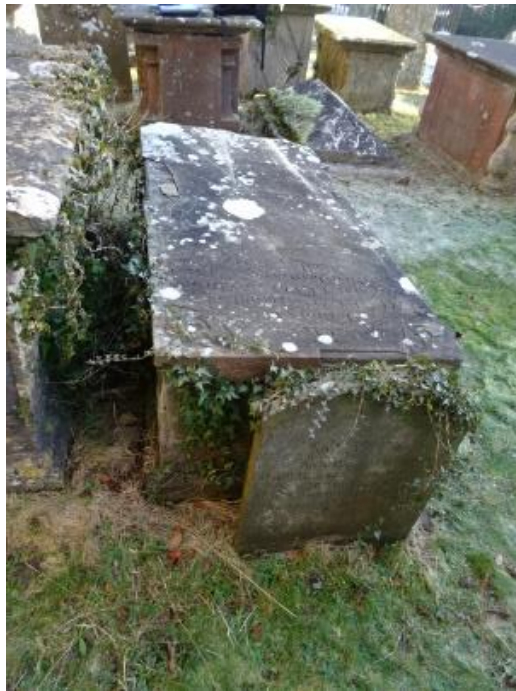
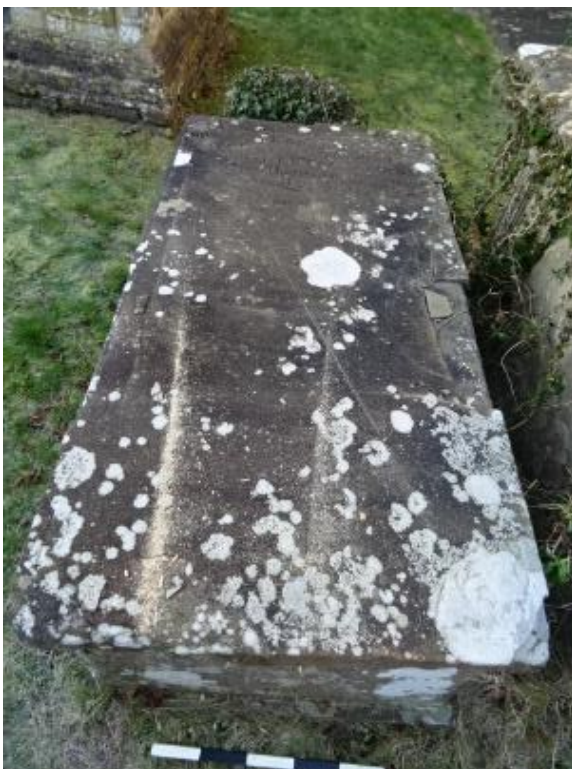
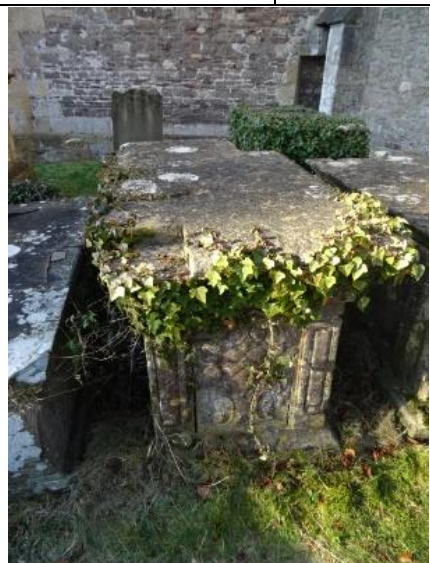
| | The tomb has a rich biological patina including large white patches of lichen on the lid. Ivy is taking hold on the north and east sides. The lid has two previous areas of piecing-in on the lid that are subsequently missing. The larger section at the north west corner measures 510 x 240 x 150mm and appears to have been victim to frost damage. The smaller section is at the south east corner and measures 280 x 280 x 60mm. | | Prev. repairs | | |

| | Remove ivy.<br>Push back and cramp the south east corner post.<br>Repoint open joints.<br>Piece-in missing lid corners. | | | | |

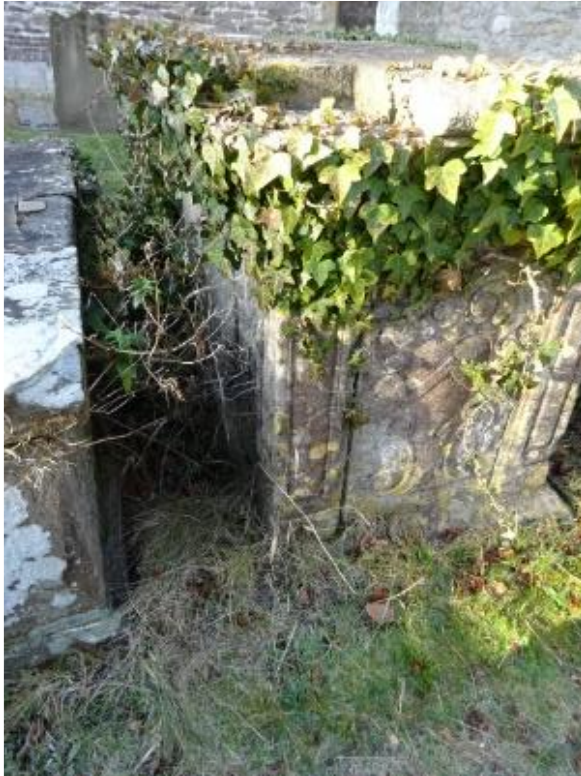
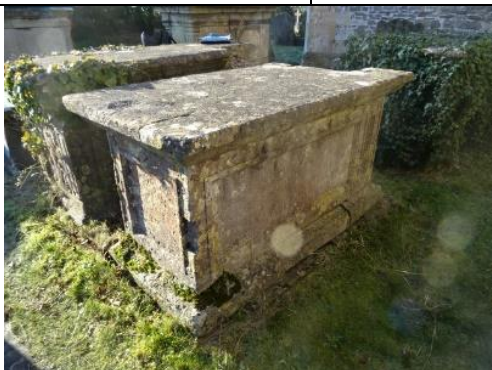
| | The surface has a rich biological patina. Soil possibly from an ant nest is encroaching onto the base at the south west corner. Previous intervention has seen the installation of two pieced-in sections of stone on the lid. One section is now missing at the south west corner (580 x 300 x 150mm) exposing the cramp and allowing the elements inside the structure. | | Prev. repairs | |
| | There is slight distortion of the tomb giving rise to a few open joints. The inside of the tomb is exposed due to the missing corner. | | Unstable | |

| | Remove vegetation.<br>Repoint open joints.<br>Treat exposed cramp with a rust inhibitor.<br>Piece-in new section of stone. | | | |

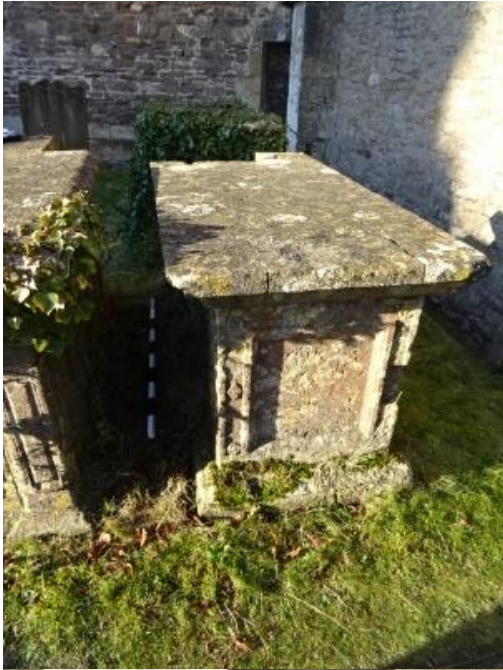
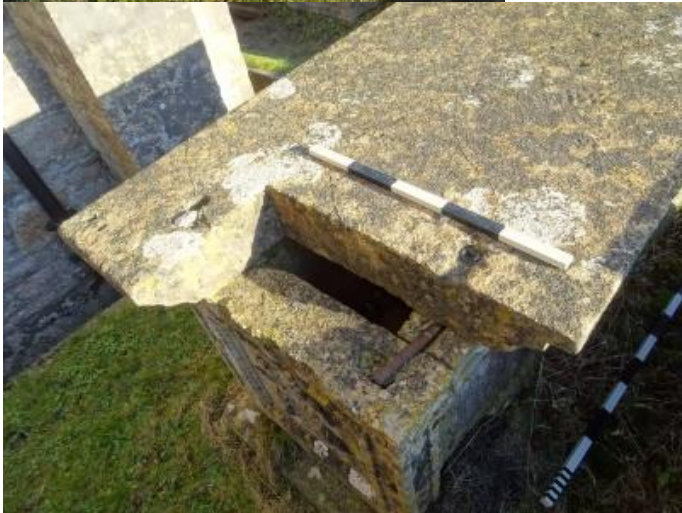
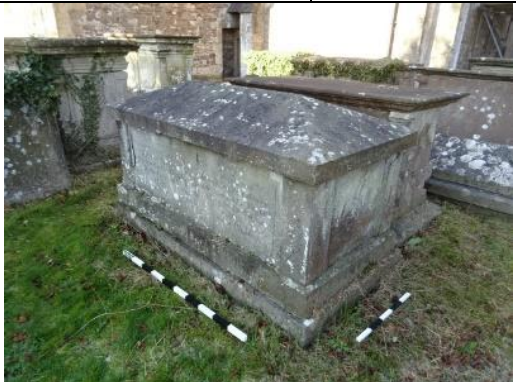
| | <p>The tomb has a rich biological patina. Delaminating stone towards the west end of the south panel, also present on the east and west end panels. The inscription on the west end is hollow when tapped but appears too thin to be able to grout successfully.</p> | | Prev. repairs | |

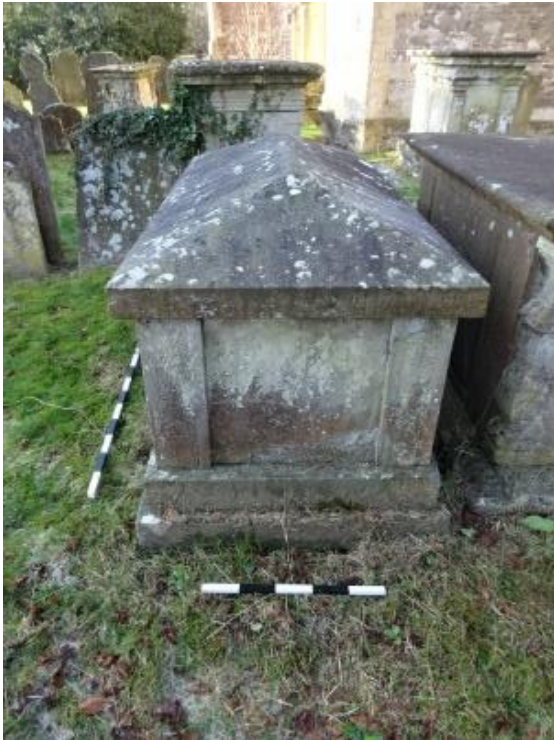
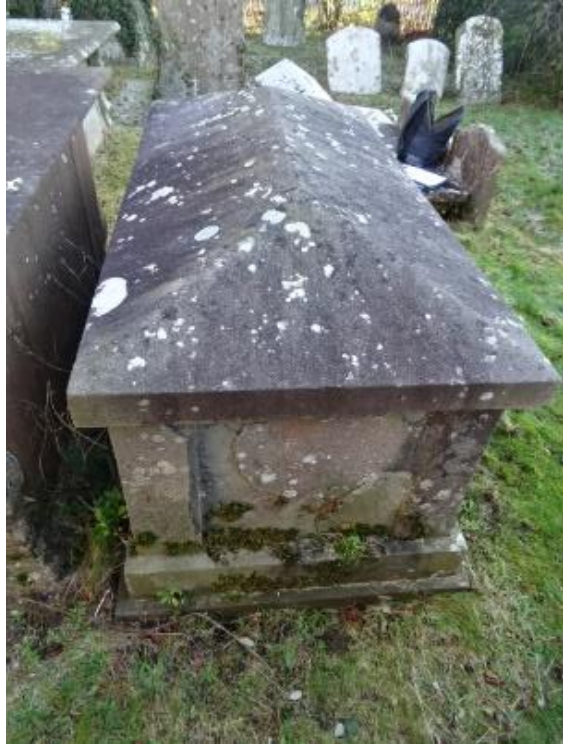
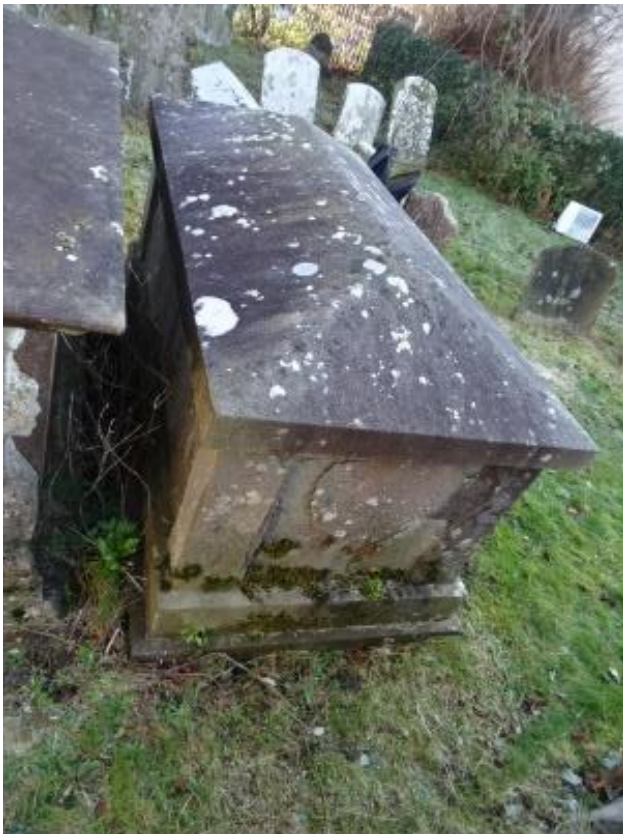
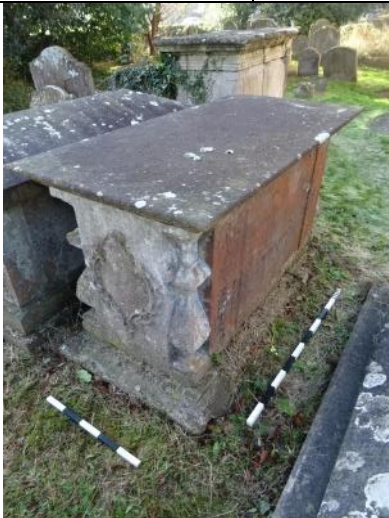
| IDENTIFICATION | CHURCHYARD | St. Mary's, Thornbury BS35 1HQ | GRAVE REFERENCE | 191 |

| | Rich biological patina. | | Prev. repairs | |

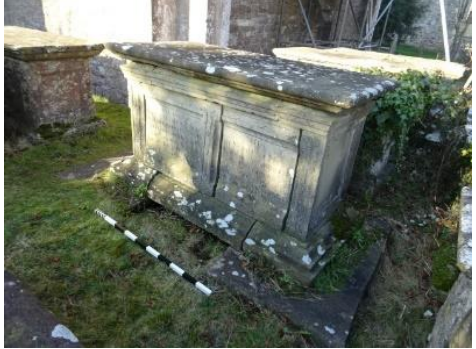
| | The tomb has been constructed upon three large slabs that span the grave. The central slab is relatively thin at 50mm compared to the slabs at either end which are 110mm deep. The central slab may be in two parts as it appears to be dipping into the grave from both sides but particularly on the south side. This has caused distortion that is much more pronounced on the south side where the moulded base stone is rotating inwards affecting all the elements above. Both the stones that form the south side panel lean into the tomb at the centre and spring when tapped. The central architrave section above these no longer bears the weight of the lid and is effectively loose in its position leaving the end panels and the north side to carry all the weight. All this distortion has resulted in numerous open joints and has left the the tomb vulnerable to structurally damaging ivy and general collapse. | | Unstable | |

| | <p>The tomb ideally requires a stable foundation which may involve complete dismantling and for which a contingency should be made available. However, as the north side of the tomb presents less disruption than the south side it may be possible to save some time by focusing on the south side collapse. This would involve setting aside the lid to the south side without blocking out work access to the area of repair.</p> <p>It is likely that the cavity into which the central foundation slab dips will require backfilling with compacted gravel and or concrete lintels to span the void and this would involve the supervision of an archaeologist. It would be prudent to replace all the accessible iron cramps with stainless steel versions if they are found to be corroding or treat them by cleaning and applying a rust inhibitor if they are not. The tomb would then be rebuilt using lime mortar for the construction.</p> | | |

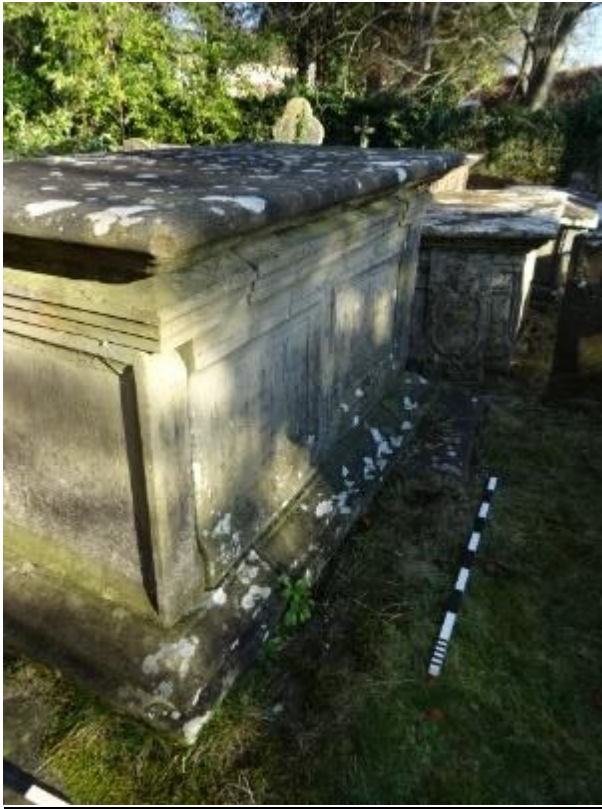
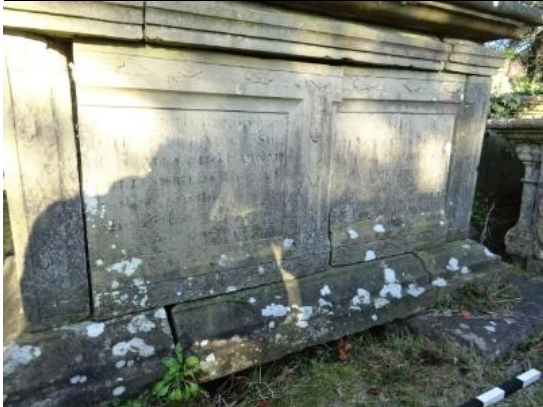
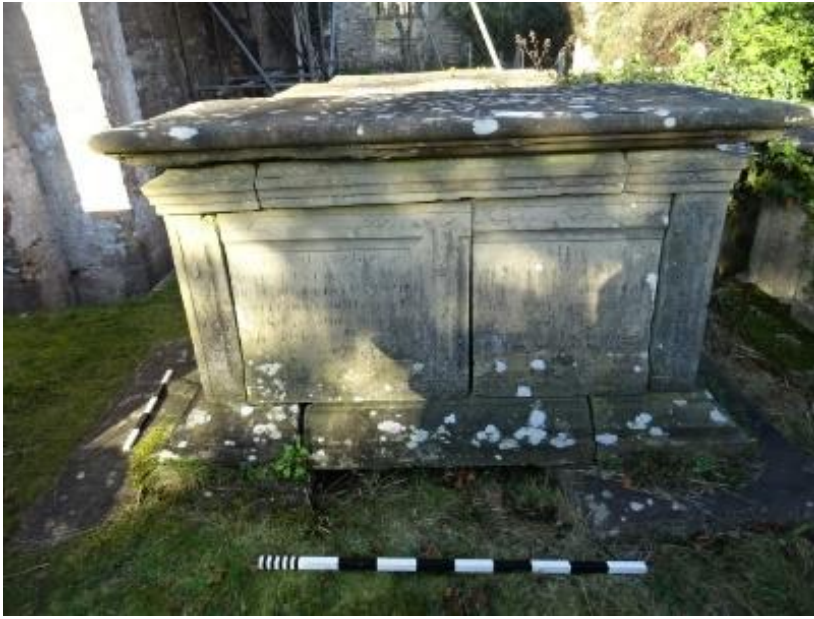
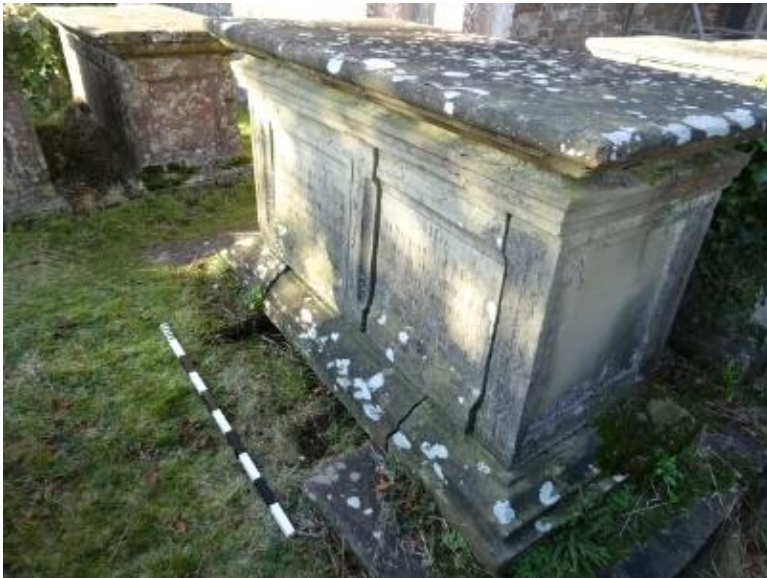
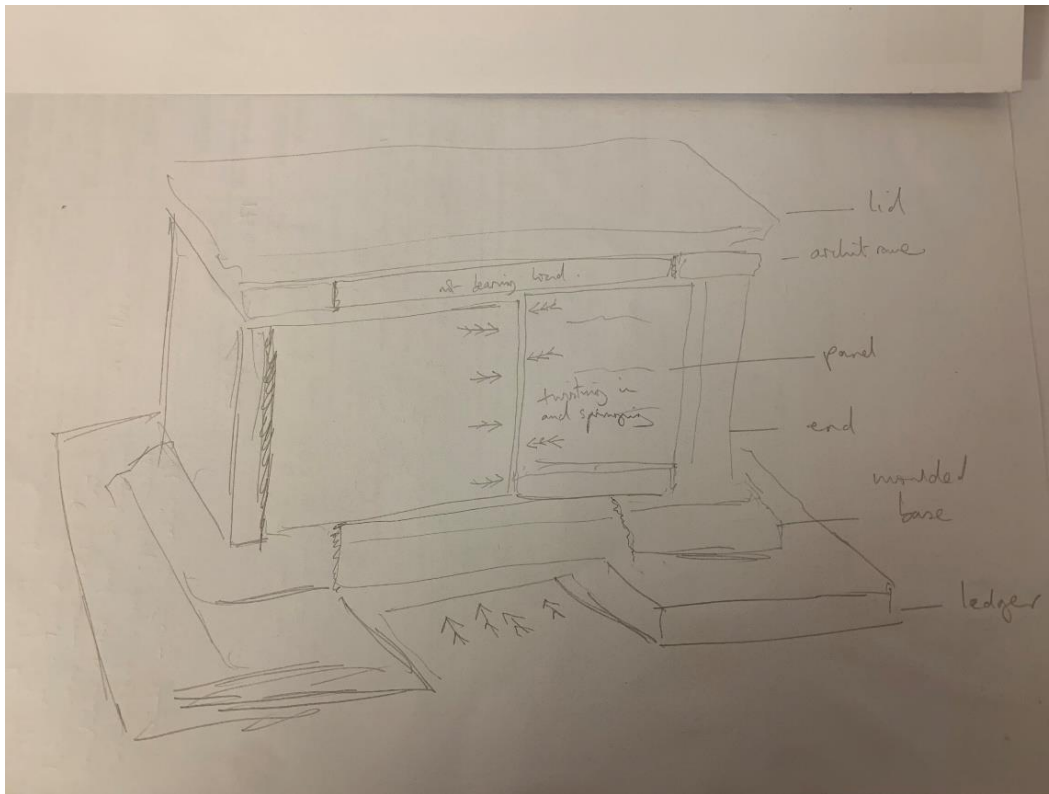
| | The tomb has a rich biological patina. Ivy is exploiting the joints and there is frost has damaged the moulded base on the north side. | | Prev. repairs | |
| | The tomb is stable. There is a missing base corner at the south east. | | Unstable | |

| | Remove ivy.<br>Point open joints.<br>Repair frost damaged base section. | | | |

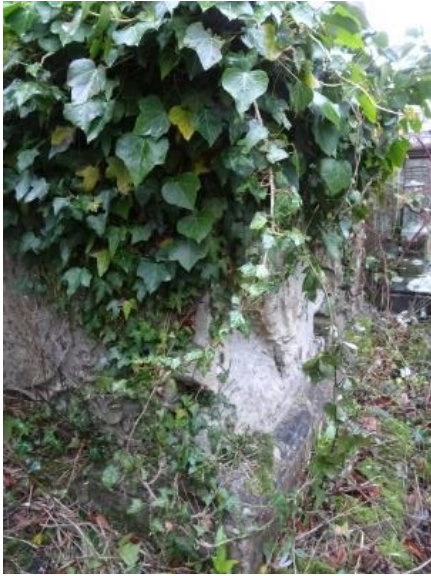
| | <p>The tomb has a rich biological patina. There are exposed quartz veins on the lid running from the south west to the north east. The lid is slightly dished on the south side that allows water to pond.</p> | | Prev. repairs | |

| | <p>Remove vegetation.<br/>Repoint two open joints.</p> | | | |
