# St. Mary's Church, Thornbury

## Churchyard Monument Condition Report

## Report into The Condition of The Churchyard Monuments, St. Mary's Church, Thornbury

Report prepared for  
Thornbury PCC

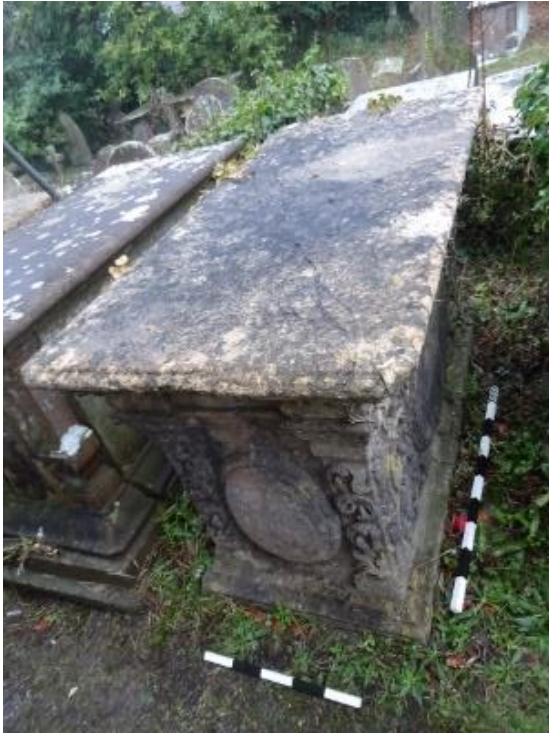
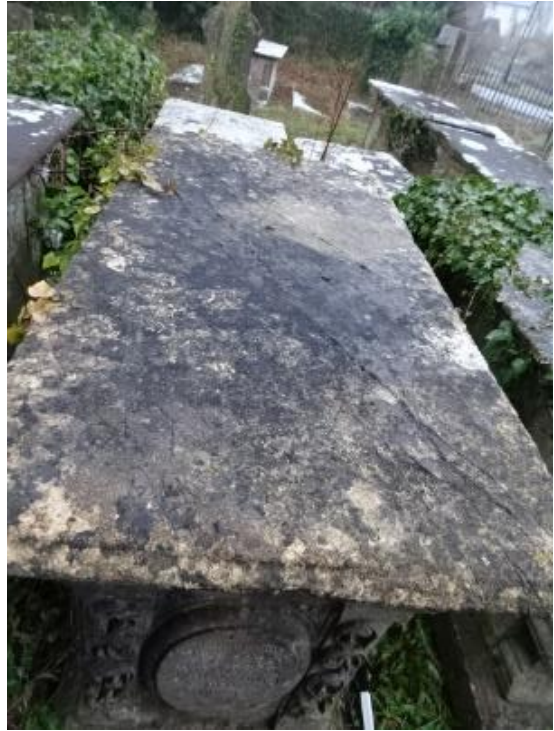
| | <p>The surface has a rich biological patina. There are thin skins of delaminating stone on all sides including the inscriptions.</p> | | Prev. repairs | |
| | <p>The tomb is leaning to the south east which has caused some distortion at the joints. Several of the moulded base stones have open joints and one on the south side is twisted inwards and is being exploited by ivy.</p> | | Unstable | |

| | <p>Remove vegetation.</p> <p>Attempt to correct misaligned moulded base section without having to dismantle the structure.</p> <p>Repoint all open joints.</p> | | | |

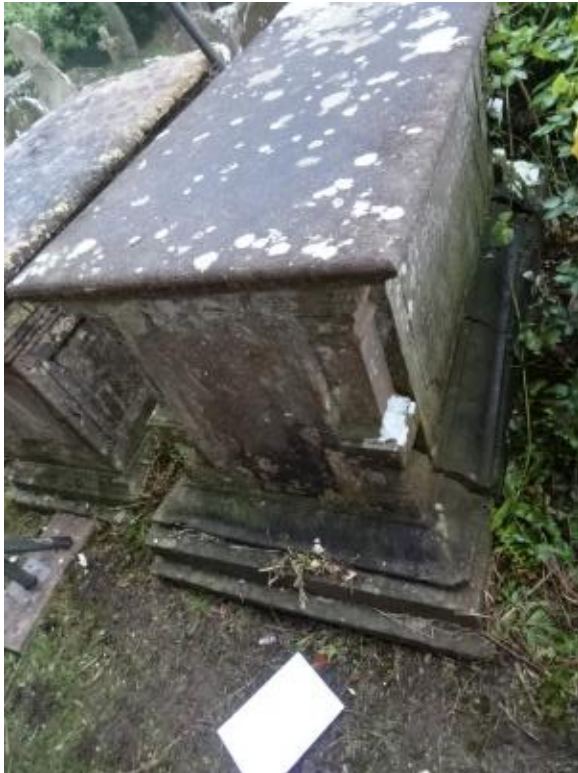
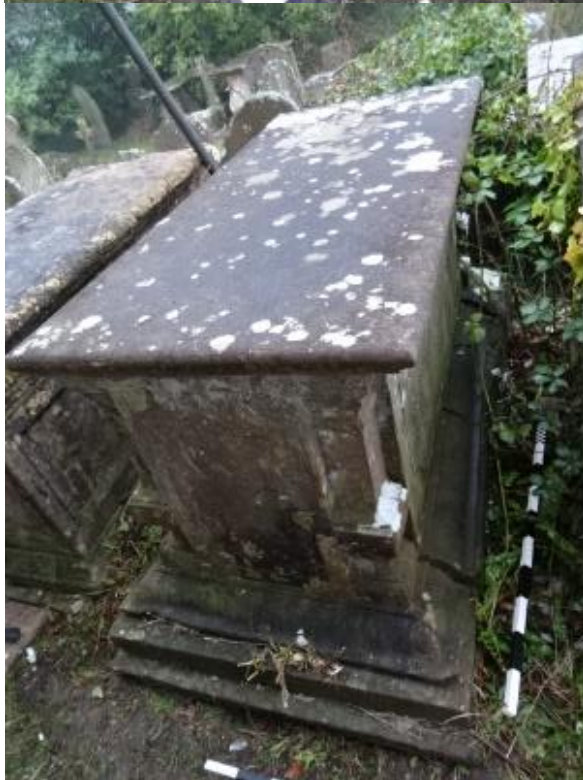
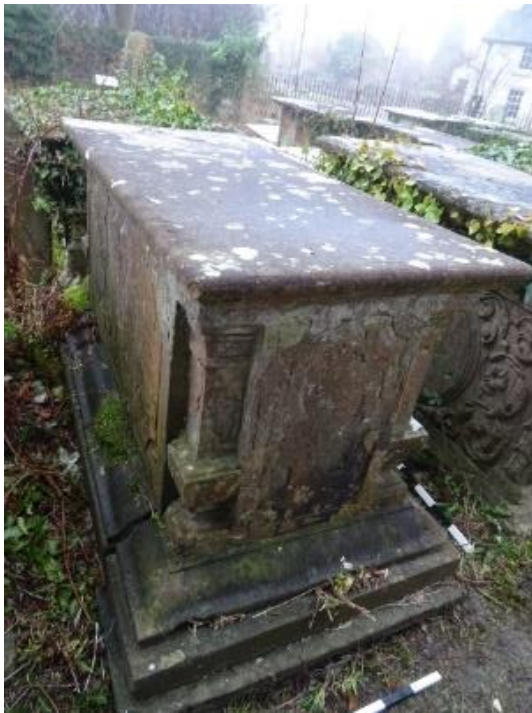
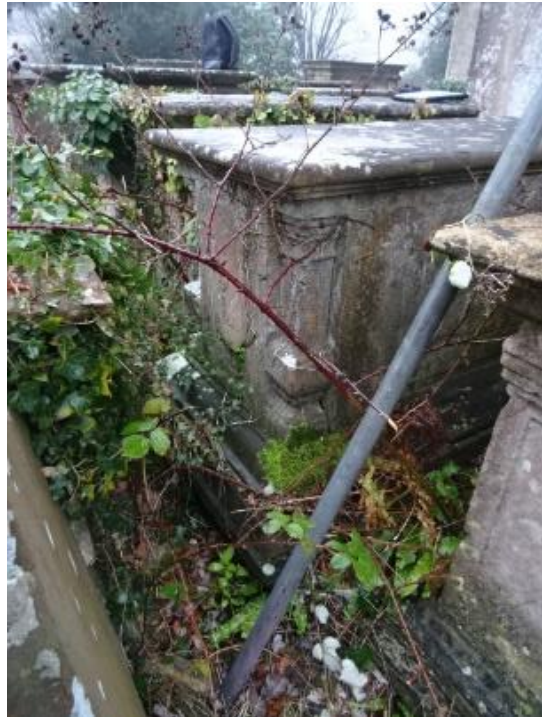
| | The surface has a rich biological patina. There is frost damage and pitting of the stone at the north east corner of the lid. | | Prev. repairs | |

| | Repoint open joints. | | | |

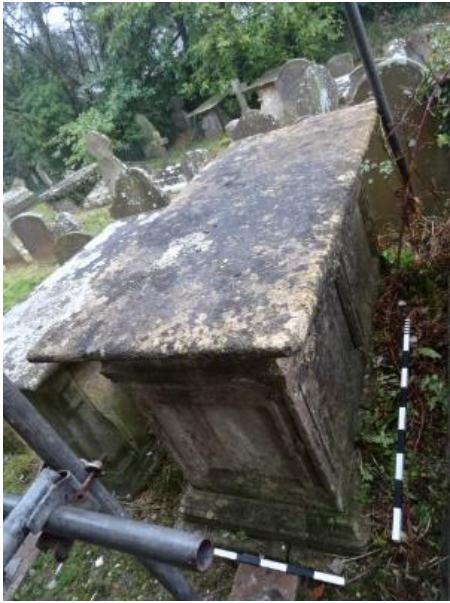
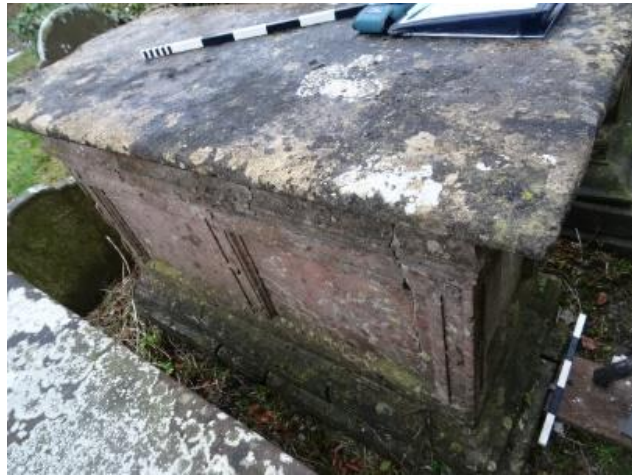
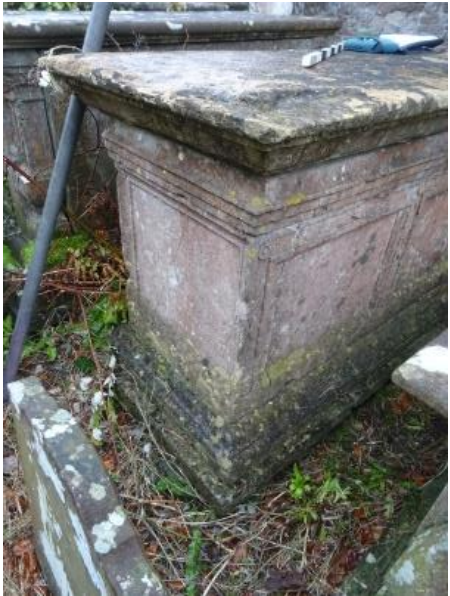
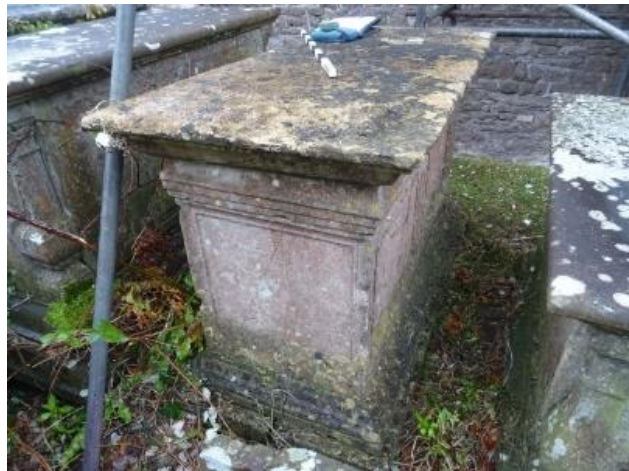
| | <p>The tomb has a rich biological patina. There is some weather erosion at the top left corner of the south panel where a 30cm x 30cm patch of stone has spalled off.</p> | | Prev. repairs | |
| | <p>The tomb is stable having undergone recent repair work. The tomb has been reconstructed upon a blue plastic damp proof membrane. A large vertical crack on the north panel has been repaired 1/3 of the distance from the east end.</p> | | Unstable | |

| | None. | | | |

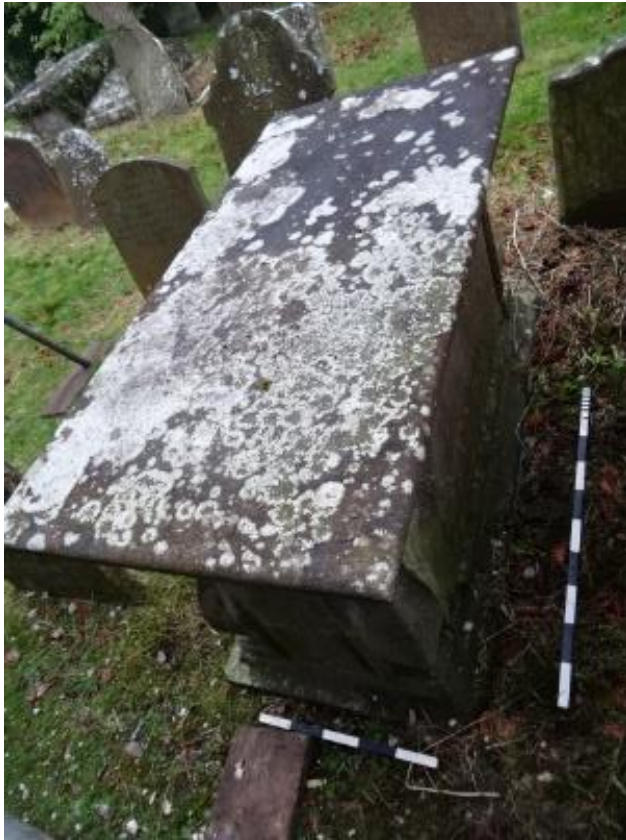
| | Approximately 70% of the surface is covered by white lichen. | | Prev. repairs | |

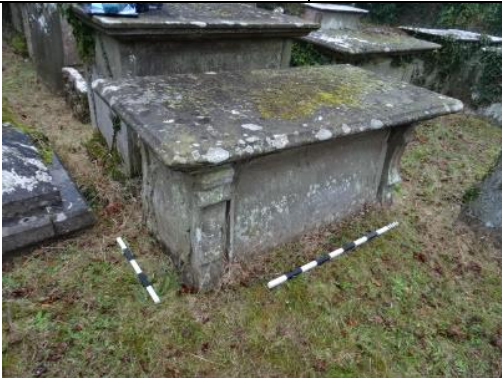
| | <p>The surface has a rich biological patina of lichens and moss. There is erosion around the top of the inscription on the south side.</p> | | Prev. repairs | |

| | Repoint open joints. | | | |

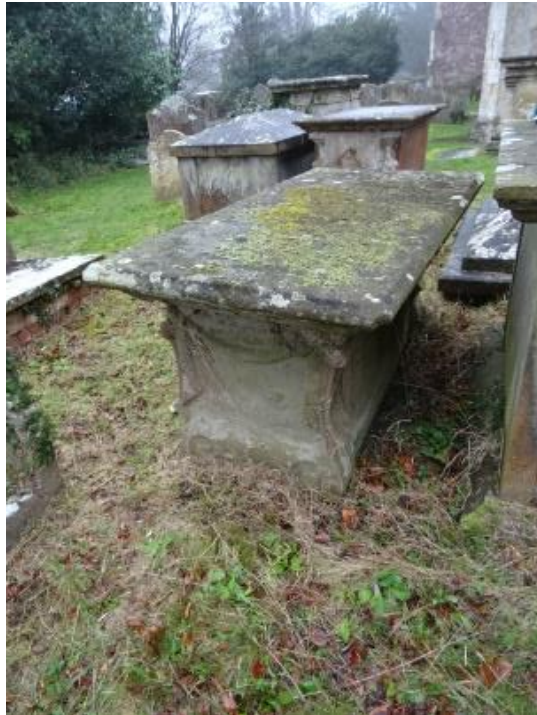
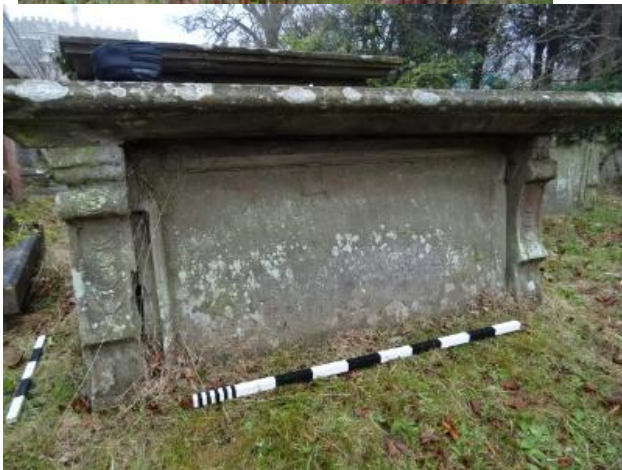
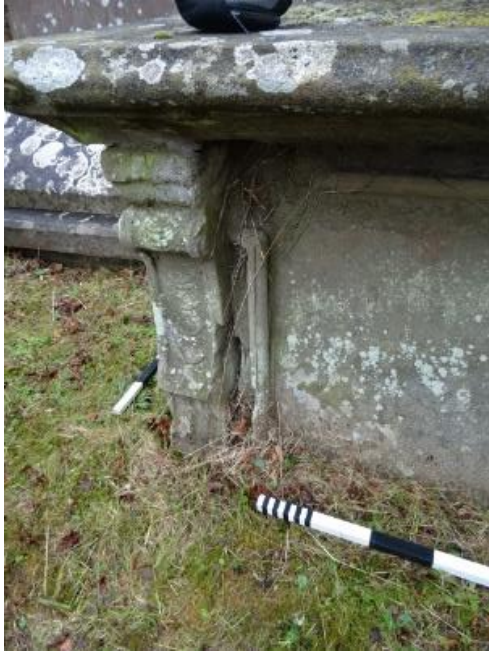
| | The surface has a rich biological patina. | | Prev. repairs | |

| | Remove ivy.<br>Repoint open joints. | | | |

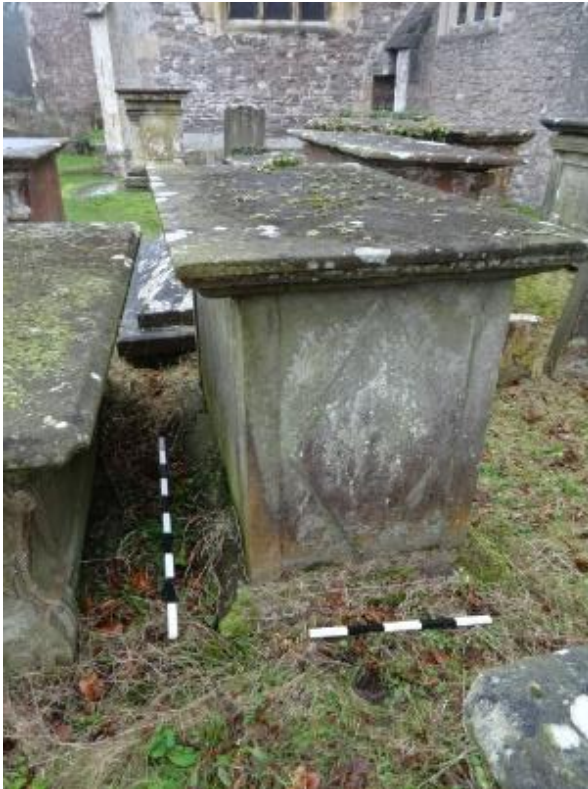
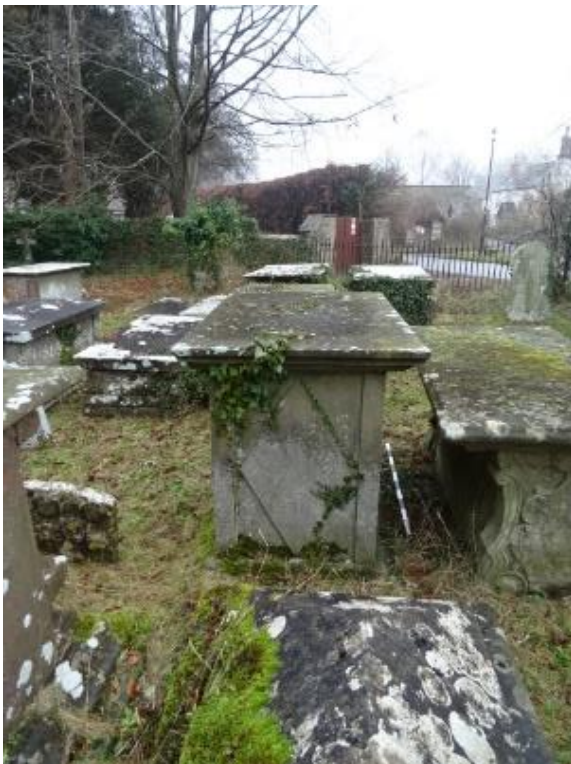
| | The tomb is dipping to the north but is stable. Both sections that form the base below the south side inscription panel have been inserted upside down so that the architrave moulding framing the inscription does not align at the bottom. These sections are loose and are pushed into the tomb where they meet at the centre. The sections only support the inscription panel at their east and west ends. As a consequence, the inscription panel has dropped by approximately 10mm. It would be difficult and too disruptive to correct the base stones, however, the base stones should be supported from below with new stone or concrete blocks to make them engage with the panel above. | | | Unstable | | |

| | Insert new stone to support the base stones on the south side.<br>Repoint open joints. | | | | | |

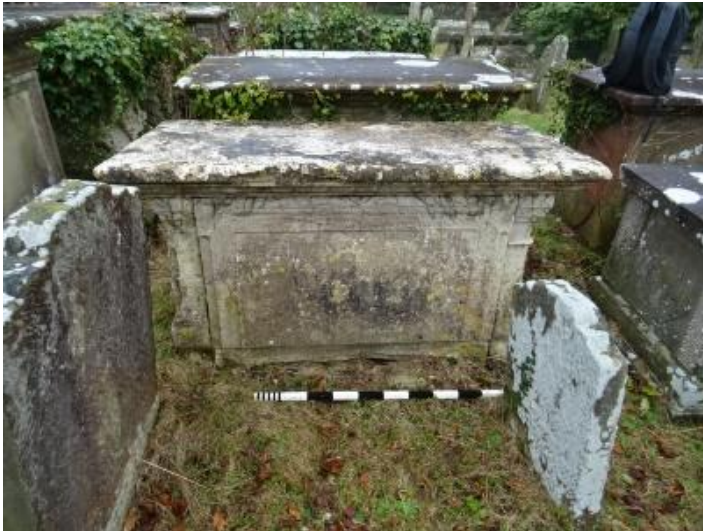
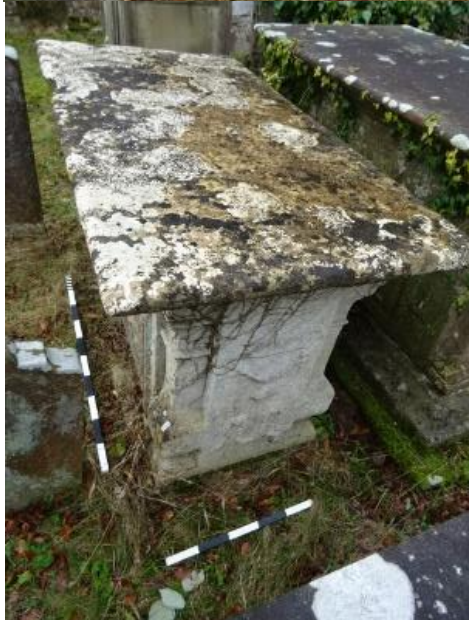
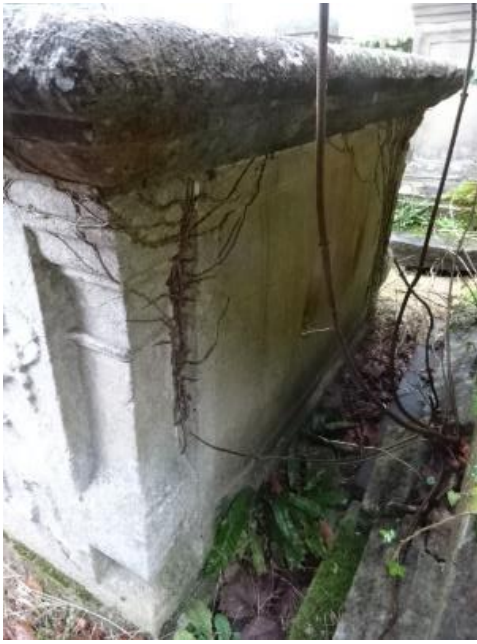
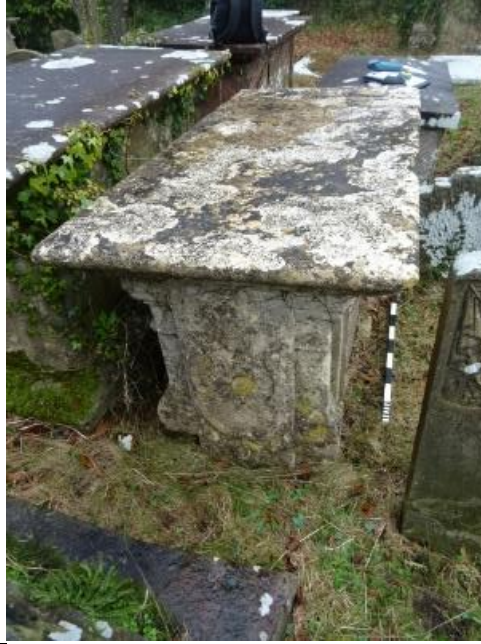
| | <p>The surface has a rich biological patina and is supporting moss and ivy growth. Black paint is present on the engaged pilasters on the east end panel. White lead paint can appear black when oxidised therefore a paint analysis would be necessary to determine the original paint scheme. Approximately 20% of the inscription on the south side has been lost and the inscription on the north side is blistered.</p> | | Prev. repairs | |

| | <p>Remove vegetation including the tree sapling.<br/>Reset the dislodged base stone and repoint open joints.</p> | | | |

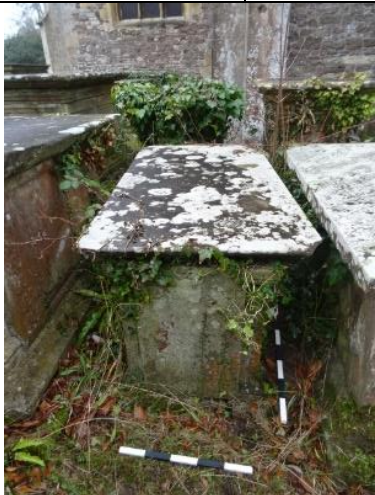
| | <p>The surface has a rich biological patina and has been partially colonised by ivy. A Sycamore sapling is growing to the south side of the tomb. The inscription on the northside panel is not legible due to stone decay.</p> | | Prev. repairs | |
| | <p>The lid of the tomb is turned anticlockwise so that it overhangs the northeast corner exposing the cramp hole but with missing cramp. Only one cramp was detected at the south east corner. There is some distortion to the tomb resulting in open joints; there is a 2cm gap between the panels at the east end. One of the base stones at the east end is missing.</p> | | Unstable | |

| | <p>Remove ivy.<br/>Repoint open joints.<br/>Tile repair missing base stone at the east end.</p> | | | |

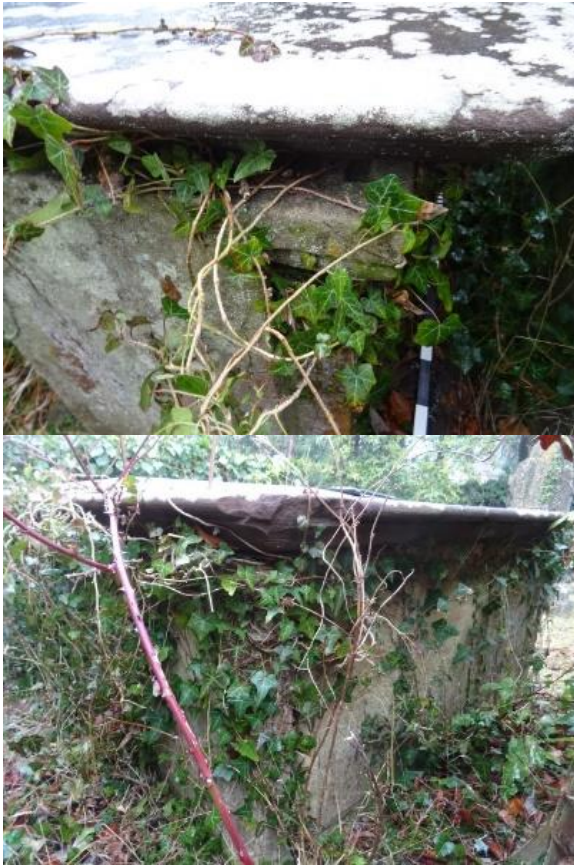
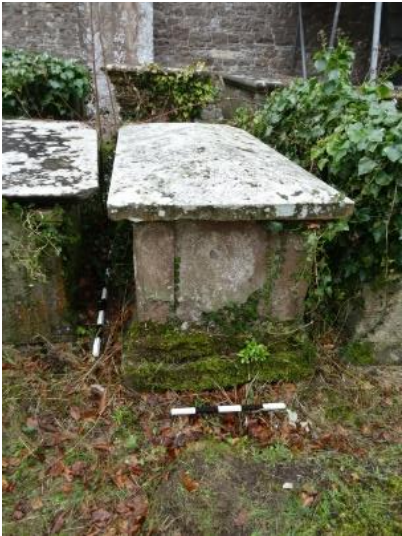
| | The tomb surface has a rich biological patina including lichens which cover 95% of the lid. | | Prev. repairs | |
| | There is little distortion to the vertical joints of the tomb but there is stone decay on the underside of the of the lid and the resulting gap is being exploited by ivy. | | Unstable | |

| | Remove ivy and tree sapling.<br>Repoint the underside of the lid to inhibit ivy growth. | | | |

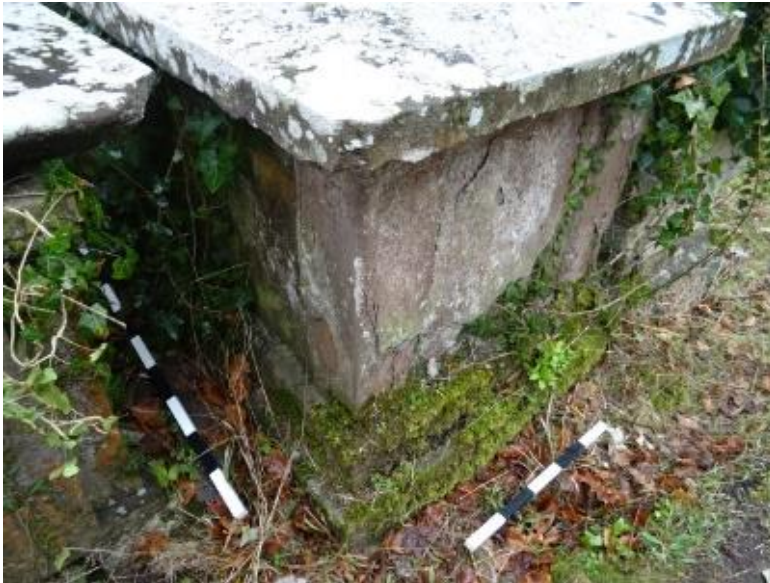
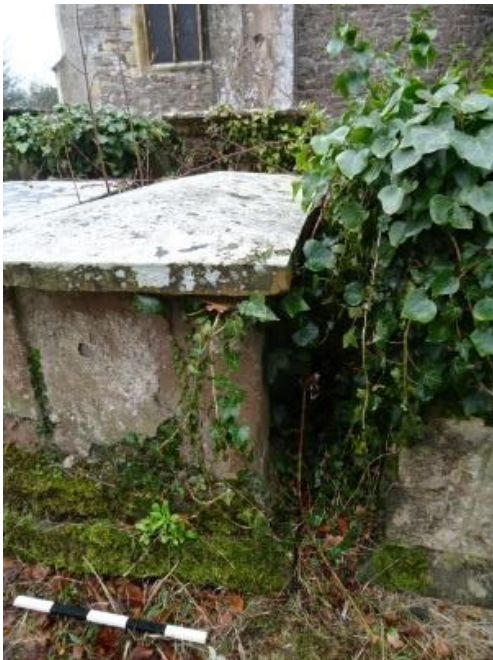
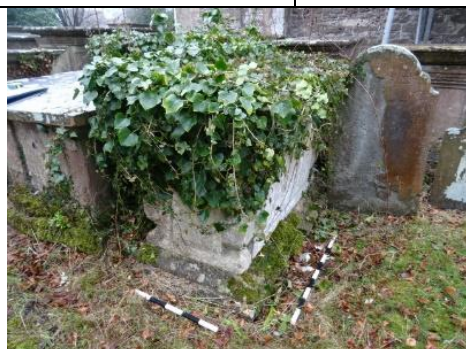
| | The surface has a rich biological patina including moss. There is a lot of ivy on the lid and sides. | | | Prev. repairs | | |
| | The tomb has little support along its northern base as some of the bricks are missing or dislodged. There is a large open vertical joint at the west end that is being exploited by ivy. The tomb is dipping to the north and is almost touching a neighbouring headstone. Cramps were detected at the upper corners of the panels and ends. | | | Unstable | | |

| | Remove ivy.<br>Insert brick or tile to support the base tones along the north side of the tomb.<br>Repoint open joints. | | | | | |

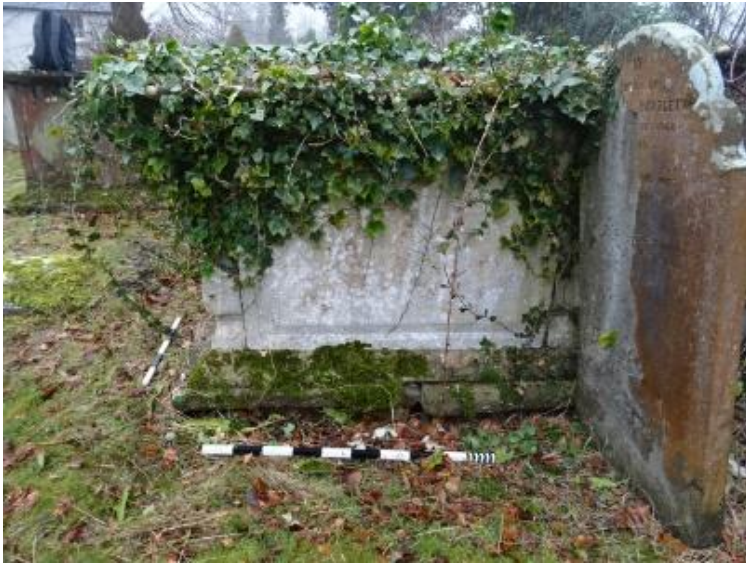
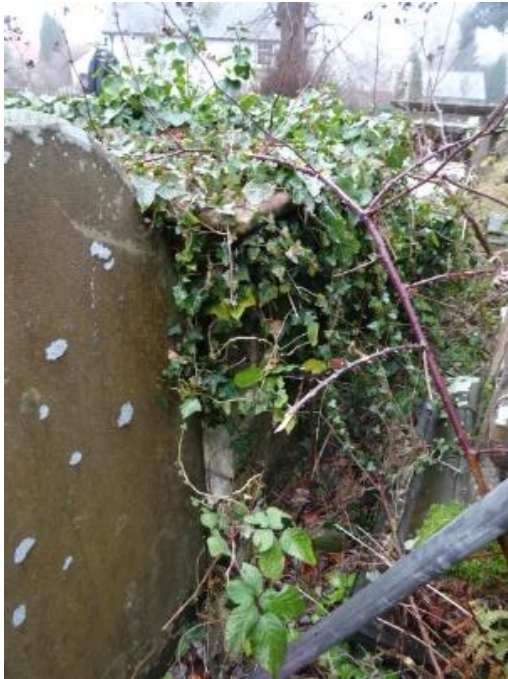
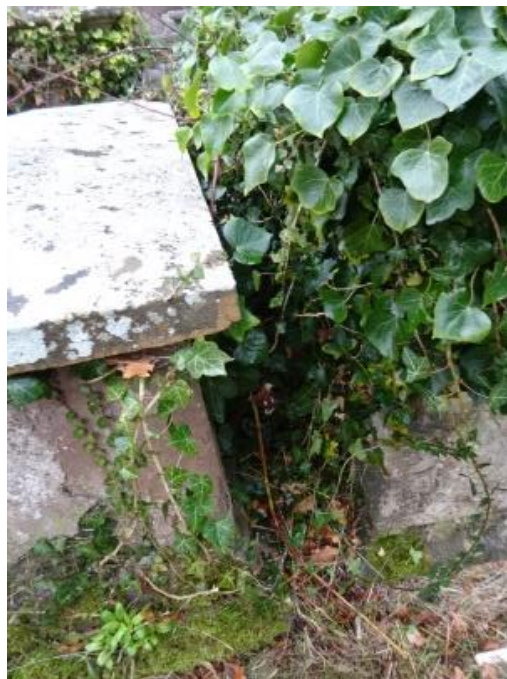
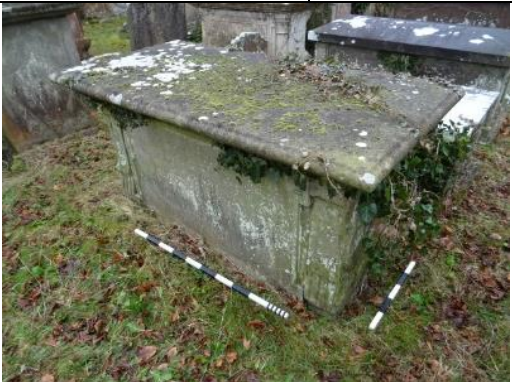
| | The tomb surface has a rich biological patina. Ivy is starting to encroach at the north west corner. There are remains of a painted surface on the south side inscription panel. | | Prev. repairs | |

| | Remove ivy.<br>Point open joint | | | |

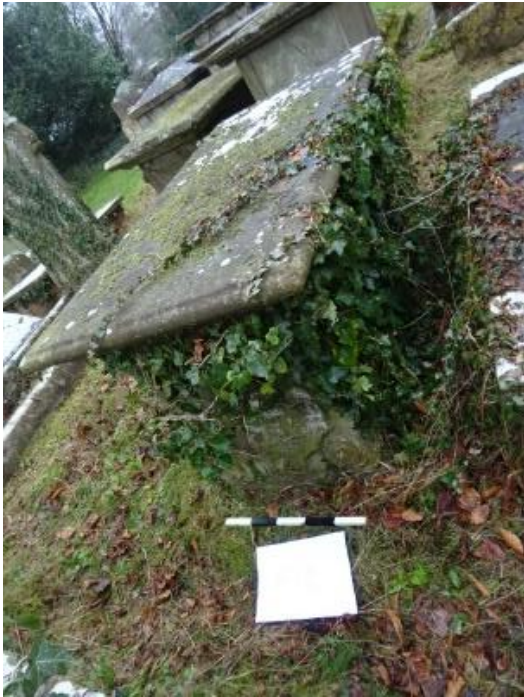
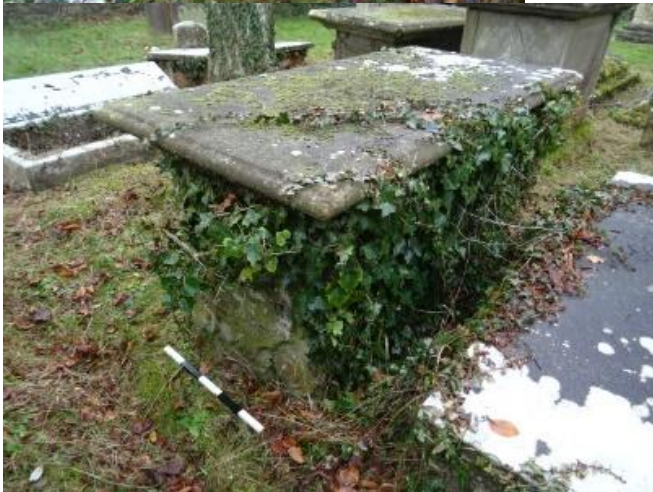
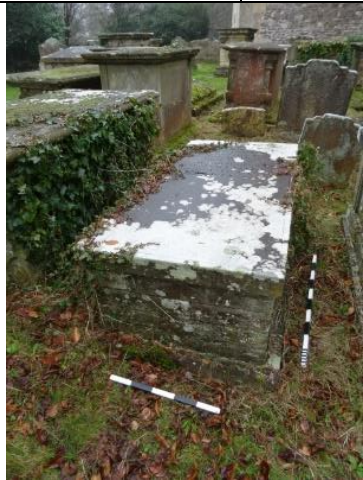
| | The surface has a rich biological patina. Approximately 45% of the lid is covered with lichens. Ivy has taken hold on the south side. | | Prev. repairs | |

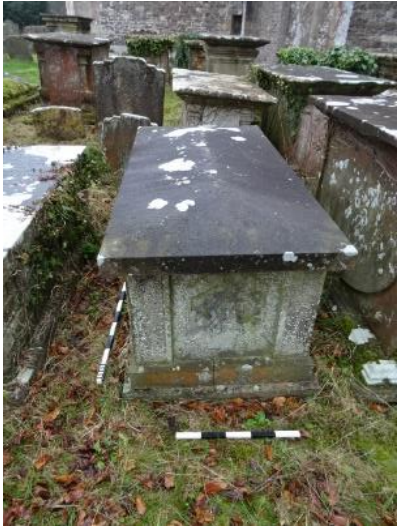
| IDENTIFICATION | CHURCHYARD | St. Mary's, Thornbury BS35 1HQ | GRAVE REFERENCE | 228 |

| | There is delaminating stone on the north side inscription and the east end. | | Prev. repairs | |

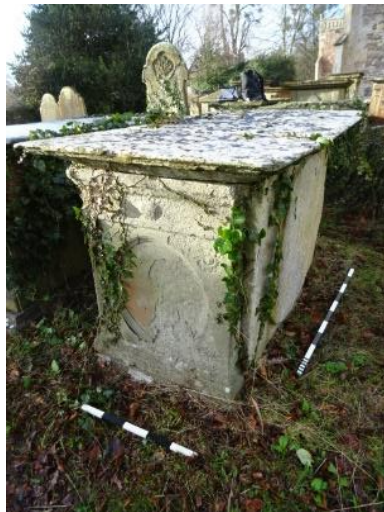
| | The surface of the lid is richly patinated with lichens. Ivy has started to take hold on the sides. | | Prev. repairs | |
| | The tomb is dipping to the north resulting in some open joints. There is a large diagonal crack in the lid one third of the distance from the east end. There is a large gap between the panels forming the south west and the underside of the lid due to stone decay caused by a corroding cramp. | | Unstable | |

| | Remove ivy.<br>Repoint open joints including gap under the lid at the south west corner.<br>Repair crack on the lid. | | | |

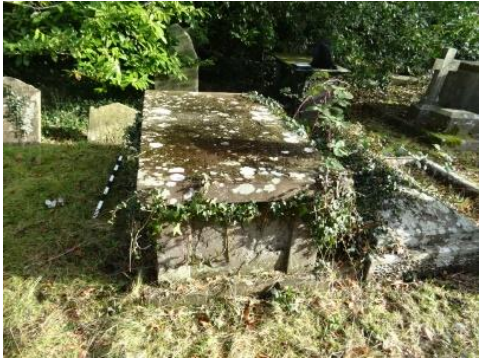
| IDENTIFICATION | CHURCHYARD | St. Mary's, Thornbury BS35 1HQ | GRAVE REFERENCE | 249 |

| | Stone delamination on the north side and west end. | | Prev. repairs | |

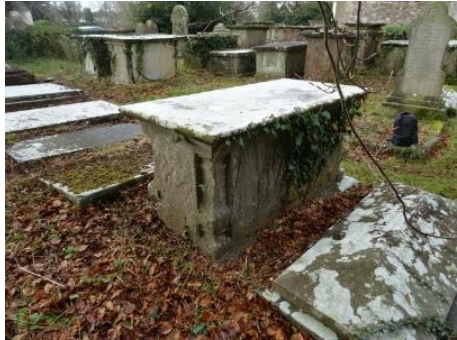
| | <p>The surface has a rich biological patina. There is delaminating stone on the upper part of the south side inscription panel and on the north side and both ends. The north side underside of the lid has broken and is loose for 300 x 200 x 25mm.</p> | | Prev. repairs | |

| | <p>Remove ivy.<br/>Fix back broken underside of the lid.</p> | | | |

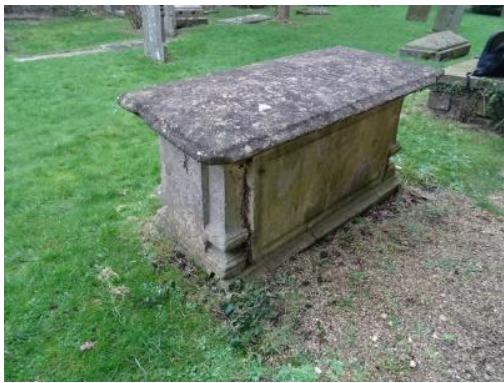
| IDENTIFICATION | <b>CHURCHYARD</b> | St. Mary's, Thornbury BS35 1HQ | <b>GRAVE REFERENCE</b> | 366 |

| | Although dead in most places the ivy survives within the joints. | | Prev. repairs | |

| | Remove dead ivy from joints.<br>Repoint open joints.<br>Treat exposed cramp. | | | |

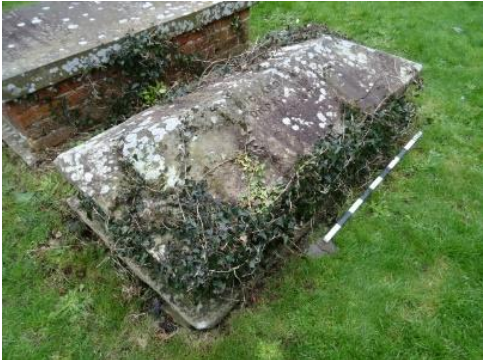
| IDENTIFICATION | CHURCHYARD | St. Mary's, Thornbury BS35 1HQ | GRAVE REFERENCE | 381 |

| | There is stone delamination around all the lower portions of the sloping cope stone. | | Prev. repairs | |
| | The structure is stable with some open joints and a missing north west corner block (200 x 500 x 200mm) | | Unstable | |

| | Remove ivy.<br>Repoint open joints.<br>Replace missing corner block with a tile repair. | | | |

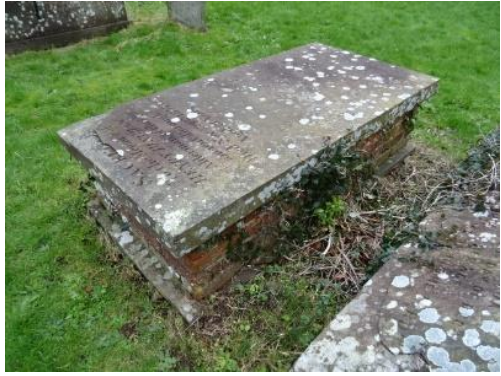
| | The north west corner of the lid is broken and some of the material is missing. | | Prev. repairs | |

| | Fix back the broken corner material and fillet around the break edges with mortar.<br>Remove ivy.<br>Repoint open joints. | | | |

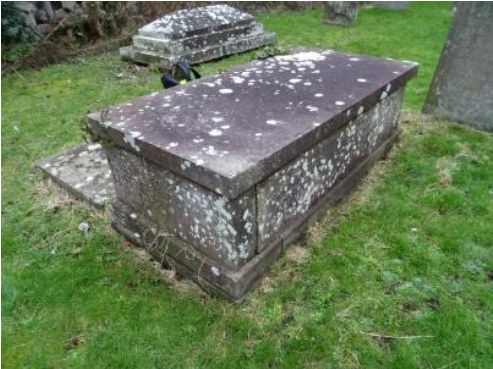
| IDENTIFICATION | CHURCHYARD | St. Mary's, Thornbury BS35 1HQ | GRAVE REFERENCE | 383 |

| | The surface has a rich biological patina. | | Prev. repairs | |

| | Remove ivy.<br>Repoint open joints. | | | |

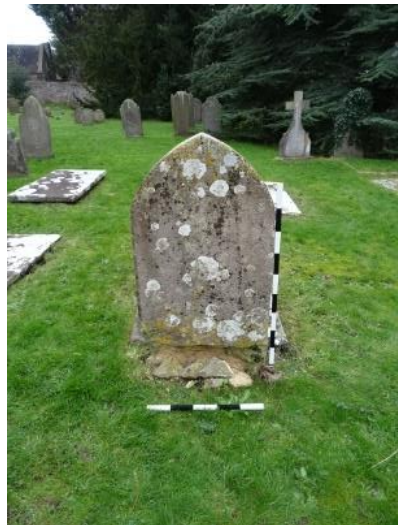
| | DESCRIPTION OF OBJECT | Bath stone headstone with ground level frost damage. | | | | | |
| | The surface has a rich biological patina. Ivy is growing at the base. | | Prev. repairs | | | | |
| | The structural stability has been weakened by significant frost damage at ground level. The loss is up to 40mm deep which is one third of the original thickness of 120mm. Fractured stone has been penetrated by grass roots and is vulnerable to exploitation by ivy which is growing close by. | | Unstable | | | | |

| | The options are to lay the stone down, insert stainless steel supports attached to the back or protect the exposed stone from further damage by adding a sacrificial render to shed water and regularly monitor for stability thereafter. | | | | | | |

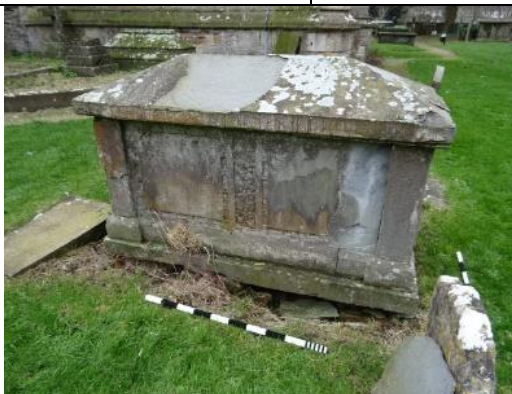
| | Much of the surface of the tomb has been affected by delamination. Approximately one third of the north side sloping inscription has sheered off and is resting on the ground below. It seems pointless to try to fix back such a thin sheet of stone in such a vulnerable position. | | Prev. repairs | |

| | Support the structure by filling the large cavity beneath the base ledger with block and tile shims set in lime mortar.<br>Fillet the broken edges of some of the worst areas of loss to support the remaining material.<br>Repoint open joints. | | | |

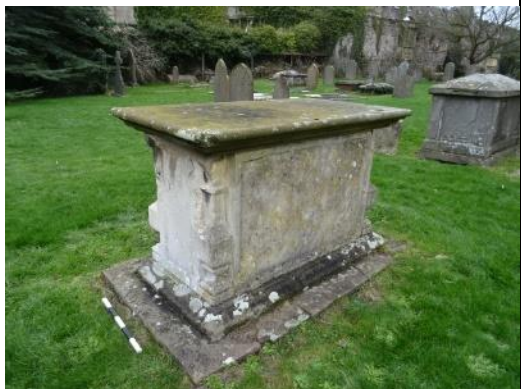
| | The tomb is covered with a rich biological patina. There is sulphation staining on both ends and on the upper part of the north side inscription panel. | | Prev. repairs | |
| | The sandstone ledger slab base has broken into several fragments. There have been previous repairs carried out in lime mortar possibly gauged with cement. These are located on the upper portions of the ends and on the upper parts of the moulding of the north and south sides panels. No cramps were detected at the upper corners which may have been replaced with stainless steel when the mortar repairs were carried out. However, iron cramps were detected at the ground level corners and one of these has blown the stone at the north east corner and the bottom right corner of the east end baluster base. This has been fixed in the past with polyester resin but the iron has continued to expand so that the corner is sitting loose. The moulded base below this has also cracked around the same corroding pin. There are two further points where iron cramps have blown the stone on the base of the north side panel. These | | Unstable | |

| | Replace the north east corner pin with stainless steel.<br>Set back moulded corner base and broken part of the east end baluster.<br>Investigate two further cracks in the base on the south side.<br>Repoint open joints. | | |

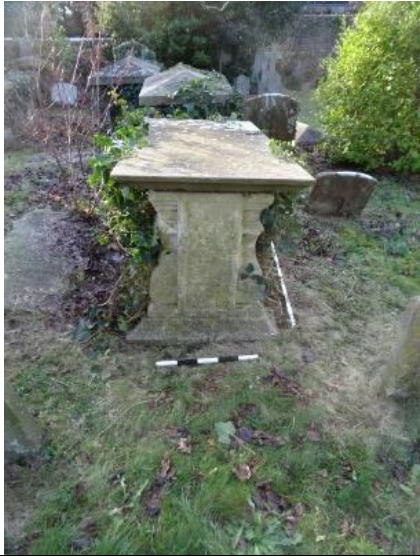
| | <p>The surface has a rich biological patina including green and white lichens. Ivy has taken hold of the structure which makes a full assessment difficult. This may need revision once the ivy has been removed. The south side inscription panel has delaminated and lost most of its detail. The south west corner of the lid has contour scaling. The underside of the lid at the south east corner is delaminating</p> | | Prev. repairs | |

| | Remove ivy.<br>Repoint open joints. | | | |

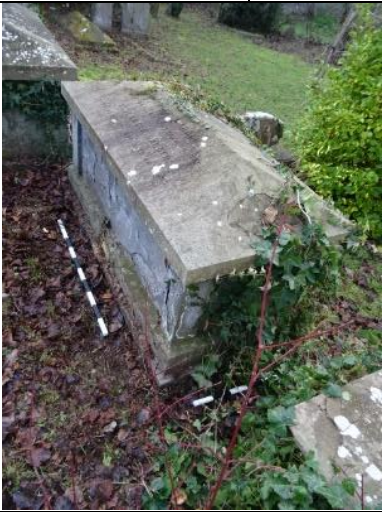
| | <p>The surface has a rich biological patina and ivy has taken hold on the north and east side. There is delamination at the east and north east corners of the lid and both the inscriptions on the lid are hollow when tapped. Approximately 70% of the south side inscription panel has been lost to delamination.</p> | | Prev. repairs | |
| | <p>Some mechanical damage but otherwise stable</p> | | Unstable | |

| | <p>Remove ivy.<br/> Repoint open joints.<br/> Apply mortar fillets to the broken edges of the remains of the south side inscription panel.<br/> Defrass the remaining decayed stone.<br/> Attempt to grout the hollow inscription panels on the coped lid.</p> | | | |

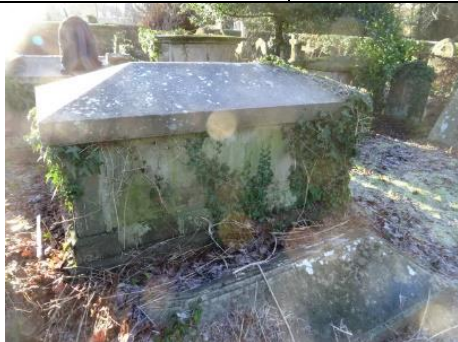
| | <p>The surface has a rich biological patina. Ivy is taking hold on the north side and east end. Delaminating stone is present along the bottom arris of the lid at the north east corner and on the corner post below. The corner post at the south west corner is also delaminating.</p> | | Prev. repairs | |

| | <p>Remove ivy.<br/>Point joints at base level.<br/>Grout cracks in the damaged ends with colour-matching grout.</p> | | | |

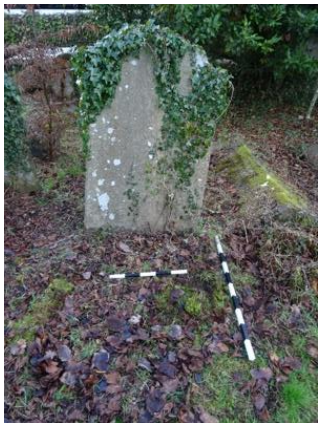
| IDENTIFICATION | CHURCHYARD | St. Mary's, Thornbury BS35 1HQ | GRAVE REFERENCE | 470 |

| | There are blotches of white lichen on the east elevation and light delamination. | | Prev. repairs | |

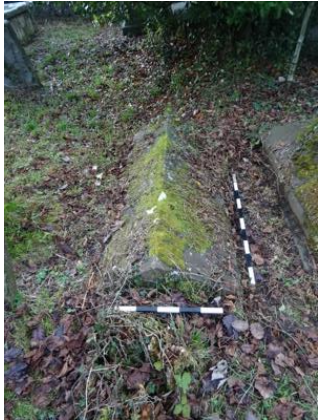
| | There is a crack along the ridge on the south side running from the west to midway along its length. The surface is covered with moss and would benefit from a light clean. | | Prev. repairs | |

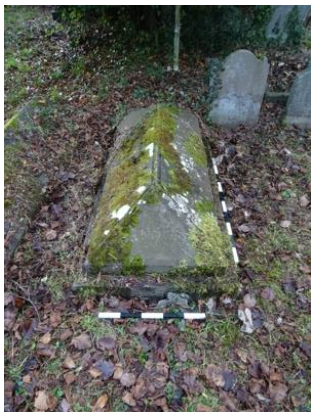
| | Moss and white lichen covers approximately 40% of the surface. The gravestone would benefit from a light clean. To remove only the moss. The east facing hip surface has delaminated and sits at the front of the stone. | | Prev. repairs | |

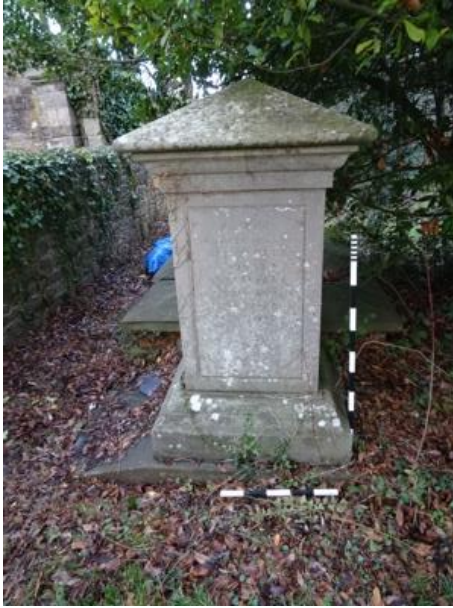
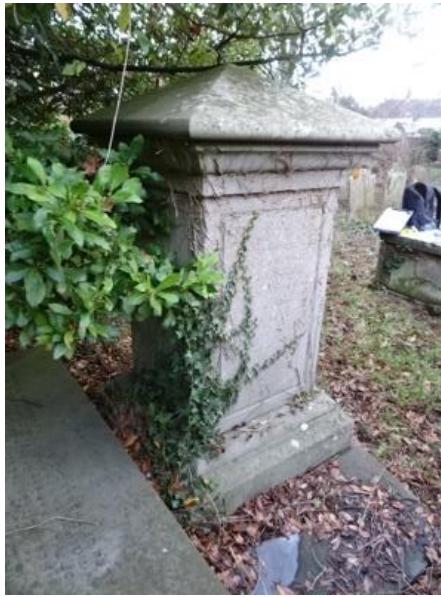
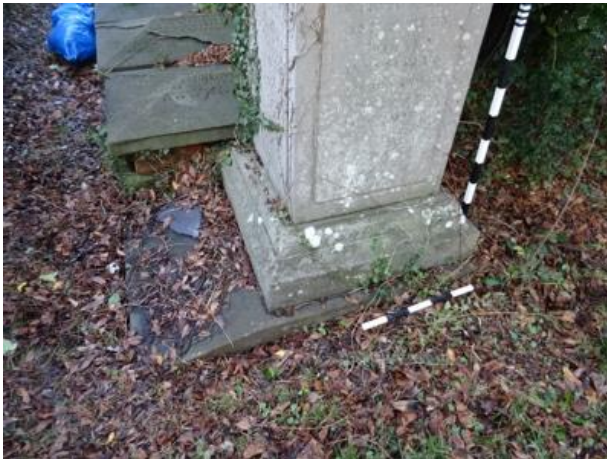
| | The surface is in good condition but is being whipped by overhanging bay tree branches. | | Prev. repairs | |

| | Remove ivy and brambles and trim overhanging branches. | | | |

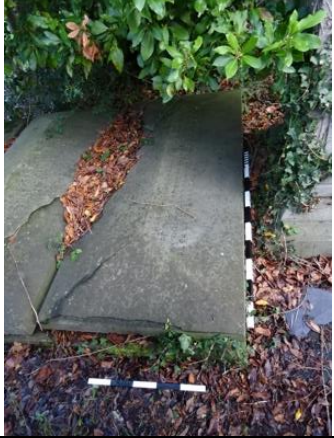
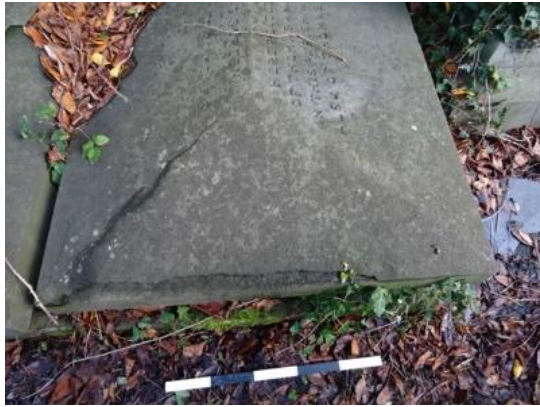
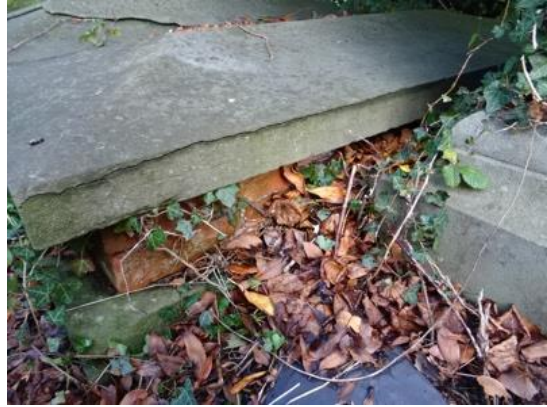
| IDENTIFICATION | CHURCHYARD | St. Mary's, Thornbury BS35 1HQ | GRAVE REFERENCE | 499 |

| | There is cracking on the west facing hip and the stone is starting to delaminate along the west side leaving hollows. | | Prev. repairs | |

| | Grout the delaminating edges. | | | |

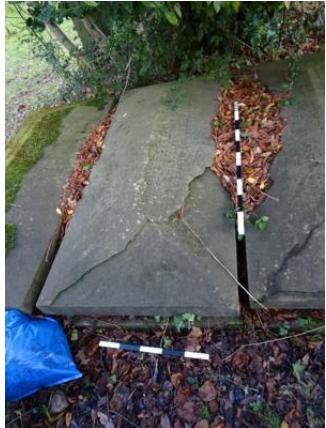
| | <p>There is much delamination on the inscribed south side surface and approximately 30% of the west hip inscribed surface is missing. The north side inscription is almost entirely hollow due to delamination.</p> | | Prev. repairs | |

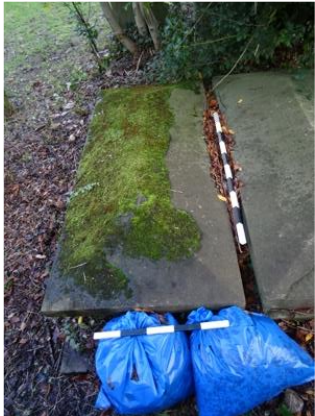
| IDENTIFICATION | CHURCHYARD | St. Mary's, Thornbury BS35 1HQ | GRAVE REFERENCE | 501 |

| | Moss is obscuring the surface. There is slight but stable delamination on the north west surface. | | Prev. repairs | |

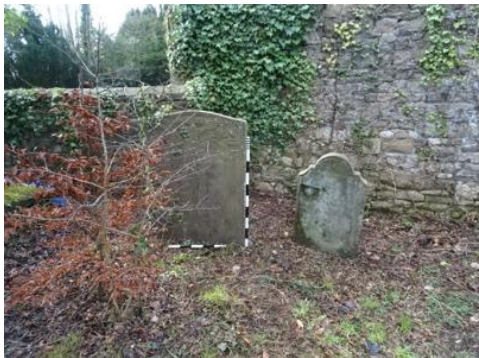
| | There are two patches of delamination on the east facing inscription. One is around the word "daughter" and the other is close to ground level. | | Prev. repairs | |

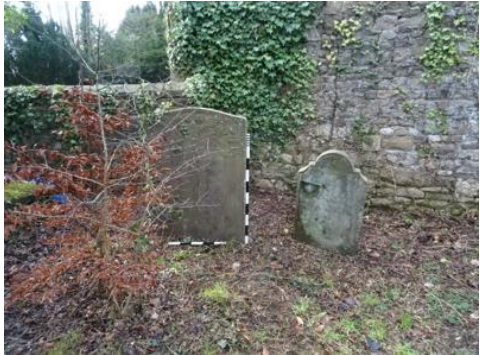
| | There are two patches of delamination on the east facing inscription. One is around the word "daughter" and the other is close to ground level. | | Prev. repairs | |

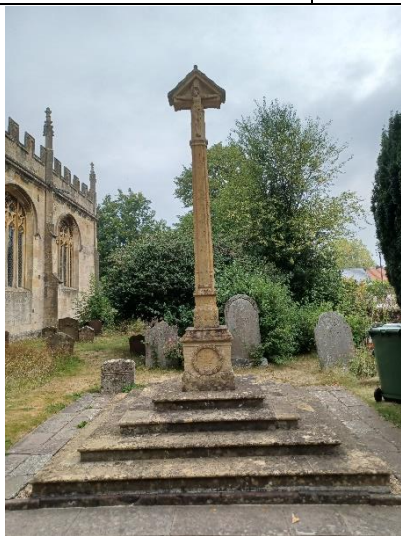
### War Memorial

| | Generally weathered but without loss of detail. Access was not afforded to the upper parts of the cross shaft but there were no visible losses. | | Prev. repairs | x | | |
| | Several areas of spalling to the steps, with some losses. Notably the losses tend to occur in areas of previous repair | | Unstable | | | |

| | Allow to carry our pieced repairs in 3no areas<br>General cleaning to steps recommended<br>Repoint all open joints | | | | | |

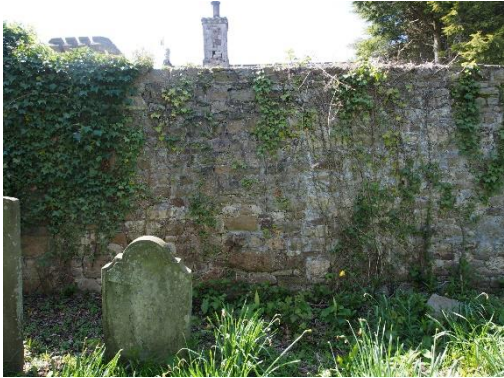
| | Generally very covered with ivy and other plant growth, loss of pointing and mortar to joints. Patch repairs in a variety of materials | | Prev. repairs | X |

| | <ul style="list-style-type: none"> <li>Remove ivy particularly where the roots are seen to be causing movement to coursing.</li> <li>Where cement repointing is apparent, remove loose and repoint in lime.</li> <li>Repoint all open joints – allow 30% overall</li> </ul> <p>Note – access is difficult due to the uneven ground and graves nearby.</p> <p>Access may also need to be made to the walling to the other side – it is not clear who ownership of the wall lies with as it forms part of the castle entrance.</p> | | | |
