# St. Mary's Church, Thornbury

## Churchyard Monument Condition Report

## Report into The Condition of The Churchyard Monuments, St. Mary's Church, Thornbury

Report prepared for  
Thornbury PCC

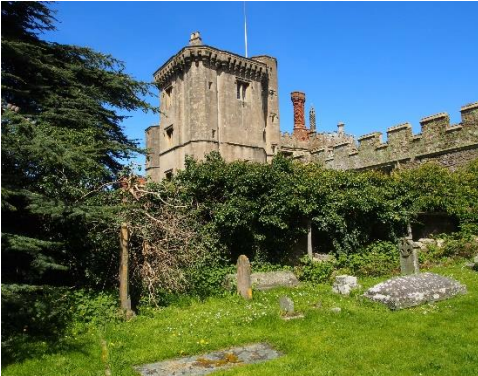
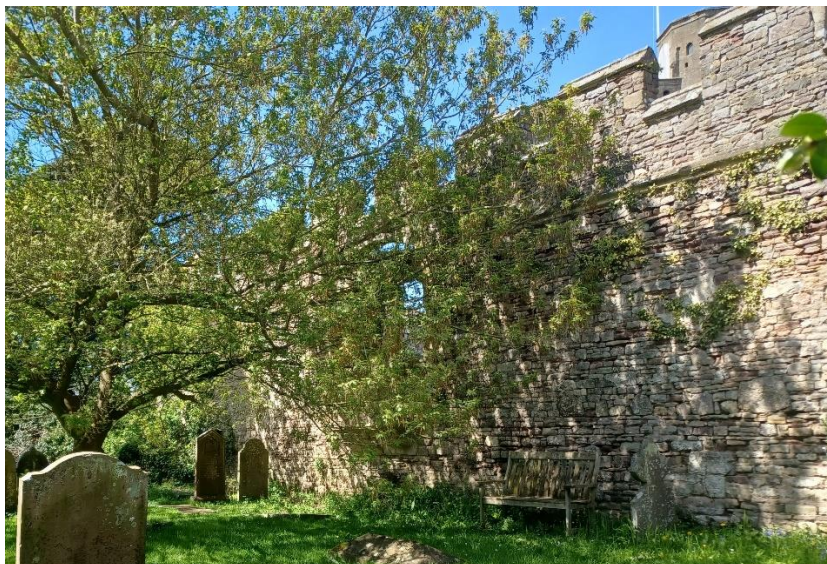
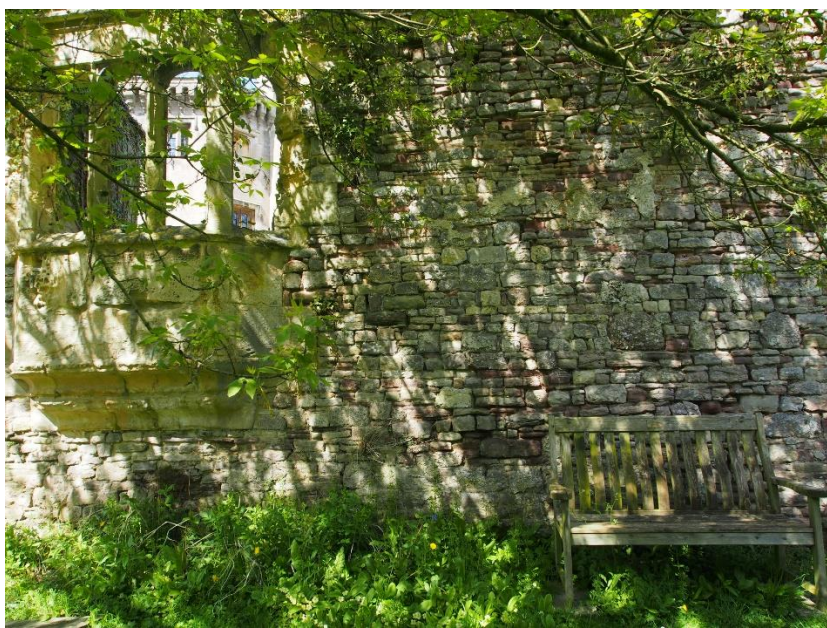
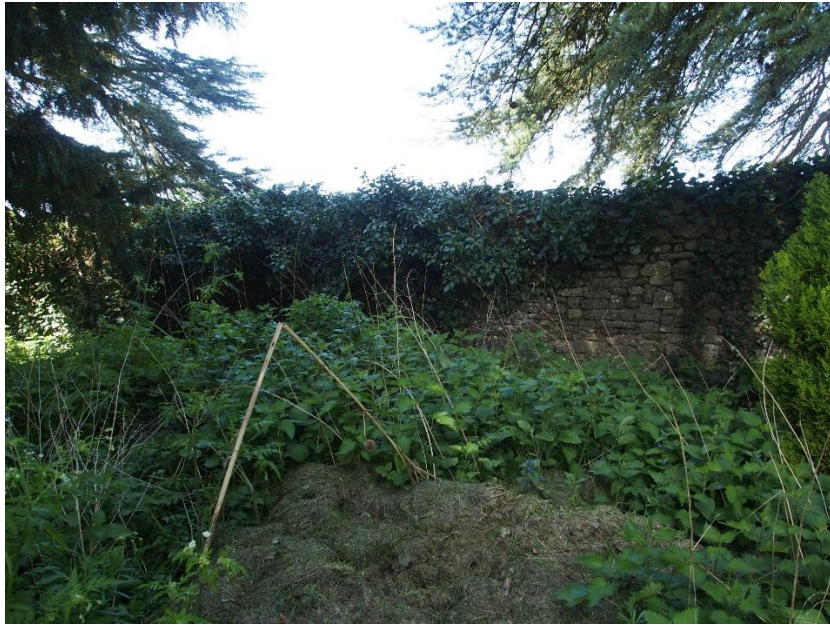
| | General loss of pointing to the areas that could be seen, but structurally appears stable. The window openings have very fine mullions which appears in good condition, but the mortar surrounding the windows shows deep losses of material. There is some growth to the copings, which in time will lead to losses.<br><br>General weathering of walling stone and to moulded stonework but otherwise sound | | Unstable | |

| | <p>Clarity should be sought as to the responsibilities of the walling as this clearly forms part of the castle outer walling, but it is not clear whether any ownership transferred between castle and church.</p> <ul style="list-style-type: none"> <li>• Clear ground to North west and remove ivy to North west corner to allow a fuller assessment. Allow for 50% repointing to this area due to likely presence of vine roots</li> <li>• North East/castle walling – allow repointing. Deep pack and repoint to window surrounds, scaffold required for upper levels.</li> <li>• Remove plant growth to coping stones</li> <li>• Allow for 80% patch repointing in lime mortar below string course</li> </ul> | | | |

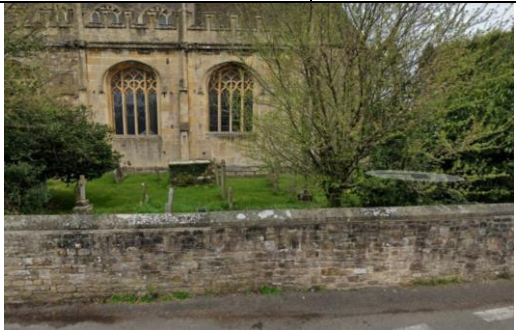
| | LOCATION | South of churchyard | | |

| | Considerable ivy growth | | Prev. repairs | |
