BUILDING SURVEY

**Redruth Town Clock
Fore Street
Redruth
Cornwall**

**on behalf of
Redruth Town Council**

Ref:WT/BS17(6597)

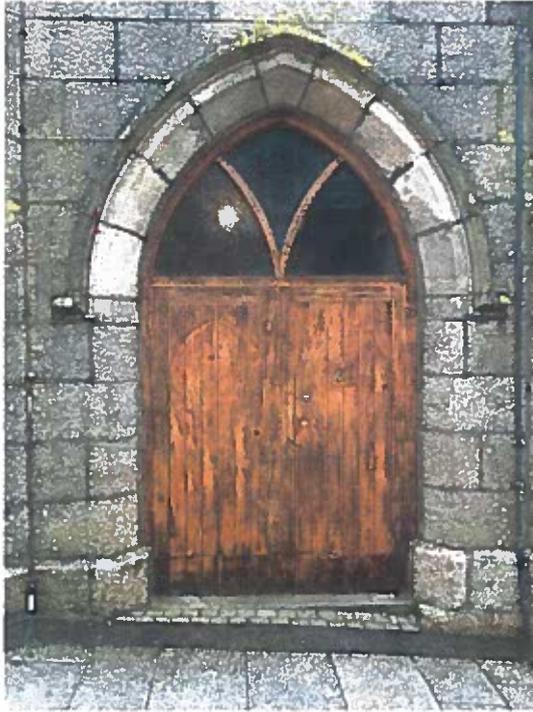
The front entrance door is of a high quality hardwood bespoke design and this is well installed. It is in reasonable condition and looks to have been relatively well maintained.

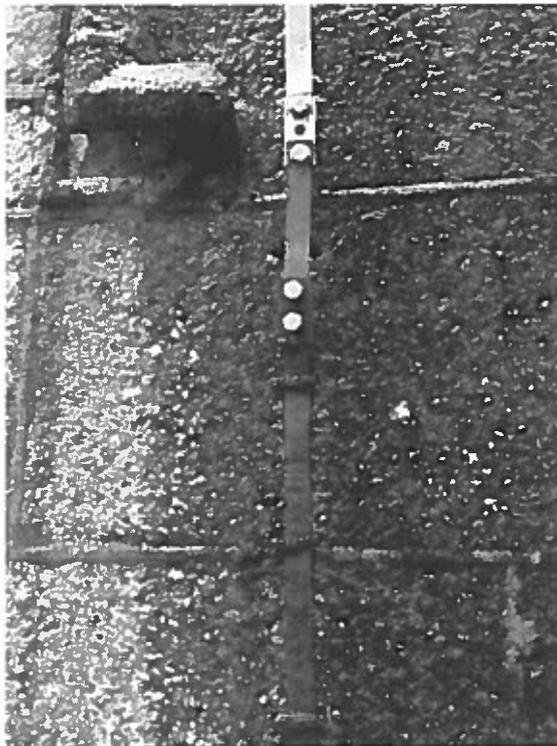
There is a lightning conductor system installed whereby the tower will be protected from a lightning strike with the energy being deflected through a copper strip which is earthed to the ground. This needs to be kept well maintained.

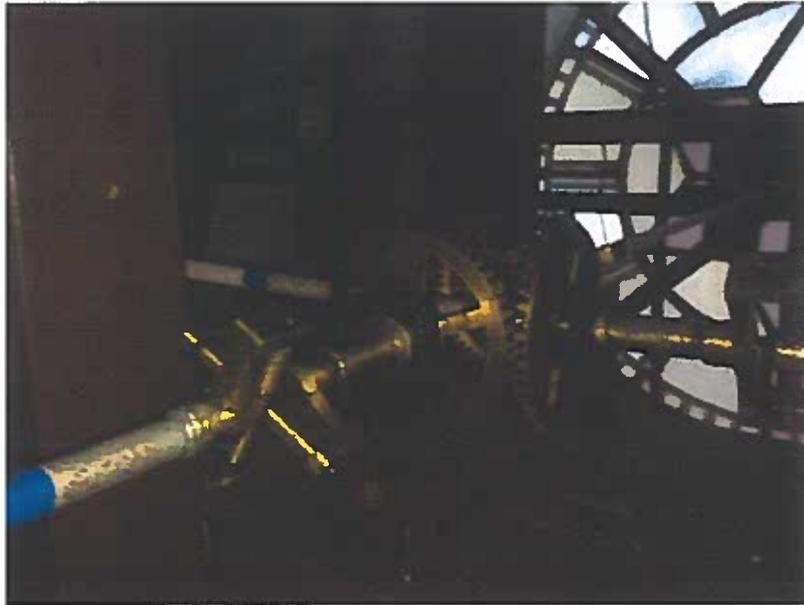
The clock mechanisms are an engineering work of art and look to have been relatively well maintained. Unfortunately, the debris and defects within the building will start to affect this mechanism.

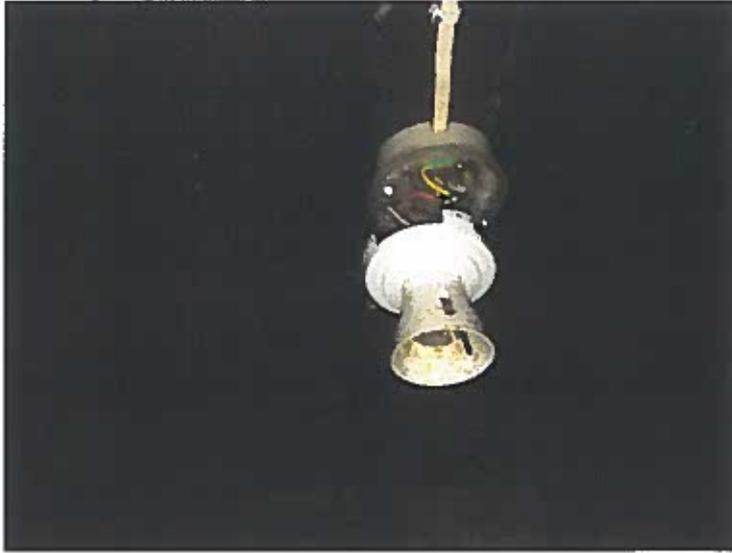
Mains electricity is installed and the consumer unit can be found in the ground floor internal left hand elevation. This is a modern system incorporating RCD and MCB switches and looks to be relative up to date. There is evidence of poor wiring and you are advised to have this system inspected by a suitably qualified electrical engineer and certified.
