**CBC Asbestos Refurbishment Survey Report
Neville House, George Street, Corby
22nd – 24th March 2016**

Reference:					
Issue			Prepared by	Verified by	
V1	Apr 16	JQ

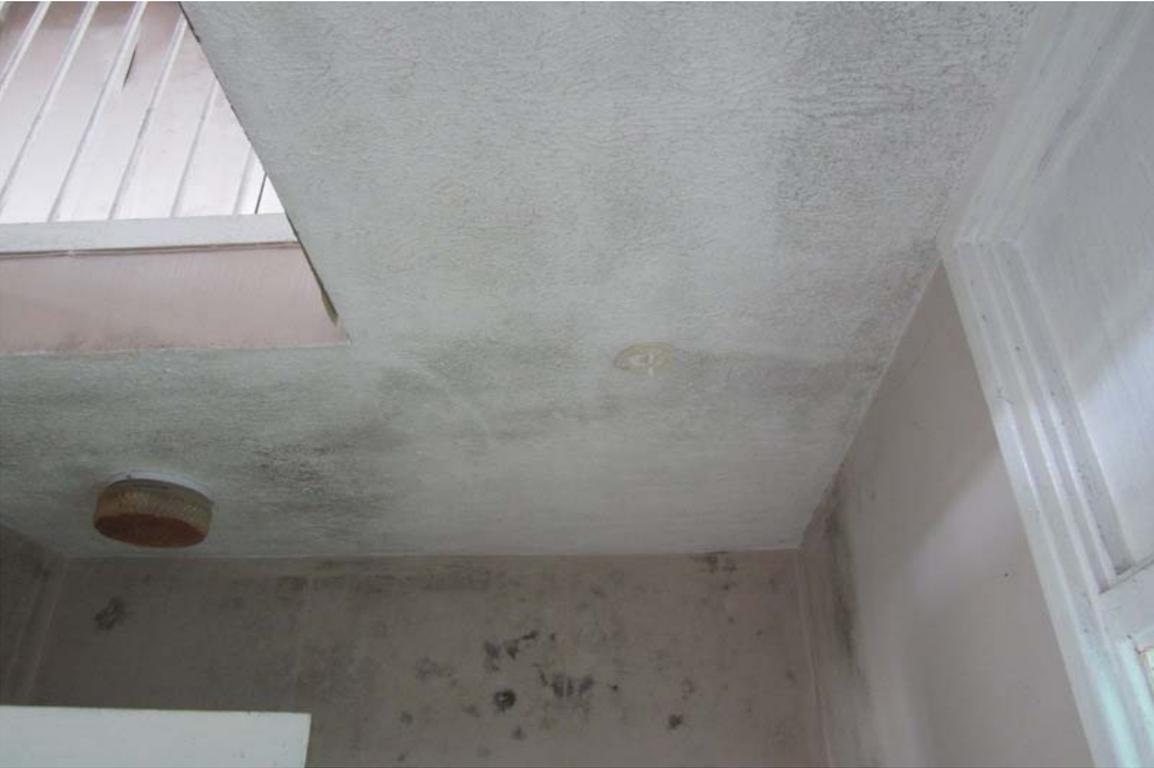
Photo Number	1	Reference number	220316MW01
Inspection / Sample	Inspection	Inspection Cross Reference / Visual I.D.	220316MW02

Notes	NADIS: No Asbestos Detected In Sample

Building	Flat 12 - Neville House	Condition	Poor	2
Floor Level	3rd floor	Surface Treatment	Composite materials, reinforced plastics, resin, vinyl materials	0
Location	01 / Lobby	Material Friability	Low	1
Feature	Coating to ceiling	Asbestos Type	Strongly Presumed N.A.D.I.S	0
Material Type	Textured Coating			
Extent	3 sq. m.			
Recommendation	No action necessary	Assessment Score		0
		Assessment Band		E

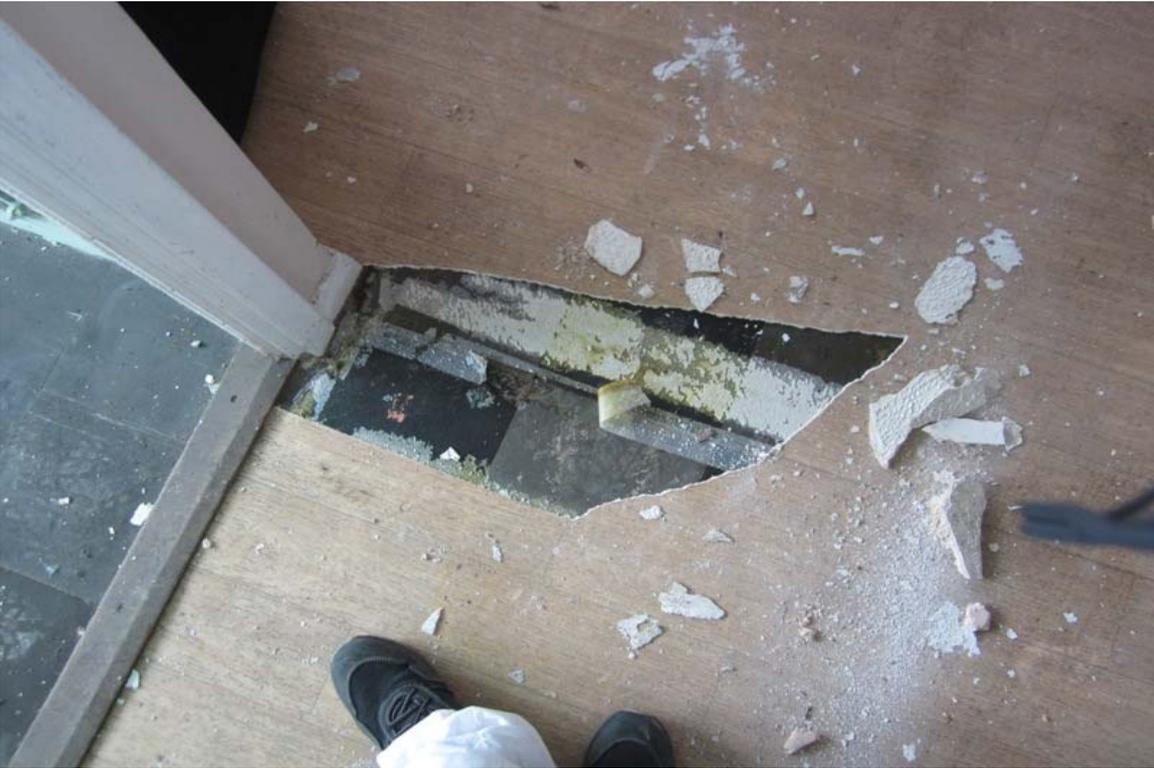
Photo Number	2	Reference number	220316MW03
Inspection / Sample	Sample	Inspection Cross Reference / Visual I.D.	Not Applicable

Notes	ACM: Asbestos Containing Material

Building	Flat 12 - Neville House	Condition	Fair	1
Floor Level	3rd floor	Surface Treatment	Composite materials, reinforced plastics, resin, vinyl materials	0
Location	01 / Lobby	Material Friability	Low	1
Feature	Black and grey floor tiles and adhesive	Asbestos Type	Chrysotile (White)	1
Material Type	Floor Tile / Covering			
Extent	3 sq. m.			
Recommendation	Remove if likely to be disturbed during the refurbishment works	Assessment Score		3
		Assessment Band		D

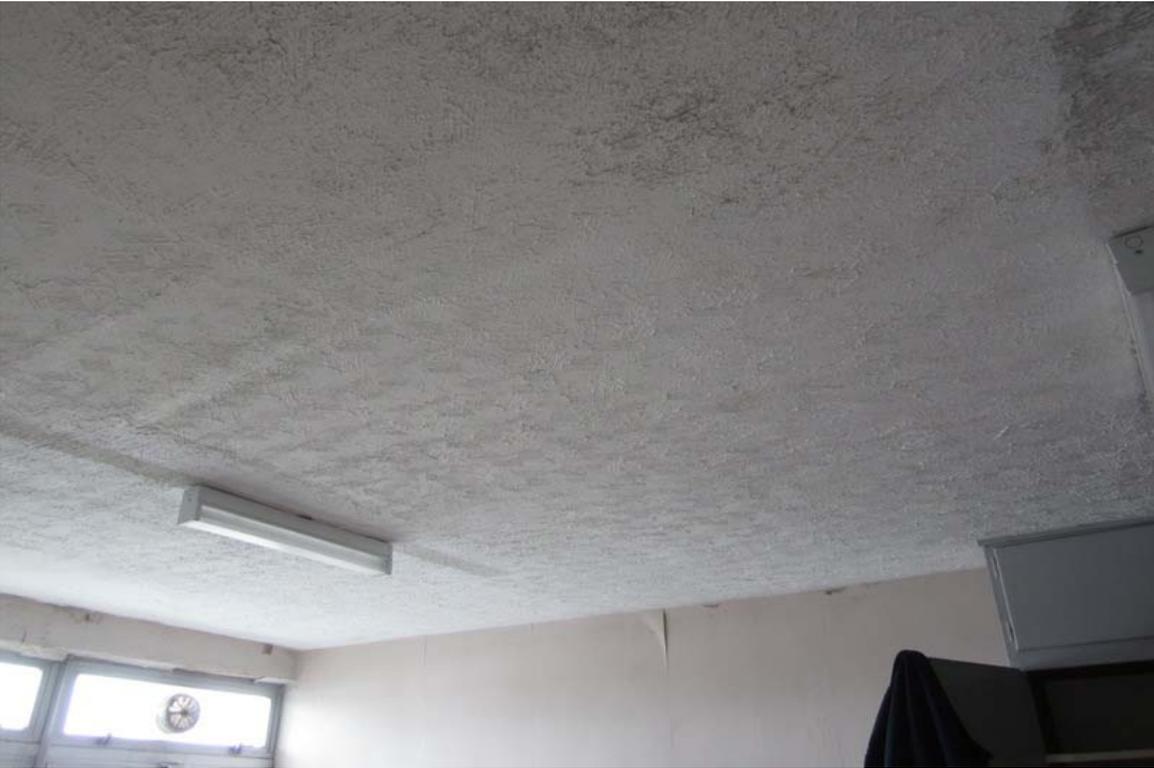
Photo Number	3	Reference number	220316MW02
Inspection / Sample	Sample	Inspection Cross Reference / Visual I.D.	Not Applicable

Notes	NADIS: No Asbestos Detected In Sample

Building	Flat 12 - Neville House	Condition	Poor	2
Floor Level	3rd floor	Surface Treatment	Composite materials, reinforced plastics, resin, vinyl materials	0
Location	02 / Kitchen	Material Friability	Low	1
Feature	Coating to ceiling	Asbestos Type	N.A.D.I.S	0
Material Type	Textured Coating			
Extent	10 sq. m.			
Recommendation	No action necessary	Assessment Score		0
		Assessment Band		E

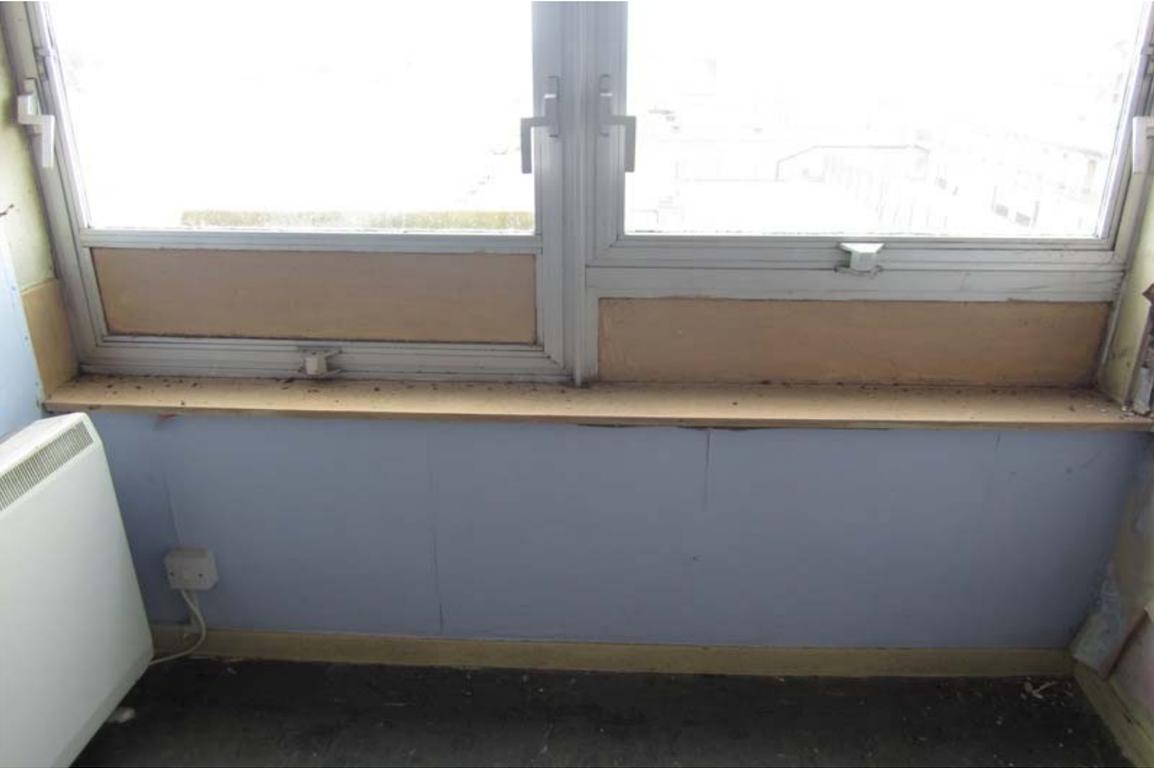
Photo Number	4	Reference number	220316MW17
Inspection / Sample	Inspection	Inspection Cross Reference / Visual I.D.	220316MW16

Notes	NADIS: No Asbestos Detected In Sample

Building	Flat 12 - Neville House	Condition	Fair	1
Floor Level	3rd floor	Surface Treatment	Unsealed AIB or encapsulated lagging and spray	2
Location	02 / Kitchen	Material Friability	Medium	2
Feature	Panelling beneath window	Asbestos Type	Strongly Presumed N.A.D.I.S	0
Material Type	Insulating Board			
Extent	2 sq. m.			
Recommendation	No action necessary	Assessment Score		0
		Assessment Band		E

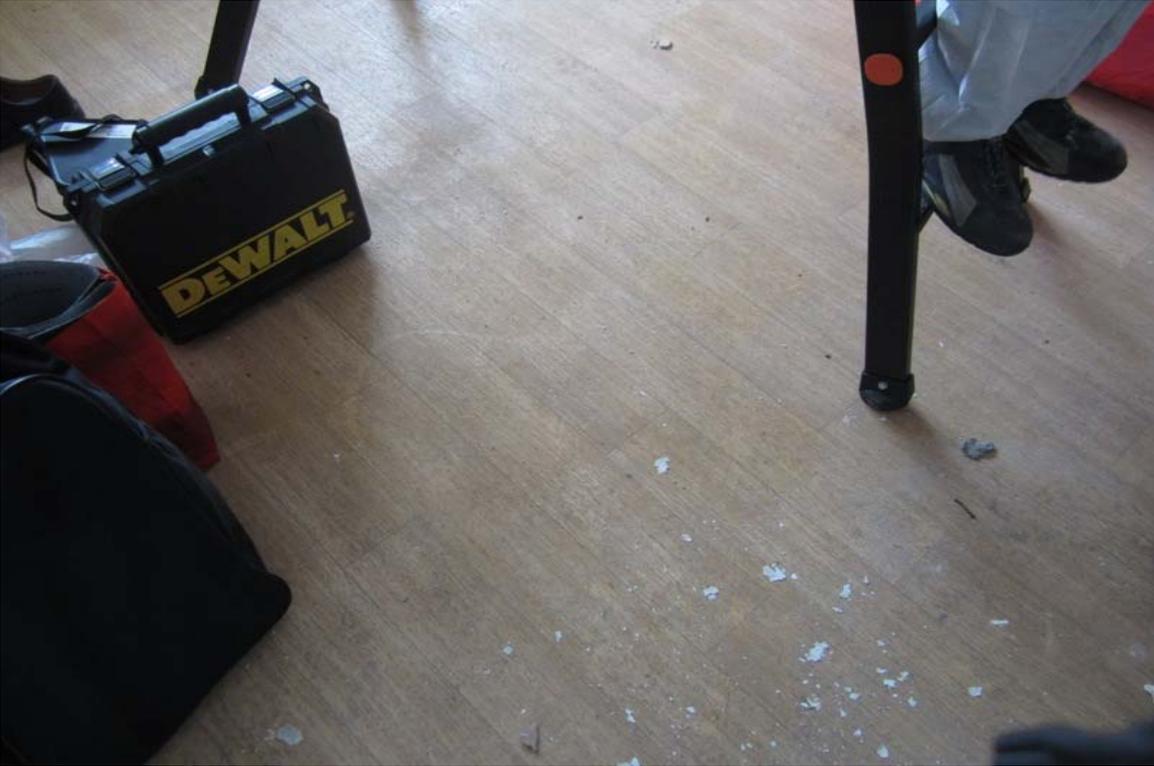
Photo Number	5	Reference number	220316MW04
Inspection / Sample	Inspection	Inspection Cross Reference / Visual I.D.	220316MW03

Notes	ACM: Asbestos Containing Material

Building	Flat 12 - Neville House	Condition	Fair	1
Floor Level	3rd floor	Surface Treatment	Composite materials, reinforced plastics, resin, vinyl materials	0
Location	02 / Kitchen	Material Friability	Low	1
Feature	Black and grey floor tiles and adhesive	Asbestos Type	Strongly Presumed Chrysotile (White)	1
Material Type	Floor Tile / Covering			
Extent	10 sq. m.			
Recommendation	Remove if likely to be disturbed during the refurbishment works	Assessment Score		3
		Assessment Band		D

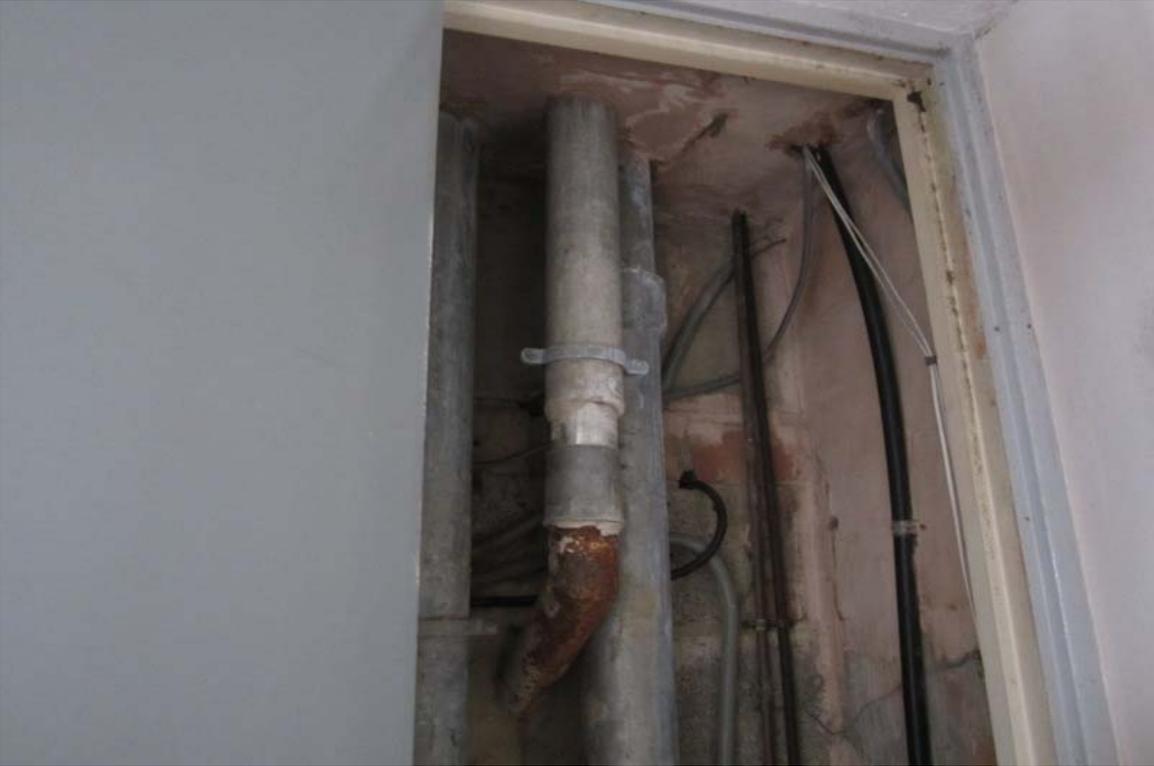
Photo Number	6	Reference number	220316MW05
Inspection / Sample	Sample	Inspection Cross Reference / Visual I.D.	Not Applicable

Notes	ACM: Asbestos Containing Material

Building	Flat 12 - Neville House	Condition	Fair	1
Floor Level	3rd floor	Surface Treatment	Enclosed sprays and lagging, encapsulated AIB, cement etc.	1
Location	04 / Cupboard	Material Friability	Low	1
Feature	Top section of down pipe	Asbestos Type	Chrysotile (White)	1
Material Type	Cement			
Extent	1 m.			
Recommendation	Remove if likely to be disturbed during the refurbishment works	Assessment Score		4
		Assessment Band		D

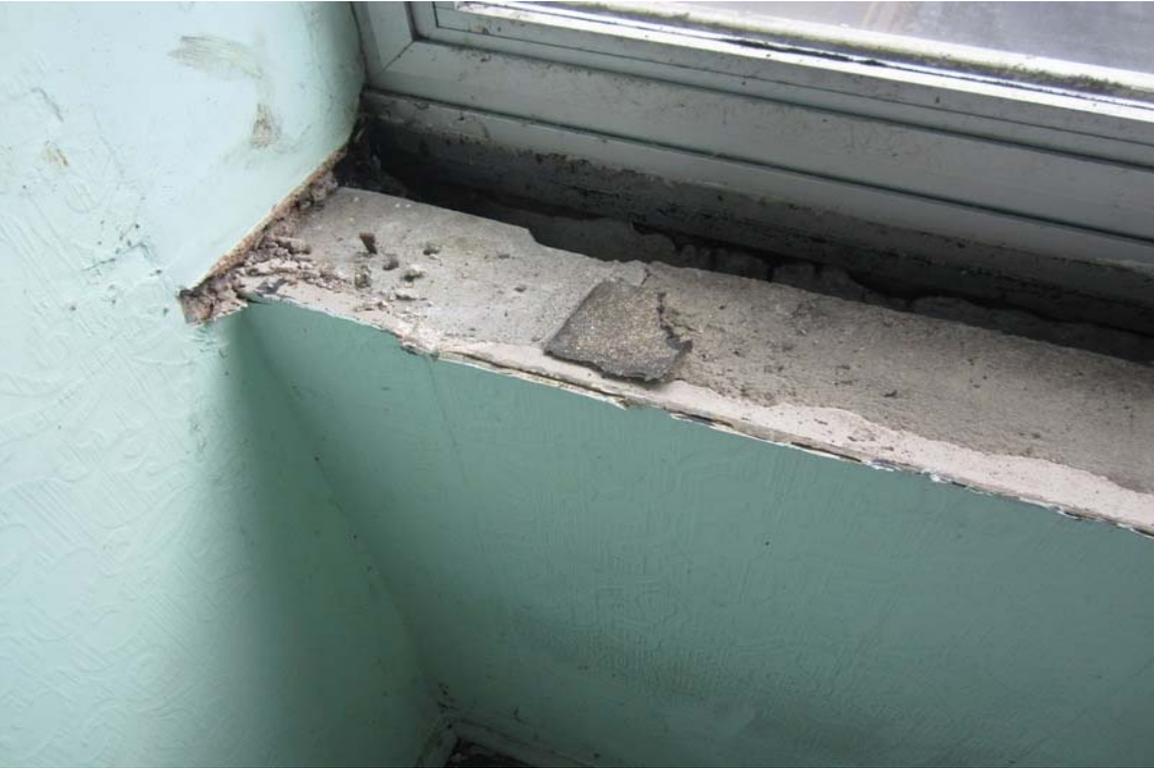
Photo Number	7	Reference number	220316MW06
Inspection / Sample	Sample	Inspection Cross Reference / Visual I.D.	Not Applicable

Notes	ACM: Asbestos Containing Material

Building	Flat 12 - Neville House	Condition	Fair	1
Floor Level	3rd floor	Surface Treatment	Composite materials, reinforced plastics, resin, vinyl materials	0
Location	05 / Bedroom 3	Material Friability	Low	1
Feature	Packer below window ledge	Asbestos Type	Chrysotile (White)	1
Material Type	Bitumen			
Extent	<1 sq. m.			
Recommendation	Remove if likely to be disturbed during the refurbishment works	Assessment Score		3
		Assessment Band		D

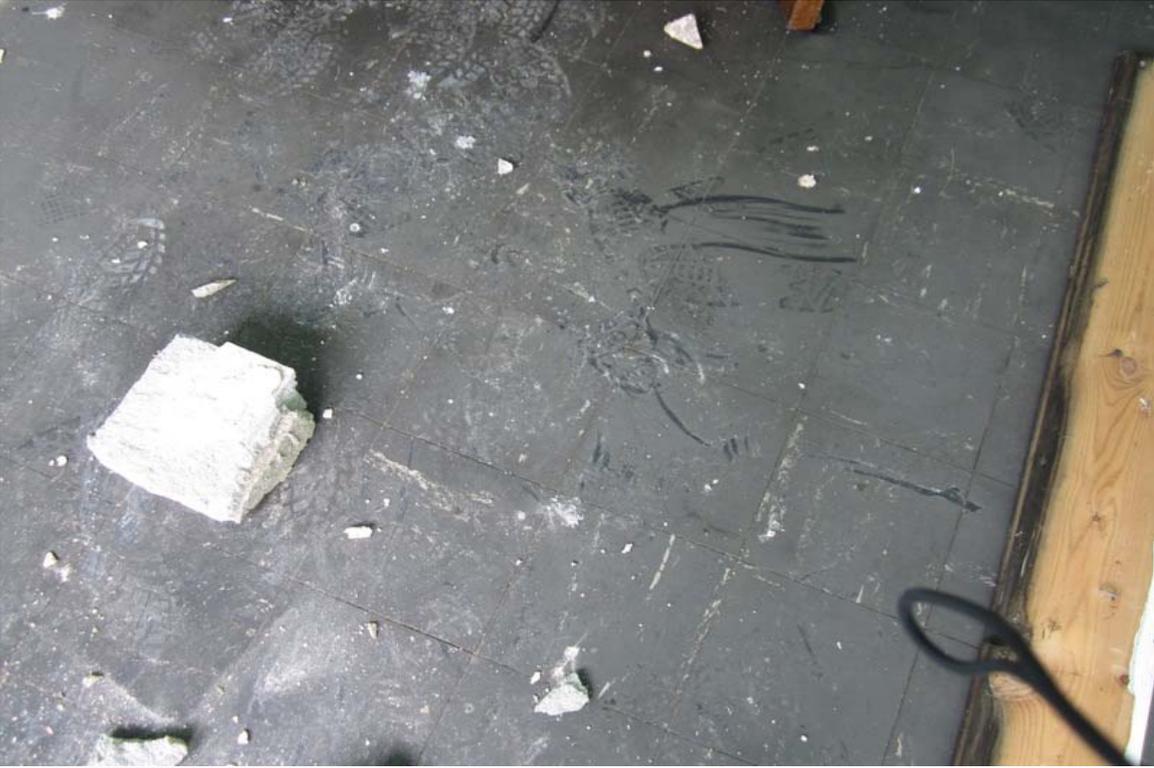
Photo Number	9	Reference number	220316MW07
Inspection / Sample	Sample	Inspection Cross Reference / Visual I.D.	Not Applicable

Notes	ACM: Asbestos Containing Material

Building	Flat 12 - Neville House	Condition	Good	0
Floor Level	3rd floor	Surface Treatment	Composite materials, reinforced plastics, resin, vinyl materials	0
Location	05 / Bedroom 3	Material Friability	Low	1
Feature	Brown floor tiles and adhesive	Asbestos Type	Chrysotile (White)	1
Material Type	Floor Tile / Covering			
Extent	6 sq. m.			
Recommendation	Remove if likely to be disturbed during the refurbishment works	Assessment Score		2
		Assessment Band		D

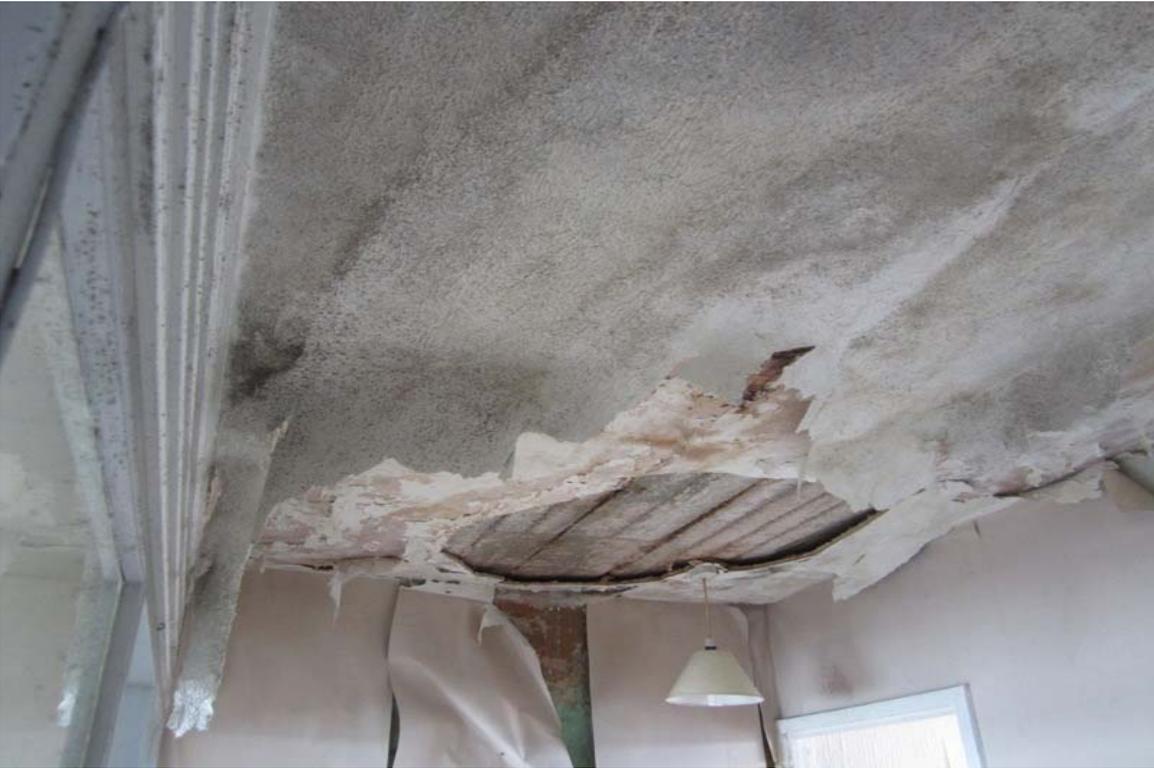
Photo Number	10	Reference number	220316MW08
Inspection / Sample	Sample	Inspection Cross Reference / Visual I.D.	Not Applicable

Notes	NADIS: No Asbestos Detected In Sample

Building	Flat 12 - Neville House	Condition	Poor	2
Floor Level	4th floor	Surface Treatment	Composite materials, reinforced plastics, resin, vinyl materials	0
Location	06 / Landing	Material Friability	Low	1
Feature	Coating to ceiling	Asbestos Type	N.A.D.I.S	0
Material Type	Textured Coating			
Extent	10 sq. m.			
Recommendation	No action necessary	Assessment Score		0
		Assessment Band		E

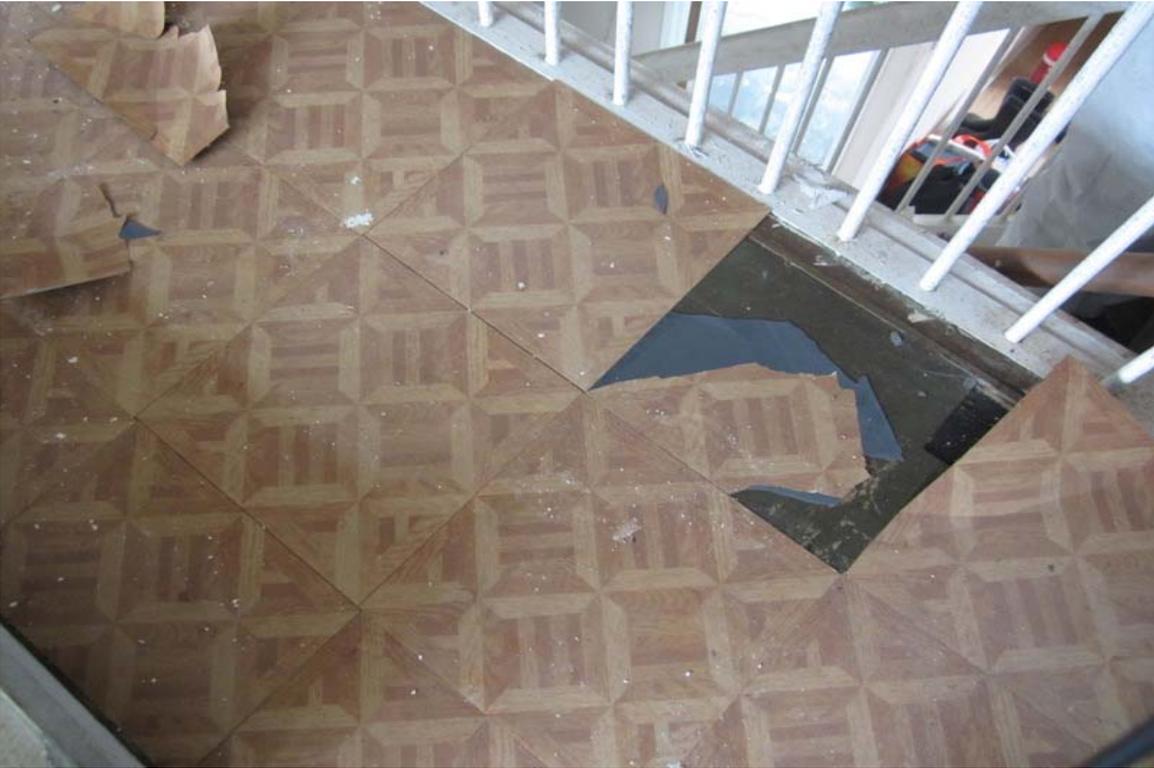
Photo Number	12	Reference number	220316MW09
Inspection / Sample	Sample	Inspection Cross Reference / Visual I.D.	Not Applicable

Notes	ACM: Asbestos Containing Material

Building	Flat 12 - Neville House	Condition	Good	0
Floor Level	4th floor	Surface Treatment	Composite materials, reinforced plastics, resin, vinyl materials	0
Location	06 / Landing	Material Friability	Low	1
Feature	Green floor tiles and adhesive	Asbestos Type	Chrysotile (White)	1
Material Type	Floor Tile / Covering			
Extent	7 sq. m.			
Recommendation	Remove if likely to be disturbed during the refurbishment works	Assessment Score		2
		Assessment Band		D

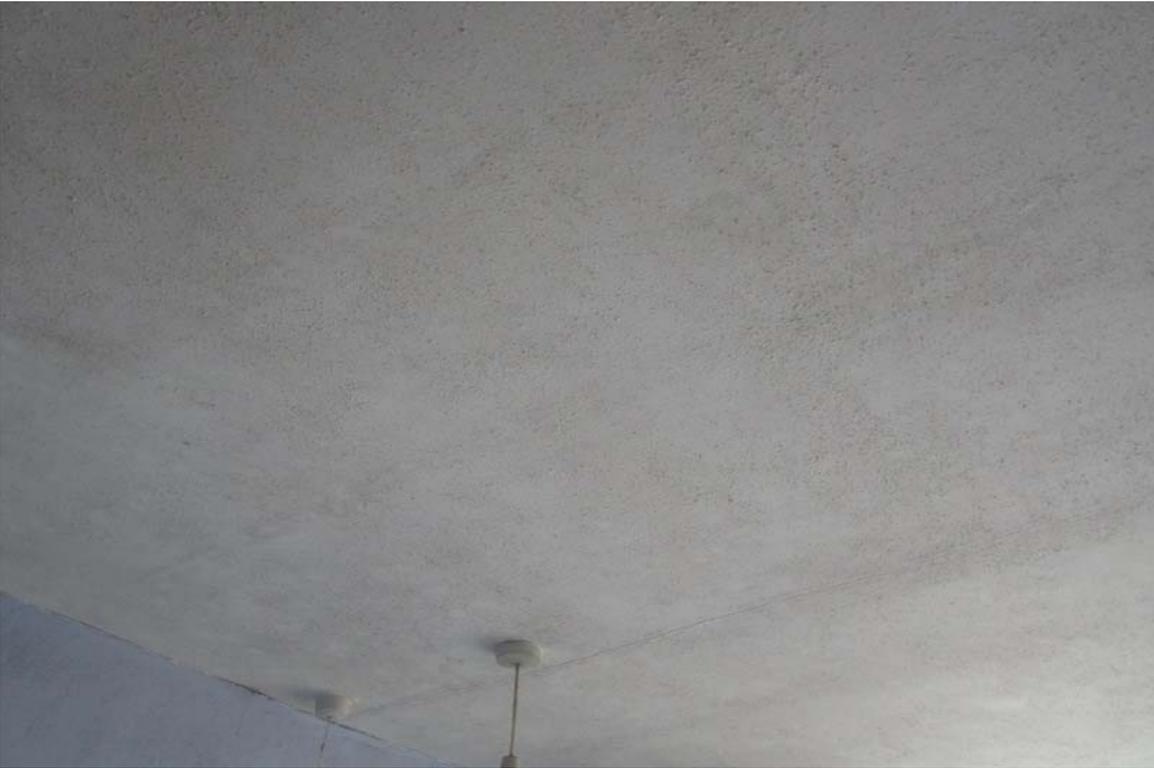
Photo Number	13	Reference number	220316MW13
Inspection / Sample	Sample	Inspection Cross Reference / Visual I.D.	Not Applicable

Notes	NADIS: No Asbestos Detected In Sample

Building	Flat 12 - Neville House	Condition	Fair	1
Floor Level	4th floor	Surface Treatment	Composite materials, reinforced plastics, resin, vinyl materials	0
Location	07 / Bedroom 1	Material Friability	Low	1
Feature	Coating to ceiling	Asbestos Type	N.A.D.I.S	0
Material Type	Textured Coating			
Extent	10 sq. m.			
Recommendation	No action necessary	Assessment Score		0
		Assessment Band		E

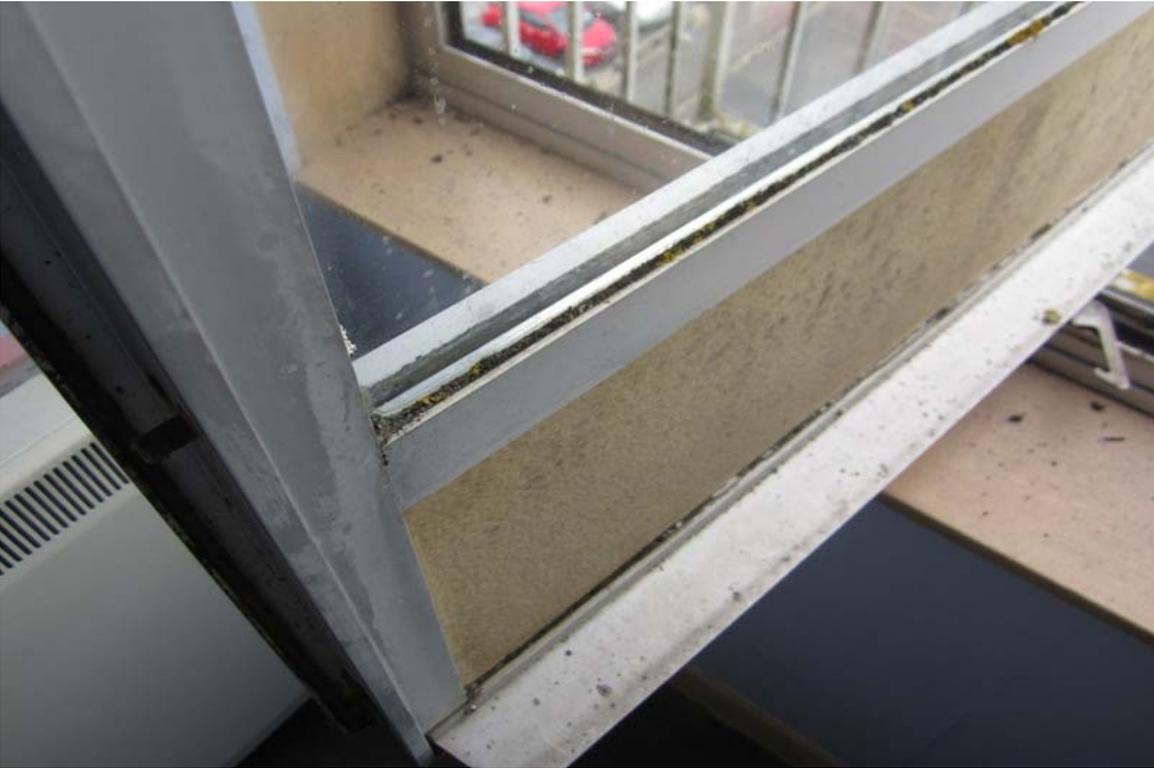
Photo Number	14	Reference number	220316MW14
Inspection / Sample	Sample	Inspection Cross Reference / Visual I.D.	Not Applicable

Notes	NADIS: No Asbestos Detected In Sample

Building	Flat 12 - Neville House	Condition	Fair	1
Floor Level	4th floor	Surface Treatment	Composite materials, reinforced plastics, resin, vinyl materials	0
Location	07 / Bedroom 1	Material Friability	Medium	2
Feature	Putty to windows	Asbestos Type	N.A.D.I.S	0
Material Type	Gasket / Seal			
Extent	1 m.			
Recommendation	No action necessary	Assessment Score		0
		Assessment Band		E

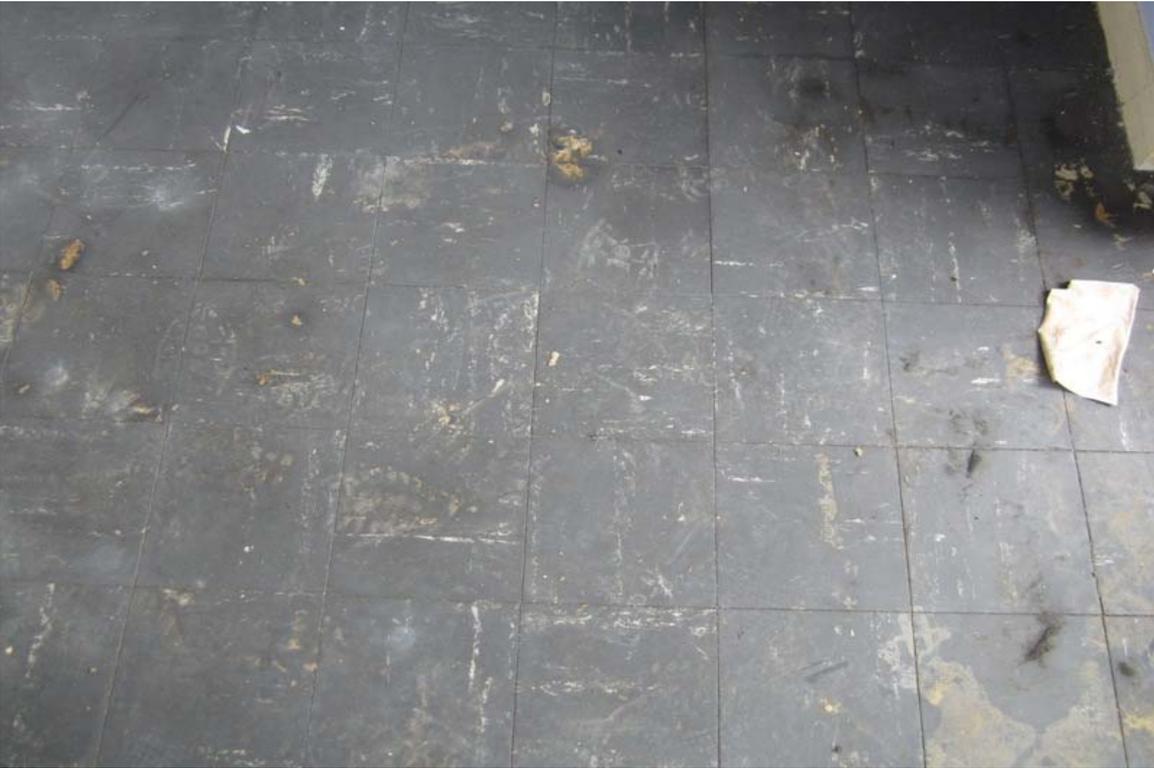
Photo Number	16	Reference number	220316MW12
Inspection / Sample	Sample	Inspection Cross Reference / Visual I.D.	Not Applicable

Notes	ACM: Asbestos Containing Material

Building	Flat 12 - Neville House	Condition	Good	0
Floor Level	4th floor	Surface Treatment	Composite materials, reinforced plastics, resin, vinyl materials	0
Location	07 / Bedroom 1	Material Friability	Low	1
Feature	Black floor tiles and adhesive	Asbestos Type	Chrysotile (White)	1
Material Type	Floor Tile / Covering			
Extent	10 sq. m.			
Recommendation	Remove if likely to be disturbed during the refurbishment works	Assessment Score		2
		Assessment Band		D

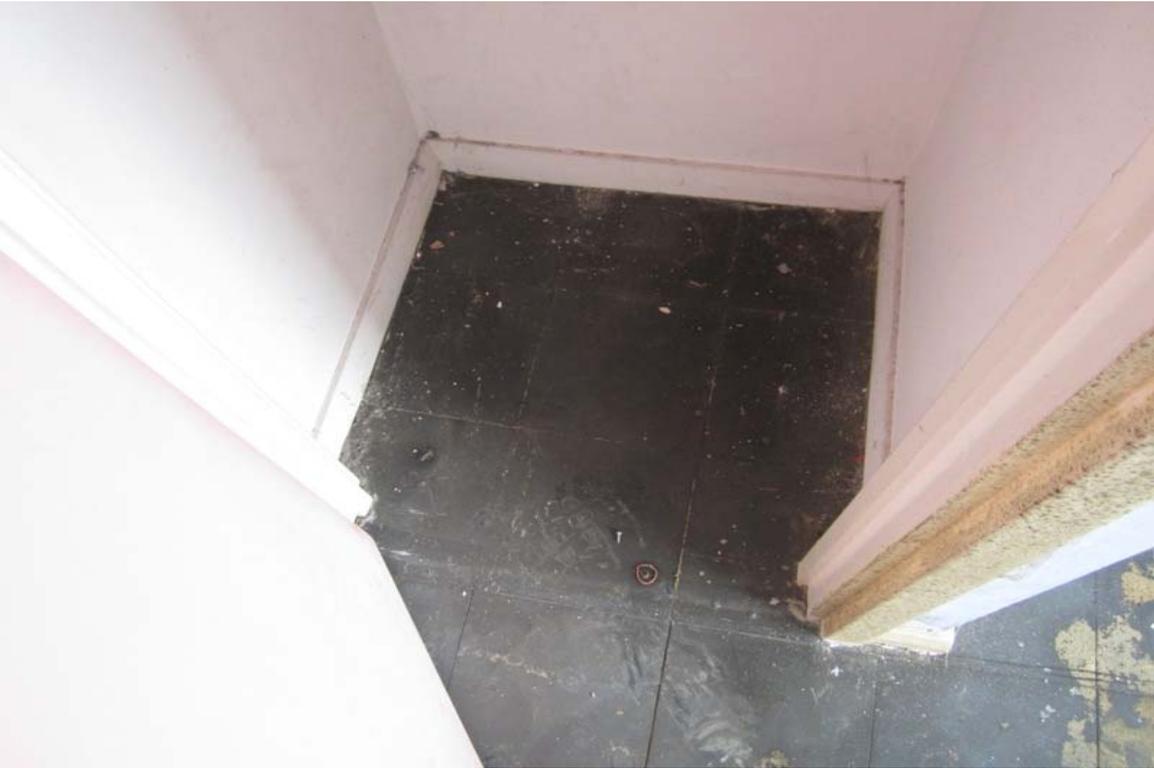
Photo Number	17	Reference number	220316MW11
Inspection / Sample	Inspection	Inspection Cross Reference / Visual I.D.	220316MW12

Notes	ACM: Asbestos Containing Material

Building	Flat 12 - Neville House	Condition	Good	0
Floor Level	4th floor	Surface Treatment	Composite materials, reinforced plastics, resin, vinyl materials	0
Location	08 / Cupboard	Material Friability	Low	1
Feature	Black floor tiles and adhesive	Asbestos Type	Strongly Presumed Chrysotile (White)	1
Material Type	Floor Tile / Covering			
Extent	0.5 sq. m.			
Recommendation	Remove if likely to be disturbed during the refurbishment works	Assessment Score		2
		Assessment Band		D

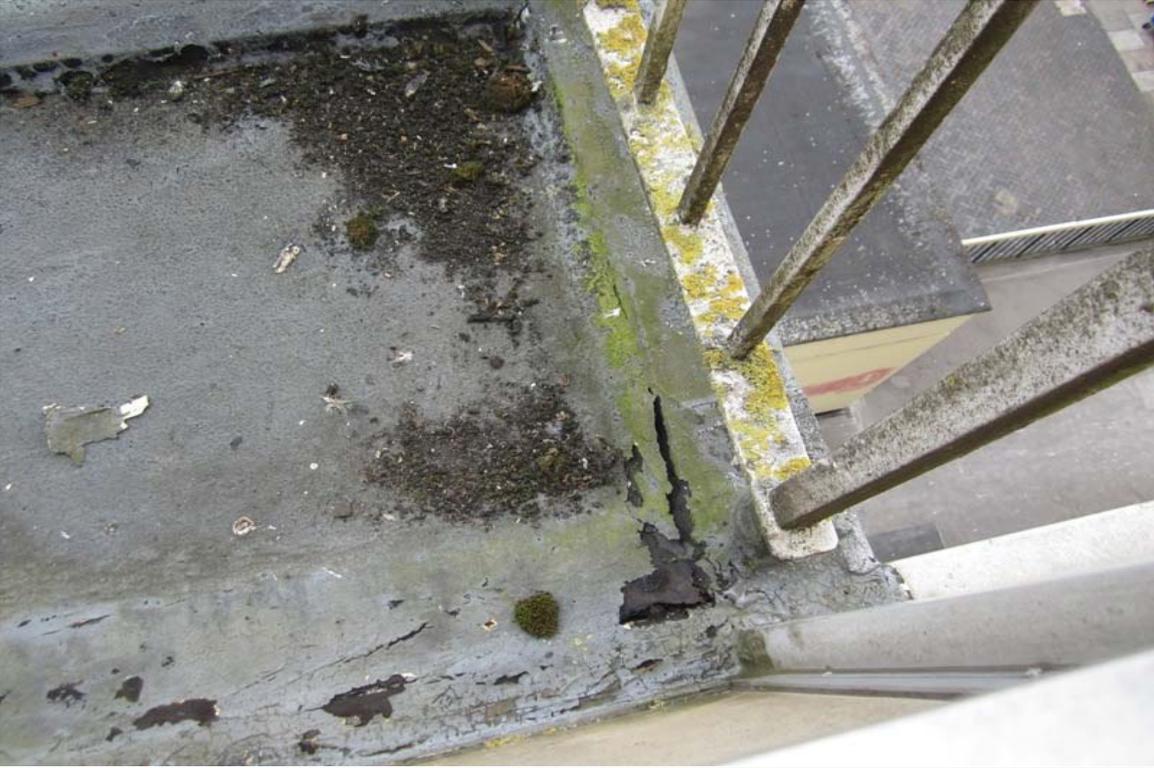
Photo Number	18	Reference number	220316MW15
Inspection / Sample	Sample	Inspection Cross Reference / Visual I.D.	Not Applicable

Notes	NADIS: No Asbestos Detected In Sample

Building	Flat 12 - Neville House	Condition	Fair	1
Floor Level	4th floor	Surface Treatment	Composite materials, reinforced plastics, resin, vinyl materials	0
Location	09 / Balcony	Material Friability	Low	1
Feature	Floor covering	Asbestos Type	N.A.D.I.S	0
Material Type	Bitumen			
Extent	1 sq. m.			
Recommendation	No action necessary	Assessment Score		0
		Assessment Band		E

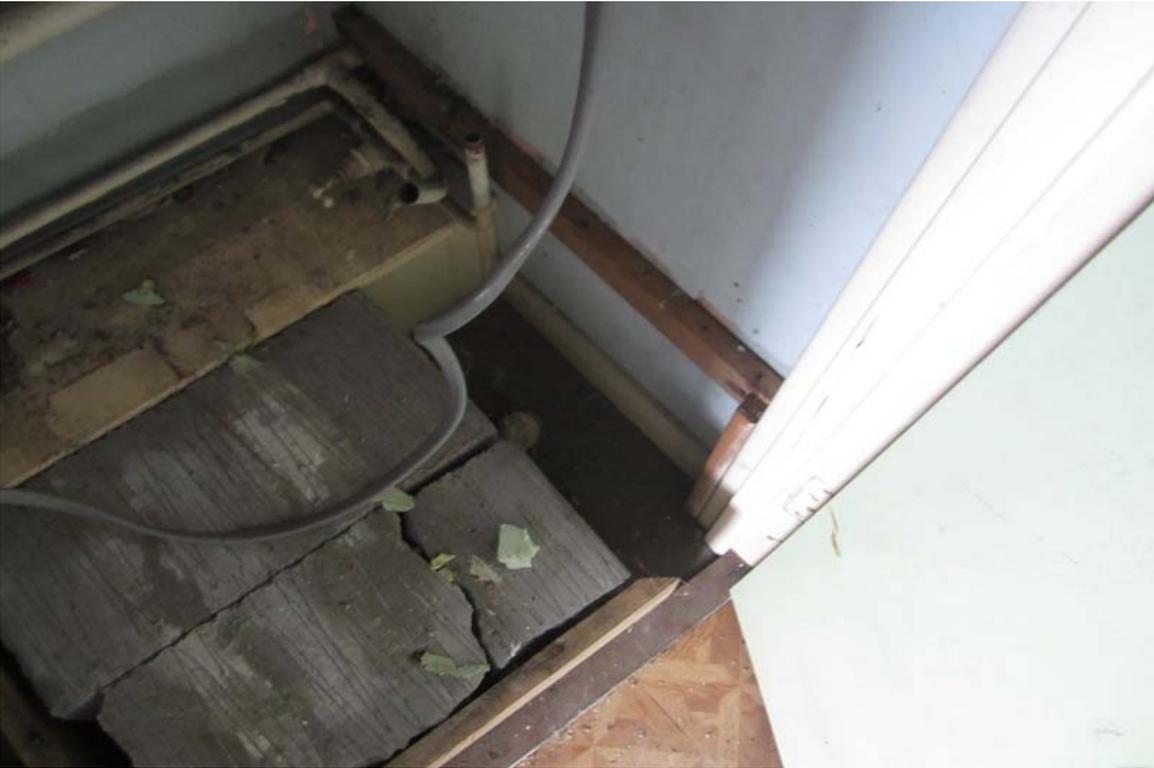
Photo Number	20	Reference number	220316MW19
Inspection / Sample	Inspection	Inspection Cross Reference / Visual I.D.	220316MW09

Notes	ACM: Asbestos Containing Material

Building	Flat 12 - Neville House	Condition	Fair	1
Floor Level	4th floor	Surface Treatment	Composite materials, reinforced plastics, resin, vinyl materials	0
Location	10 / Cupboard	Material Friability	Low	1
Feature	Green floor tiles and adhesive	Asbestos Type	Strongly Presumed Chrysotile (White)	1
Material Type	Floor Tile / Covering			
Extent	1 sq. m.			
Recommendation	Remove if likely to be disturbed during the refurbishment works	Assessment Score		3
		Assessment Band		D

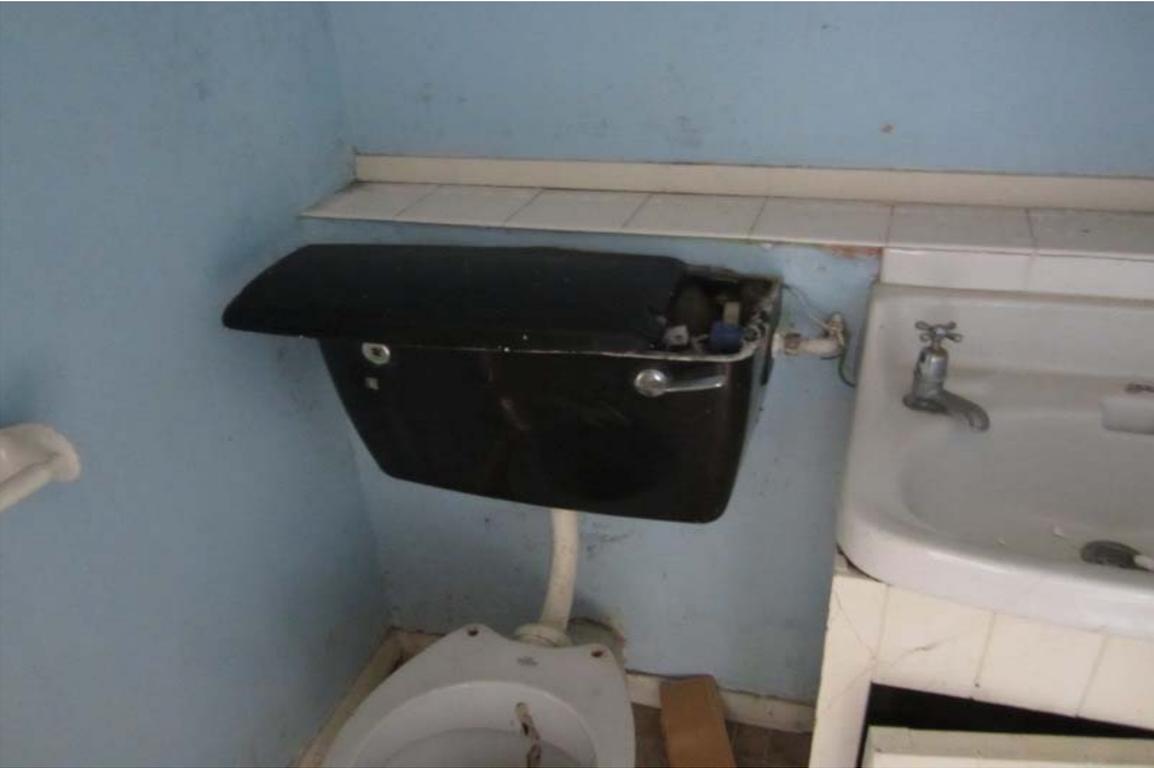
Photo Number	21	Reference number	220316MW20
Inspection / Sample	Sample	Inspection Cross Reference / Visual I.D.	Not Applicable

Notes	ACM: Asbestos Containing Material

Building	Flat 12 - Neville House	Condition	Fair	1
Floor Level	4th floor	Surface Treatment	Composite materials, reinforced plastics, resin, vinyl materials	0
Location	11 / Bathroom	Material Friability	Low	1
Feature	Toilet cistern	Asbestos Type	Amosite (Brown)	2
Material Type	Composite / Resin			
Extent	1 No.			
Recommendation	Remove if likely to be disturbed during the refurbishment works	Assessment Score		4
		Assessment Band		D

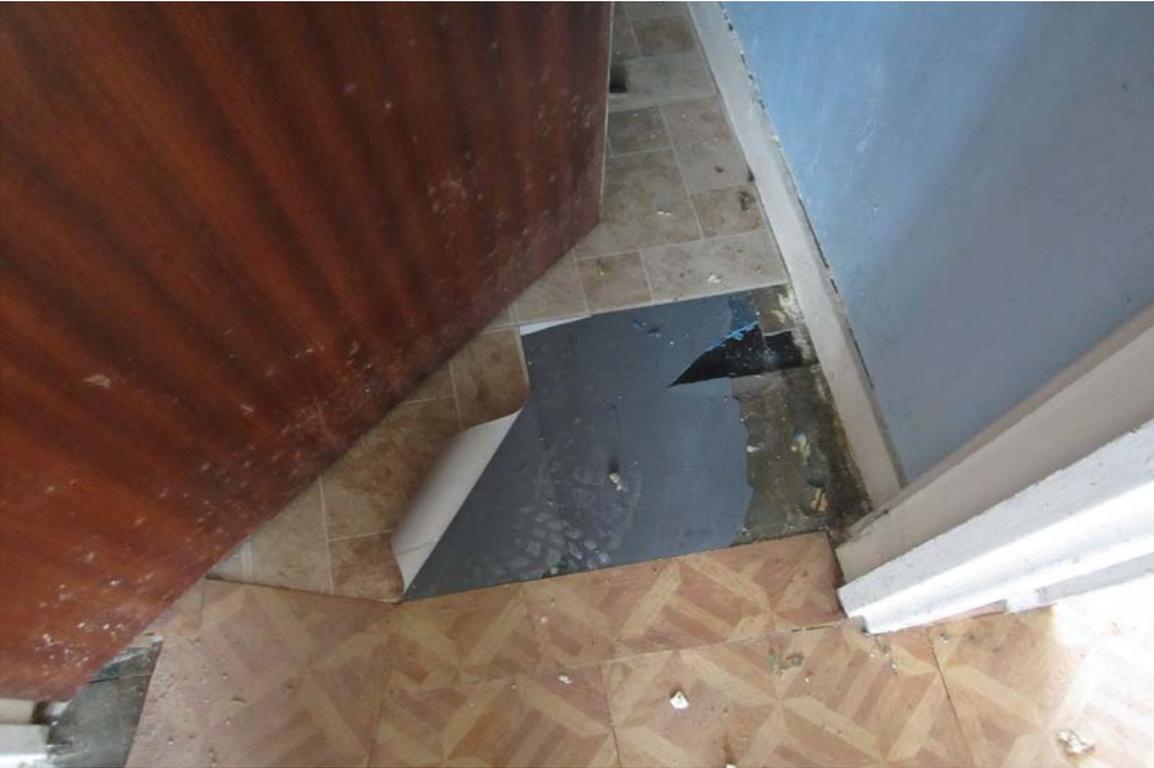
Photo Number	22	Reference number	220316MW22
Inspection / Sample	Sample	Inspection Cross Reference / Visual I.D.	Not Applicable

Notes	ACM: Asbestos Containing Material

Building	Flat 12 - Neville House	Condition	Fair	1
Floor Level	4th floor	Surface Treatment	Composite materials, reinforced plastics, resin, vinyl materials	0
Location	11 / Bathroom	Material Friability	Low	1
Feature	Blue and green floor tiles and adhesive	Asbestos Type	Chrysotile (White)	1
Material Type	Floor Tile / Covering			
Extent	4 sq. m.			
Recommendation	Remove if likely to be disturbed during the refurbishment works	Assessment Score		3
		Assessment Band		D

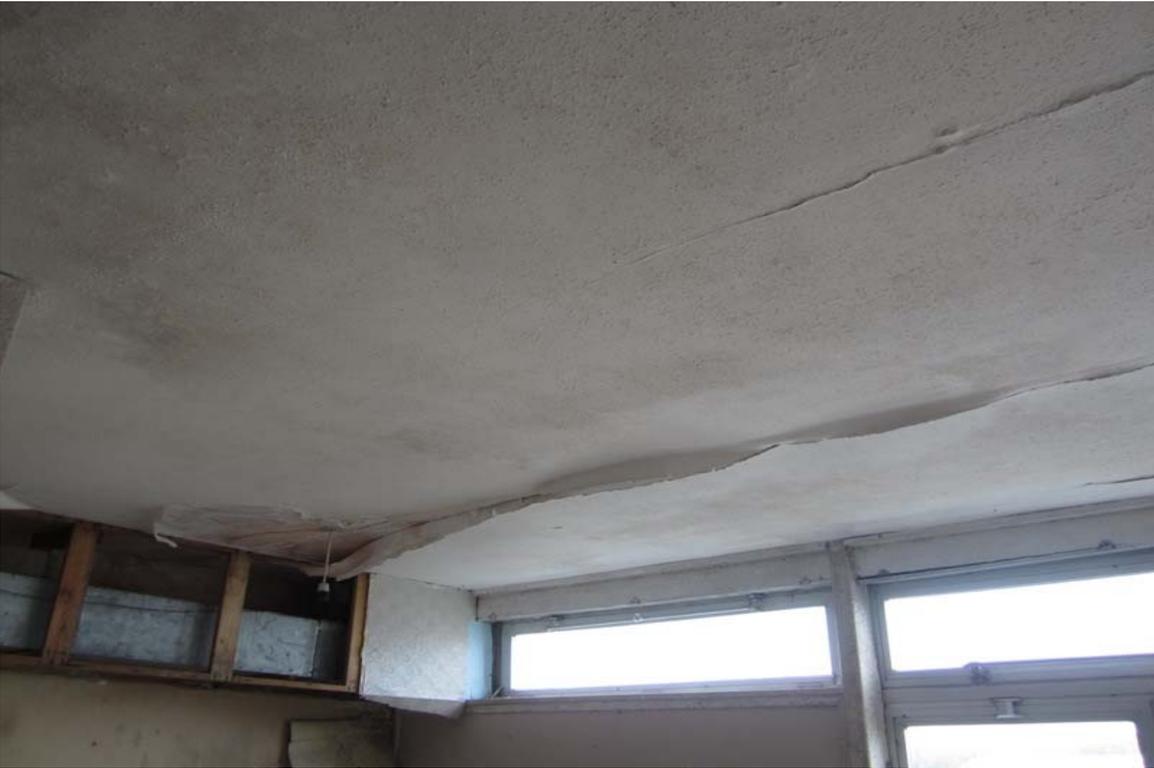
Photo Number	23	Reference number	220316MW23
Inspection / Sample	Inspection	Inspection Cross Reference / Visual I.D.	220316MW13

Notes	NADIS: No Asbestos Detected In Sample

Building	Flat 12 - Neville House	Condition	Fair	1
Floor Level	4th floor	Surface Treatment	Composite materials, reinforced plastics, resin, vinyl materials	0
Location	12 / Lounge	Material Friability	Low	1
Feature	Coating to ceiling	Asbestos Type	Strongly Presumed N.A.D.I.S	0
Material Type	Textured Coating			
Extent	15 sq. m.			
Recommendation	No action necessary	Assessment Score		0
		Assessment Band		E

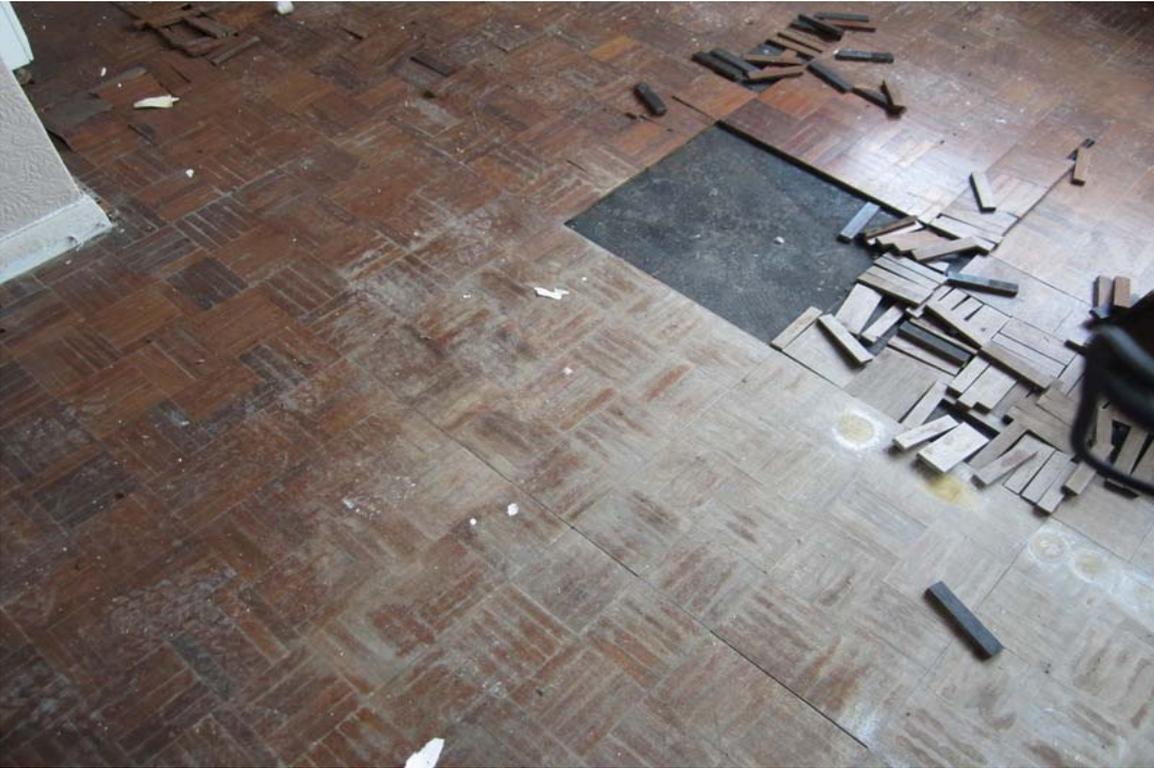
Photo Number	24	Reference number	220316MW24
Inspection / Sample	Sample	Inspection Cross Reference / Visual I.D.	Not Applicable

Notes	NADIS: No Asbestos Detected In Sample

Building	Flat 12 - Neville House	Condition	Fair	1
Floor Level	4th floor	Surface Treatment	Composite materials, reinforced plastics, resin, vinyl materials	0
Location	12 / Lounge	Material Friability	Low	1
Feature	Bitumen adhesive beneath parquet flooring	Asbestos Type	N.A.D.I.S	0
Material Type	Bitumen			
Extent	15 sq. m.			
Recommendation	No action necessary	Assessment Score		0
		Assessment Band		E

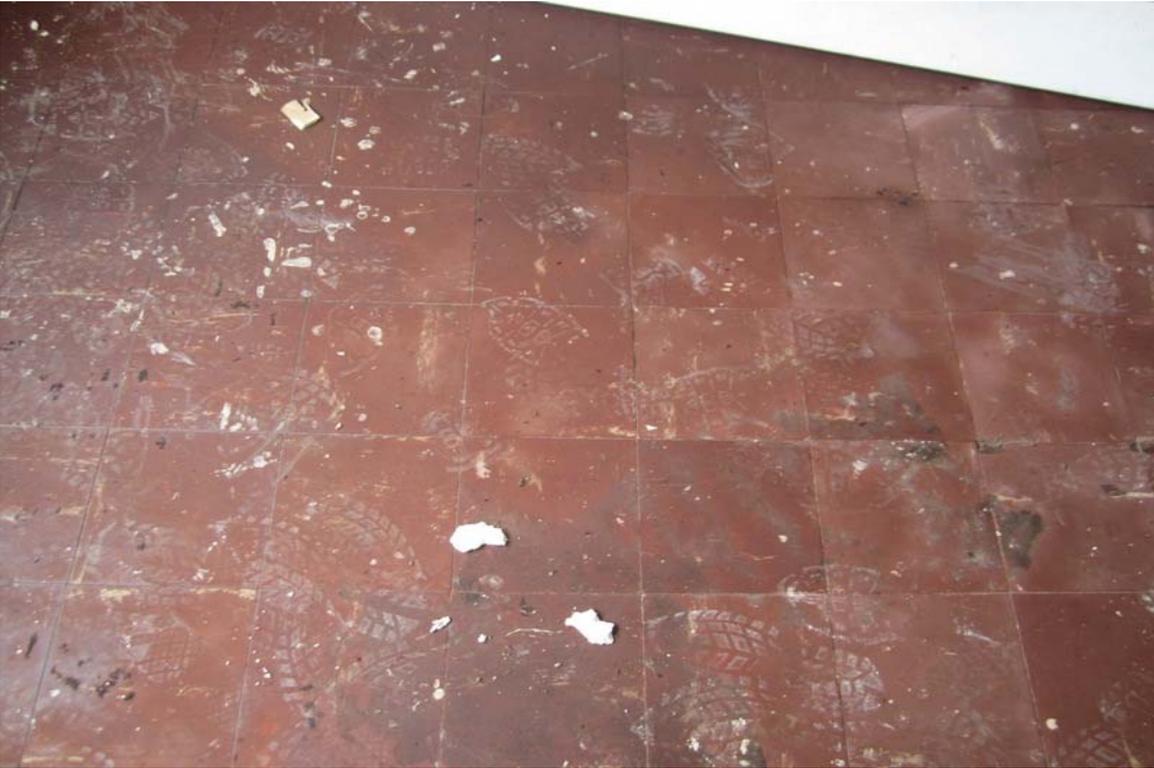
Photo Number	25	Reference number	220316MW25
Inspection / Sample	Sample	Inspection Cross Reference / Visual I.D.	Not Applicable

Notes	ACM: Asbestos Containing Material

Building	Flat 12 - Neville House	Condition	Fair	1
Floor Level	4th floor	Surface Treatment	Composite materials, reinforced plastics, resin, vinyl materials	0
Location	13 / Bedroom 2	Material Friability	Low	1
Feature	Red floor tiles and adhesive	Asbestos Type	Chrysotile (White)	1
Material Type	Floor Tile / Covering			
Extent	8 sq. m.			
Recommendation	Remove if likely to be disturbed during the refurbishment works	Assessment Score		3
		Assessment Band		D
