**CBC Asbestos Refurbishment Survey Report
Neville House, George Street, Corby
22nd – 24th March 2016**

Reference:					
Issue			Prepared by	Verified by	
V1	Apr 16	JQ

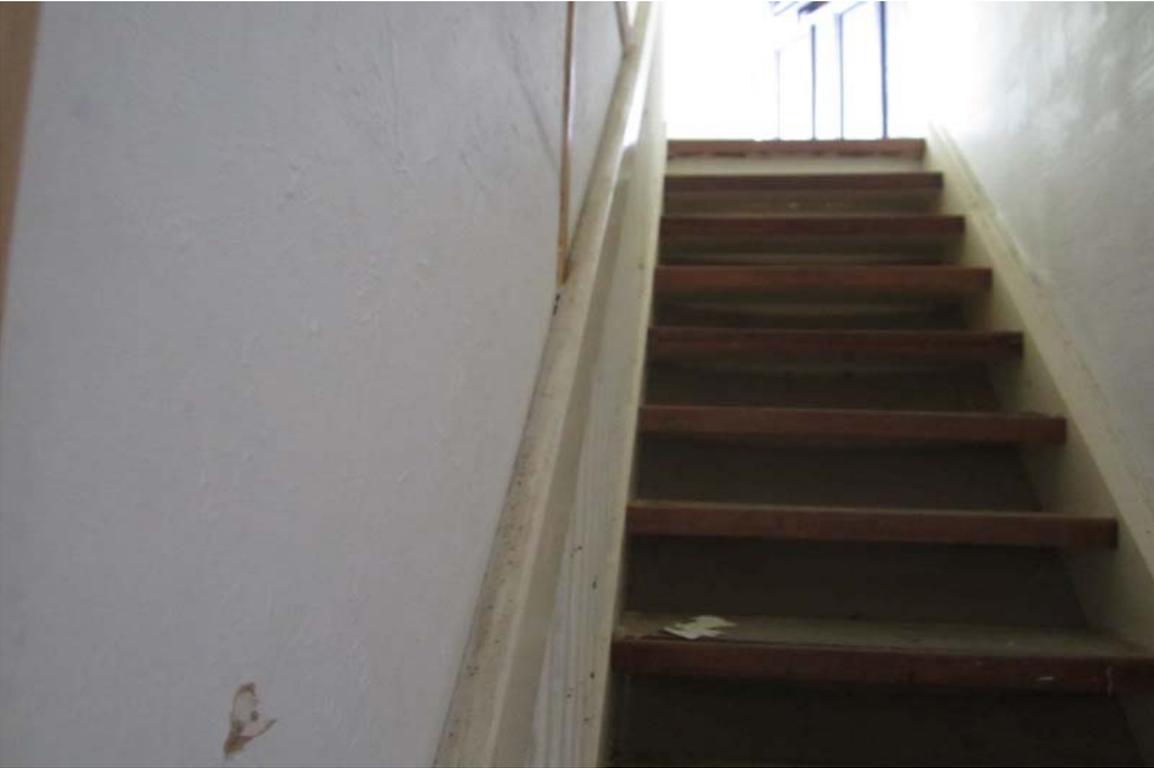
Photo Number	27	Reference number	220316MW41
Inspection / Sample	Sample	Inspection Cross Reference / Visual I.D.	Not Applicable

Notes	NADIS: No Asbestos Detected In Sample

Building	Flat 11 - Neville House	Condition	Good	0
Floor Level	3rd floor	Surface Treatment	Composite materials, reinforced plastics, resin, vinyl materials	0
Location	01 / Hallway	Material Friability	Low	1
Feature	Coating to stairwell walls	Asbestos Type	N.A.D.I.S	0
Material Type	Textured Coating			
Extent	2 sq. m.			
Recommendation	No action necessary	Assessment Score		0
		Assessment Band		E

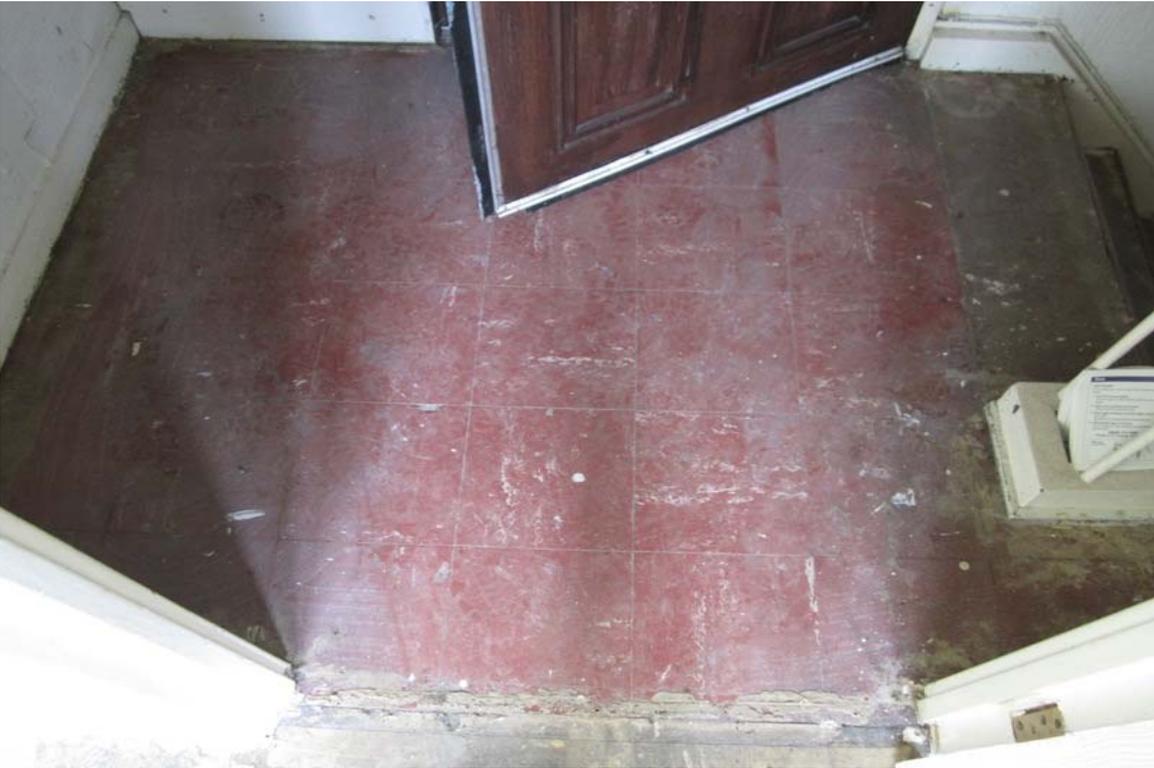
Photo Number	28	Reference number	220316MW36
Inspection / Sample	Inspection	Inspection Cross Reference / Visual I.D.	220316MW25

Notes	ACM: Asbestos Containing Material

Building	Flat 11 - Neville House	Condition	Good	0
Floor Level	3rd floor	Surface Treatment	Composite materials, reinforced plastics, resin, vinyl materials	0
Location	01 / Hallway	Material Friability	Low	1
Feature	Red floor tiles and adhesive	Asbestos Type	Strongly Presumed Chrysotile (White)	1
Material Type	Floor Tile / Covering			
Extent	2 sq. m.			
Recommendation	Remove if likely to be disturbed during the refurbishment works	Assessment Score		2
		Assessment Band		D

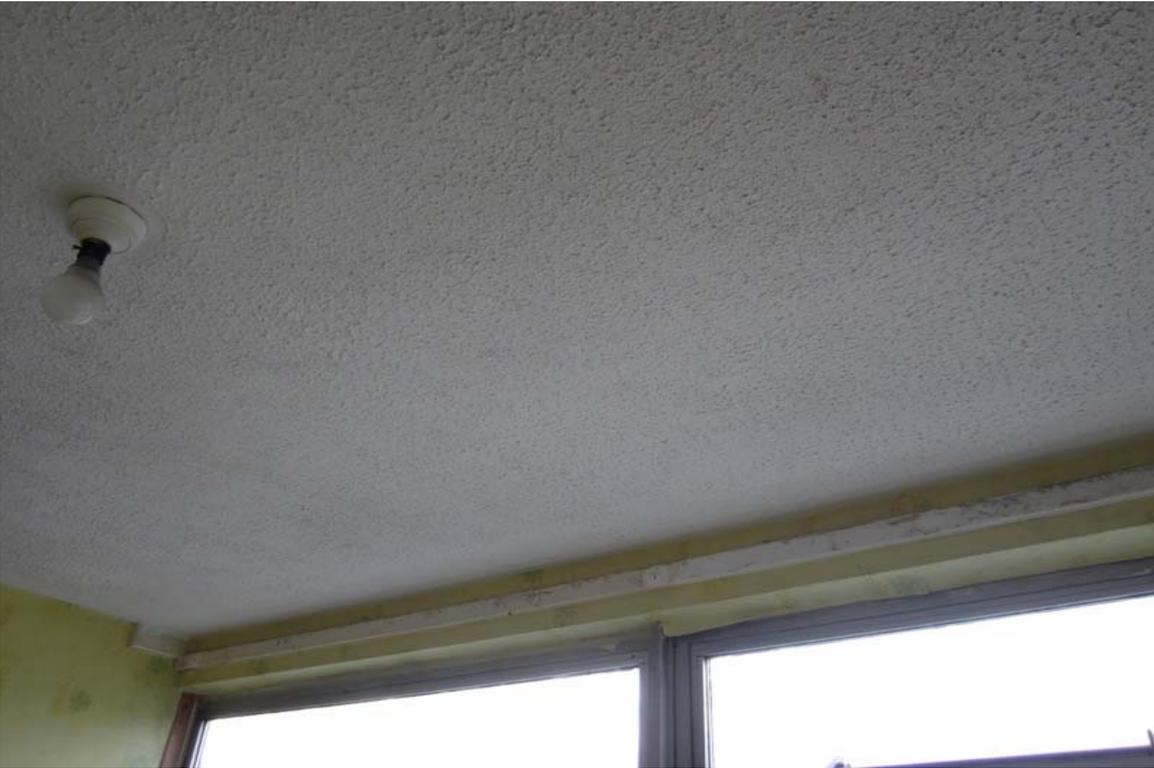
Photo Number	29	Reference number	220316MW37
Inspection / Sample	Inspection	Inspection Cross Reference / Visual I.D.	220316MW42

Notes	NADIS: No Asbestos Detected In Sample

Building	Flat 11 - Neville House	Condition	Good	0
Floor Level	3rd floor	Surface Treatment	Composite materials, reinforced plastics, resin, vinyl materials	0
Location	02 / Kitchen	Material Friability	Low	1
Feature	Coating to ceiling	Asbestos Type	Strongly Presumed N.A.D.I.S	0
Material Type	Textured Coating			
Extent	15 sq. m.			
Recommendation	No action necessary	Assessment Score		0
		Assessment Band		E

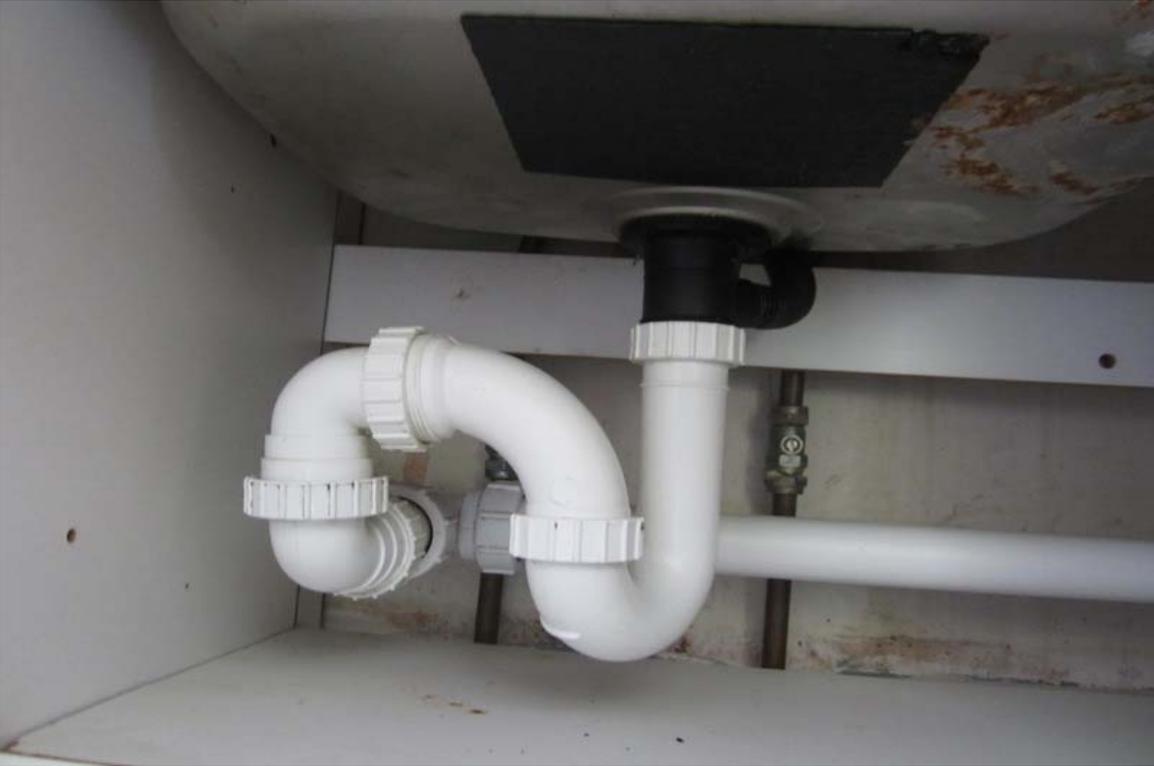
Photo Number	30	Reference number	220316MW38
Inspection / Sample	Sample	Inspection Cross Reference / Visual I.D.	Not Applicable

Notes	NADIS: No Asbestos Detected In Sample

Building	Flat 11 - Neville House	Condition	Good	0
Floor Level	3rd floor	Surface Treatment	Composite materials, reinforced plastics, resin, vinyl materials	0
Location	02 / Kitchen	Material Friability	Low	1
Feature	Acoustic pad to underside of sink	Asbestos Type	N.A.D.I.S	0
Material Type	Bitumen			
Extent	1 No.			
Recommendation	No action necessary	Assessment Score		0
		Assessment Band		E

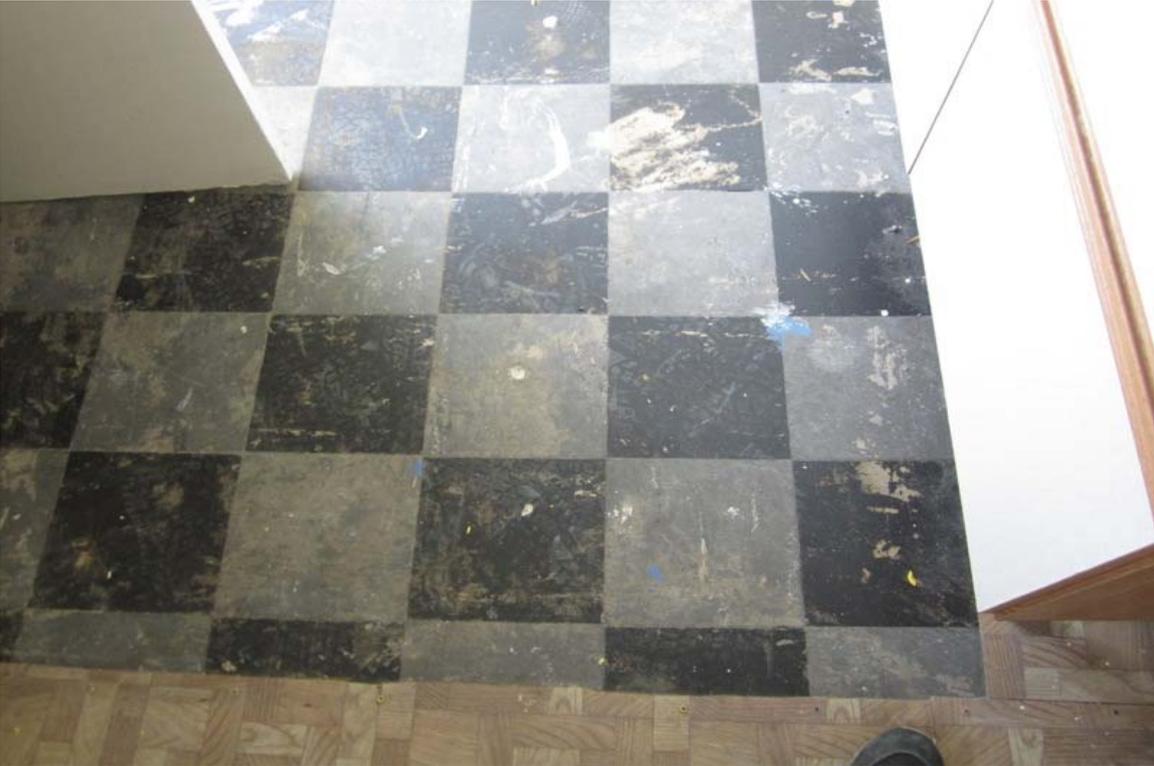
Photo Number	31	Reference number	220316MW39
Inspection / Sample	Inspection	Inspection Cross Reference / Visual I.D.	220316MW03

Notes	ACM: Asbestos Containing Material

Building	Flat 11 - Neville House	Condition	Good	0
Floor Level	3rd floor	Surface Treatment	Composite materials, reinforced plastics, resin, vinyl materials	0
Location	02 / Kitchen	Material Friability	Low	1
Feature	Grey and black floor tiles and adhesive	Asbestos Type	Strongly Presumed Chrysotile (White)	1
Material Type	Floor Tile / Covering			
Extent	15 sq. m.			
Recommendation	Remove if likely to be disturbed during the refurbishment works	Assessment Score		2
		Assessment Band		D

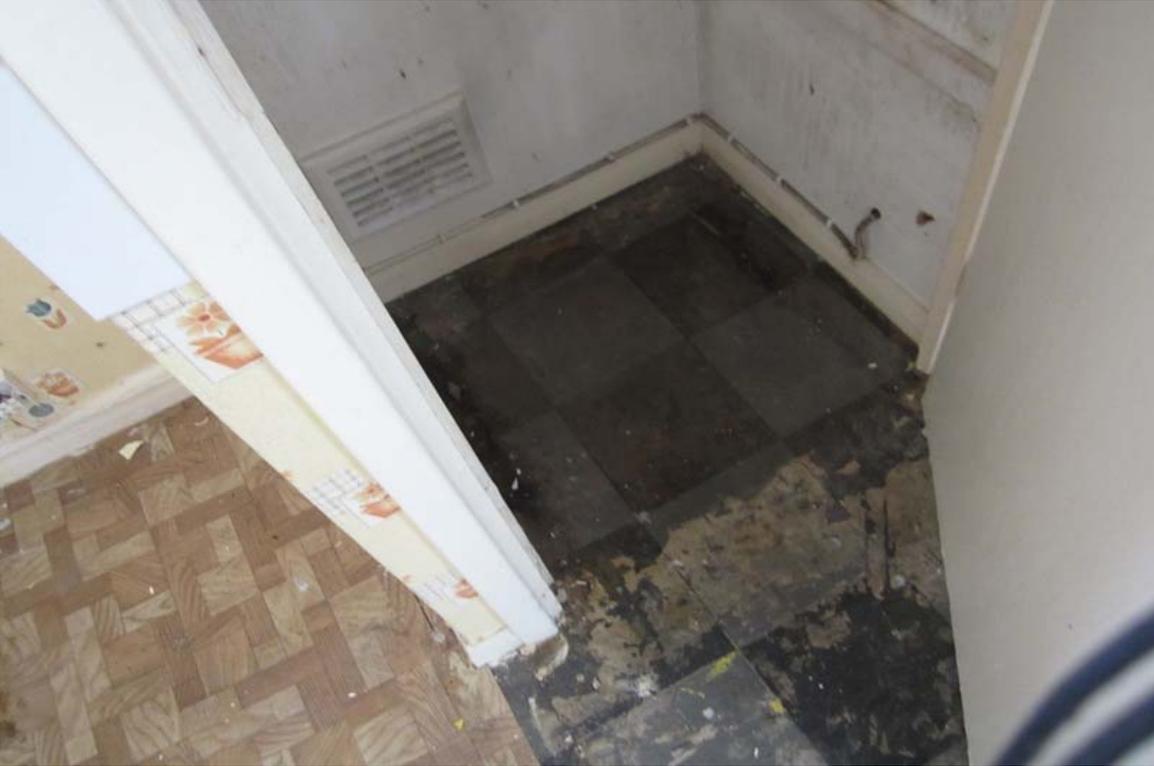
Photo Number	32	Reference number	220316MW40
Inspection / Sample	Inspection	Inspection Cross Reference / Visual I.D.	220316MW03

Notes	ACM: Asbestos Containing Material

Building	Flat 11 - Neville House	Condition	Good	0
Floor Level	3rd floor	Surface Treatment	Composite materials, reinforced plastics, resin, vinyl materials	0
Location	04 / Cupboard	Material Friability	Low	1
Feature	Grey and black floor tiles and adhesive	Asbestos Type	Strongly Presumed Chrysotile (White)	1
Material Type	Floor Tile / Covering			
Extent	1 sq. m.			
Recommendation	Remove if likely to be disturbed during the refurbishment works	Assessment Score		2
		Assessment Band		D

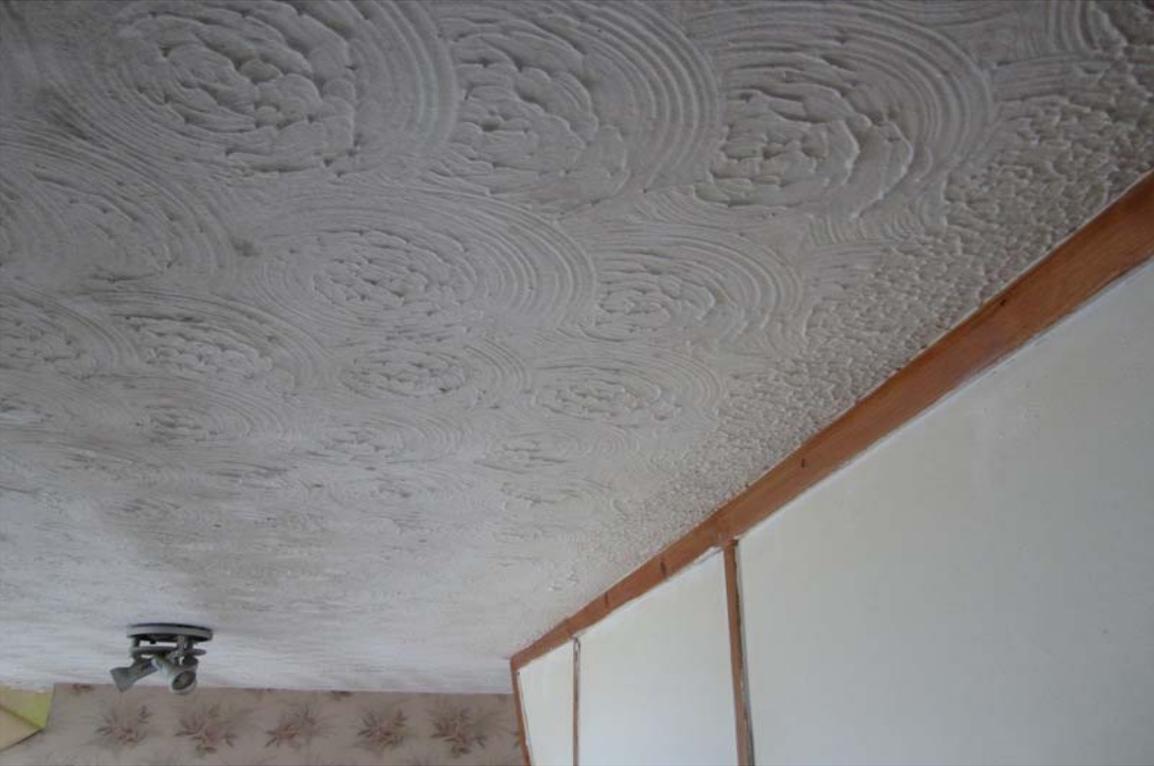
Photo Number	33	Reference number	220316MW42
Inspection / Sample	Sample	Inspection Cross Reference / Visual I.D.	Not Applicable

Notes	NADIS: No Asbestos Detected In Sample

Building	Flat 11 - Neville House	Condition	Fair	1
Floor Level	2nd floor	Surface Treatment	Composite materials, reinforced plastics, resin, vinyl materials	0
Location	05 / Lounge	Material Friability	Low	1
Feature	Coating to ceiling	Asbestos Type	N.A.D.I.S	0
Material Type	Textured Coating			
Extent	2 sq. m.			
Recommendation	No action necessary	Assessment Score		0
		Assessment Band		E

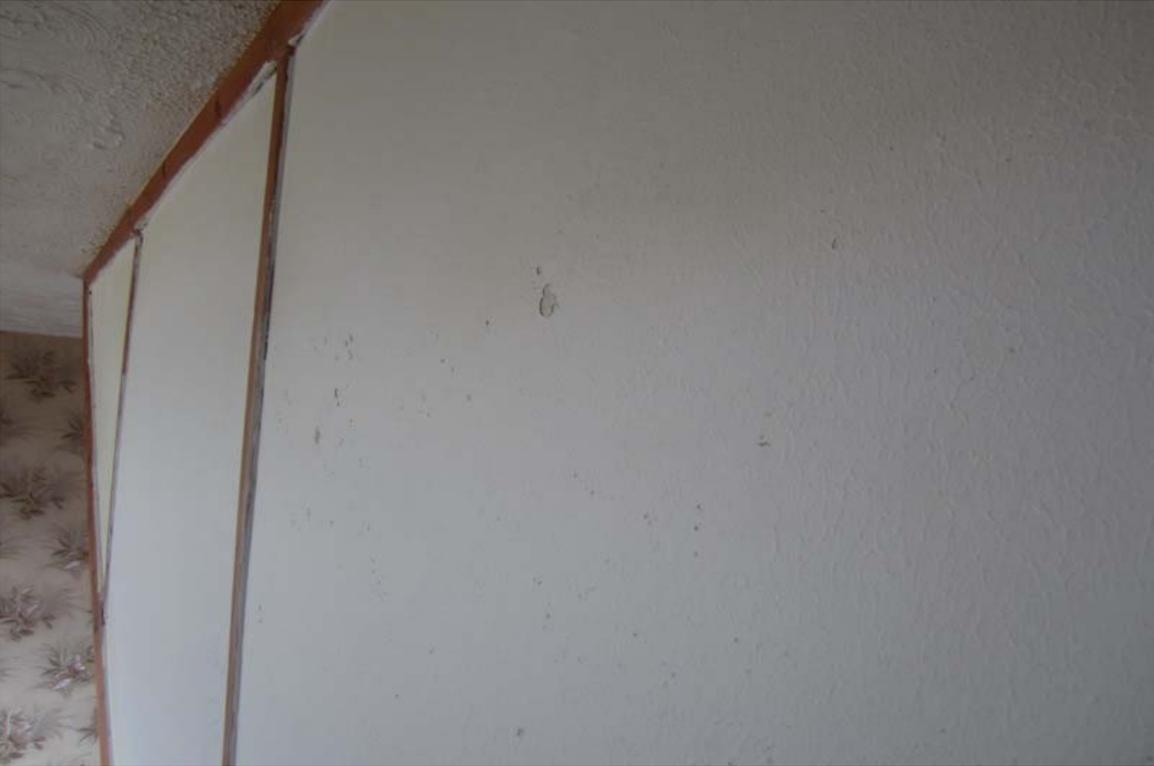
Photo Number	34	Reference number	220316MW43
Inspection / Sample	Inspection	Inspection Cross Reference / Visual I.D.	220316MW41

Notes	NADIS: No Asbestos Detected In Sample

Building	Flat 11 - Neville House	Condition	Fair	1
Floor Level	2nd floor	Surface Treatment	Composite materials, reinforced plastics, resin, vinyl materials	0
Location	05 / Lounge	Material Friability	Low	1
Feature	Coating to walls	Asbestos Type	Strongly Presumed N.A.D.I.S	0
Material Type	Textured Coating			
Extent	12 sq. m.			
Recommendation	No action necessary	Assessment Score		0
		Assessment Band		E

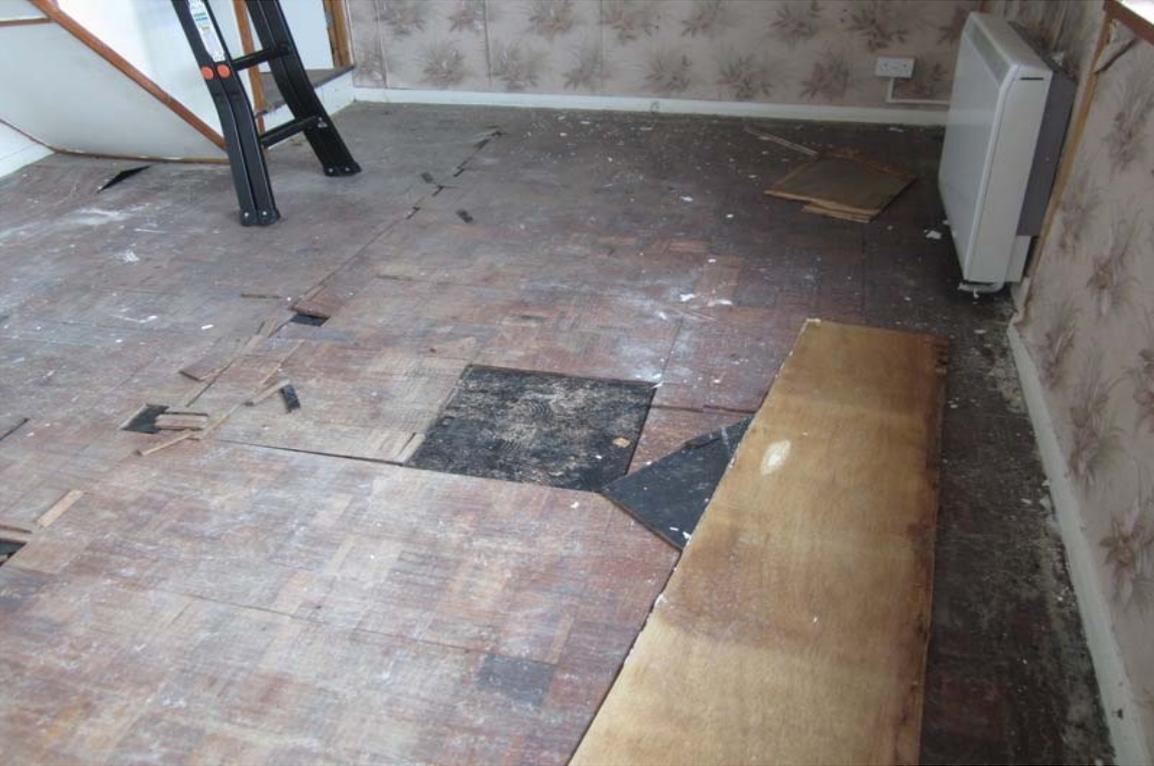
Photo Number	35	Reference number	220316MW44
Inspection / Sample	Inspection	Inspection Cross Reference / Visual I.D.	220316MW15

Notes	NADIS: No Asbestos Detected In Sample

Building	Flat 11 - Neville House	Condition	Fair	1
Floor Level	2nd floor	Surface Treatment	Composite materials, reinforced plastics, resin, vinyl materials	0
Location	05 / Lounge	Material Friability	Low	1
Feature	Bitumen adhesive beneath parquet flooring	Asbestos Type	Strongly Presumed N.A.D.I.S	0
Material Type	Bitumen			
Extent	12 sq. m.			
Recommendation	No action necessary	Assessment Score		0
		Assessment Band		E

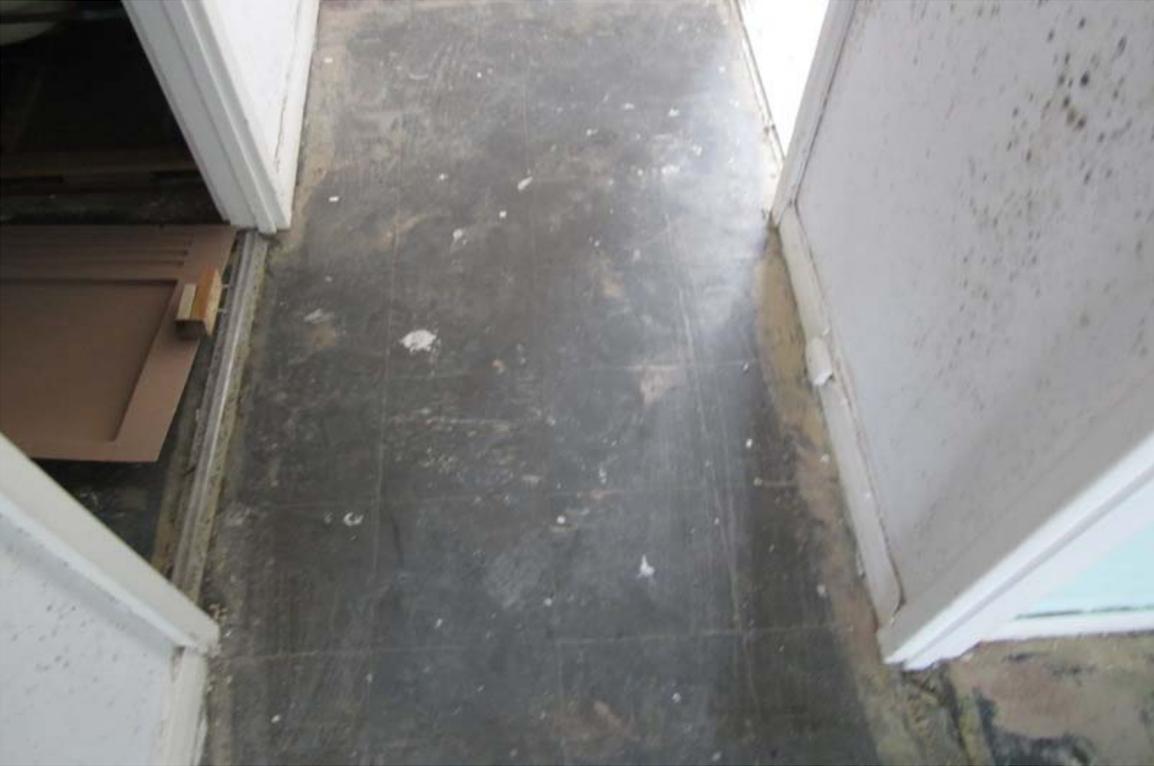
Photo Number	36	Reference number	220316MW45
Inspection / Sample	Inspection	Inspection Cross Reference / Visual I.D.	220316MW03

Notes	ACM: Asbestos Containing Material

Building	Flat 11 - Neville House	Condition	Good	0
Floor Level	2nd floor	Surface Treatment	Composite materials, reinforced plastics, resin, vinyl materials	0
Location	06 / Hallway	Material Friability	Low	1
Feature	Grey floor tiles and adhesive	Asbestos Type	Strongly Presumed Chrysotile (White)	1
Material Type	Floor Tile / Covering			
Extent	3 sq. m.			
Recommendation	Remove if likely to be disturbed during the refurbishment works	Assessment Score		2
		Assessment Band		D

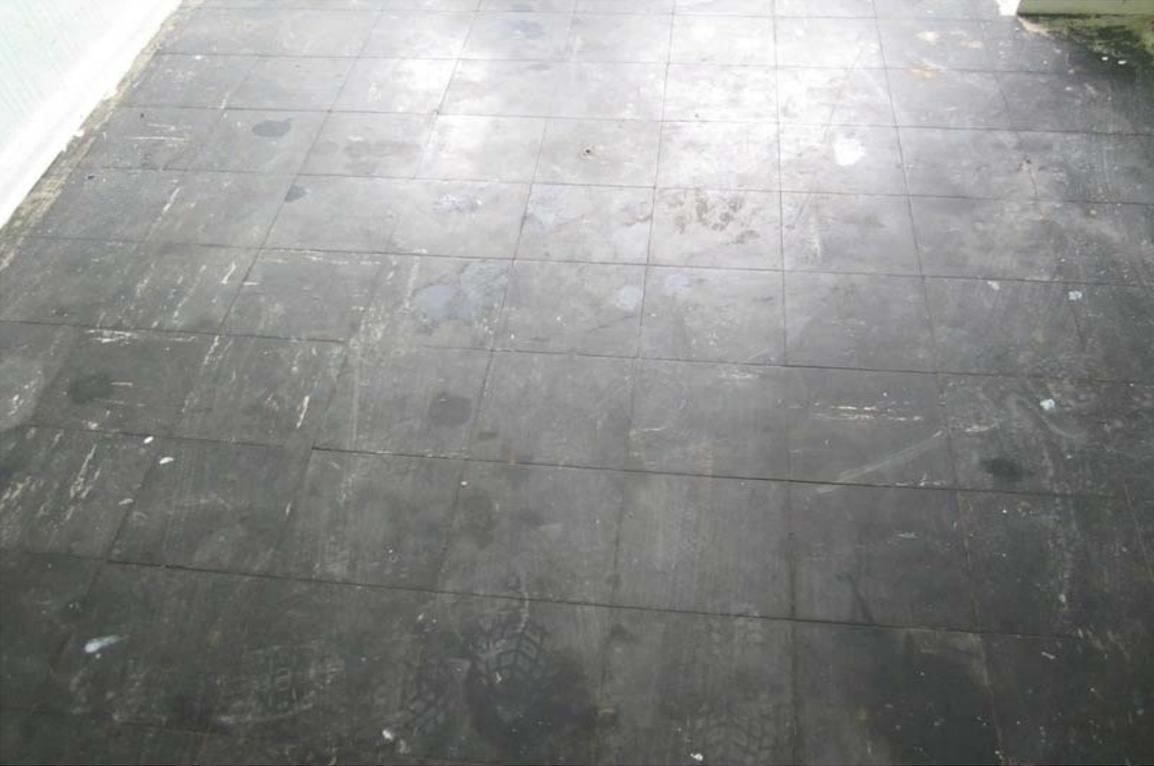
Photo Number	37	Reference number	220316MW46
Inspection / Sample	Inspection	Inspection Cross Reference / Visual I.D.	220316MW03

Notes	ACM: Asbestos Containing Material

Building	Flat 11 - Neville House	Condition	Good	0
Floor Level	2nd floor	Surface Treatment	Composite materials, reinforced plastics, resin, vinyl materials	0
Location	07 / Bedroom 1	Material Friability	Low	1
Feature	Grey floor tiles and adhesive	Asbestos Type	Strongly Presumed Chrysotile (White)	1
Material Type	Floor Tile / Covering			
Extent	11 sq. m.			
Recommendation	Remove if likely to be disturbed during the refurbishment works	Assessment Score		2
		Assessment Band		D

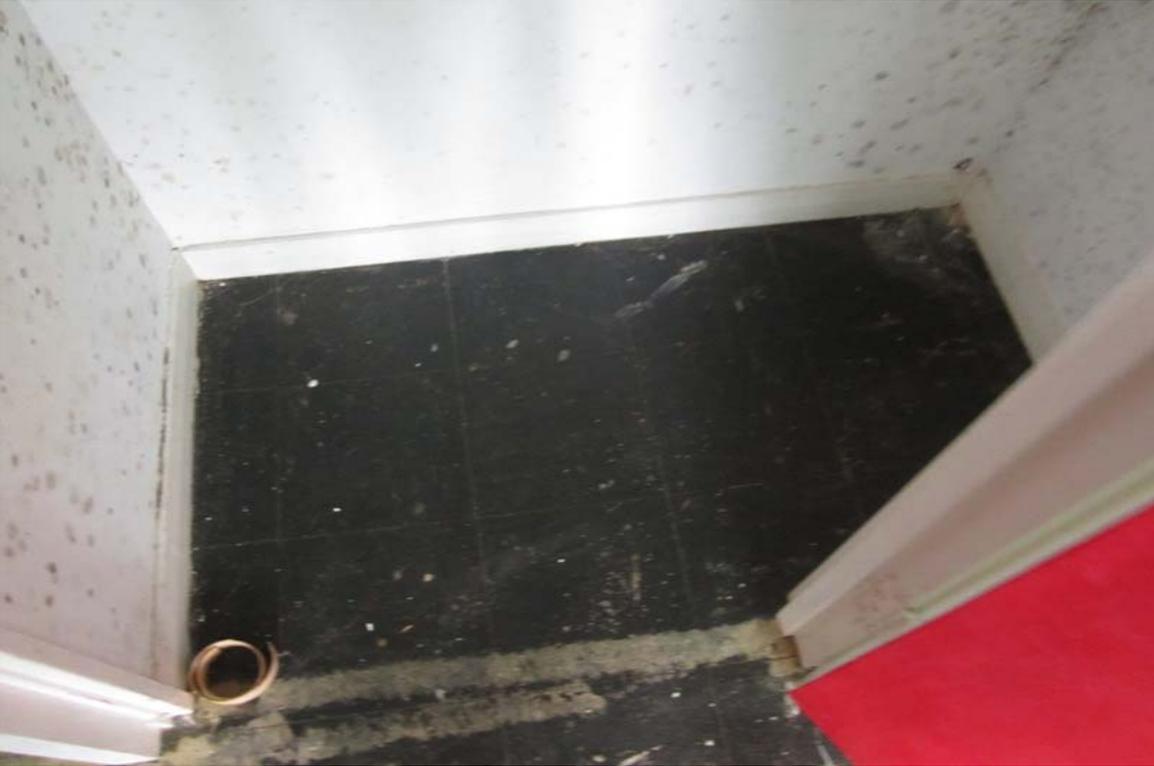
Photo Number	38	Reference number	220316MW47
Inspection / Sample	Inspection	Inspection Cross Reference / Visual I.D.	220316MW03

Notes	ACM: Asbestos Containing Material

Building	Flat 11 - Neville House	Condition	Good	0
Floor Level	2nd floor	Surface Treatment	Composite materials, reinforced plastics, resin, vinyl materials	0
Location	08 / Cupboard	Material Friability	Low	1
Feature	Grey floor tiles and adhesive	Asbestos Type	Strongly Presumed Chrysotile (White)	1
Material Type	Floor Tile / Covering			
Extent	0.5 sq. m.			
Recommendation	Remove if likely to be disturbed during the refurbishment works	Assessment Score		2
		Assessment Band		D

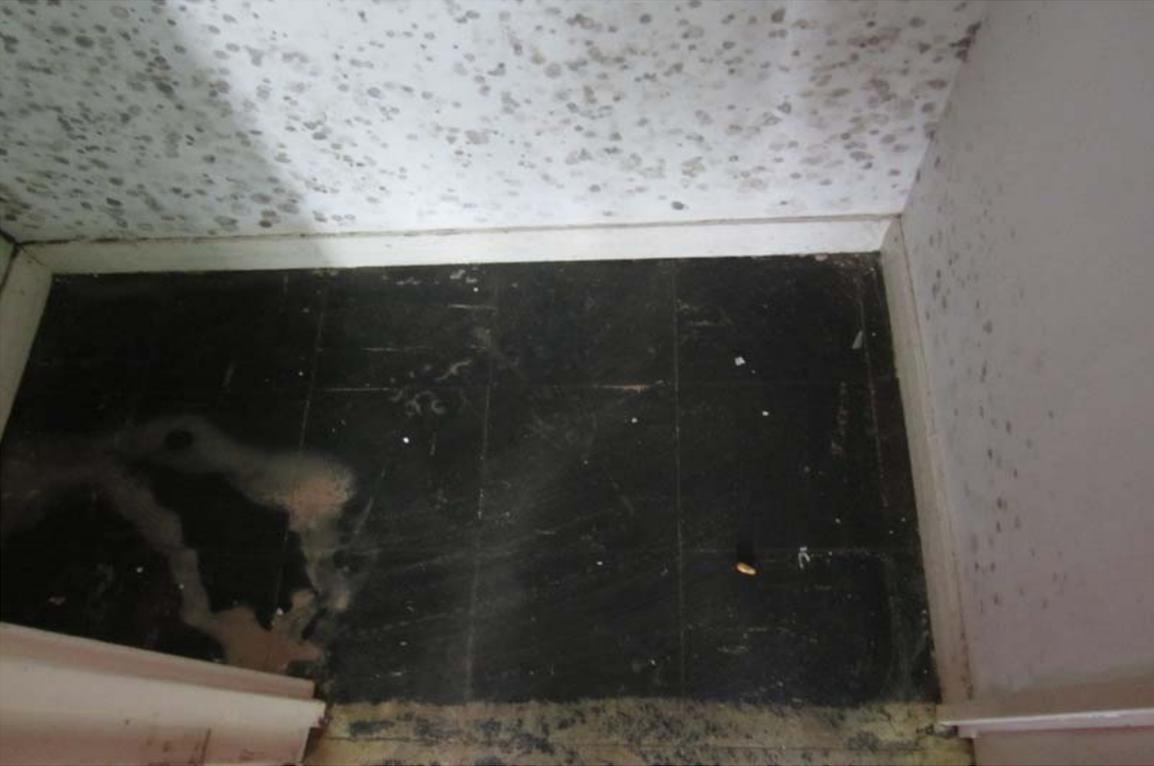
Photo Number	39	Reference number	220316MW48
Inspection / Sample	Inspection	Inspection Cross Reference / Visual I.D.	220316MW03

Notes	ACM: Asbestos Containing Material

Building	Flat 11 - Neville House	Condition	Good	0
Floor Level	2nd floor	Surface Treatment	Composite materials, reinforced plastics, resin, vinyl materials	0
Location	09 / Cupboard	Material Friability	Low	1
Feature	Grey floor tiles and adhesive	Asbestos Type	Strongly Presumed Chrysotile (White)	1
Material Type	Floor Tile / Covering			
Extent	0.5 sq. m.			
Recommendation	Remove if likely to be disturbed during the refurbishment works	Assessment Score		2
		Assessment Band		D

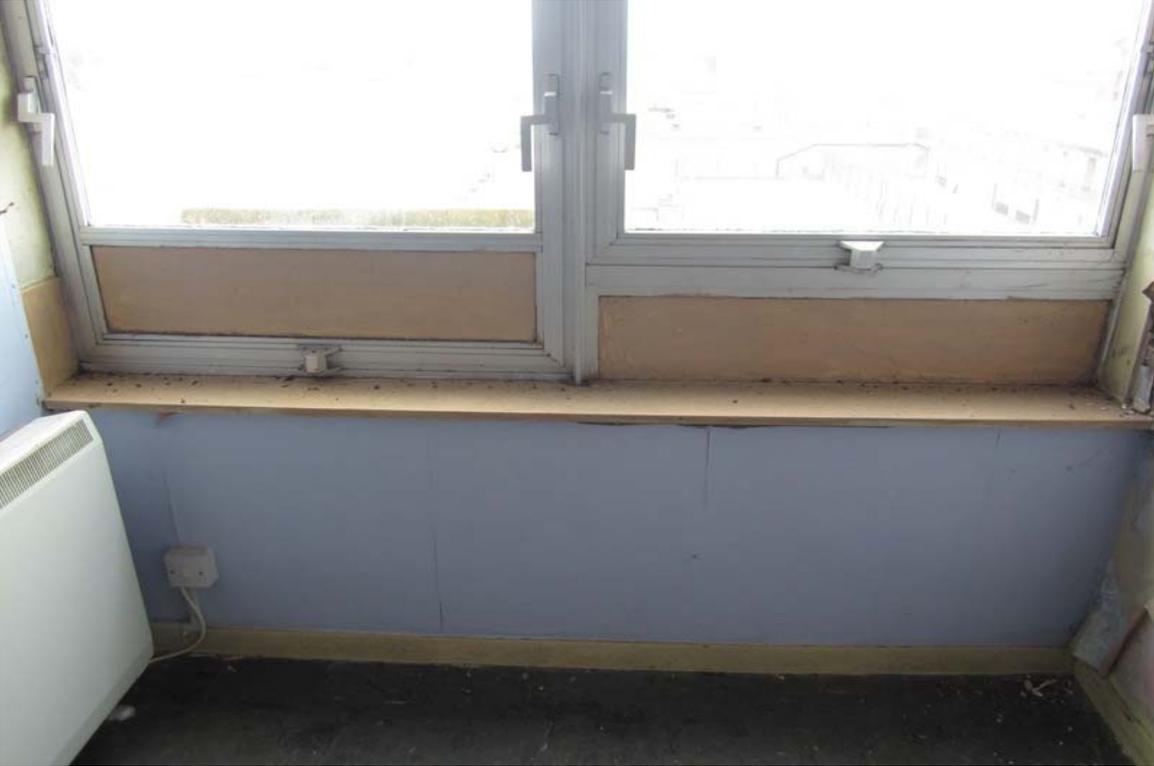
Photo Number	40	Reference number	220316MW49
Inspection / Sample	Sample	Inspection Cross Reference / Visual I.D.	Not Applicable

Notes	NADIS: No Asbestos Detected In Sample

Building	Flat 11 - Neville House	Condition	Fair	1
Floor Level	2nd floor	Surface Treatment	Unsealed AIB or encapsulated lagging and spray	2
Location	10 / Bedroom 2	Material Friability	Medium	2
Feature	Panelling beneath window	Asbestos Type	N.A.D.I.S	0
Material Type	Insulating Board			
Extent	2 sq. m.			
Recommendation	No action necessary	Assessment Score		0
		Assessment Band		E

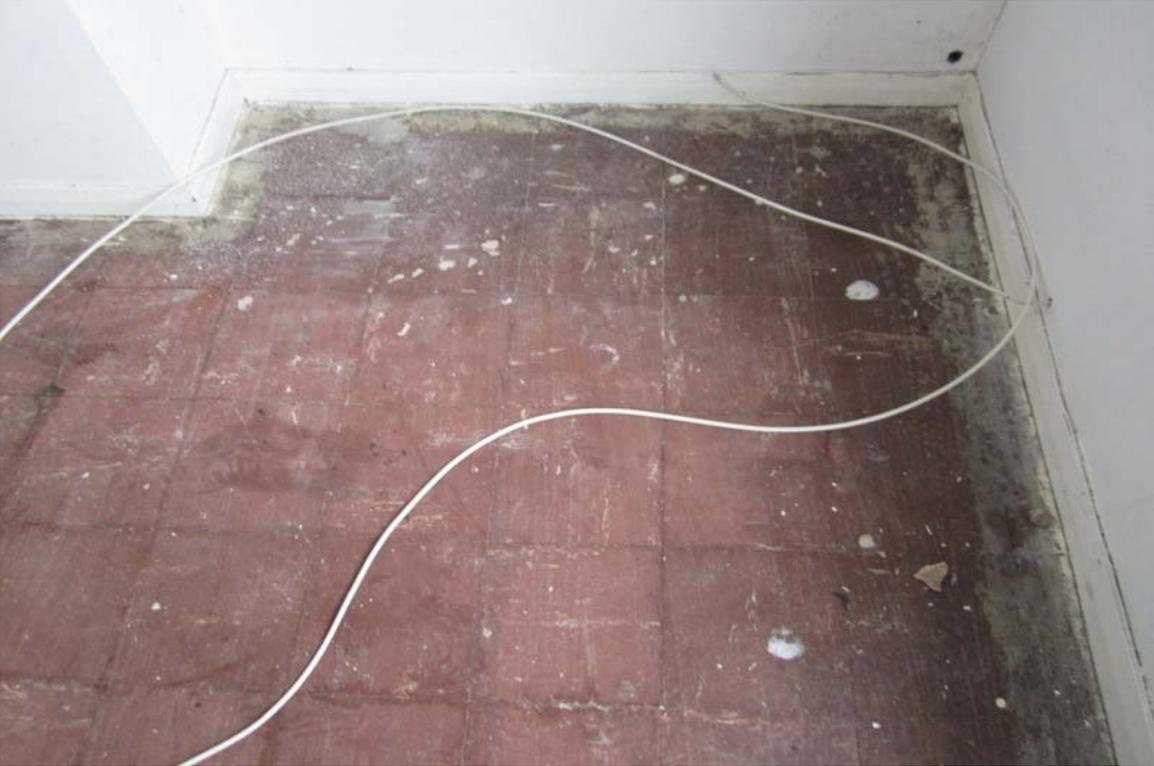
Photo Number	41	Reference number	220316MW50
Inspection / Sample	Inspection	Inspection Cross Reference / Visual I.D.	220316MW25

Notes	ACM: Asbestos Containing Material

Building	Flat 11 - Neville House	Condition	Good	0
Floor Level	2nd floor	Surface Treatment	Composite materials, reinforced plastics, resin, vinyl materials	0
Location	10 / Bedroom 2	Material Friability	Low	1
Feature	Red floor tiles and adhesive	Asbestos Type	Strongly Presumed Chrysotile (White)	1
Material Type	Floor Tile / Covering			
Extent	8 sq. m.			
Recommendation	Remove if likely to be disturbed during the refurbishment works	Assessment Score		2
		Assessment Band		D

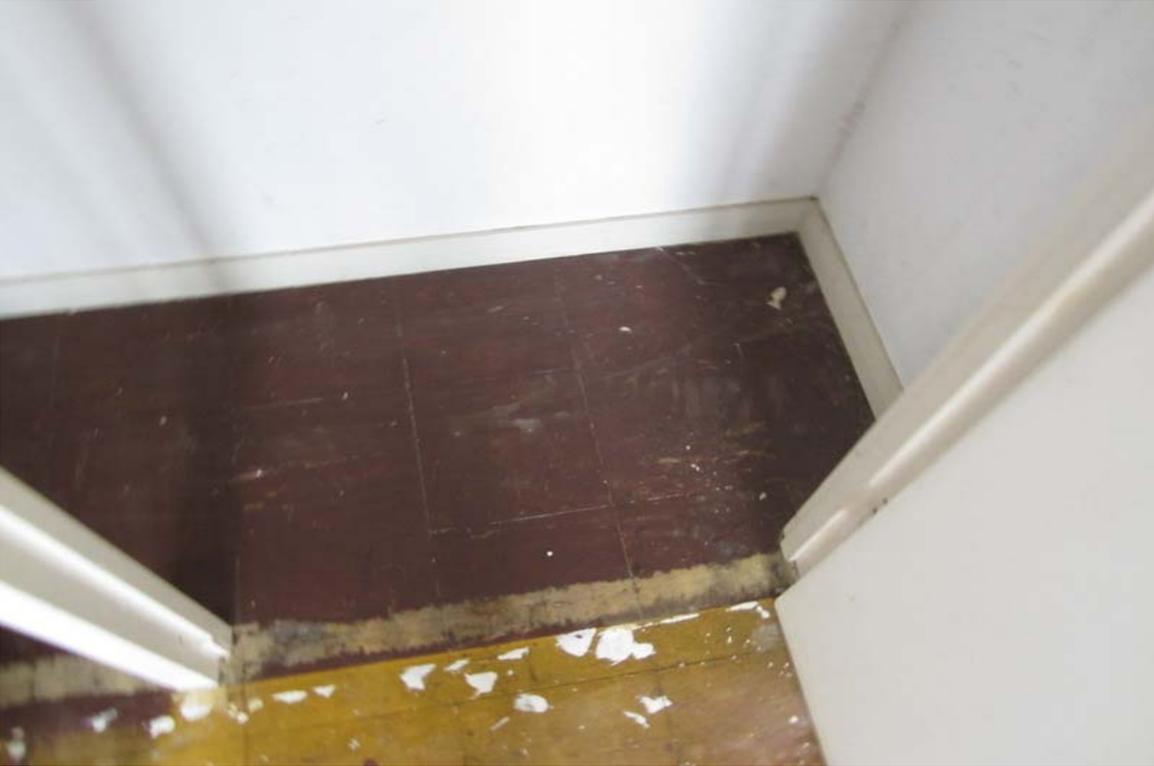
Photo Number	42	Reference number	220316MW51
Inspection / Sample	Inspection	Inspection Cross Reference / Visual I.D.	220316MW25

Notes	ACM: Asbestos Containing Material

Building	Flat 11 - Neville House	Condition	Good	0
Floor Level	2nd floor	Surface Treatment	Composite materials, reinforced plastics, resin, vinyl materials	0
Location	11 / Cupboard	Material Friability	Low	1
Feature	Red floor tiles and adhesive	Asbestos Type	Strongly Presumed Chrysotile (White)	1
Material Type	Floor Tile / Covering			
Extent	8 sq. m.			
Recommendation	Remove if likely to be disturbed during the refurbishment works	Assessment Score		2
		Assessment Band		D

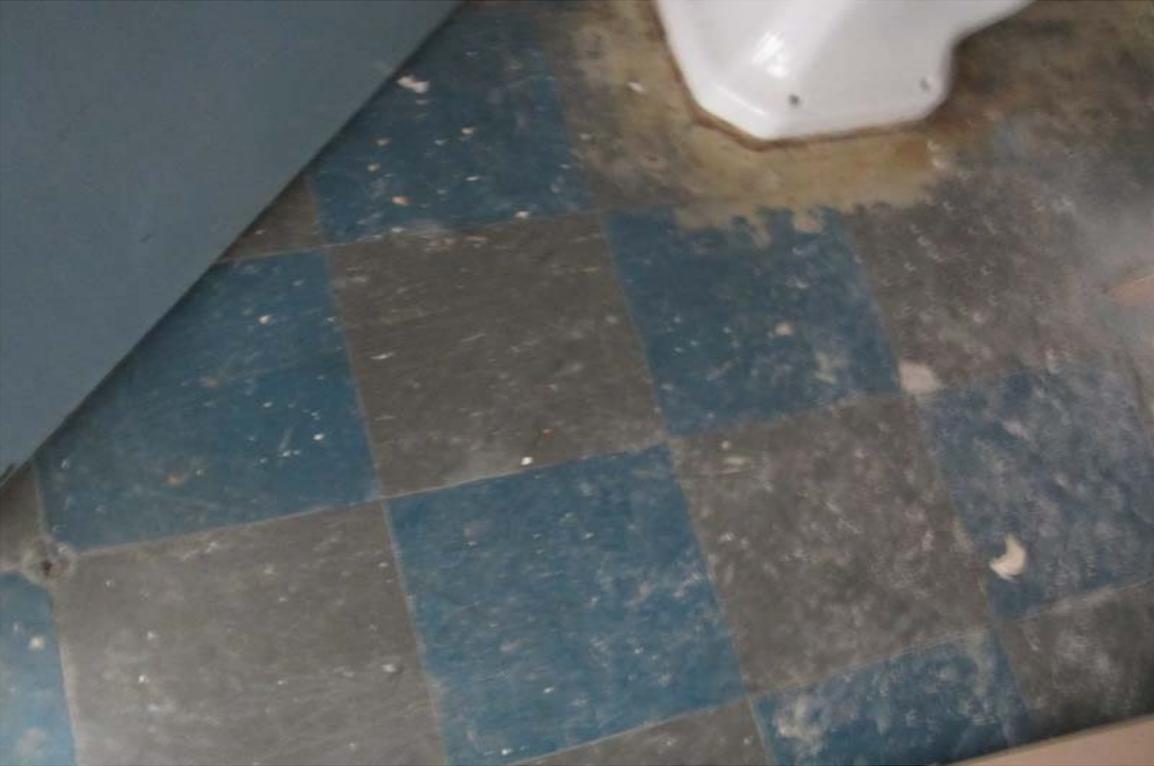
Photo Number	43	Reference number	220316MW52
Inspection / Sample	Inspection	Inspection Cross Reference / Visual I.D.	220316MW22

Notes	ACM: Asbestos Containing Material

Building	Flat 11 - Neville House	Condition	Good	0
Floor Level	2nd floor	Surface Treatment	Composite materials, reinforced plastics, resin, vinyl materials	0
Location	12 / Bathroom	Material Friability	Low	1
Feature	Blue and green floor tiles and adhesive	Asbestos Type	Strongly Presumed Chrysotile (White)	1
Material Type	Floor Tile / Covering			
Extent	4 sq. m.			
Recommendation	Remove if likely to be disturbed during the refurbishment works	Assessment Score		2
		Assessment Band		D

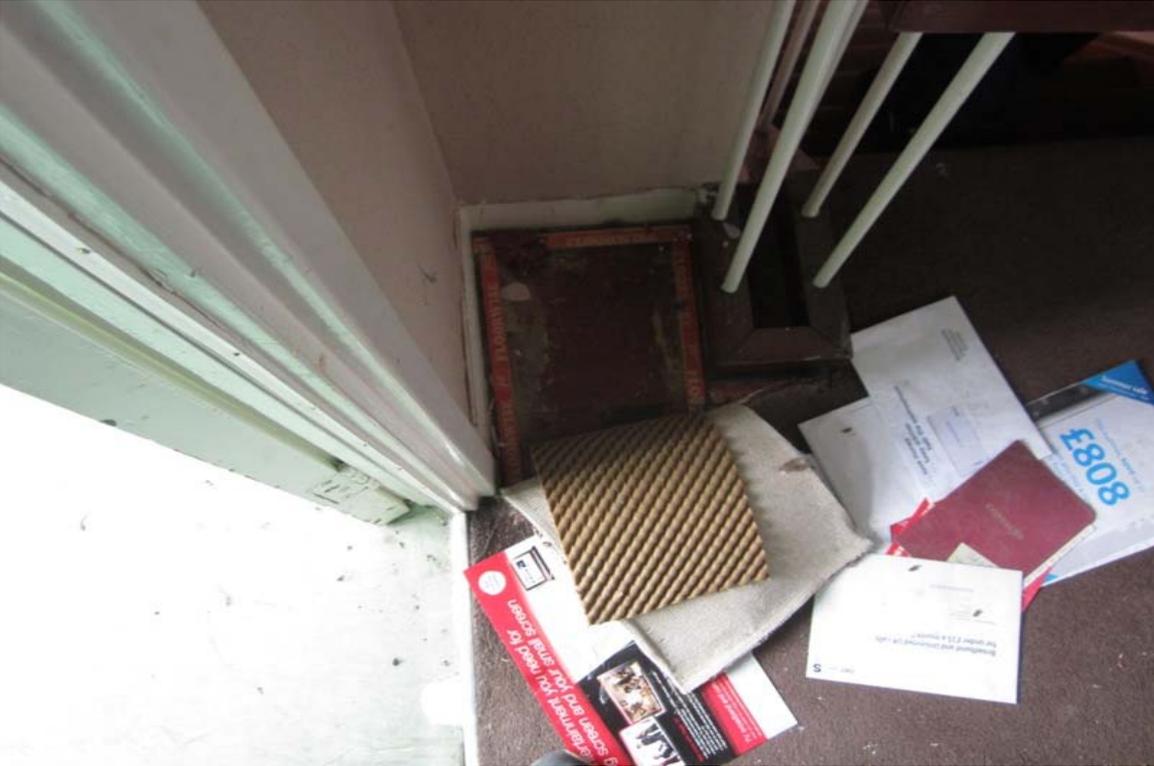
Photo Number	44	Reference number	220316MW55
Inspection / Sample	Sample	Inspection Cross Reference / Visual I.D.	Not Applicable

Notes	ACM: Asbestos Containing Material

Building	Flat 10 - Neville House	Condition	Fair	1
Floor Level	3rd floor	Surface Treatment	Composite materials, reinforced plastics, resin, vinyl materials	0
Location	01 / Lobby	Material Friability	Low	1
Feature	Red floor tiles and adhesive	Asbestos Type	Chrysotile (White)	1
Material Type	Floor Tile / Covering			
Extent	2 sq. m.			
Recommendation	Remove if likely to be disturbed during the refurbishment works	Assessment Score		3
		Assessment Band		D

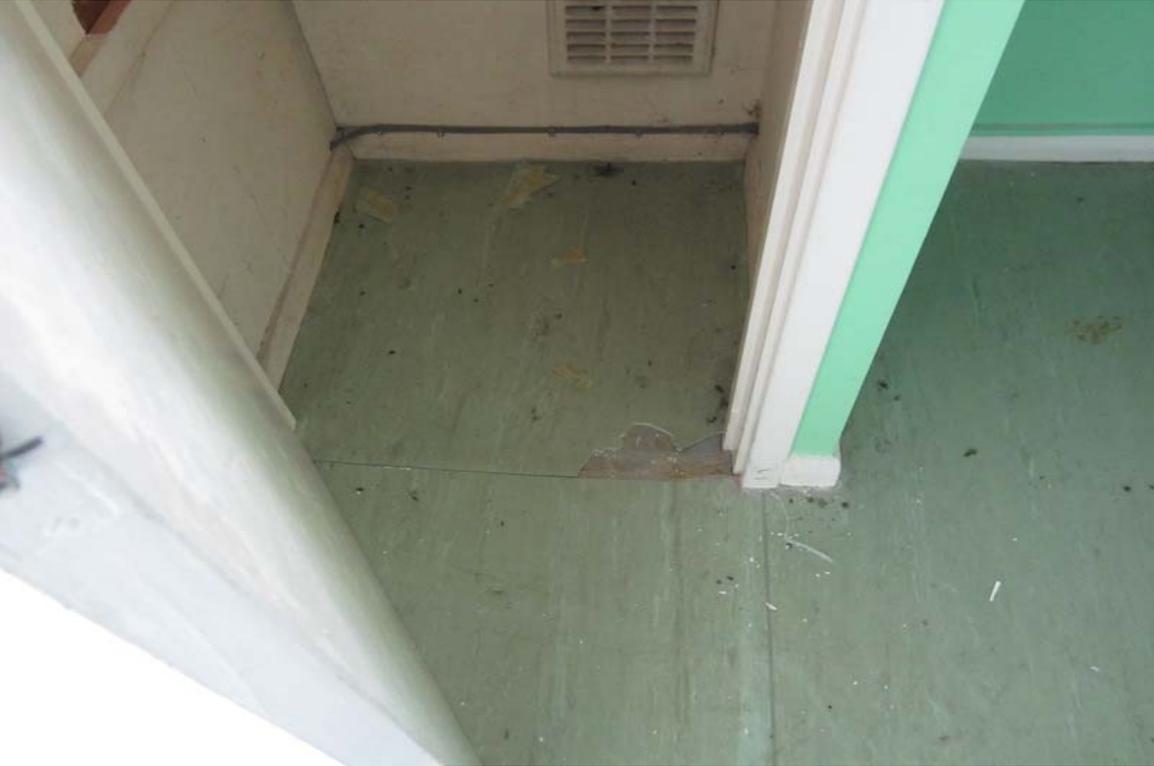
Photo Number	46	Reference number	220316MW57
Inspection / Sample	Inspection	Inspection Cross Reference / Visual I.D.	220316MW56

Notes	ACM: Asbestos Containing Material

Building	Flat 10 - Neville House	Condition	Fair	1
Floor Level	3rd floor	Surface Treatment	Composite materials, reinforced plastics, resin, vinyl materials	0
Location	03 / Cupboard	Material Friability	Low	1
Feature	Grey floor tiles and adhesive	Asbestos Type	Strongly Presumed Chrysotile (White)	1
Material Type	Floor Tile / Covering			
Extent	0.5 sq. m.			
Recommendation	Remove if likely to be disturbed during the refurbishment works	Assessment Score		3
		Assessment Band		D

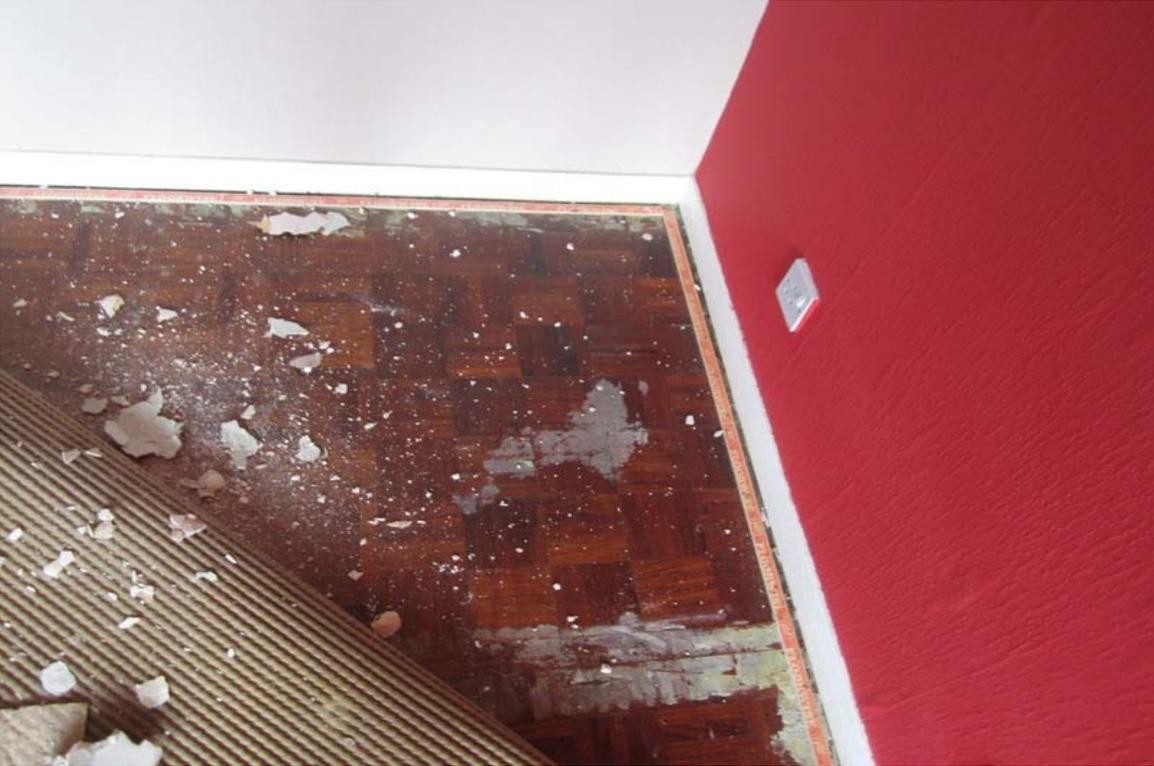
Photo Number	47	Reference number	220316MW58
Inspection / Sample	Inspection	Inspection Cross Reference / Visual I.D.	220316MW24

Notes	NADIS: No Asbestos Detected In Sample

Building	Flat 10 - Neville House	Condition	Good	0
Floor Level	2nd floor	Surface Treatment	Composite materials, reinforced plastics, resin, vinyl materials	0
Location	05 / Lounge	Material Friability	Low	1
Feature	Bitumen adhesive beneath parquet flooring	Asbestos Type	Strongly Presumed N.A.D.I.S	0
Material Type	Bitumen			
Extent	20 sq. m.			
Recommendation	No action necessary	Assessment Score		0
		Assessment Band		E

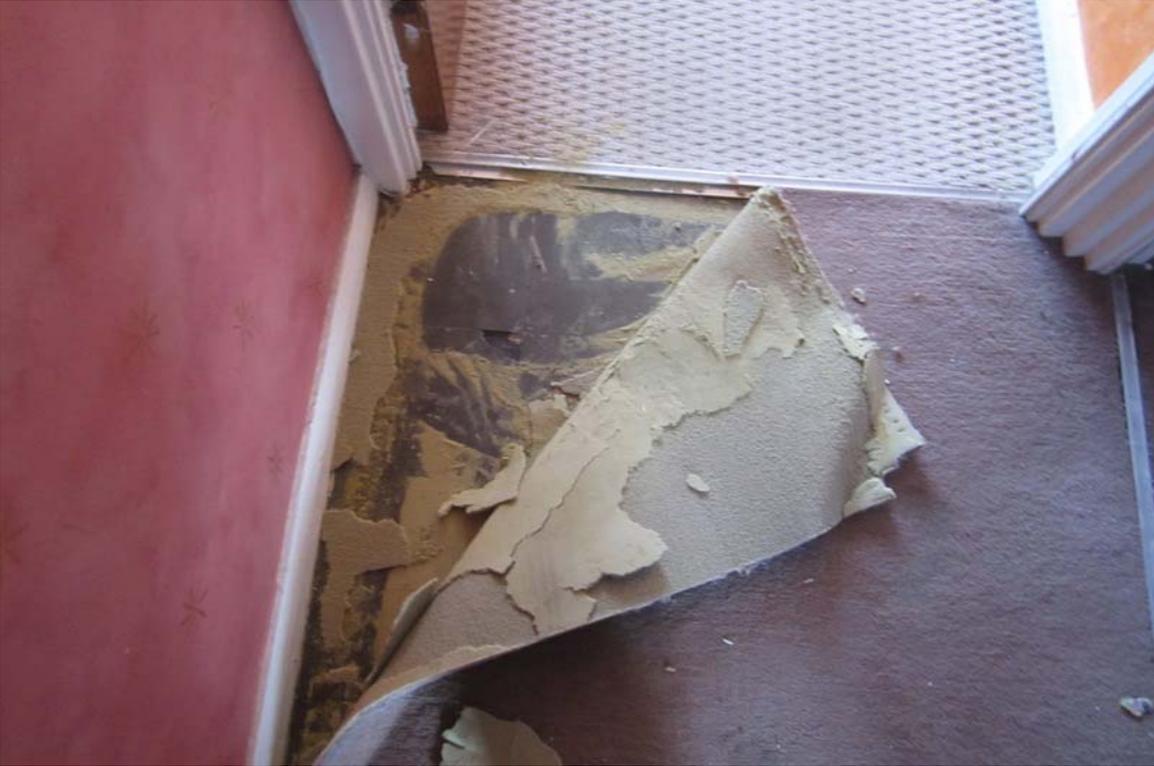
Photo Number	48	Reference number	220316MW59
Inspection / Sample	Sample	Inspection Cross Reference / Visual I.D.	Not Applicable

Notes	ACM: Asbestos Containing Material

Building	Flat 10 - Neville House	Condition	Good	0
Floor Level	2nd floor	Surface Treatment	Composite materials, reinforced plastics, resin, vinyl materials	0
Location	06 / Hallway	Material Friability	Low	1
Feature	Grey floor tiles and adhesive	Asbestos Type	Chrysotile (White)	1
Material Type	Floor Tile / Covering			
Extent	2 sq. m.			
Recommendation	Remove if likely to be disturbed during the refurbishment works	Assessment Score		2
		Assessment Band		D
