**CBC Asbestos Refurbishment Survey Report
Neville House, George Street, Corby
22nd – 24th March 2016**

Reference:					
Issue			Prepared by	Verified by	
V1	Apr 16	JQ

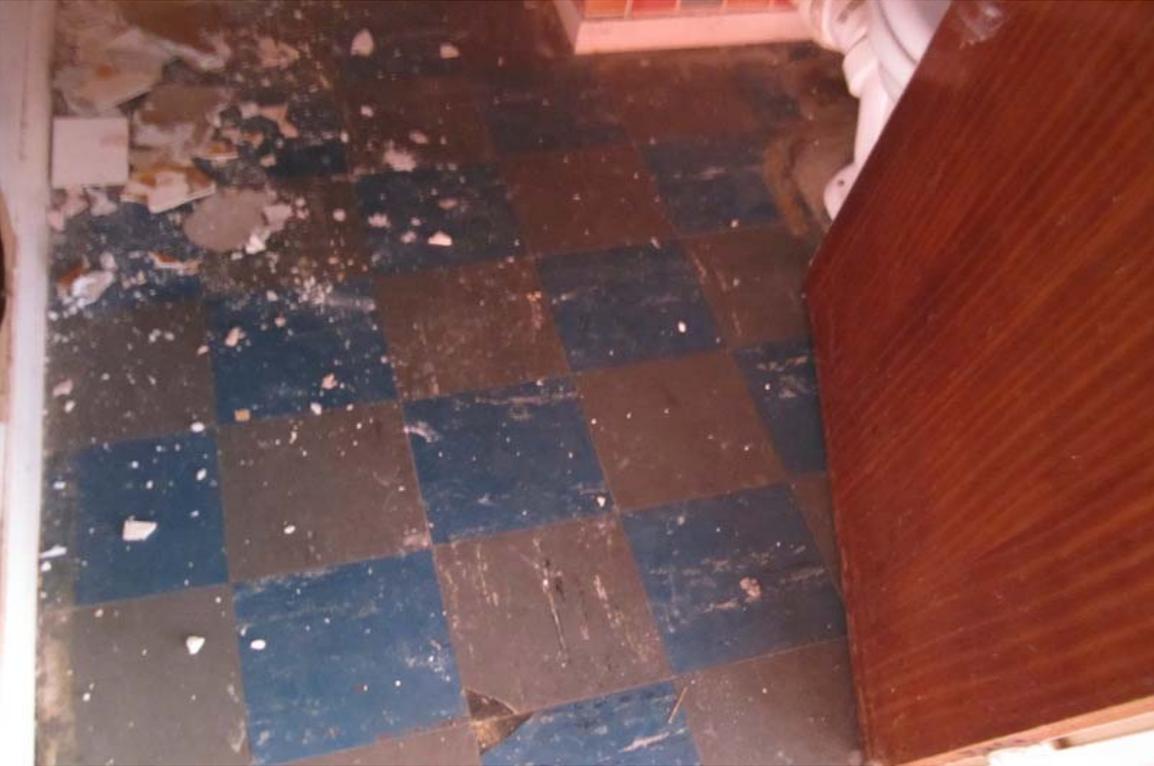
Photo Number	49	Reference number	220316MW60
Inspection / Sample	Sample	Inspection Cross Reference / Visual I.D.	Not Applicable

Notes	ACM: Asbestos Containing Material

Building	Flat 10 - Neville House	Condition	Fair	1
Floor Level	2nd floor	Surface Treatment	Composite materials, reinforced plastics, resin, vinyl materials	0
Location	07 / Bathroom	Material Friability	Low	1
Feature	Brown and blue floor tiles and adhesive	Asbestos Type	Chrysotile (White)	1
Material Type	Floor Tile / Covering			
Extent	3 sq. m.			
Recommendation	Remove if likely to be disturbed during the refurbishment works	Assessment Score		3
		Assessment Band		D

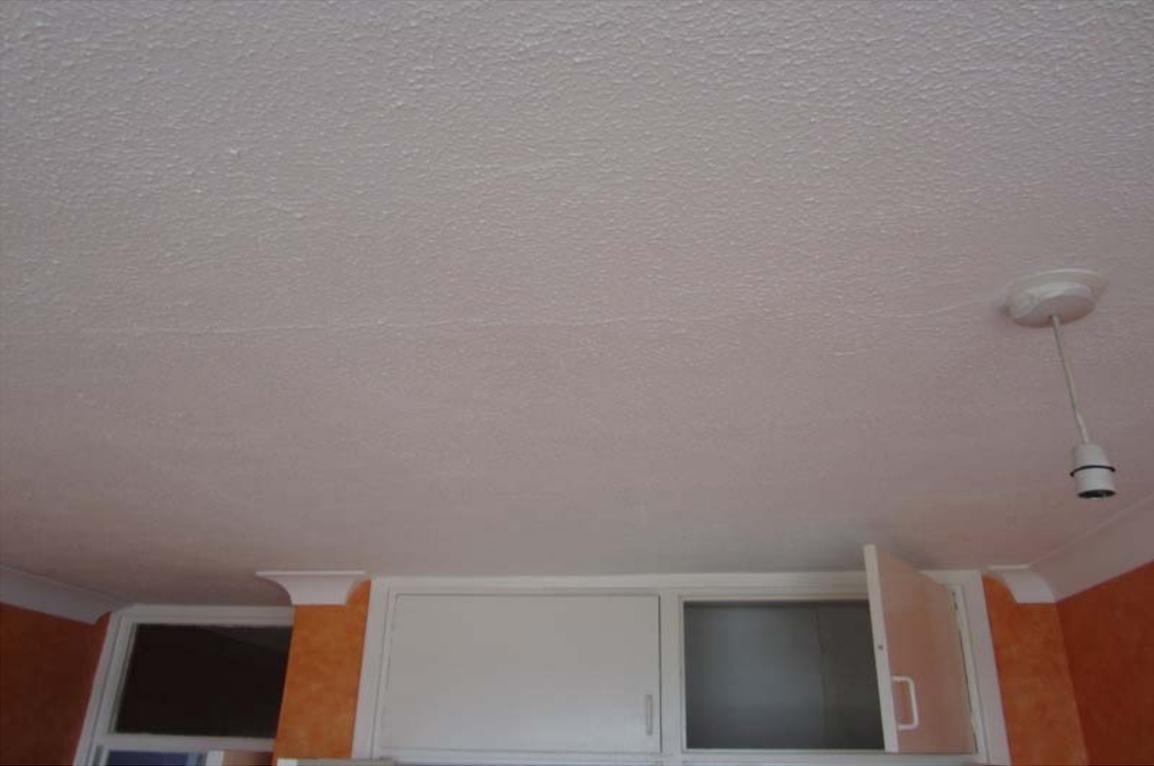
Photo Number	50	Reference number	220316MW61
Inspection / Sample	Sample	Inspection Cross Reference / Visual I.D.	Not Applicable

Notes	NADIS: No Asbestos Detected In Sample

Building	Flat 10 - Neville House	Condition	Fair	1
Floor Level	2nd floor	Surface Treatment	Composite materials, reinforced plastics, resin, vinyl materials	0
Location	08 / Bedroom 1	Material Friability	Low	1
Feature	Coating to ceiling	Asbestos Type	N.A.D.I.S	0
Material Type	Textured Coating			
Extent	8 sq. m.			
Recommendation	No action necessary	Assessment Score		0
		Assessment Band		E

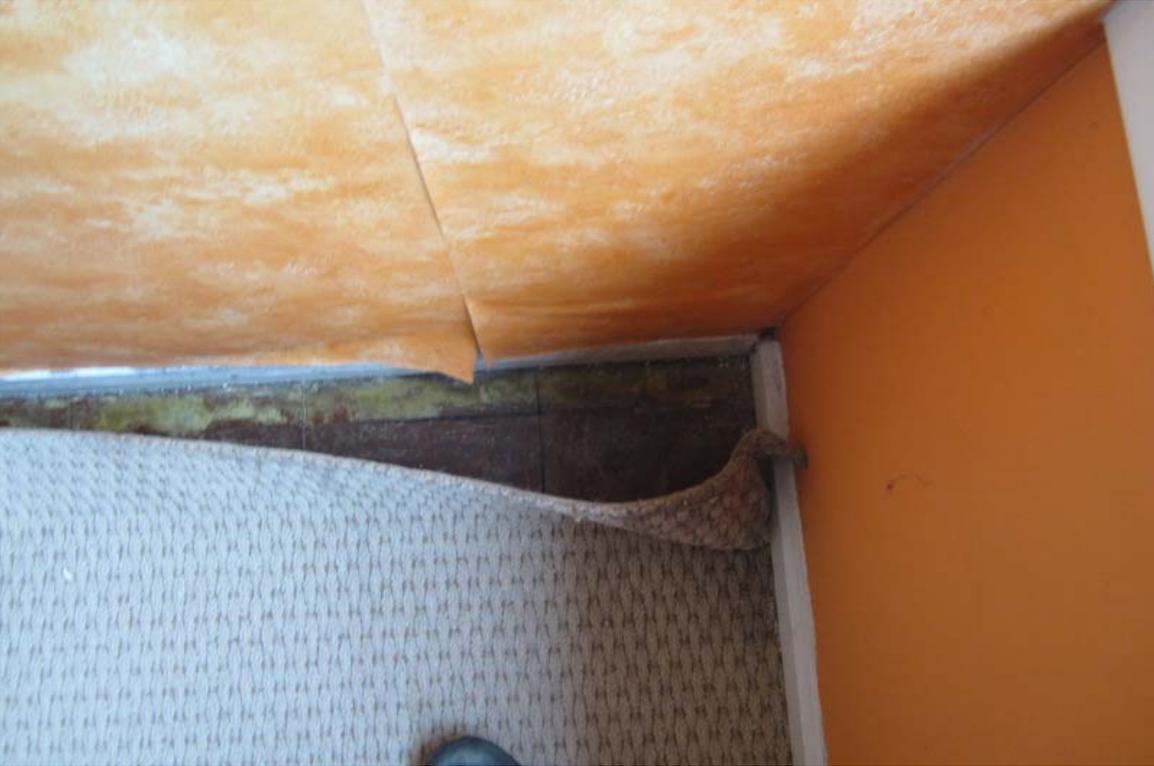
Photo Number	51	Reference number	220316MW62
Inspection / Sample	Sample	Inspection Cross Reference / Visual I.D.	Not Applicable

Notes	ACM: Asbestos Containing Material

Building	Flat 10 - Neville House	Condition	Fair	1
Floor Level	2nd floor	Surface Treatment	Composite materials, reinforced plastics, resin, vinyl materials	0
Location	08 / Bedroom 1	Material Friability	Low	1
Feature	Brown floor tiles and adhesive	Asbestos Type	Chrysotile (White)	1
Material Type	Floor Tile / Covering			
Extent	8 sq. m.			
Recommendation	Remove if likely to be disturbed during the refurbishment works	Assessment Score		3
		Assessment Band		D

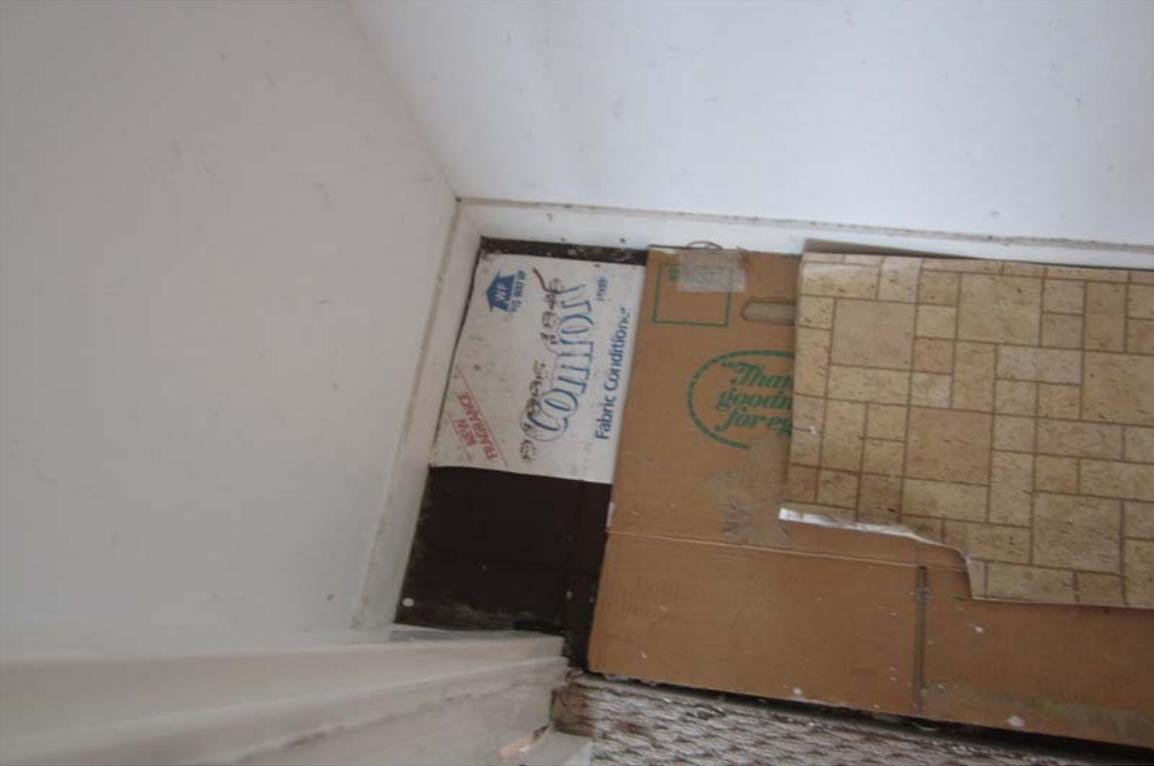
Photo Number	52	Reference number	220316MW63
Inspection / Sample	Inspection	Inspection Cross Reference / Visual I.D.	220316MW62

Notes	ACM: Asbestos Containing Material

Building	Flat 10 - Neville House	Condition	Fair	1
Floor Level	2nd floor	Surface Treatment	Composite materials, reinforced plastics, resin, vinyl materials	0
Location	09 / Cupboard	Material Friability	Low	1
Feature	Brown floor tiles and adhesive	Asbestos Type	Strongly Presumed Chrysotile (White)	1
Material Type	Floor Tile / Covering			
Extent	2 sq. m.			
Recommendation	Remove if likely to be disturbed during the refurbishment works	Assessment Score		3
		Assessment Band		D

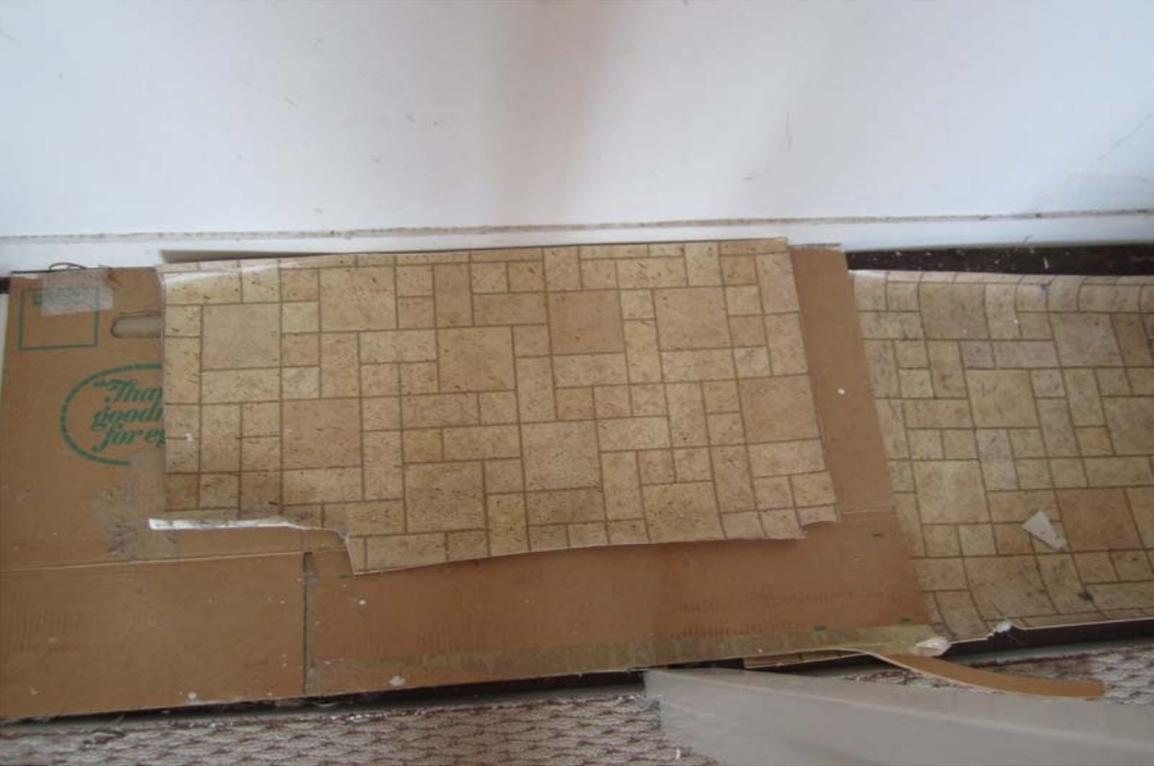
Photo Number	53	Reference number	220316MW64
Inspection / Sample	Sample	Inspection Cross Reference / Visual I.D.	Not Applicable

Notes	NADIS: No Asbestos Detected In Sample

Building	Flat 10 - Neville House	Condition	Fair	1
Floor Level	2nd floor	Surface Treatment	Composite materials, reinforced plastics, resin, vinyl materials	0
Location	09 / Cupboard	Material Friability	Medium	2
Feature	Backing to lino	Asbestos Type	N.A.D.I.S	0
Material Type	Paper			
Extent	2 sq. m.			
Recommendation	No action necessary	Assessment Score		0
		Assessment Band		E

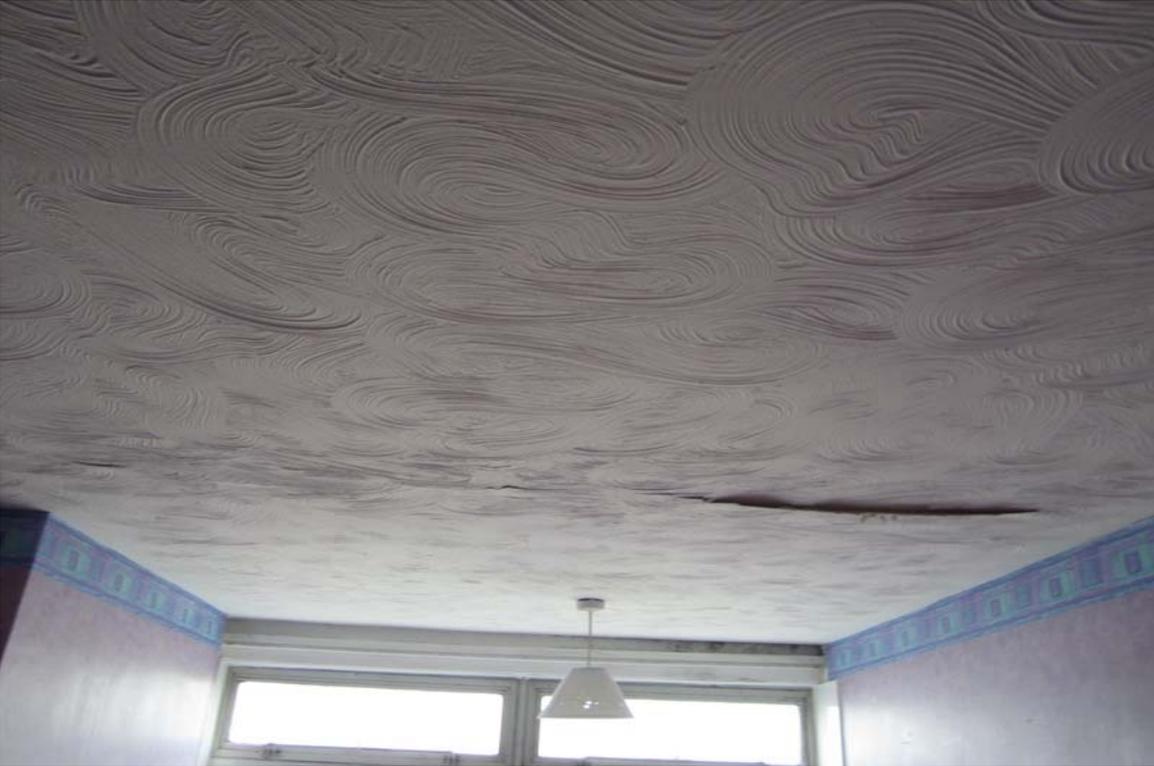
Photo Number	54	Reference number	220316MW65
Inspection / Sample	Sample	Inspection Cross Reference / Visual I.D.	Not Applicable

Notes	NADIS: No Asbestos Detected In Sample

Building	Flat 10 - Neville House	Condition	Fair	1
Floor Level	2nd floor	Surface Treatment	Composite materials, reinforced plastics, resin, vinyl materials	0
Location	10 / Bedroom 2	Material Friability	Low	1
Feature	Coating to ceiling	Asbestos Type	N.A.D.I.S	0
Material Type	Textured Coating			
Extent	12 sq. m.			
Recommendation	No action necessary	Assessment Score		0
		Assessment Band		E

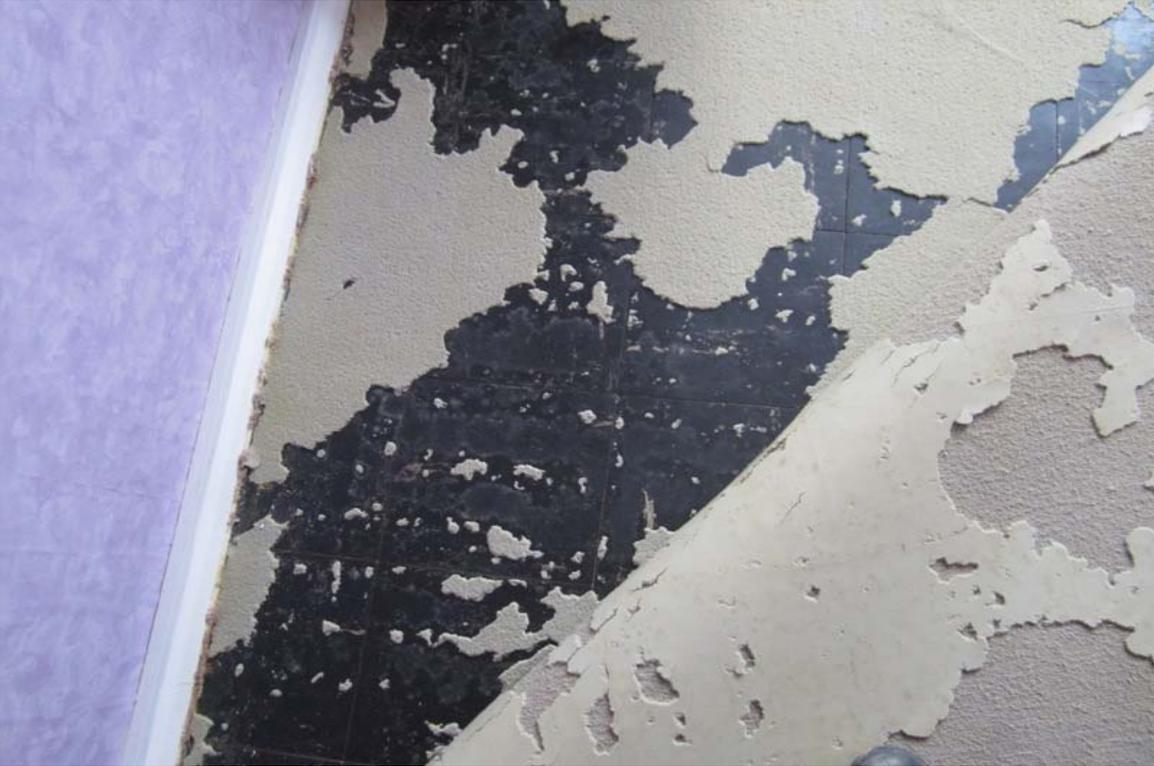
Photo Number	55	Reference number	220316MW66
Inspection / Sample	Sample	Inspection Cross Reference / Visual I.D.	Not Applicable

Notes	ACM: Asbestos Containing Material

Building	Flat 10 - Neville House	Condition	Fair	1
Floor Level	2nd floor	Surface Treatment	Composite materials, reinforced plastics, resin, vinyl materials	0
Location	10 / Bedroom 2	Material Friability	Low	1
Feature	Black floor tiles and adhesive	Asbestos Type	Chrysotile (White)	1
Material Type	Floor Tile / Covering			
Extent	12 sq. m.			
Recommendation	Remove if likely to be disturbed during the refurbishment works	Assessment Score		3
		Assessment Band		D

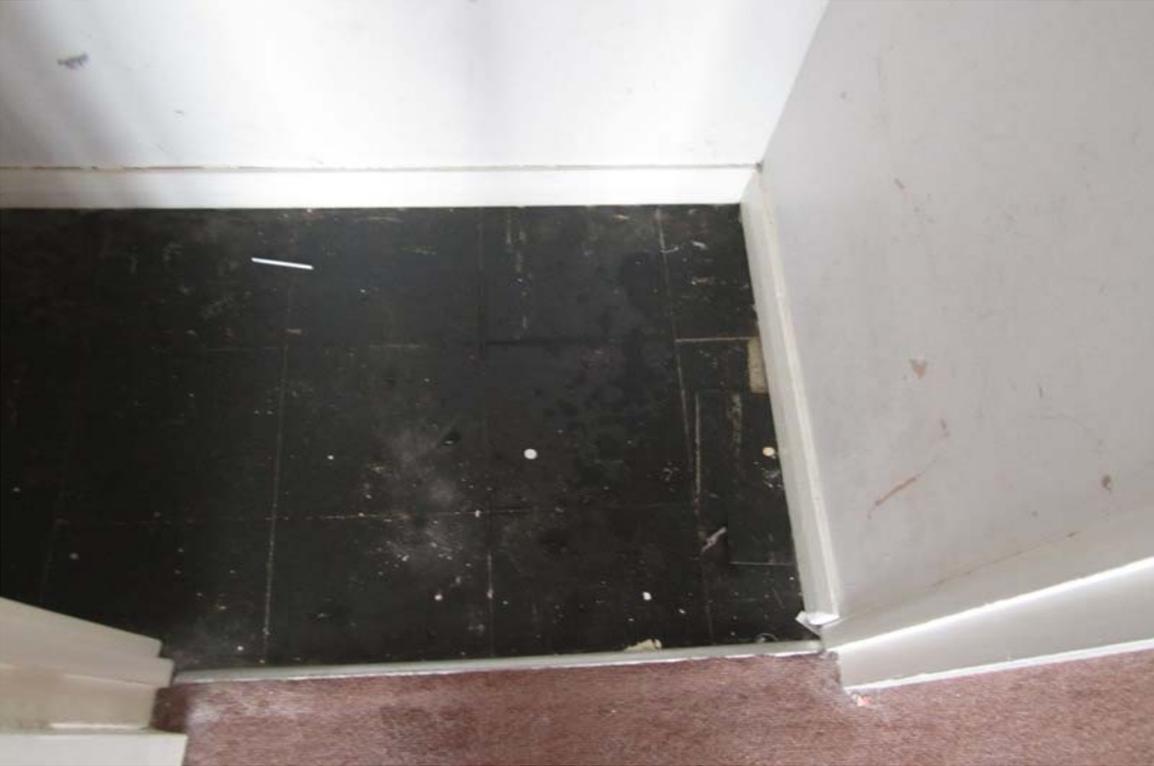
Photo Number	56	Reference number	220316MW67
Inspection / Sample	Inspection	Inspection Cross Reference / Visual I.D.	220316MW66

Notes	ACM: Asbestos Containing Material

Building	Flat 10 - Neville House	Condition	Fair	1
Floor Level	2nd floor	Surface Treatment	Composite materials, reinforced plastics, resin, vinyl materials	0
Location	11 / Cupboard	Material Friability	Low	1
Feature	Black floor tiles and adhesive	Asbestos Type	Strongly Presumed Chrysotile (White)	1
Material Type	Floor Tile / Covering			
Extent	1 sq. m.			
Recommendation	Remove if likely to be disturbed during the refurbishment works	Assessment Score		3
		Assessment Band		D

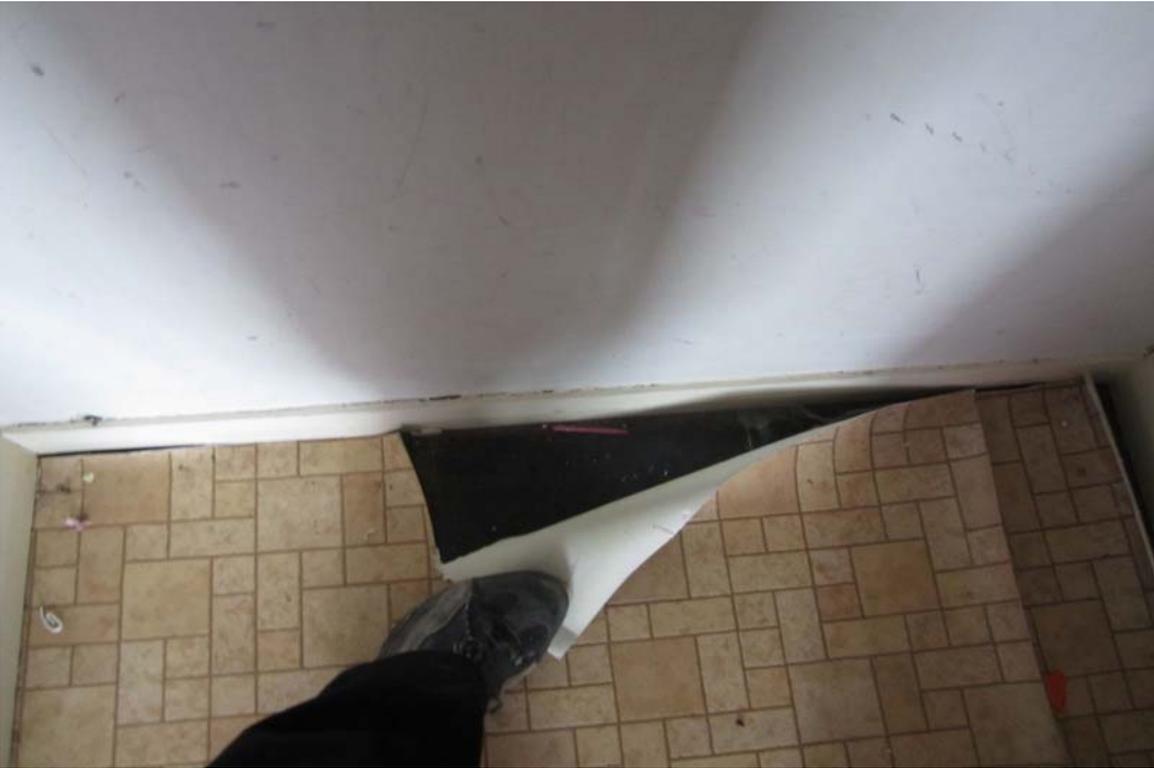
Photo Number	57	Reference number	220316MW68
Inspection / Sample	Inspection	Inspection Cross Reference / Visual I.D.	220316MW66

Notes	ACM: Asbestos Containing Material

Building	Flat 10 - Neville House	Condition	Fair	1
Floor Level	2nd floor	Surface Treatment	Composite materials, reinforced plastics, resin, vinyl materials	0
Location	12 / Cupboard	Material Friability	Low	1
Feature	Black floor tiles and adhesive	Asbestos Type	Strongly Presumed Chrysotile (White)	1
Material Type	Floor Tile / Covering			
Extent	1 sq. m.			
Recommendation	Remove if likely to be disturbed during the refurbishment works	Assessment Score		3
		Assessment Band		D

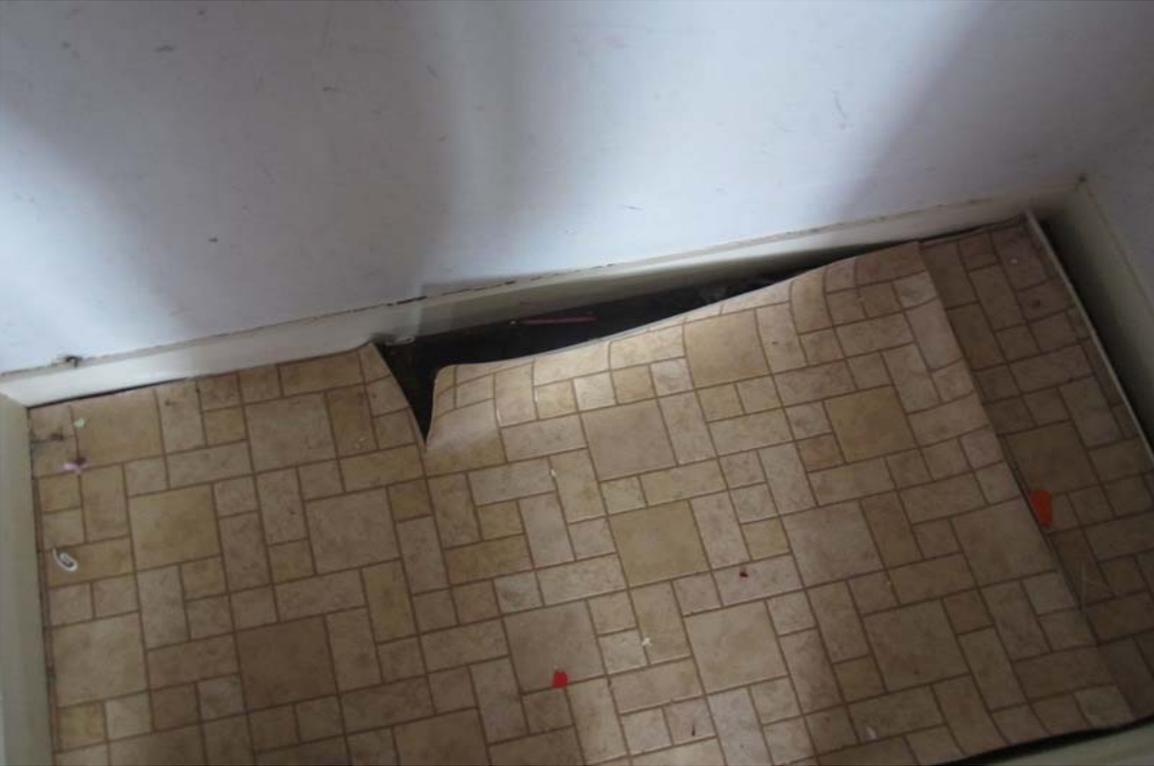
Photo Number	58	Reference number	220316MW69
Inspection / Sample	Inspection	Inspection Cross Reference / Visual I.D.	220316MW64

Notes	NADIS: No Asbestos Detected In Sample

Building	Flat 10 - Neville House	Condition	Fair	1
Floor Level	2nd floor	Surface Treatment	Composite materials, reinforced plastics, resin, vinyl materials	0
Location	12 / Cupboard	Material Friability	Medium	2
Feature	Backing to lino	Asbestos Type	Strongly Presumed N.A.D.I.S	0
Material Type	Paper			
Extent	1 sq. m.			
Recommendation	No action necessary	Assessment Score		0
		Assessment Band		E

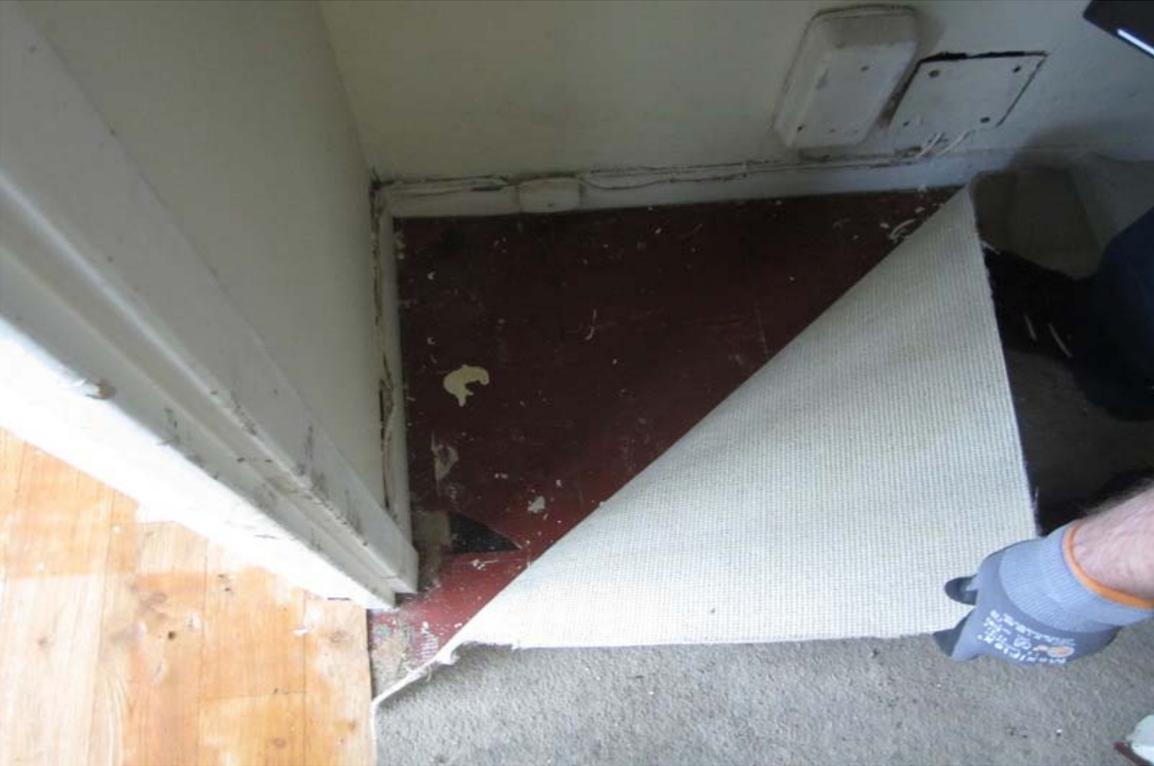
Photo Number	59	Reference number	230316MW70
Inspection / Sample	Sample	Inspection Cross Reference / Visual I.D.	Not Applicable

Notes	ACM: Asbestos Containing Material

Building	Flat 9 - Neville House	Condition	Good	0
Floor Level	3rd floor	Surface Treatment	Composite materials, reinforced plastics, resin, vinyl materials	0
Location	01 / Hallway	Material Friability	Low	1
Feature	Red floor tiles and adhesive	Asbestos Type	Chrysotile (White)	1
Material Type	Floor Tile / Covering			
Extent	2 sq. m.			
Recommendation	Remove if likely to be disturbed during the refurbishment works	Assessment Score		2
		Assessment Band		D

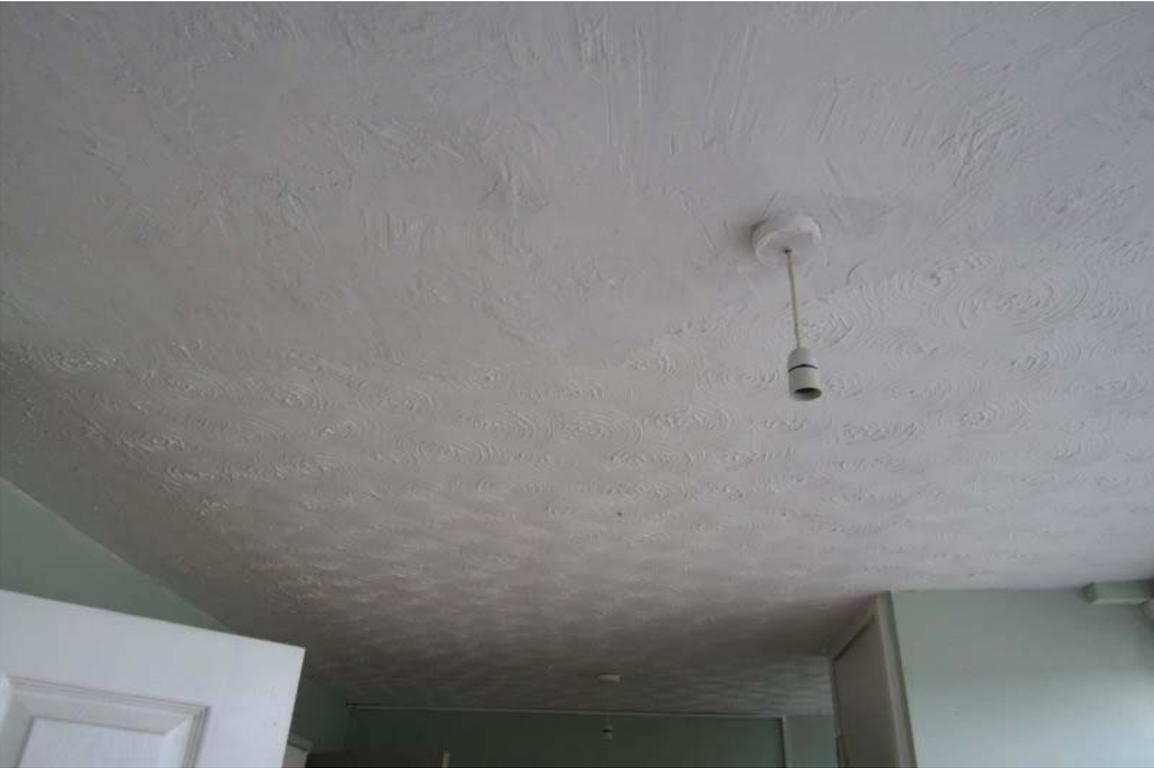
Photo Number	60	Reference number	230316MW71
Inspection / Sample	Sample	Inspection Cross Reference / Visual I.D.	Not Applicable

Notes	NADIS: No Asbestos Detected In Sample

Building	Flat 9 - Neville House	Condition	Fair	1
Floor Level	3rd floor	Surface Treatment	Composite materials, reinforced plastics, resin, vinyl materials	0
Location	02 / Kitchen	Material Friability	Low	1
Feature	Coating to ceiling	Asbestos Type	N.A.D.I.S	0
Material Type	Textured Coating			
Extent	12 sq. m.			
Recommendation	No action necessary	Assessment Score		0
		Assessment Band		E

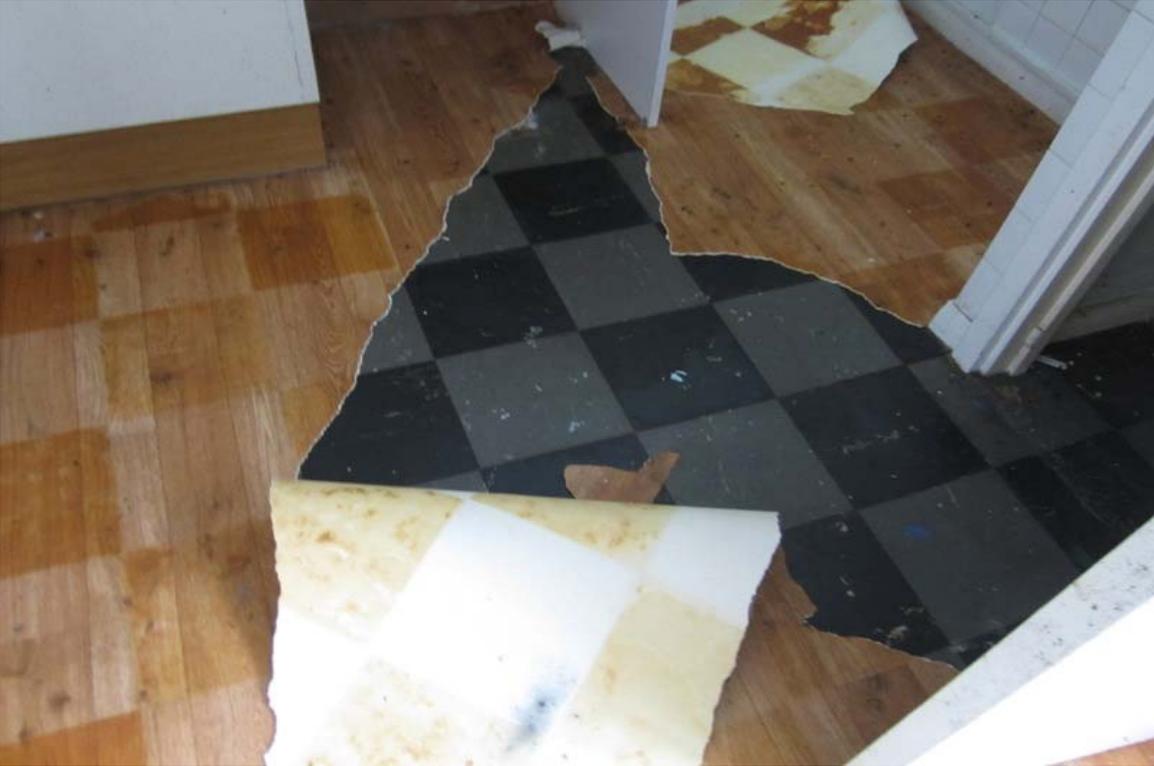
Photo Number	61	Reference number	230316MW72
Inspection / Sample	Sample	Inspection Cross Reference / Visual I.D.	Not Applicable

Notes	ACM: Asbestos Containing Material

Building	Flat 9 - Neville House	Condition	Fair	1
Floor Level	3rd floor	Surface Treatment	Composite materials, reinforced plastics, resin, vinyl materials	0
Location	02 / Kitchen	Material Friability	Low	1
Feature	Grey and black floor tiles and adhesive	Asbestos Type	Chrysotile (White)	1
Material Type	Floor Tile / Covering			
Extent	12 sq. m.			
Recommendation	Remove if likely to be disturbed during the refurbishment works	Assessment Score		3
		Assessment Band		D

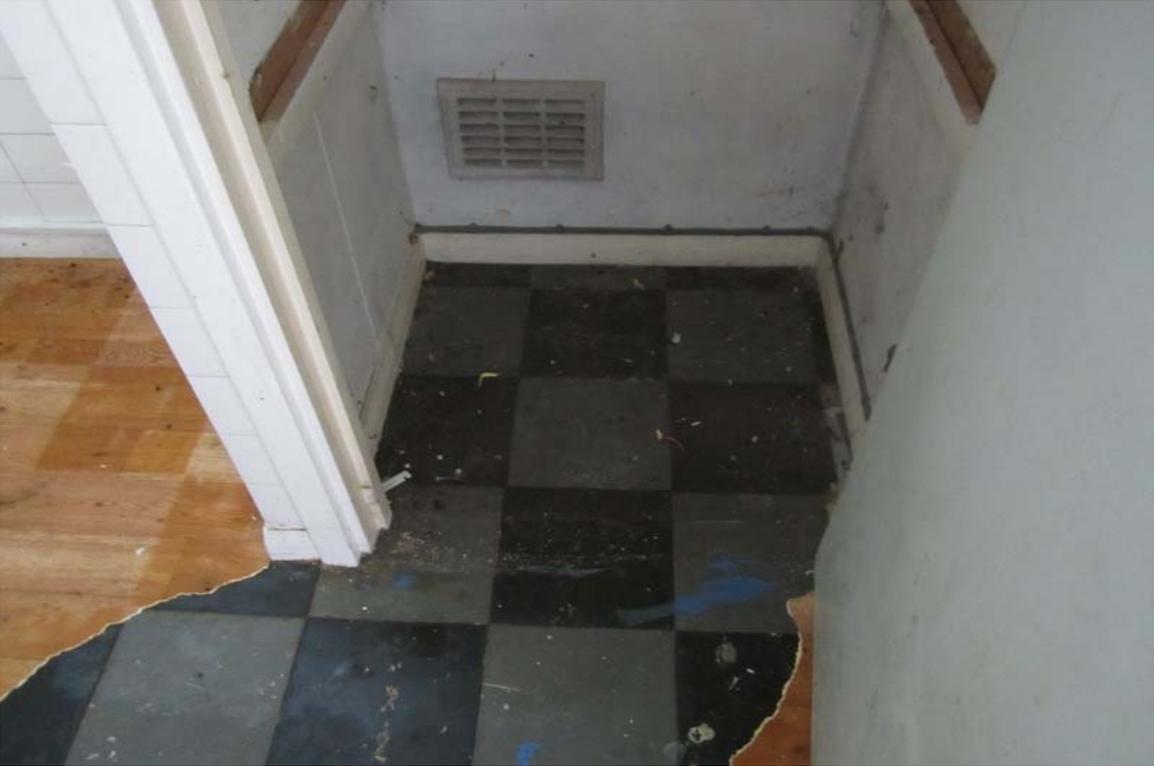
Photo Number	62	Reference number	230316MW73
Inspection / Sample	Inspection	Inspection Cross Reference / Visual I.D.	230316MW72

Notes	ACM: Asbestos Containing Material

Building	Flat 9 - Neville House	Condition	Fair	1
Floor Level	3rd floor	Surface Treatment	Composite materials, reinforced plastics, resin, vinyl materials	0
Location	03 / Cupboard	Material Friability	Low	1
Feature	Grey and black floor tiles and adhesive	Asbestos Type	Strongly Presumed Chrysotile (White)	1
Material Type	Floor Tile / Covering			
Extent	0.5 sq. m.			
Recommendation	Remove if likely to be disturbed during the refurbishment works	Assessment Score		3
		Assessment Band		D

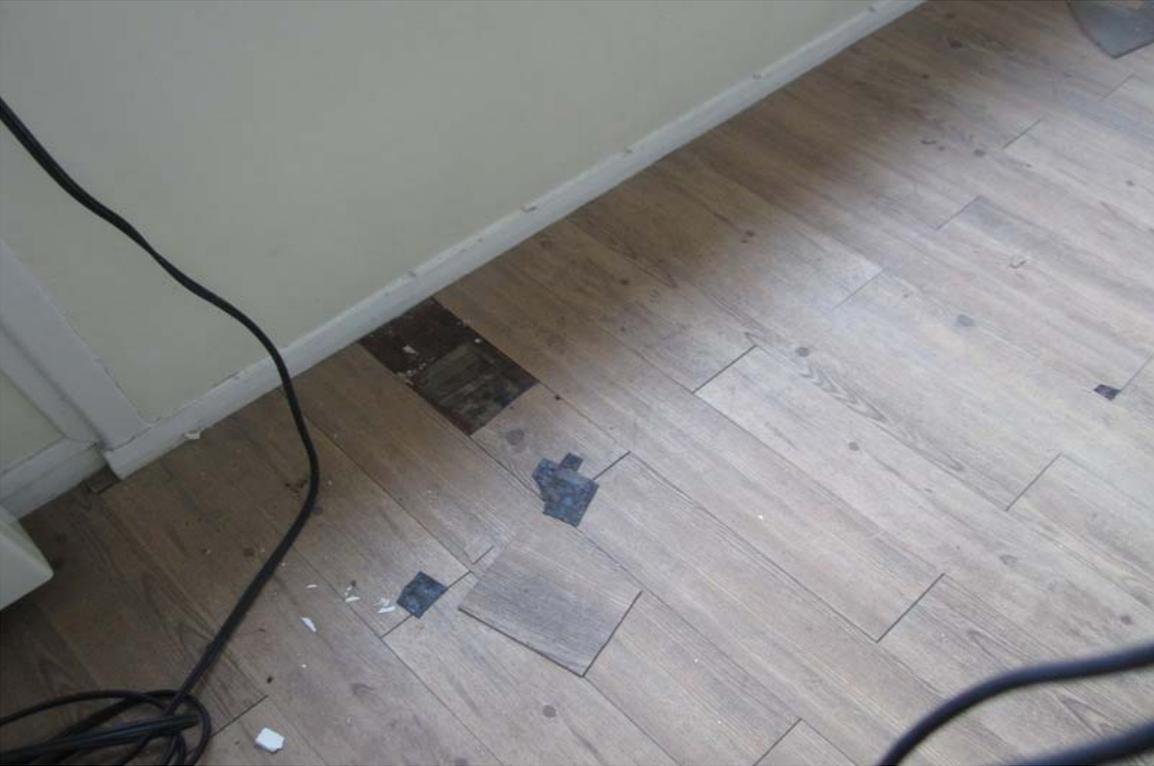
Photo Number	63	Reference number	230316MW74
Inspection / Sample	Sample	Inspection Cross Reference / Visual I.D.	Not Applicable

Notes	NADIS: No Asbestos Detected In Sample

Building	Flat 9 - Neville House	Condition	Good	0
Floor Level	2nd floor	Surface Treatment	Composite materials, reinforced plastics, resin, vinyl materials	0
Location	06 / Lounge	Material Friability	Low	1
Feature	Lino to floor	Asbestos Type	N.A.D.I.S	0
Material Type	Floor Tile / Covering			
Extent	20 sq. m.			
Recommendation	No action necessary	Assessment Score		0
		Assessment Band		E

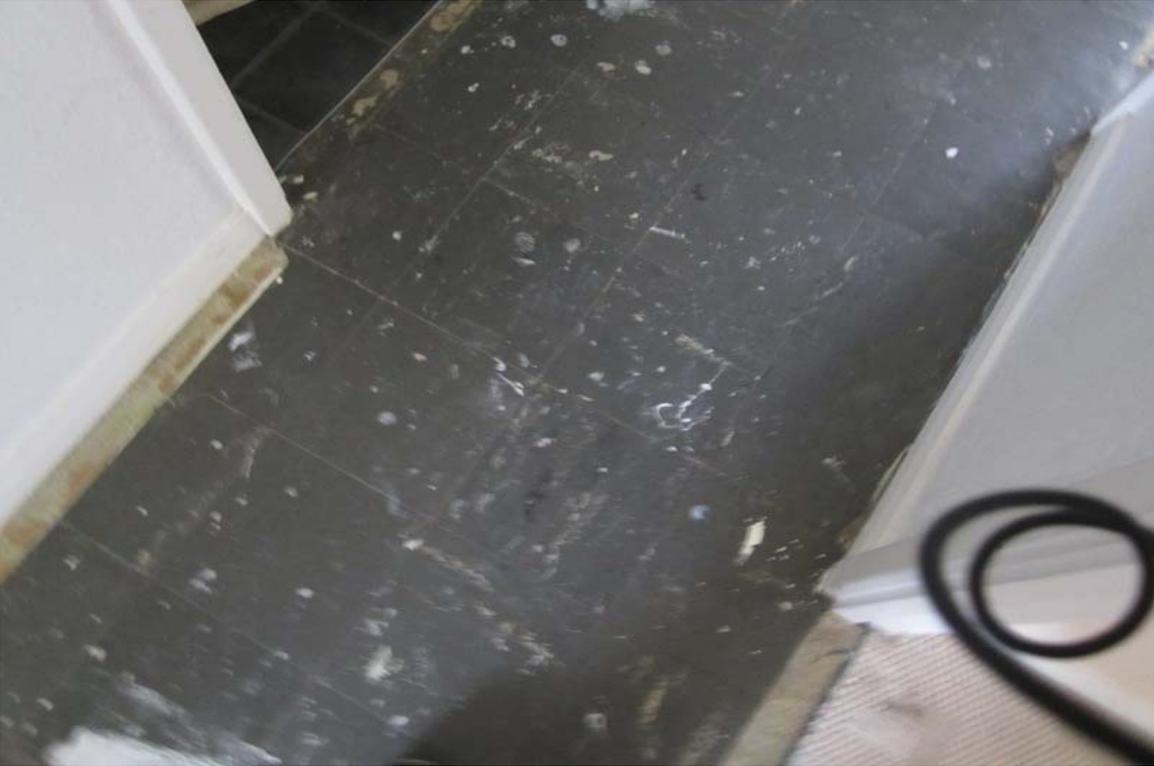
Photo Number	65	Reference number	230316MW75
Inspection / Sample	Inspection	Inspection Cross Reference / Visual I.D.	230316MW72

Notes	ACM: Asbestos Containing Material

Building	Flat 9 - Neville House	Condition	Fair	1
Floor Level	2nd floor	Surface Treatment	Composite materials, reinforced plastics, resin, vinyl materials	0
Location	07 / Hallway	Material Friability	Low	1
Feature	Grey floor tiles and adhesive	Asbestos Type	Strongly Presumed Chrysotile (White)	1
Material Type	Floor Tile / Covering			
Extent	2 sq. m.			
Recommendation	Remove if likely to be disturbed during the refurbishment works	Assessment Score		3
		Assessment Band		D

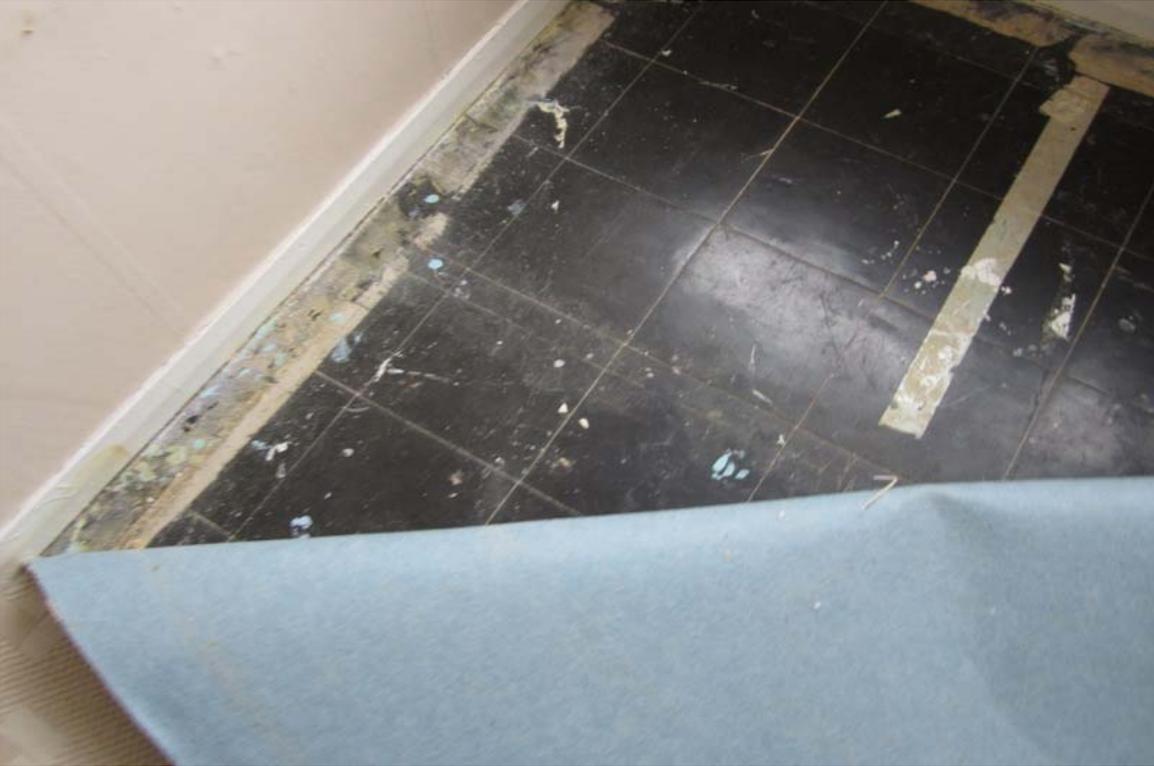
Photo Number	66	Reference number	230316MW76
Inspection / Sample	Inspection	Inspection Cross Reference / Visual I.D.	230316MW72

Notes	ACM: Asbestos Containing Material

Building	Flat 9 - Neville House	Condition	Fair	1
Floor Level	2nd floor	Surface Treatment	Composite materials, reinforced plastics, resin, vinyl materials	0
Location	08 / Bedroom 2	Material Friability	Low	1
Feature	Black floor tiles and adhesive	Asbestos Type	Strongly Presumed Chrysotile (White)	1
Material Type	Floor Tile / Covering			
Extent	12 sq. m.			
Recommendation	Remove if likely to be disturbed during the refurbishment works	Assessment Score		3
		Assessment Band		D

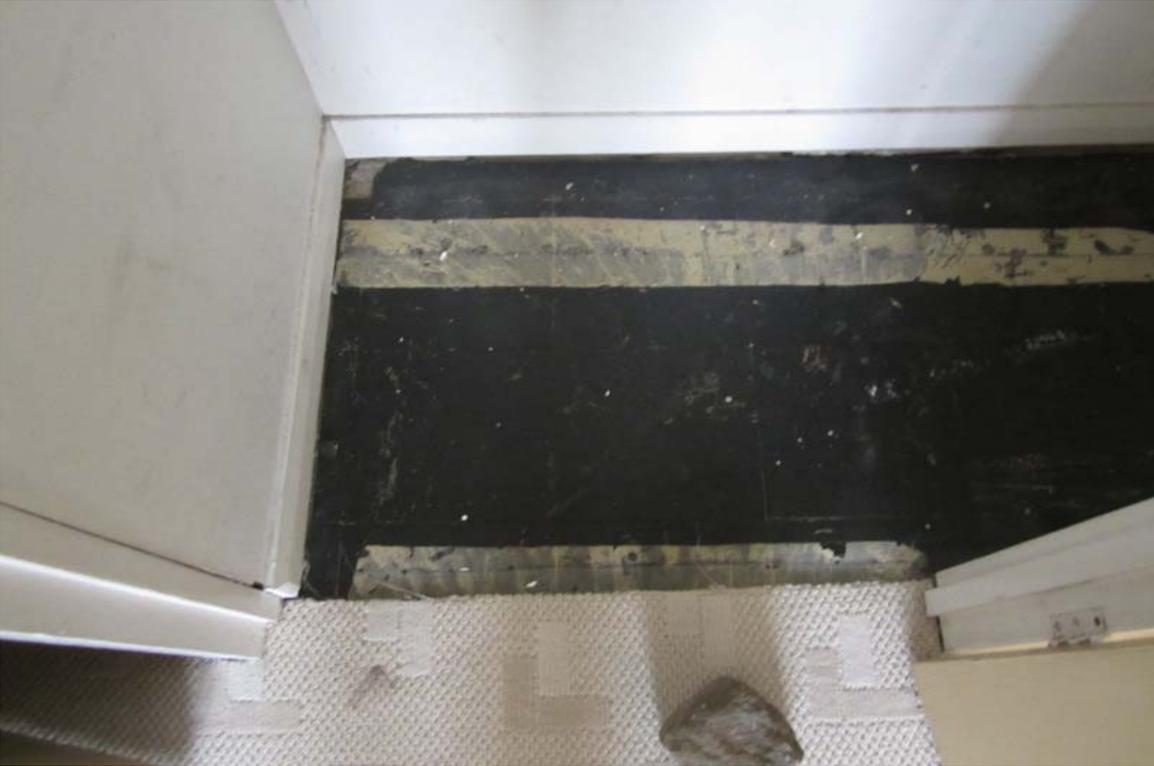
Photo Number	67	Reference number	230316MW77
Inspection / Sample	Inspection	Inspection Cross Reference / Visual I.D.	230316MW72

Notes	ACM: Asbestos Containing Material

Building	Flat 9 - Neville House	Condition	Fair	1
Floor Level	2nd floor	Surface Treatment	Composite materials, reinforced plastics, resin, vinyl materials	0
Location	09 / Cupboard	Material Friability	Low	1
Feature	Black floor tiles and adhesive	Asbestos Type	Strongly Presumed Chrysotile (White)	1
Material Type	Floor Tile / Covering			
Extent	0.5 sq. m.			
Recommendation	Remove if likely to be disturbed during the refurbishment works	Assessment Score		3
		Assessment Band		D

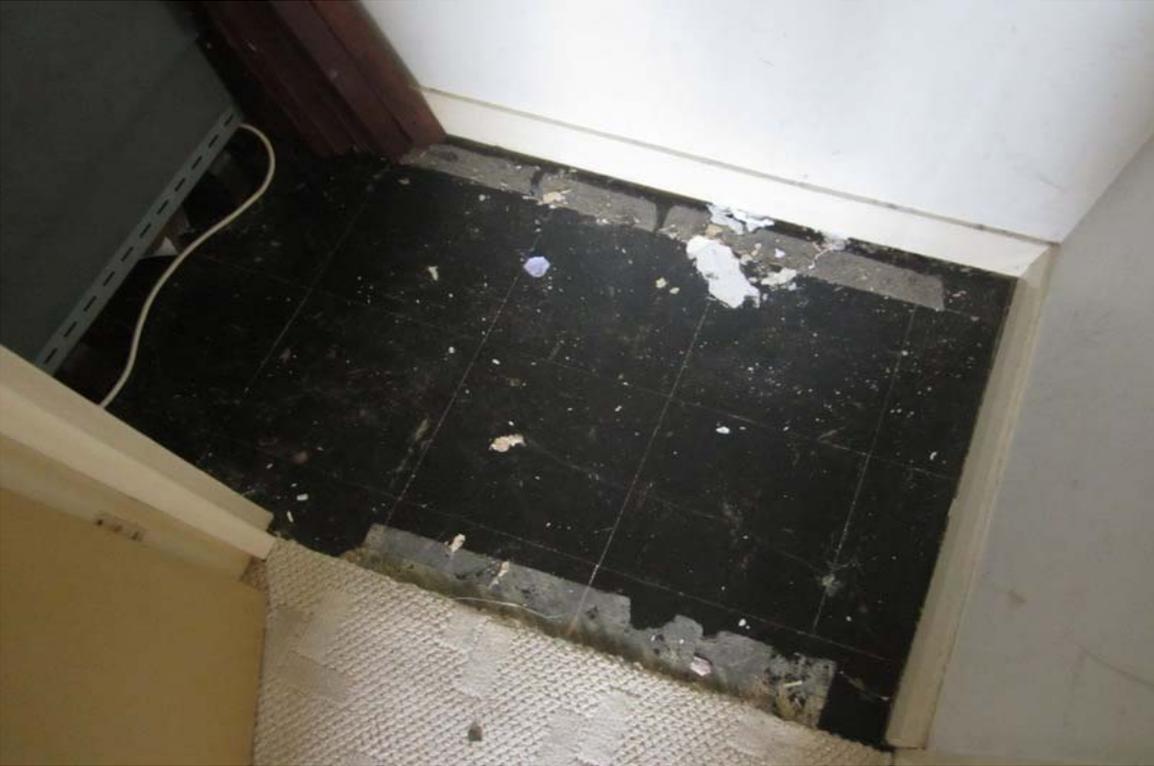
Photo Number	68	Reference number	230316MW78
Inspection / Sample	Inspection	Inspection Cross Reference / Visual I.D.	230316MW72

Notes	ACM: Asbestos Containing Material

Building	Flat 9 - Neville House	Condition	Fair	1
Floor Level	2nd floor	Surface Treatment	Composite materials, reinforced plastics, resin, vinyl materials	0
Location	10 / Cupboard	Material Friability	Low	1
Feature	Black floor tiles and adhesive	Asbestos Type	Strongly Presumed Chrysotile (White)	1
Material Type	Floor Tile / Covering			
Extent	0.5 sq. m.			
Recommendation	Remove if likely to be disturbed during the refurbishment works	Assessment Score		3
		Assessment Band		D

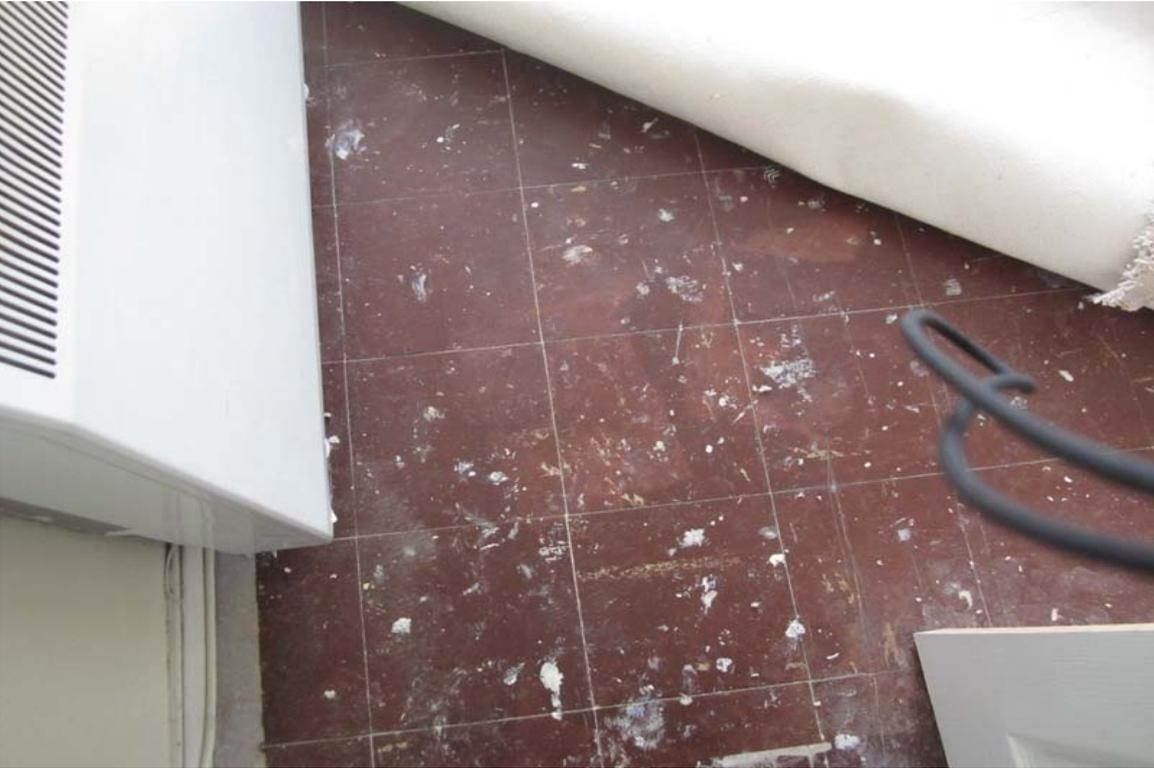
Photo Number	69	Reference number	230316MW79
Inspection / Sample	Sample	Inspection Cross Reference / Visual I.D.	Not Applicable

Notes	ACM: Asbestos Containing Material

Building	Flat 9 - Neville House	Condition	Fair	1
Floor Level	2nd floor	Surface Treatment	Composite materials, reinforced plastics, resin, vinyl materials	0
Location	11 / Bedroom 1	Material Friability	Low	1
Feature	Red floor tiles and adhesive	Asbestos Type	Chrysotile (White)	1
Material Type	Floor Tile / Covering			
Extent	10 sq. m.			
Recommendation	Remove if likely to be disturbed during the refurbishment works	Assessment Score		3
		Assessment Band		D

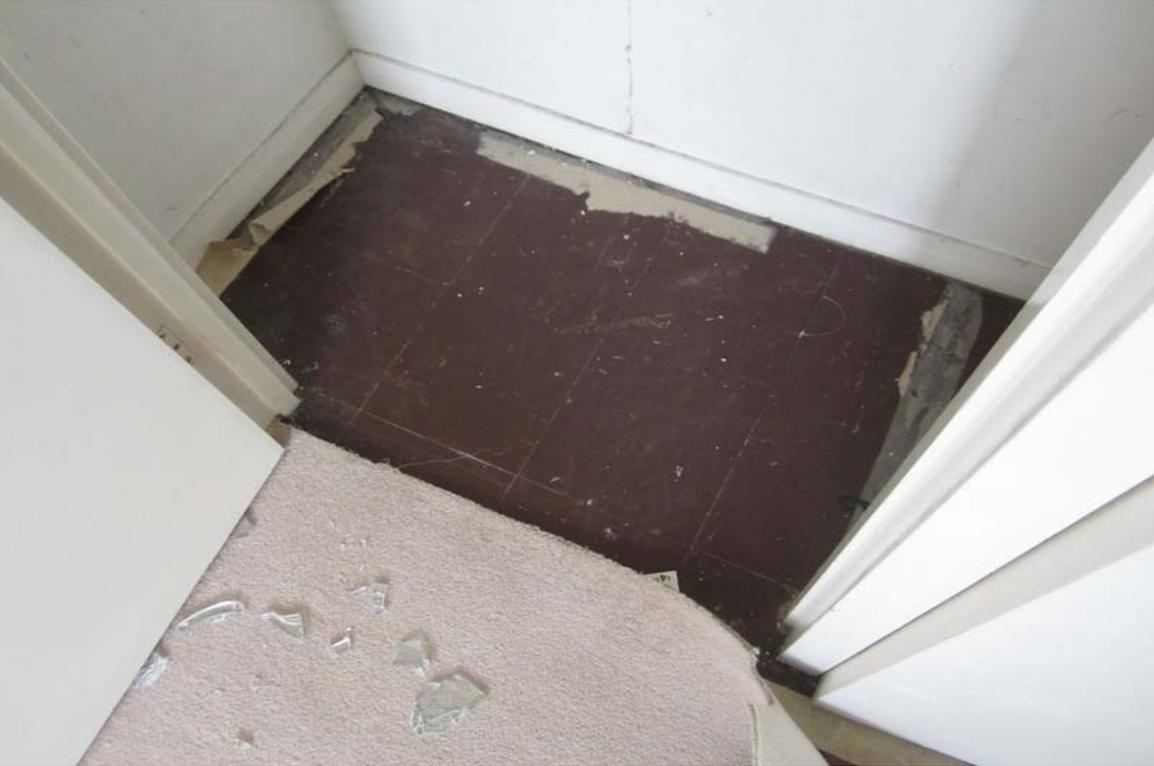
Photo Number	70	Reference number	230316MW80
Inspection / Sample	Inspection	Inspection Cross Reference / Visual I.D.	230316MW79

Notes	ACM: Asbestos Containing Material

Building	Flat 9 - Neville House	Condition	Fair	1
Floor Level	2nd floor	Surface Treatment	Composite materials, reinforced plastics, resin, vinyl materials	0
Location	12 / Cupboard	Material Friability	Low	1
Feature	Red floor tiles and adhesive	Asbestos Type	Strongly Presumed Chrysotile (White)	1
Material Type	Floor Tile / Covering			
Extent	1 sq. m.			
Recommendation	Remove if likely to be disturbed during the refurbishment works	Assessment Score		3
		Assessment Band		D
