**CBC Asbestos Refurbishment Survey Report
Neville House, George Street, Corby
22nd – 24th March 2016**

Reference:					
Issue			Prepared by	Verified by	
V1	Apr 16	JQ

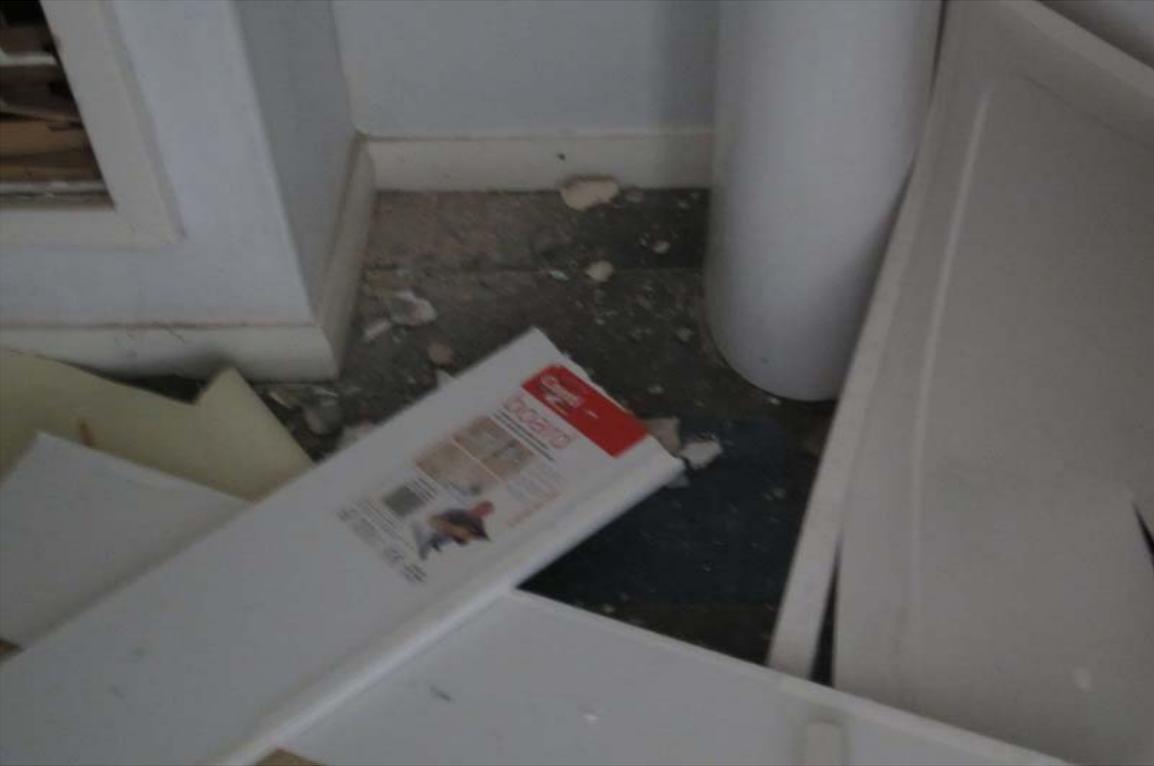
Photo Number	71	Reference number	230316MW81
Inspection / Sample	Sample	Inspection Cross Reference / Visual I.D.	Not Applicable

Notes	ACM: Asbestos Containing Material

Building	Flat 9 - Neville House	Condition	Fair	1
Floor Level	2nd floor	Surface Treatment	Composite materials, reinforced plastics, resin, vinyl materials	0
Location	13 / Bathroom	Material Friability	Low	1
Feature	Blue and green floor tiles and adhesive	Asbestos Type	Chrysotile (White)	1
Material Type	Floor Tile / Covering			
Extent	4 sq. m.			
Recommendation	Remove if likely to be disturbed during the refurbishment works	Assessment Score		3
		Assessment Band		D

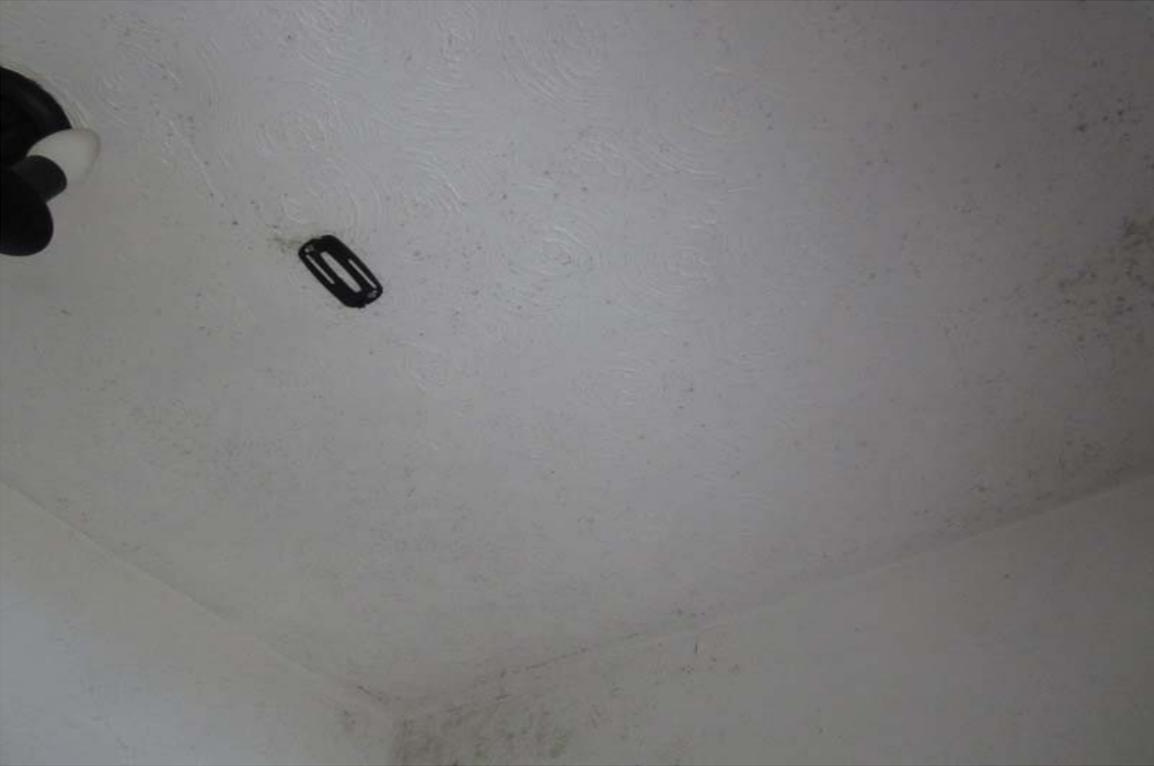
Photo Number	72	Reference number	230316MW82
Inspection / Sample	Sample	Inspection Cross Reference / Visual I.D.	Not Applicable

Notes	NADIS: No Asbestos Detected In Sample

Building	Flat 8 - Neville House	Condition	Fair	1
Floor Level	3rd floor	Surface Treatment	Composite materials, reinforced plastics, resin, vinyl materials	0
Location	01 / Hallway	Material Friability	Low	1
Feature	Coating to ceiling	Asbestos Type	N.A.D.I.S	0
Material Type	Textured Coating			
Extent	2 sq. m.			
Recommendation	No action necessary	Assessment Score		0
		Assessment Band		E

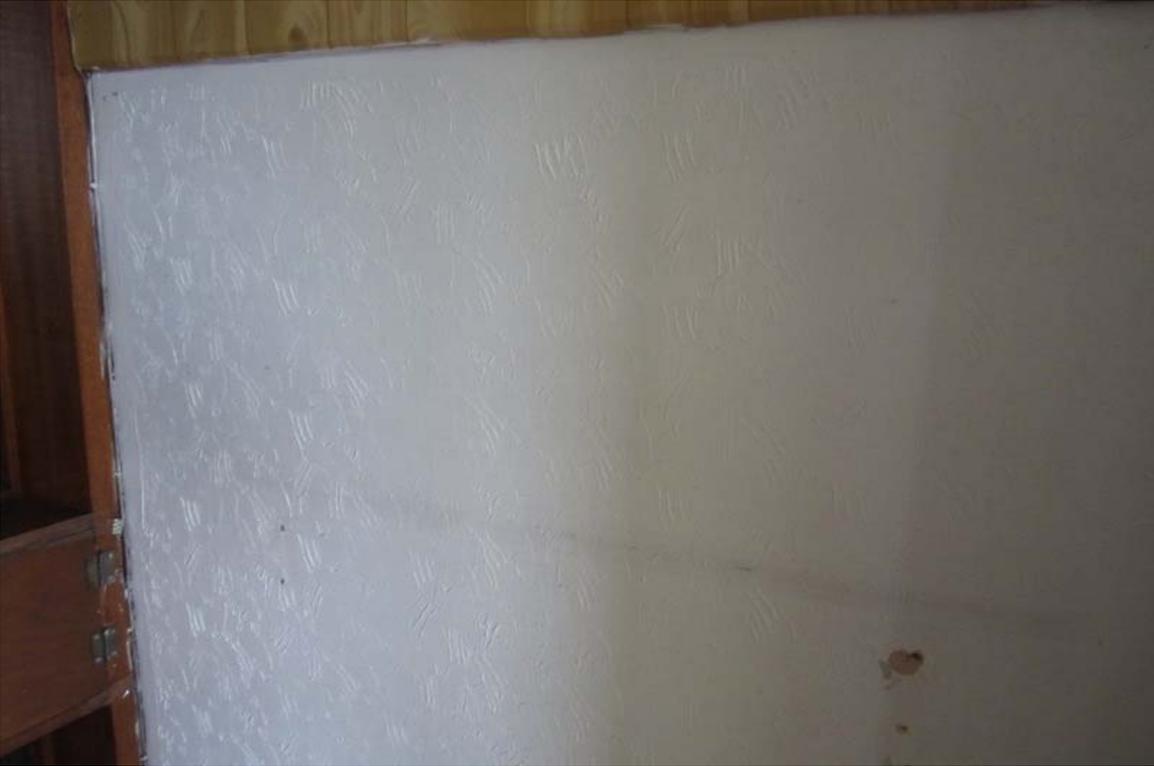
Photo Number	73	Reference number	230316MW83
Inspection / Sample	Sample	Inspection Cross Reference / Visual I.D.	Not Applicable

Notes	NADIS: No Asbestos Detected In Sample

Building	Flat 8 - Neville House	Condition	Fair	1
Floor Level	3rd floor	Surface Treatment	Composite materials, reinforced plastics, resin, vinyl materials	0
Location	01 / Hallway	Material Friability	Low	1
Feature	Coating to walls	Asbestos Type	N.A.D.I.S	0
Material Type	Textured Coating			
Extent	5 sq. m.			
Recommendation	No action necessary	Assessment Score		0
		Assessment Band		E

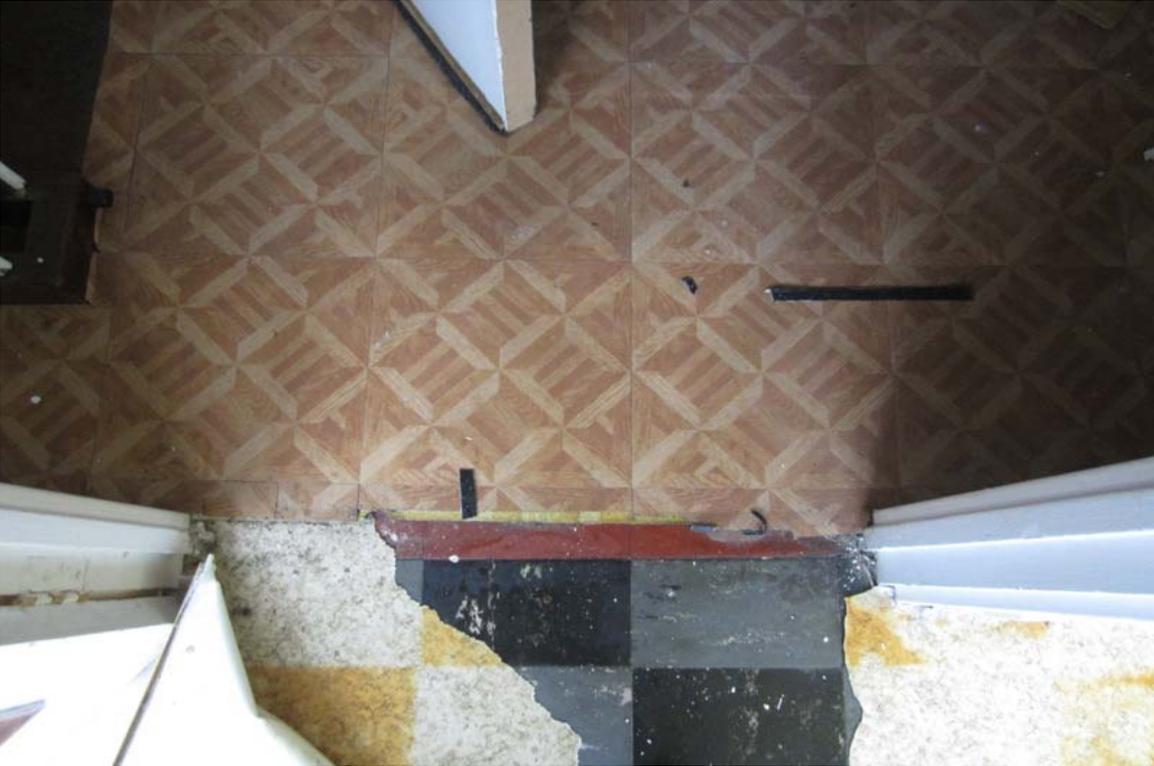
Photo Number	74	Reference number	230316MW84
Inspection / Sample	Inspection	Inspection Cross Reference / Visual I.D.	230316MW70

Notes	ACM: Asbestos Containing Material

Building	Flat 8 - Neville House	Condition	Fair	1
Floor Level	3rd floor	Surface Treatment	Composite materials, reinforced plastics, resin, vinyl materials	0
Location	01 / Hallway	Material Friability	Low	1
Feature	Red floor tiles and adhesive	Asbestos Type	Strongly Presumed Chrysotile (White)	1
Material Type	Floor Tile / Covering			
Extent	2 sq. m.			
Recommendation	Remove if likely to be disturbed during the refurbishment works	Assessment Score		3
		Assessment Band		D

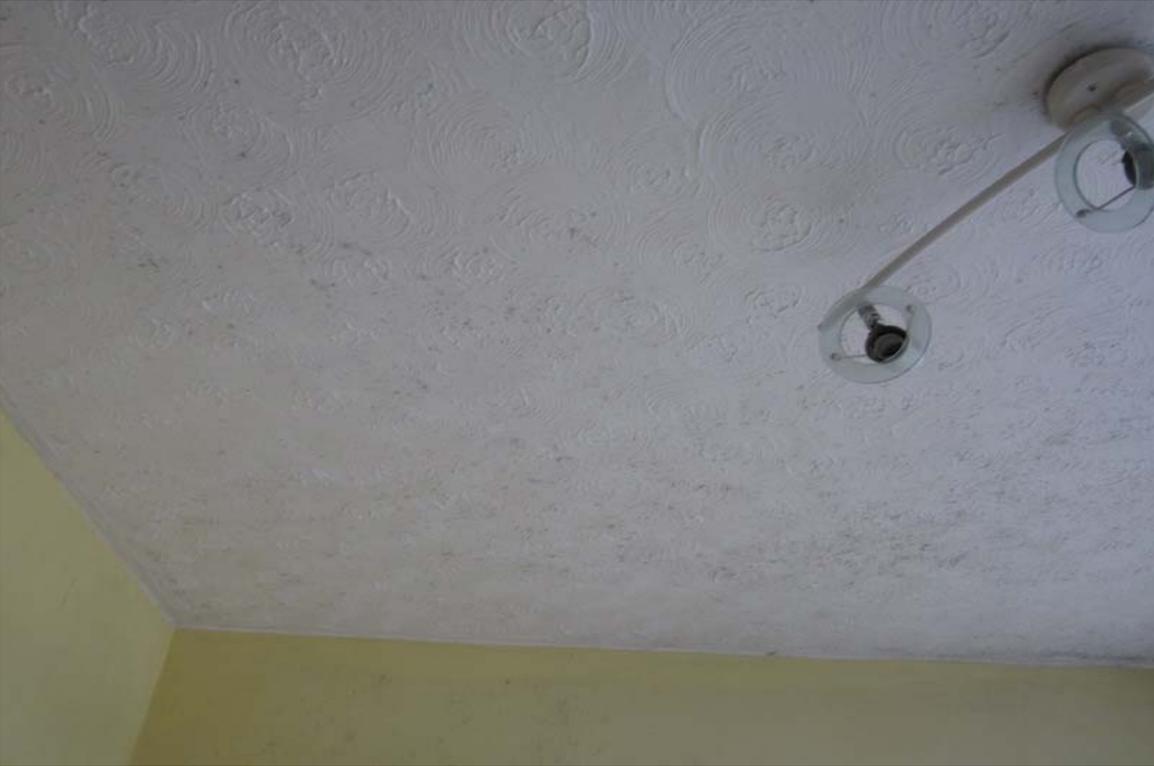
Photo Number	75	Reference number	230316MW85
Inspection / Sample	Inspection	Inspection Cross Reference / Visual I.D.	230316MW82

Notes	NADIS: No Asbestos Detected In Sample

Building	Flat 8 - Neville House	Condition	Fair	1
Floor Level	3rd floor	Surface Treatment	Composite materials, reinforced plastics, resin, vinyl materials	0
Location	02 / Kitchen	Material Friability	Low	1
Feature	Coating to ceiling	Asbestos Type	Strongly Presumed N.A.D.I.S	0
Material Type	Textured Coating			
Extent	15 sq. m.			
Recommendation	No action necessary	Assessment Score		0
		Assessment Band		E

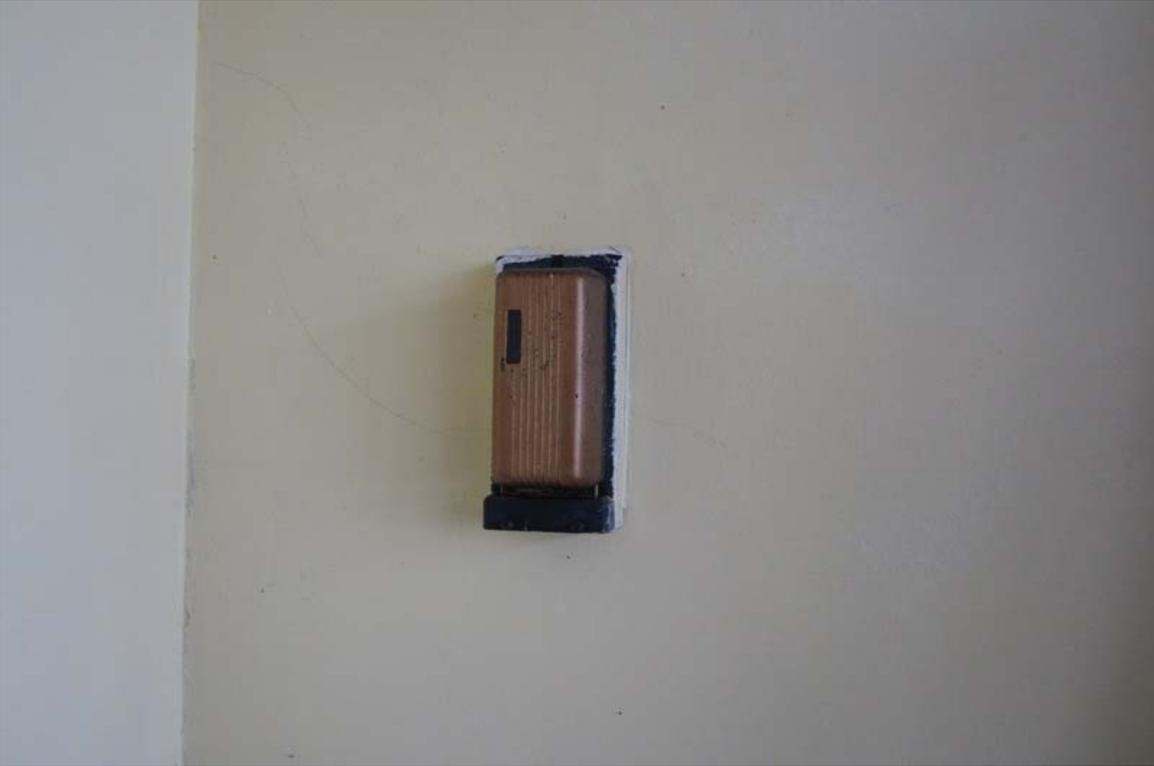
Photo Number	76	Reference number	230316MW86
Inspection / Sample	Sample	Inspection Cross Reference / Visual I.D.	Not Applicable

Notes	NADIS: No Asbestos Detected In Sample

Building	Flat 8 - Neville House	Condition	Fair	1
Floor Level	3rd floor	Surface Treatment	Composite materials, reinforced plastics, resin, vinyl materials	0
Location	02 / Kitchen	Material Friability	Low	1
Feature	Surround to door bell	Asbestos Type	N.A.D.I.S	0
Material Type	Composite / Resin			
Extent	1 No.			
Recommendation	No action necessary	Assessment Score		0
		Assessment Band		E

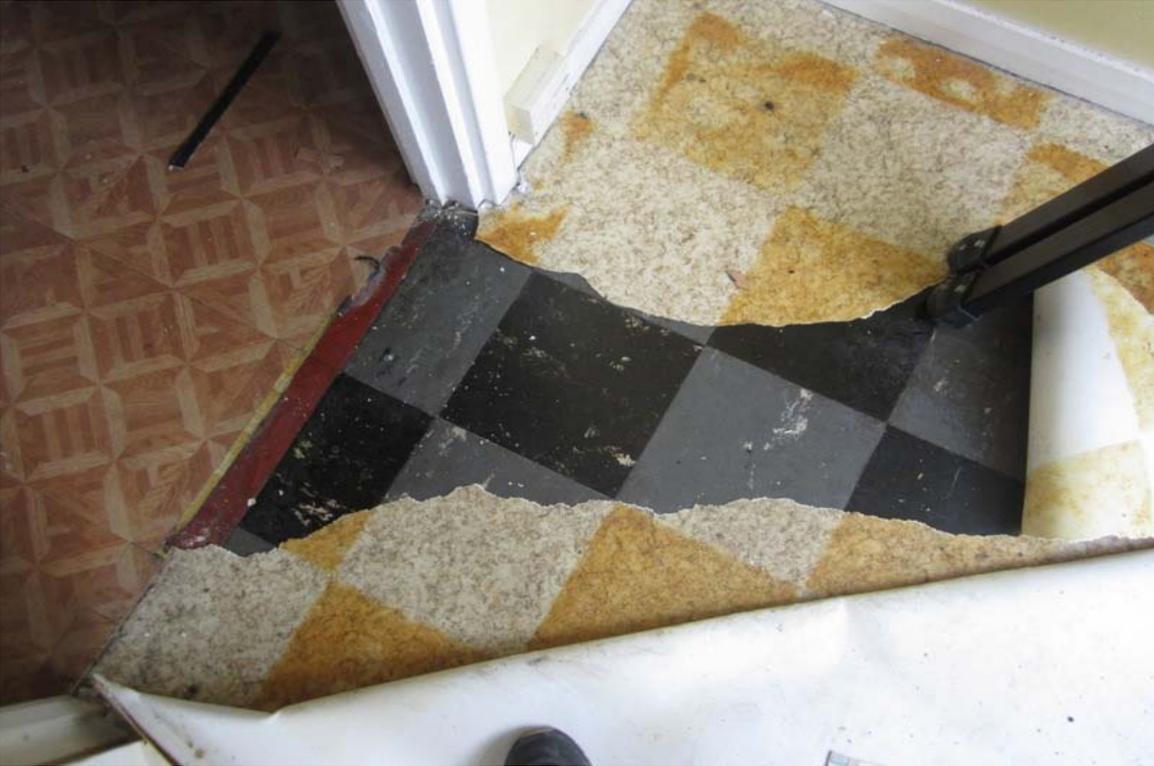
Photo Number	77	Reference number	230316MW87
Inspection / Sample	Inspection	Inspection Cross Reference / Visual I.D.	230316MW72

Notes	ACM: Asbestos Containing Material

Building	Flat 8 - Neville House	Condition	Fair	1
Floor Level	3rd floor	Surface Treatment	Composite materials, reinforced plastics, resin, vinyl materials	0
Location	02 / Kitchen	Material Friability	Low	1
Feature	Grey and black floor tiles and adhesive	Asbestos Type	Strongly Presumed Chrysotile (White)	1
Material Type	Floor Tile / Covering			
Extent	15 sq. m.			
Recommendation	Remove if likely to be disturbed during the refurbishment works	Assessment Score		3
		Assessment Band		D

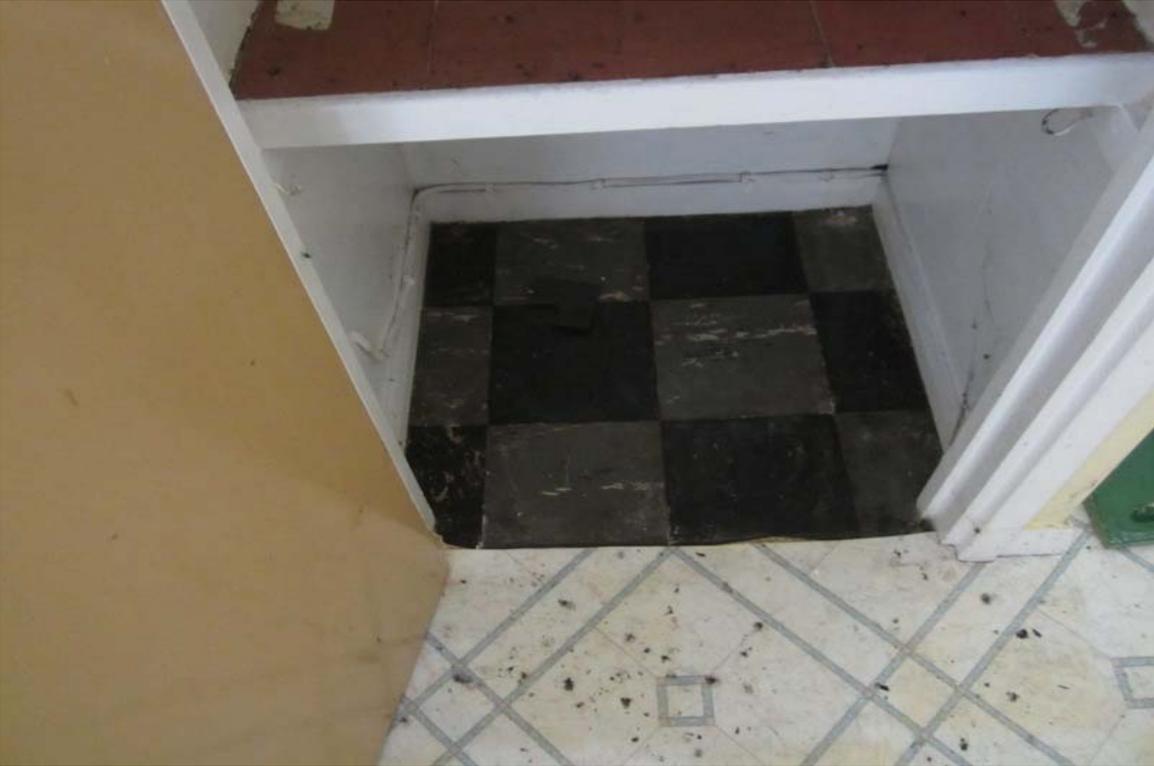
Photo Number	78	Reference number	230316MW88
Inspection / Sample	Inspection	Inspection Cross Reference / Visual I.D.	230316MW72

Notes	ACM: Asbestos Containing Material

Building	Flat 8 - Neville House	Condition	Fair	1
Floor Level	3rd floor	Surface Treatment	Composite materials, reinforced plastics, resin, vinyl materials	0
Location	03 / Cupboard	Material Friability	Low	1
Feature	Grey and black floor tiles and adhesive	Asbestos Type	Strongly Presumed Chrysotile (White)	1
Material Type	Floor Tile / Covering			
Extent	0.5 sq. m.			
Recommendation	Remove if likely to be disturbed during the refurbishment works	Assessment Score		3
		Assessment Band		D

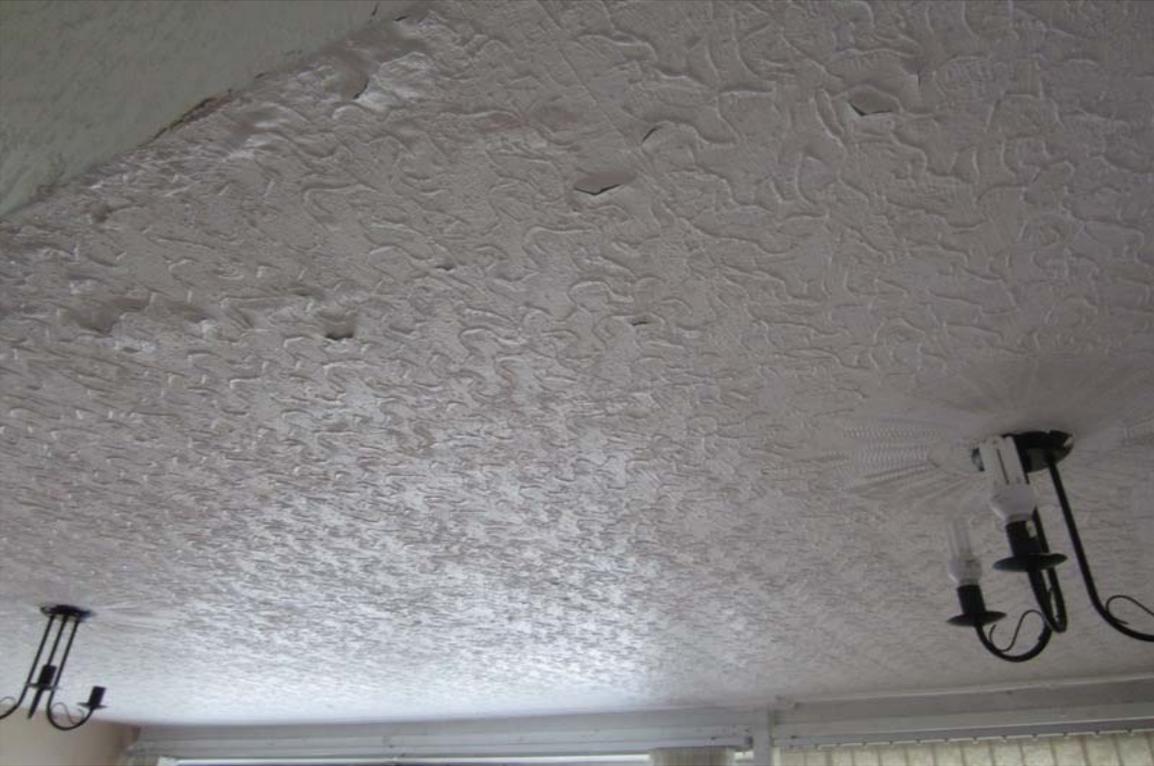
Photo Number	79	Reference number	230316MW88A
Inspection / Sample	Sample	Inspection Cross Reference / Visual I.D.	Not Applicable

Notes	NADIS: No Asbestos Detected In Sample

Building	Flat 8 - Neville House	Condition	Fair	1
Floor Level	2nd floor	Surface Treatment	Composite materials, reinforced plastics, resin, vinyl materials	0
Location	05 / Lounge	Material Friability	Low	1
Feature	Coating to ceiling	Asbestos Type	N.A.D.I.S	0
Material Type	Textured Coating			
Extent	20 sq. m.			
Recommendation	No action necessary	Assessment Score		0
		Assessment Band		E

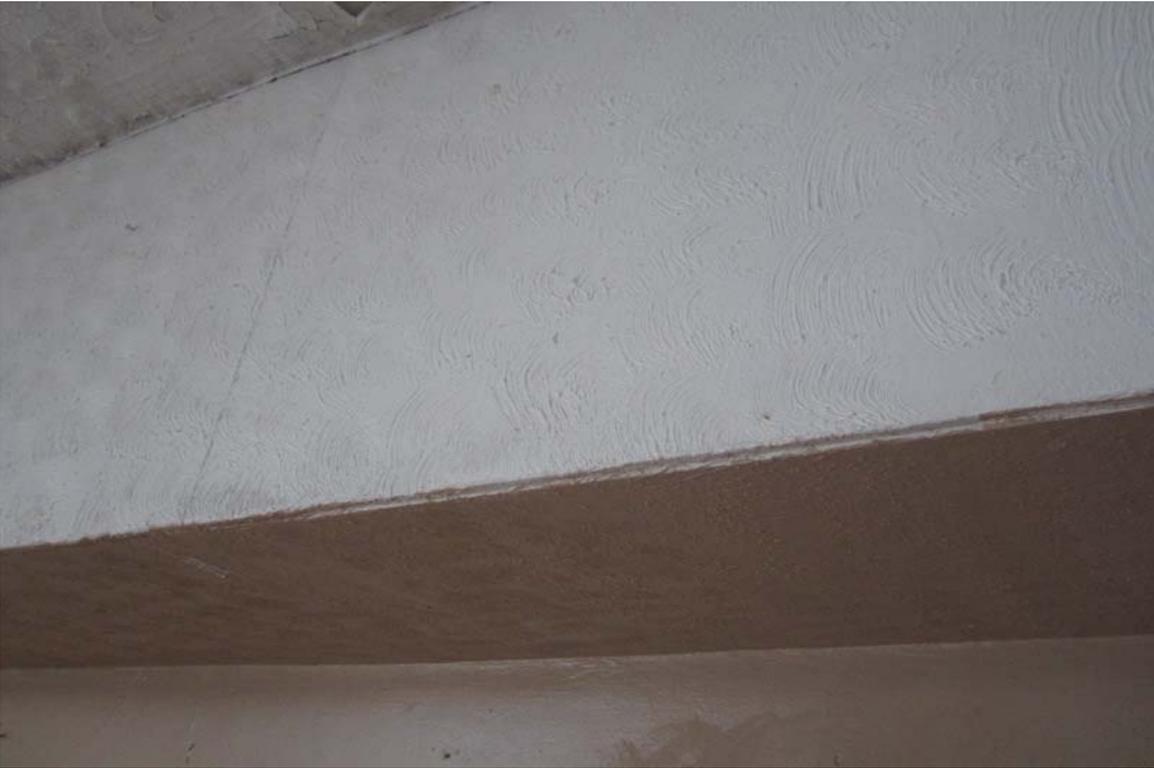
Photo Number	80	Reference number	230316MW88B
Inspection / Sample	Sample	Inspection Cross Reference / Visual I.D.	Not Applicable

Notes	NADIS: No Asbestos Detected In Sample

Building	Flat 8 - Neville House	Condition	Fair	1
Floor Level	2nd floor	Surface Treatment	Composite materials, reinforced plastics, resin, vinyl materials	0
Location	05 / Lounge	Material Friability	Low	1
Feature	Coating to high level boxing (bottom of stairs)	Asbestos Type	N.A.D.I.S	0
Material Type	Textured Coating			
Extent	3 sq. m.			
Recommendation	No action necessary	Assessment Score		0
		Assessment Band		E

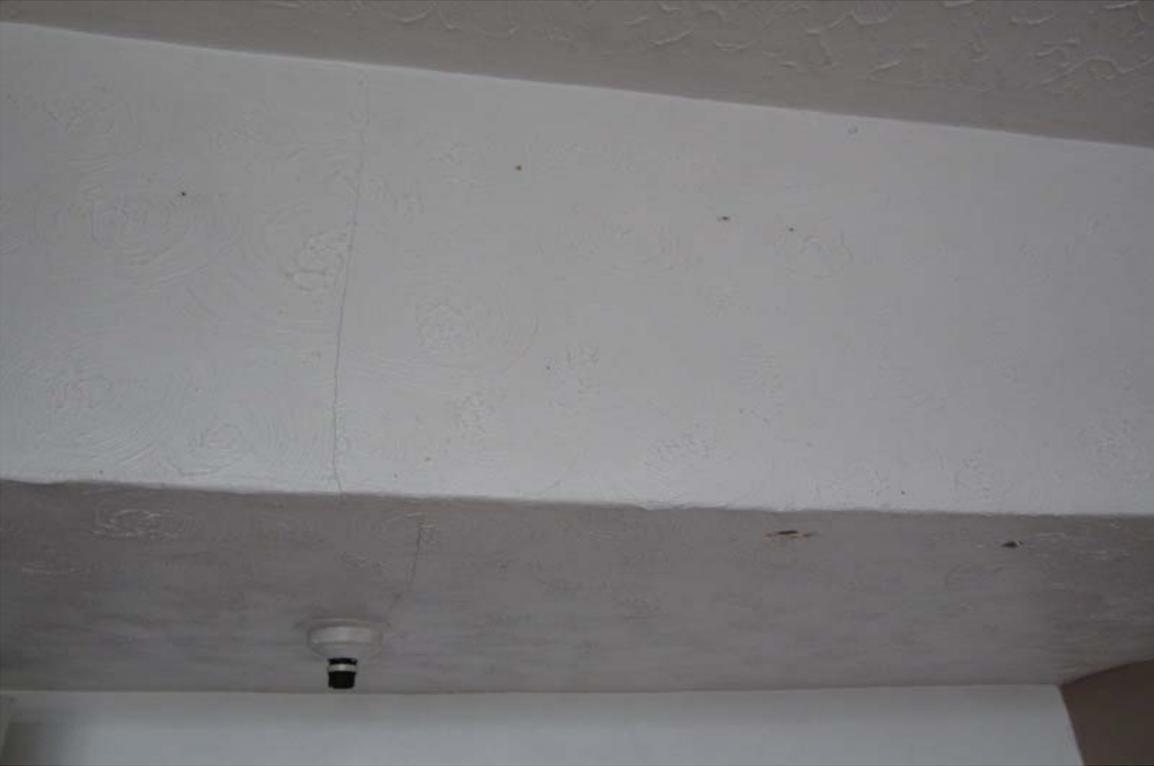
Photo Number	81	Reference number	230316MW89
Inspection / Sample	Sample	Inspection Cross Reference / Visual I.D.	Not Applicable

Notes	NADIS: No Asbestos Detected In Sample

Building	Flat 8 - Neville House	Condition	Fair	1
Floor Level	2nd floor	Surface Treatment	Composite materials, reinforced plastics, resin, vinyl materials	0
Location	05 / Lounge	Material Friability	Low	1
Feature	Coating to high level boxing (behind stairs)	Asbestos Type	N.A.D.I.S	0
Material Type	Textured Coating			
Extent	3 sq. m.			
Recommendation	No action necessary	Assessment Score		0
		Assessment Band		E

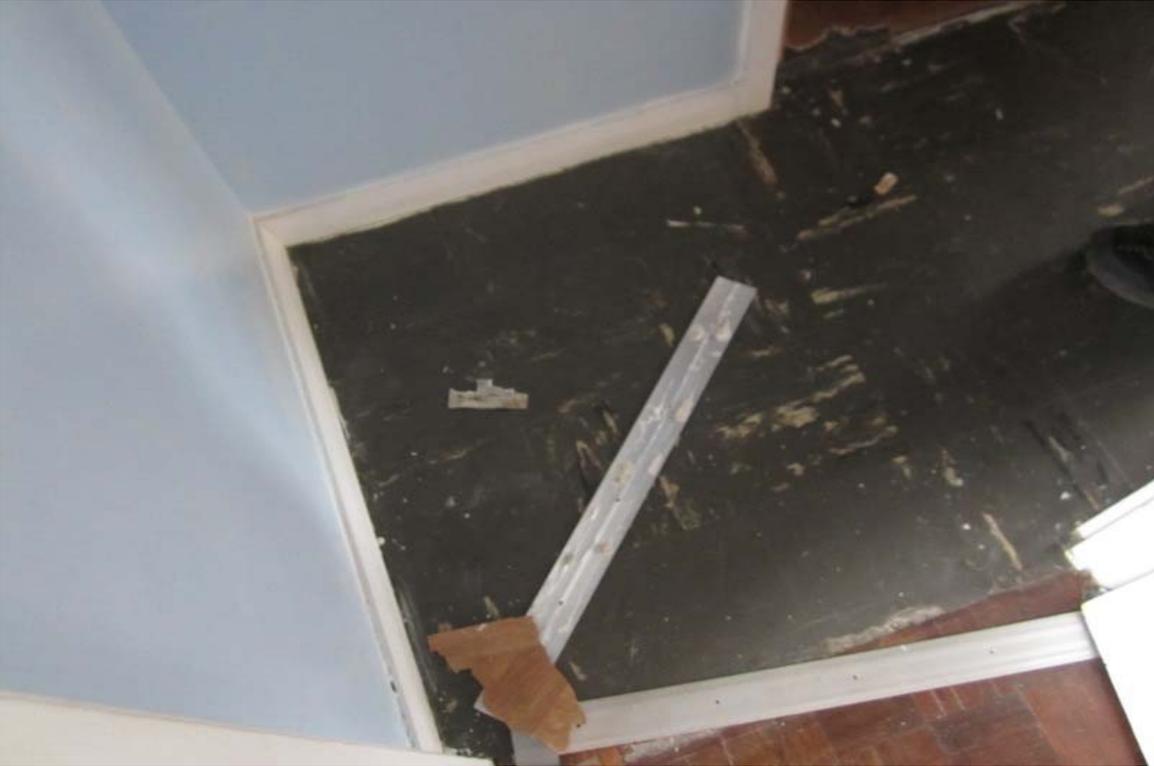
Photo Number	82	Reference number	230316MW90
Inspection / Sample	Inspection	Inspection Cross Reference / Visual I.D.	230316MW72

Notes	ACM: Asbestos Containing Material

Building	Flat 8 - Neville House	Condition	Fair	1
Floor Level	2nd floor	Surface Treatment	Composite materials, reinforced plastics, resin, vinyl materials	0
Location	06 / Hallway	Material Friability	Low	1
Feature	Grey floor tiles and adhesive	Asbestos Type	Strongly Presumed Chrysotile (White)	1
Material Type	Floor Tile / Covering			
Extent	2 sq. m.			
Recommendation	Remove if likely to be disturbed during the refurbishment works	Assessment Score		3
		Assessment Band		D

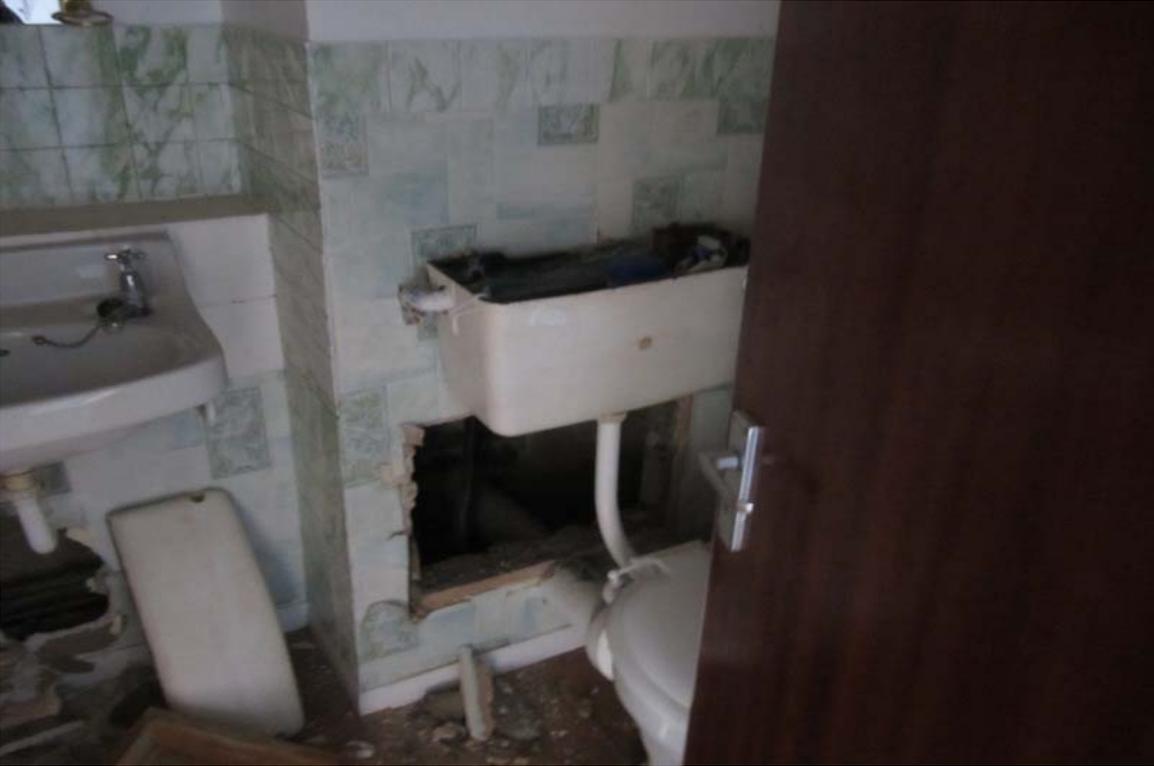
Photo Number	83	Reference number	230316MW91
Inspection / Sample	Inspection	Inspection Cross Reference / Visual I.D.	220316MW20

Notes	ACM: Asbestos Containing Material

Building	Flat 8 - Neville House	Condition	Fair	1
Floor Level	2nd floor	Surface Treatment	Composite materials, reinforced plastics, resin, vinyl materials	0
Location	07 / Bathroom	Material Friability	Low	1
Feature	Toilet cistern	Asbestos Type	Strongly Presumed Amosite (Brown)	2
Material Type	Composite / Resin			
Extent	1 No.			
Recommendation	Remove if likely to be disturbed during the refurbishment works	Assessment Score		4
		Assessment Band		D

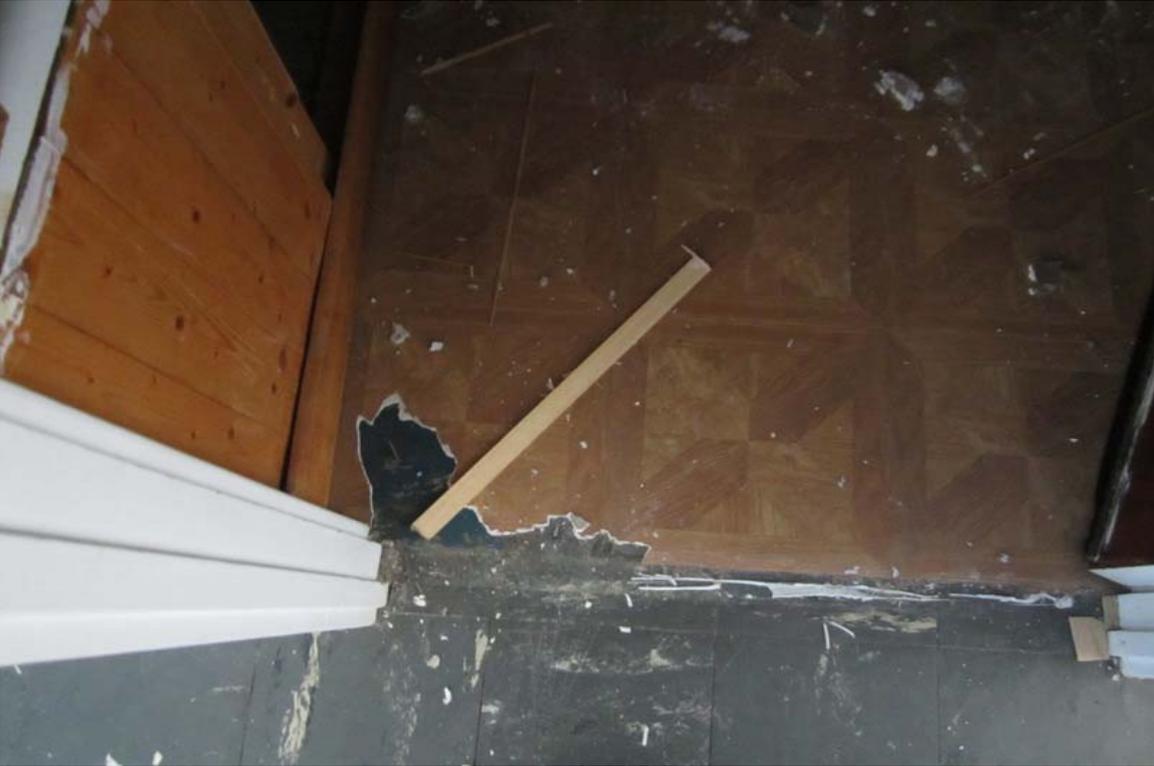
Photo Number	84	Reference number	230316MW92
Inspection / Sample	Inspection	Inspection Cross Reference / Visual I.D.	230316MW81

Notes	ACM: Asbestos Containing Material

Building	Flat 8 - Neville House	Condition	Fair	1
Floor Level	2nd floor	Surface Treatment	Composite materials, reinforced plastics, resin, vinyl materials	0
Location	07 / Bathroom	Material Friability	Low	1
Feature	Blue and green floor tiles and adhesive	Asbestos Type	Strongly Presumed Chrysotile (White)	1
Material Type	Floor Tile / Covering			
Extent	2 sq. m.			
Recommendation	Remove if likely to be disturbed during the refurbishment works	Assessment Score		3
		Assessment Band		D

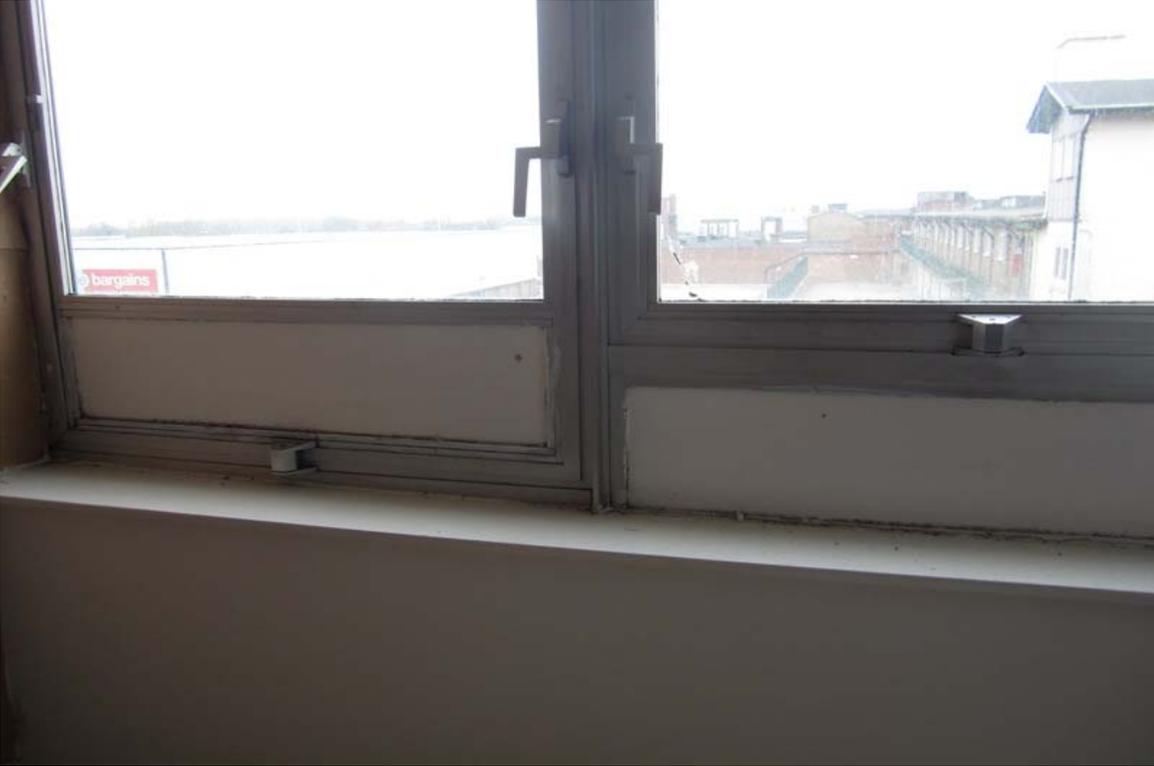
Photo Number	85	Reference number	230316MW93
Inspection / Sample	Sample	Inspection Cross Reference / Visual I.D.	Not Applicable

Notes	NADIS: No Asbestos Detected In Sample

Building	Flat 8 - Neville House	Condition	Fair	1
Floor Level	2nd floor	Surface Treatment	Unsealed AIB or encapsulated lagging and spray	2
Location	08 / Bedroom 2	Material Friability	Medium	2
Feature	Panelling beneath window	Asbestos Type	N.A.D.I.S	0
Material Type	Insulating Board			
Extent	2 sq. m.			
Recommendation	No action necessary	Assessment Score		0
		Assessment Band		E

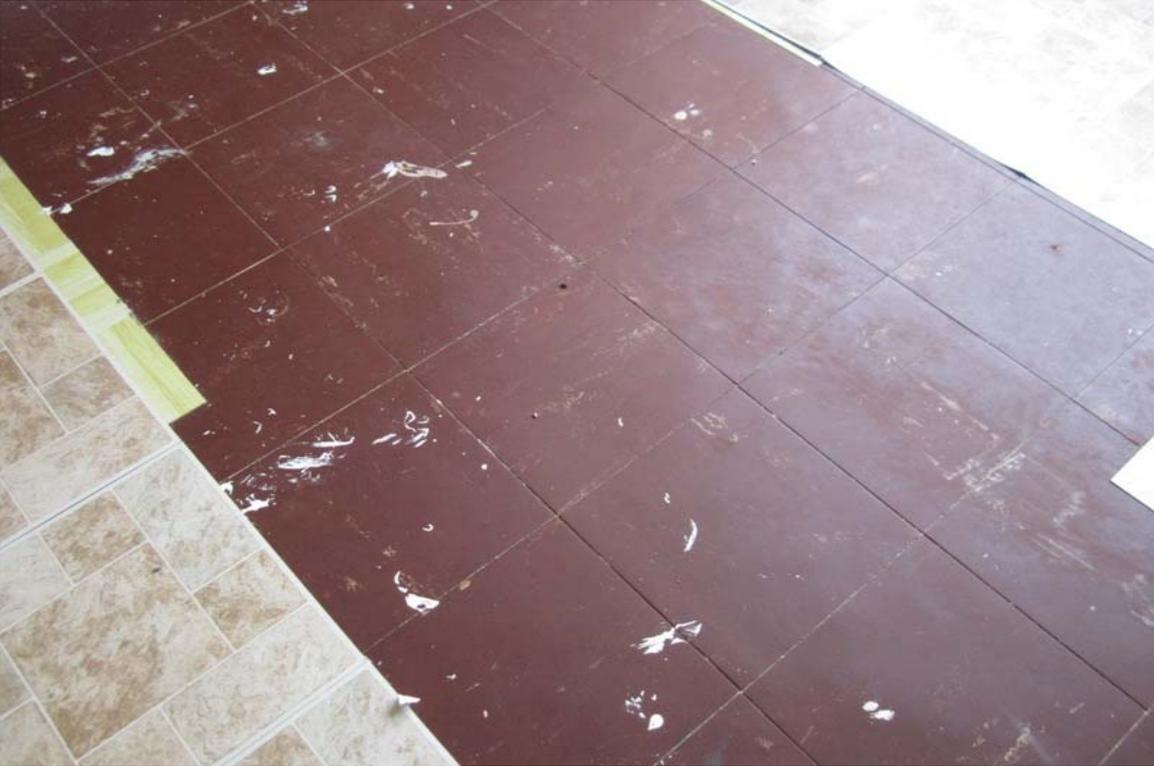
Photo Number	86	Reference number	230316MW94
Inspection / Sample	Inspection	Inspection Cross Reference / Visual I.D.	230316MW70

Notes	ACM: Asbestos Containing Material

Building	Flat 8 - Neville House	Condition	Fair	1
Floor Level	2nd floor	Surface Treatment	Composite materials, reinforced plastics, resin, vinyl materials	0
Location	08 / Bedroom 2	Material Friability	Low	1
Feature	Red floor tiles and adhesive	Asbestos Type	Strongly Presumed Chrysotile (White)	1
Material Type	Floor Tile / Covering			
Extent	12 sq. m.			
Recommendation	Remove if likely to be disturbed during the refurbishment works	Assessment Score		3
		Assessment Band		D

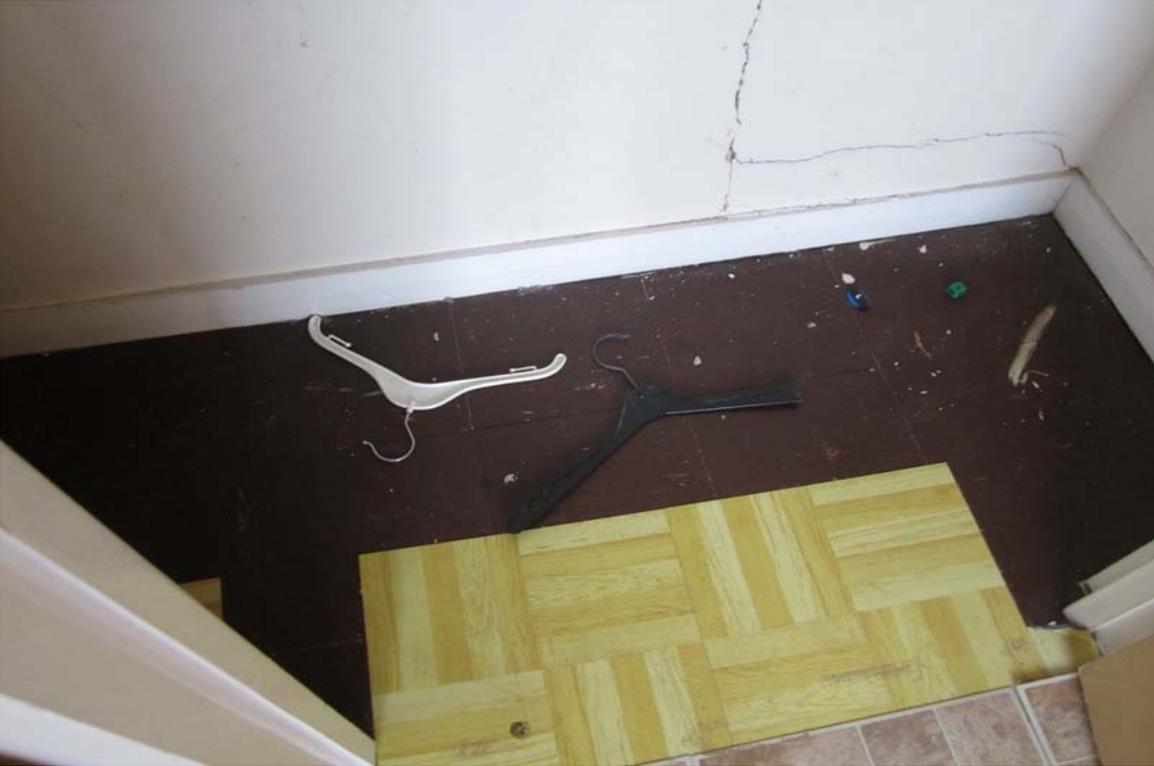
Photo Number	87	Reference number	230316MW95
Inspection / Sample	Inspection	Inspection Cross Reference / Visual I.D.	230316MW70

Notes	ACM: Asbestos Containing Material

Building	Flat 8 - Neville House	Condition	Fair	1
Floor Level	2nd floor	Surface Treatment	Composite materials, reinforced plastics, resin, vinyl materials	0
Location	09 / Cupboard	Material Friability	Low	1
Feature	Red floor tiles and adhesive	Asbestos Type	Strongly Presumed Chrysotile (White)	1
Material Type	Floor Tile / Covering			
Extent	2 sq. m.			
Recommendation	Remove if likely to be disturbed during the refurbishment works	Assessment Score		3
		Assessment Band		D

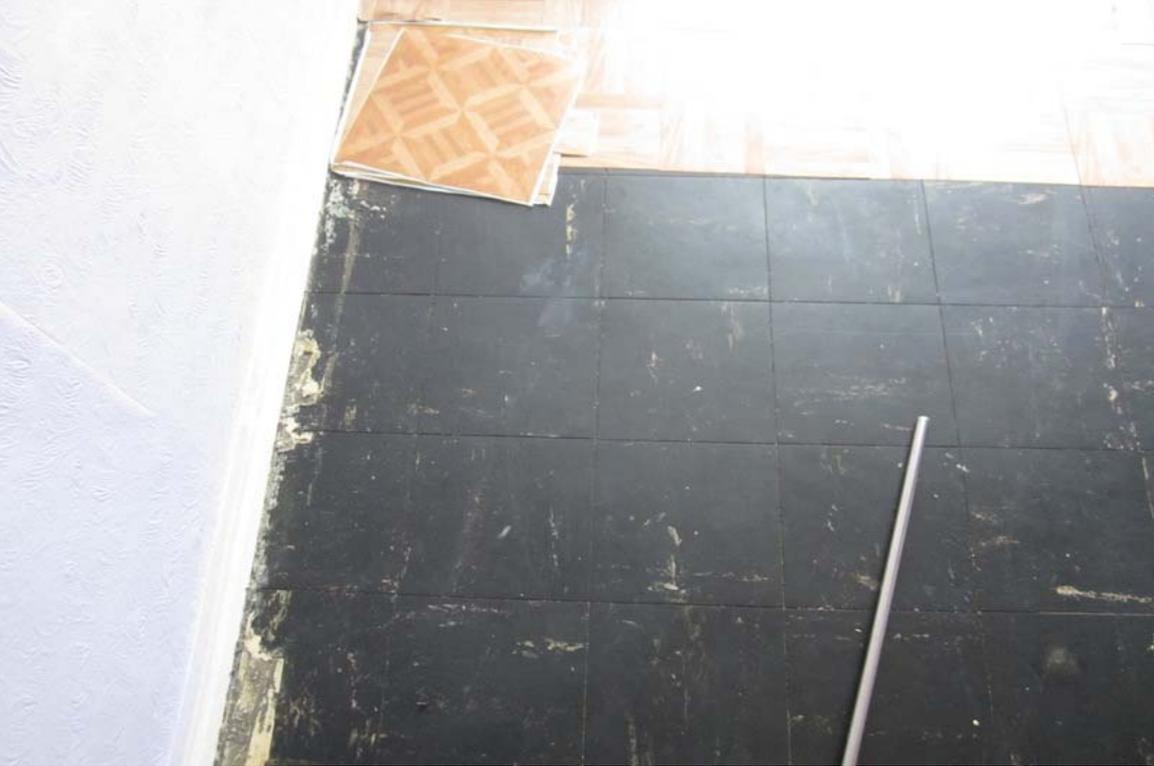
Photo Number	88	Reference number	230316MW96
Inspection / Sample	Inspection	Inspection Cross Reference / Visual I.D.	230316MW72

Notes	ACM: Asbestos Containing Material

Building	Flat 8 - Neville House	Condition	Fair	1
Floor Level	2nd floor	Surface Treatment	Composite materials, reinforced plastics, resin, vinyl materials	0
Location	10 / Bedroom 1	Material Friability	Low	1
Feature	Black floor tiles and adhesive	Asbestos Type	Strongly Presumed Chrysotile (White)	1
Material Type	Floor Tile / Covering			
Extent	10 sq. m.			
Recommendation	Remove if likely to be disturbed during the refurbishment works	Assessment Score		3
		Assessment Band		D

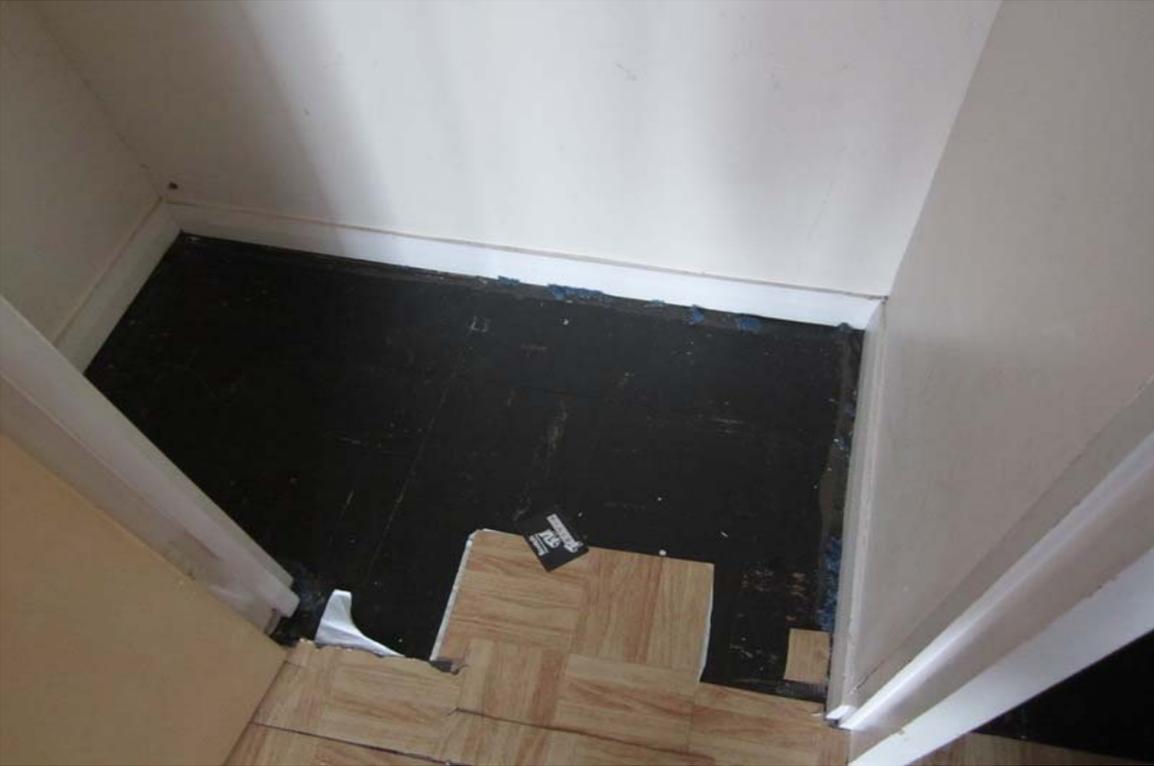
Photo Number	89	Reference number	230316MW97
Inspection / Sample	Inspection	Inspection Cross Reference / Visual I.D.	230316MW72

Notes	ACM: Asbestos Containing Material

Building	Flat 8 - Neville House	Condition	Fair	1
Floor Level	2nd floor	Surface Treatment	Composite materials, reinforced plastics, resin, vinyl materials	0
Location	11 / Cupboard	Material Friability	Low	1
Feature	Black floor tiles and adhesive	Asbestos Type	Strongly Presumed Chrysotile (White)	1
Material Type	Floor Tile / Covering			
Extent	0.5 sq. m.			
Recommendation	Remove if likely to be disturbed during the refurbishment works	Assessment Score		3
		Assessment Band		D

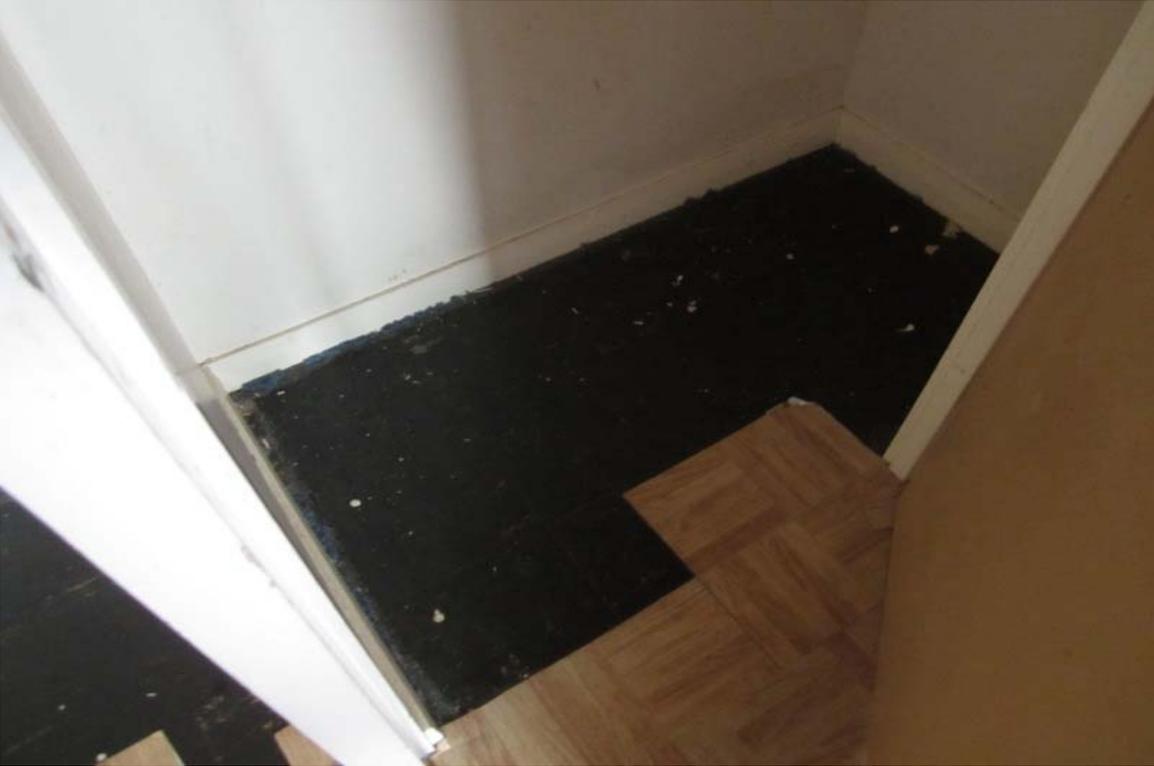
Photo Number	90	Reference number	230316MW98
Inspection / Sample	Inspection	Inspection Cross Reference / Visual I.D.	230316MW72

Notes	ACM: Asbestos Containing Material

Building	Flat 8 - Neville House	Condition	Fair	1
Floor Level	2nd floor	Surface Treatment	Composite materials, reinforced plastics, resin, vinyl materials	0
Location	12 / Cupboard	Material Friability	Low	1
Feature	Black floor tiles and adhesive	Asbestos Type	Strongly Presumed Chrysotile (White)	1
Material Type	Floor Tile / Covering			
Extent	0.5 sq. m.			
Recommendation	Remove if likely to be disturbed during the refurbishment works	Assessment Score		3
		Assessment Band		D

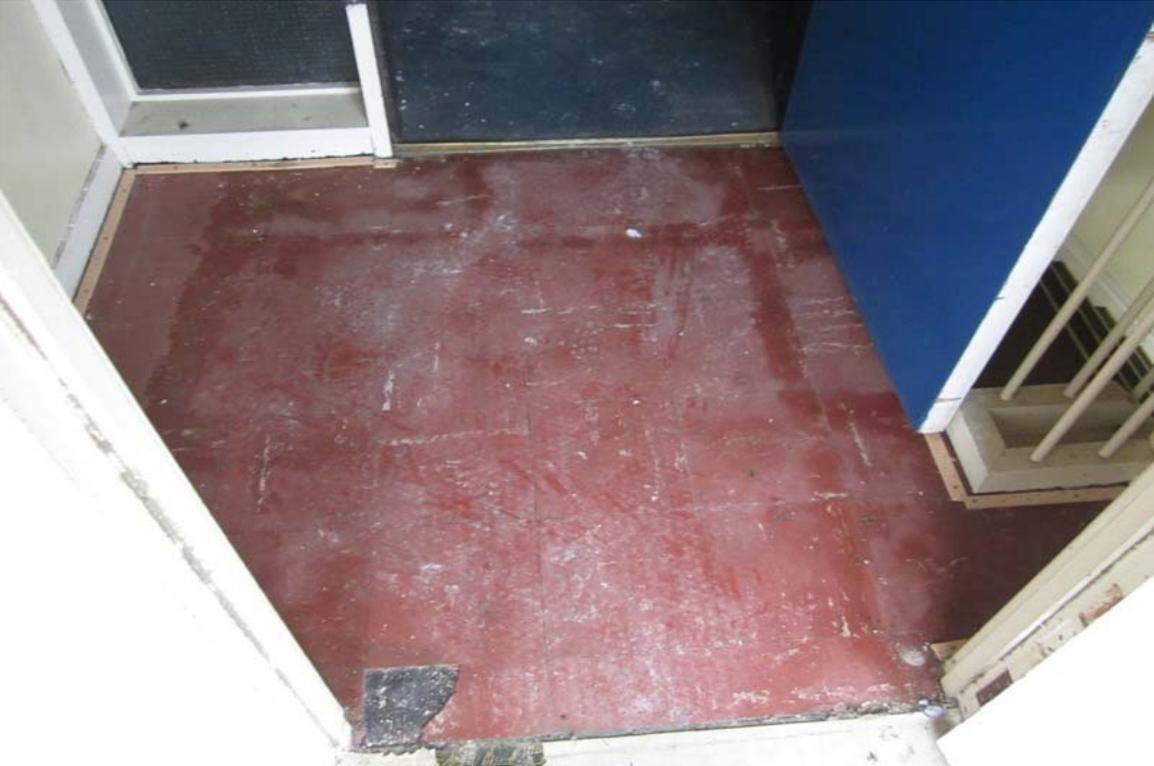
Photo Number	91	Reference number	230316MW99
Inspection / Sample	Inspection	Inspection Cross Reference / Visual I.D.	230316MW70

Notes	ACM: Asbestos Containing Material

Building	Flat 7 - Neville House	Condition	Fair	1
Floor Level	3rd floor	Surface Treatment	Composite materials, reinforced plastics, resin, vinyl materials	0
Location	01 / Hallway	Material Friability	Low	1
Feature	Red floor tiles and adhesive	Asbestos Type	Strongly Presumed Chrysotile (White)	1
Material Type	Floor Tile / Covering			
Extent	2 sq. m.			
Recommendation	Remove if likely to be disturbed during the refurbishment works	Assessment Score		3
		Assessment Band		D
