**CBC Asbestos Refurbishment Survey Report
Neville House, George Street, Corby
22nd – 24th March 2016**

Reference:					
Issue			Prepared by	Verified by	
V1	Apr 16	JQ

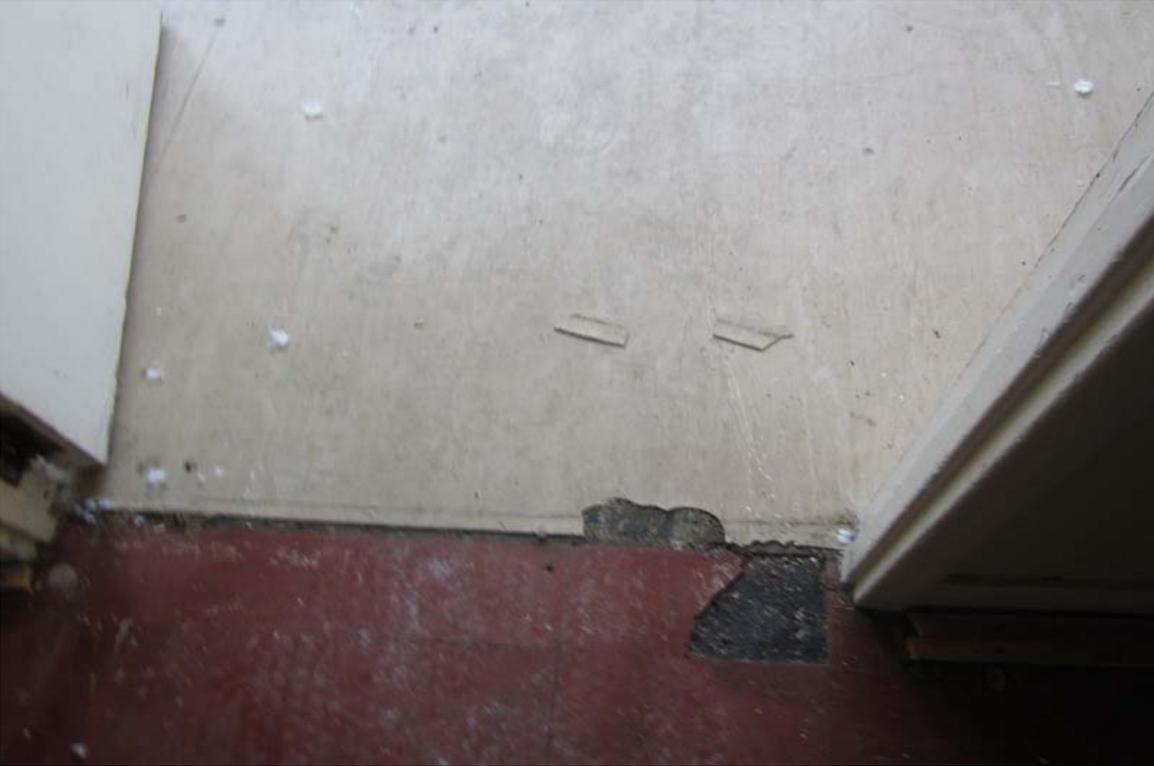
Photo Number	92	Reference number	230316MW100
Inspection / Sample	Inspection	Inspection Cross Reference / Visual I.D.	230316MW72

Notes	ACM: Asbestos Containing Material

Building	Flat 7 - Neville House	Condition	Fair	1
Floor Level	3rd floor	Surface Treatment	Composite materials, reinforced plastics, resin, vinyl materials	0
Location	02 / Kitchen	Material Friability	Low	1
Feature	Grey and black floor tiles and adhesive	Asbestos Type	Strongly Presumed Chrysotile (White)	1
Material Type	Floor Tile / Covering			
Extent	15 sq. m.			
Recommendation	Remove if likely to be disturbed during the refurbishment works	Assessment Score		3
		Assessment Band		D

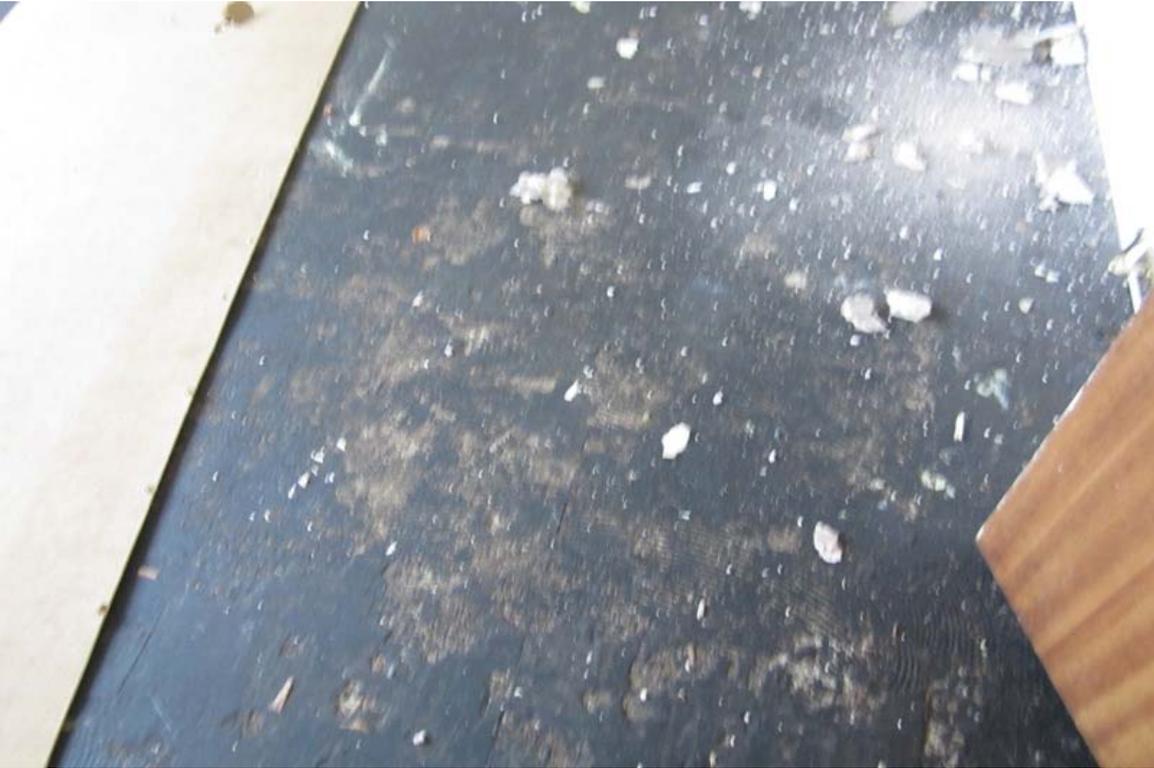
Photo Number	93	Reference number	230316MW101
Inspection / Sample	Inspection	Inspection Cross Reference / Visual I.D.	220316MW24

Notes	NADIS: No Asbestos Detected In Sample

Building	Flat 7 - Neville House	Condition	Fair	1
Floor Level	2nd floor	Surface Treatment	Composite materials, reinforced plastics, resin, vinyl materials	0
Location	04 / Lounge	Material Friability	Low	1
Feature	Bitumen adhesive beneath parquet flooring	Asbestos Type	Strongly Presumed N.A.D.I.S	0
Material Type	Bitumen			
Extent	20 sq. m.			
Recommendation	No action necessary	Assessment Score		0
		Assessment Band		E

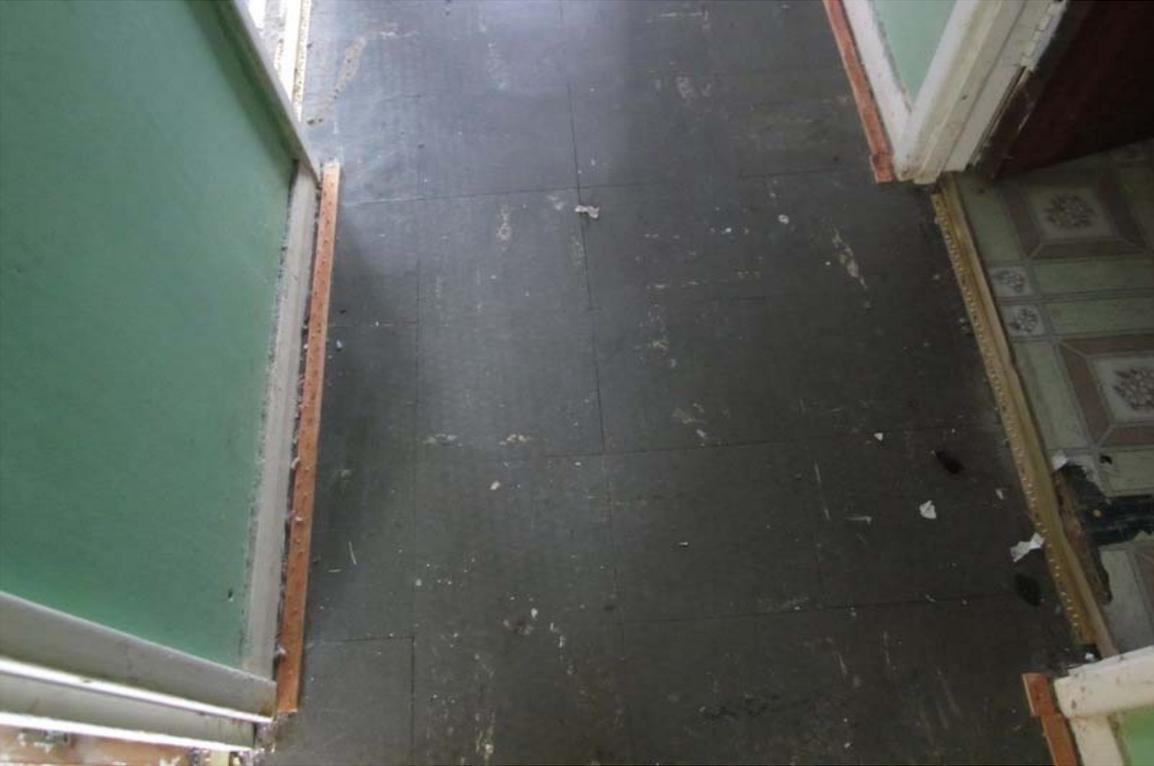
Photo Number	94	Reference number	230316MW102
Inspection / Sample	Inspection	Inspection Cross Reference / Visual I.D.	230316MW72

Notes	ACM: Asbestos Containing Material

Building	Flat 7 - Neville House	Condition	Fair	1
Floor Level	2nd floor	Surface Treatment	Composite materials, reinforced plastics, resin, vinyl materials	0
Location	05 / Hallway	Material Friability	Low	1
Feature	Grey floor tiles and adhesive	Asbestos Type	Strongly Presumed Chrysotile (White)	1
Material Type	Floor Tile / Covering			
Extent	2 sq. m.			
Recommendation	Remove if likely to be disturbed during the refurbishment works	Assessment Score		3
		Assessment Band		D

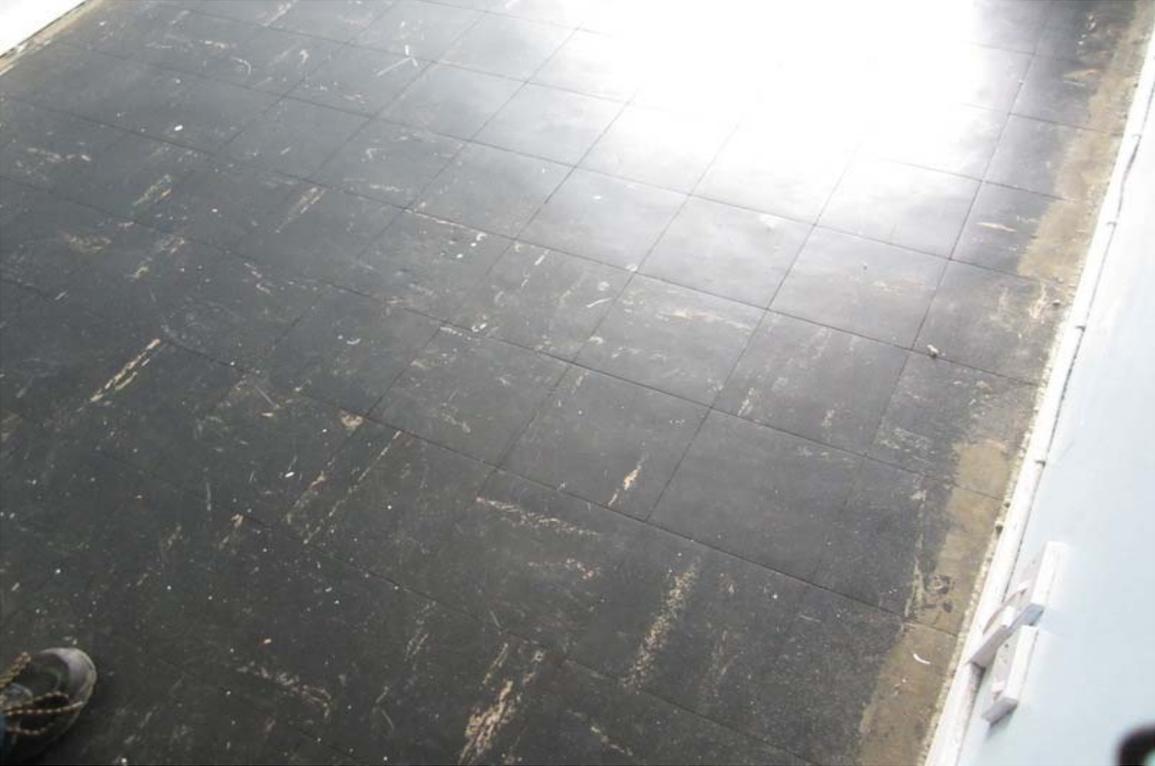
Photo Number	95	Reference number	230316MW103
Inspection / Sample	Inspection	Inspection Cross Reference / Visual I.D.	230316MW72

Notes	ACM: Asbestos Containing Material

Building	Flat 7 - Neville House	Condition	Fair	1
Floor Level	2nd floor	Surface Treatment	Composite materials, reinforced plastics, resin, vinyl materials	0
Location	06 / Bedroom 2	Material Friability	Low	1
Feature	Black floor tiles and adhesive	Asbestos Type	Strongly Presumed Chrysotile (White)	1
Material Type	Floor Tile / Covering			
Extent	10 sq. m.			
Recommendation	Remove if likely to be disturbed during the refurbishment works	Assessment Score		3
		Assessment Band		D

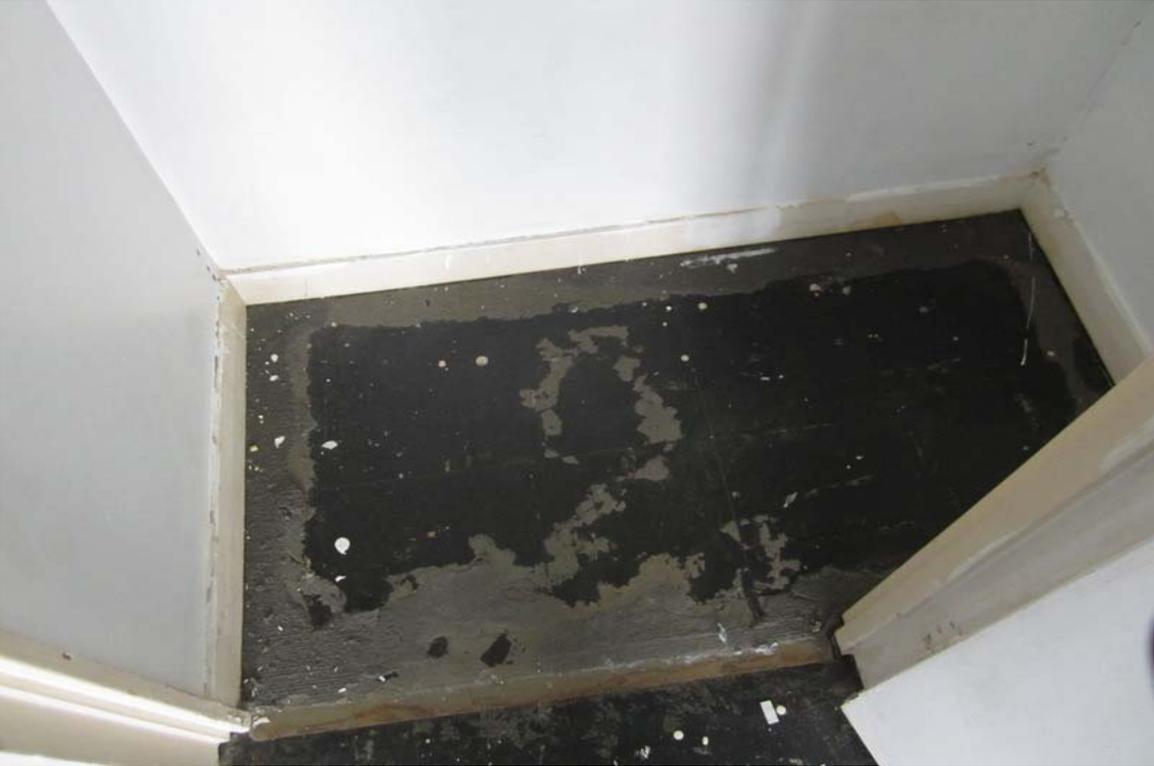
Photo Number	96	Reference number	230316MW104
Inspection / Sample	Inspection	Inspection Cross Reference / Visual I.D.	230316MW72

Notes	ACM: Asbestos Containing Material

Building	Flat 7 - Neville House	Condition	Fair	1
Floor Level	2nd floor	Surface Treatment	Composite materials, reinforced plastics, resin, vinyl materials	0
Location	07 / Cupboard	Material Friability	Low	1
Feature	Black floor tiles and adhesive	Asbestos Type	Strongly Presumed Chrysotile (White)	1
Material Type	Floor Tile / Covering			
Extent	0.5 sq. m.			
Recommendation	Remove if likely to be disturbed during the refurbishment works	Assessment Score		3
		Assessment Band		D

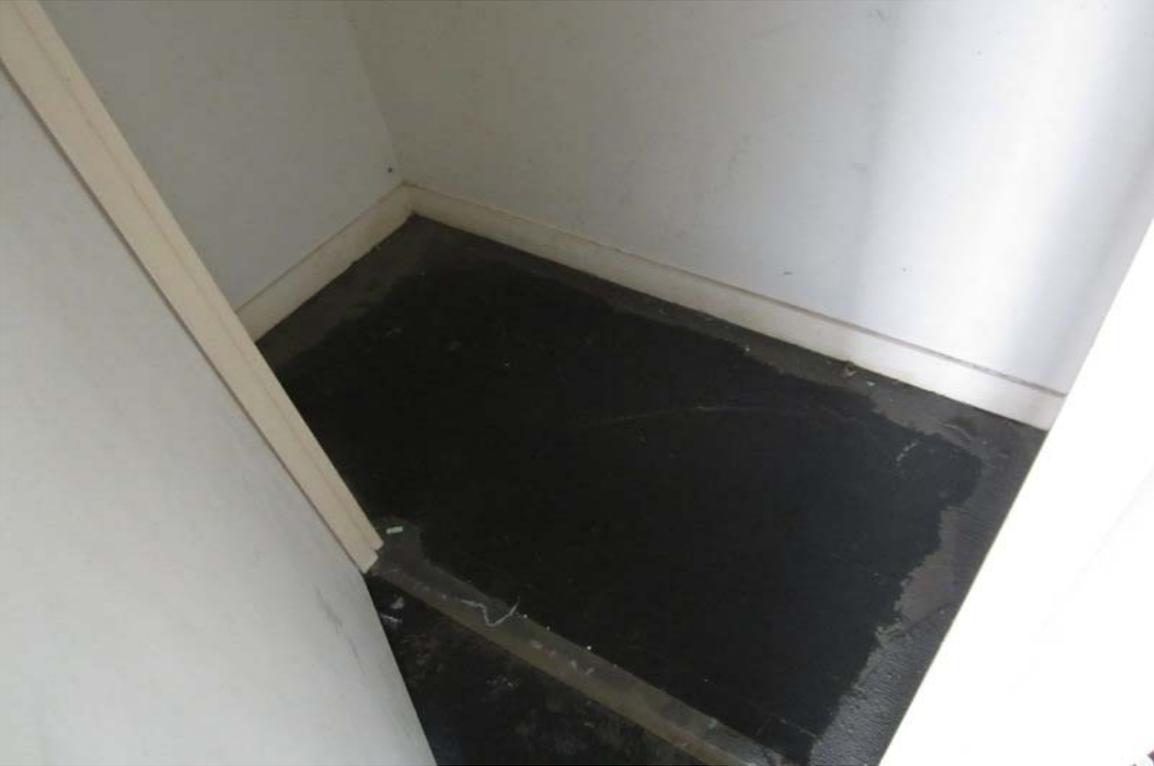
Photo Number	97	Reference number	230316MW105
Inspection / Sample	Inspection	Inspection Cross Reference / Visual I.D.	230316MW72

Notes	ACM: Asbestos Containing Material

Building	Flat 7 - Neville House	Condition	Fair	1
Floor Level	2nd floor	Surface Treatment	Composite materials, reinforced plastics, resin, vinyl materials	0
Location	08 / Cupboard	Material Friability	Low	1
Feature	Black floor tiles and adhesive	Asbestos Type	Strongly Presumed Chrysotile (White)	1
Material Type	Floor Tile / Covering			
Extent	0.5 sq. m.			
Recommendation	Remove if likely to be disturbed during the refurbishment works	Assessment Score		3
		Assessment Band		D

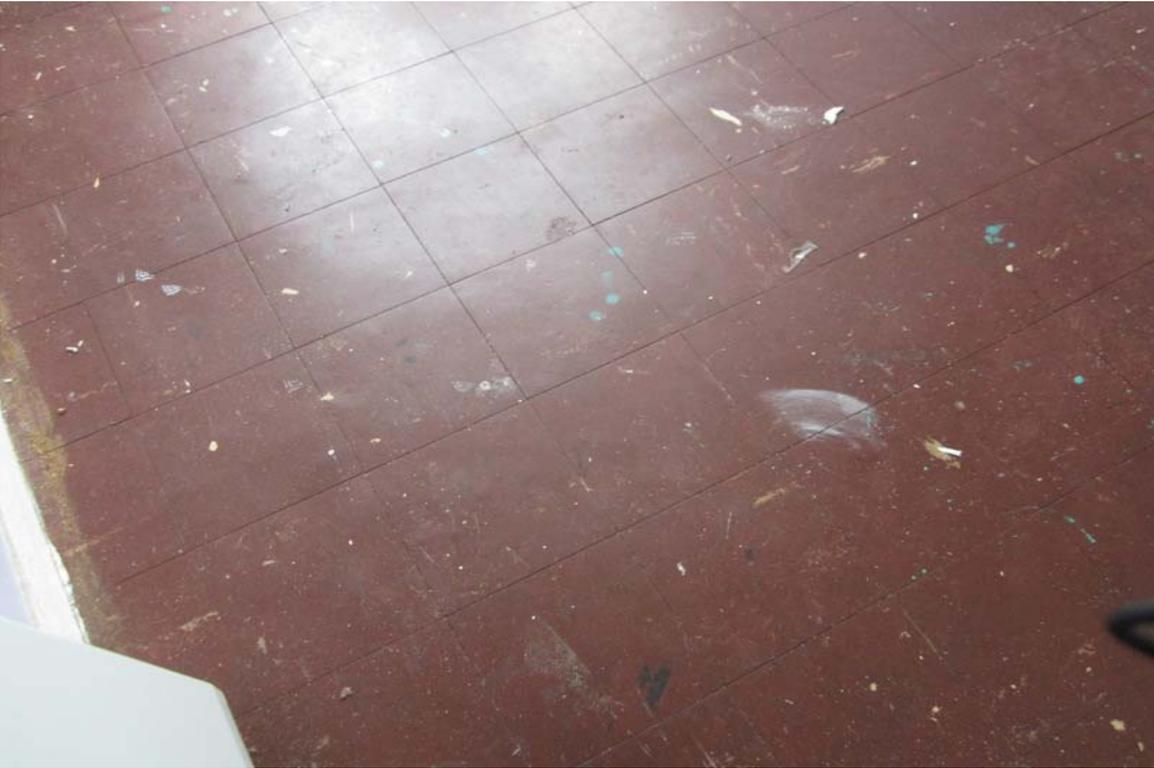
Photo Number	98	Reference number	230316MW106
Inspection / Sample	Inspection	Inspection Cross Reference / Visual I.D.	230316MW70

Notes	ACM: Asbestos Containing Material

Building	Flat 7 - Neville House	Condition	Fair	1
Floor Level	2nd floor	Surface Treatment	Composite materials, reinforced plastics, resin, vinyl materials	0
Location	09 / Bedroom 1	Material Friability	Low	1
Feature	Red floor tiles and adhesive	Asbestos Type	Strongly Presumed Chrysotile (White)	1
Material Type	Floor Tile / Covering			
Extent	10 sq. m.			
Recommendation	Remove if likely to be disturbed during the refurbishment works	Assessment Score		3
		Assessment Band		D

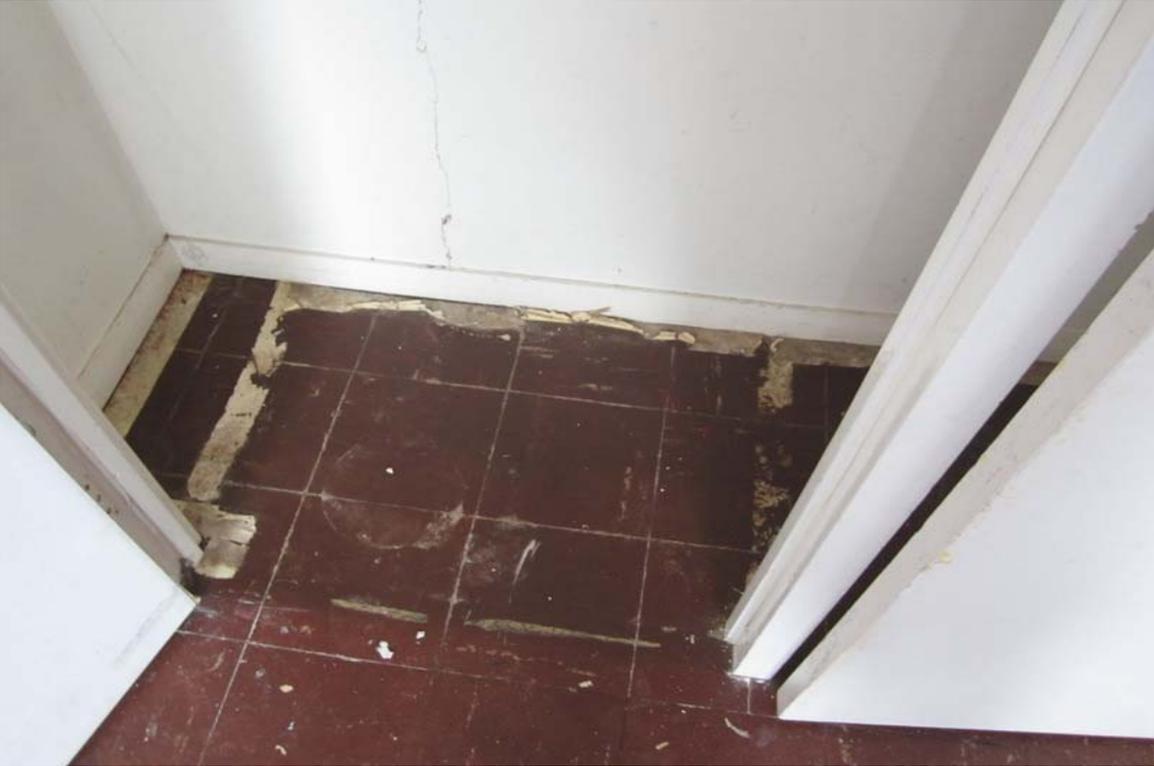
Photo Number	99	Reference number	230316MW107
Inspection / Sample	Inspection	Inspection Cross Reference / Visual I.D.	230316MW70

Notes	ACM: Asbestos Containing Material

Building	Flat 7 - Neville House	Condition	Fair	1
Floor Level	2nd floor	Surface Treatment	Composite materials, reinforced plastics, resin, vinyl materials	0
Location	10 / Cupboard	Material Friability	Low	1
Feature	Red floor tiles and adhesive	Asbestos Type	Strongly Presumed Chrysotile (White)	1
Material Type	Floor Tile / Covering			
Extent	2 sq. m.			
Recommendation	Remove if likely to be disturbed during the refurbishment works	Assessment Score		3
		Assessment Band		D

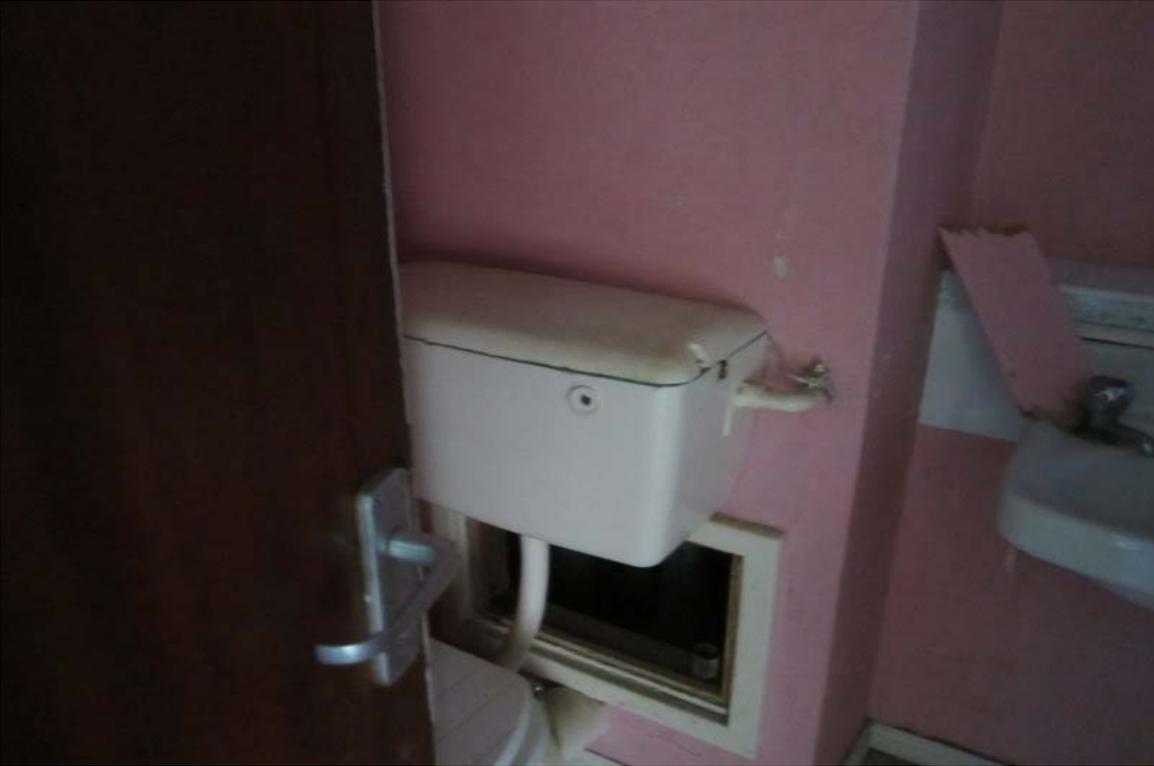
Photo Number	100	Reference number	230316MW108
Inspection / Sample	Inspection	Inspection Cross Reference / Visual I.D.	220316MW20

Notes	ACM: Asbestos Containing Material

Building	Flat 7 - Neville House	Condition	Fair	1
Floor Level	2nd floor	Surface Treatment	Composite materials, reinforced plastics, resin, vinyl materials	0
Location	11 / Bathroom	Material Friability	Low	1
Feature	Toilet cistern	Asbestos Type	Strongly Presumed Amosite (Brown)	2
Material Type	Composite / Resin			
Extent	1 No.			
Recommendation	Remove if likely to be disturbed during the refurbishment works	Assessment Score		4
		Assessment Band		D

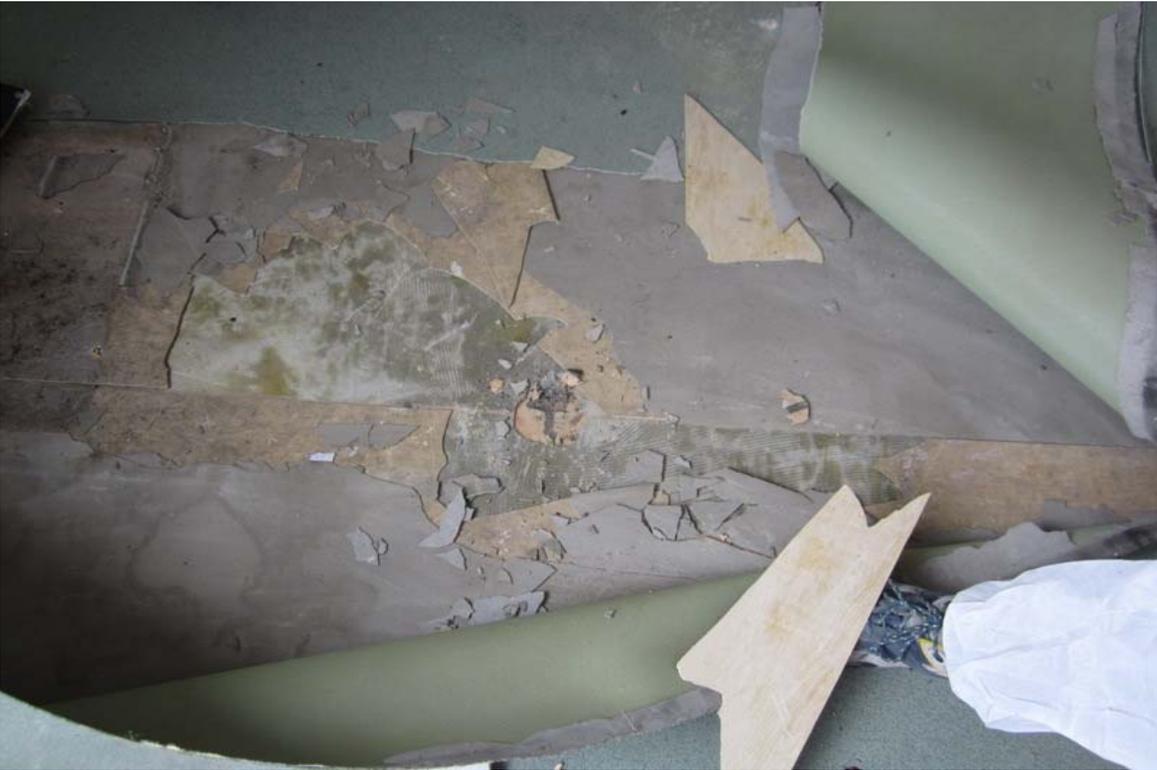
Photo Number	103	Reference number	230316MW111
Inspection / Sample	Inspection	Inspection Cross Reference / Visual I.D.	230316MW72

Notes	ACM: Asbestos Containing Material

Building	Flat 6 - Neville House	Condition	Fair	1
Floor Level	3rd floor	Surface Treatment	Composite materials, reinforced plastics, resin, vinyl materials	0
Location	02 / Kitchen	Material Friability	Low	1
Feature	Grey and black floor tiles and adhesive	Asbestos Type	Strongly Presumed Chrysotile (White)	1
Material Type	Floor Tile / Covering			
Extent	15 sq. m.			
Recommendation	Remove if likely to be disturbed during the refurbishment works	Assessment Score		3
		Assessment Band		D

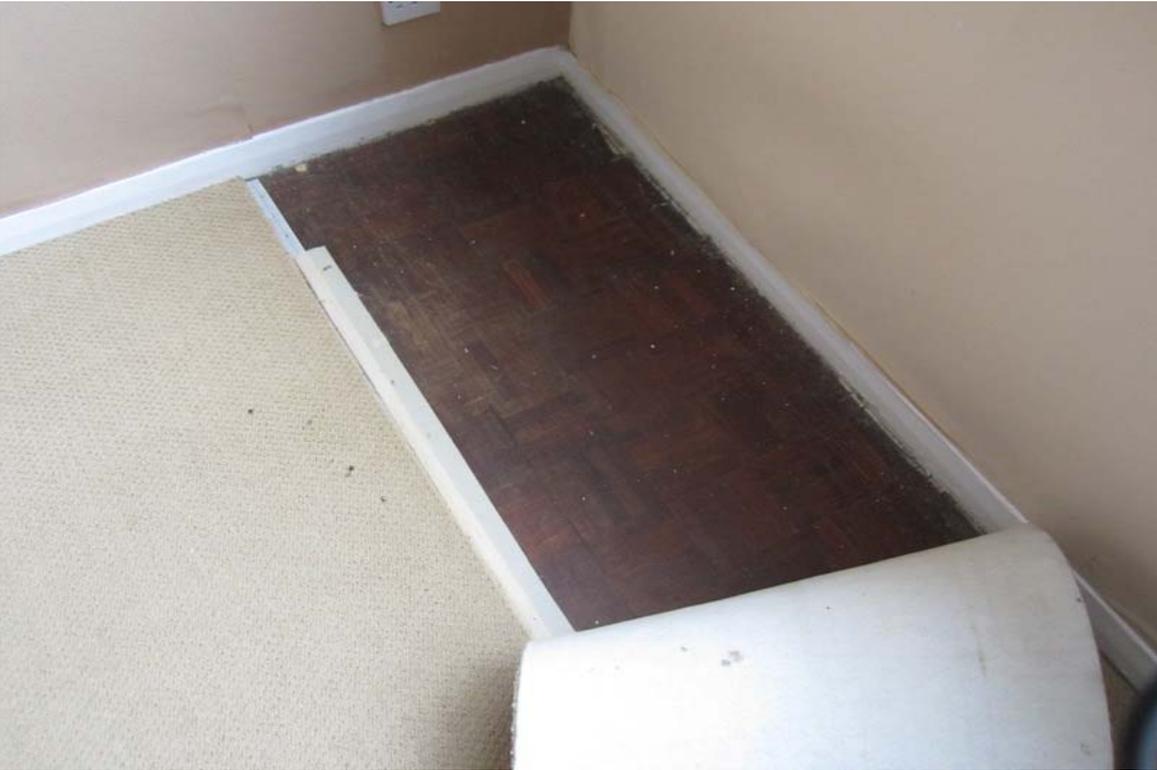
Photo Number	104	Reference number	230316MW112
Inspection / Sample	Inspection	Inspection Cross Reference / Visual I.D.	220316MW24

Notes	NADIS: No Asbestos Detected In Sample

Building	Flat 6 - Neville House	Condition	Fair	1
Floor Level	2nd floor	Surface Treatment	Composite materials, reinforced plastics, resin, vinyl materials	0
Location	04 / Lounge	Material Friability	Low	1
Feature	Bitumen adhesive beneath parquet flooring	Asbestos Type	Strongly Presumed N.A.D.I.S	0
Material Type	Bitumen			
Extent	20 sq. m.			
Recommendation	No action necessary	Assessment Score		0
		Assessment Band		E

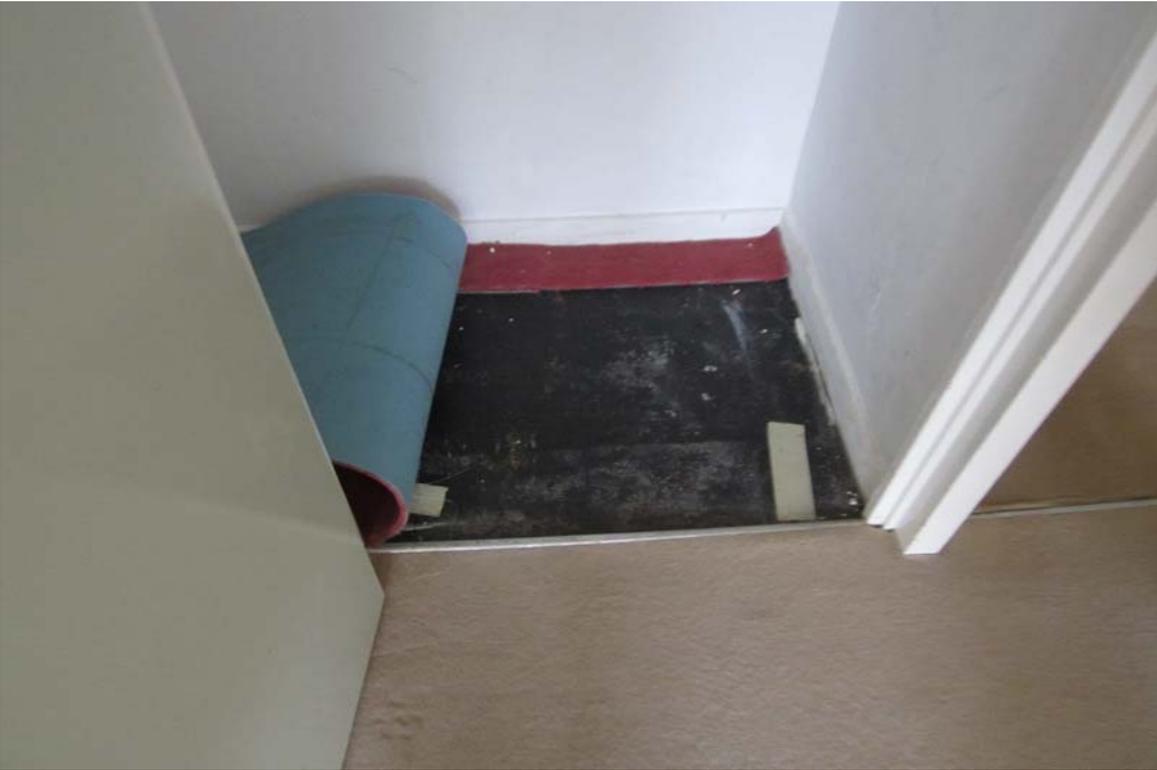
Photo Number	111	Reference number	230316MW119
Inspection / Sample	Inspection	Inspection Cross Reference / Visual I.D.	230316MW72

Notes	ACM: Asbestos Containing Material

Building	Flat 6 - Neville House	Condition	Fair	1
Floor Level	2nd floor	Surface Treatment	Composite materials, reinforced plastics, resin, vinyl materials	0
Location	10 / Cupboard	Material Friability	Low	1
Feature	Black floor tiles and adhesive	Asbestos Type	Strongly Presumed Chrysotile (White)	1
Material Type	Floor Tile / Covering			
Extent	0.5 sq. m.			
Recommendation	Remove if likely to be disturbed during the refurbishment works	Assessment Score		3
		Assessment Band		D

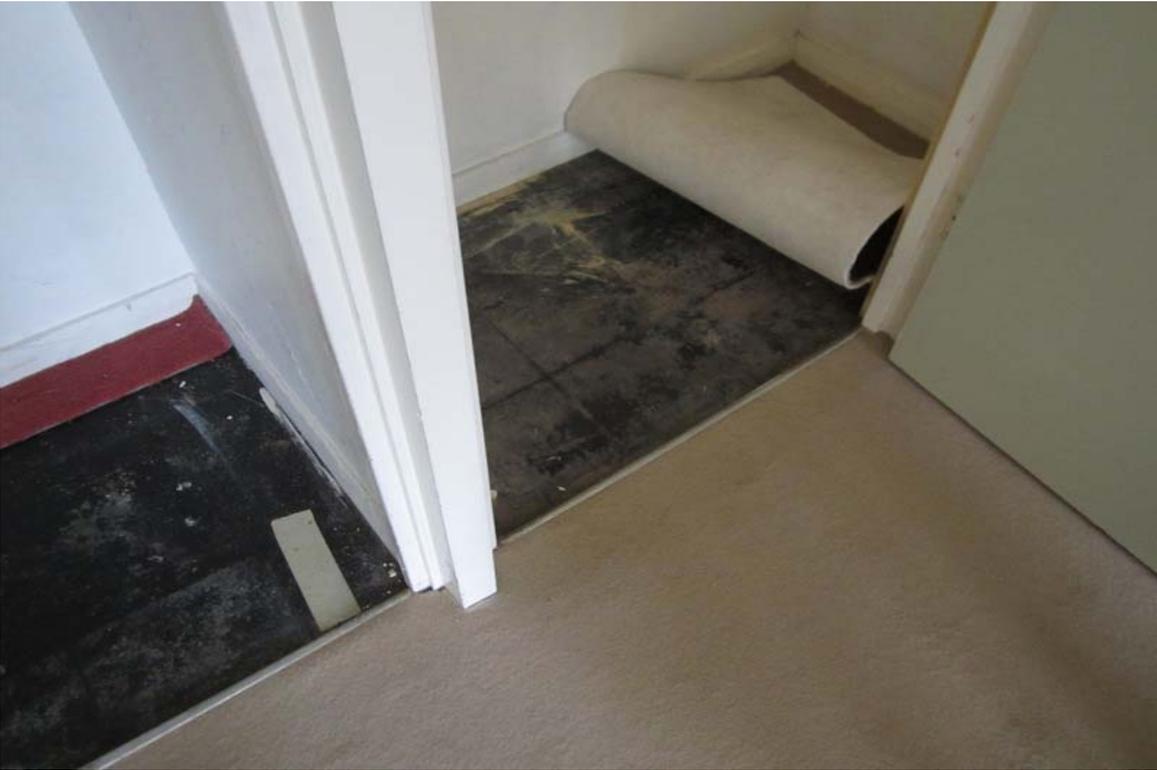
Photo Number	112	Reference number	230316MW120
Inspection / Sample	Inspection	Inspection Cross Reference / Visual I.D.	230316MW72

Notes	ACM: Asbestos Containing Material

Building	Flat 6 - Neville House	Condition	Fair	1
Floor Level	2nd floor	Surface Treatment	Composite materials, reinforced plastics, resin, vinyl materials	0
Location	11 / Cupboard	Material Friability	Low	1
Feature	Black floor tiles and adhesive	Asbestos Type	Strongly Presumed Chrysotile (White)	1
Material Type	Floor Tile / Covering			
Extent	0.5 sq. m.			
Recommendation	Remove if likely to be disturbed during the refurbishment works	Assessment Score		3
		Assessment Band		D

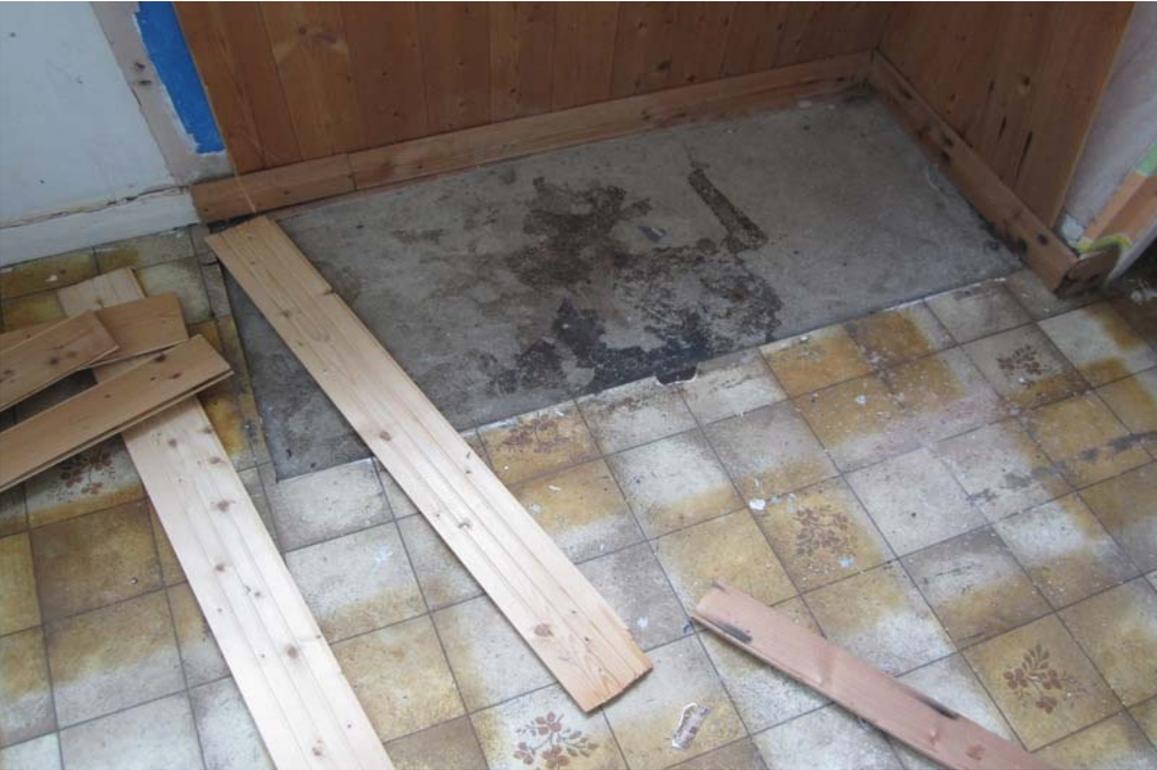
Photo Number	114	Reference number	230316MW122
Inspection / Sample	Inspection	Inspection Cross Reference / Visual I.D.	230316MW72

Notes	ACM: Asbestos Containing Material

Building	Flat 5 - Neville House	Condition	Fair	1
Floor Level	3rd floor	Surface Treatment	Composite materials, reinforced plastics, resin, vinyl materials	0
Location	02 / Kitchen	Material Friability	Low	1
Feature	Grey and black floor tiles and adhesive	Asbestos Type	Strongly Presumed Chrysotile (White)	1
Material Type	Floor Tile / Covering			
Extent	12 sq. m.			
Recommendation	Remove if likely to be disturbed during the refurbishment works	Assessment Score		3
		Assessment Band		D

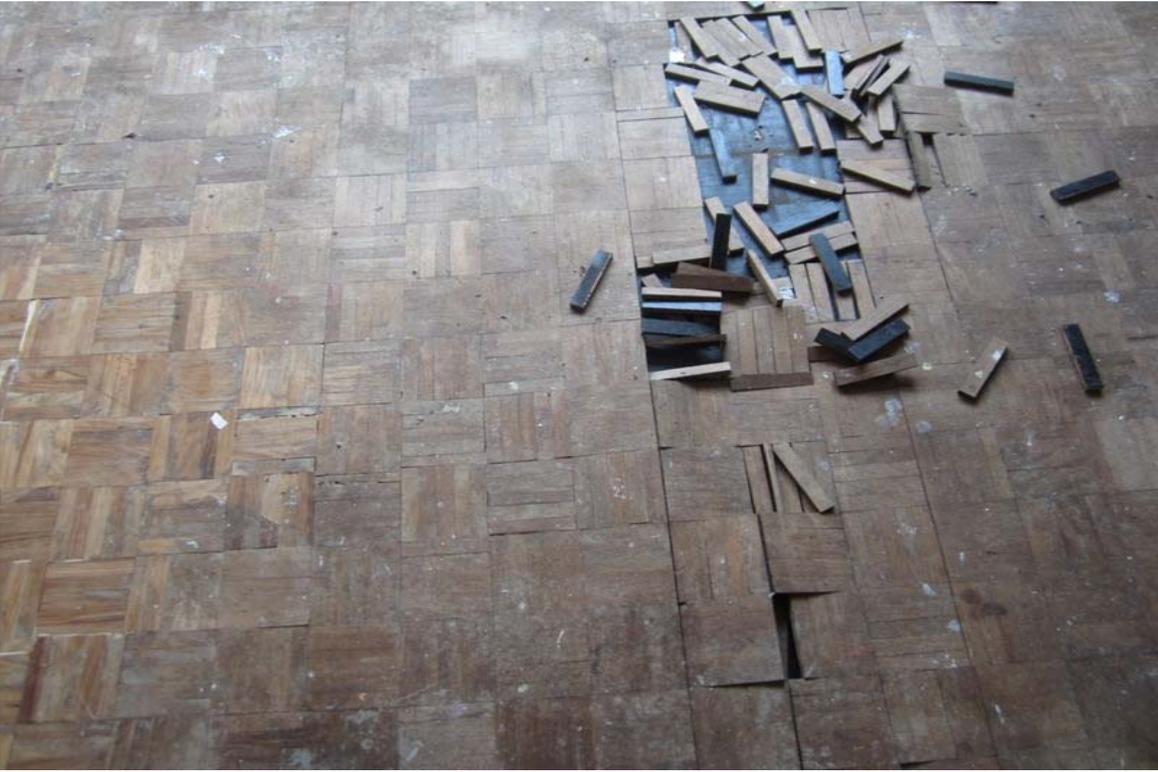
Photo Number	120	Reference number	230316MW128
Inspection / Sample	Sample	Inspection Cross Reference / Visual I.D.	Not Applicable

Notes	NADIS: No Asbestos Detected In Sample

Building	Flat 5 - Neville House	Condition	Fair	1
Floor Level	4th floor	Surface Treatment	Composite materials, reinforced plastics, resin, vinyl materials	0
Location	09 / Lounge	Material Friability	Low	1
Feature	Bitumen adhesive beneath parquet flooring	Asbestos Type	N.A.D.I.S	0
Material Type	Bitumen			
Extent	16 sq. m.			
Recommendation	No action necessary	Assessment Score		0
		Assessment Band		E

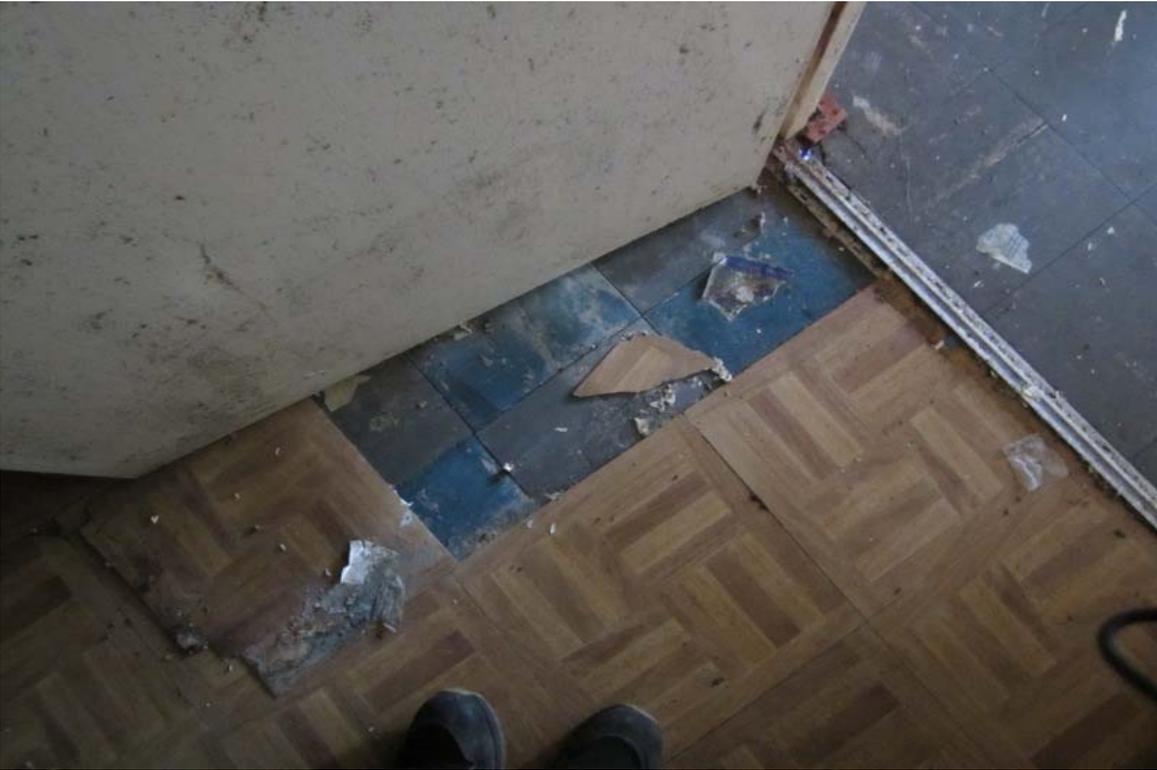
Photo Number	122	Reference number	230316MW130
Inspection / Sample	Inspection	Inspection Cross Reference / Visual I.D.	230316MW81

Notes	ACM: Asbestos Containing Material

Building	Flat 5 - Neville House	Condition	Fair	1
Floor Level	4th floor	Surface Treatment	Composite materials, reinforced plastics, resin, vinyl materials	0
Location	10 / Bathroom	Material Friability	Low	1
Feature	Blue and green floor tiles and adhesive	Asbestos Type	Strongly Presumed Chrysotile (White)	1
Material Type	Floor Tile / Covering			
Extent	2 sq. m.			
Recommendation	Remove if likely to be disturbed during the refurbishment works	Assessment Score		3
		Assessment Band		D

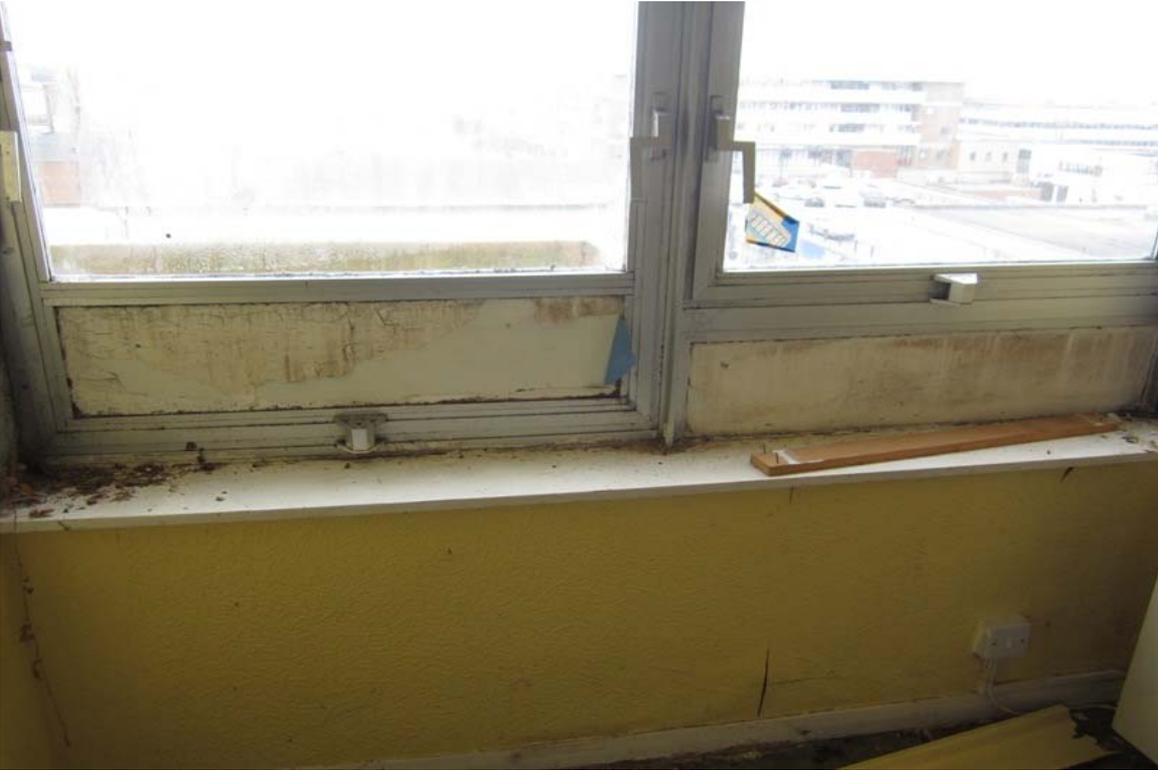
Photo Number	125	Reference number	230316MW133
Inspection / Sample	Sample	Inspection Cross Reference / Visual I.D.	Not Applicable

Notes	NADIS: No Asbestos Detected In Sample

Building	Flat 5 - Neville House	Condition	Fair	1
Floor Level	4th floor	Surface Treatment	Unsealed AIB or encapsulated lagging and spray	2
Location	12 / Bedroom 2	Material Friability	Medium	2
Feature	Panelling beneath window	Asbestos Type	N.A.D.I.S	0
Material Type	Insulating Board			
Extent	2 sq. m.			
Recommendation	No action necessary	Assessment Score		0
		Assessment Band		E

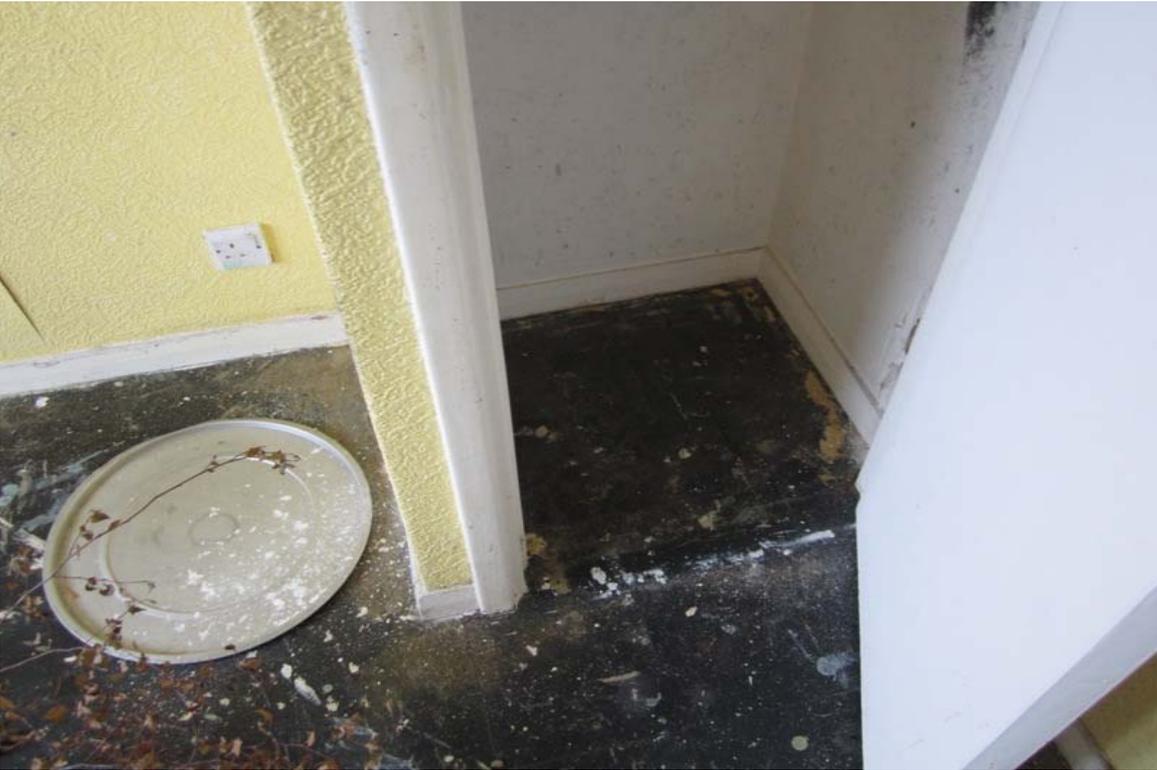
Photo Number	126	Reference number	230316MW134
Inspection / Sample	Inspection	Inspection Cross Reference / Visual I.D.	230316MW72

Notes	ACM: Asbestos Containing Material

Building	Flat 5 - Neville House	Condition	Fair	1
Floor Level	4th floor	Surface Treatment	Composite materials, reinforced plastics, resin, vinyl materials	0
Location	13 / Cupboard	Material Friability	Low	1
Feature	Black floor tiles and adhesive	Asbestos Type	Strongly Presumed Chrysotile (White)	1
Material Type	Floor Tile / Covering			
Extent	0.5 sq. m.			
Recommendation	Remove if likely to be disturbed during the refurbishment works	Assessment Score		3
		Assessment Band		D

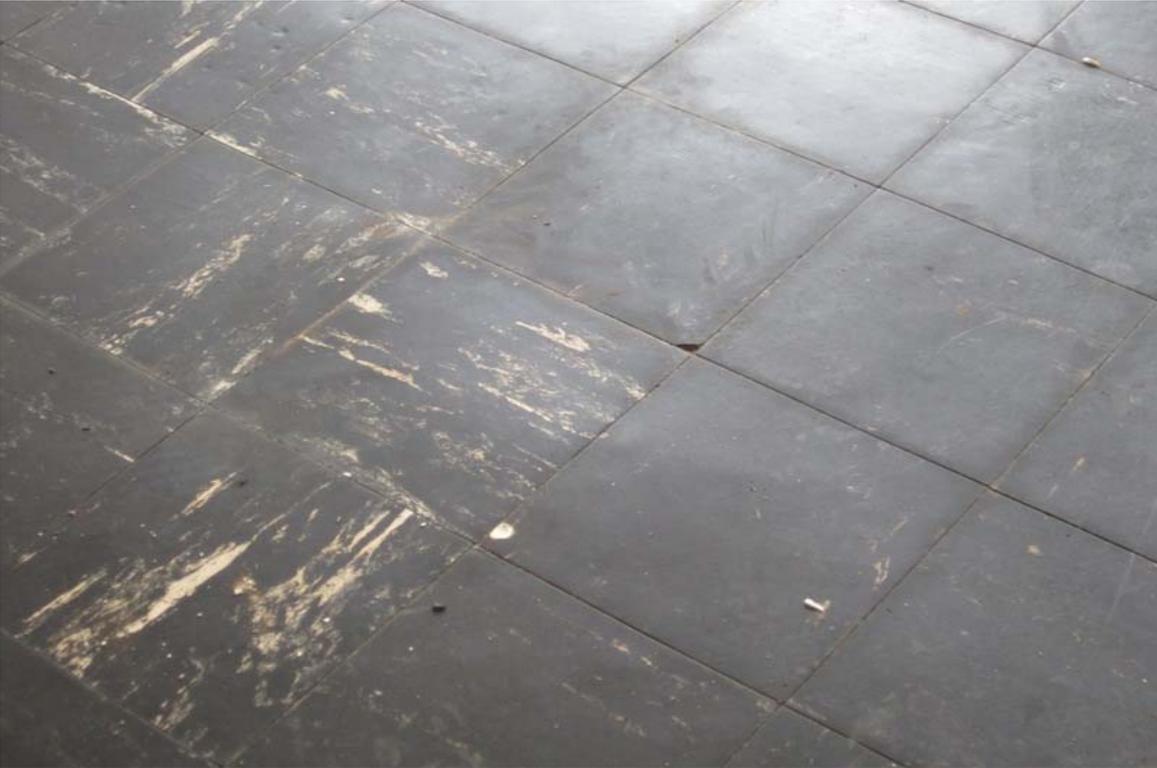
Photo Number	131	Reference number	230316MW138
Inspection / Sample	Inspection	Inspection Cross Reference / Visual I.D.	230316MW72

Notes	ACM: Asbestos Containing Material

Building	Flat 4 - Neville House	Condition	Fair	1
Floor Level	4th floor	Surface Treatment	Composite materials, reinforced plastics, resin, vinyl materials	0
Location	06 / Bedroom 1	Material Friability	Low	1
Feature	Black floor tiles and adhesive	Asbestos Type	Strongly Presumed Chrysotile (White)	1
Material Type	Floor Tile / Covering			
Extent	15 sq. m.			
Recommendation	Remove if likely to be disturbed during the refurbishment works	Assessment Score		3
		Assessment Band		D

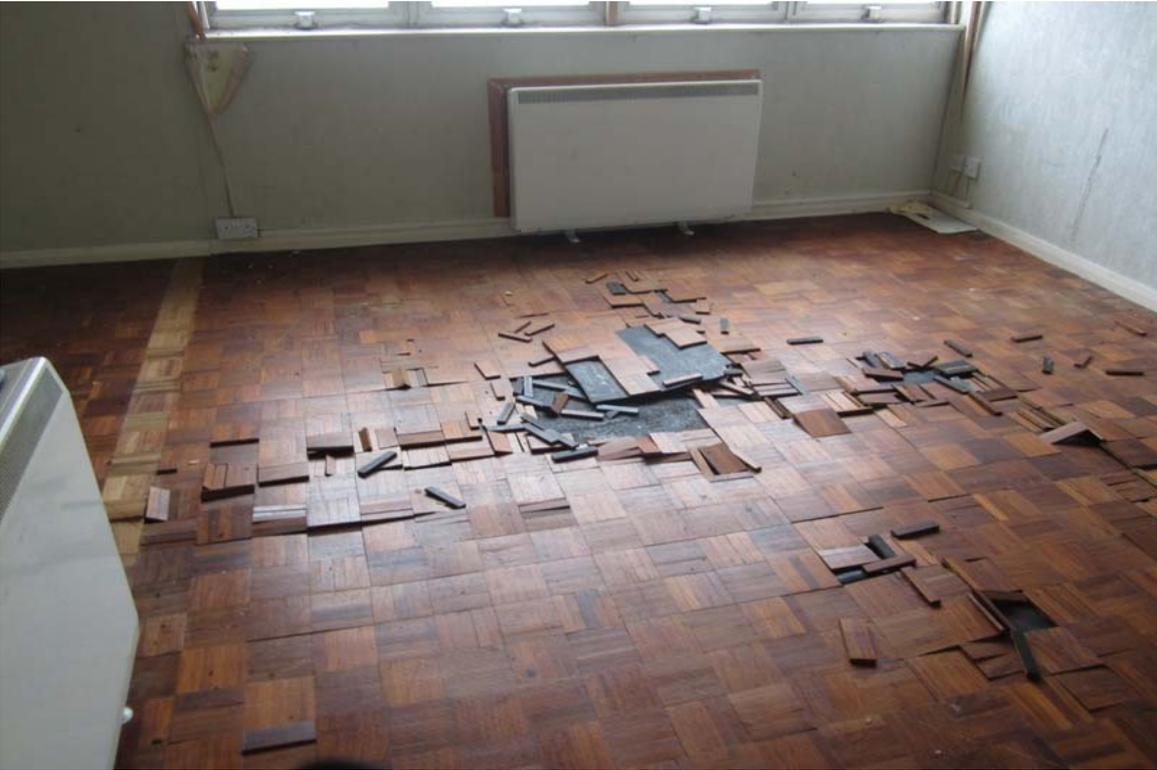
Photo Number	133	Reference number	230316MW141
Inspection / Sample	Sample	Inspection Cross Reference / Visual I.D.	Not Applicable

Notes	NADIS: No Asbestos Detected In Sample

Building	Flat 4 - Neville House	Condition	Fair	1
Floor Level	4th floor	Surface Treatment	Composite materials, reinforced plastics, resin, vinyl materials	0
Location	09 / Lounge	Material Friability	Low	1
Feature	Bitumen adhesive beneath parquet flooring	Asbestos Type	N.A.D.I.S	0
Material Type	Bitumen			
Extent	20 sq. m.			
Recommendation	No action necessary	Assessment Score		0
		Assessment Band		E

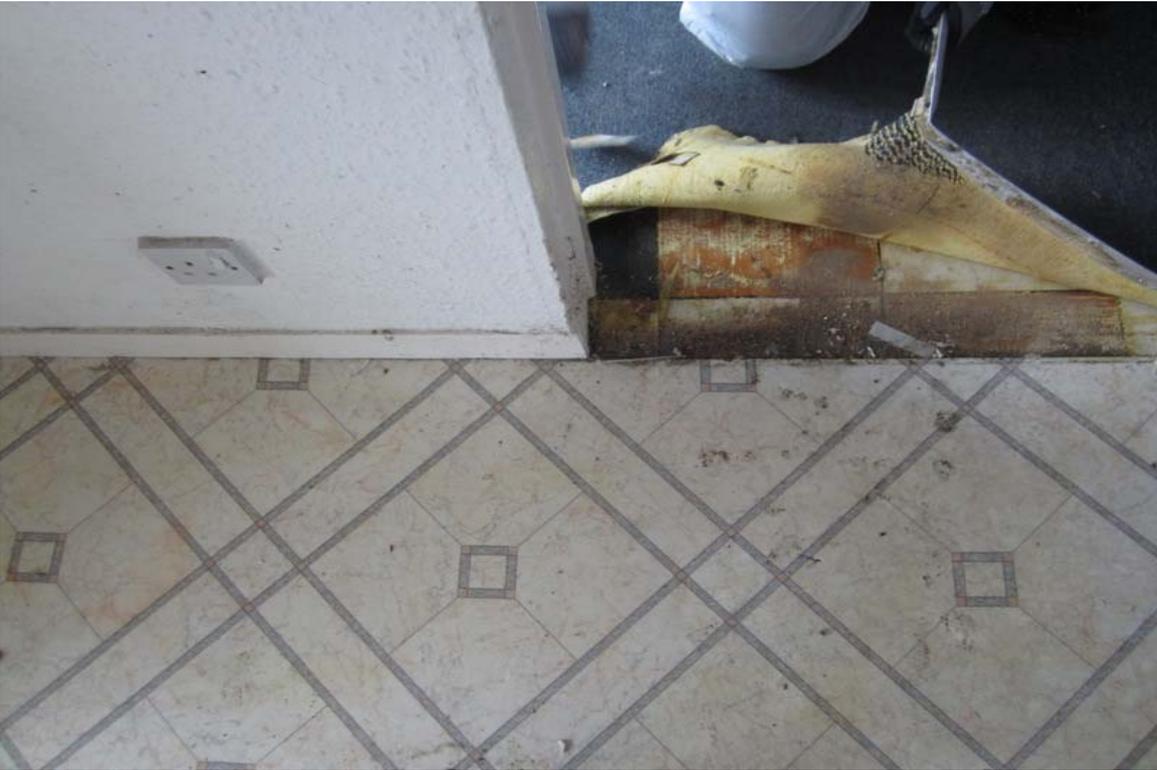
Photo Number	135	Reference number	230316MW143
Inspection / Sample	Inspection	Inspection Cross Reference / Visual I.D.	230316MW72

Notes	ACM: Asbestos Containing Material

Building	Flat 3 - Neville House	Condition	Fair	1
Floor Level	3rd floor	Surface Treatment	Composite materials, reinforced plastics, resin, vinyl materials	0
Location	01 / Lobby	Material Friability	Low	1
Feature	Grey and black floor tiles and adhesive	Asbestos Type	Strongly Presumed Chrysotile (White)	1
Material Type	Floor Tile / Covering			
Extent	2 sq. m.			
Recommendation	Remove if likely to be disturbed during the refurbishment works	Assessment Score		3
		Assessment Band		D
