**CBC Asbestos Refurbishment Survey Report
Neville House, George Street, Corby
22nd – 24th March 2016**

Reference:					
Issue			Prepared by	Verified by	
V1	Apr 16	JQ

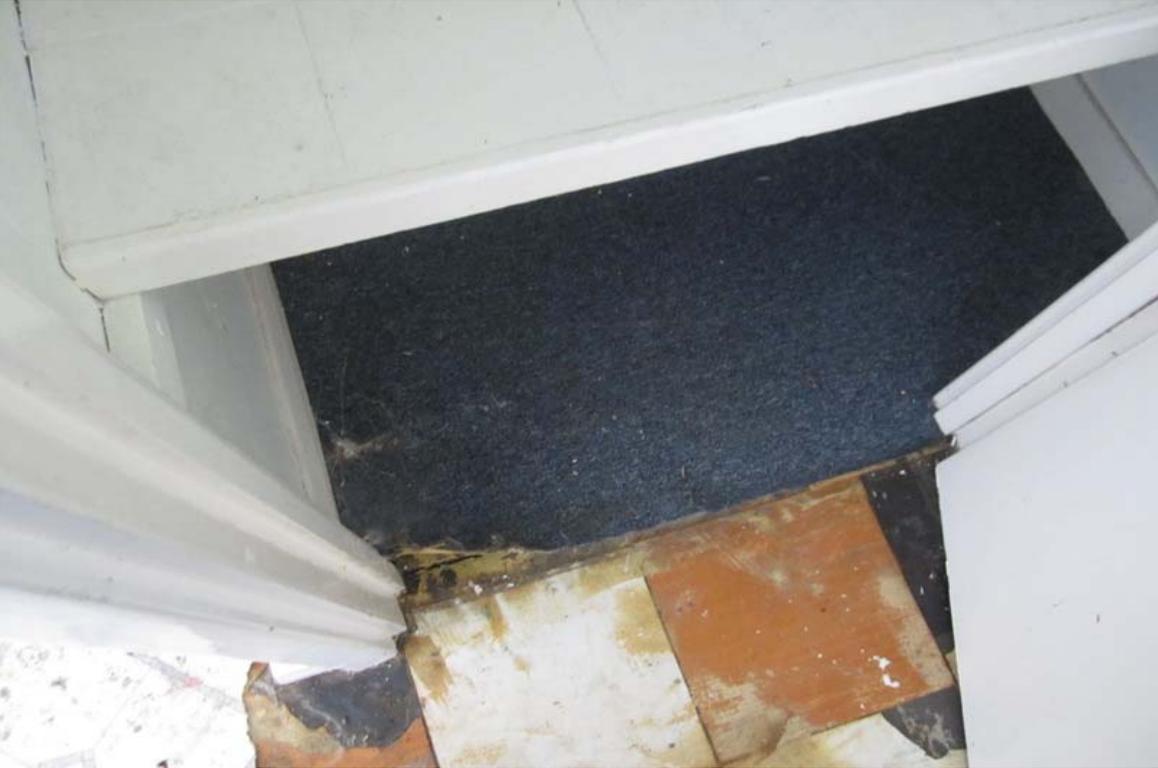
Photo Number	137	Reference number	230316MW145
Inspection / Sample	Inspection	Inspection Cross Reference / Visual I.D.	230316MW72

Notes	ACM: Asbestos Containing Material

Building	Flat 3 - Neville House	Condition	Fair	1
Floor Level	3rd floor	Surface Treatment	Composite materials, reinforced plastics, resin, vinyl materials	0
Location	03 / Cupboard	Material Friability	Low	1
Feature	Grey and black floor tiles and adhesive	Asbestos Type	Strongly Presumed Chrysotile (White)	1
Material Type	Floor Tile / Covering			
Extent	0.5 sq. m.			
Recommendation	Remove if likely to be disturbed during the refurbishment works	Assessment Score		3
		Assessment Band		D

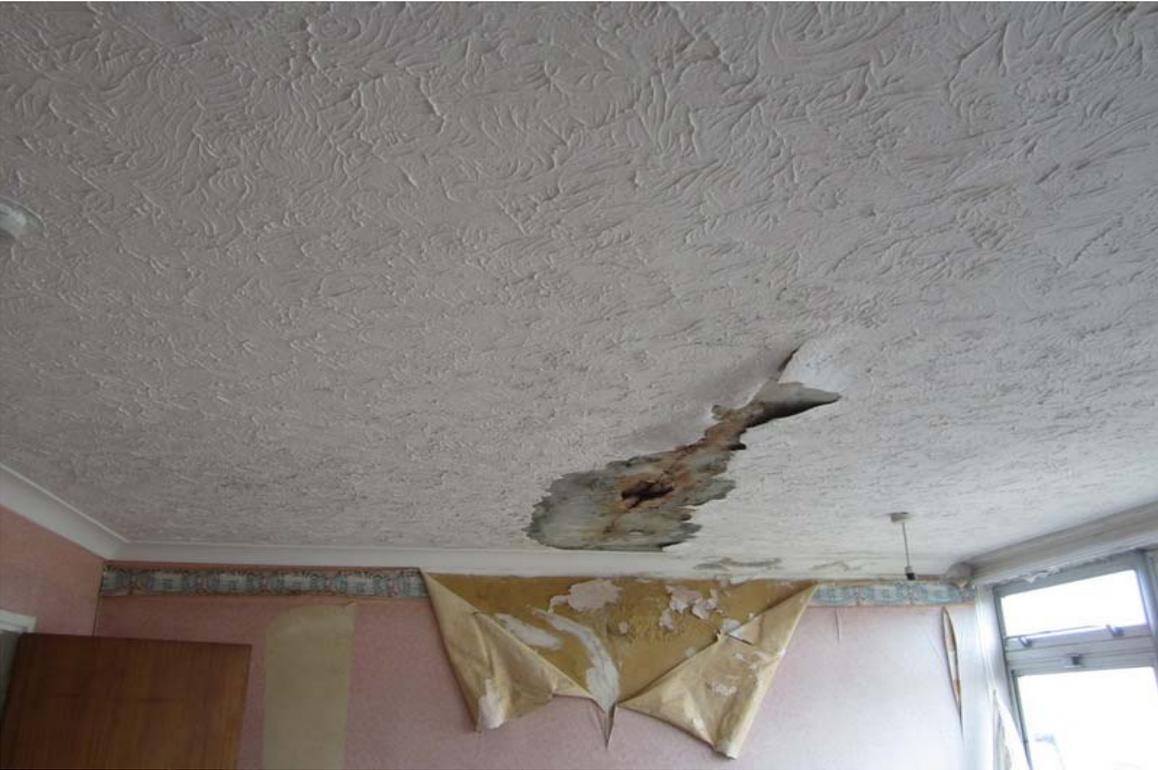
Photo Number	140	Reference number	230316MW148
Inspection / Sample	Sample	Inspection Cross Reference / Visual I.D.	Not Applicable

Notes	NADIS: No Asbestos Detected In Sample

Building	Flat 3 - Neville House	Condition	Poor	2
Floor Level	4th floor	Surface Treatment	Composite materials, reinforced plastics, resin, vinyl materials	0
Location	07 / Bedroom 1	Material Friability	Low	1
Feature	Coating to ceiling	Asbestos Type	N.A.D.I.S	0
Material Type	Textured Coating			
Extent	20 sq. m.			
Recommendation	No action necessary	Assessment Score		0
		Assessment Band		E

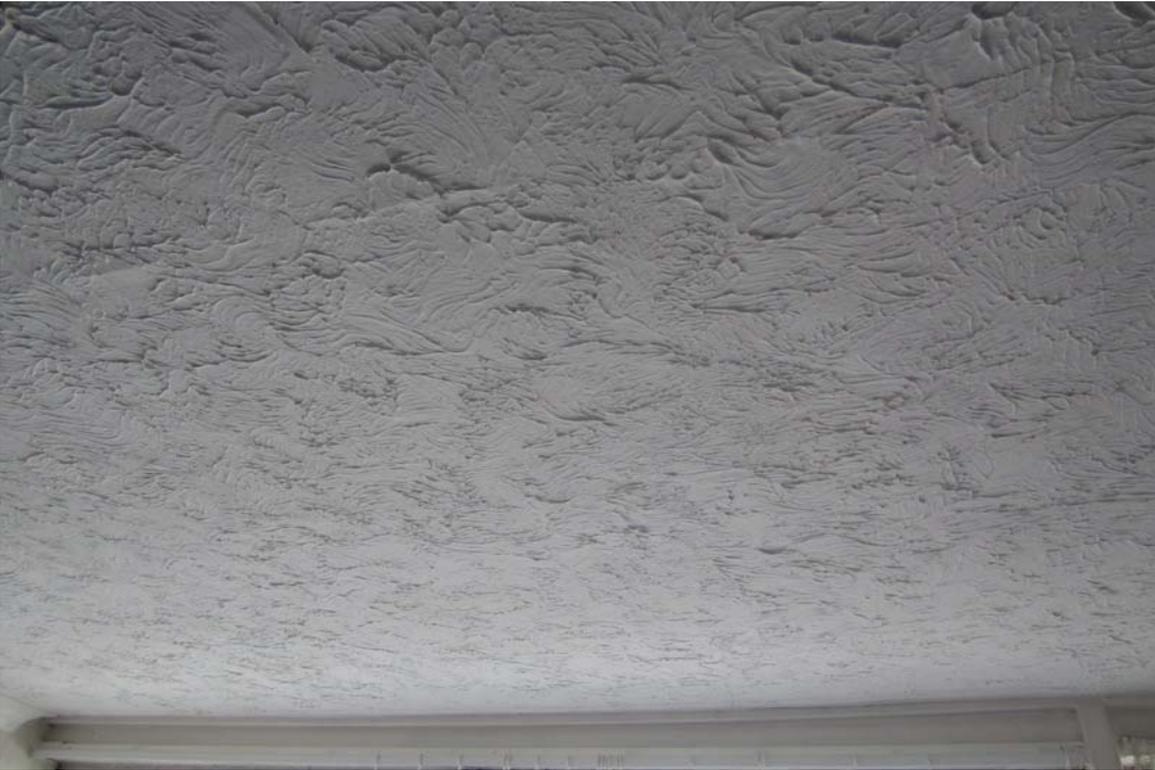
Photo Number	142	Reference number	230316MW150
Inspection / Sample	Inspection	Inspection Cross Reference / Visual I.D.	230316MW148

Notes	NADIS: No Asbestos Detected In Sample

Building	Flat 3 - Neville House	Condition	Fair	1
Floor Level	4th floor	Surface Treatment	Composite materials, reinforced plastics, resin, vinyl materials	0
Location	08 / Lounge	Material Friability	Low	1
Feature	Coating to ceiling	Asbestos Type	Strongly Presumed N.A.D.I.S	0
Material Type	Textured Coating			
Extent	20 sq. m.			
Recommendation	No action necessary	Assessment Score		0
		Assessment Band		E

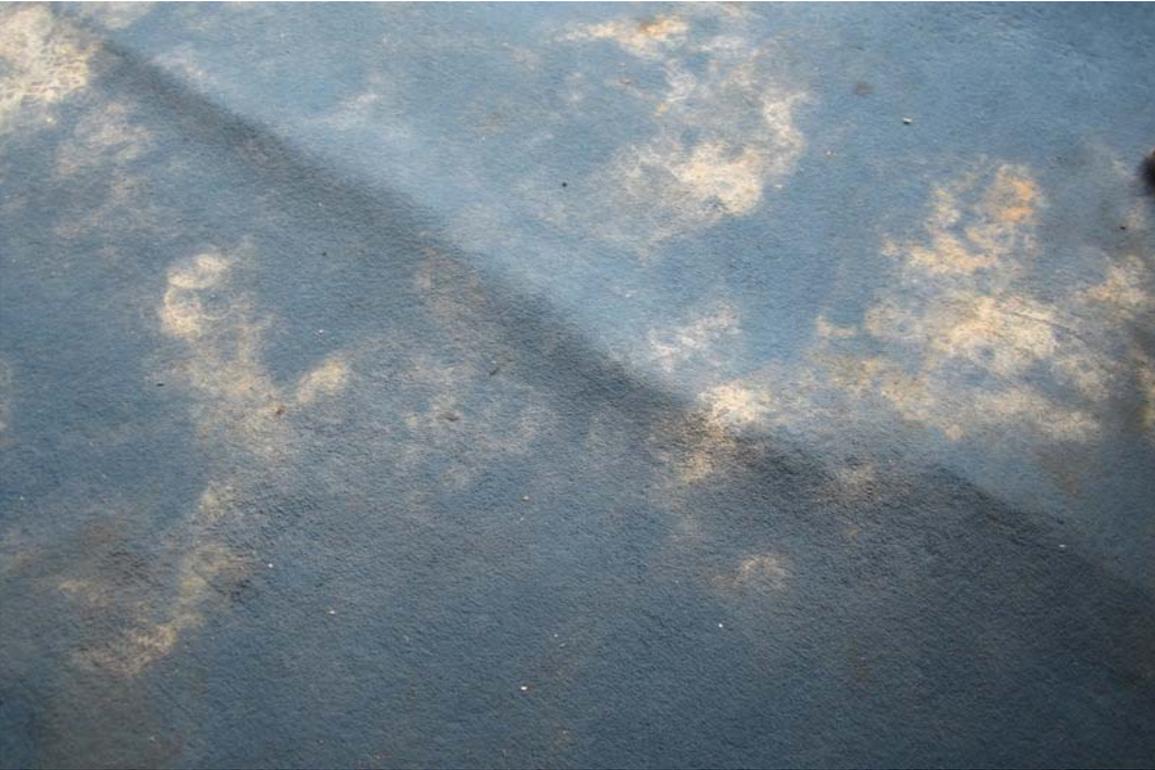
Photo Number	143	Reference number	230316MW151
Inspection / Sample	Inspection	Inspection Cross Reference / Visual I.D.	230316MW128

Notes	NADIS: No Asbestos Detected In Sample

Building	Flat 3 - Neville House	Condition	Fair	1
Floor Level	4th floor	Surface Treatment	Composite materials, reinforced plastics, resin, vinyl materials	0
Location	08 / Lounge	Material Friability	Low	1
Feature	Bitumen adhesive beneath parquet flooring	Asbestos Type	Strongly Presumed N.A.D.I.S	0
Material Type	Bitumen			
Extent	20 sq. m.			
Recommendation	No action necessary	Assessment Score		0
		Assessment Band		E

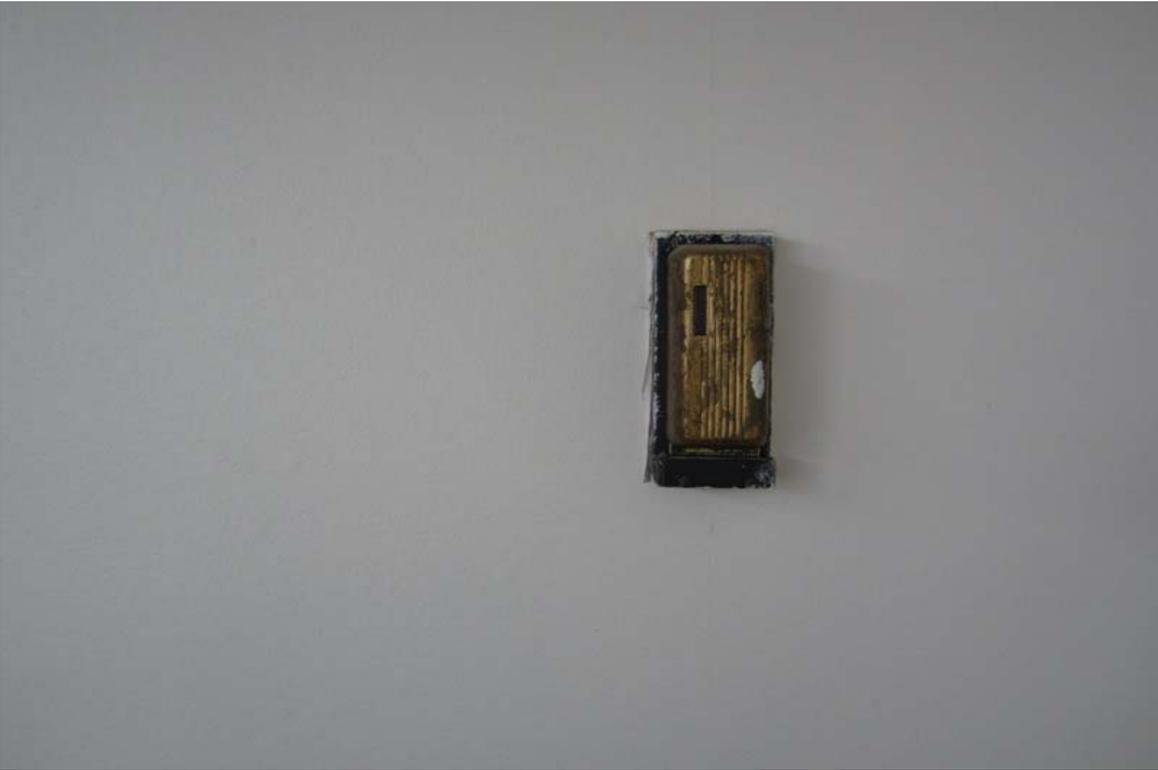
Photo Number	144	Reference number	230316MW152
Inspection / Sample	Inspection	Inspection Cross Reference / Visual I.D.	230316MW86

Notes	NADIS: No Asbestos Detected In Sample

Building	Flat 3 - Neville House	Condition	Fair	1
Floor Level	4th floor	Surface Treatment	Composite materials, reinforced plastics, resin, vinyl materials	0
Location	08 / Lounge	Material Friability	Low	1
Feature	Surround to door bell	Asbestos Type	Strongly Presumed N.A.D.I.S	0
Material Type	Composite / Resin			
Extent	1 No.			
Recommendation	No action necessary	Assessment Score		0
		Assessment Band		E

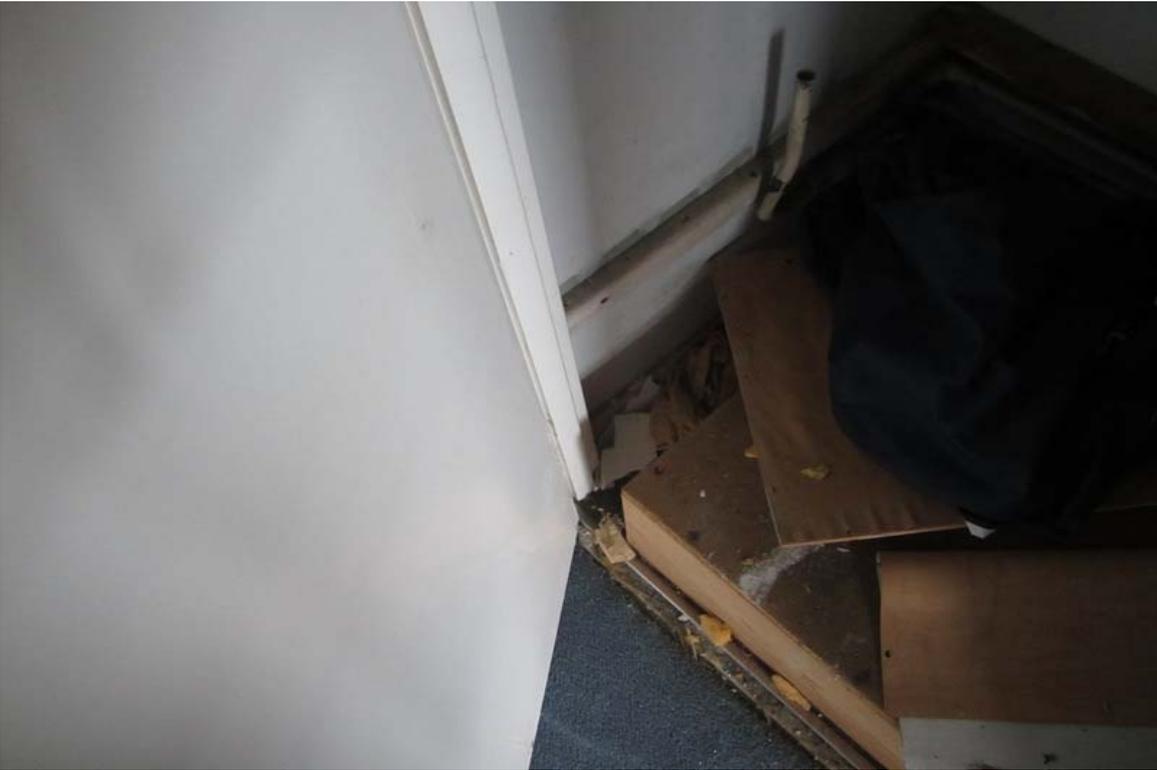
Photo Number	146	Reference number	230316MW154
Inspection / Sample	Inspection	Inspection Cross Reference / Visual I.D.	230316MW72

Notes	ACM: Asbestos Containing Material

Building	Flat 3 - Neville House	Condition	Fair	1
Floor Level	4th floor	Surface Treatment	Composite materials, reinforced plastics, resin, vinyl materials	0
Location	10 / Cupboard	Material Friability	Low	1
Feature	Grey floor tiles and adhesive	Asbestos Type	Strongly Presumed Chrysotile (White)	1
Material Type	Floor Tile / Covering			
Extent	0.5 sq. m.			
Recommendation	Remove if likely to be disturbed during the refurbishment works	Assessment Score		3
		Assessment Band		D

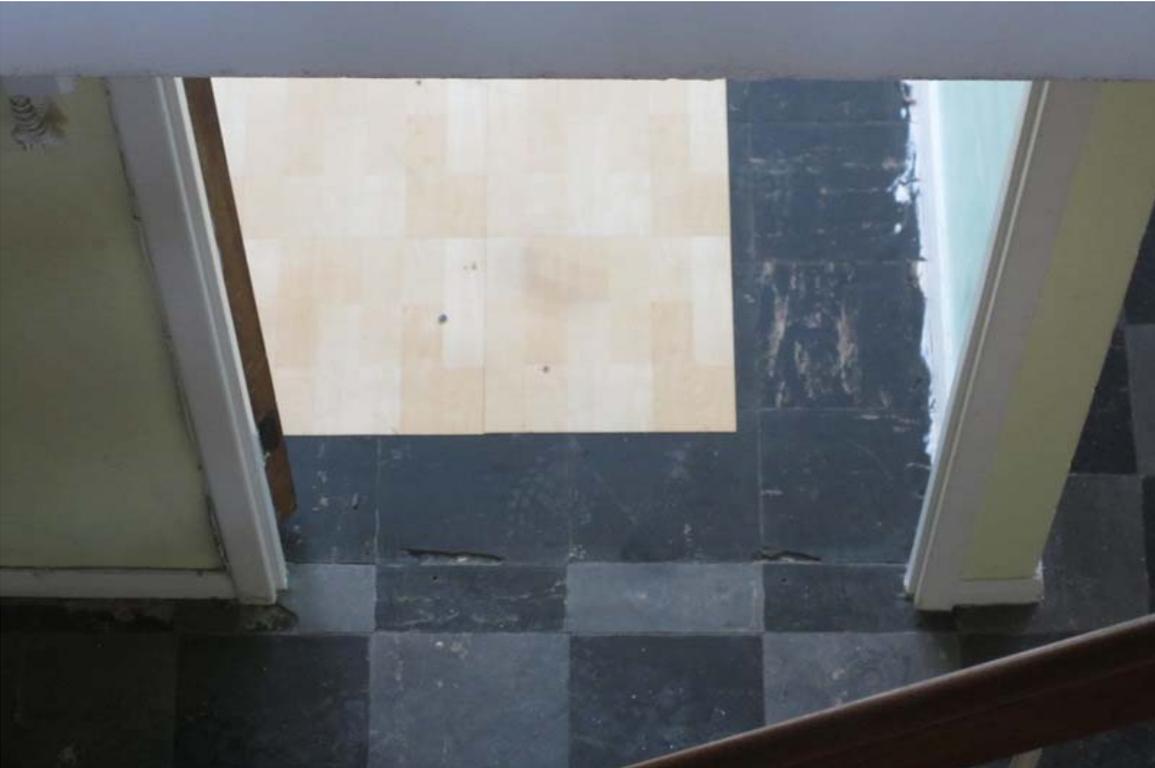
Photo Number	150	Reference number	230316MW158
Inspection / Sample	Inspection	Inspection Cross Reference / Visual I.D.	230316MW72

Notes	ACM: Asbestos Containing Material

Building	Flat 2 - Neville House	Condition	Fair	1
Floor Level	3rd floor	Surface Treatment	Composite materials, reinforced plastics, resin, vinyl materials	0
Location	05 / Bedroom 3	Material Friability	Low	1
Feature	Black floor tiles and adhesive	Asbestos Type	Strongly Presumed Chrysotile (White)	1
Material Type	Floor Tile / Covering			
Extent	8 sq. m.			
Recommendation	Remove if likely to be disturbed during the refurbishment works	Assessment Score		3
		Assessment Band		D

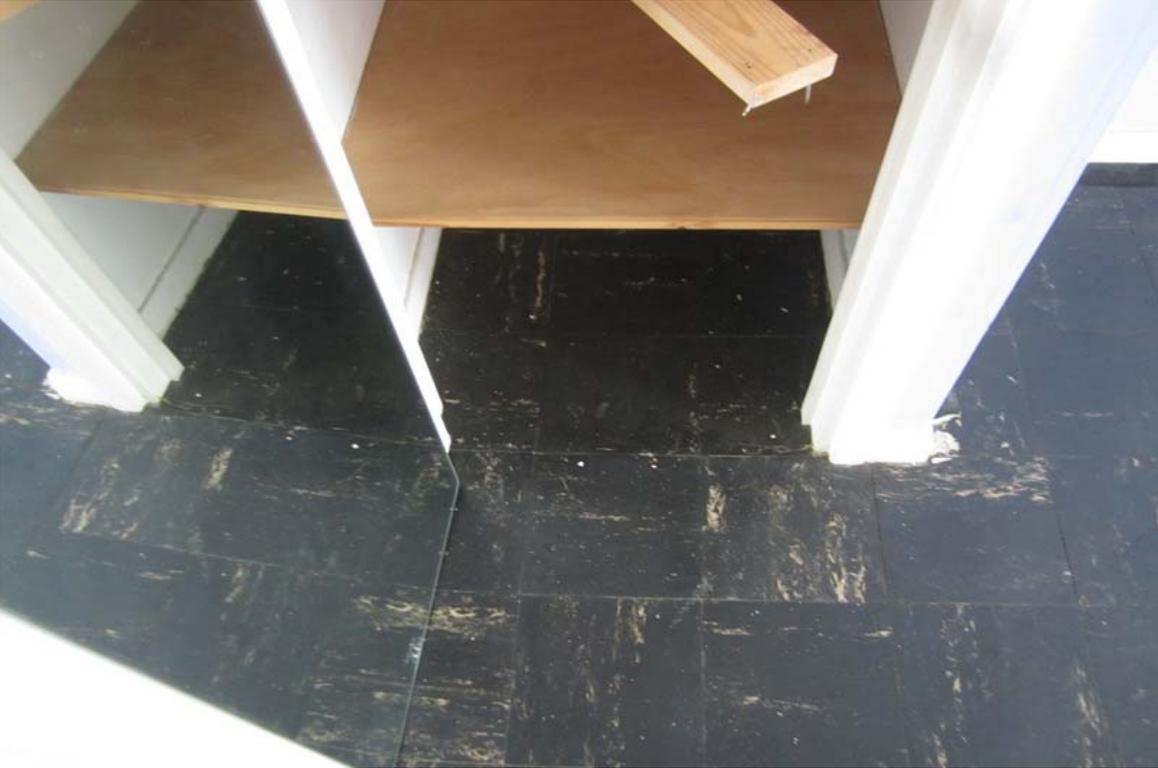
Photo Number	153	Reference number	230316MW161
Inspection / Sample	Inspection	Inspection Cross Reference / Visual I.D.	230316MW72

Notes	ACM: Asbestos Containing Material

Building	Flat 2 - Neville House	Condition	Fair	1
Floor Level	4th floor	Surface Treatment	Composite materials, reinforced plastics, resin, vinyl materials	0
Location	08 / Cupboard	Material Friability	Low	1
Feature	Black floor tiles and adhesive	Asbestos Type	Strongly Presumed Chrysotile (White)	1
Material Type	Floor Tile / Covering			
Extent	0.5 sq. m.			
Recommendation	Remove if likely to be disturbed during the refurbishment works	Assessment Score		3
		Assessment Band		D

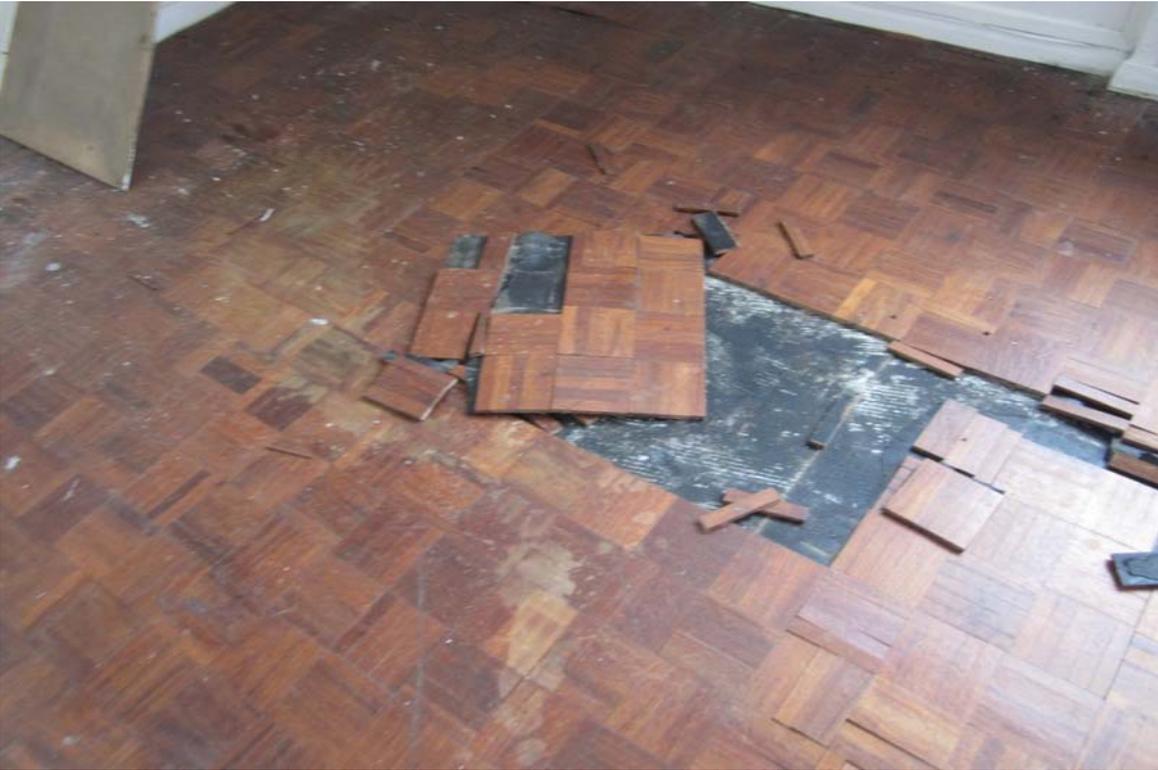
Photo Number	157	Reference number	230316MW165
Inspection / Sample	Inspection	Inspection Cross Reference / Visual I.D.	230316MW128

Notes	NADIS: No Asbestos Detected In Sample

Building	Flat 2 - Neville House	Condition	Fair	1
Floor Level	4th floor	Surface Treatment	Composite materials, reinforced plastics, resin, vinyl materials	0
Location	11 / Lounge	Material Friability	Low	1
Feature	Bitumen adhesive beneath parquet flooring	Asbestos Type	Strongly Presumed N.A.D.I.S	0
Material Type	Bitumen			
Extent	20 sq. m.			
Recommendation	No action necessary	Assessment Score		0
		Assessment Band		E

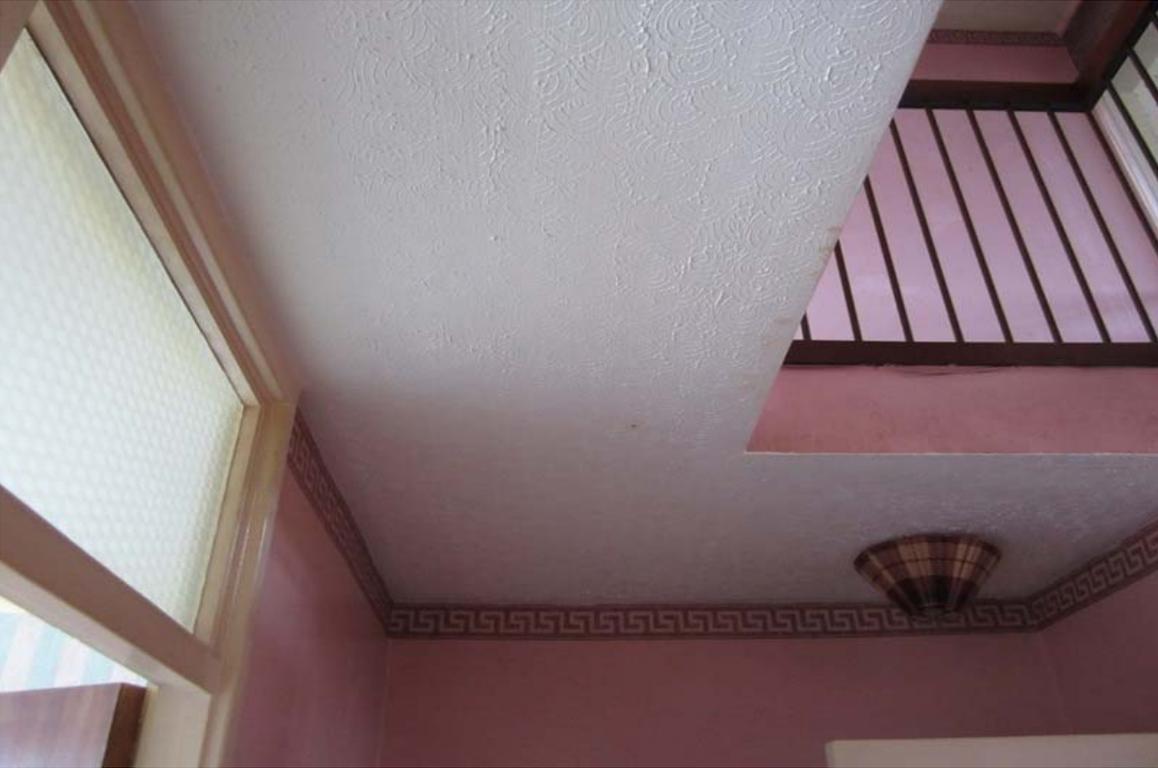
Photo Number	160	Reference number	230316MW170
Inspection / Sample	Inspection	Inspection Cross Reference / Visual I.D.	230316MW172

Notes	NADIS: No Asbestos Detected In Sample

Building	Flat 1 - Neville House	Condition	Fair	1
Floor Level	3rd floor	Surface Treatment	Composite materials, reinforced plastics, resin, vinyl materials	0
Location	01 / Lobby	Material Friability	Low	1
Feature	Coating to ceiling	Asbestos Type	Strongly Presumed N.A.D.I.S	0
Material Type	Textured Coating			
Extent	4 sq. m.			
Recommendation	No action necessary	Assessment Score		0
		Assessment Band		E

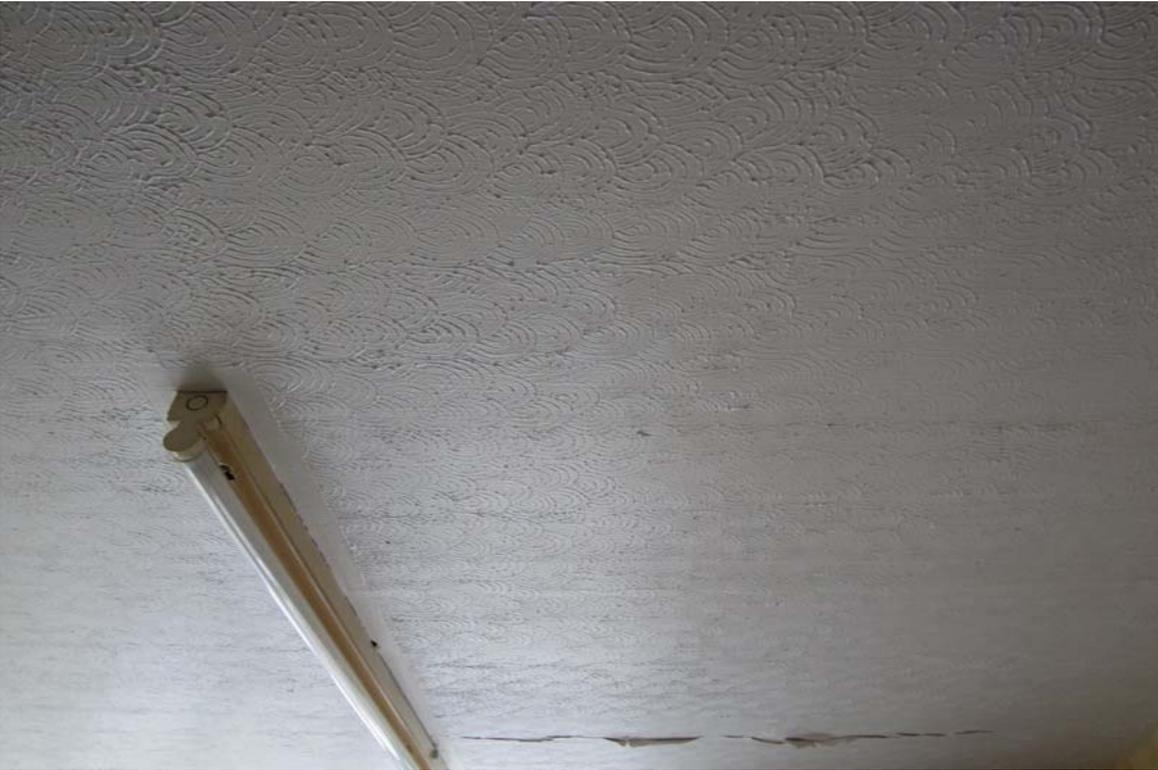
Photo Number	162	Reference number	230316MW172
Inspection / Sample	Sample	Inspection Cross Reference / Visual I.D.	Not Applicable

Notes	NADIS: No Asbestos Detected In Sample

Building	Flat 1 - Neville House	Condition	Fair	1
Floor Level	3rd floor	Surface Treatment	Composite materials, reinforced plastics, resin, vinyl materials	0
Location	02 / Kitchen	Material Friability	Low	1
Feature	Coating to ceiling	Asbestos Type	N.A.D.I.S	0
Material Type	Textured Coating			
Extent	10 sq. m.			
Recommendation	No action necessary	Assessment Score		0
		Assessment Band		E

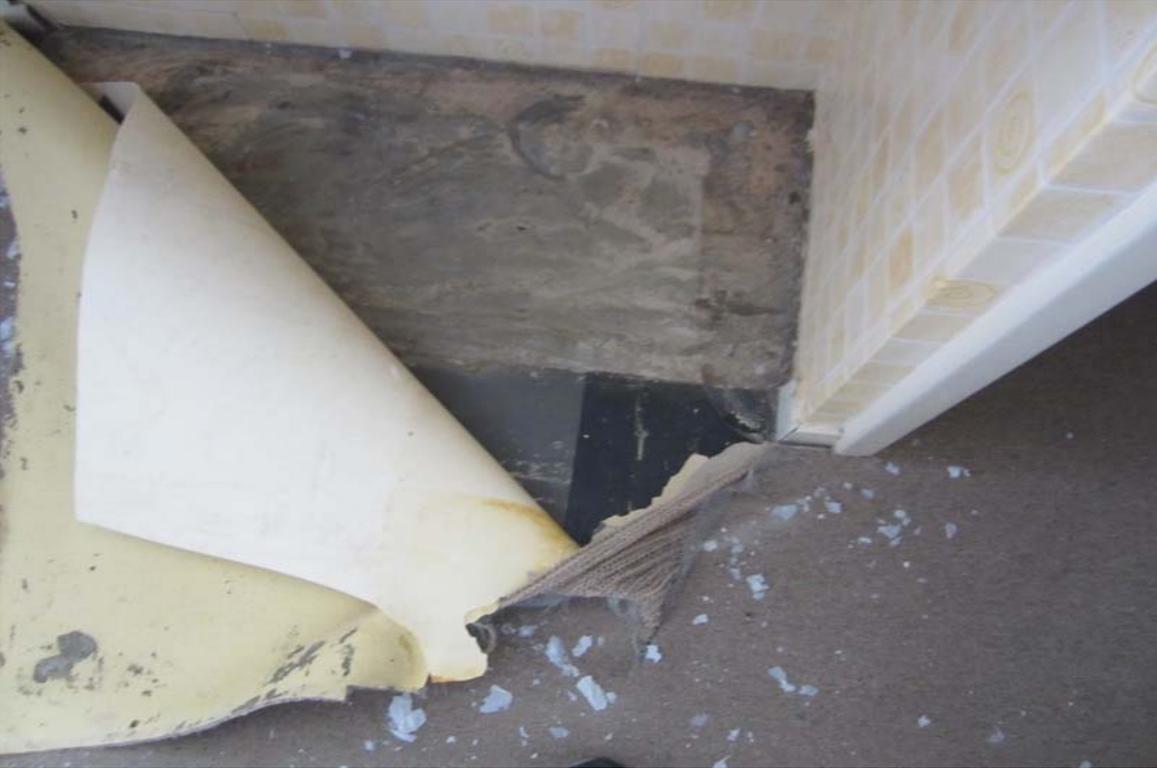
Photo Number	163	Reference number	230316MW173
Inspection / Sample	Inspection	Inspection Cross Reference / Visual I.D.	230316MW72

Notes	ACM: Asbestos Containing Material

Building	Flat 1 - Neville House	Condition	Fair	1
Floor Level	3rd floor	Surface Treatment	Composite materials, reinforced plastics, resin, vinyl materials	0
Location	02 / Kitchen	Material Friability	Low	1
Feature	Grey and black floor tiles and adhesive	Asbestos Type	Strongly Presumed Chrysotile (White)	1
Material Type	Floor Tile / Covering			
Extent	10 sq. m.			
Recommendation	Remove if likely to be disturbed during the refurbishment works	Assessment Score		3
		Assessment Band		D

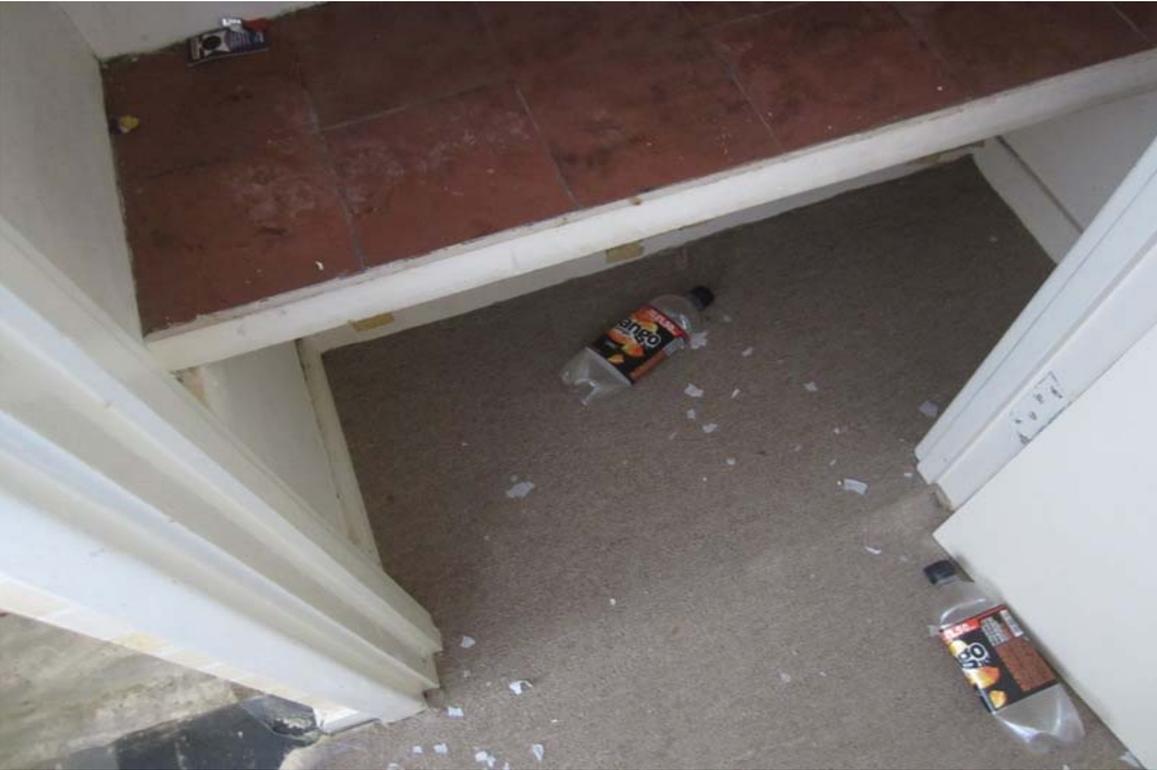
Photo Number	164	Reference number	230316MW174
Inspection / Sample	Inspection	Inspection Cross Reference / Visual I.D.	230316MW72

Notes	ACM: Asbestos Containing Material

Building	Flat 1 - Neville House	Condition	Fair	1
Floor Level	3rd floor	Surface Treatment	Composite materials, reinforced plastics, resin, vinyl materials	0
Location	03 / Cupboard	Material Friability	Low	1
Feature	Grey and black floor tiles and adhesive	Asbestos Type	Strongly Presumed Chrysotile (White)	1
Material Type	Floor Tile / Covering			
Extent	0.5 sq. m.			
Recommendation	Remove if likely to be disturbed during the refurbishment works	Assessment Score		3
		Assessment Band		D

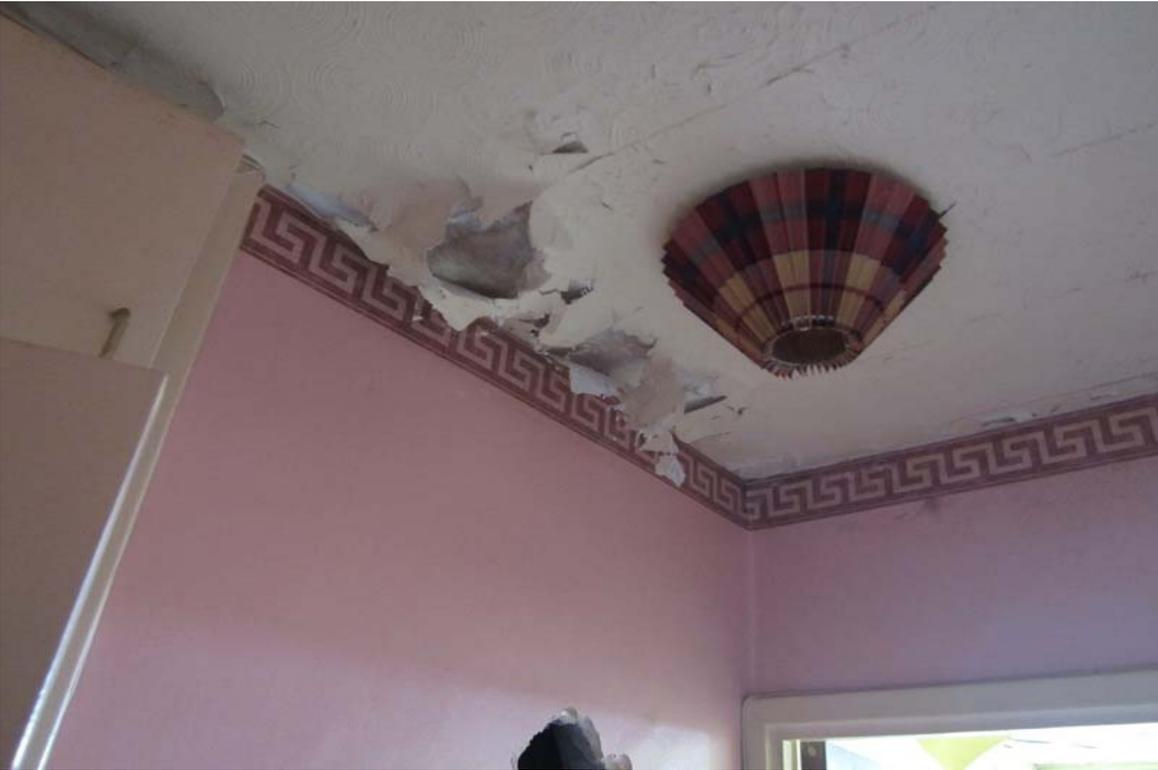
Photo Number	167	Reference number	230316MW177
Inspection / Sample	Sample	Inspection Cross Reference / Visual I.D.	Not Applicable

Notes	NADIS: No Asbestos Detected In Sample

Building	Flat 1 - Neville House	Condition	Poor	2
Floor Level	4th floor	Surface Treatment	Composite materials, reinforced plastics, resin, vinyl materials	0
Location	06 / Landing	Material Friability	Low	1
Feature	Coating to ceiling	Asbestos Type	N.A.D.I.S	0
Material Type	Textured Coating			
Extent	10 sq. m.			
Recommendation	No action necessary	Assessment Score		0
		Assessment Band		E

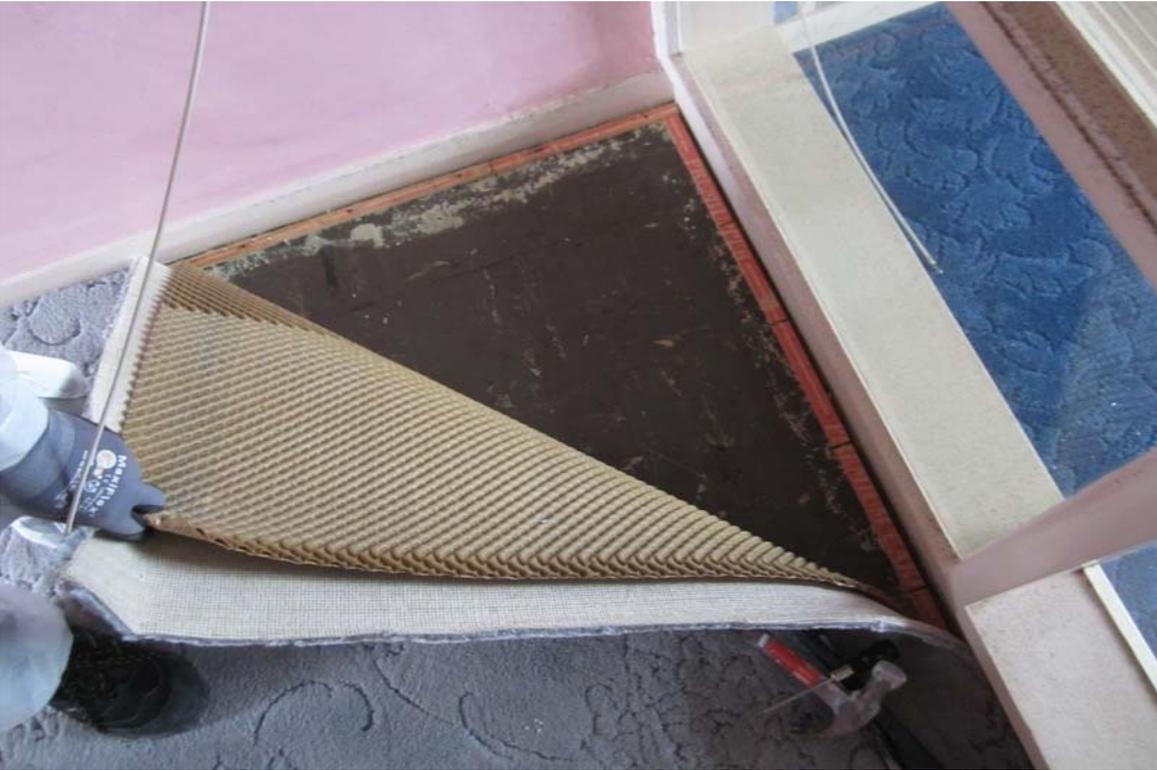
Photo Number	168	Reference number	230316MW178
Inspection / Sample	Inspection	Inspection Cross Reference / Visual I.D.	230316MW72

Notes	ACM: Asbestos Containing Material

Building	Flat 1 - Neville House	Condition	Fair	1
Floor Level	4th floor	Surface Treatment	Composite materials, reinforced plastics, resin, vinyl materials	0
Location	06 / Landing	Material Friability	Low	1
Feature	Grey floor tiles and adhesive	Asbestos Type	Strongly Presumed Chrysotile (White)	1
Material Type	Floor Tile / Covering			
Extent	10 sq. m.			
Recommendation	Remove if likely to be disturbed during the refurbishment works	Assessment Score		3
		Assessment Band		D

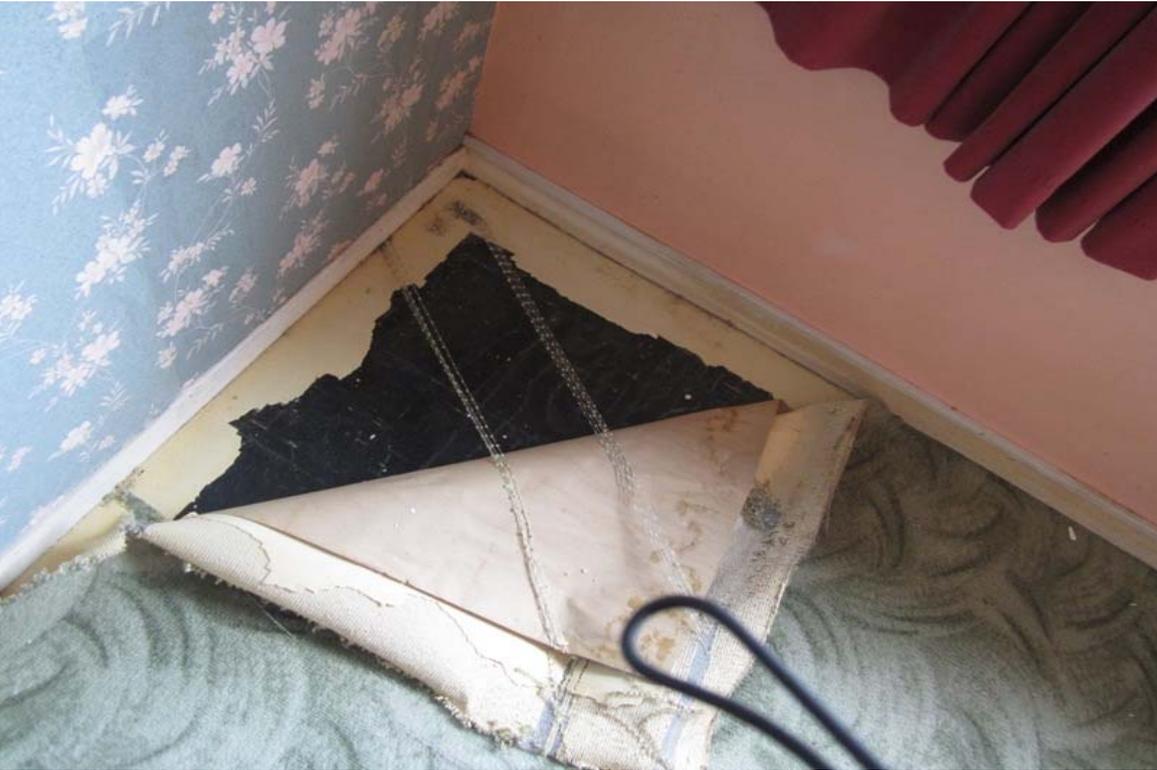
Photo Number	169	Reference number	230316MW179
Inspection / Sample	Inspection	Inspection Cross Reference / Visual I.D.	230316MW72

Notes	ACM: Asbestos Containing Material

Building	Flat 1 - Neville House	Condition	Fair	1
Floor Level	4th floor	Surface Treatment	Composite materials, reinforced plastics, resin, vinyl materials	0
Location	07 / Bedroom 1	Material Friability	Low	1
Feature	Black floor tiles and adhesive	Asbestos Type	Strongly Presumed Chrysotile (White)	1
Material Type	Floor Tile / Covering			
Extent	8 sq. m.			
Recommendation	Remove if likely to be disturbed during the refurbishment works	Assessment Score		3
		Assessment Band		D

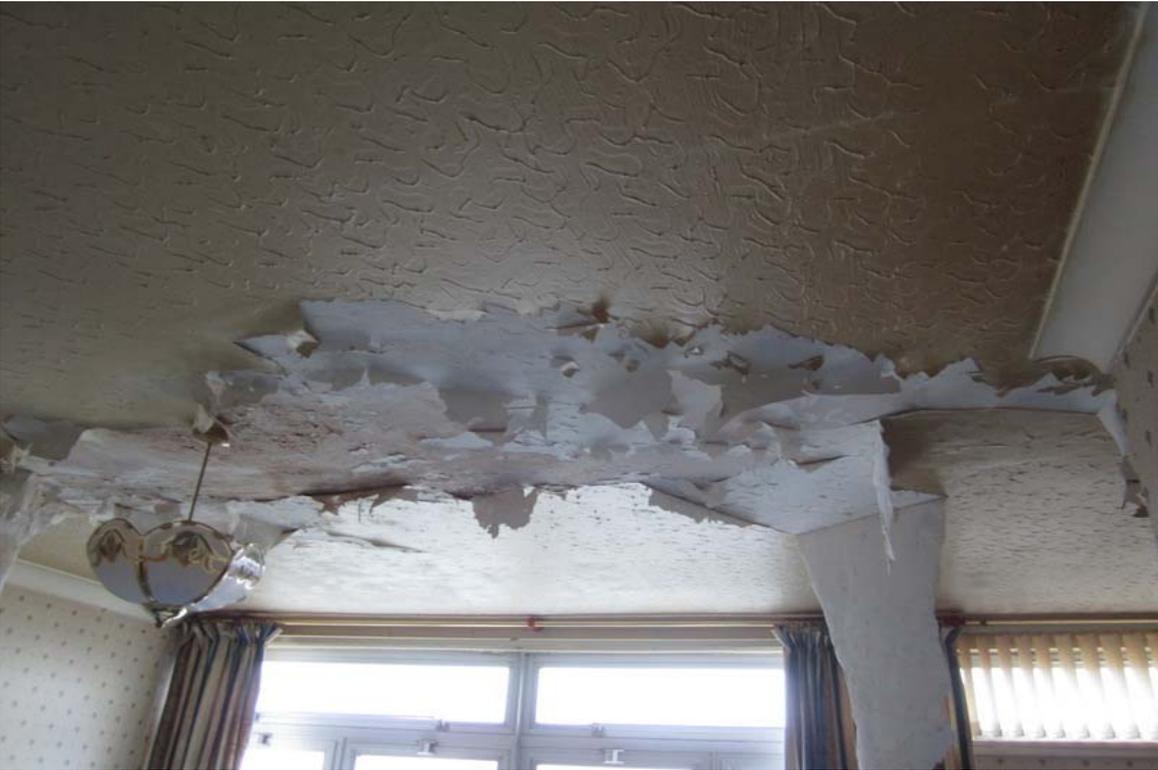
Photo Number	170	Reference number	230316MW180
Inspection / Sample	Sample	Inspection Cross Reference / Visual I.D.	Not Applicable

Notes	NADIS: No Asbestos Detected In Sample

Building	Flat 1 - Neville House	Condition	Poor	2
Floor Level	4th floor	Surface Treatment	Composite materials, reinforced plastics, resin, vinyl materials	0
Location	08 / Lounge	Material Friability	Low	1
Feature	Coating to ceiling	Asbestos Type	N.A.D.I.S	0
Material Type	Textured Coating			
Extent	15 sq. m.			
Recommendation	No action necessary	Assessment Score		0
		Assessment Band		E

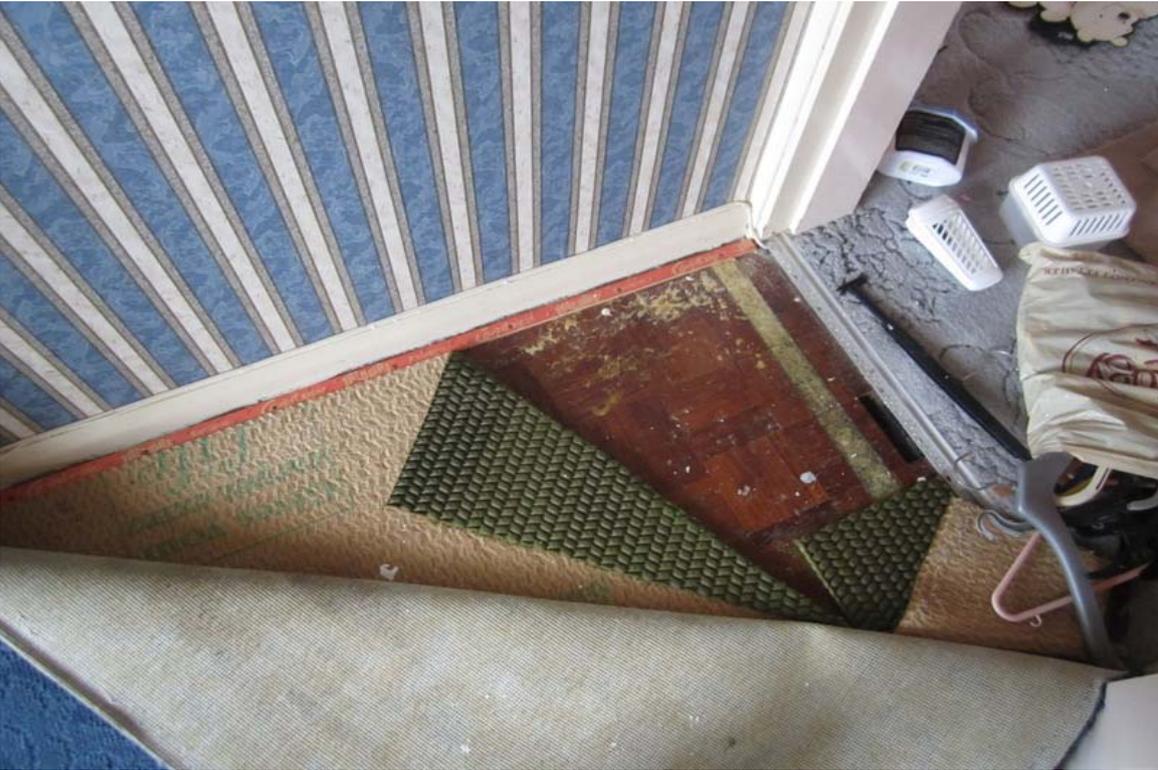
Photo Number	171	Reference number	230316MW181
Inspection / Sample	Inspection	Inspection Cross Reference / Visual I.D.	230316MW128

Notes	NADIS: No Asbestos Detected In Sample

Building	Flat 1 - Neville House	Condition	Fair	1
Floor Level	4th floor	Surface Treatment	Composite materials, reinforced plastics, resin, vinyl materials	0
Location	08 / Lounge	Material Friability	Low	1
Feature	Bitumen adhesive beneath parquet flooring	Asbestos Type	Strongly Presumed N.A.D.I.S	0
Material Type	Bitumen			
Extent	15 sq. m.			
Recommendation	No action necessary	Assessment Score		0
		Assessment Band		E

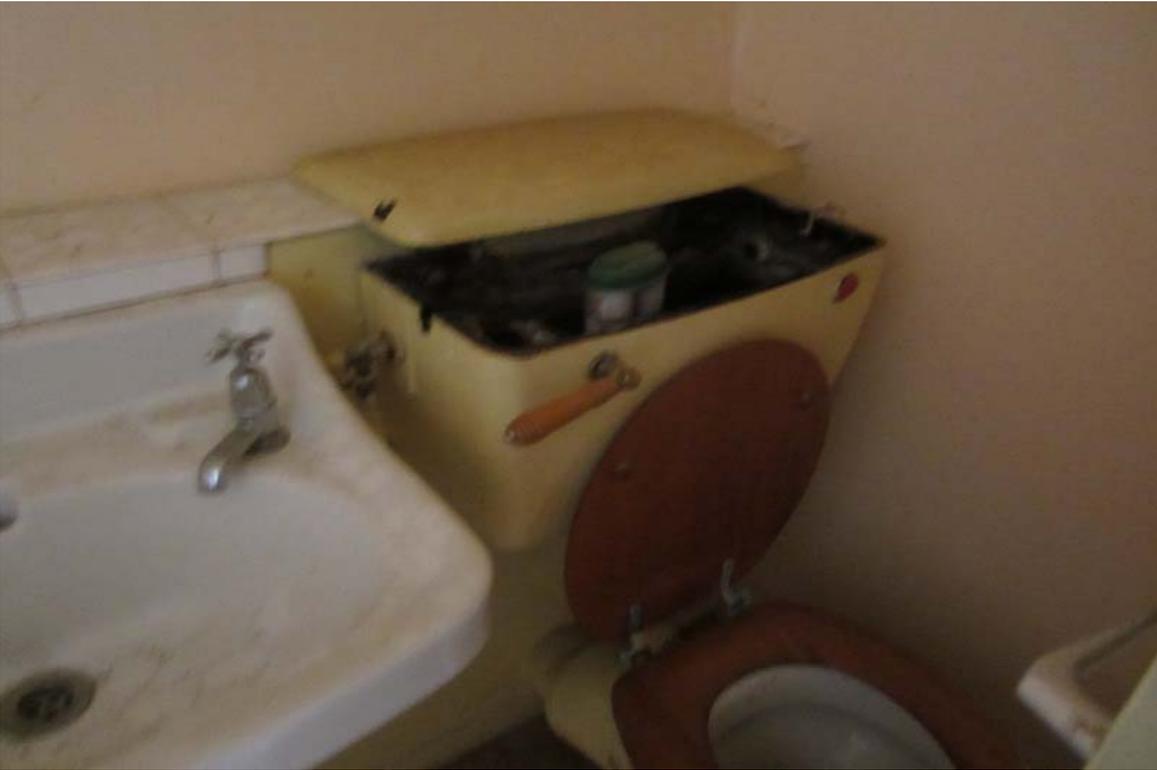
Photo Number	172	Reference number	230316MW182
Inspection / Sample	Inspection	Inspection Cross Reference / Visual I.D.	220316MW20

Notes	ACM: Asbestos Containing Material

Building	Flat 1 - Neville House	Condition	Poor	2
Floor Level	4th floor	Surface Treatment	Composite materials, reinforced plastics, resin, vinyl materials	0
Location	09 / Bathroom	Material Friability	Low	1
Feature	Toilet cistern	Asbestos Type	Strongly Presumed Amosite (Brown)	2
Material Type	Composite / Resin			
Extent	1 No.			
Recommendation	Remove if likely to be disturbed during the refurbishment works	Assessment Score		5
		Assessment Band		C

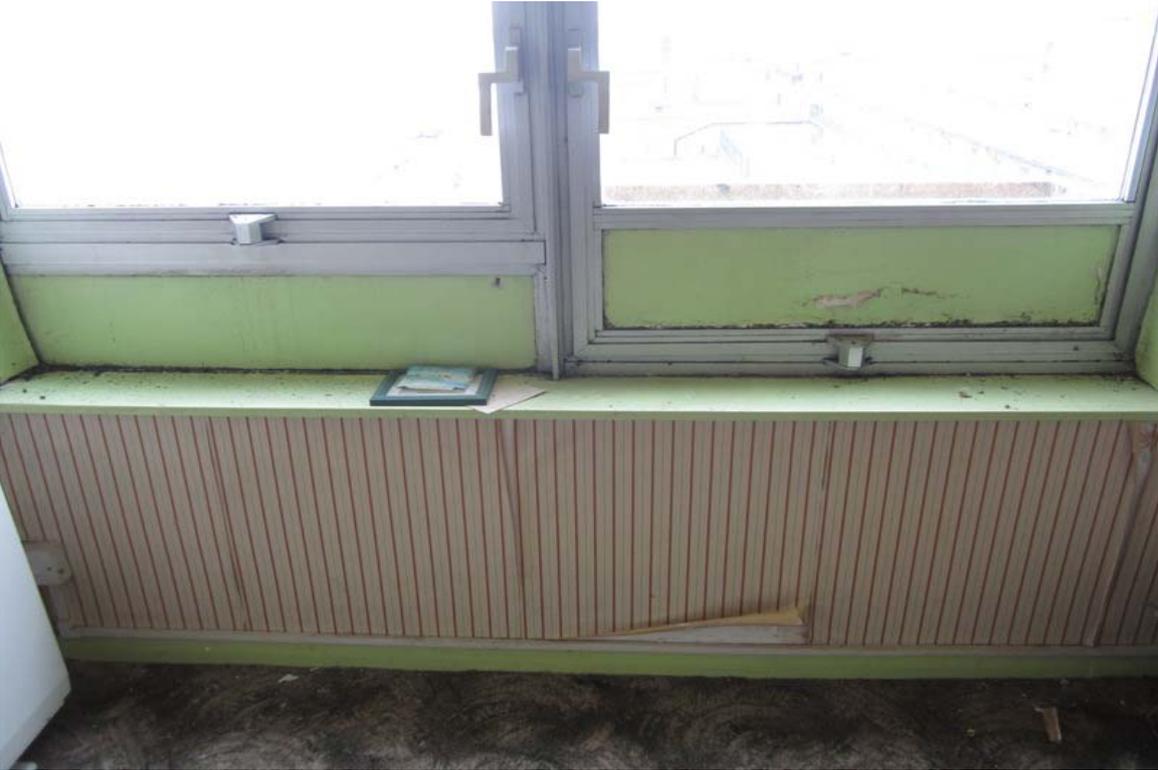
Photo Number	175	Reference number	230316MW185
Inspection / Sample	Sample	Inspection Cross Reference / Visual I.D.	Not Applicable

Notes	NADIS: No Asbestos Detected In Sample

Building	Flat 1 - Neville House	Condition	Poor	2
Floor Level	4th floor	Surface Treatment	Unsealed AIB or encapsulated lagging and spray	2
Location	11 / Bedroom 2	Material Friability	Medium	2
Feature	Panelling beneath window	Asbestos Type	N.A.D.I.S	0
Material Type	Insulating Board			
Extent	2 sq. m.			
Recommendation	No action necessary	Assessment Score		0
		Assessment Band		E

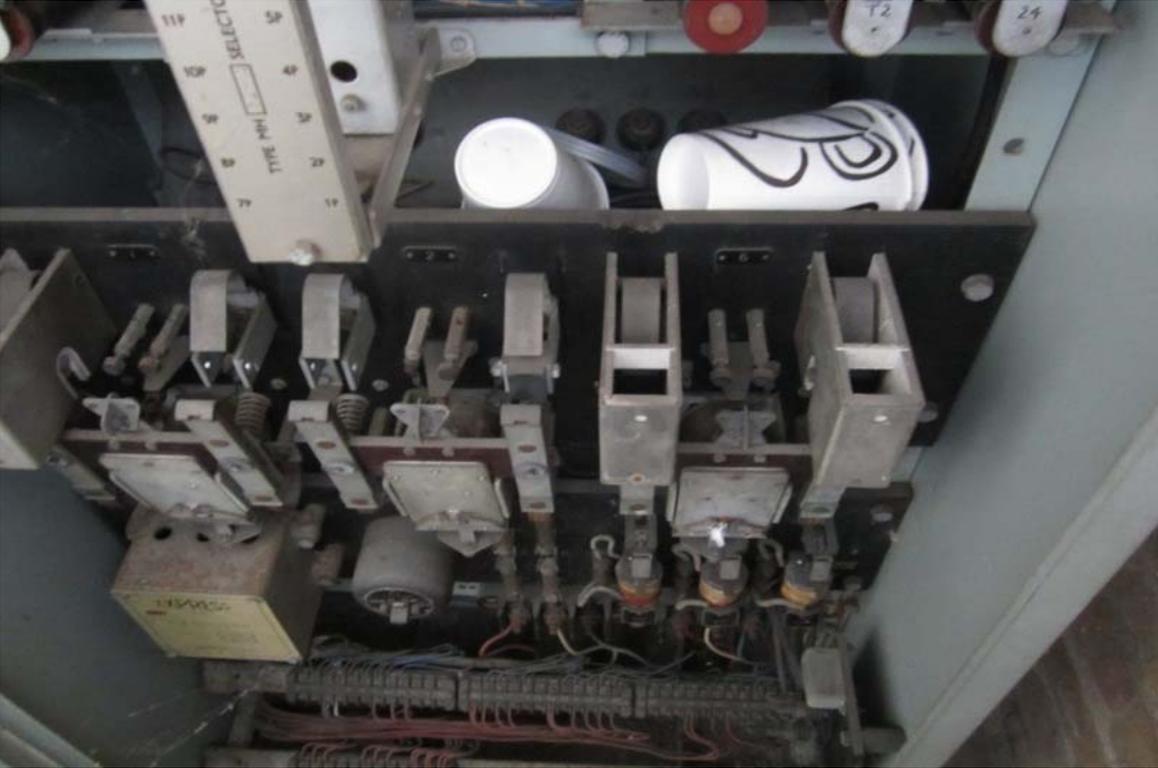
Photo Number	178	Reference number	220316MW32
Inspection / Sample	Inspection	Inspection Cross Reference / Visual I.D.	220316MW29

Notes	ACM: Asbestos Containing Material

Building	Communal Areas - Neville House	Condition	Fair	1
Floor Level	5th floor	Surface Treatment	Enclosed sprays and lagging, encapsulated AIB, cement etc.	1
Location	5.03 / Lift Motor Room	Material Friability	Medium	2
Feature	Flash guard within fuses box to back wall	Asbestos Type	Strongly Presumed Chrysotile (White)	1
Material Type	Textile			
Extent	1 Box			
Recommendation	Remove if likely to be disturbed during the refurbishment works	Assessment Score		5
		Assessment Band		C
