**CBC Asbestos Refurbishment Survey Report
Neville House, George Street, Corby
22nd – 24th March 2016**

Reference:					
Issue			Prepared by	Verified by	
V1	Apr 16	JQ

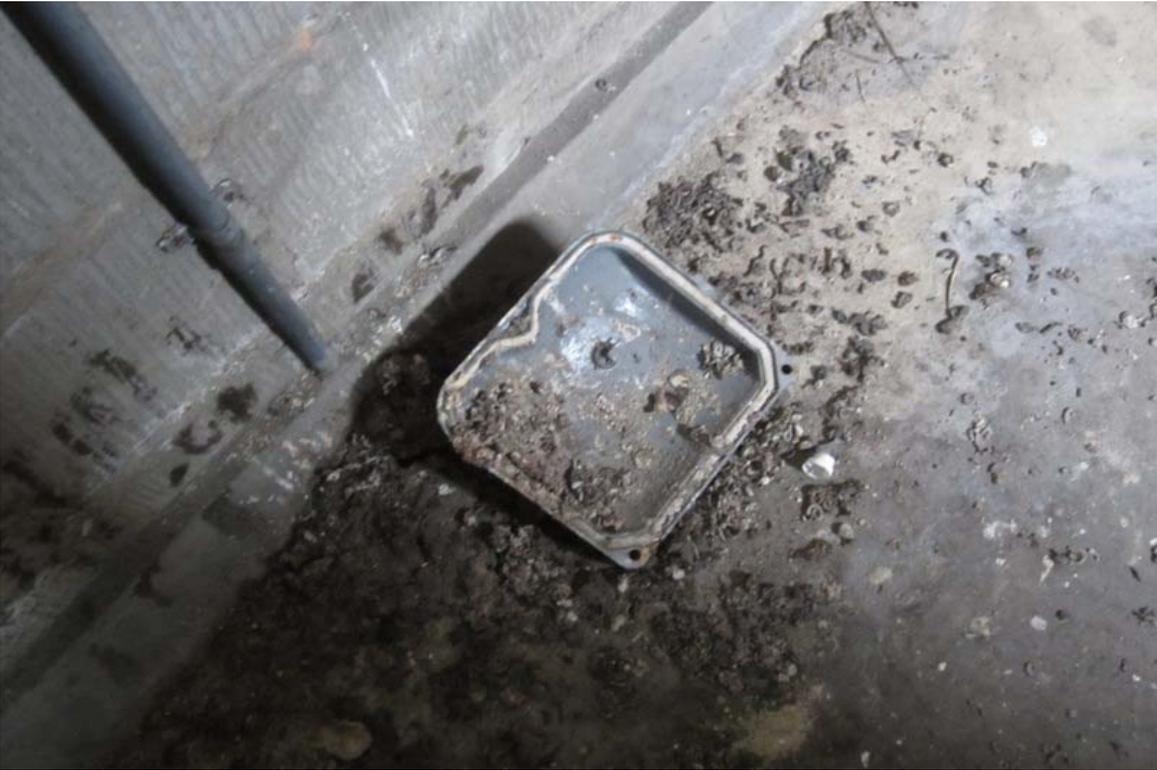
Photo Number	179	Reference number	220316MW33
Inspection / Sample	Inspection	Inspection Cross Reference / Visual I.D.	220316MW28

Notes	NADIS: No Asbestos Detected In Sample

Building	Communal Areas - Neville House	Condition	Fair	1
Floor Level	5th floor	Surface Treatment	Enclosed sprays and lagging, encapsulated AIB, cement etc.	1
Location	5.03 / Lift Motor Room	Material Friability	Medium	2
Feature	Rope seal within fuses box to back wall	Asbestos Type	Strongly Presumed N.A.D.I.S	0
Material Type	Textile			
Extent	1 Box			
Recommendation	No action necessary	Assessment Score		0
		Assessment Band		E

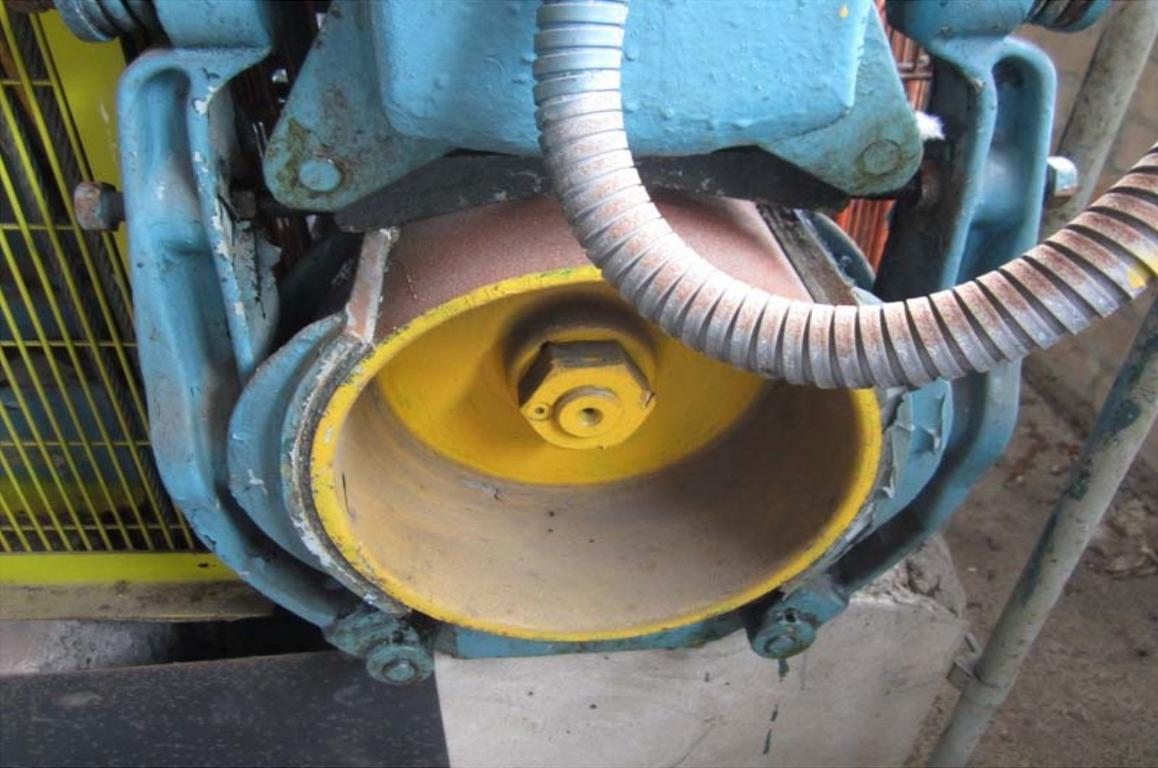
Photo Number	180	Reference number	220316MW34
Inspection / Sample	Sample	Inspection Cross Reference / Visual I.D.	Not Applicable

Notes	ACM: Asbestos Containing Material

Building	Communal Areas - Neville House	Condition	Fair	1
Floor Level	5th floor	Surface Treatment	Enclosed sprays and lagging, encapsulated AIB, cement etc.	1
Location	5.03 / Lift Motor Room	Material Friability	Low	1
Feature	Brake shoe to lift motor (left of door)	Asbestos Type	Chrysotile (White)	1
Material Type	Cement			
Extent	2 No.			
Recommendation	Remove if likely to be disturbed during the refurbishment works	Assessment Score		4
		Assessment Band		D

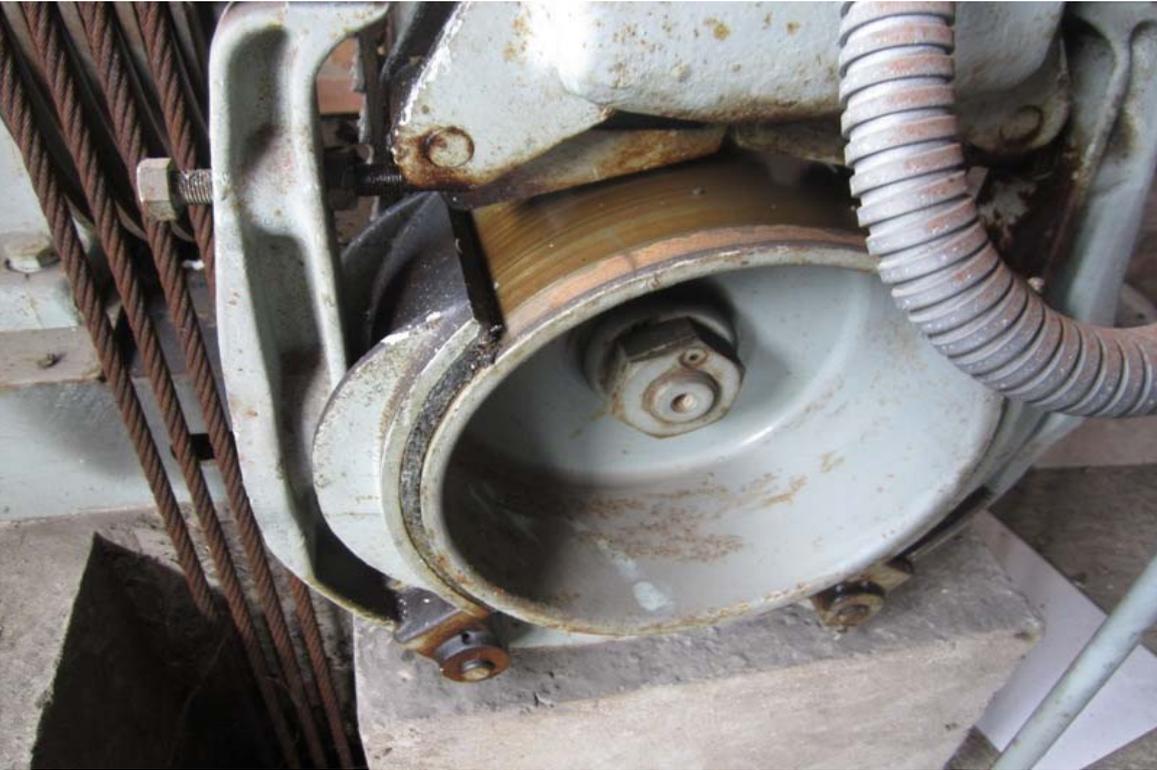
Photo Number	181	Reference number	220316MW35
Inspection / Sample	Sample	Inspection Cross Reference / Visual I.D.	Not Applicable

Notes	ACM: Asbestos Containing Material

Building	Communal Areas - Neville House	Condition	Fair	1
Floor Level	5th floor	Surface Treatment	Enclosed sprays and lagging, encapsulated AIB, cement etc.	1
Location	5.03 / Lift Motor Room	Material Friability	Medium	2
Feature	Brake shoe to lift motor (right of door)	Asbestos Type	Chrysotile (White)	1
Material Type	Textile			
Extent	2 No.			
Recommendation	Remove if likely to be disturbed during the refurbishment works	Assessment Score		5
		Assessment Band		C

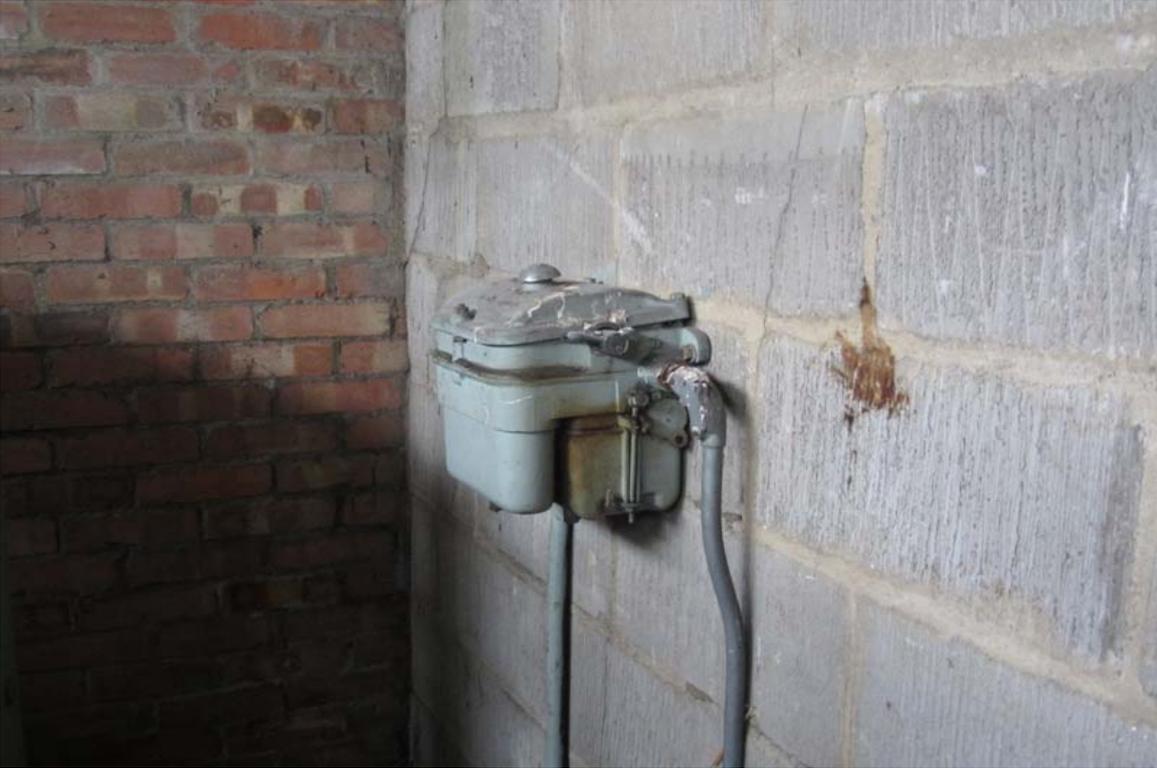
Photo Number	182	Reference number	240316MW190
Inspection / Sample	Inspection	Inspection Cross Reference / Visual I.D.	220316MW28

Notes	NADIS: No Asbestos Detected In Sample

Building	Communal Areas - Neville House	Condition	Fair	1
Floor Level	5th floor	Surface Treatment	Enclosed sprays and lagging, encapsulated AIB, cement etc.	1
Location	5.03 / Lift Motor Room	Material Friability	Medium	2
Feature	Rope seal within fuses boxes to door wall	Asbestos Type	Strongly Presumed N.A.D.I.S	0
Material Type	Textile			
Extent	2 No.			
Recommendation	No action necessary	Assessment Score		0
		Assessment Band		E

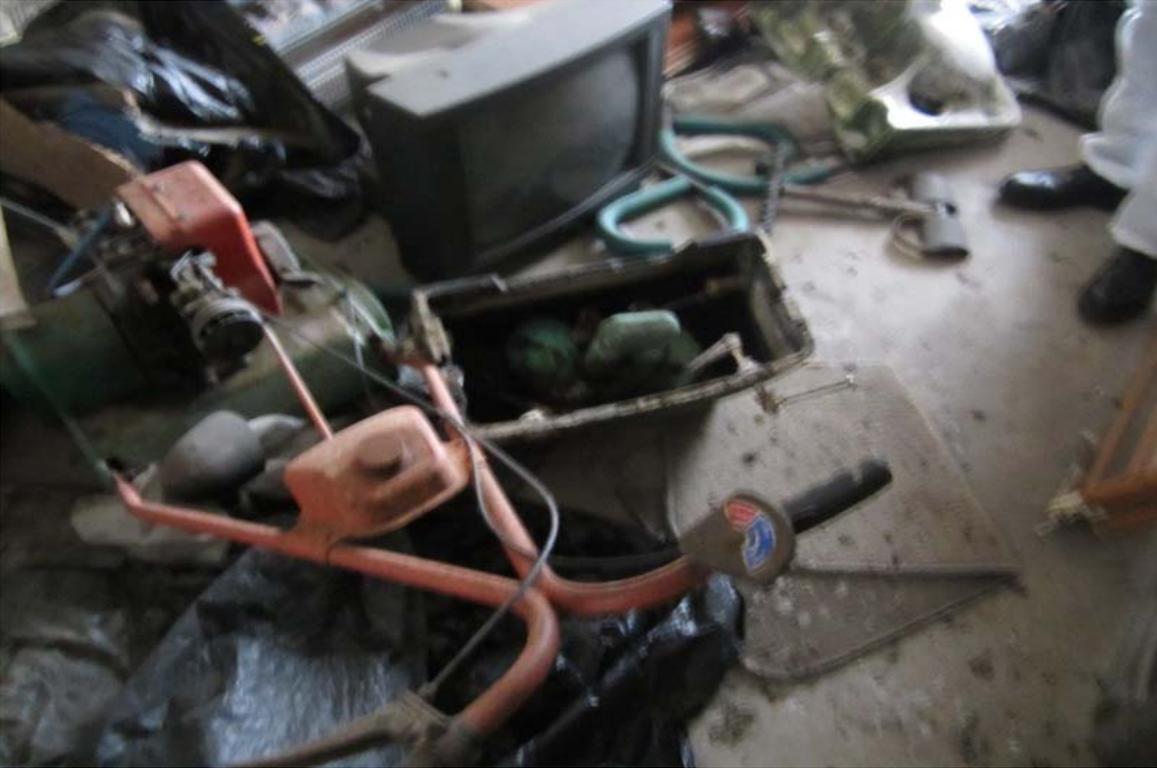
Photo Number	183	Reference number	240316MW191
Inspection / Sample	Inspection	Inspection Cross Reference / Visual I.D.	220316MW20

Notes	ACM: Asbestos Containing Material

Building	Communal Areas - Neville House	Condition	Poor	2
Floor Level	5th floor	Surface Treatment	Composite materials, reinforced plastics, resin, vinyl materials	0
Location	5.05 / Store	Material Friability	Low	1
Feature	Redundant toilet cistern	Asbestos Type	Strongly Presumed Amosite (Brown)	2
Material Type	Composite / Resin			
Extent	1 No.			
Recommendation	Remove if likely to be disturbed during the refurbishment works	Assessment Score		5
		Assessment Band		C

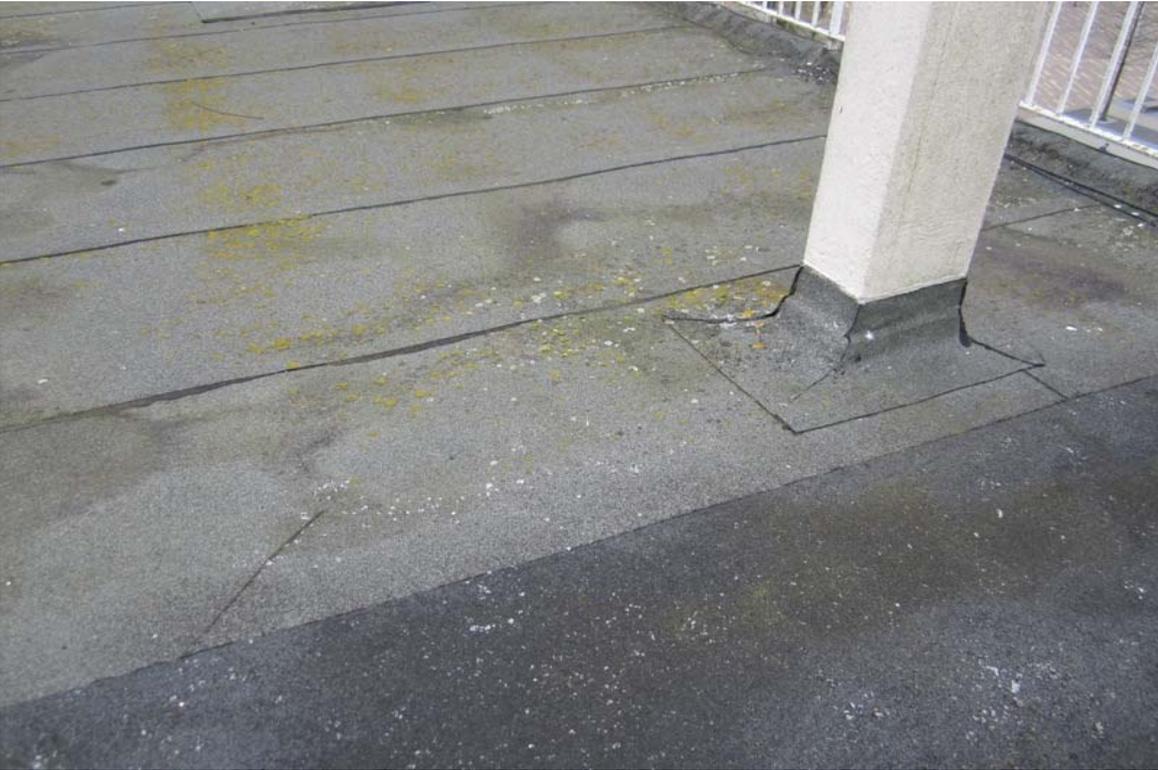
Photo Number	186	Reference number	240316MW196
Inspection / Sample	Inspection	Inspection Cross Reference / Visual I.D.	240316MW192

Notes	NADIS: No Asbestos Detected In Sample

Building	Communal Areas - Neville House	Condition	Fair	1
Floor Level	5th floor	Surface Treatment	Composite materials, reinforced plastics, resin, vinyl materials	0
Location	5.06 / Roof (Right)	Material Friability	Low	1
Feature	Roof felt	Asbestos Type	Strongly Presumed N.A.D.I.S	0
Material Type	Bitumen			
Extent	300 sq. m.			
Recommendation	No action necessary	Assessment Score		0
		Assessment Band		E

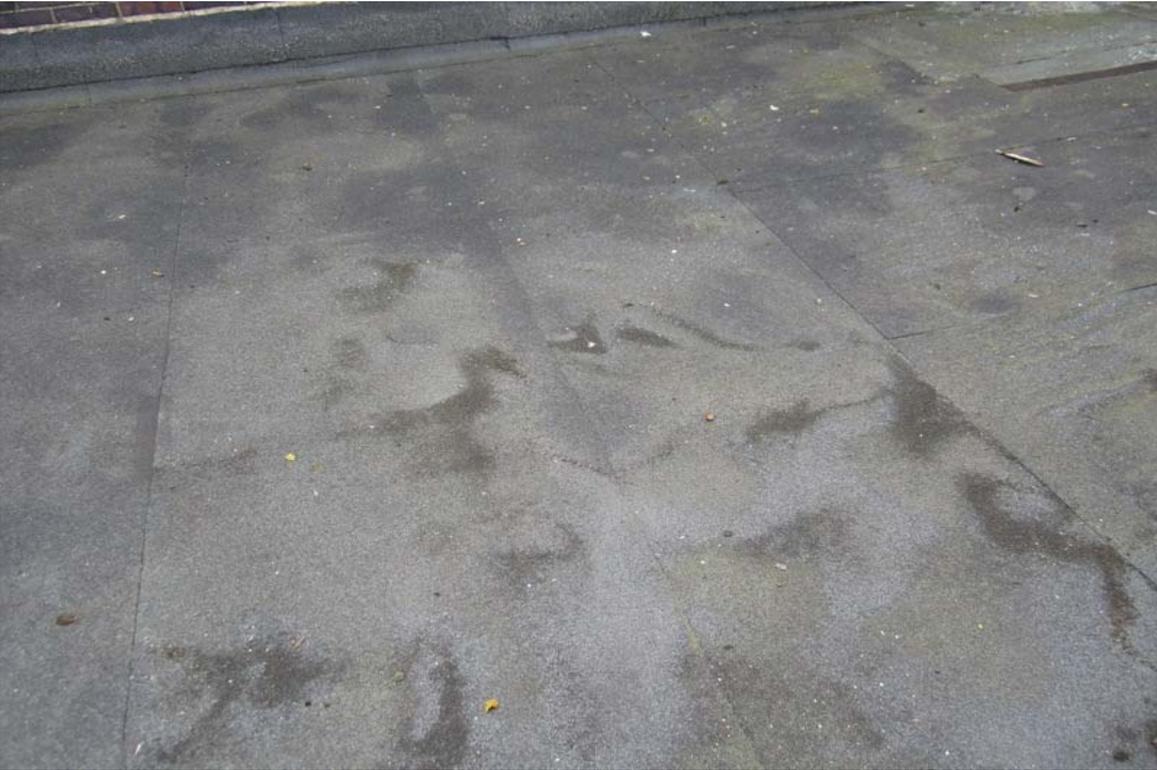
Photo Number	187	Reference number	240316MW192
Inspection / Sample	Sample	Inspection Cross Reference / Visual I.D.	Not Applicable

Notes	NADIS: No Asbestos Detected In Sample

Building	Communal Areas - Neville House	Condition	Fair	1
Floor Level	5th floor	Surface Treatment	Enclosed sprays and lagging, encapsulated AIB, cement etc.	1
Location	5.07 / Roof (Left)	Material Friability	Low	1
Feature	Roof felt	Asbestos Type	N.A.D.I.S	0
Material Type	Bitumen			
Extent	2 m.			
Recommendation	No action necessary	Assessment Score		0
		Assessment Band		E

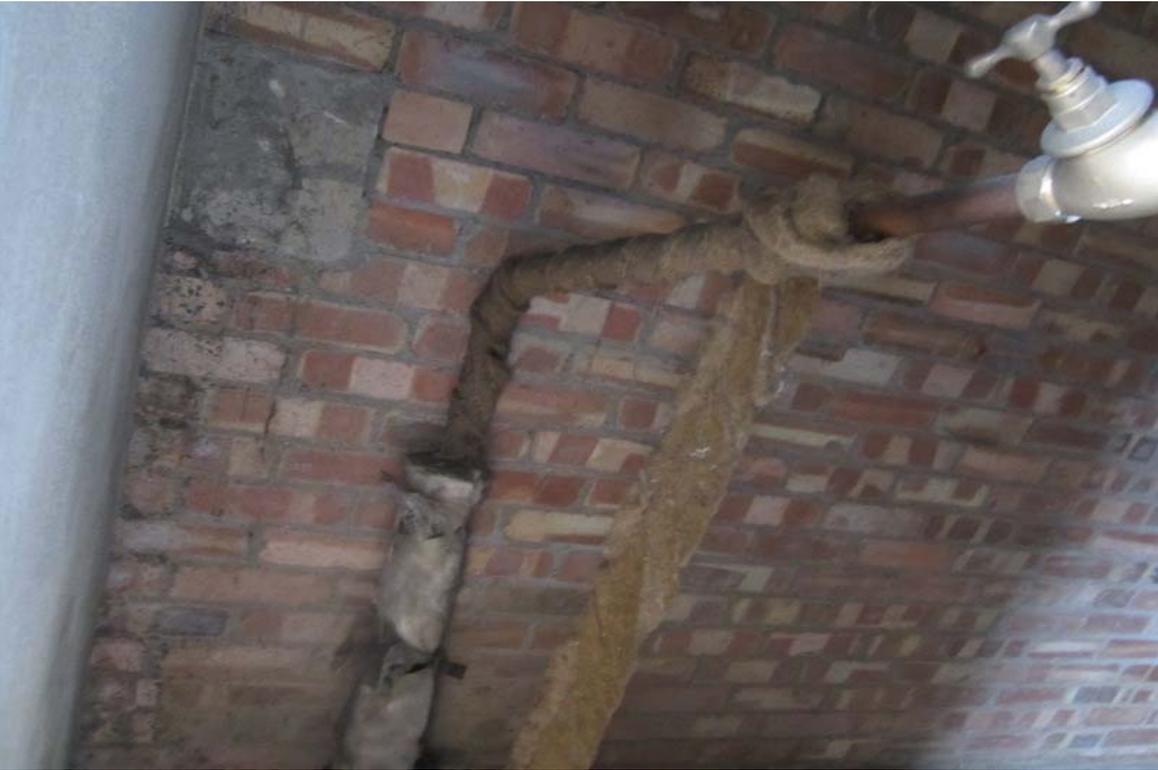
Photo Number	189	Reference number	240316MW197
Inspection / Sample	Sample	Inspection Cross Reference / Visual I.D.	Not Applicable

Notes	NADIS: No Asbestos Detected In Sample

Building	Communal Areas - Neville House	Condition	Poor	2
Floor Level	4th floor	Surface Treatment	Composite materials, reinforced plastics, resin, vinyl materials	0
Location	4.04 / Tank Room	Material Friability	Medium	2
Feature	Pipe wrap string (top)	Asbestos Type	N.A.D.I.S	0
Material Type	Textile			
Extent	1 m.			
Recommendation	No action necessary	Assessment Score		0
		Assessment Band		E

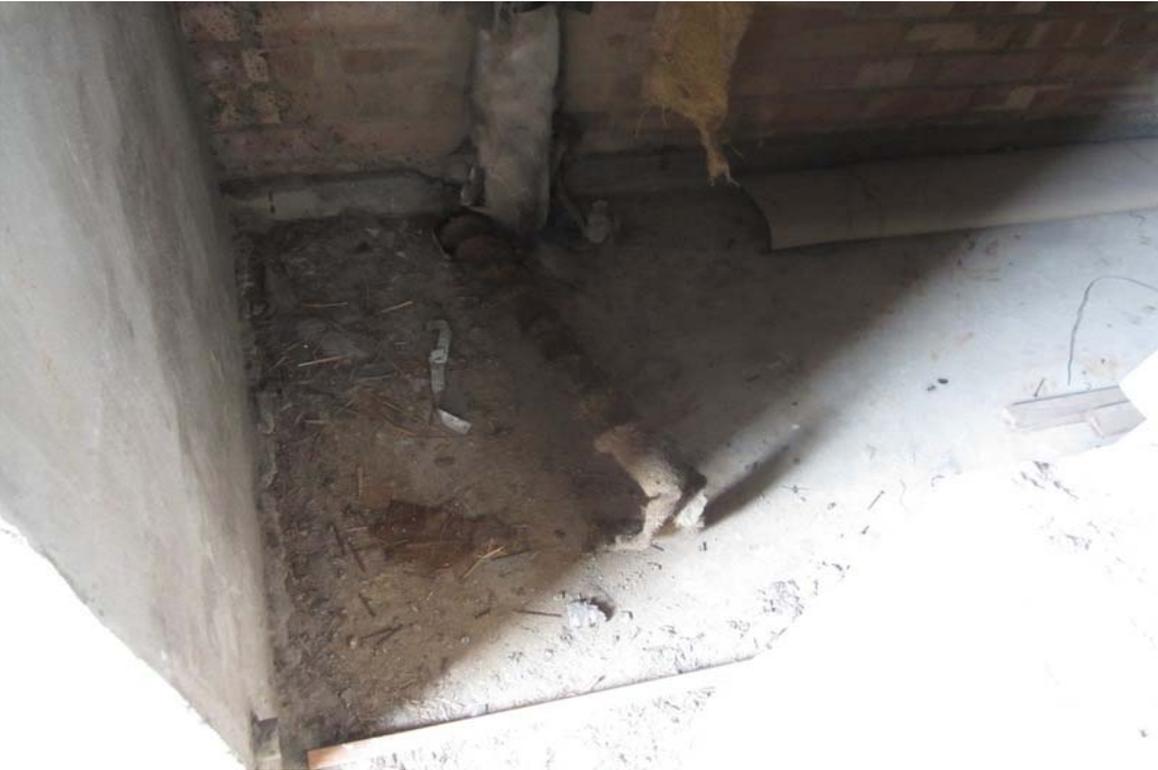
Photo Number	190	Reference number	240316MW198
Inspection / Sample	Inspection	Inspection Cross Reference / Visual I.D.	240316MW197

Notes	NADIS: No Asbestos Detected In Sample

Building	Communal Areas - Neville House	Condition	Poor	2
Floor Level	4th floor	Surface Treatment	Composite materials, reinforced plastics, resin, vinyl materials	0
Location	4.04 / Tank Room	Material Friability	Medium	2
Feature	Pipe wrap string (bottom)	Asbestos Type	Strongly Presumed N.A.D.I.S	0
Material Type	Textile			
Extent	1 m.			
Recommendation	No action necessary	Assessment Score		0
		Assessment Band		E

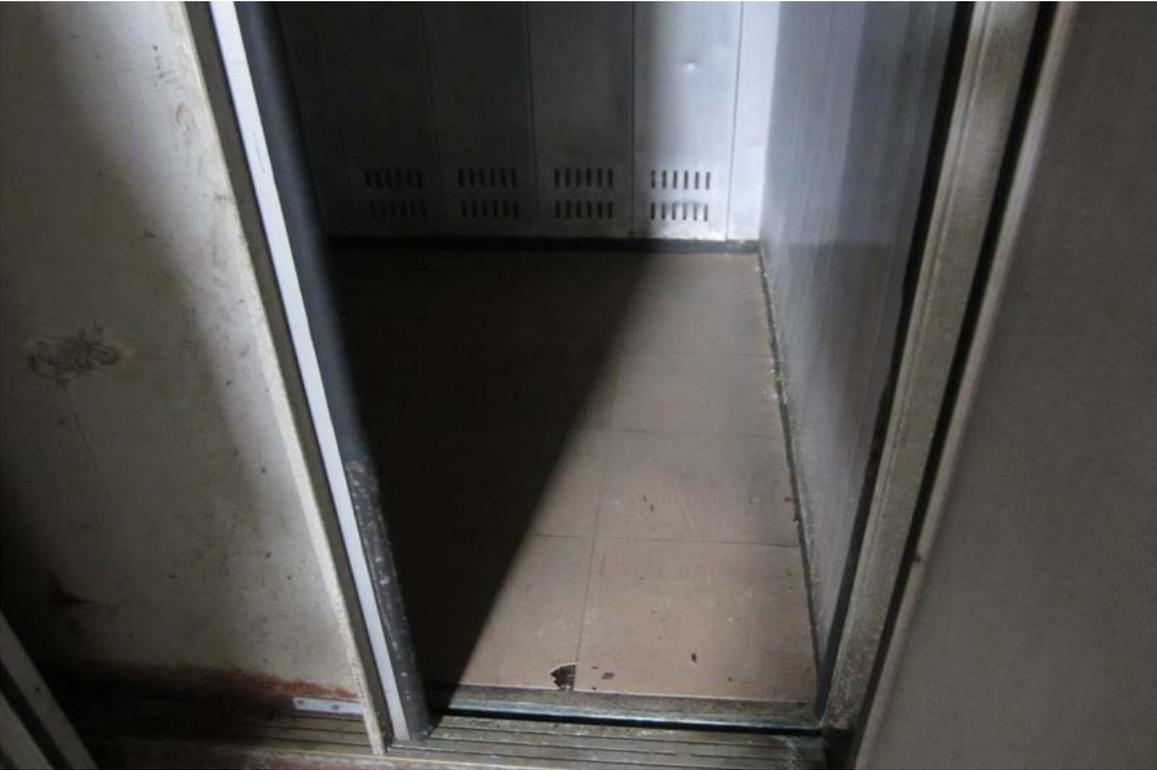
Photo Number	191	Reference number	240316MW204
Inspection / Sample	Sample	Inspection Cross Reference / Visual I.D.	Not Applicable

Notes	ACM: Asbestos Containing Material

Building	Communal Areas - Neville House	Condition	Fair	1
Floor Level	4th floor	Surface Treatment	Composite materials, reinforced plastics, resin, vinyl materials	0
Location	4.05 / Lift Shaft	Material Friability	Low	1
Feature	Floor tiles and adhesive within lift car	Asbestos Type	Chrysotile (White)	1
Material Type	Floor Tile / Covering			
Extent	3 sq. m.			
Recommendation	Remove if likely to be disturbed during the refurbishment works	Assessment Score		3
		Assessment Band		D

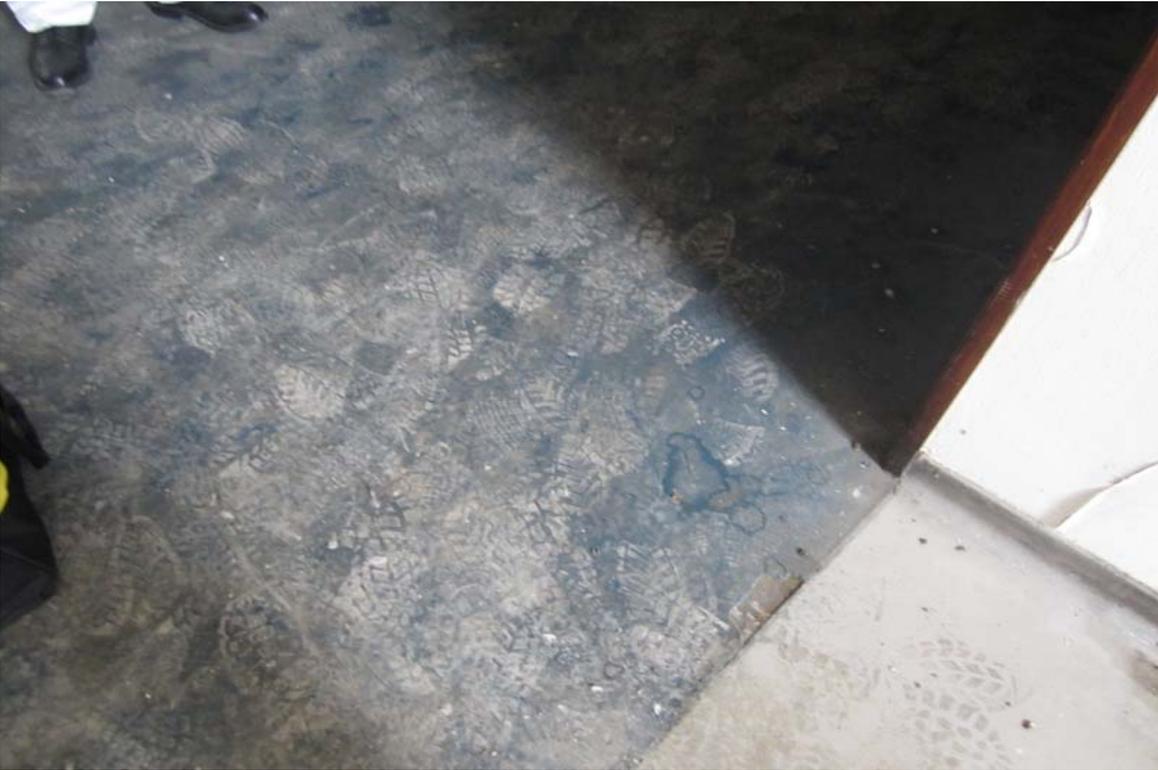
Photo Number	192	Reference number	240316MW199
Inspection / Sample	Sample	Inspection Cross Reference / Visual I.D.	Not Applicable

Notes	NADIS: No Asbestos Detected In Sample

Building	Communal Areas - Neville House	Condition	Fair	1
Floor Level	3rd floor	Surface Treatment	Composite materials, reinforced plastics, resin, vinyl materials	0
Location	3.01 / Landing and Stairs	Material Friability	Low	1
Feature	Blue floor covering	Asbestos Type	N.A.D.I.S	0
Material Type	Floor Tile / Covering			
Extent	30 sq. m.			
Recommendation	No action necessary	Assessment Score		0
		Assessment Band		E

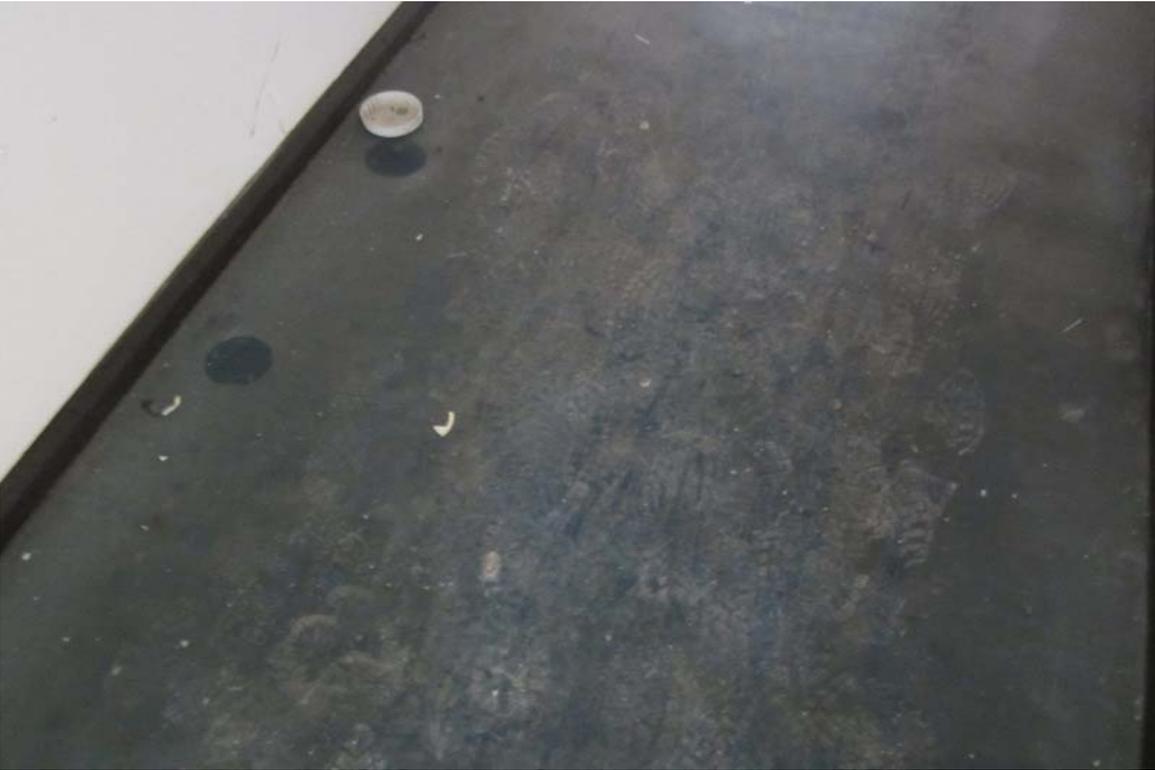
Photo Number	193	Reference number	240316MW201
Inspection / Sample	Inspection	Inspection Cross Reference / Visual I.D.	240316MW199

Notes	NADIS: No Asbestos Detected In Sample

Building	Communal Areas - Neville House	Condition	Fair	1
Floor Level	3rd floor	Surface Treatment	Composite materials, reinforced plastics, resin, vinyl materials	0
Location	3.02 / Corridor	Material Friability	Low	1
Feature	Blue floor covering	Asbestos Type	Strongly Presumed N.A.D.I.S	0
Material Type	Floor Tile / Covering			
Extent	30 sq. m.			
Recommendation	No action necessary	Assessment Score		0
		Assessment Band		E

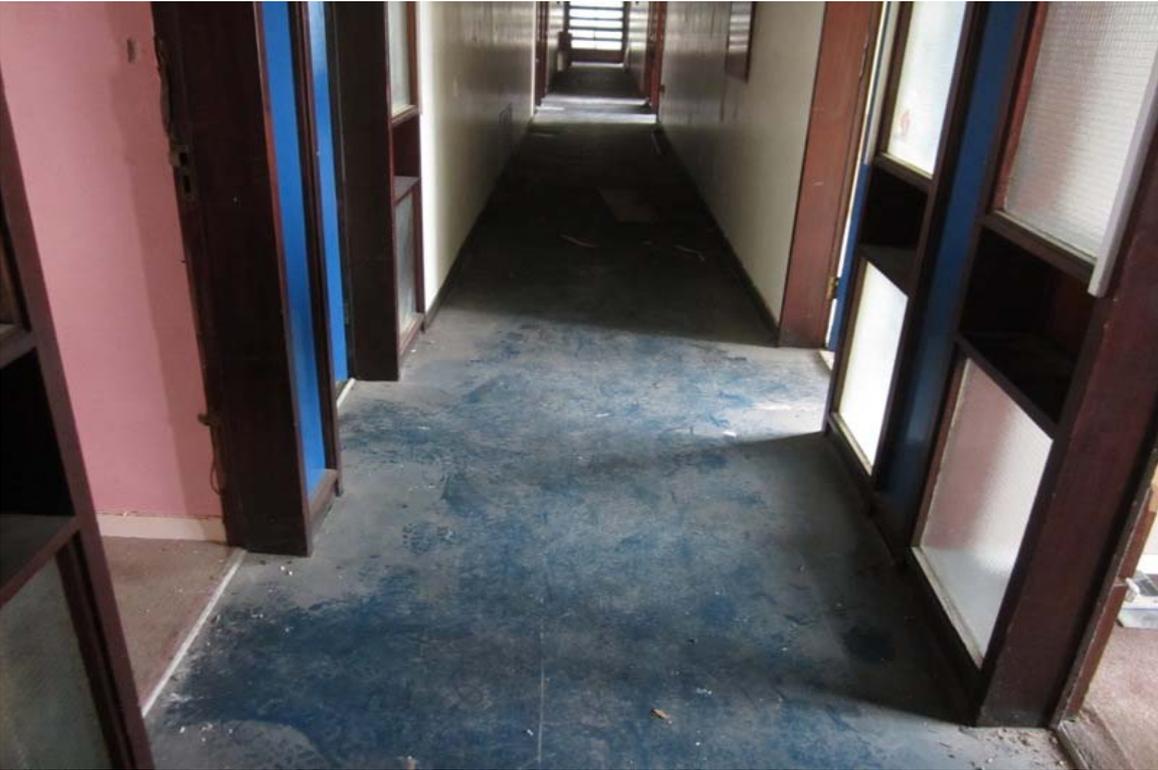
Photo Number	194	Reference number	240316MW200
Inspection / Sample	Inspection	Inspection Cross Reference / Visual I.D.	240316MW199

Notes	NADIS: No Asbestos Detected In Sample

Building	Communal Areas - Neville House	Condition	Fair	1
Floor Level	3rd floor	Surface Treatment	Composite materials, reinforced plastics, resin, vinyl materials	0
Location	3.04 / Corridor	Material Friability	Low	1
Feature	Blue floor covering	Asbestos Type	Strongly Presumed N.A.D.I.S	0
Material Type	Floor Tile / Covering			
Extent	60 sq. m.			
Recommendation	No action necessary	Assessment Score		0
		Assessment Band		E

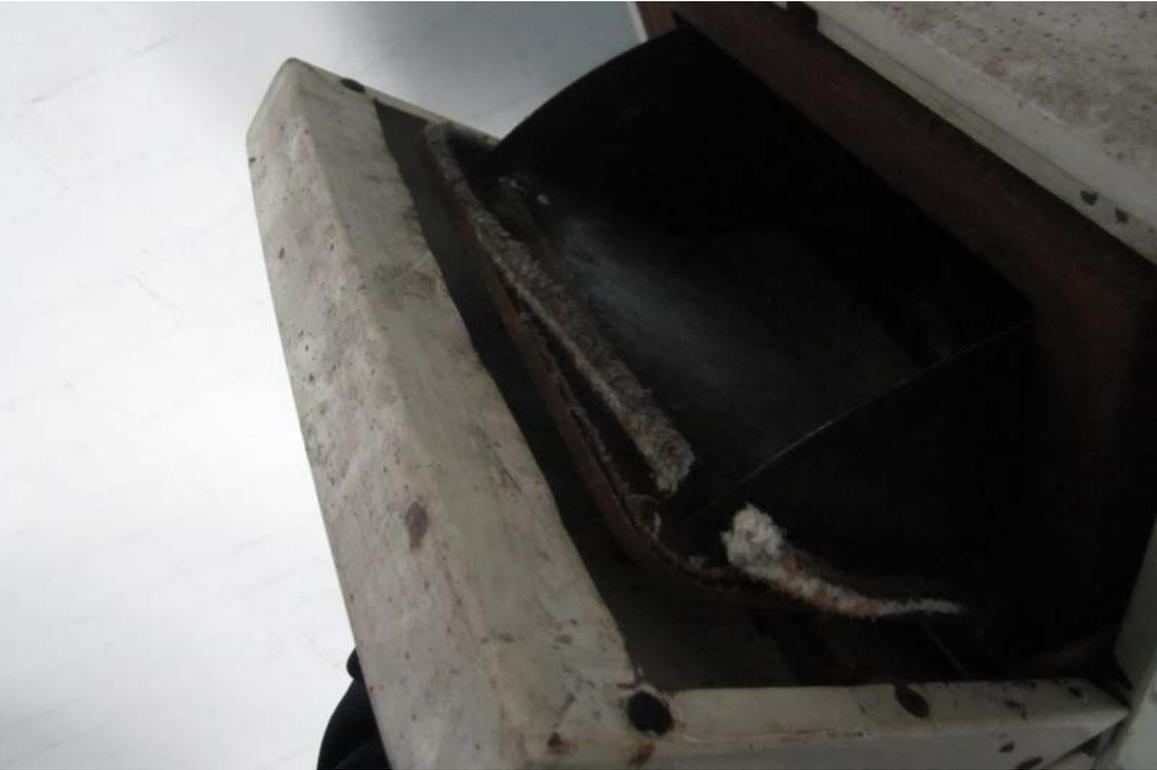
Photo Number	196	Reference number	220316MW54
Inspection / Sample	Sample	Inspection Cross Reference / Visual I.D.	Not Applicable

Notes	ACM: Asbestos Containing Material

Building	Communal Areas - Neville House	Condition	Fair	1
Floor Level	3rd floor	Surface Treatment	Enclosed sprays and lagging, encapsulated AIB, cement etc.	1
Location	3.05 / Refuse Room	Material Friability	Medium	2
Feature	Panel within sanitary burner	Asbestos Type	Chrysotile (White)	1
Material Type	Insulating Board			
Extent	1 No.			
Recommendation	Remove if likely to be disturbed during the refurbishment works	Assessment Score		5
		Assessment Band		C

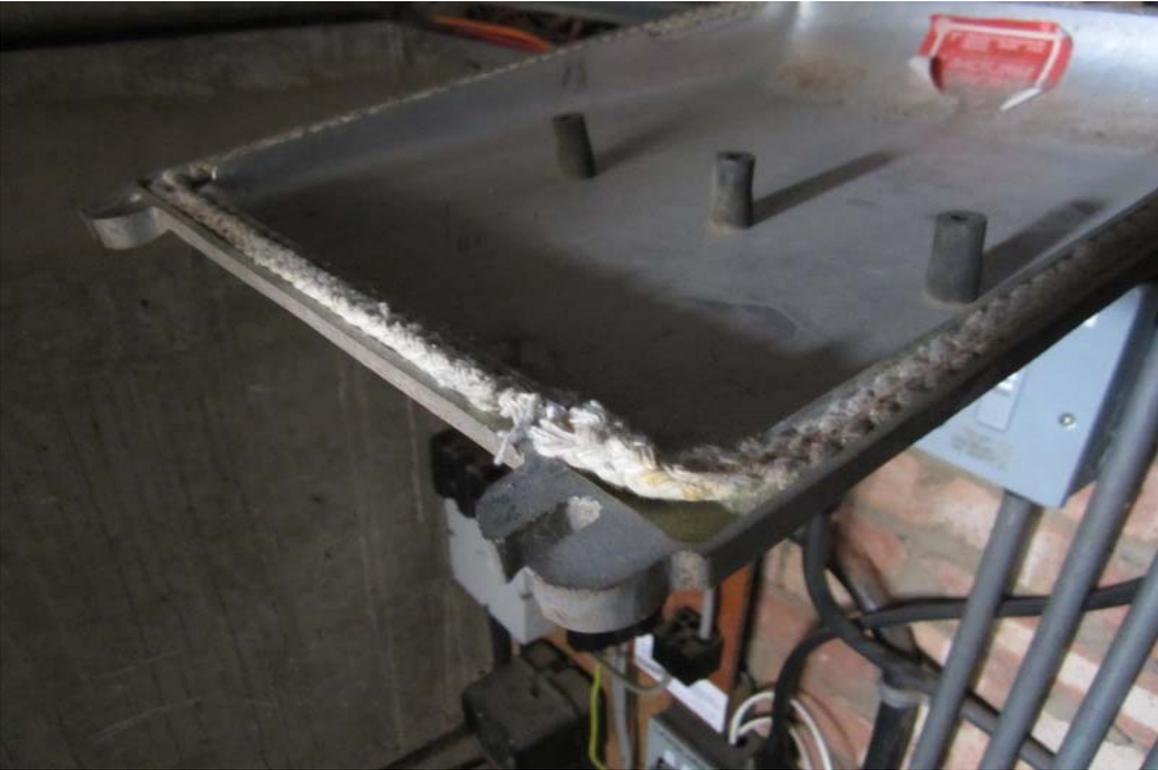
Photo Number	197	Reference number	220316MW28
Inspection / Sample	Sample	Inspection Cross Reference / Visual I.D.	Not Applicable

Notes	NADIS: No Asbestos Detected In Sample

Building	Communal Areas - Neville House	Condition	Fair	1
Floor Level	2nd floor	Surface Treatment	Enclosed sprays and lagging, encapsulated AIB, cement etc.	1
Location	2.02 / Meter Room	Material Friability	Medium	2
Feature	Rope seals within old fuse boxes	Asbestos Type	N.A.D.I.S	0
Material Type	Textile			
Extent	4 boxes			
Recommendation	No action necessary	Assessment Score		0
		Assessment Band		E

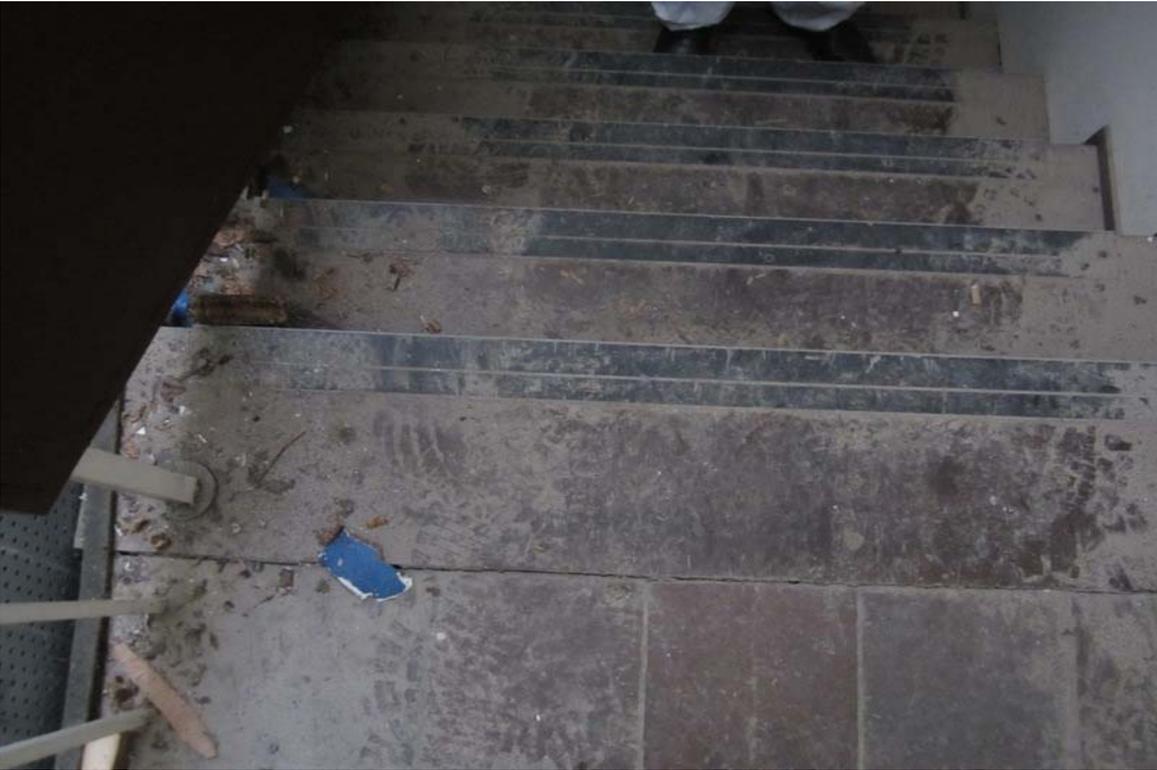
Photo Number	200	Reference number	240316MW202
Inspection / Sample	Sample	Inspection Cross Reference / Visual I.D.	Not Applicable

Notes	ACM: Asbestos Containing Material

Building	Communal Areas - Neville House	Condition	Fair	1
Floor Level	Ground	Surface Treatment	Composite materials, reinforced plastics, resin, vinyl materials	0
Location	0.01 / Entrance Lobby and Stairs	Material Friability	Low	1
Feature	Nosing strip to stairs	Asbestos Type	Chrysotile (White)	1
Material Type	Composite / Resin			
Extent	20 m.			
Recommendation	Remove if likely to be disturbed during the refurbishment works	Assessment Score		3
		Assessment Band		D

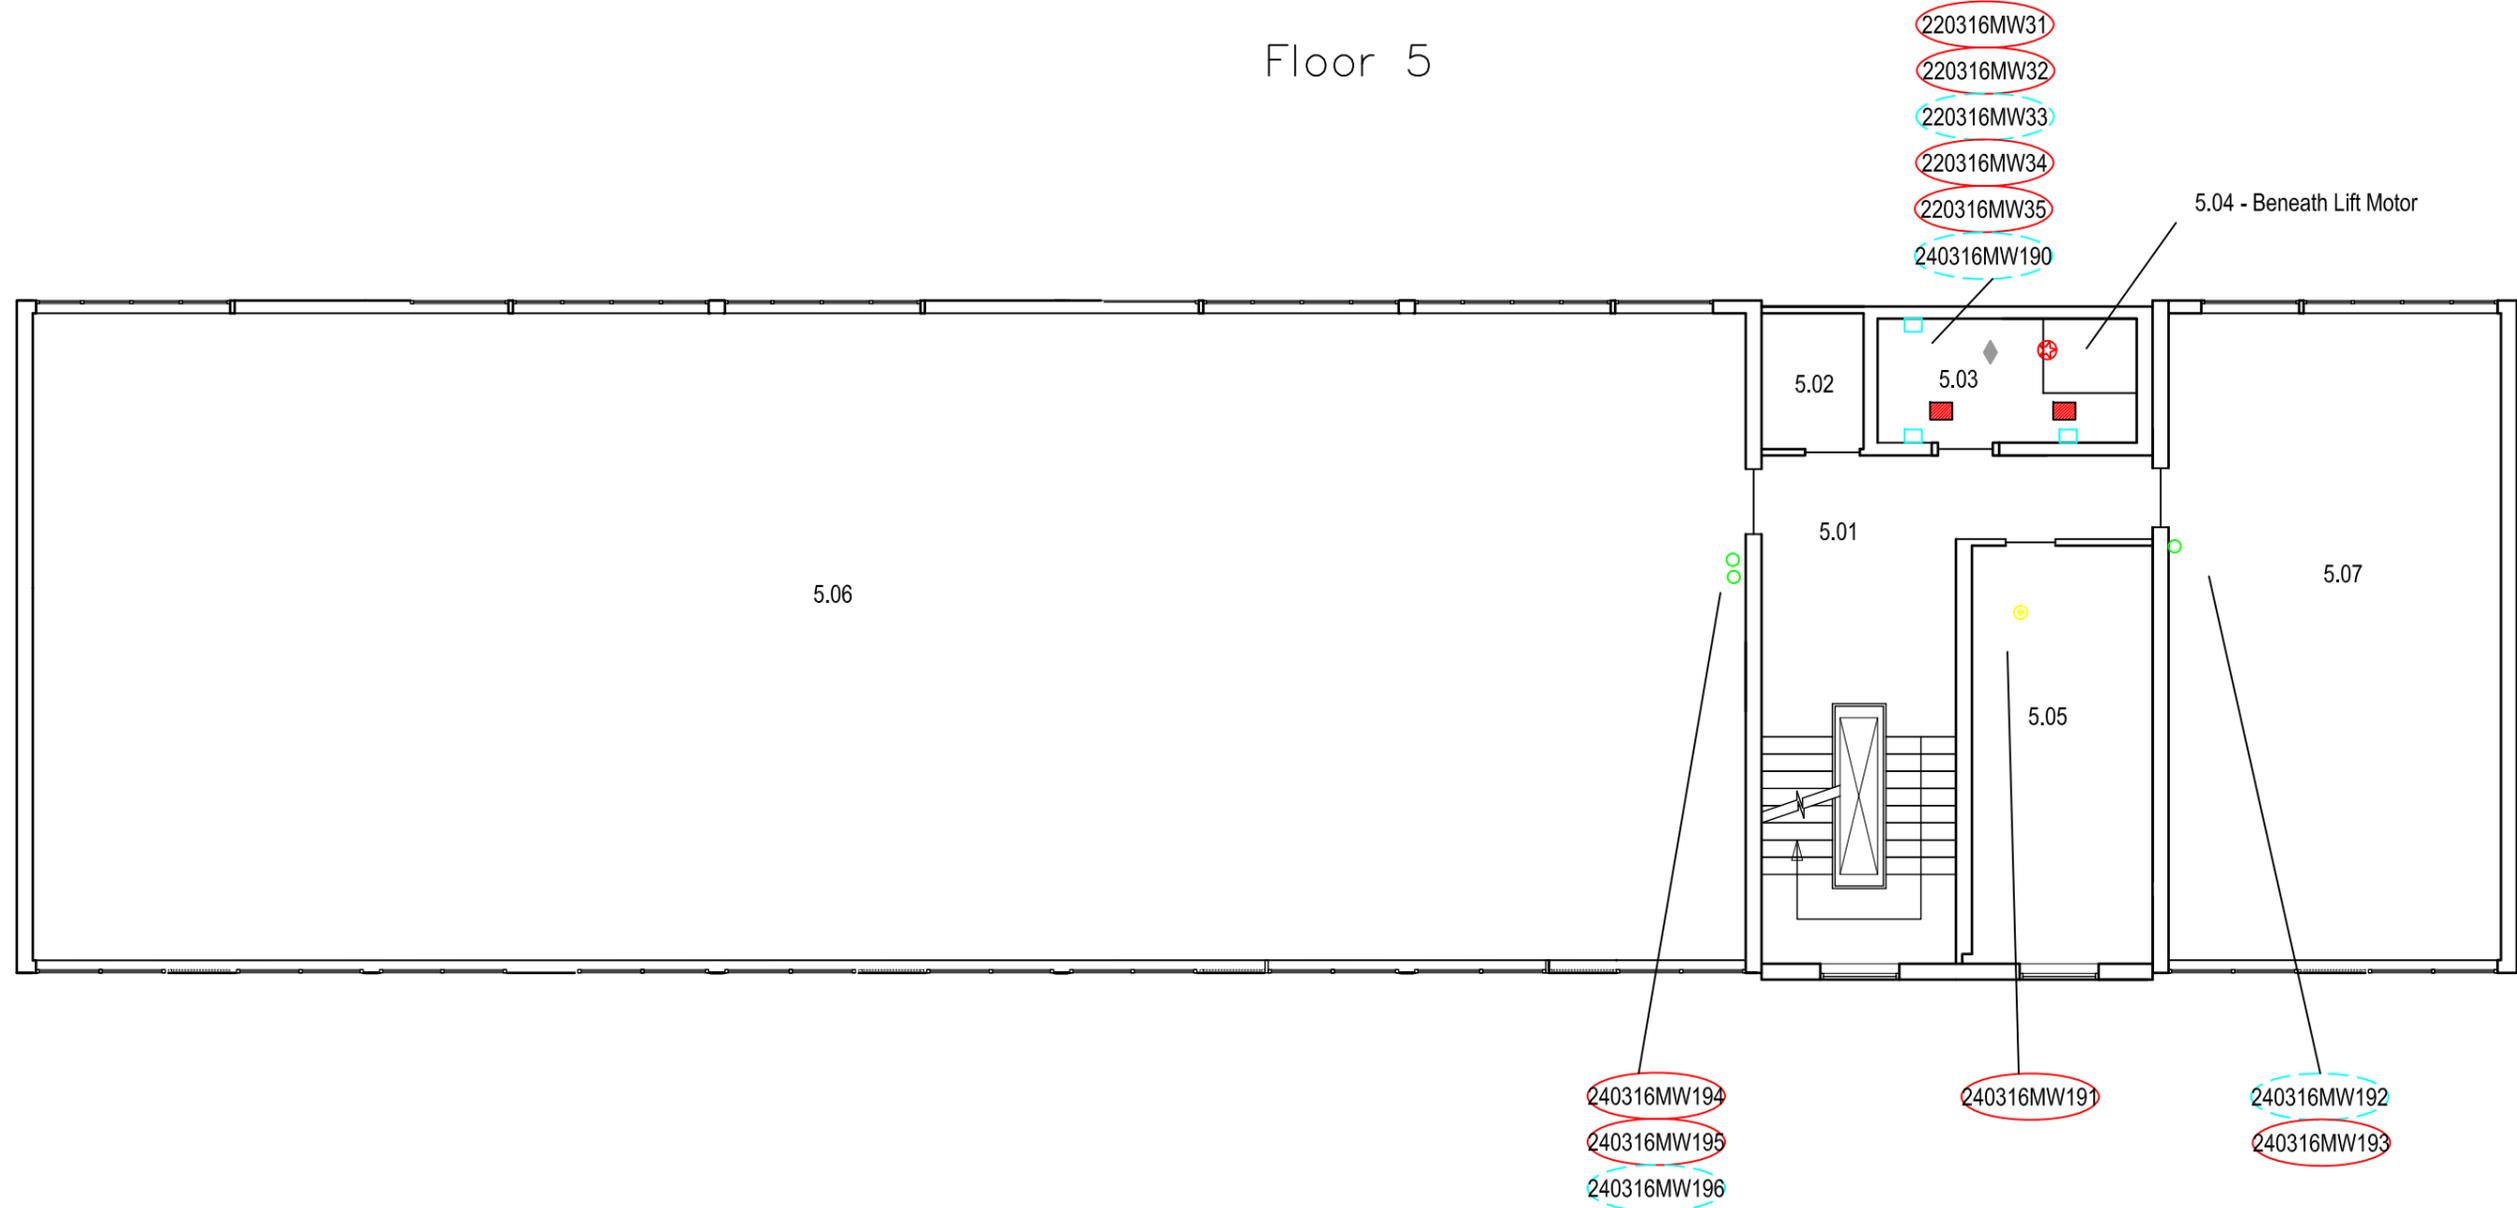
Floor 5

REFERENCE			
XXXXXXXXY01	Positive Inspection		Asbestos insulating board within lift switch
XXXXXXXXY01	Negative Inspection		Cement down pipe / cowl
	No access		Textile flash guard
			Cement brake shoe
			Textile brake shoe
			Toilet Cistern

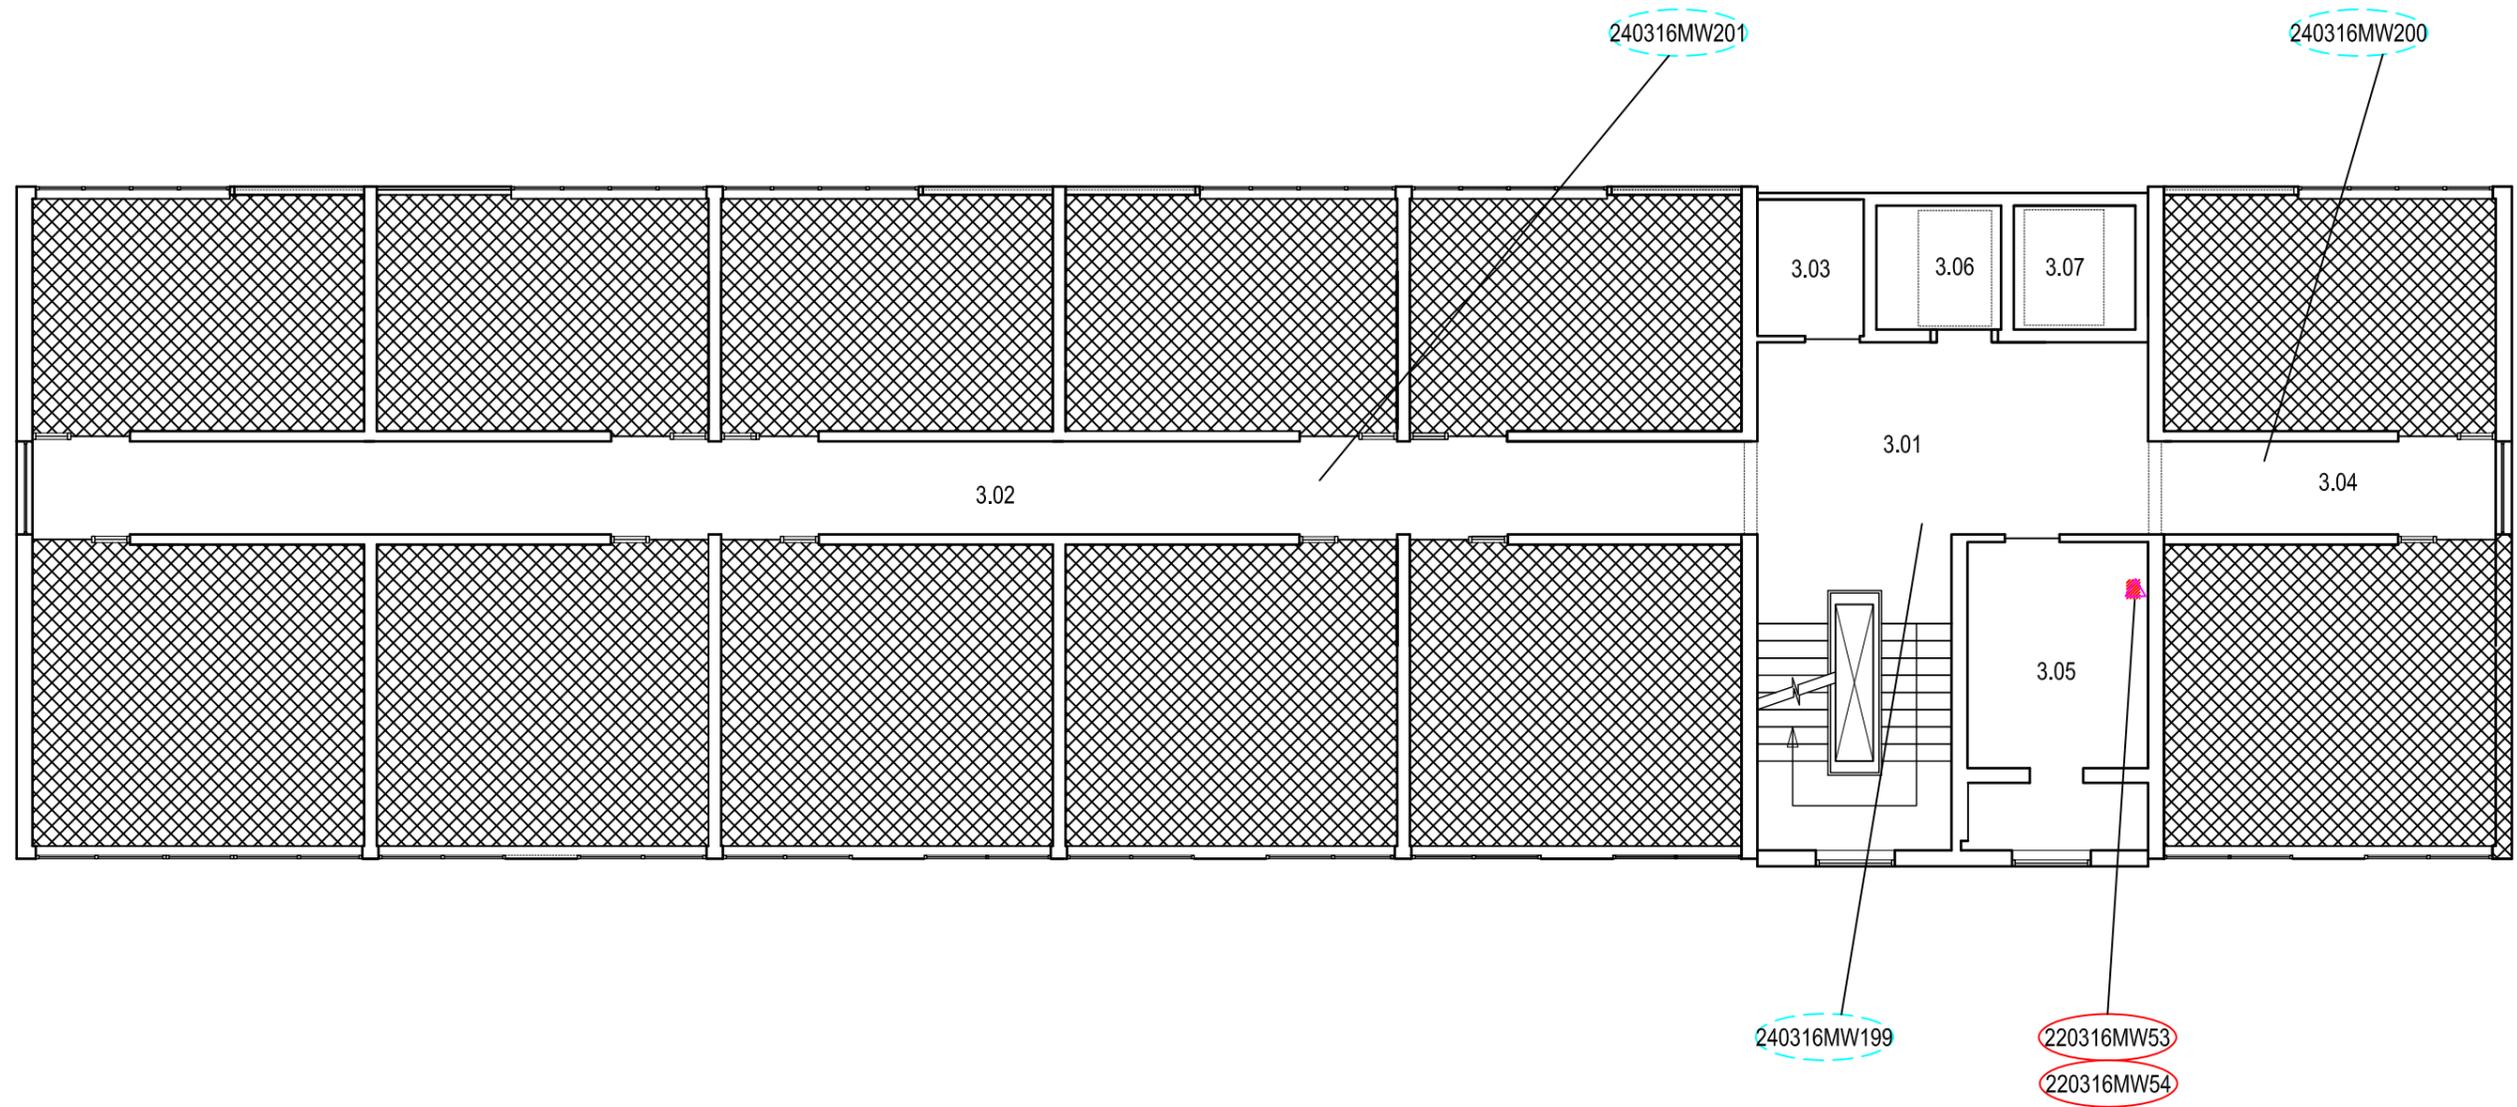
Floor 3

- XXXXXXXXY01 Positive Inspection
- XXXXXXXXY01 Negative Inspection
- No access
- AIB panel within sanitary burner
- Rope seal
