**CBC Asbestos Refurbishment Survey Report
Neville House, George Street, Corby
22nd – 24th March 2016**

Reference:					
Issue			Prepared by	Verified by	
V1	Apr 16	JQ

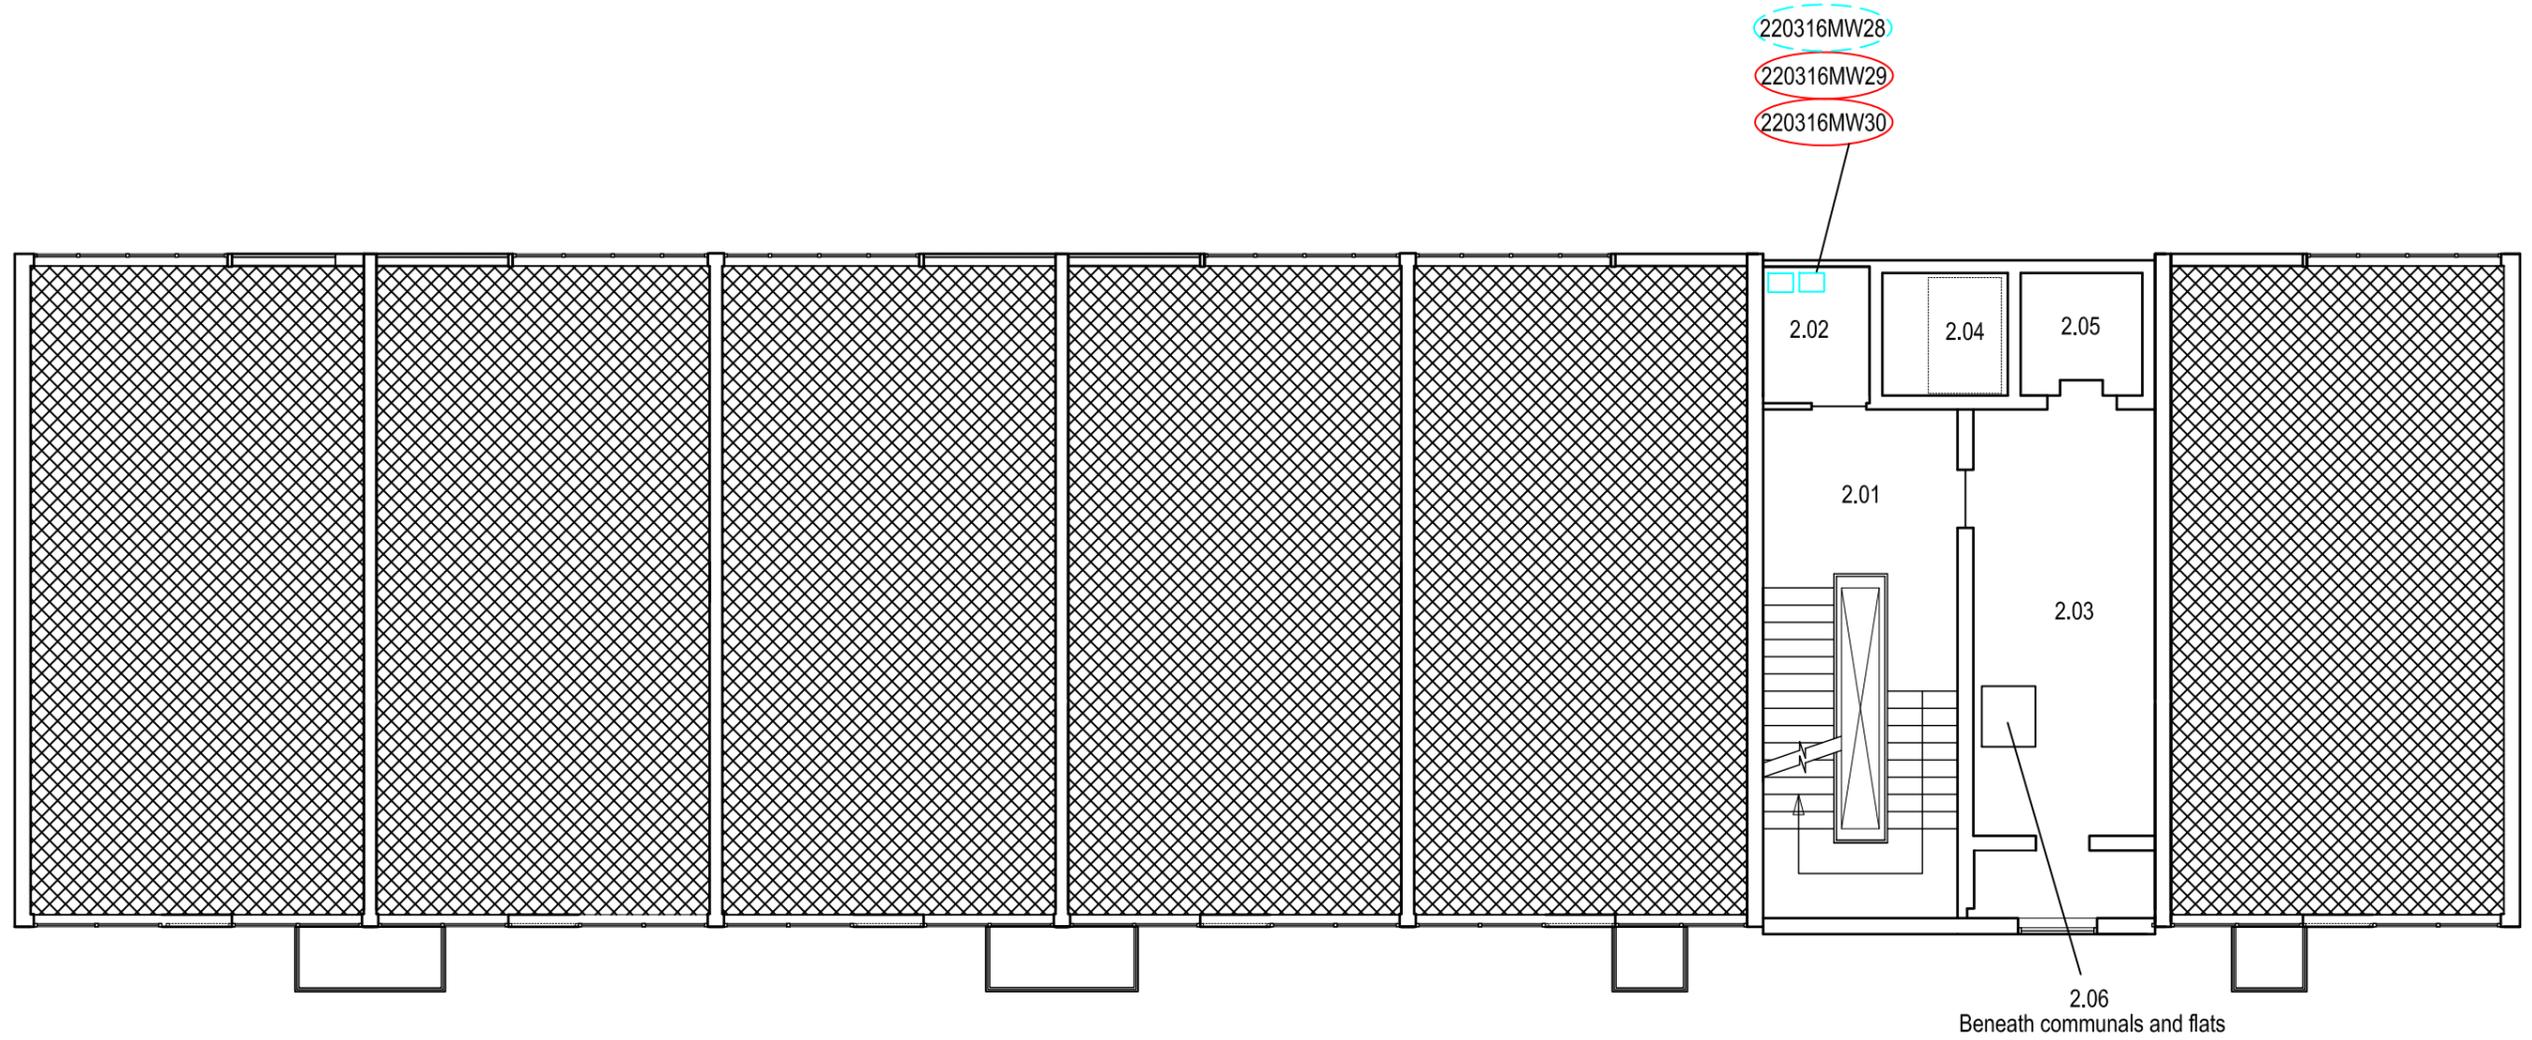
Floor 2

- REFERENCE
- XXXXXXXXY01 Positive Inspection
 - XXXXXXXXY01 Negative Inspection
 - No access
 - Flash guards and ceramic fuses
