Refurbishment Survey (with MA + PA)

Wivenhoe Town Council Offices
77 High Street
Wivenhoe
CO7 9AB

Ashbee Surveying Limited
Newbridge Farm
Fox Street
Ardleigh
Colchester
CO7 7PN

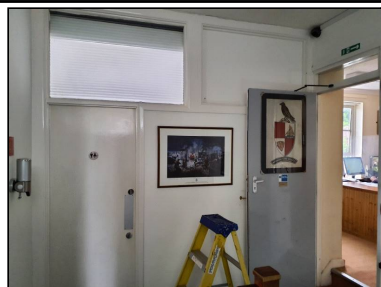
Survey Date:	Lead Surveyor	Survey Type	Floor	Analysis
	6 Jun 2022	Steve Lynn	Refurbishment Survey	1st Floor	N/A
	Building	Room	Item	Quantity	
	Main	Landing 101	No suspect materials found	N/A	
	Sample No (S,SP,P,As)	Product Type	Surface Treatment	Condition	Accessibility
	Visual (P)	N/A	N/A	N/A	N/A

Normal Occupancy	Score	Likelihood of disturbance	Score	Exposure Potential	Score	Maintenance Activity	Score
Main type of activity	N/A	Location	N/A	Number of occupants	N/A	Type of Maintenance	N/A
		Accessibility	N/A	Frequency of use	N/A	Frequency of maintenance	N/A
		Amount	N/A	Average Time	N/A		
Average Score	N/A	Average Score	N/A	Average Score	N/A	Average Score	N/A
Average of Priority	N/A						
Material Assessment Score	N/A						
Recommendation	No further action required

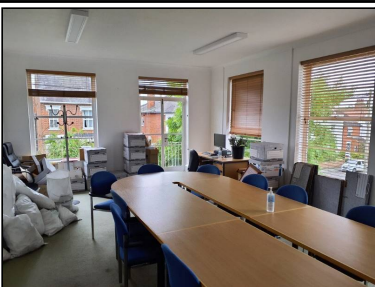
Survey Date:	Lead Surveyor	Survey Type	Floor	Analysis
	6 Jun 2022	Steve Lynn	Refurbishment Survey	1st Floor	N/A
	Building	Room	Item	Quantity	
	Main	Chambers 103	No suspect materials found	N/A	
	Sample No (S,SP,P,As)	Product Type	Surface Treatment	Condition	Accessibility
	Visual (P)	N/A	N/A	N/A	N/A

Normal Occupancy	Score	Likelihood of disturbance	Score	Exposure Potential	Score	Maintenance Activity	Score
Main type of activity	N/A	Location	N/A	Number of occupants	N/A	Type of Maintenance	N/A
		Accessibility	N/A	Frequency of use	N/A	Frequency of maintenance	N/A
		Amount	N/A	Average Time	N/A		
Average Score	N/A	Average Score	N/A	Average Score	N/A	Average Score	N/A
Average of Priority	N/A						
Material Assessment Score	N/A						
Recommendation	No further action required

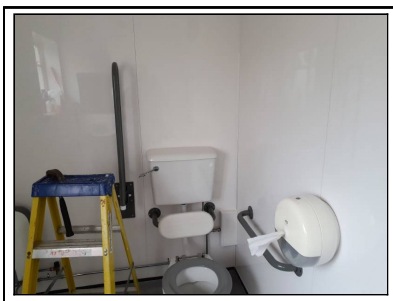
Survey Date:	Lead Surveyor	Survey Type	Floor	Analysis
	6 Jun 2022	Steve Lynn	Refurbishment Survey	1st Floor	N/A
	Building	Room	Item	Quantity	
	Main	Wc 104	No suspect materials found	N/A	
	Sample No (S,SP,P,As)	Product Type	Surface Treatment	Condition	Accessibility
	Visual (P)	N/A	N/A	N/A	N/A

Normal Occupancy	Score	Likelihood of disturbance	Score	Exposure Potential	Score	Maintenance Activity	Score
Main type of activity	N/A	Location	N/A	Number of occupants	N/A	Type of Maintenance	N/A
		Accessibility	N/A	Frequency of use	N/A	Frequency of maintenance	N/A
		Amount	N/A	Average Time	N/A		
Average Score	N/A	Average Score	N/A	Average Score	N/A	Average Score	N/A
Average of Priority	N/A						
Material Assessment Score	N/A						
Recommendation	No further action required

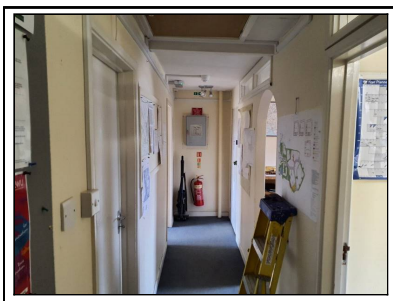
Survey Date:	Lead Surveyor	Survey Type	Floor	Analysis
	6 Jun 2022	Steve Lynn	Refurbishment Survey	1st Floor	N/A
	Building	Room	Item	Quantity	
	Main	Hallway 106	No suspect materials found	N/A	
	Sample No (S,SP,P,As)	Product Type	Surface Treatment	Condition	Accessibility
	Visual (P)	N/A	N/A	N/A	N/A

Normal Occupancy	Score	Likelihood of disturbance	Score	Exposure Potential	Score	Maintenance Activity	Score
Main type of activity	N/A	Location	N/A	Number of occupants	N/A	Type of Maintenance	N/A
		Accessibility	N/A	Frequency of use	N/A	Frequency of maintenance	N/A
		Amount	N/A	Average Time	N/A		
Average Score	N/A	Average Score	N/A	Average Score	N/A	Average Score	N/A
Average of Priority	N/A						
Material Assessment Score	N/A						
Recommendation	No further action required
