Annual Inspection

Houghton Regis Town Council

Parkside Recreation Ground - Bottom

Parkside Drive, Houghton Regis, Dunstable, LU5 5RQ

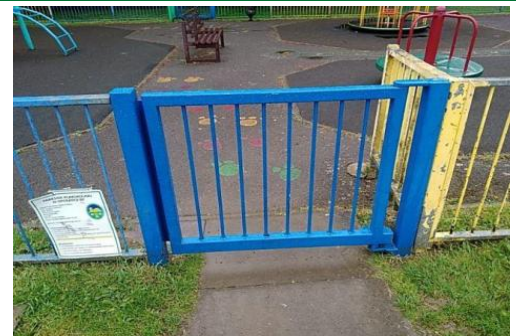
Item: Gate - Self Closing
Manufacturer: Easy Gate Ltd
Surface Type: Paving Slabs
Item Quantity: 2
Equipment Compliance: N/A
Surface Area Compliance: N/A

The gate is closing too slowly (in excess of 8 seconds) -
Take effective action to ensure the gate closes between 4 and 8 seconds

There are trip hazards at the edges of the surface -
Reinstate surrounding surface levels to remove the trip points

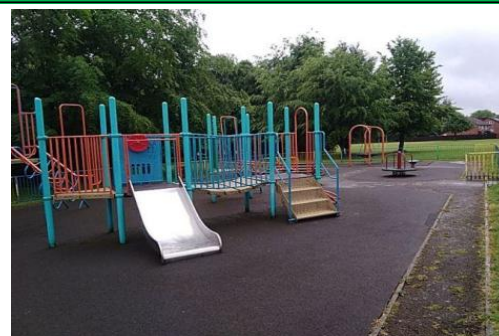
Item: Site General
Manufacturer: Owner/Operator
Surface Type: N/A
Item Quantity: 1
Equipment Compliance: N/A
Surface Area Compliance: N/A

The bitumen surface is worn or damaged - Repair the bitumen to provide a uniform surface

The surface is lifting at the edges and creating trip points - Repair perimeter of surfacing to remove trip points

There is algae, silt or moss growth on the surface resulting in slippery conditions - Clean and treat appropriately

There are trip hazards at the edges of the surface - Reinstate surrounding surface levels to remove the trip points

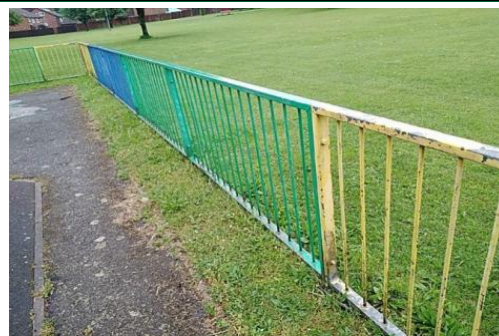
Item: Fencing - Flat Top
Manufacturer: Not Identified
Surface Type: Grass
Item Quantity: 1
Equipment Compliance: N/A
Surface Area Compliance: N/A

The paint is flaking off the metalwork - Rub down and re-paint

There is some damage to the fence sections - Monitor for any further deterioration and repair as required

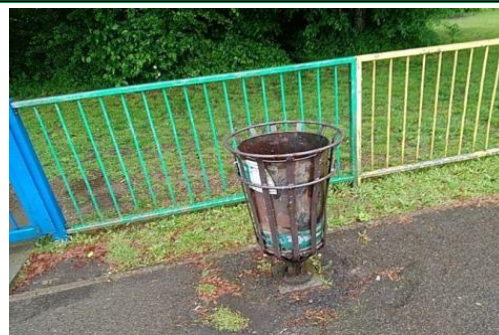
Item: Litter Bin
Manufacturer: Not Identified
Surface Type: Bitmac
Item Quantity: 2
Equipment Compliance: N/A
Surface Area Compliance: N/A

There is some evidence of fire damage to the item - Monitor for any further deterioration and repair as required

Parts of the steel on this item have corroded excessively and the metal has perforated in places - Ensure all affected areas are treated and repaired

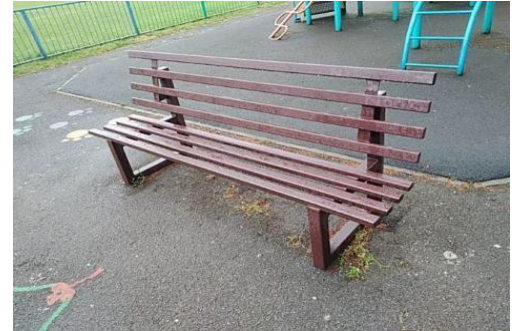
Item: Bench
Manufacturer: Not Identified
Surface Type: Bitmac
Item Quantity: 2
Equipment Compliance: N/A
Surface Area Compliance: N/A

There is some graffiti present - Remove the graffiti

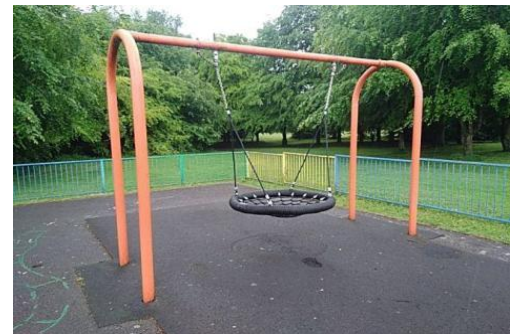
Item: Basket Swing - Type 1
Manufacturer: Miracle Recreation Equipment Company
Surface Type: Wet Pour
Item Quantity: 1
Equipment Compliance: Yes
Surface Area Compliance: Yes

There is moderate damage to the surface - Repair the damaged areas of surfacing

The safety surface around the area is beginning to wear - Monitor for any further deterioration and repair as required

The ropes/nets are worn/damaged in places - Monitor for any further deterioration and repair or replace as required

The bushes are showing signs of wear - Monitor for any further deterioration and replace as required

There is some evidence of fire damage to the surfacing - Monitor for any further deterioration and repair as required

There is some wear to the shackles. - Monitor for any further deterioration and replace when 40% worn

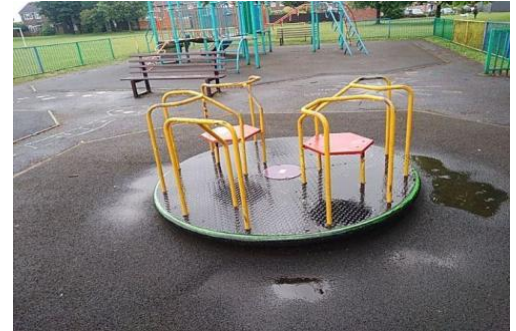
Item: Roundabout
Manufacturer: Wicksteed Playgrounds
Surface Type: Wet Pour
Item Quantity: 1
Equipment Compliance: No
Surface Area Compliance: No

The surfacing dimensions are short and do not meet with the requirements of the current applicable standard - Monitor - no remedial action recommended

There are missing fixings creating finger entrapment/s in the roundabout and the item fails to meet the requirements of BS EN 1176 Part 1 4.2.7.6 Entrapment of fingers - Replace the missing fixings to remove the entrapment

A number of fixing(s) have worked loose - Secure all loose fixings

The paintwork on this item has been damaged or worn exposing the metal underneath which is rusting / corroding - Treat affected areas and repaint

The seat has minor damage or wear - Monitor for any further deterioration and replace as required

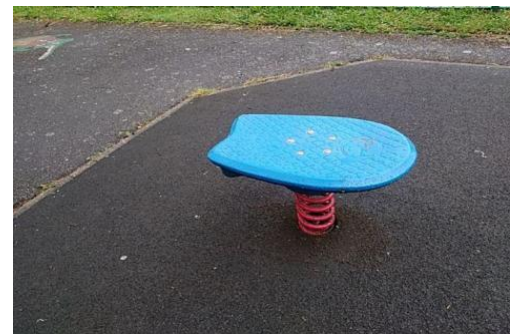
Item: Wobble Board
Manufacturer: Not Identified
Surface Type: Wet Pour
Item Quantity: 1
Equipment Compliance: Yes
Surface Area Compliance: No

The surfacing dimensions are short and do not meet with the requirements of the current applicable standard - Monitor - no remedial action recommended

The item is loose in its foundations - Reinstall item to secure

The item has been damaged - Monitor for any further deterioration and replace as required

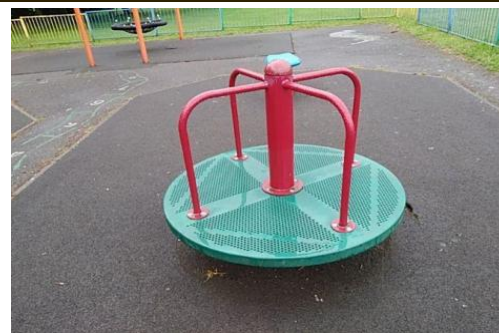
Item: Four Way Springer
Manufacturer: Miracle Recreation Equipment Company
Surface Type: Wet Pour
Item Quantity: 1
Equipment Compliance: Yes
Surface Area Compliance: No

There is moderate damage to the surface - Repair the damaged areas of surfacing

There is or are fixings missing on the item - Replace all missing fixings

The item is loose in its foundations - Reinstall item to secure

The surfacing dimensions are short and do not meet with the requirements of the current applicable standard - Monitor - no remedial action recommended

The paintwork on this item has been damaged or worn exposing the metal underneath which is rusting / corroding - Treat affected areas and repaint

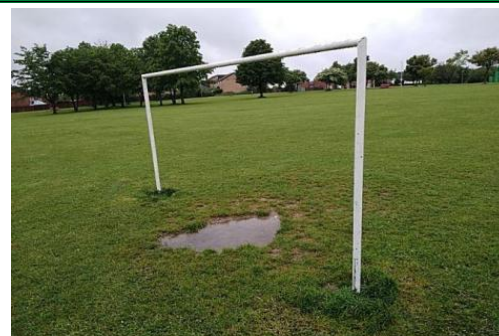
Item: 5 a side Goals
Manufacturer: Not Identified
Surface Type: Grass
Item Quantity: 1
Equipment Compliance: N/A
Surface Area Compliance: N/A

The surface has eroded in some areas and may be slippery in wet conditions - Reinstall the surface

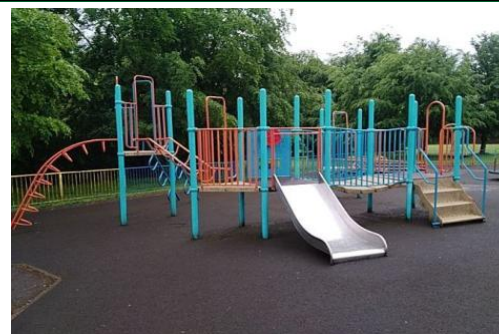
Item: Multi Play (Junior)
Manufacturer: Miracle Recreation Equipment Company
Surface Type: Wet Pour
Item Quantity: 1
Equipment Compliance: No
Surface Area Compliance: Yes

There are a number of dents in the slide surface - Monitor for any further deterioration and repair as required

There is moderate damage to the surface - Repair the damaged areas of surfacing

The paintwork on this item has been damaged or worn exposing the metal underneath which is rusting / corroding - Treat affected areas and repaint

The surface is lifting at the edges and creating trip points - Repair perimeter of surfacing to remove trip points

There is/are finger entrapment/s in the platform and the item fails to meet the requirements of BS EN 1176 Part 1 4.2.7.6 Entrapment of fingers - Monitor - No remedial work recommended

The item has been damaged - Monitor for any further deterioration and replace as required

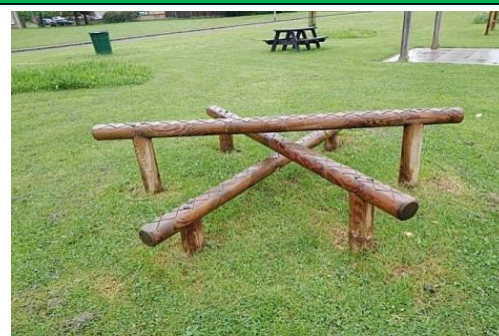
Item: Balance Beam
Manufacturer: A.E.Evans
Surface Type: Grass
Item Quantity: 1
Equipment Compliance: Yes
Surface Area Compliance: Yes

Parts of the timber are rough or splintered - Remove all rough or sharp edges

There is some strimmer / machinery damage apparent on the posts, this can penetrate the preservative applied to the timber and accelerate the rotting process - Monitor for any deterioration (rot) and replace as required

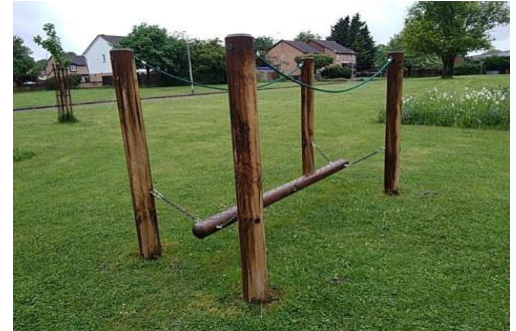
Item: Swinging Beam
Manufacturer: A.E.Evans
Surface Type: Grass
Item Quantity: 1
Equipment Compliance: Yes
Surface Area Compliance: Yes

There is some strimmer / machinery damage apparent on the posts, this can penetrate the preservative applied to the timber and accelerate the rotting process - Monitor for any deterioration (rot) and replace as required

The connecting lugs are showing signs of wear - Monitor for any further deterioration and repair as required

There is some wear to the shackles - Monitor for any further deterioration and replace when 40% worn

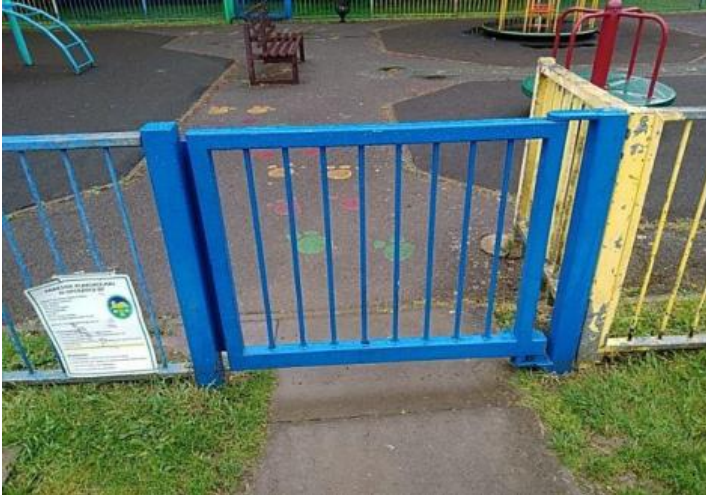
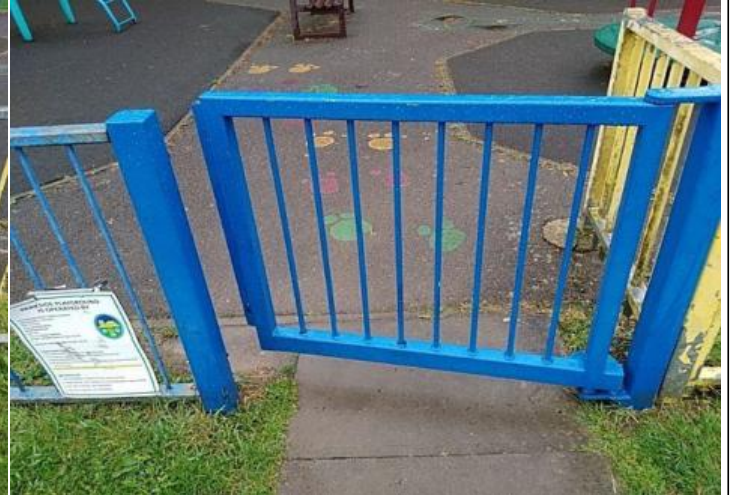
Item: Gates - Gate - Self Closing
Manufacturer: Easy Gate Ltd

Risk Level: V - Very Low Risk
Surface: Paving Slabs

Finding: The gate is closing too slowly (in excess of 8 seconds)

Action: Take effective action to ensure the gate closes between 4 and 8 seconds

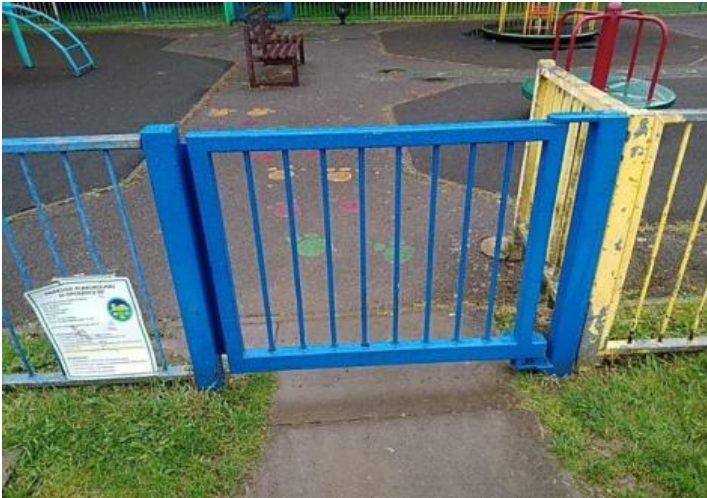
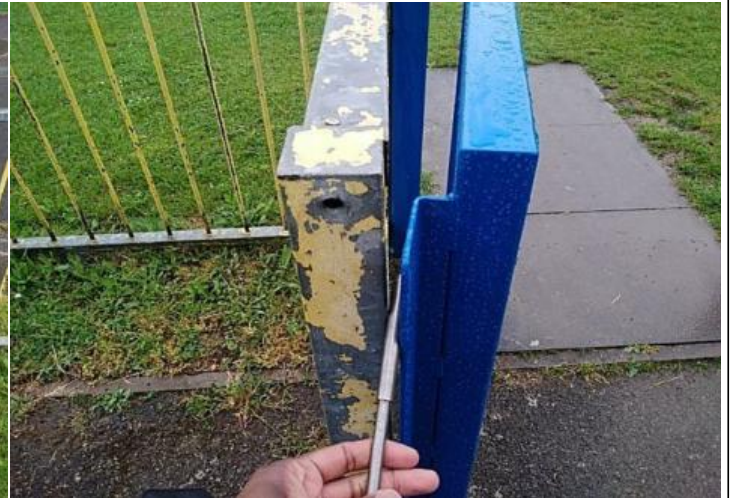
Item: Gates - Gate - Self Closing
Manufacturer: Easy Gate Ltd

Risk Level: L - Low Risk
Surface: Paving Slabs

Finding: There are openings that are less than 12mm that could trap or crush fingers

Action: Provide a 12mm gap throughout full range of motion at both sides of gate

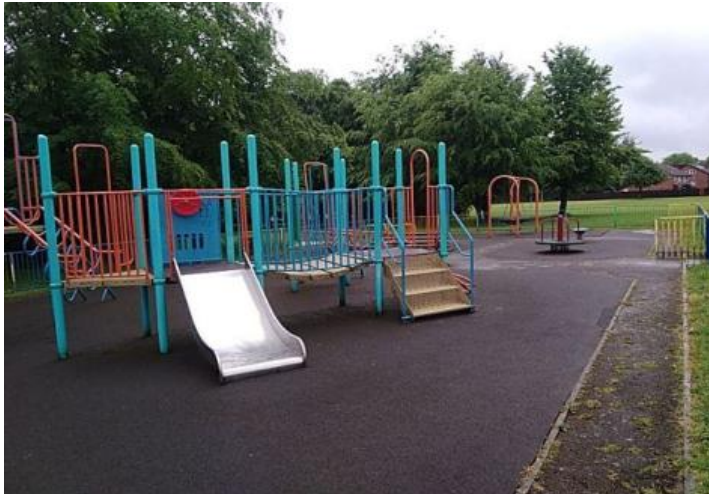
Item: Ancillary Items - Site General
Manufacturer: Owner/Operator

Risk Level: L - Low Risk
Surface: N/A

Finding: There is algae, silt or moss growth on the surface resulting in slippery conditions

Action: Clean and treat appropriately

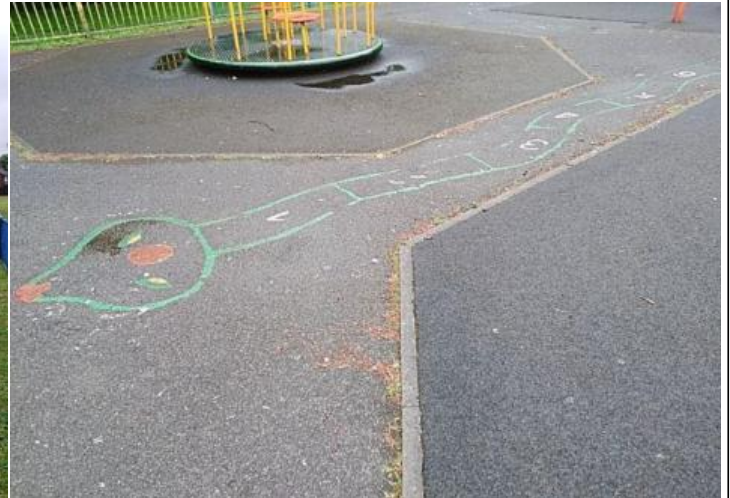
Item: Ancillary Items - Site General
Manufacturer: Owner/Operator

Risk Level: L - Low Risk
Surface: N/A

Finding: There is weed / vegetation growth on, between, or around the edges of the surfacing
Action: Remove weed / vegetation growth

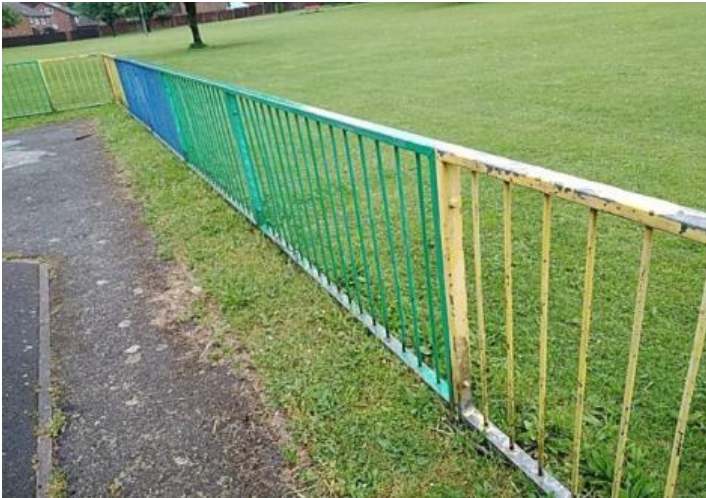
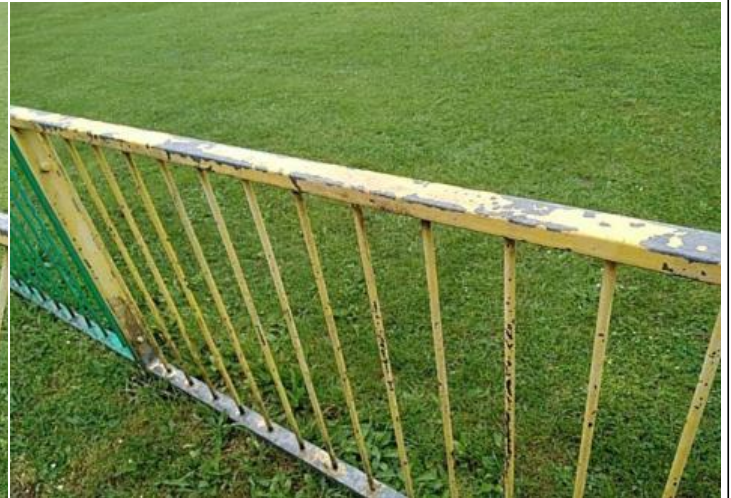
Item: Fences - Fencing - Flat Top
Manufacturer: Not Identified

Risk Level: L - Low Risk
Surface: Grass

Finding: The paint is flaking off the metalwork

Action: Rub down and re-paint

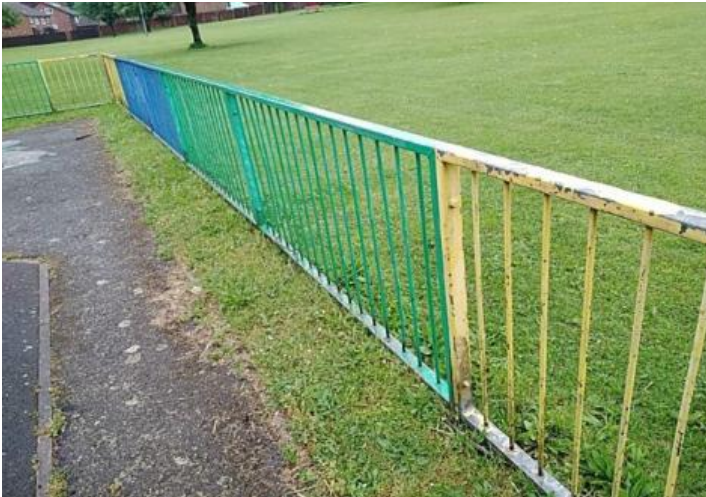
Item: Fences - Fencing - Flat Top
Manufacturer: Not Identified

Risk Level: L - Low Risk
Surface: Grass

Finding: There is some damage to the fence sections

Action: Monitor for any further deterioration and repair as required

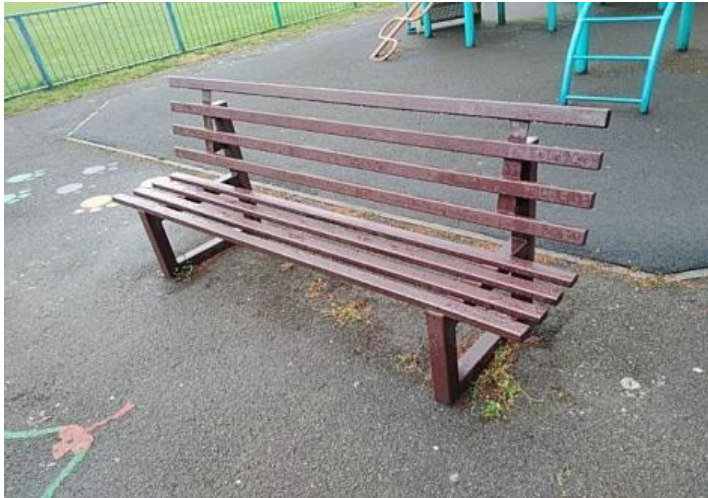
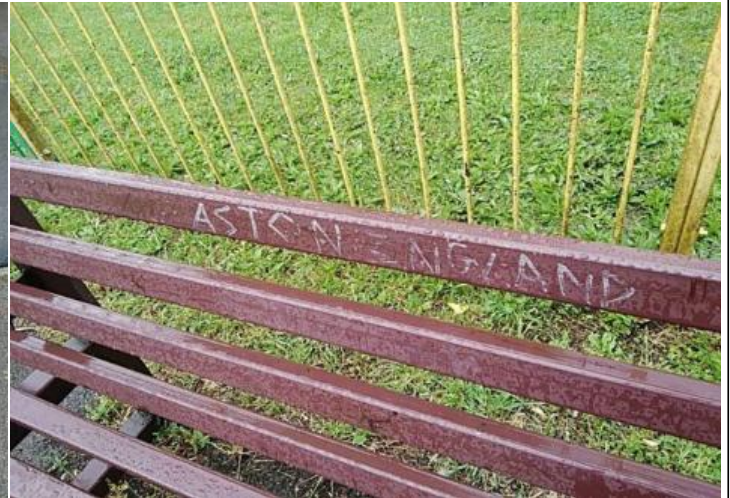
Item: Ancillary Items - Bench
Manufacturer: Not Identified

Risk Level: V - Very Low Risk
Surface: Bitmac

Finding: There is some graffiti present

Action: Remove the graffiti

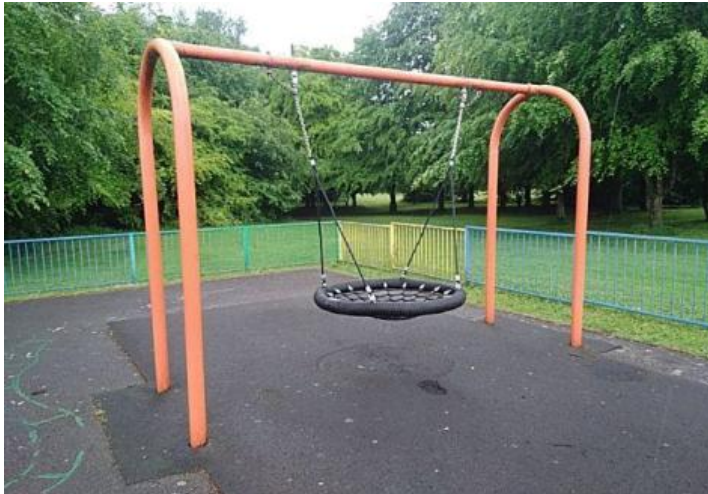
Item: Swings - Basket Swing - Type 1
Manufacturer: Miracle Recreation Equipment Company

Risk Level: L - Low Risk
Surface: Wet Pour

Finding: There is moderate damage to the surface

Action: Repair the damaged areas of surfacing

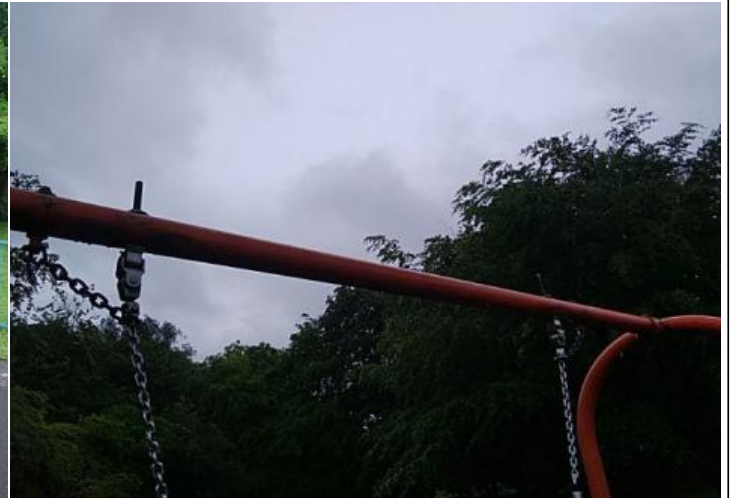
Item: Swings - Basket Swing - Type 1
Manufacturer: Miracle Recreation Equipment Company

Risk Level: L - Low Risk
Surface: Wet Pour

Finding: There are projecting bolt thread(s) present

Action: Remove excess thread length and deburr or provide cap

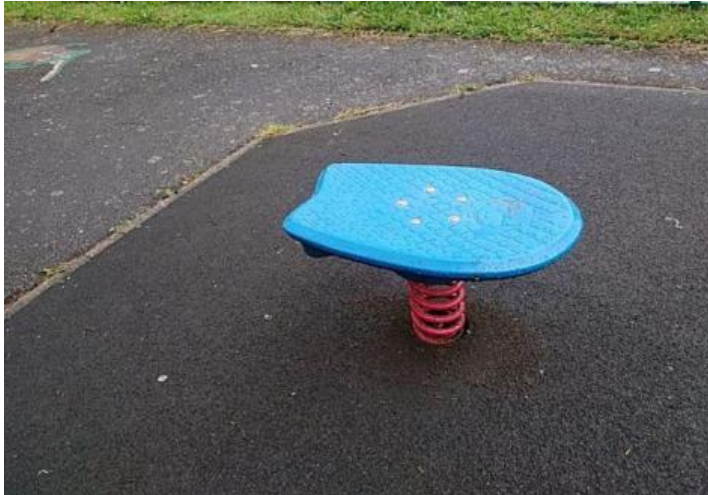
Item: Rocking Equipment - Wobble Board
Manufacturer: Not Identified

Risk Level: M - Moderate Risk
Surface: Wet Pour

Finding: The item is loose in its foundations

Action: Reinstall item to secure

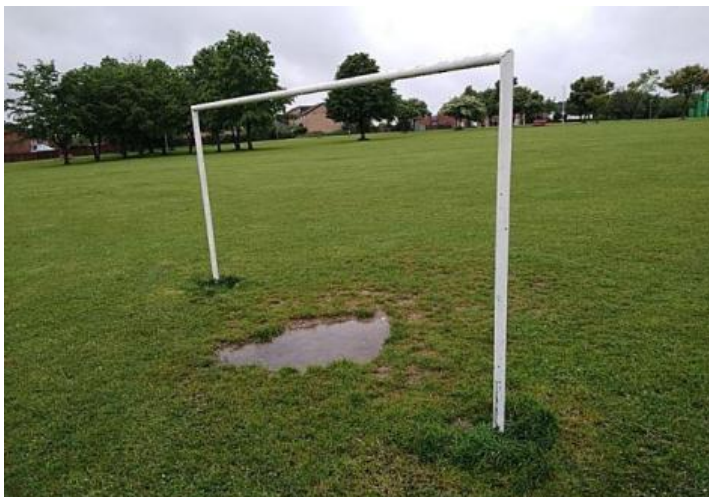
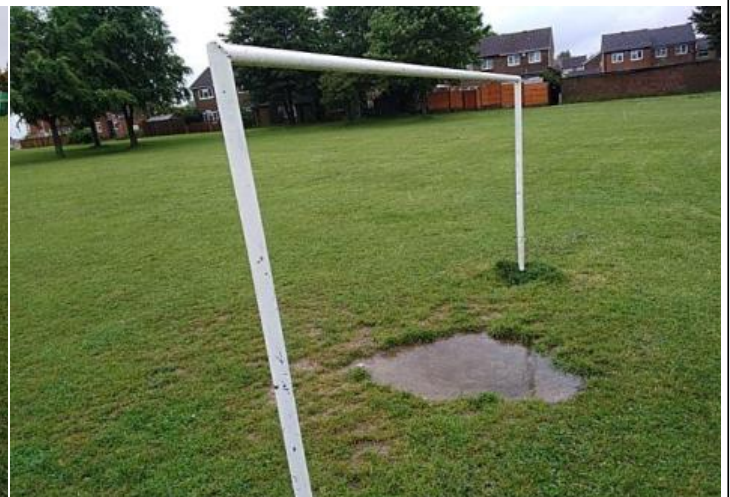
Item: Multi Use Games Area - 5 a side Goals
Manufacturer: Not Identified

Finding: NB: We have undertaken a maintenance inspection only of the football goal(s); full load testing falls outside the scope of our inspection.

Action: Implement load testing as required

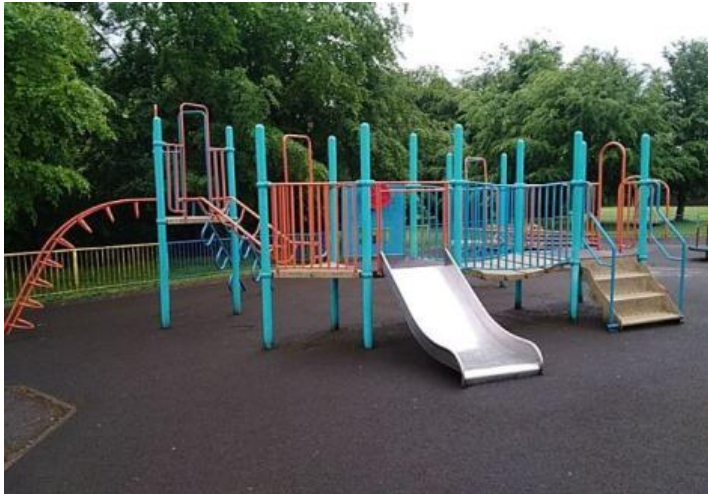
Item: Activity Equipment - Multi Play (Junior)
Manufacturer: Miracle Recreation Equipment Company

Risk Level: V - Very Low Risk
Surface: Wet Pour

Finding: There is/are finger entrapment/s in the platform and the item fails to meet the requirements of BS EN 1176 Part 1 4.2.7.6 Entrapment of fingers

Action: Monitor - No remedial work recommended

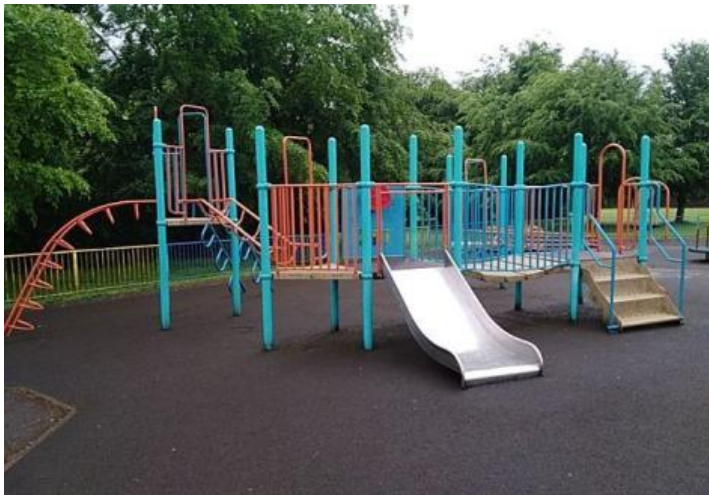
Item: Activity Equipment - Multi Play (Junior)
Manufacturer: Miracle Recreation Equipment Company

Risk Level: L - Low Risk
Surface: Wet Pour

Finding: The item has been damaged

Action: Monitor for any further deterioration and replace as required

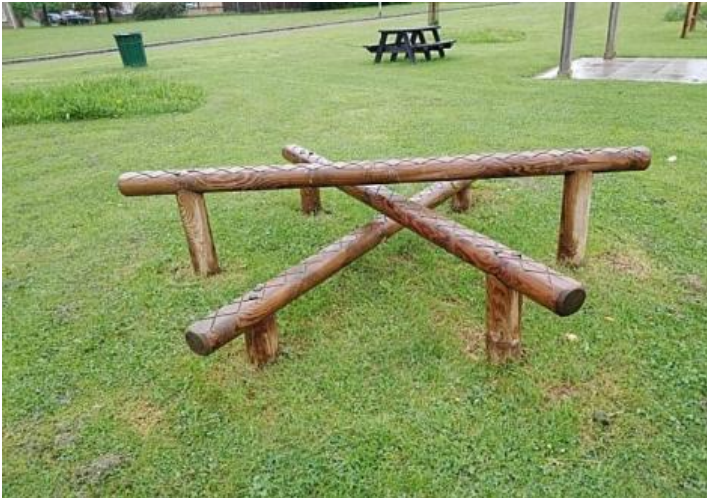
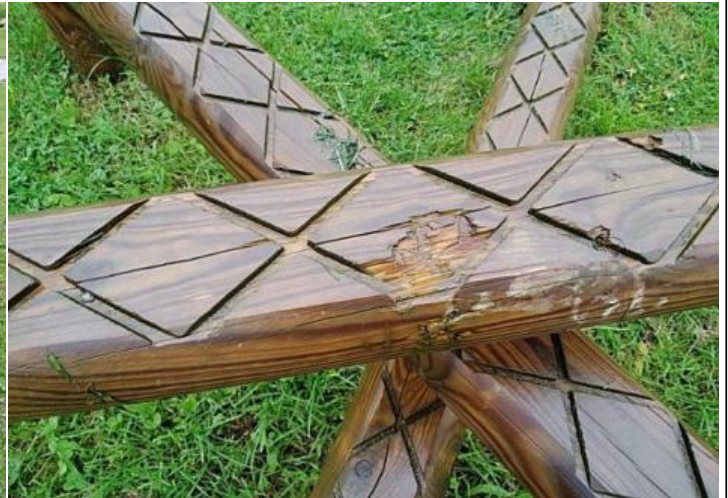
Item: Activity Equipment - Balance Beam
Manufacturer: A.E.Evans

Risk Level: L - Low Risk
Surface: Grass

Finding: Parts of the timber are rough or splintered

Action: Remove all rough or sharp edges

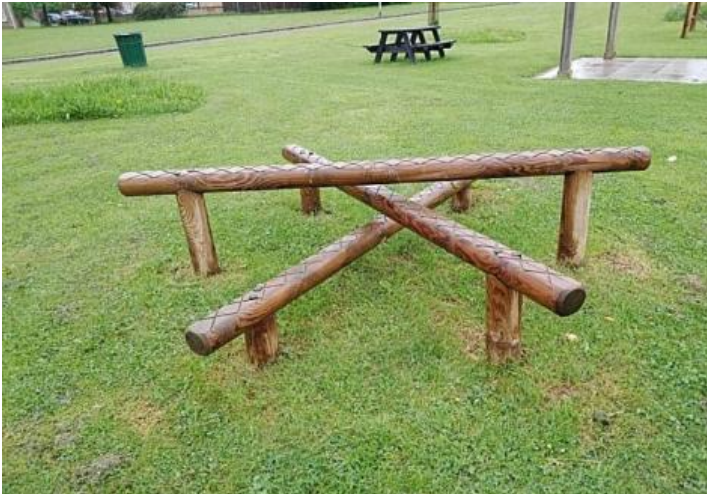
Item: Activity Equipment - Balance Beam
Manufacturer: A.E.Evans

Risk Level: L - Low Risk
Surface: Grass

Finding: There is some strimmer / machinery damage apparent on the posts, this can penetrate the preservative applied to the timber and accelerate the rotting process

Action: Monitor for any deterioration (rot) and replace as required

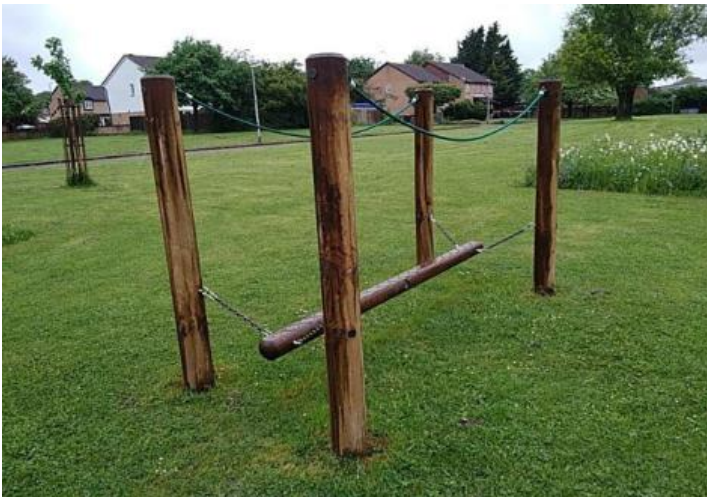
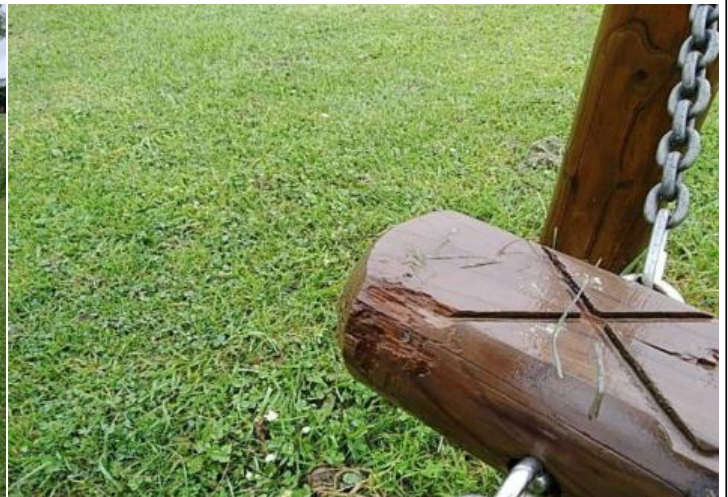
Item: Activity Equipment - Swinging Beam
Manufacturer: A.E.Evans

Finding: Parts of the timber are rough or splintered

Action: Remove all rough or sharp edges

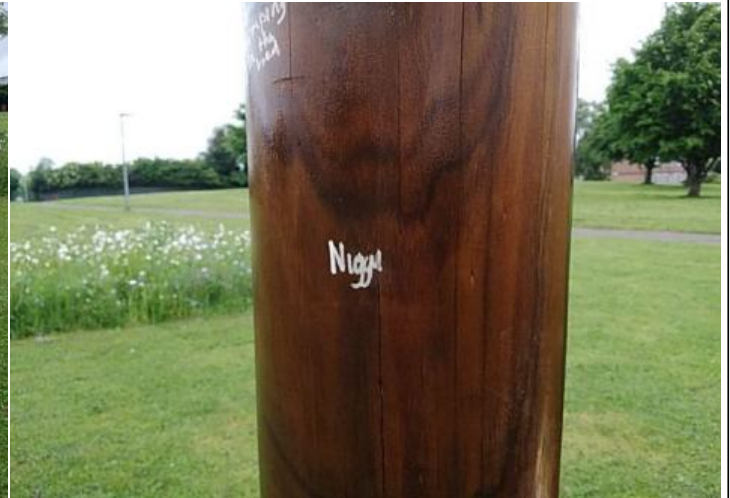
Item: Activity Equipment - Swinging Beam
Manufacturer: A.E.Evans

Finding: There is offensive graffiti present

Action: Remove as soon as practicable

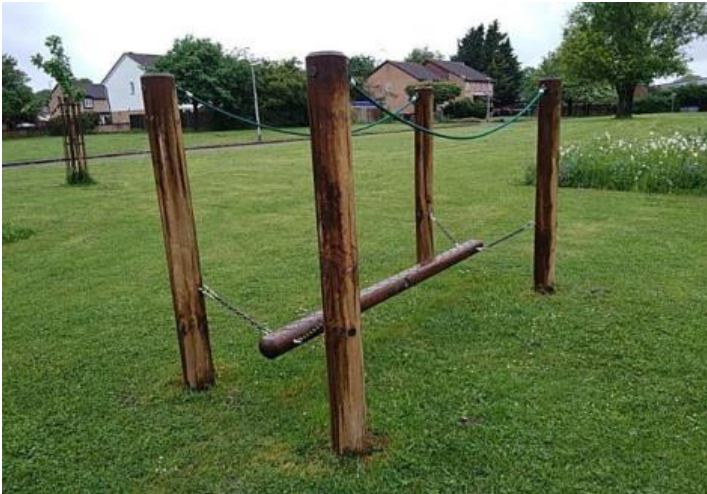
Item: Activity Equipment - Swinging Beam
Manufacturer: A.E.Evans

Finding: There is some wear to the shackles

Action: Monitor for any further deterioration and replace when 40% worn
